Structure Number: 1558
Facility Carried: I 395

Highway Bridge Inspection Report

Inspection Type(s): Routine

Bridge Name: VETERANS REMEMBRANCE

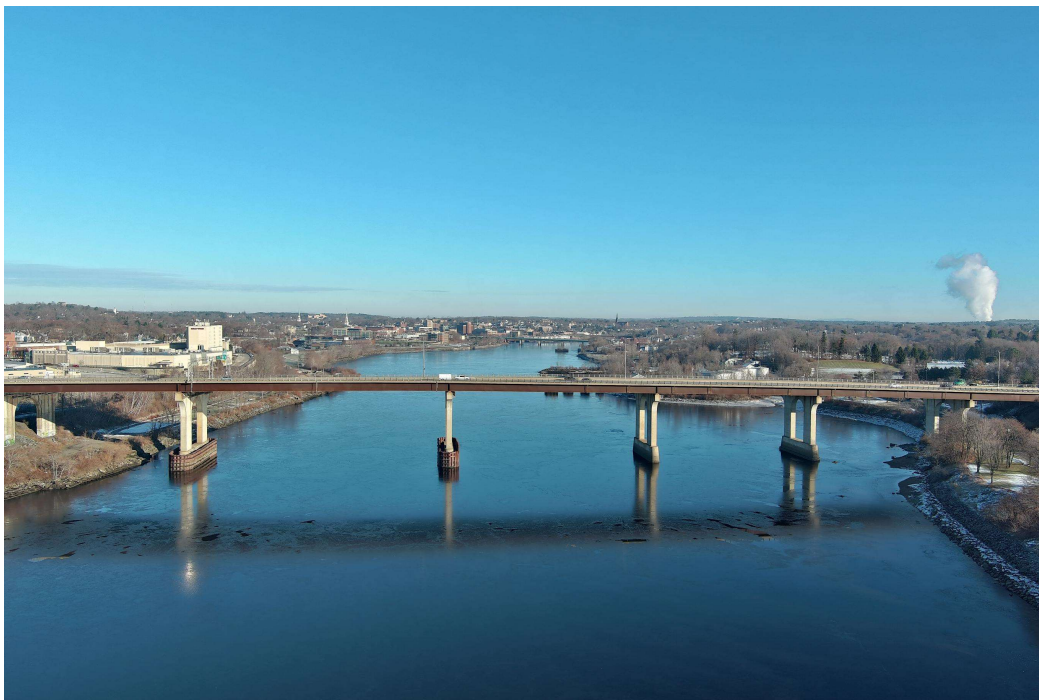
PHOTO 1

Description South elevation of the bridge.

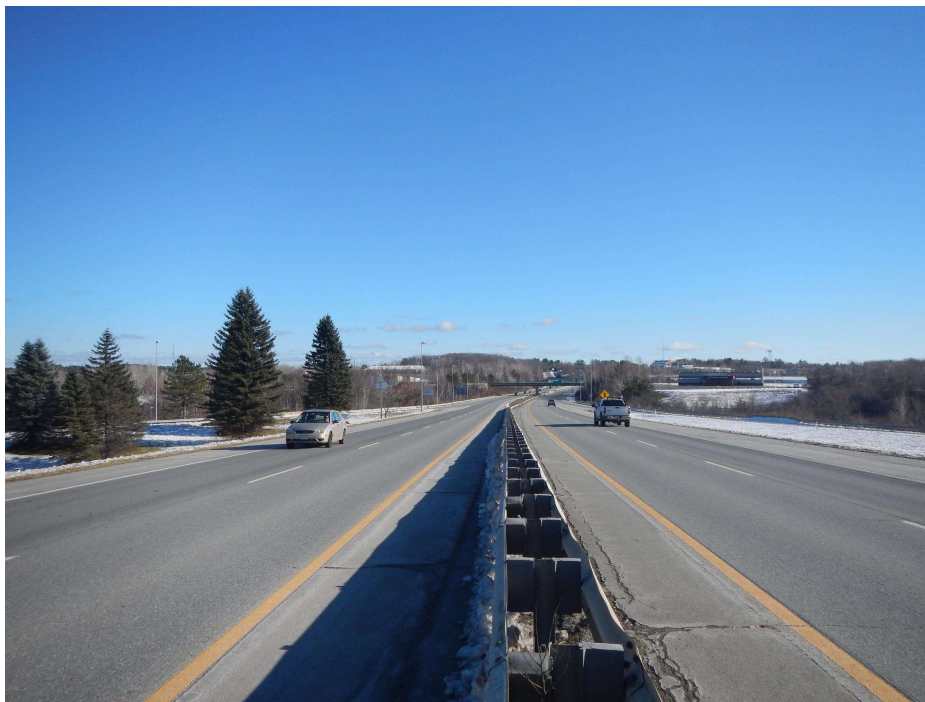
PHOTO 2

Description General view of the east approach.

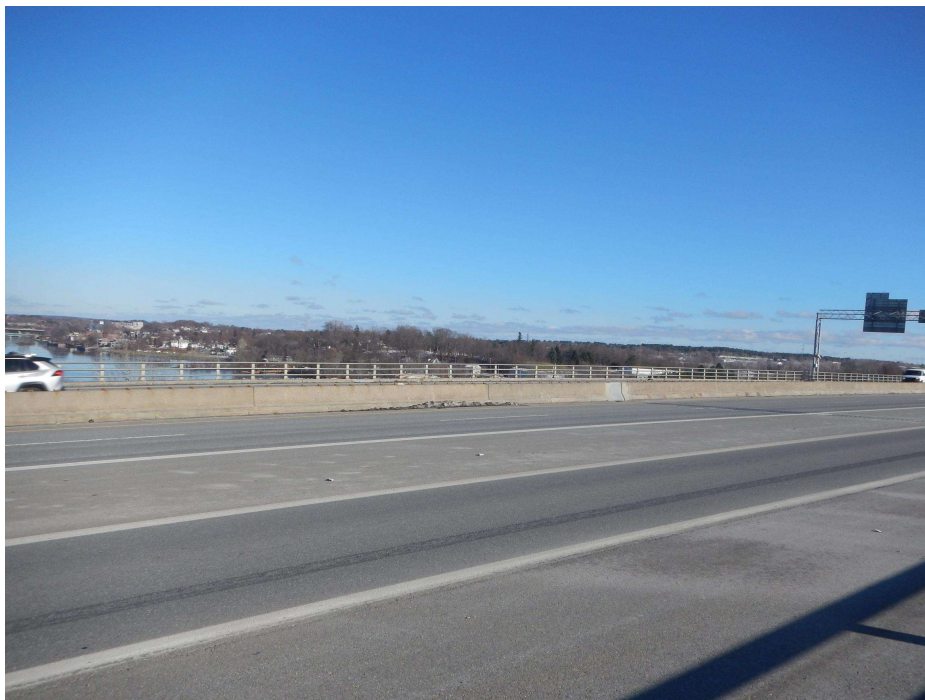
PHOTO 3

Moderate ruts in the wheel path in both the eastbound and westbound travel lanes.
The approach pavement at the west abutment is beginning to settle and crack near the header.

Description General view of the eastbound wearing surface with median barrier.

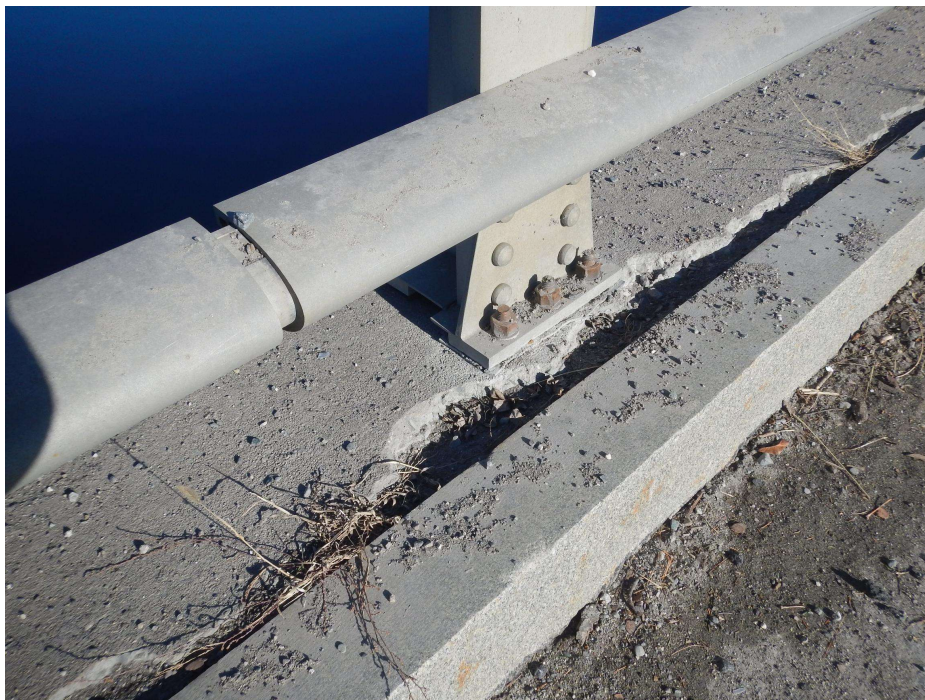
PHOTO 4

Description Spalled concrete curb with undermining at the bridge rail post.

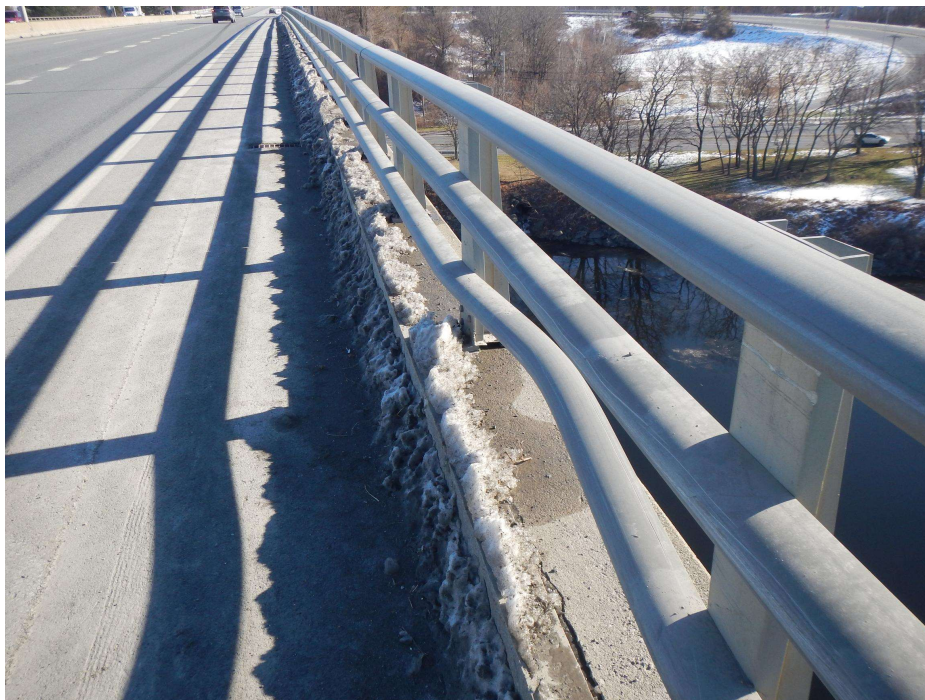
PHOTO 5

Approach rail damage at ramp 3 westbound off ramp to Bangor Main street (RT 9 & 1A).

Description Impact damage to the south bridge rail on the eastbound lane with minor crack between the granite and concrete curbs.

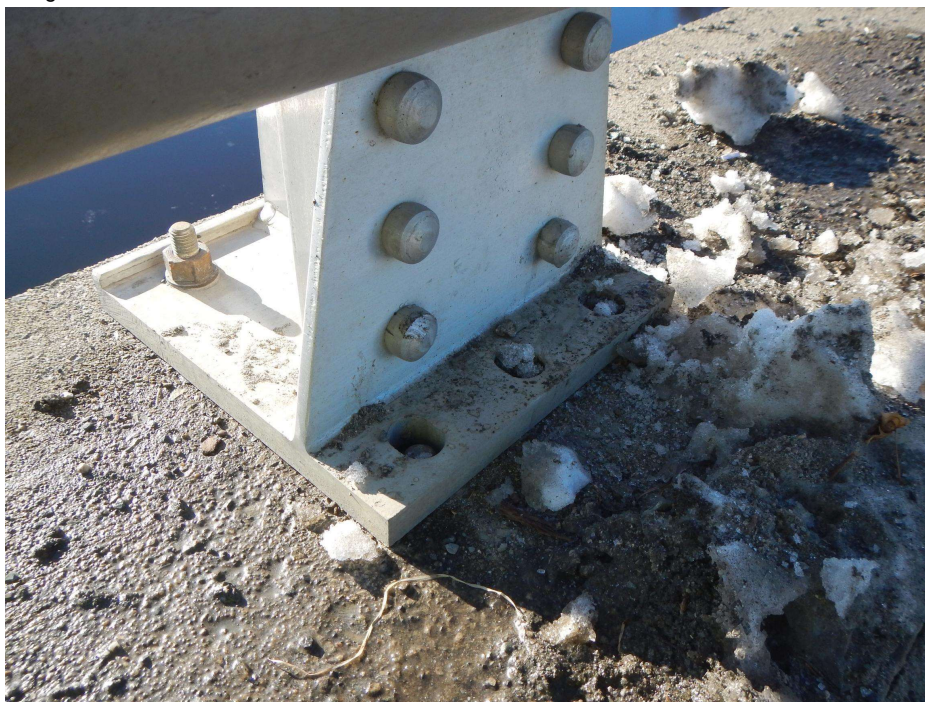
PHOTO 6

Description Typical bridge rail post with missing anchor nuts.

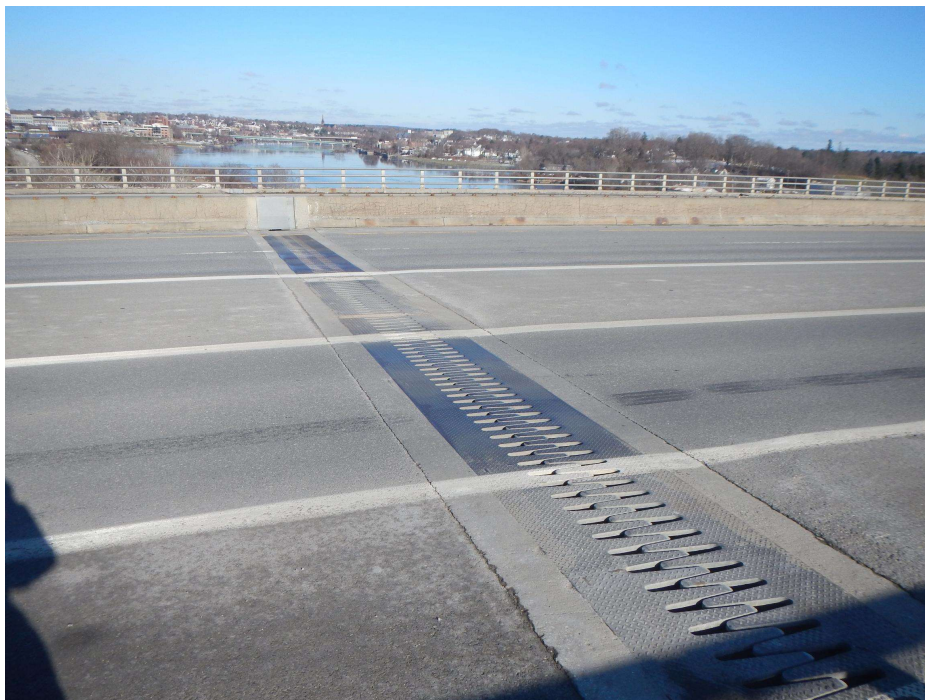
PHOTO 7

Description Typical condition of the finger joints on the bridge. Pier 2 joint shown, east abutment similar.

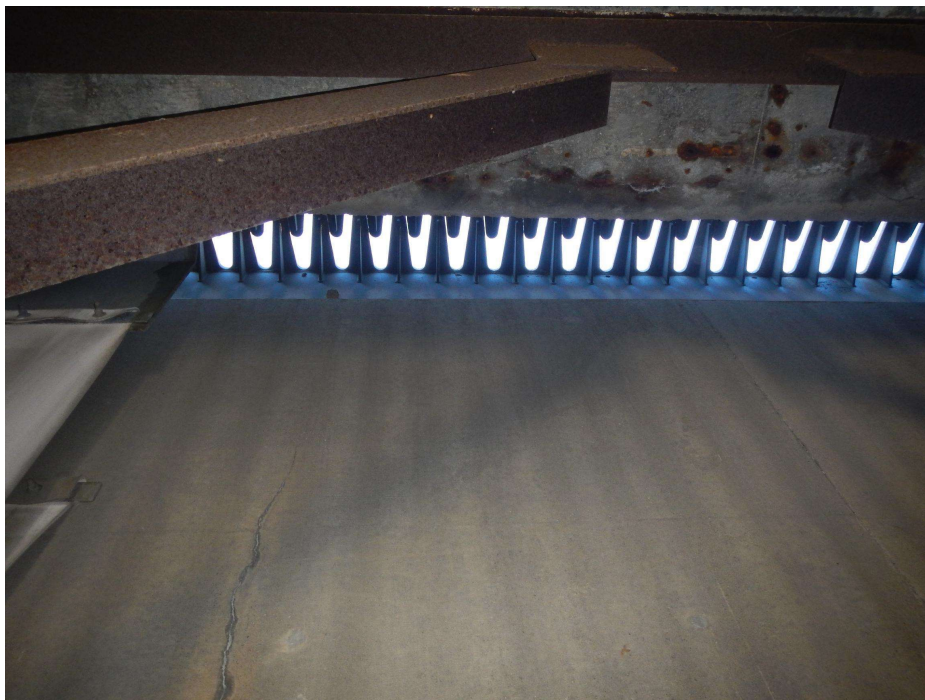
PHOTO 8

Description Underside view of the east abutment finger joint. Note the misalignment in the joint.

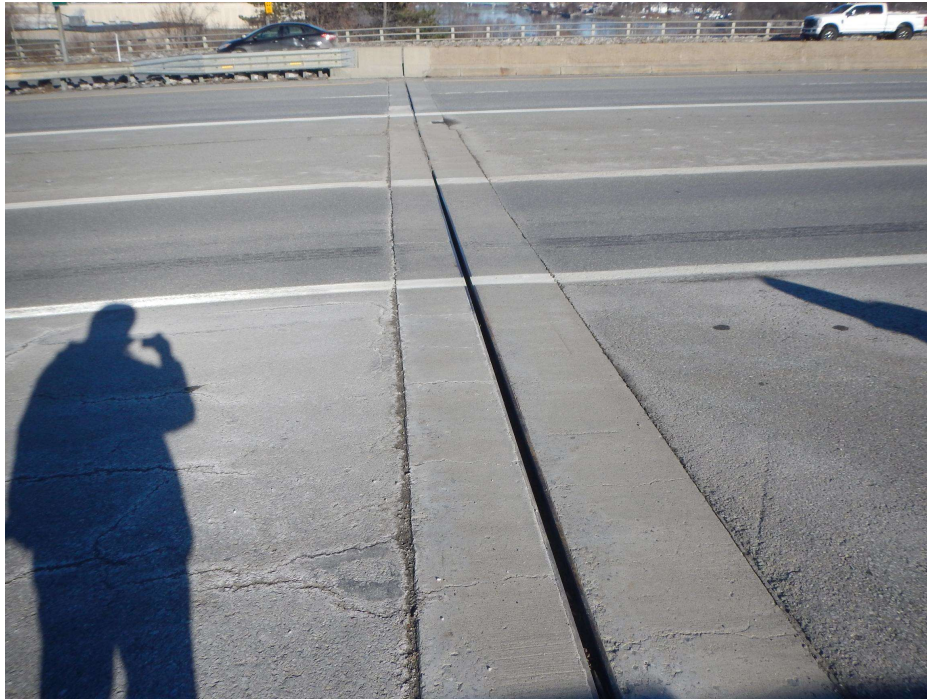
PHOTO 9

Description General view of the bridge joint at the west abutment with scattered cracks in the header and shoulder pavement.

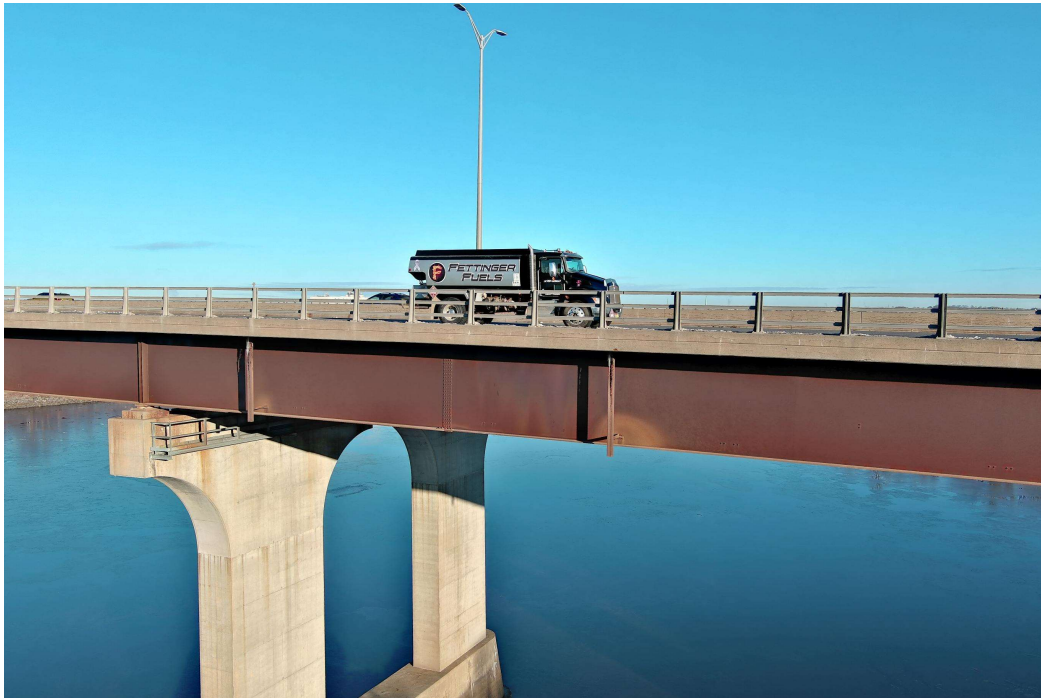
PHOTO 10

The patina on the exterior girders is failing where the bridge drain bracket connects to the web plate. There is scattered locations of patina failure between the drains.
The beam ends and bearings at Pier 2 below the open finger joint have moderate rust with significant patina failure.
The girder bottom flanges near the east abutments have minor rust scaling.
There is rust and minor section loss at the bottom members of the east end diaphragms.
The bearing slide plates are delaminating, and the teflon sheet is compressed unevenly on all bearings.
The bearings at the east abutment are expanded past neutral at an ambient temperature of 16F. All of the bearings at the east abutment are laterally shifted 1" off alignment of the masonry plate.
Bearings at both Pier 6 and 7 have slid close to maximum. This has been monitored for some time.
Girder G8 on Span 1 has a slope change at the bottom flange near the bearing with discoloration of the patina.

Description South elevation of the exterior girder patina failure on the exterior girder at the downspout connection to the web.

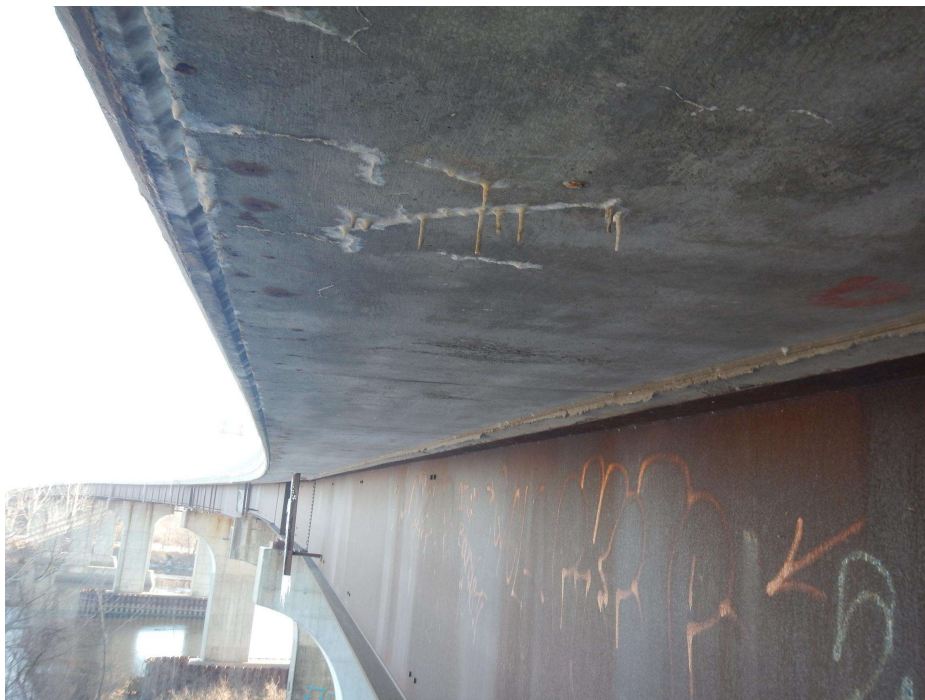
PHOTO 11

Description General view of the north fascia, exterior girder, and deck underside with cracks and efflorescence.

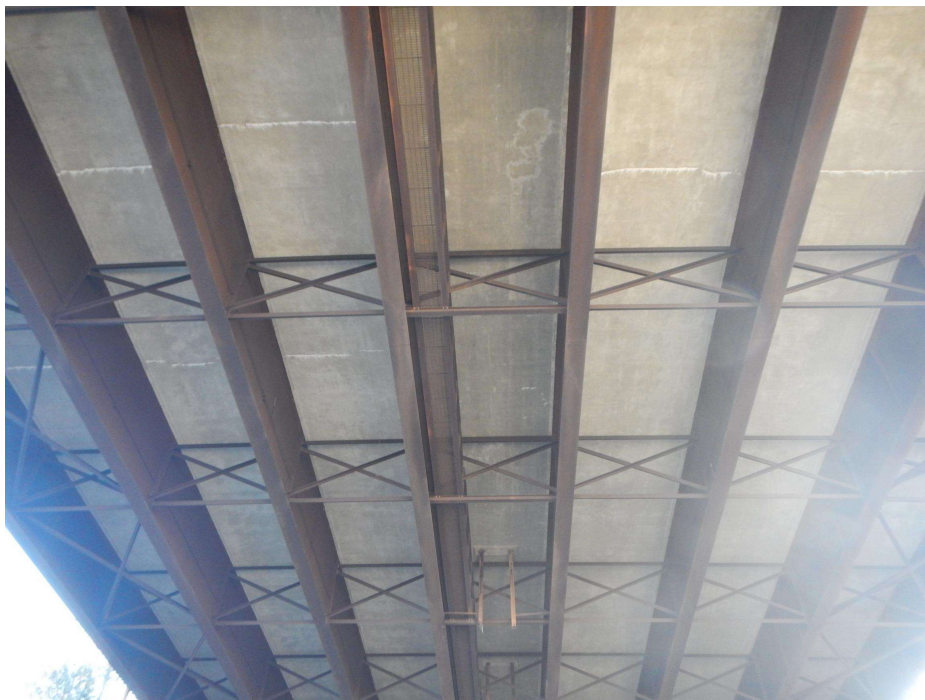
PHOTO 12

Description Typical condition of the deck underside.

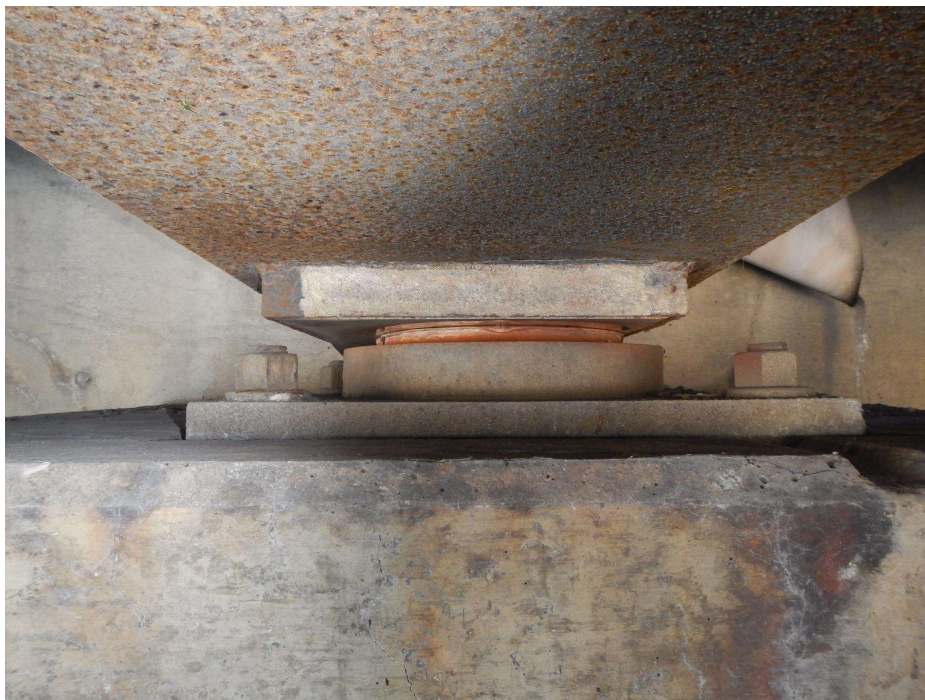
PHOTO 13

Description Typical alignment of the east abutment bearings.

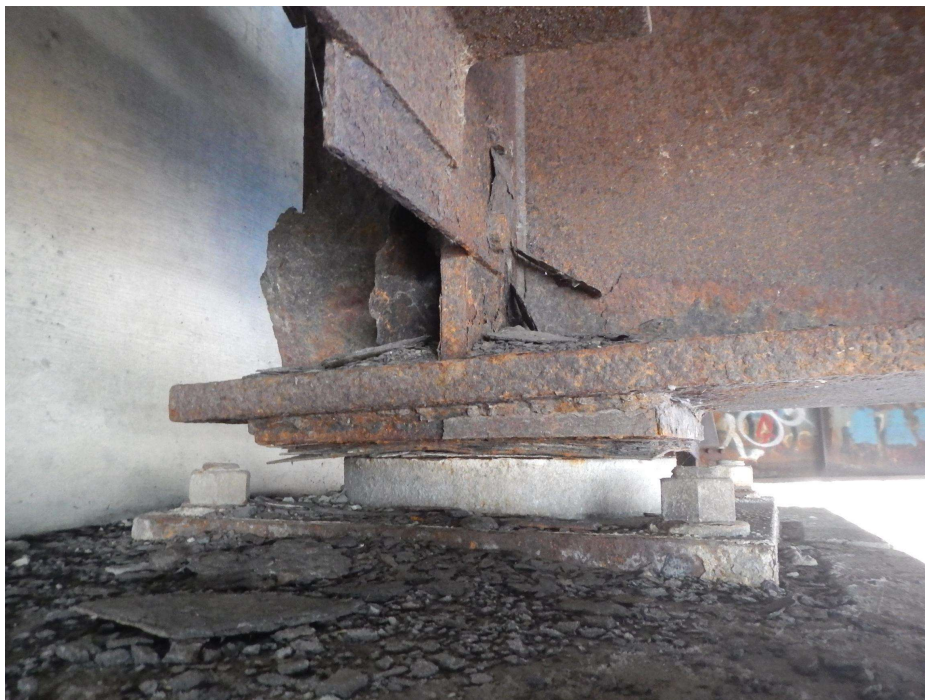
PHOTO 14

The remaining girder ends and bearings have minor rust scaling and pitting.

Description Typical condition of the bearing plate with separation of the mirror plate. Note rust and pitting at the girder end. West abutment bearing shown, others similar.

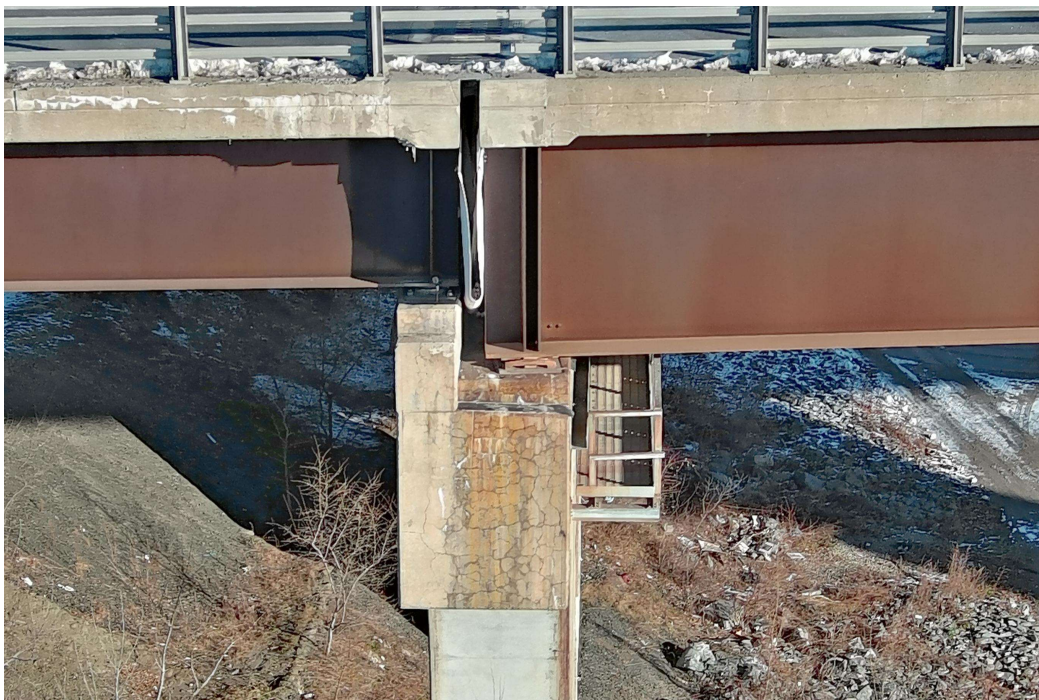
PHOTO 15

The north and south faces of the pier cap on Pier 2 have spalls and significant map cracks. There is exposed rebar on the north face. Pier 3 has tension rods in the footing and between the pier columns due to a vertical crack in the footing. The steel sheet pile protection on the west of Pier 3 is starting to bow toward the shore. The east face of Pier 7 has minor map cracks with scattered vertical hairline cracks. All of the pier footings have map cracks and efflorescence below the high tide mark. The west abutment has map cracks at the breast wall and bridge seat.

Description South elevation at Pier 2. Note longitudinal cracks in the fascia with efflorescence, and map cracks on the pier cap.

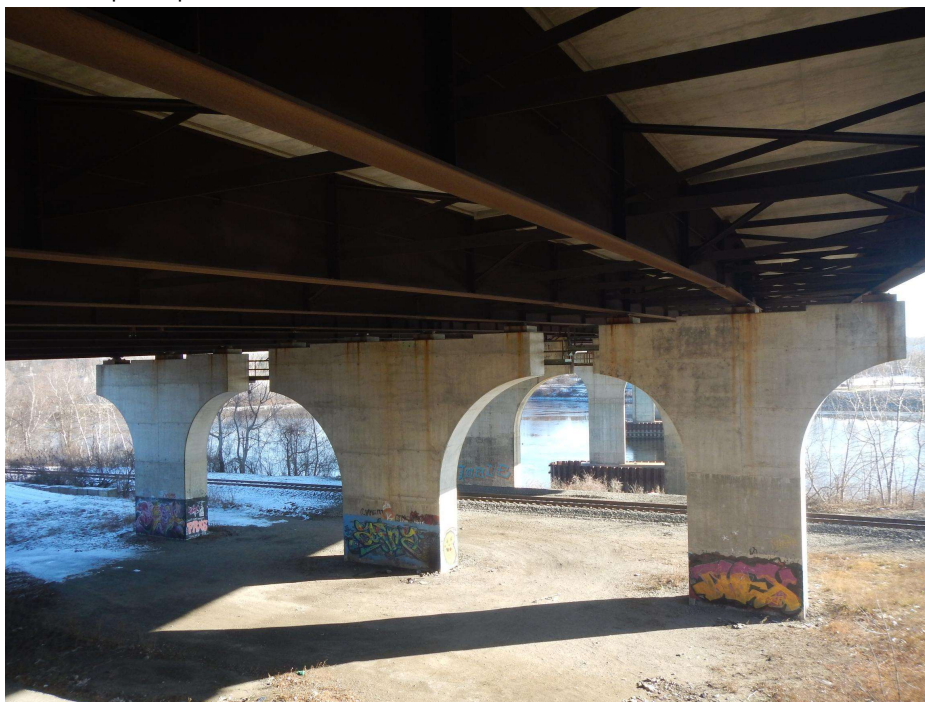
PHOTO 16

Description West elevation of Pier #1

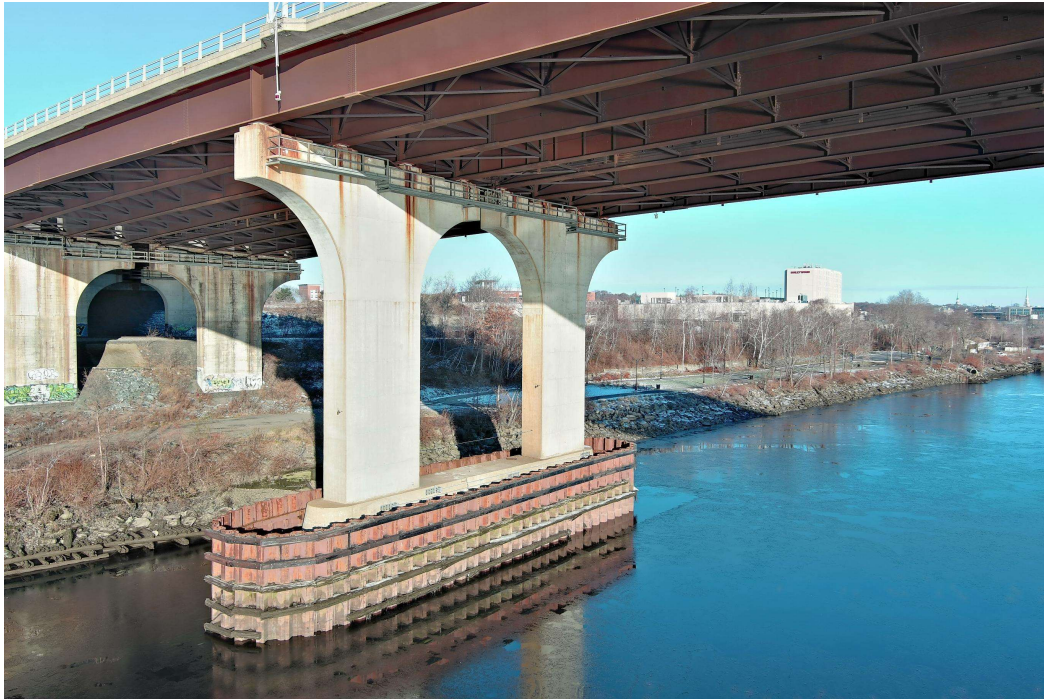
PHOTO 17

Description General view of Pier 3 with sheet piling pier protection. Pier 4 similar. Note rust stains on the pier caps below the bearings typical at all piers.

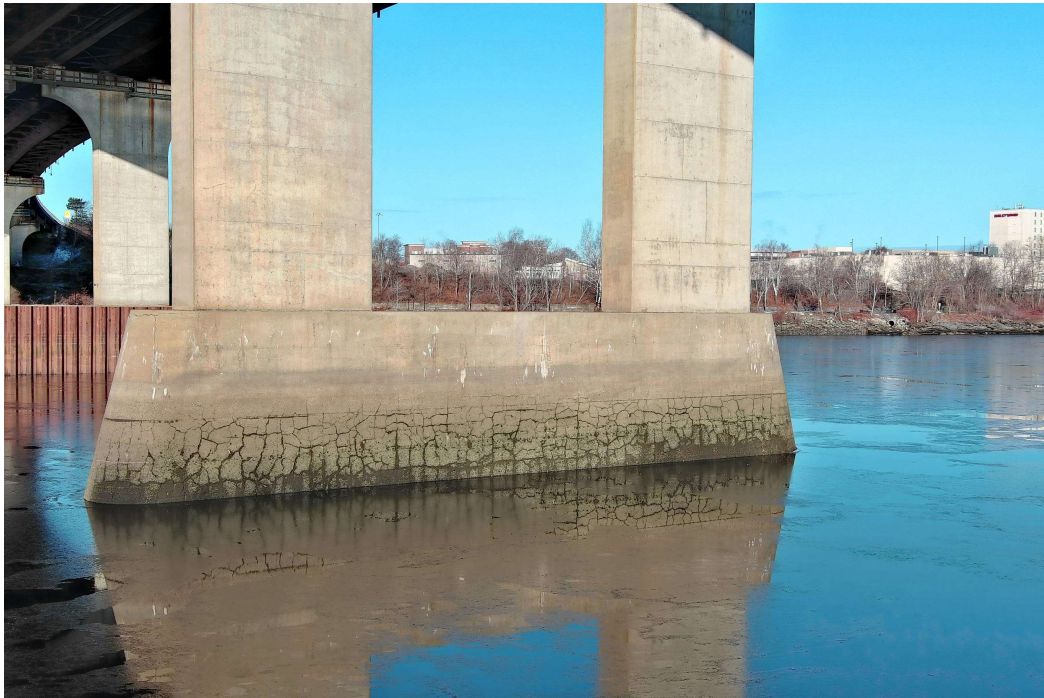
PHOTO 18

Description Typical condition of the pier footing where sheet piling is not present. Note scattered cracks, efflorescence, and map cracks below the highwater line. Pier 5 shown.

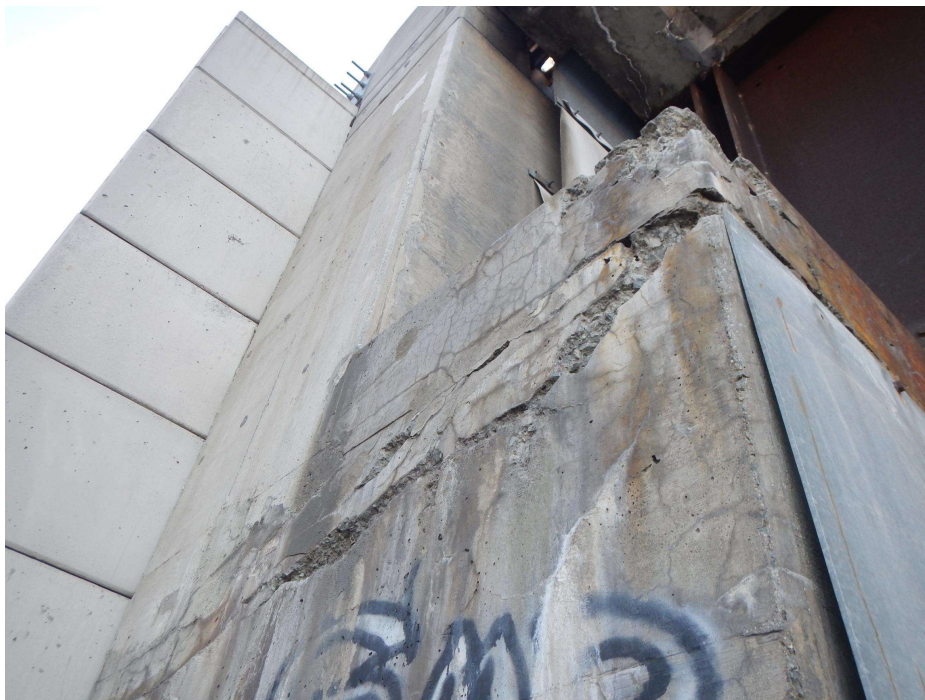
PHOTO 19

Description Large cracks and spalls at near the bridge seat at the north abutment.

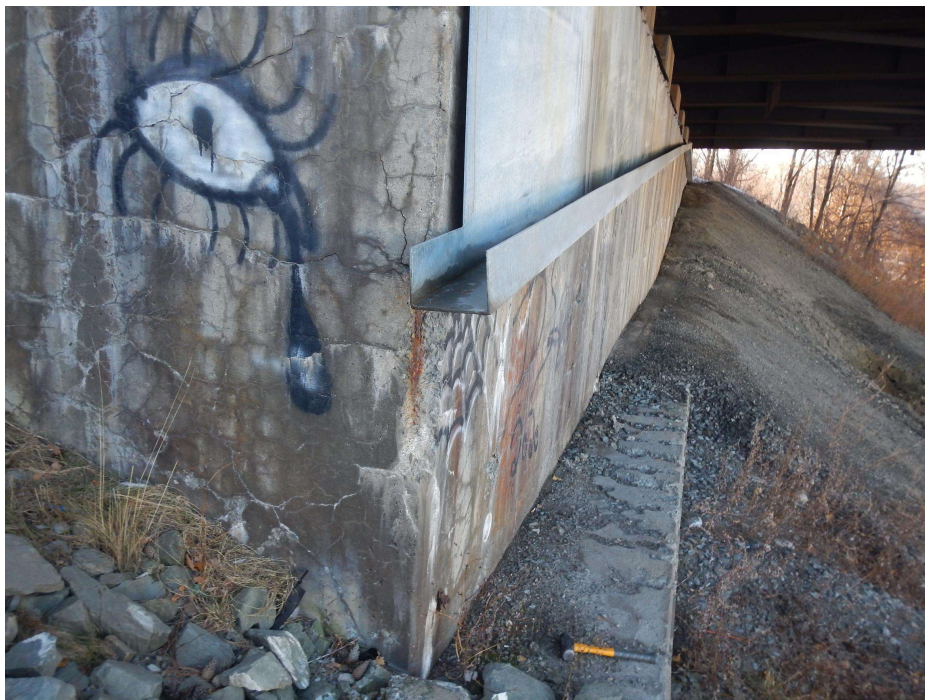
PHOTO 20

The east abutment breastwalls and backwalls have widespread cracks, rust stains, and efflorescence, with scattered areas of surface scaling.
Both corners at the east abutment have severe cracks and moderate spalls.
The east abutment footing is exposed at the north end due to erosion.
The bearing pedestals at the east abutment have rust stains and map cracks with widths up to 1/8".
The pier cap bearing pedestals have rust stains under the bearings.
The pier cap at Pier 2 has map cracks and rust stains below the open finger joint.

Description North corner of the east abutment with cracks, spalls, and exposed footing.

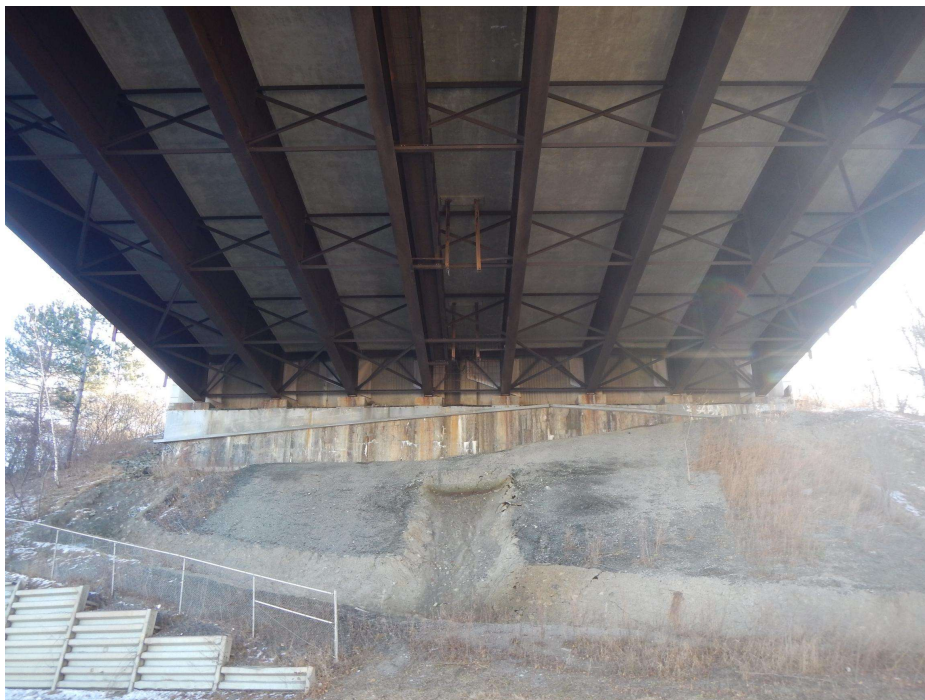
PHOTO 21

Description East abutment elevation.

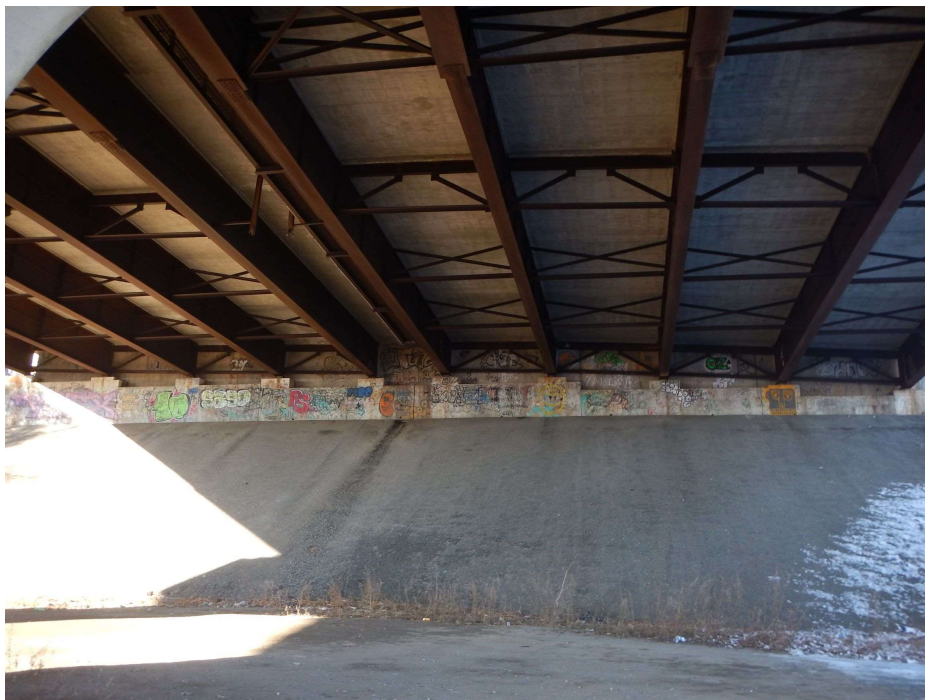
PHOTO 22

Description West abutment elevation.

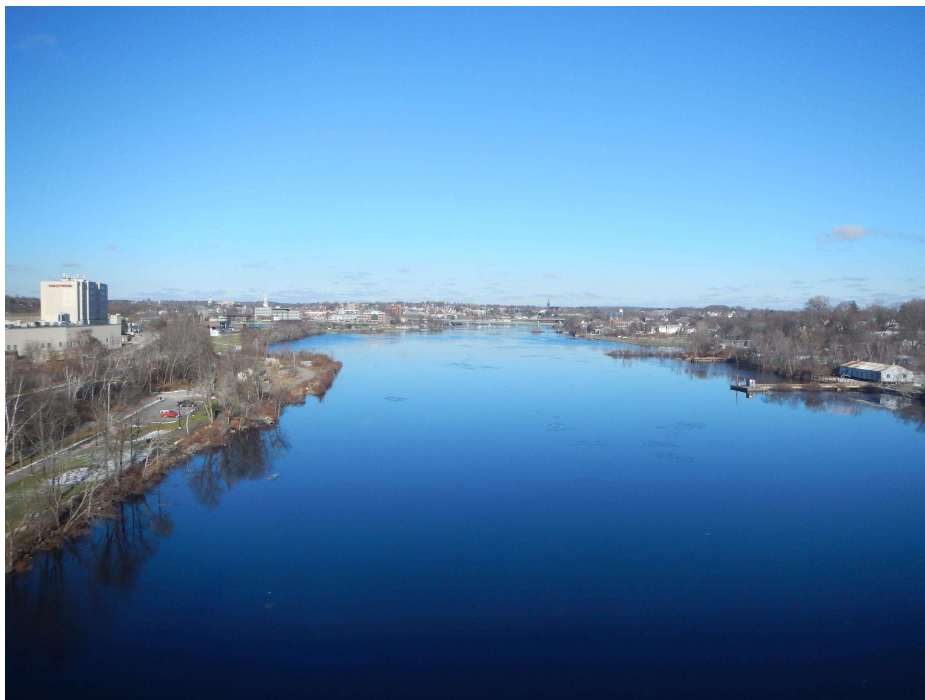
PHOTO 23

Description Upstream.

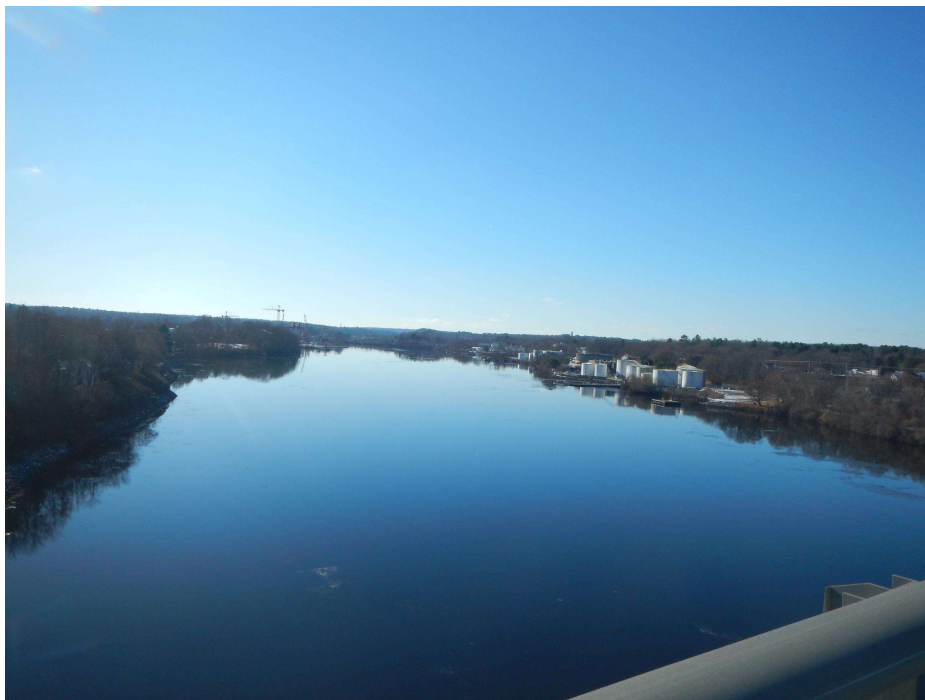
PHOTO 24

Description Downstream.
