Structure Number: 5785
Facility Carried: TOWN FARM RD

Highway Bridge Inspection Report

Inspection Type(s): Routine

Bridge Name: TOWN FARM RD / I-95

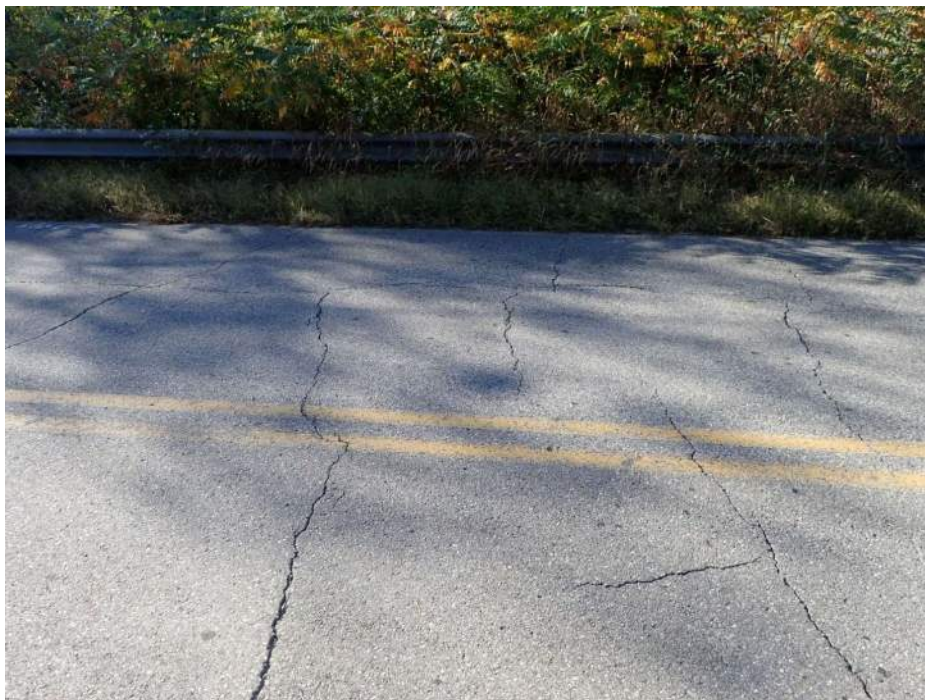
PHOTO 3 Condition
Description West Approach

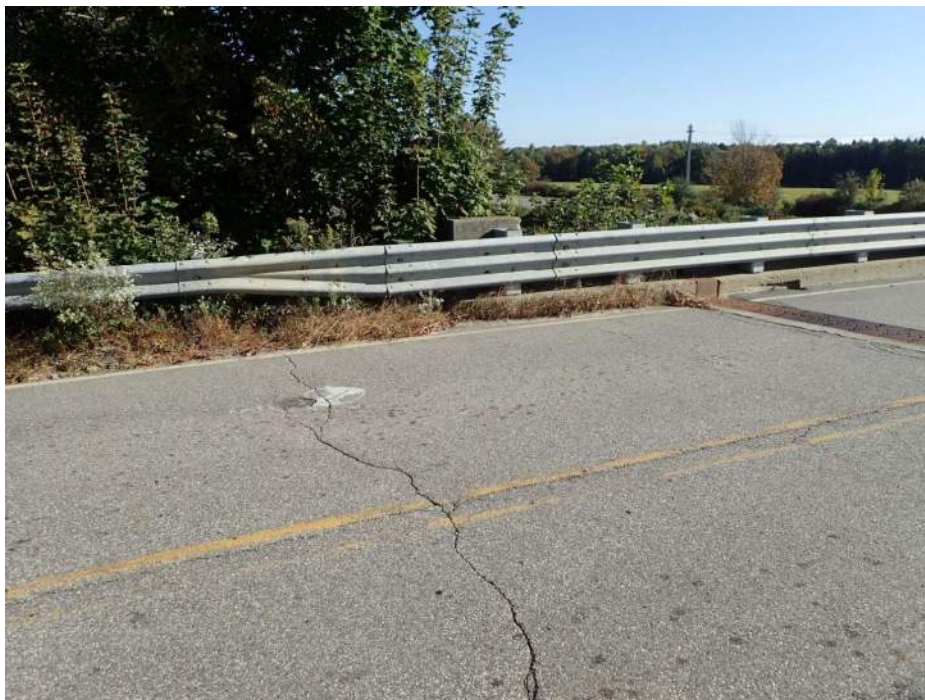
PHOTO 4 Condition
Description West Approach

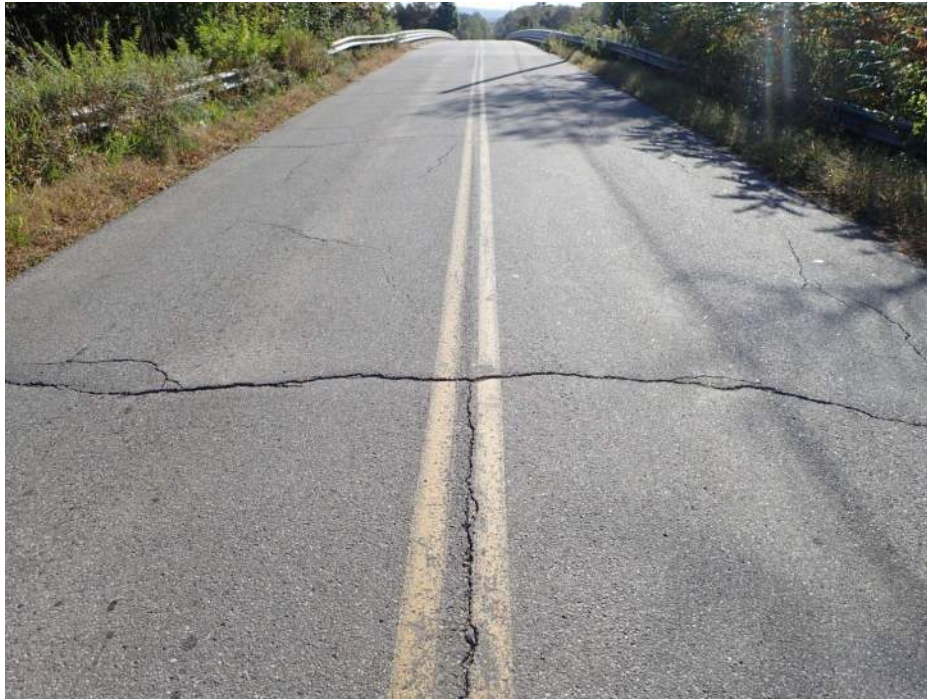
PHOTO 5 Condition
Description West Approach

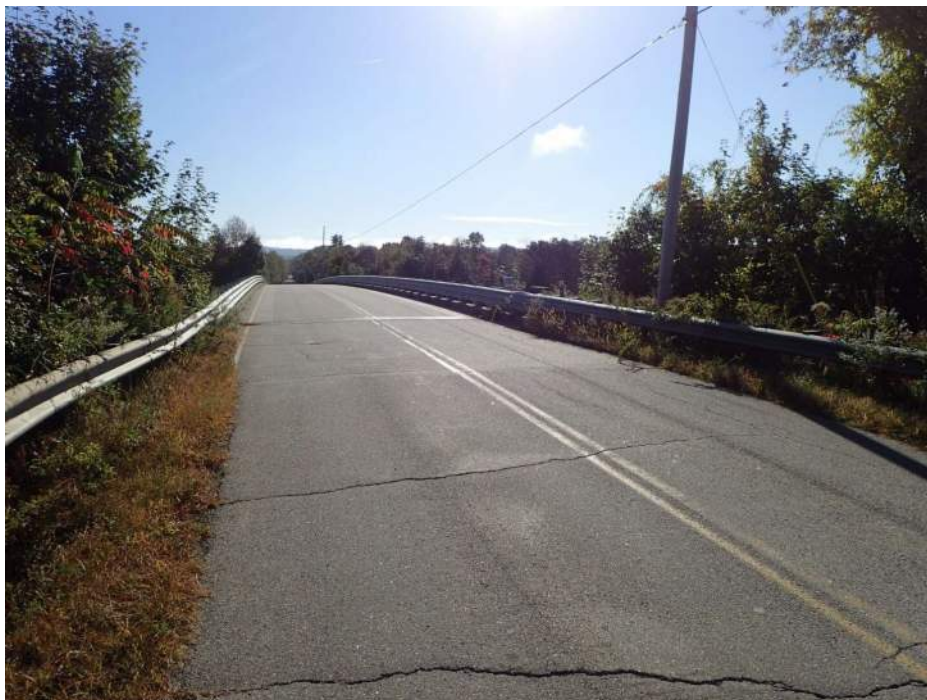
The west approach has scattered wide transverse cracking with settlement. The transverse cracking continues east for about 120' and are spaced approximately every 20'. The bituminous pavement next next to the abutment backway header exhibits wide map cracking and is breaking up.

PHOTO 6 Condition
Description West Approach - Wide cracking in pavement

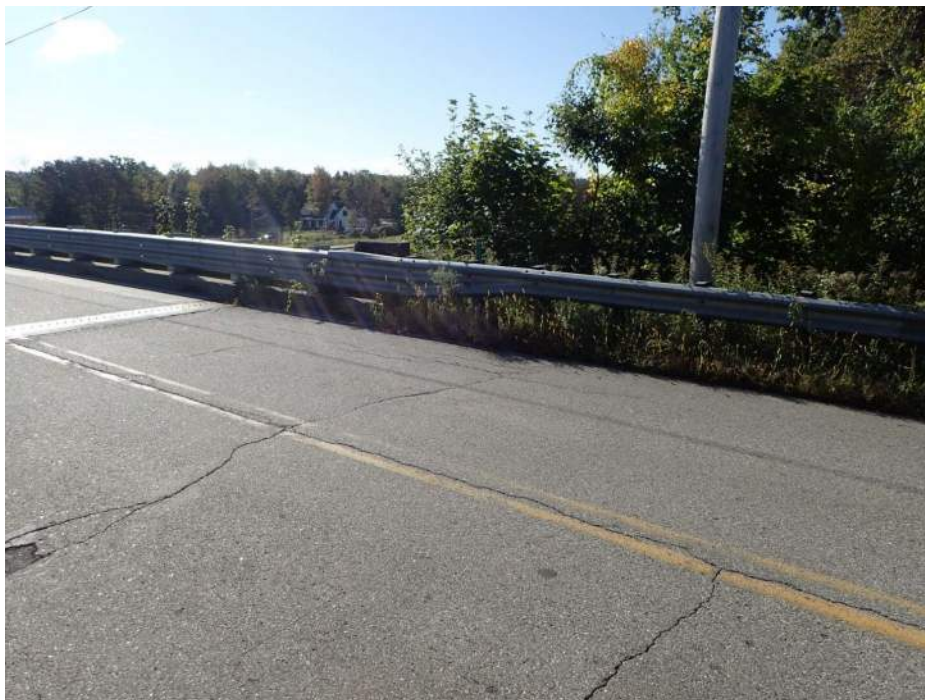
PHOTO 7 Condition
Description West Approach

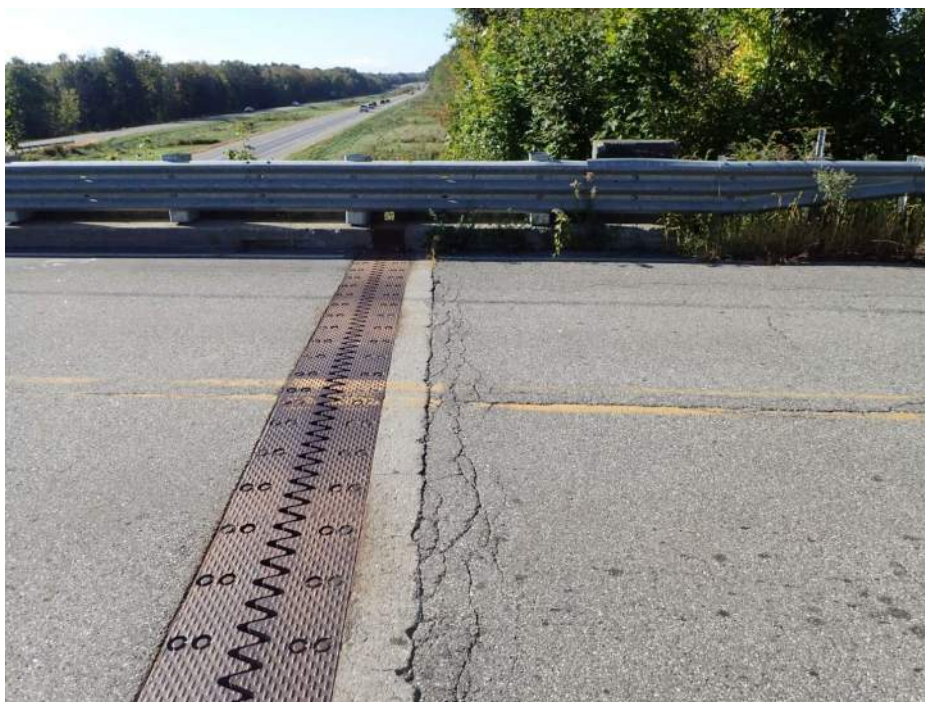
PHOTO 8 Condition
Description Finger Joint over Abutment 1 - looking South, heavy map cracking before backwall

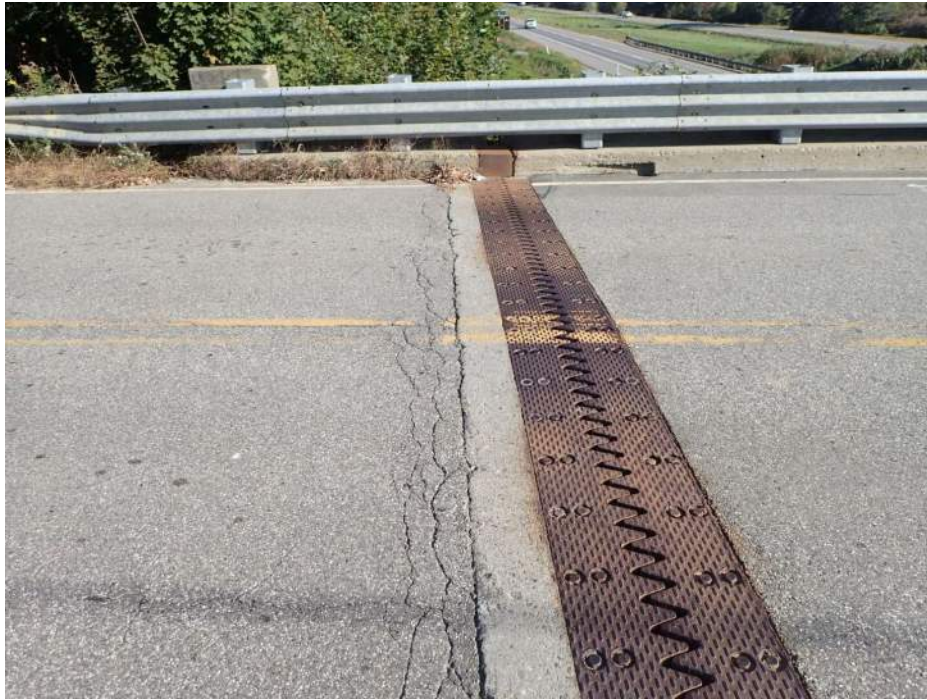
PHOTO 9 Condition

Description Finger Joint over Abutment 1 - looking North, heavy map cracking before backwall

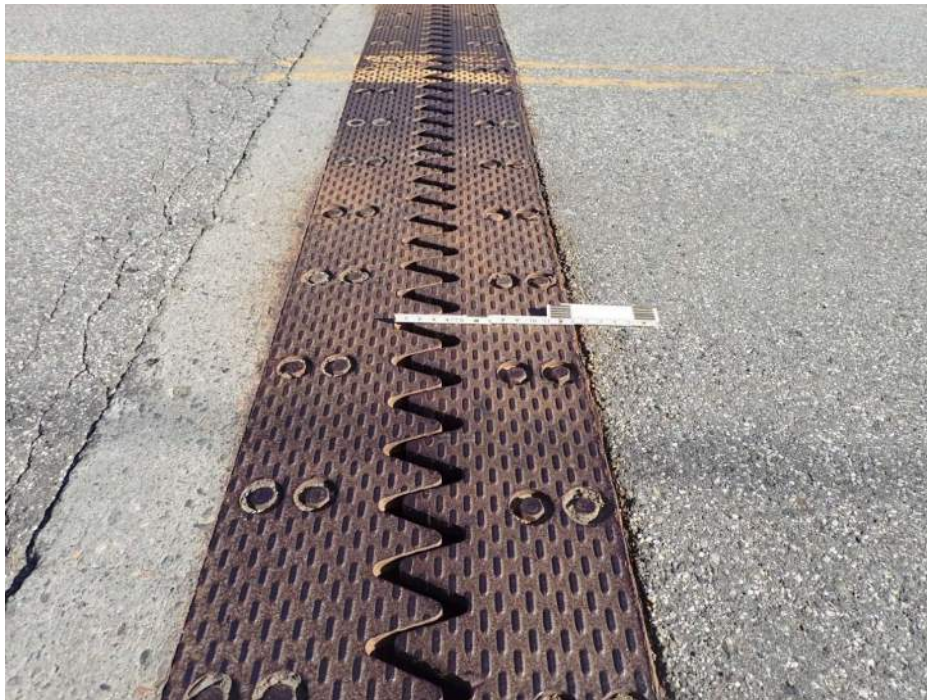
PHOTO 10 Condition

Description Finger Joint over Abutment 1 - looking North. 1 3/8" at 60 Degrees

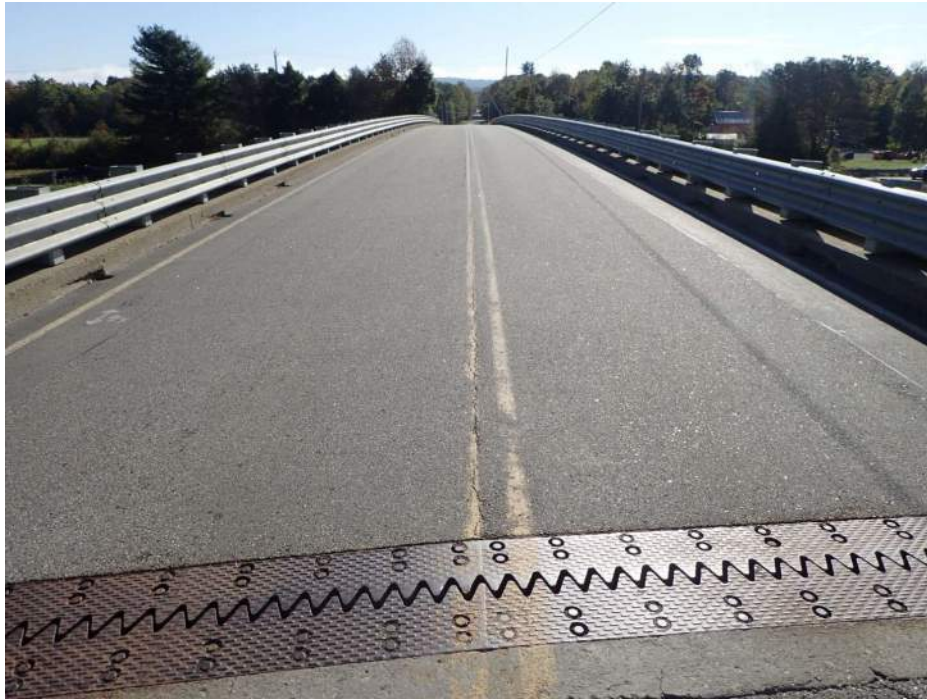
PHOTO 11 Condition

Description Finger Joint over Abutment 1 - Bridge Deck looking East

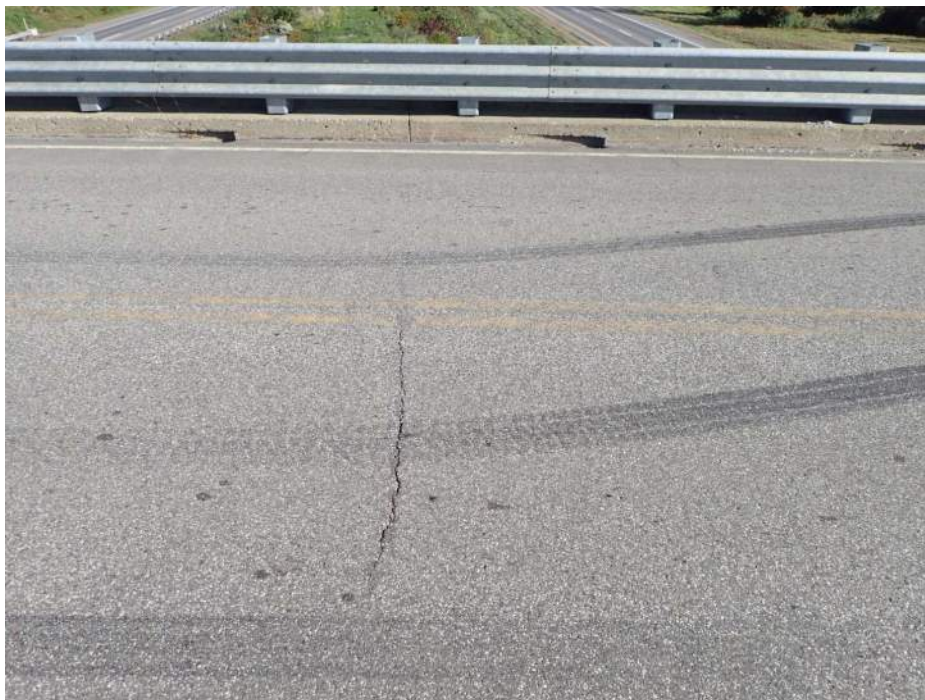
PHOTO 13 Condition

Description Bridge Deck & North Railing 2 of 4

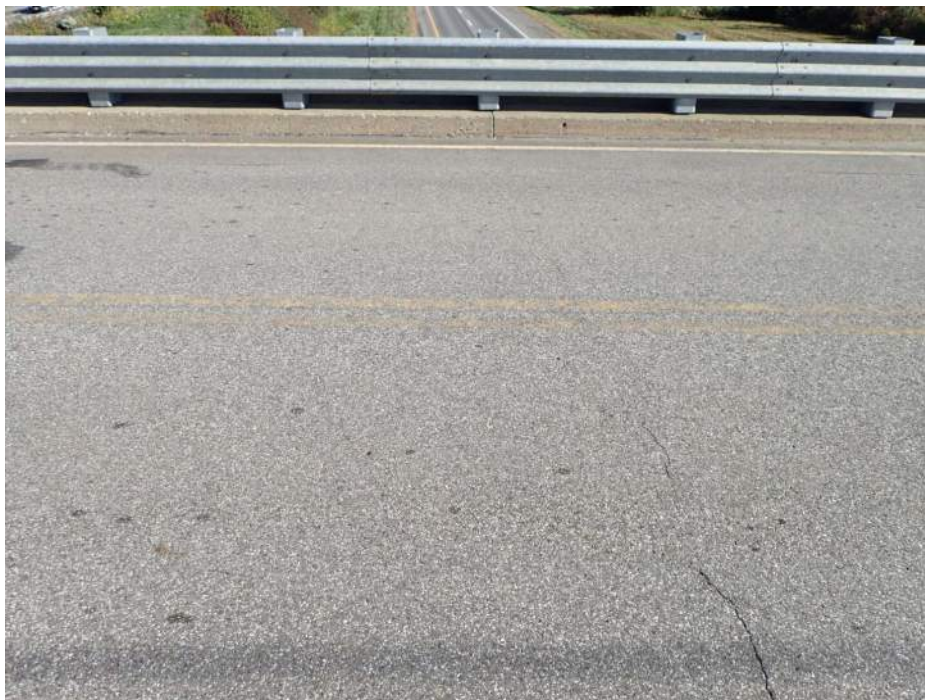
PHOTO 14 Condition

Description Bridge Deck & North Railing 3 of 4

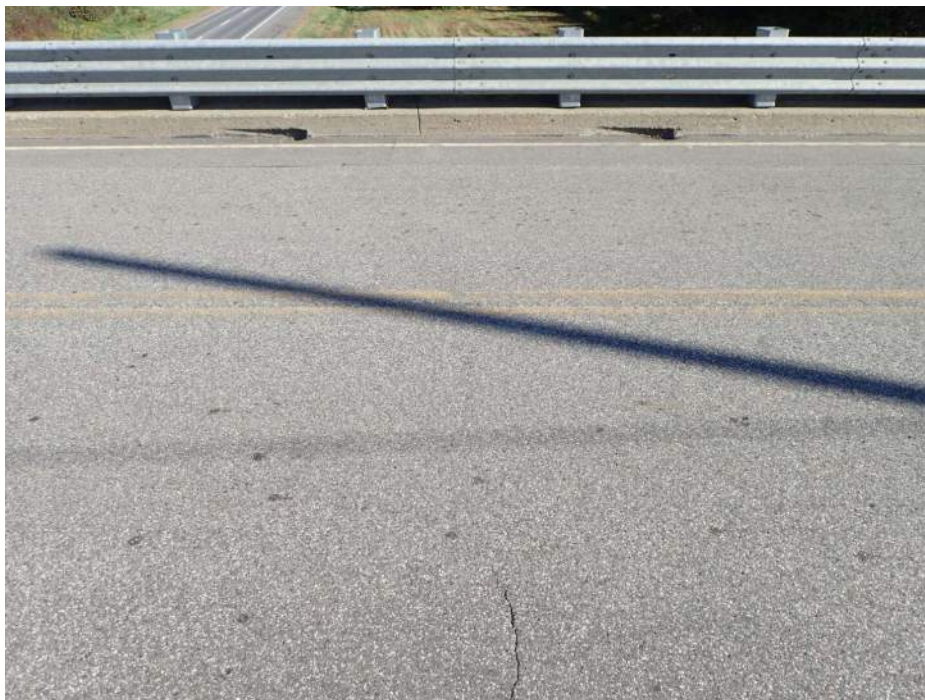
PHOTO 15 Condition

Description Bridge Deck & North Railing 4 of 4

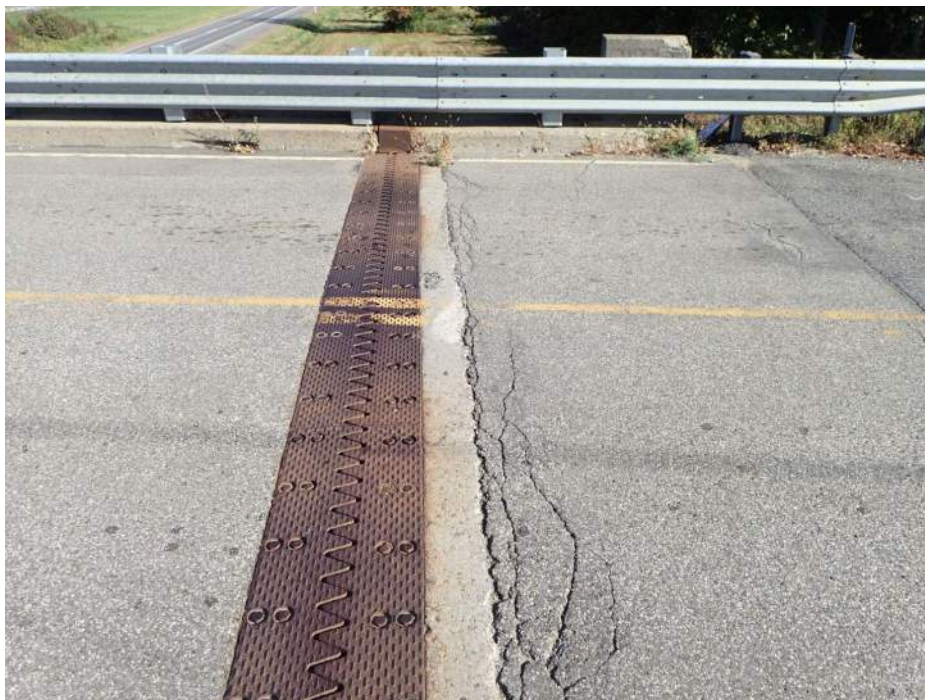
PHOTO 16 Condition

Description Finger Joint over Abutment 2 - looking North

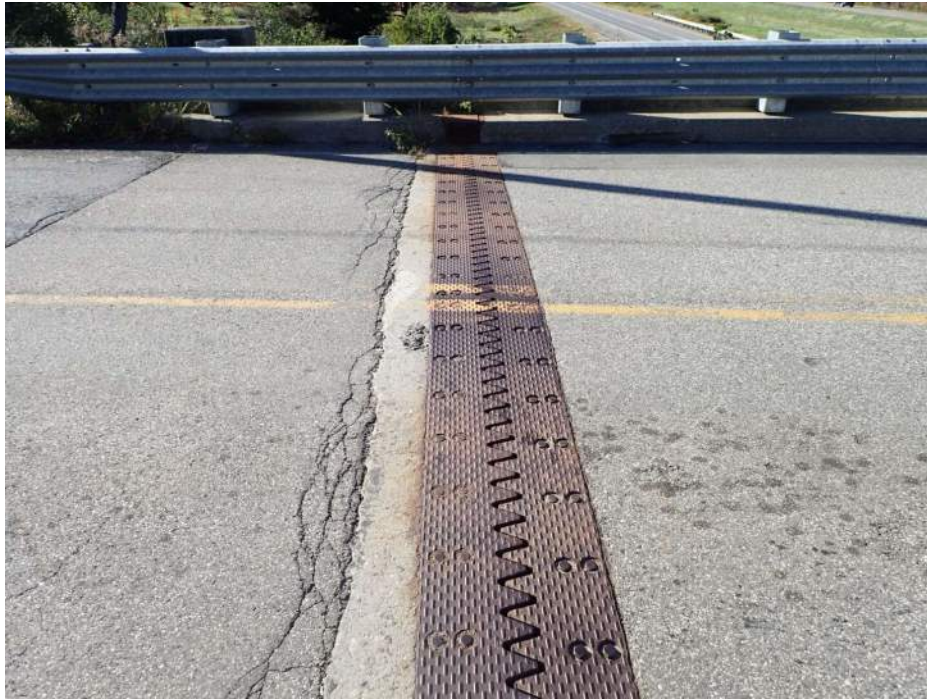
PHOTO 17 Condition

Description Finger Joint over Abutment 2 - looking South, cracking before backwall

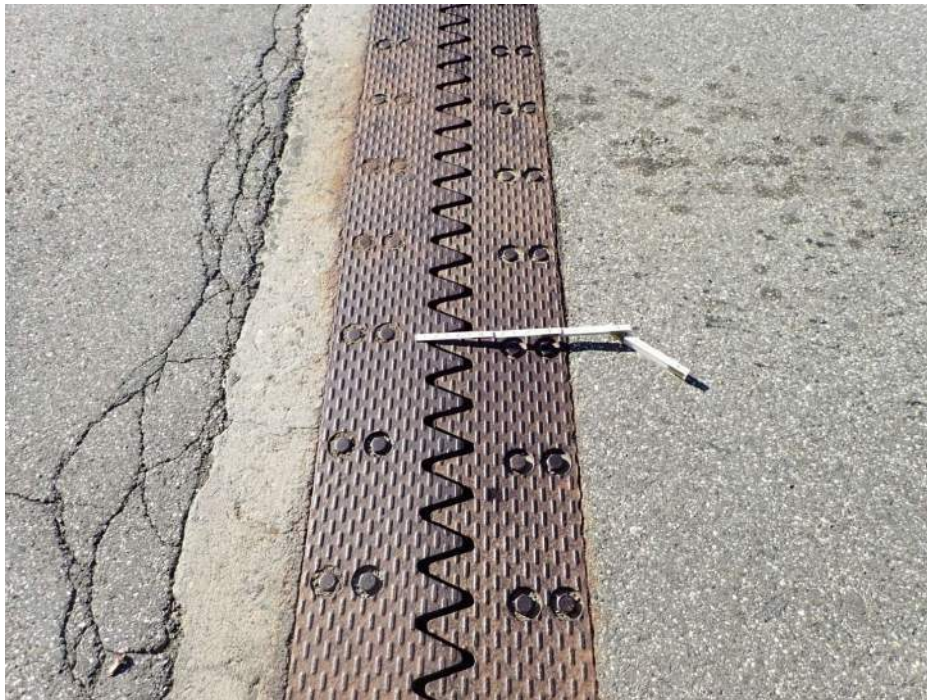
PHOTO 18 Condition

Description Finger Joint over Abutment 2 - looking South - looking South, cracking before backwall. 1" at 60 degrees.

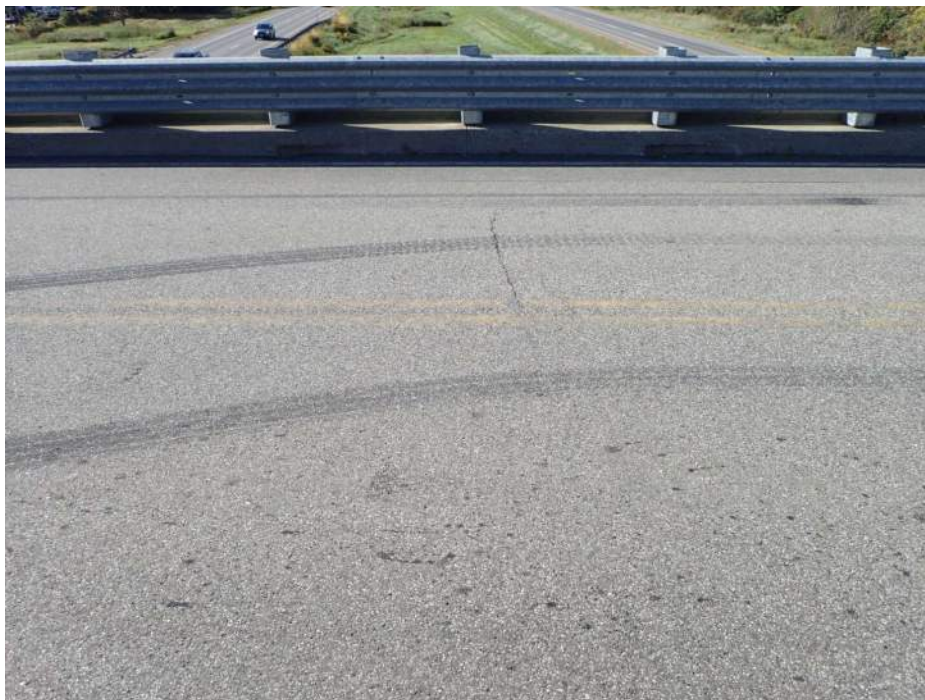
PHOTO 19 Condition

Description Bridge Deck & South Railing 1 of 3

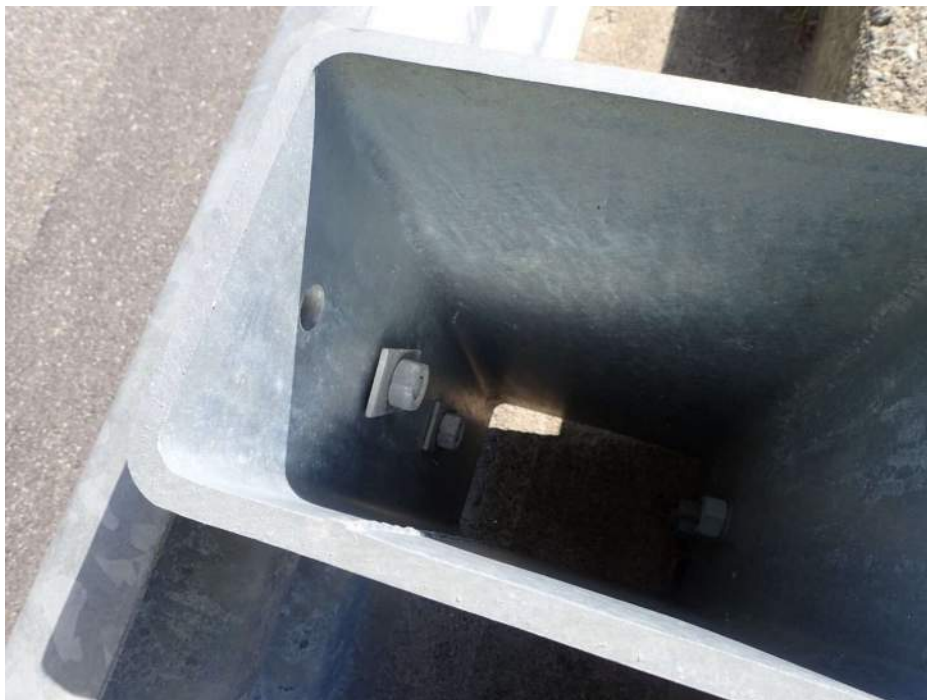
PHOTO 23 Condition

The concrete parapets exhibit minor spalls on both sides of the bridge for the entire length of the structure. The retrofitted guardrail has a few missing or loose bolts to the guardrail posts. The parapets have exposed anchor bolts from the original parapet mounted aluminum bridge railing, with moderate transverse cracking and shallow spalls, typical on both sides of the bridge and 50% of old post locations. There is minor spalling at NE expansion dam joint in curb. Both joints are in satisfactory condition.

Description Bridge Railing Post - some have loose bolts, posts with loose bolts marked on sketches.

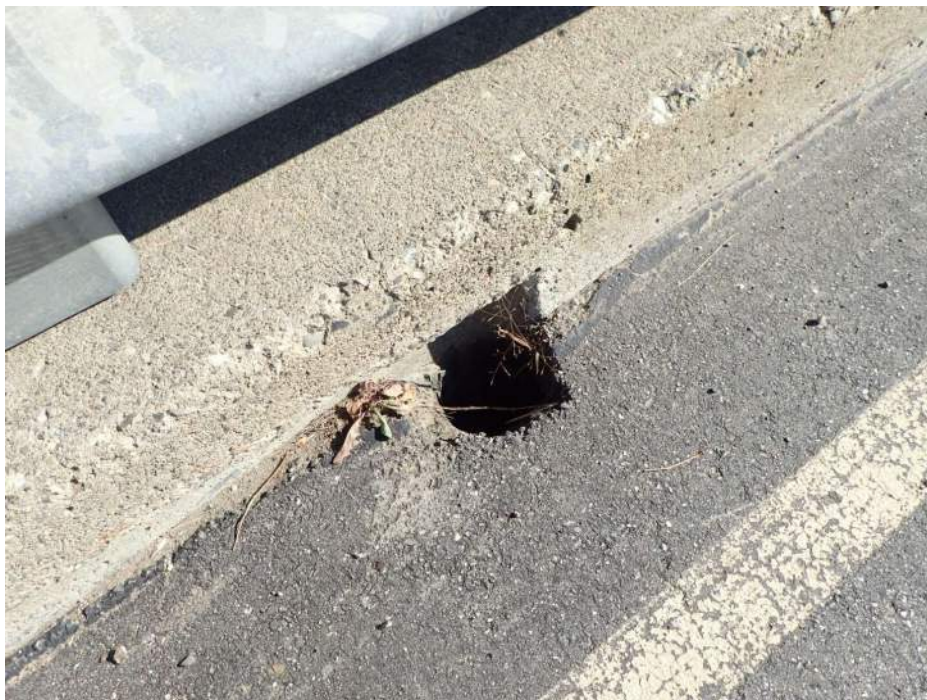
PHOTO 24 Condition

Description Bridge Drain (Typ.)

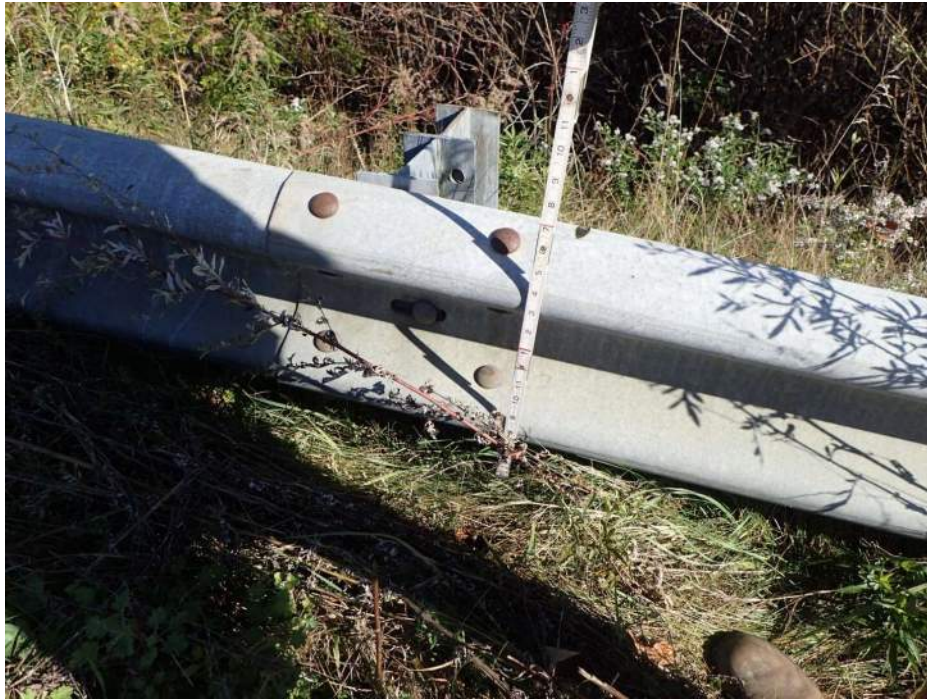
PHOTO 31 Condition

Description East Approach - top of North GR approx. 1'- 6 1/2" (18.5") in some areas.

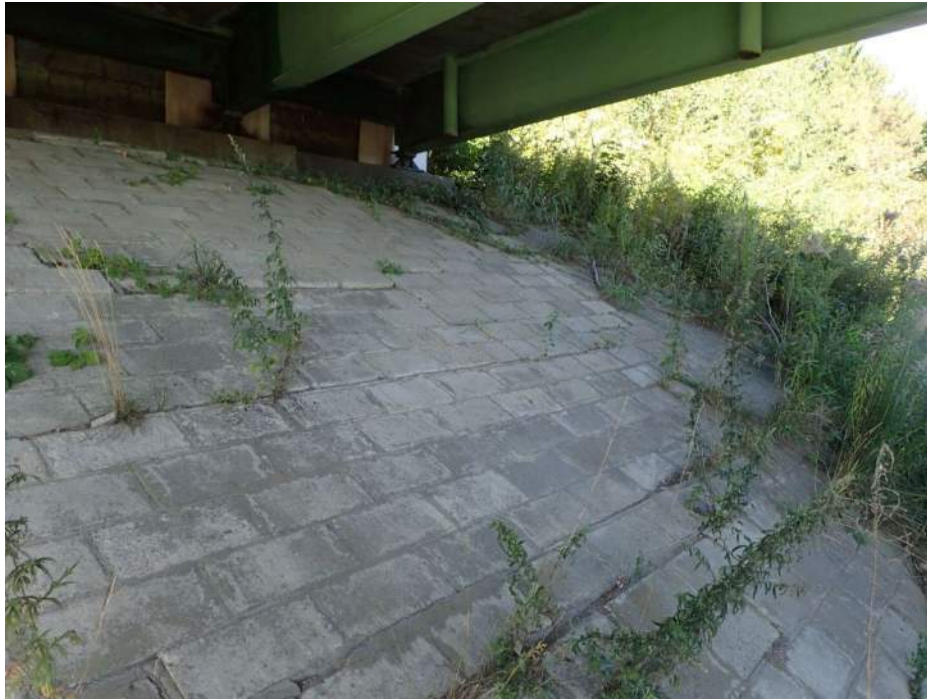
PHOTO 39 Condition

Description Abutment 1 - upper part of slope protection mostly intact with some moderate vegetation separation of joints

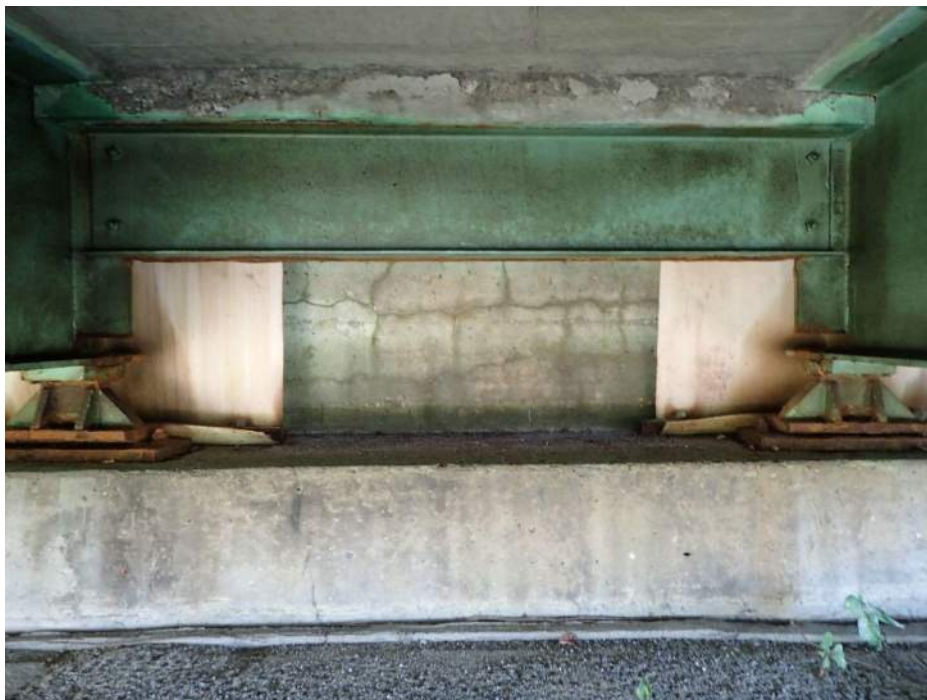
PHOTO 44 Condition
Description Abutment 1 - bay 2, girders 3 & 2, moderate cracking on backwall

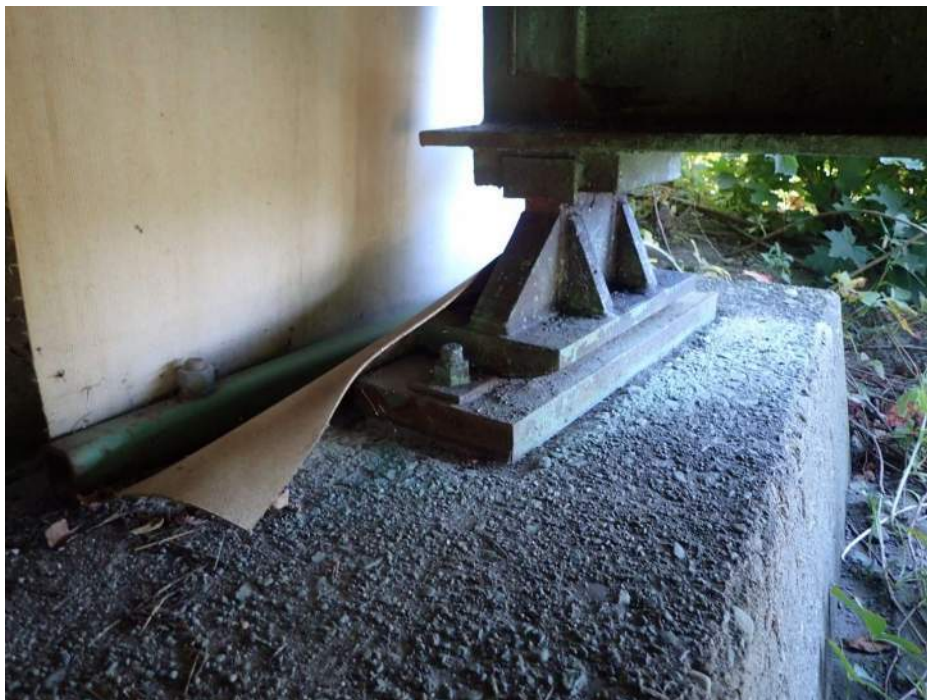
Exterior rocker bearings 1 & 4 exhibit scattered light surface corrosion. Interior rocker bearings 2 & 3 have heavy surface corrosion with some light pack rust on rockers & base plates. Pack rust may inhibit movement.

PHOTO 47 Condition
Description Abutment 1 - Girder 1 rocker bearing (60 F)

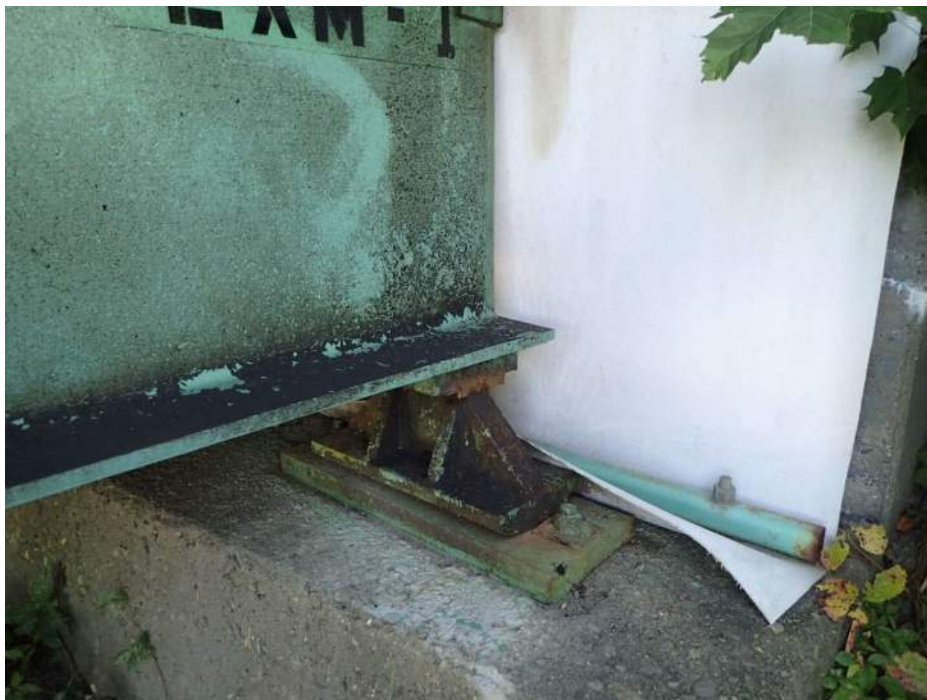
PHOTO 48 Condition
Description Abutment 1 - Girder 1 rocker bearing (60 F)

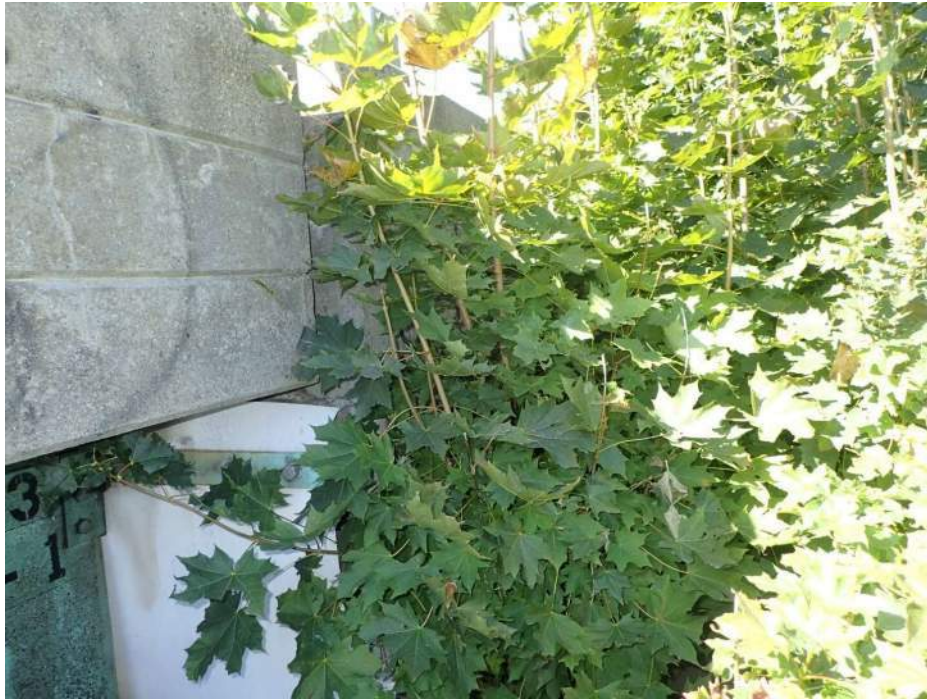
PHOTO 49 Condition

Description Abutment 1 - North return Wingwall, heavy brush

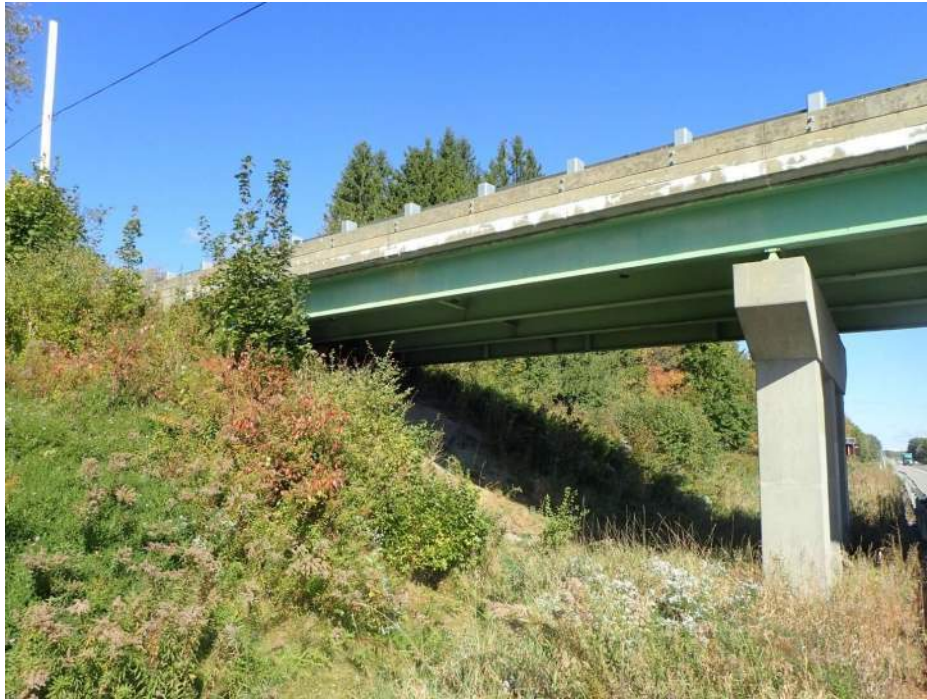
PHOTO 53 Condition

Description Span 1 - South Elevation, heavy efflorescence on fascia

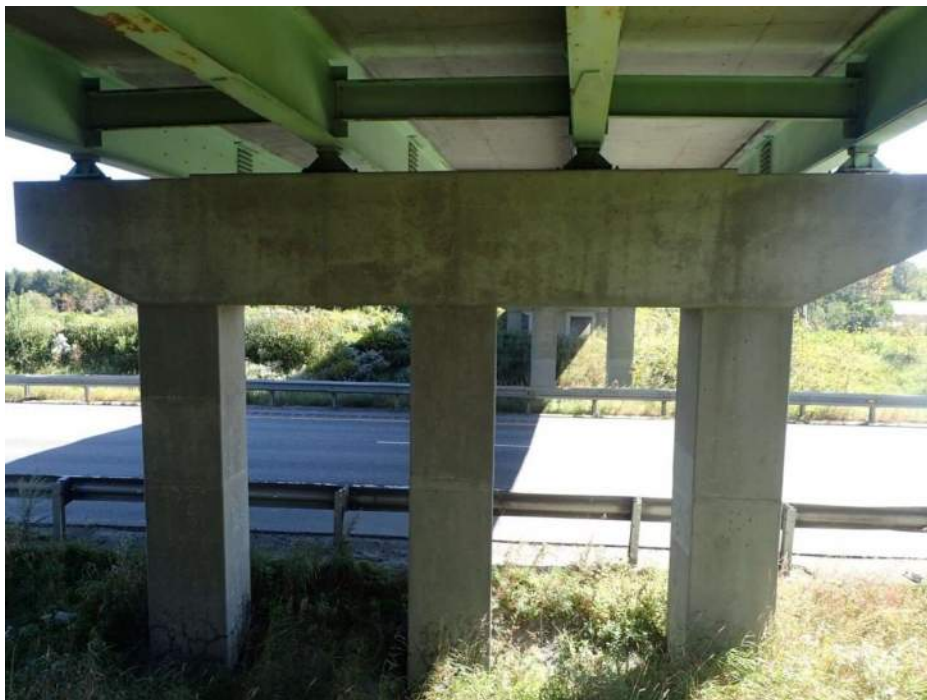
PHOTO 55 Condition
Description Pier 1 - West Elevation

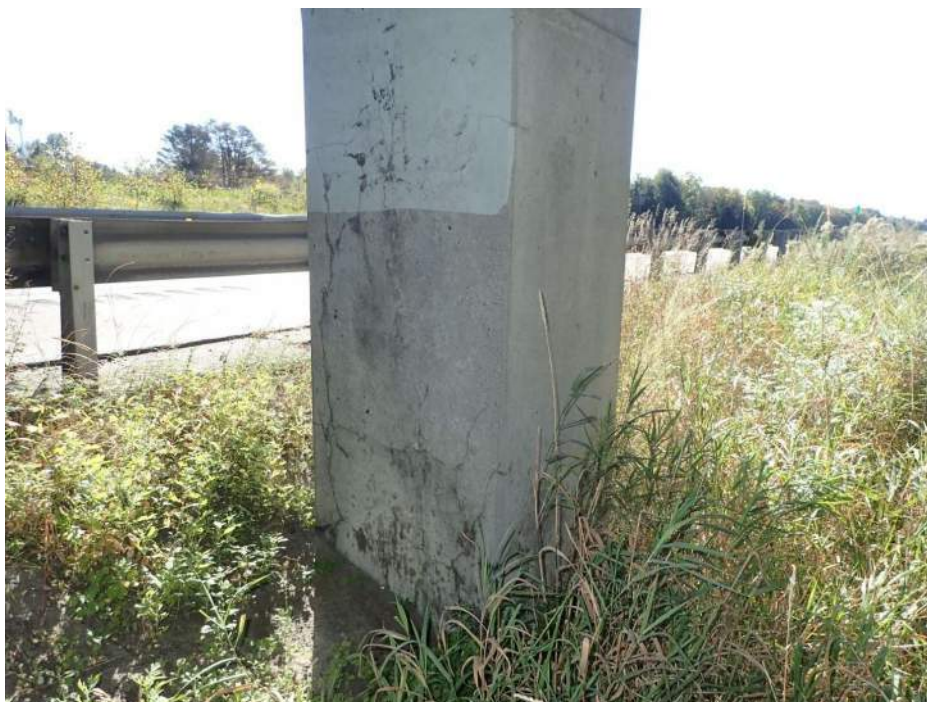
All piers have hairline cracking near existing ground levels and scattered moderate pattern map cracking throughout the columns. Pier 1 exhibits a wide vertical crack with associated delamination on the inside face.

PHOTO 56 Condition
Description Pier 1 - cracking, map cracking on column at ground level

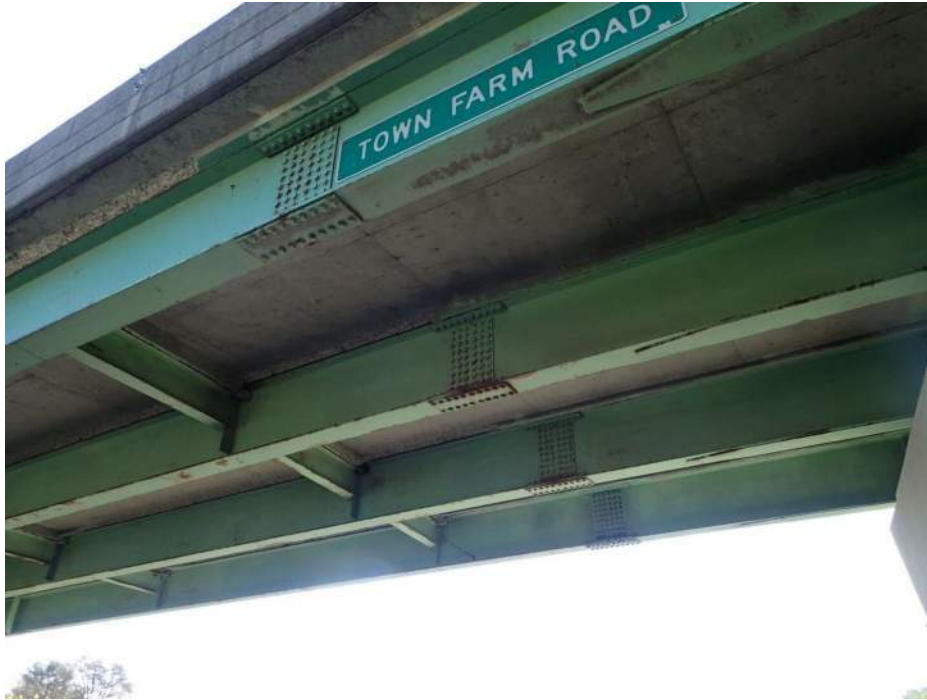
PHOTO 61 Condition
Description Span 2 - Splices

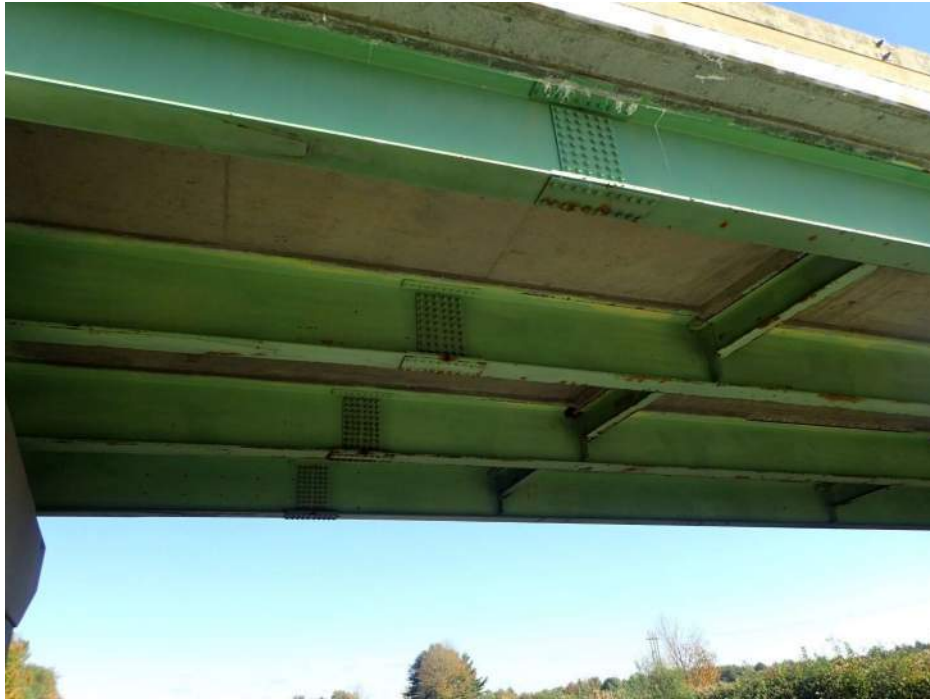
PHOTO 63 Condition

Description Span 2 - South overhang, some cracks with light efflorescence on the overhang. Heavy efflorescence on the fascia.

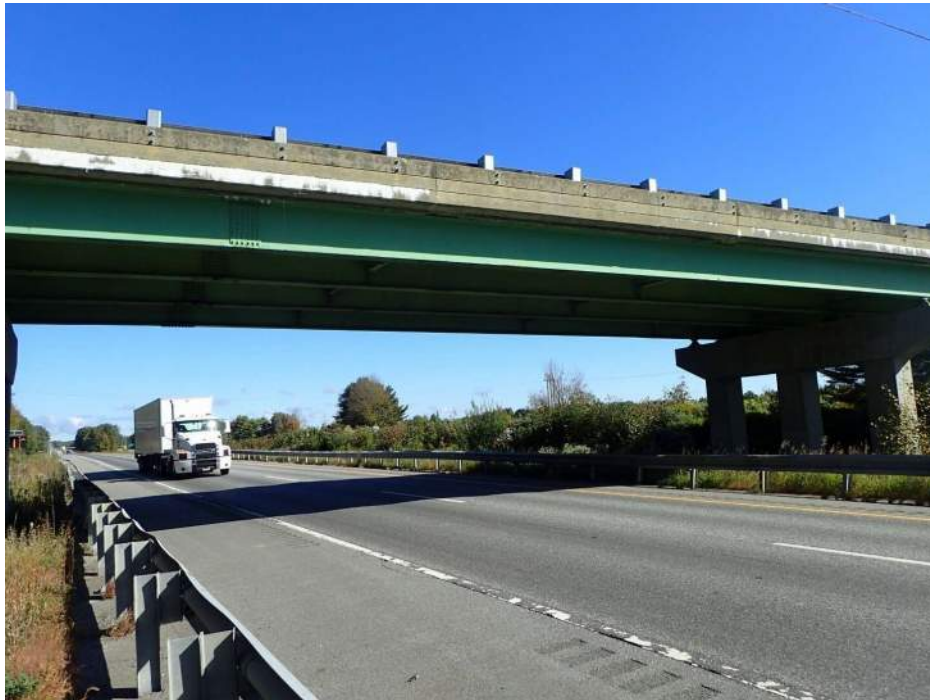
PHOTO 64 Condition

Description Span 2 - Heavy efflorescence on the fascia.

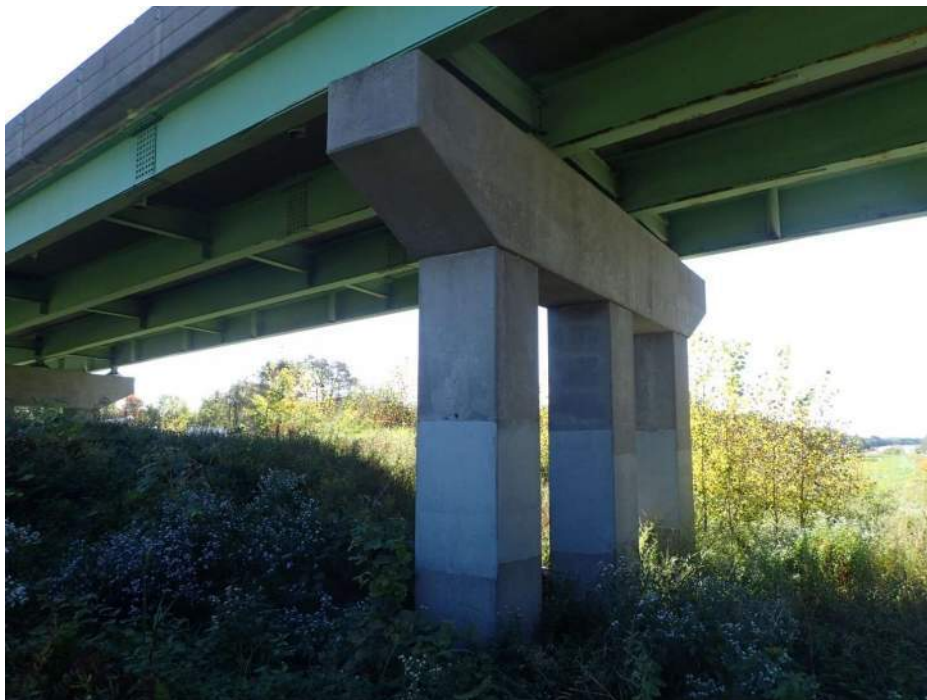
PHOTO 66 Condition
Description Pier 2 - North End

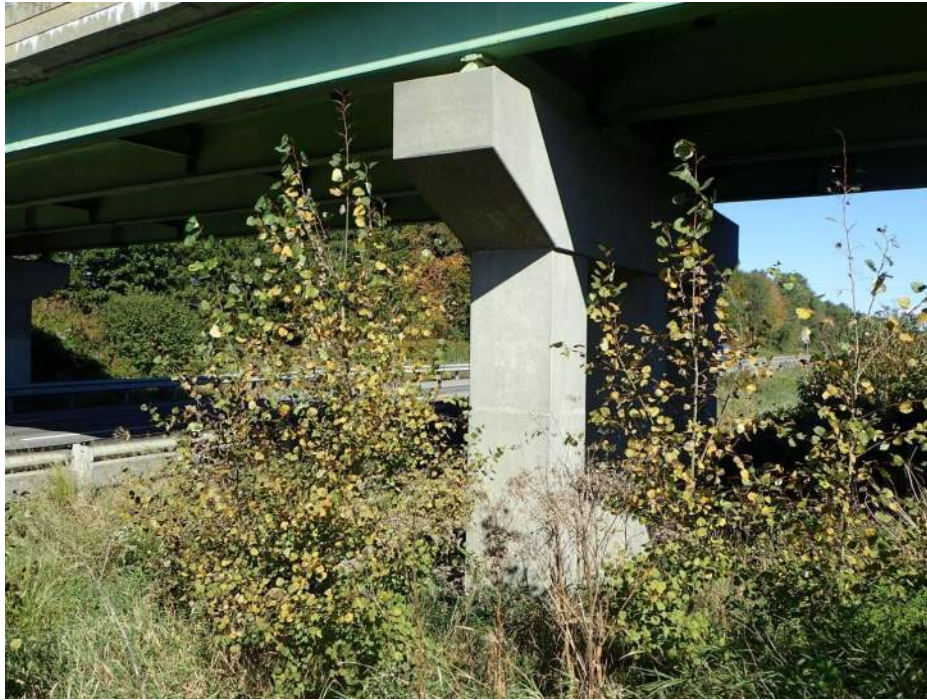
PHOTO 69 Condition
Description Pier 2 - South End

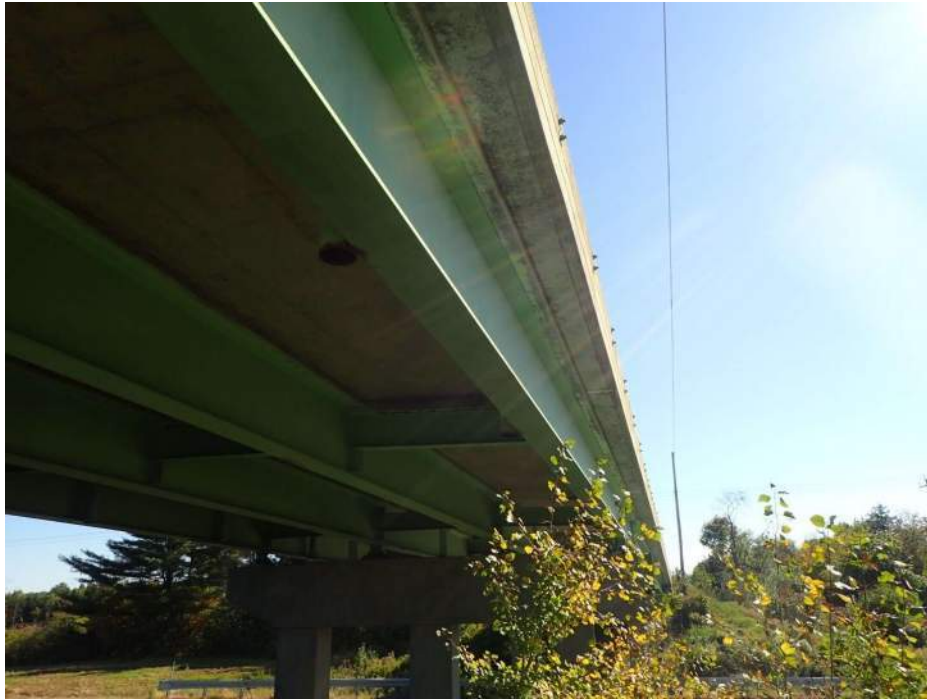
PHOTO 71 Condition

Description Span 3 - South overhang, some cracks with light efflorescence at diaphragms / joints (typ)

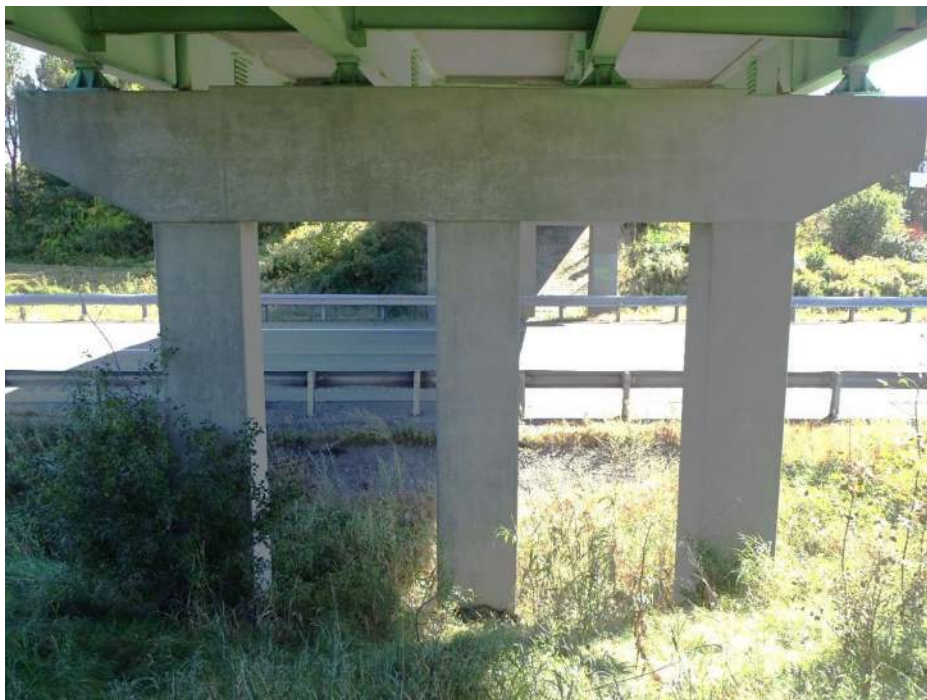
PHOTO 75 Condition

Description Pier 3 - West elevation
