Structure Number: 5785
Facility Carried: TOWN FARM RD

Highway Bridge Inspection Report

Inspection Type(s): Routine

Bridge Name: TOWN FARM RD / I-95

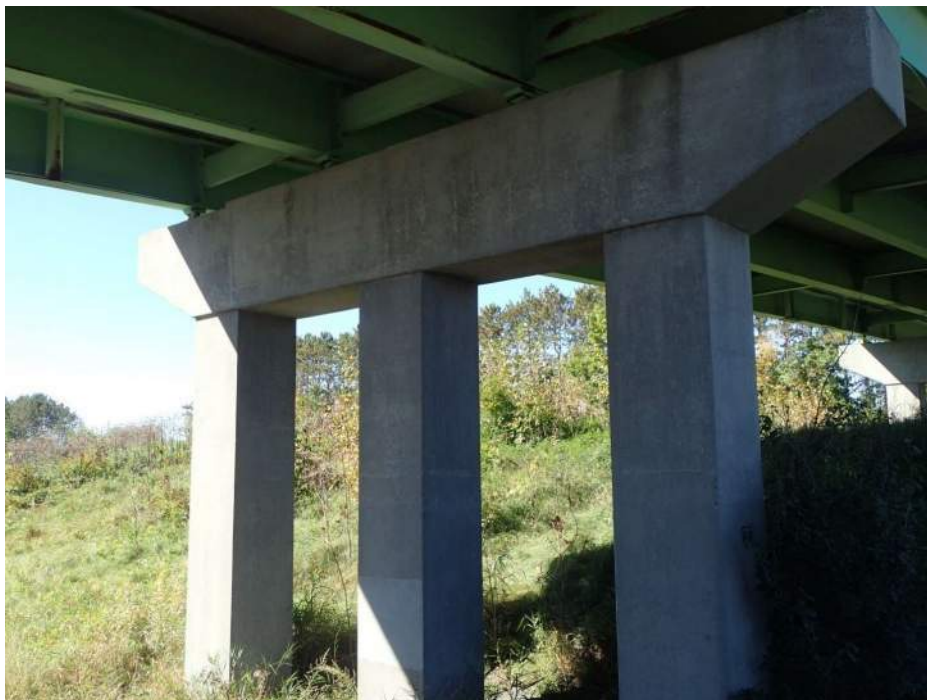
PHOTO 76 Condition

Description Pier 3 - East Elevation

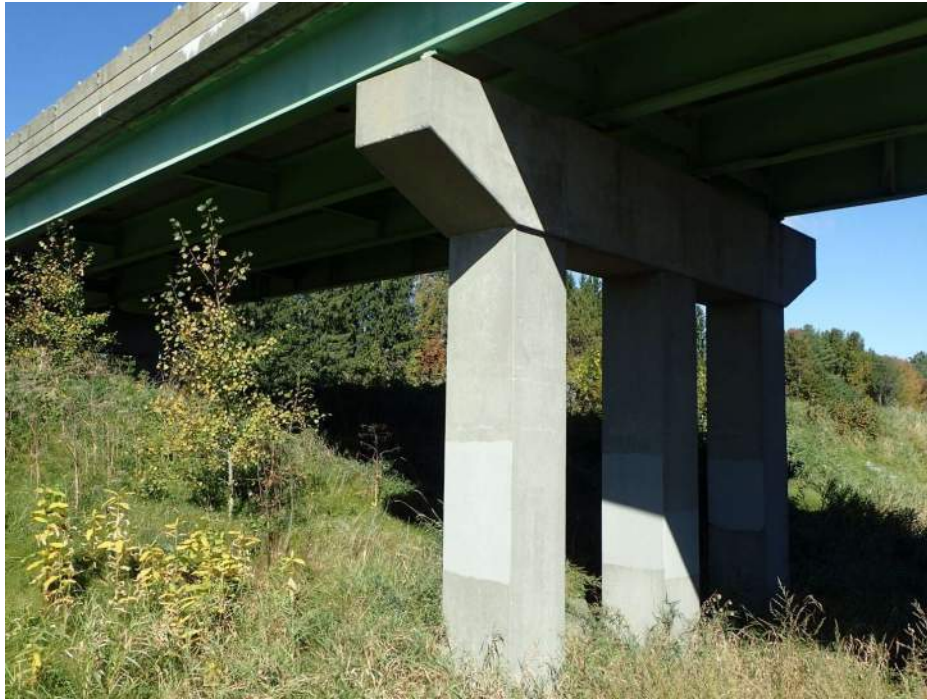
PHOTO 77 Condition
Description Pier 3 - South End

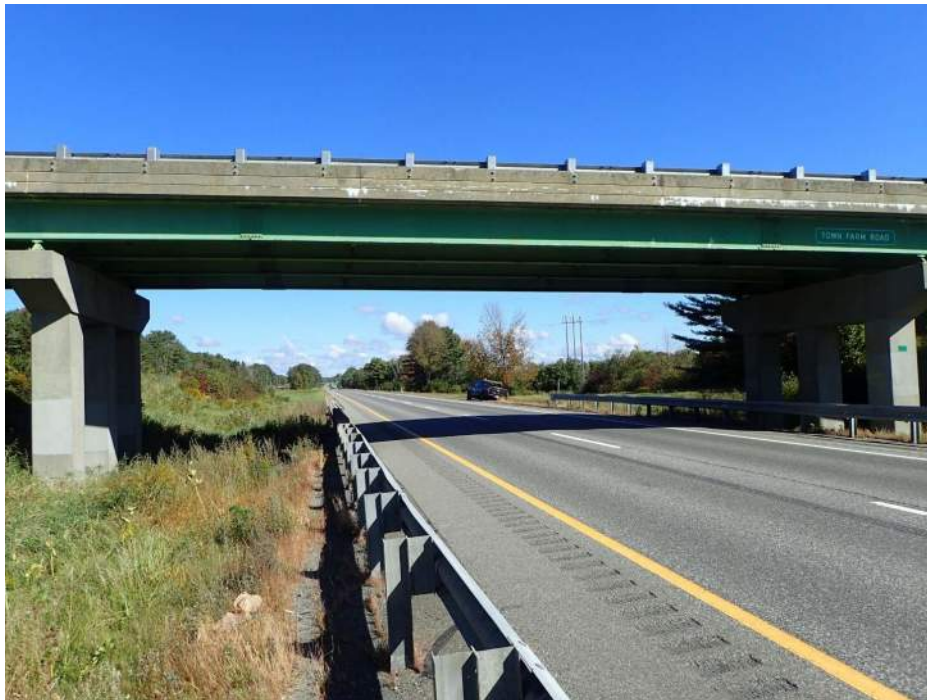
PHOTO 78 Condition
Description Span 4 - South Fascia

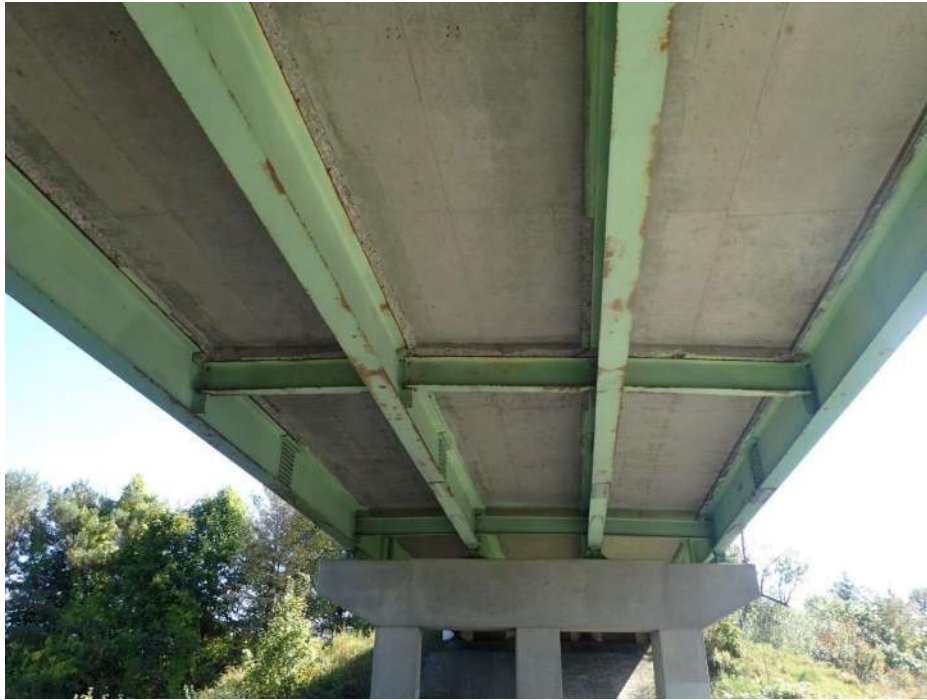
PHOTO 81 Condition

There is widespread spalled and delaminated haunches in Spans 2 and 4 (over roadway).

Description Span 4 - deck & framing, note, span is over NB lanes of I95, much of the haunch spalled but many areas still intact. Cannot confirm how secure remaining haunches are over either the NB or SB lanes (typical)

Type	Work Item	Priority	Notes
Safety	Remove Delams Over Traffic	1	Remove remaining girder haunch extensions over the travel lanes of I95
Preservation	Rehab Substructure	2	
Preservation	Coat Beam Ends		
Maintenance	Repair Joint		
Preservation	Paint

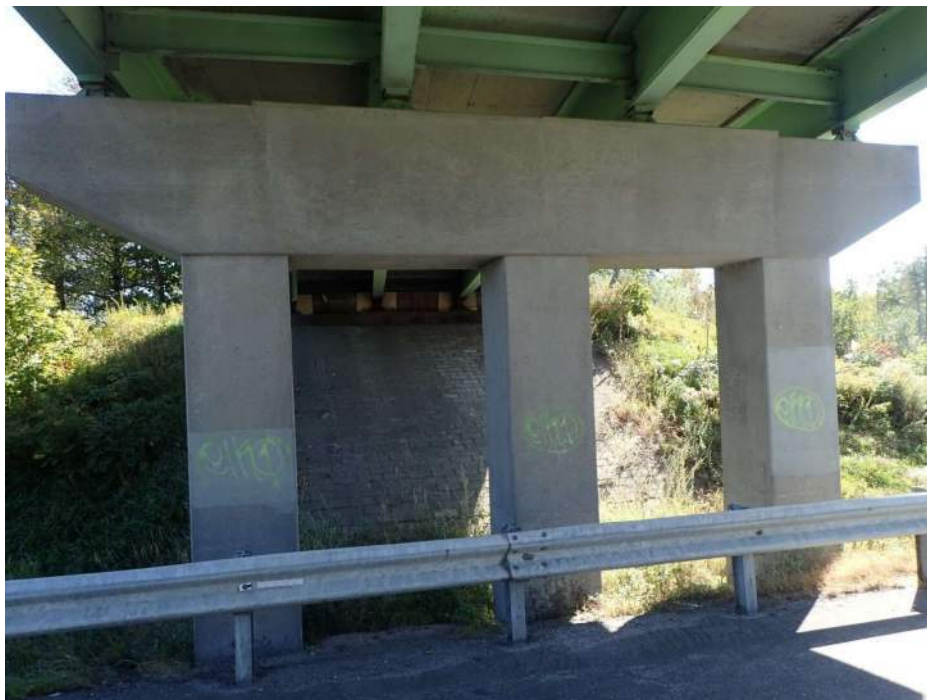
PHOTO 84 Condition

Description Pier 4 - West Elevation

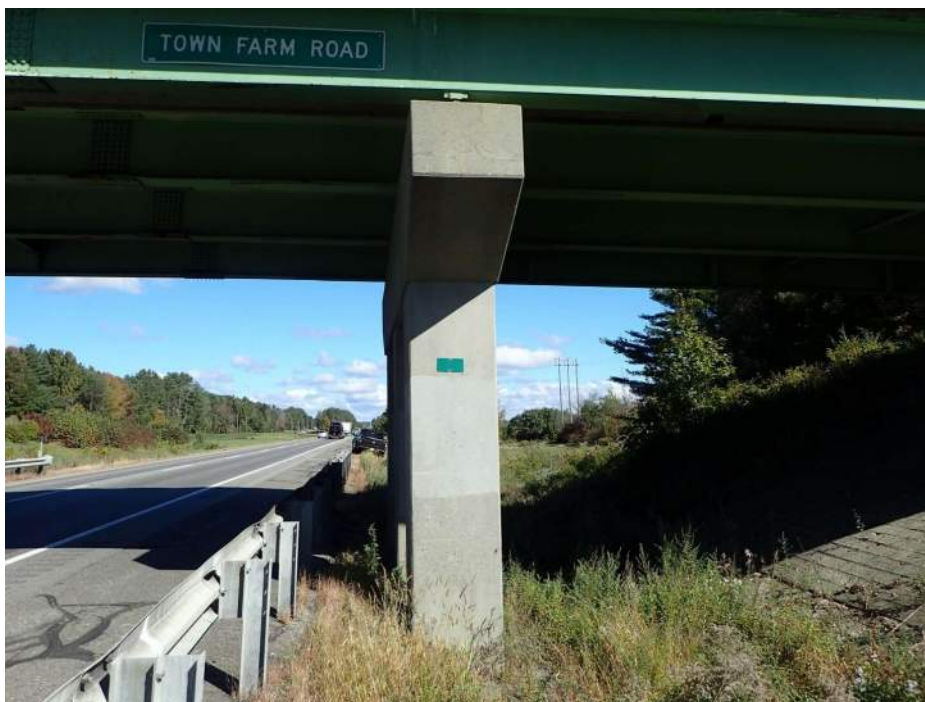
PHOTO 86 Condition

Description Pier 4 - South End

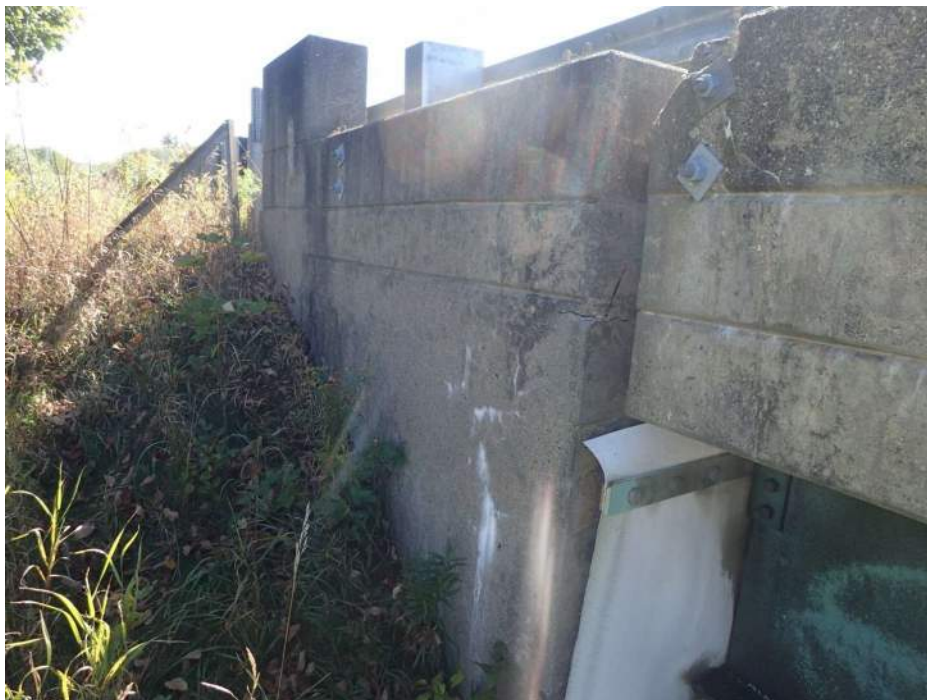
PHOTO 91 Condition

Description Abutment 2 - North return wingwall

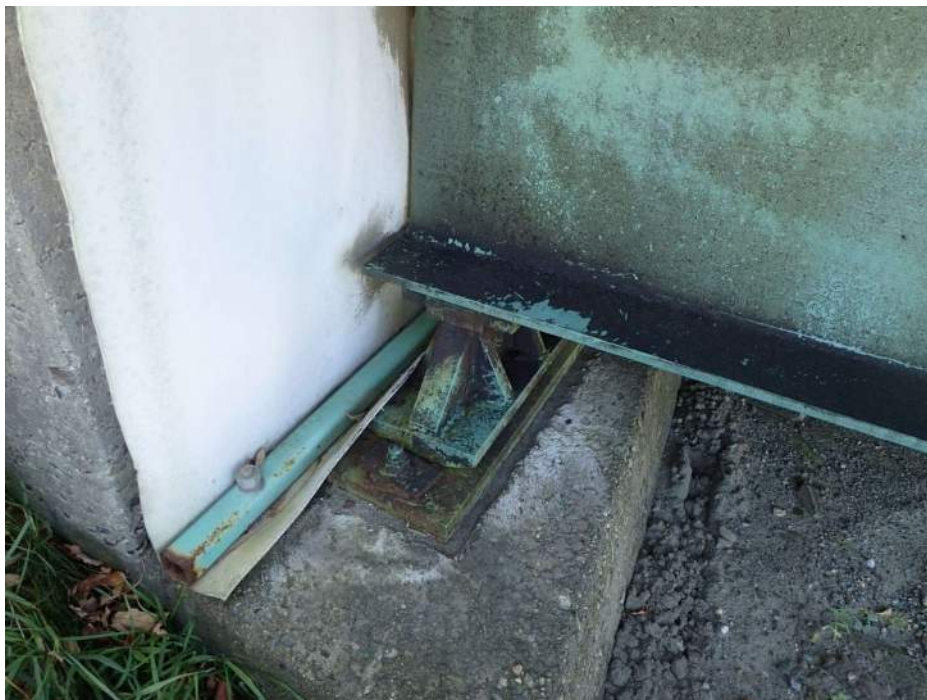
PHOTO 92 Condition

Description Abutment 2 - Girder 1 rocker bearing

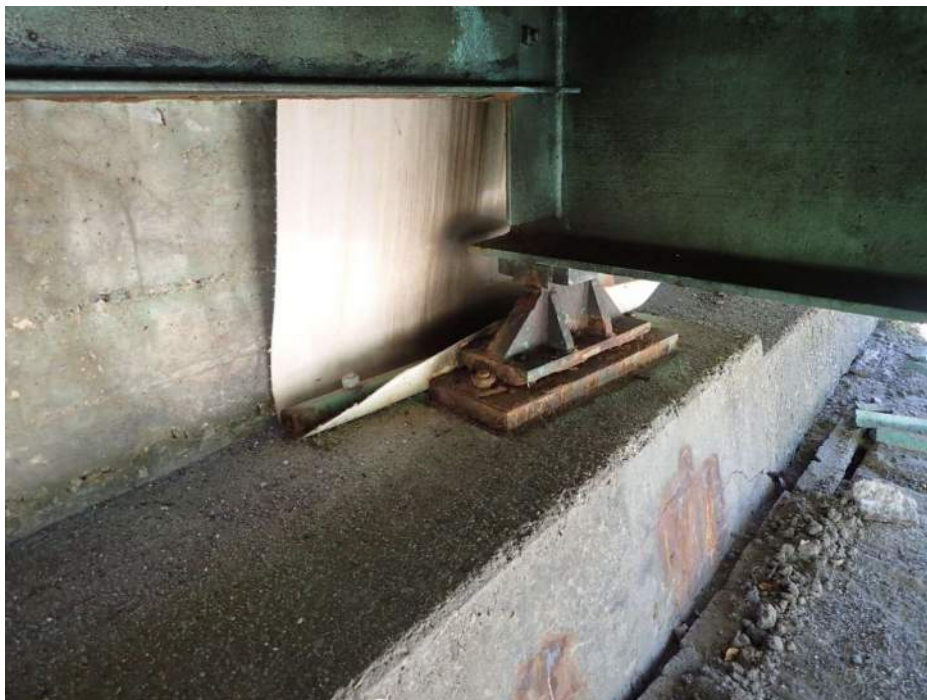
PHOTO 96 Condition

Description Abutment 2 - Girder 3 rocker bearing

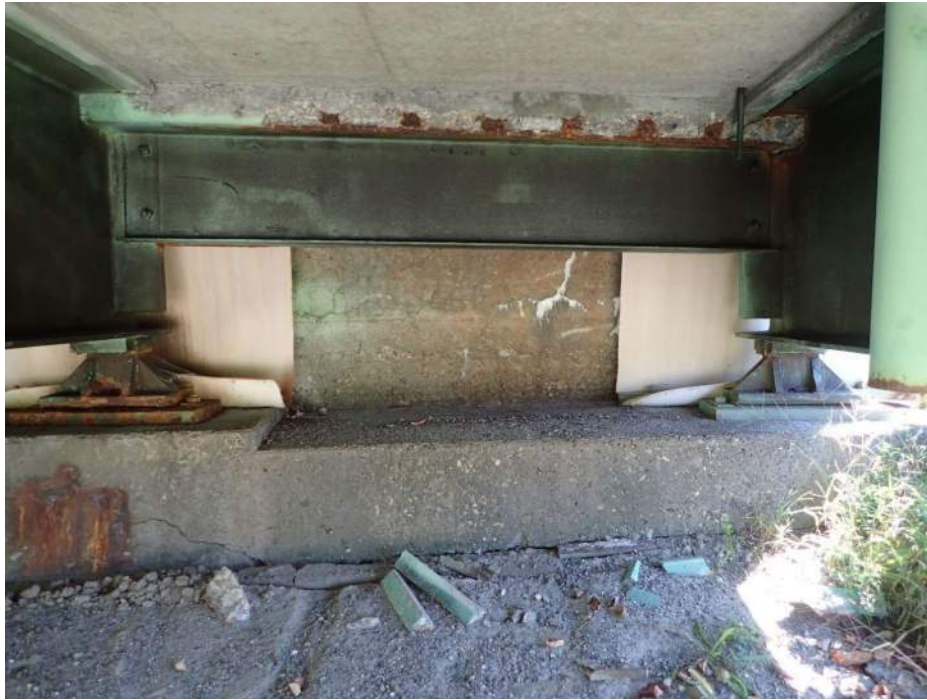
PHOTO 97 Condition

Description Abutment 2 - Bay 3, Girder 3 & 4, scattered cracking & efflorescence

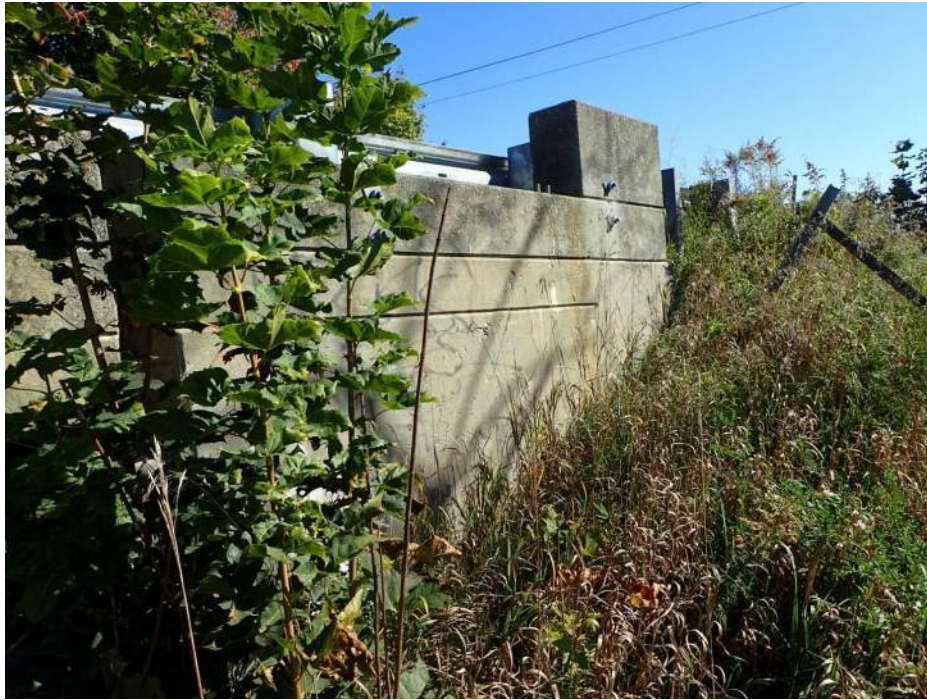
PHOTO 99 Condition

Description Abutment 2 - South return wingwall

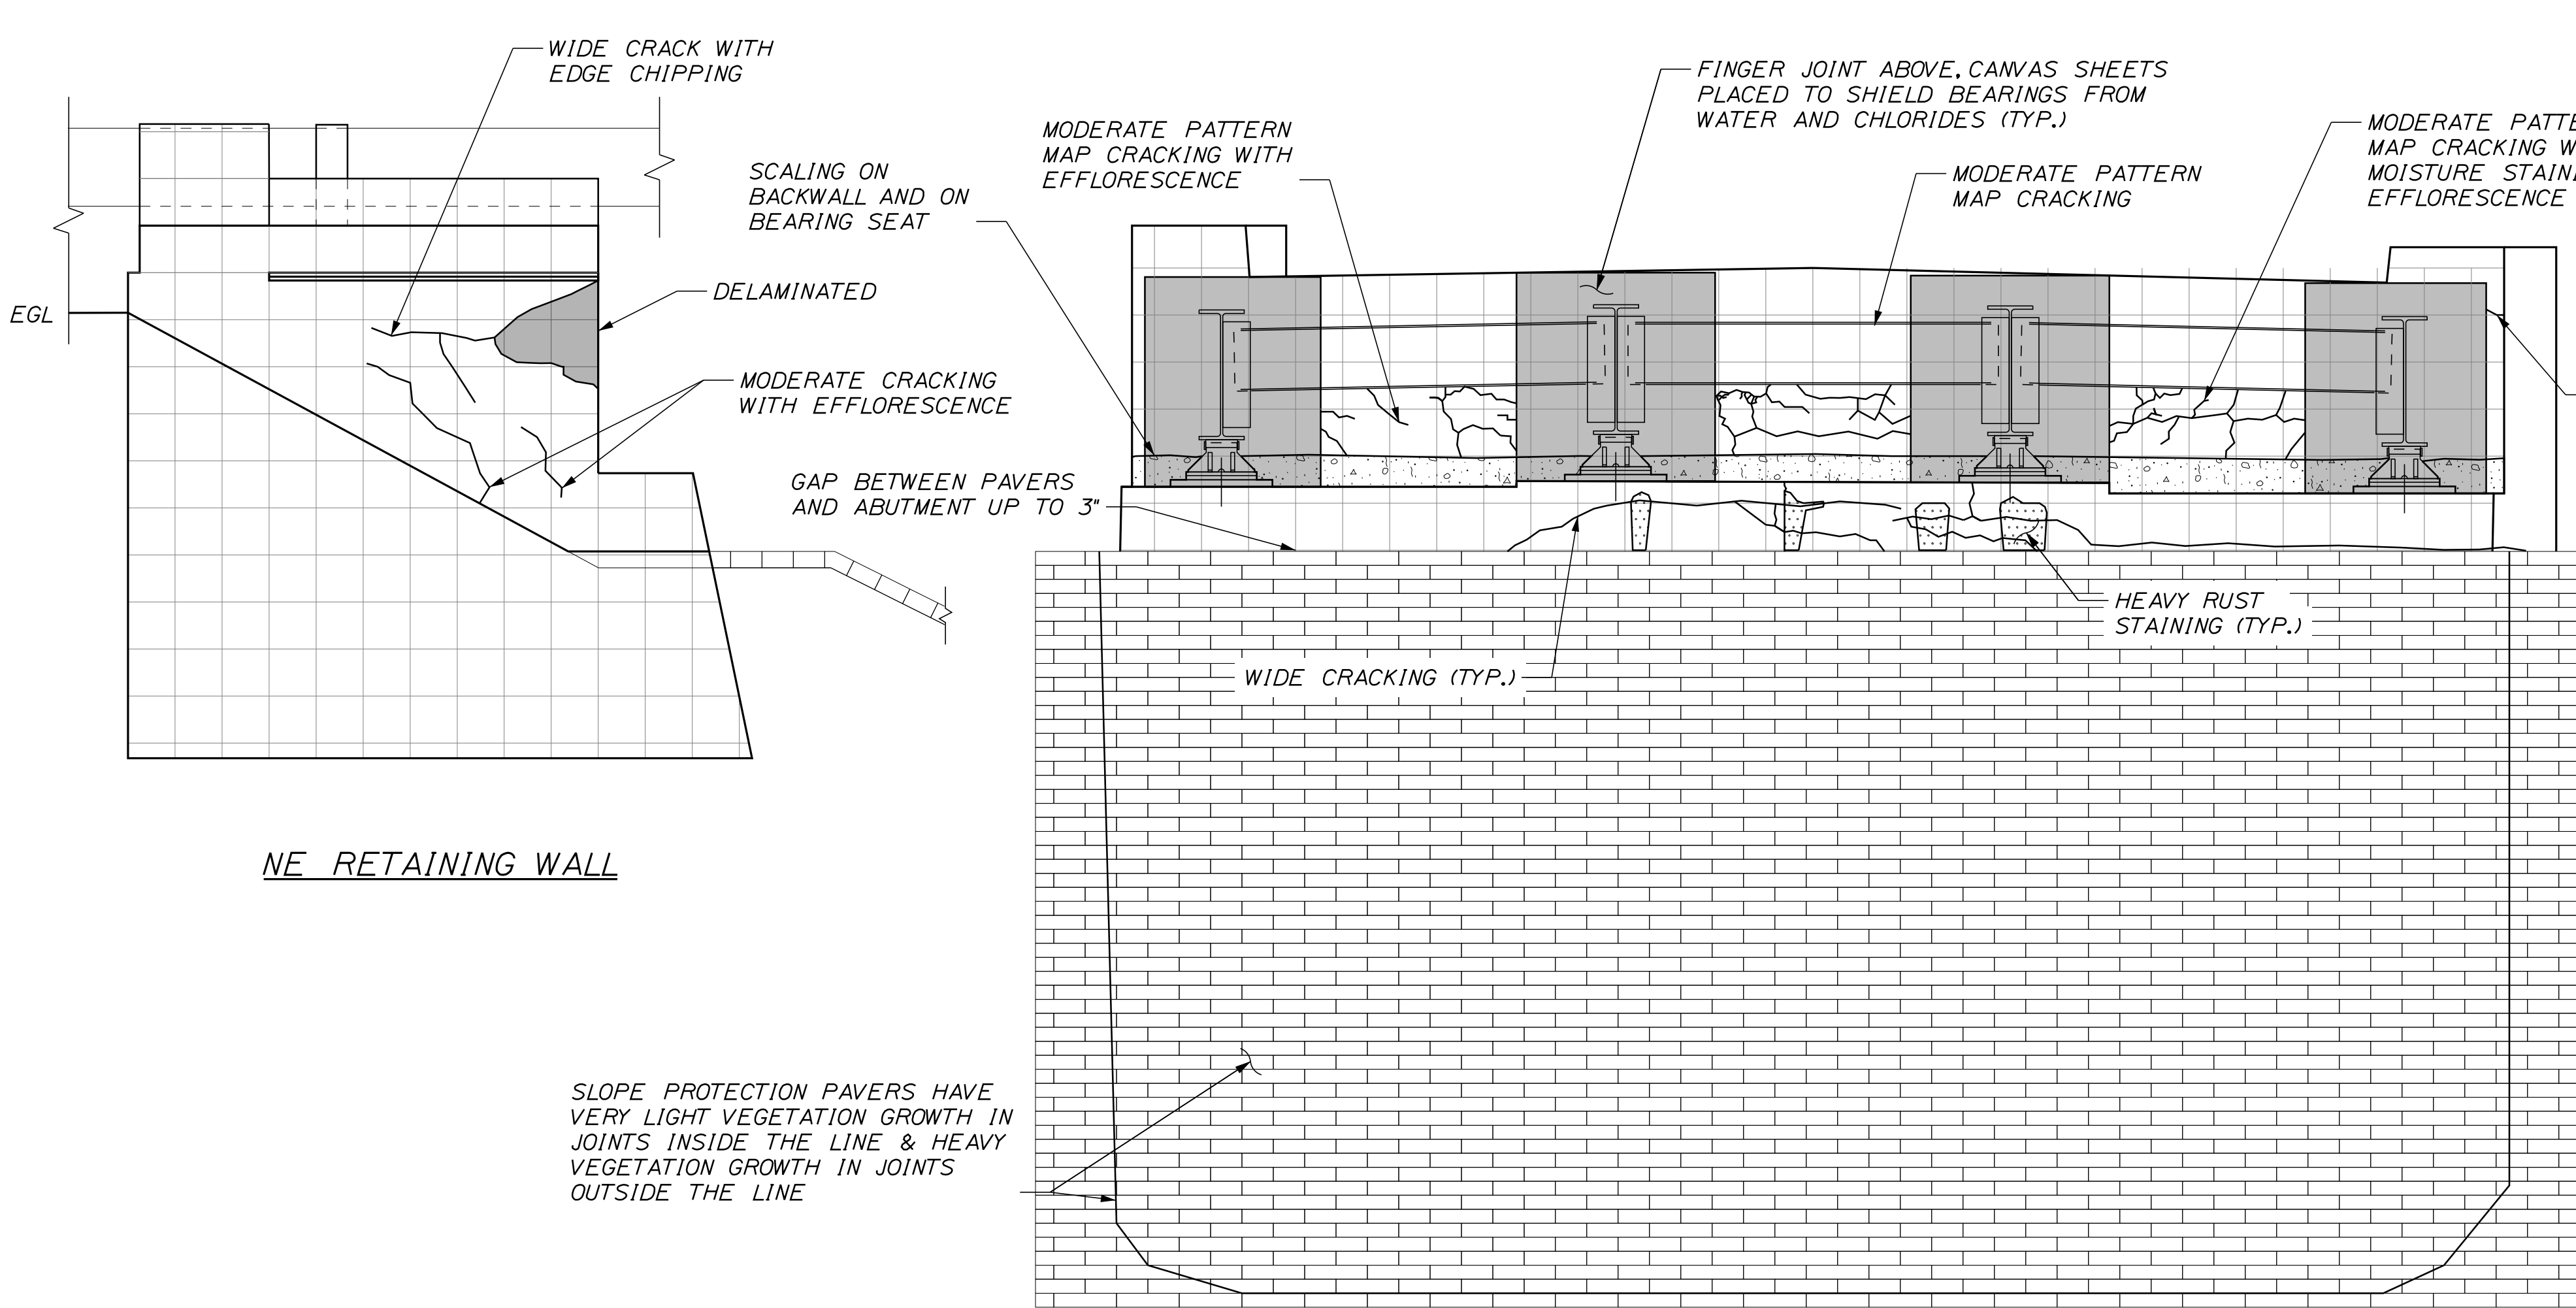
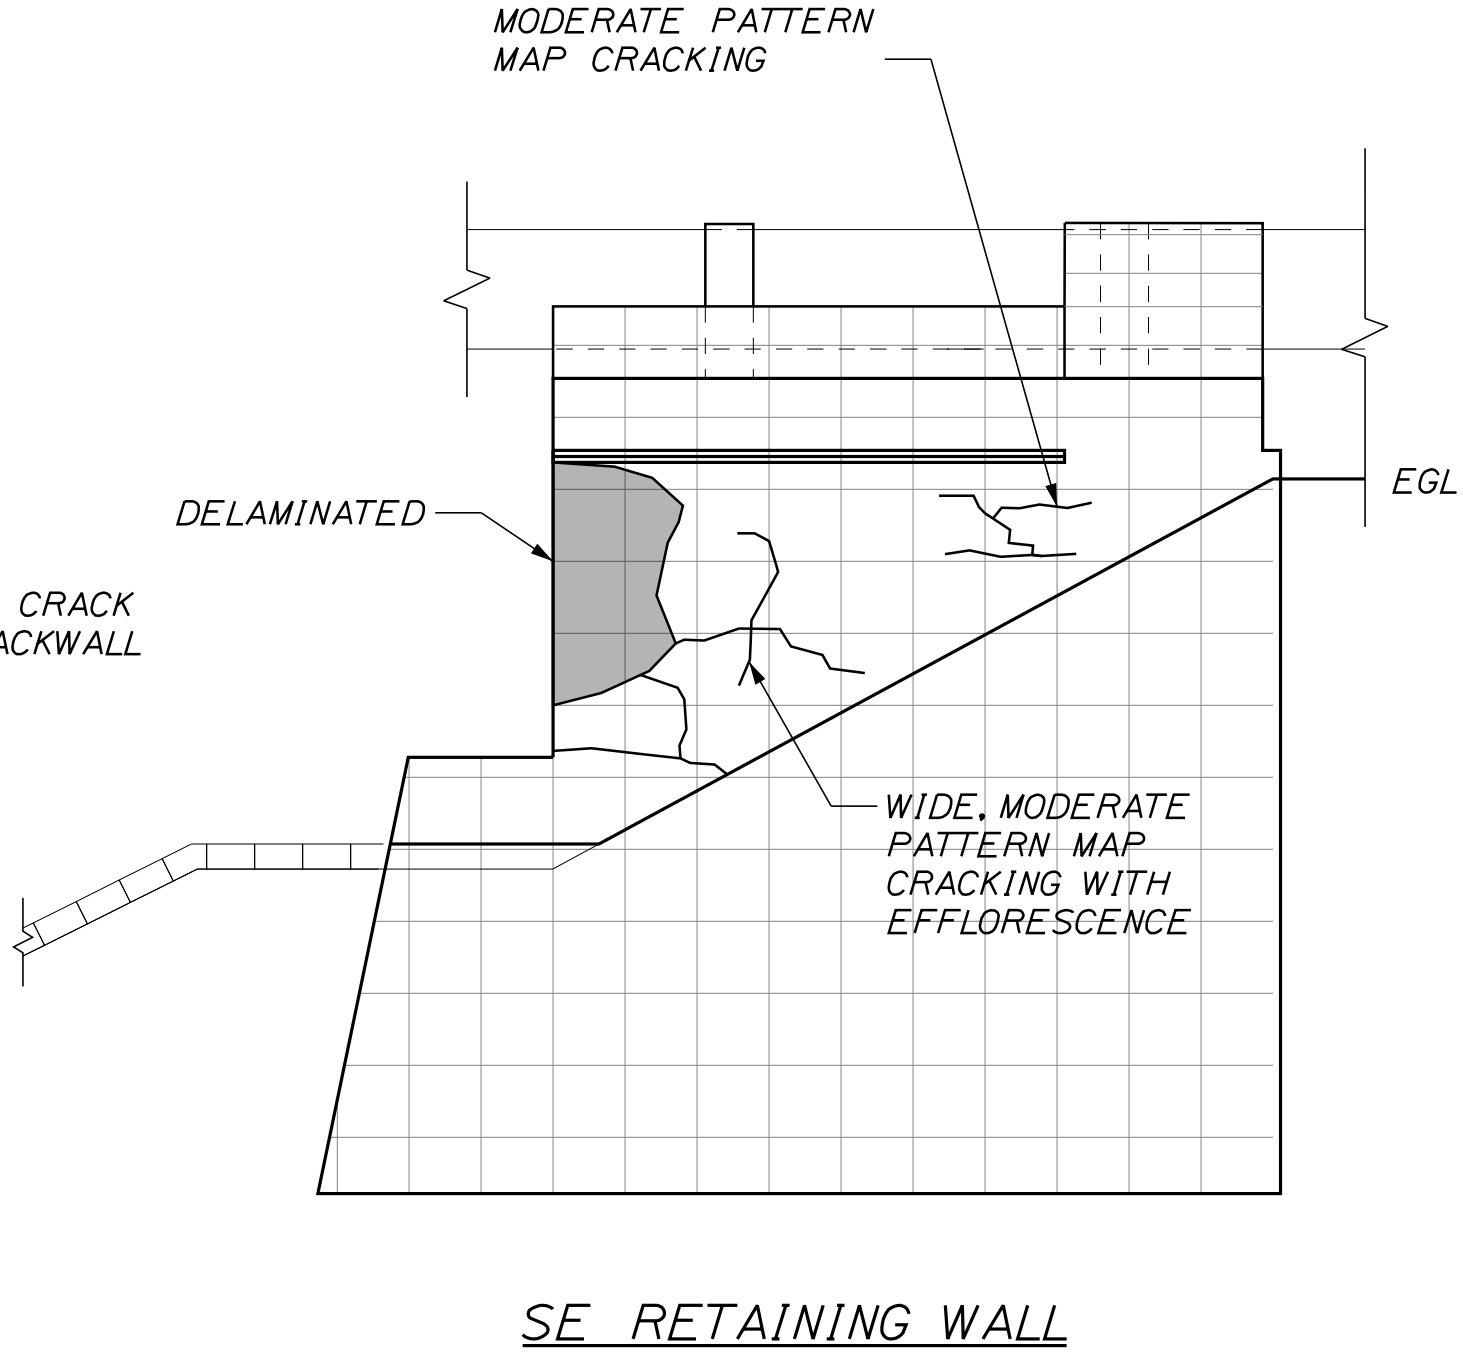
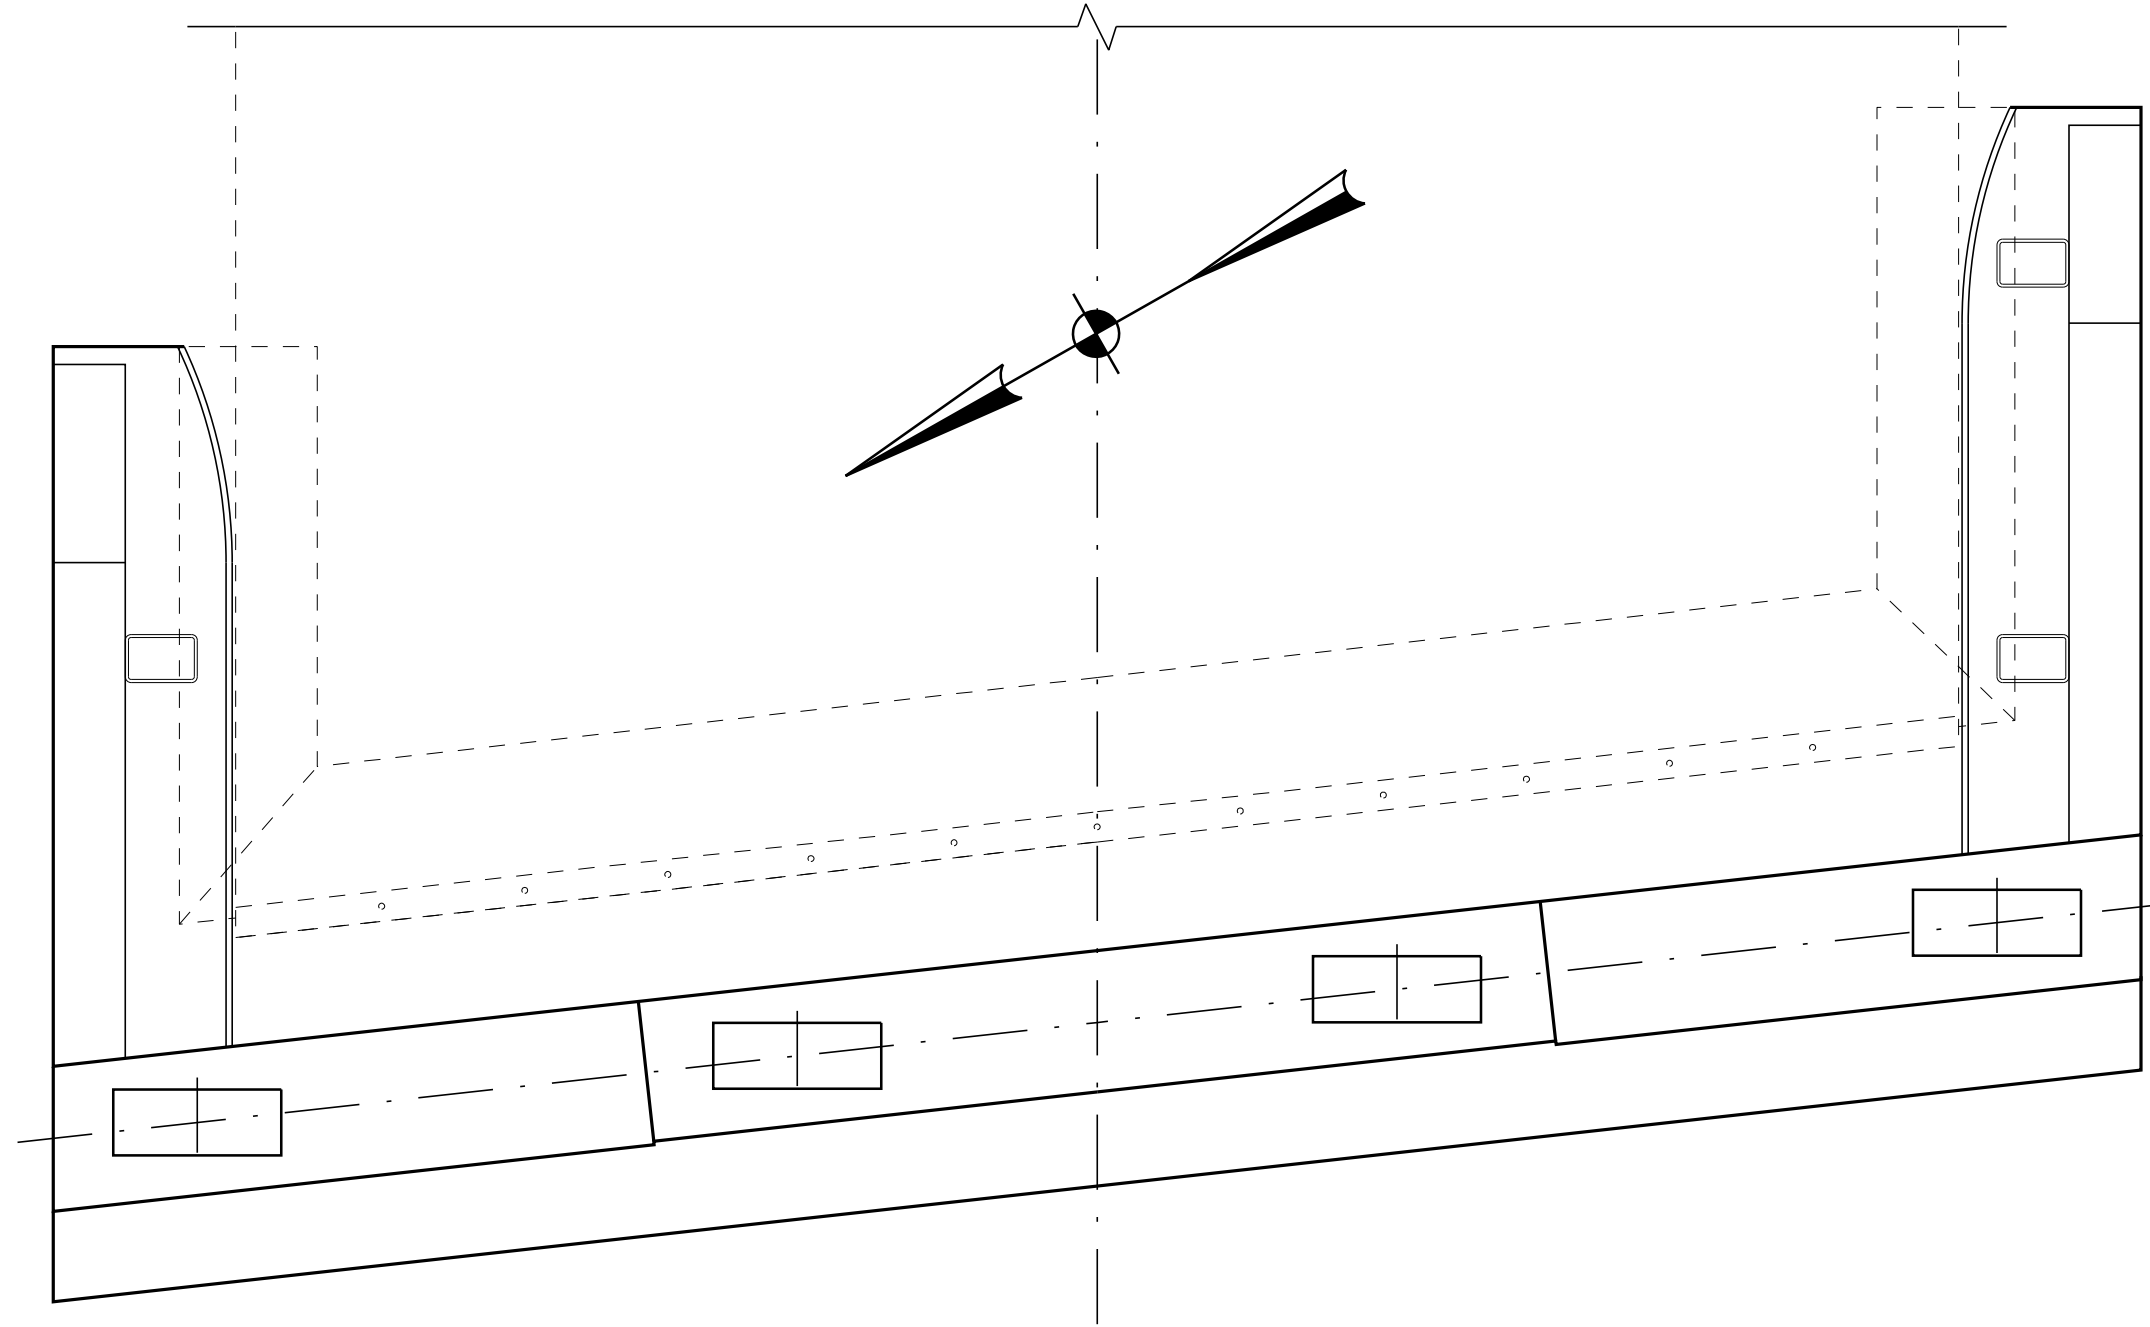
- BEARING NOTES:
1. EXTERIOR ROCKER BEARINGS 1 & 4 EXHIBIT SCATTERED LIGHT SURFACE RUST.
 2. INTERIOR ROCKER BEARINGS 2 & 3 HAVE HEAVY SURFACE CORROSION WITH SOME LIGHT PACK RUST ON BASE PLATE. PACK RUST MAY INHIBIT MOVEMENT.
