I-95-6(13)

SUBSURFACE INVESTIGATION FOR
LYONS ROAD STRUCTURE
INTERSTATE HIGHWAY PROJECT
SIDNEY, MAINE

State Highway Commission
Soils Division

April 1958

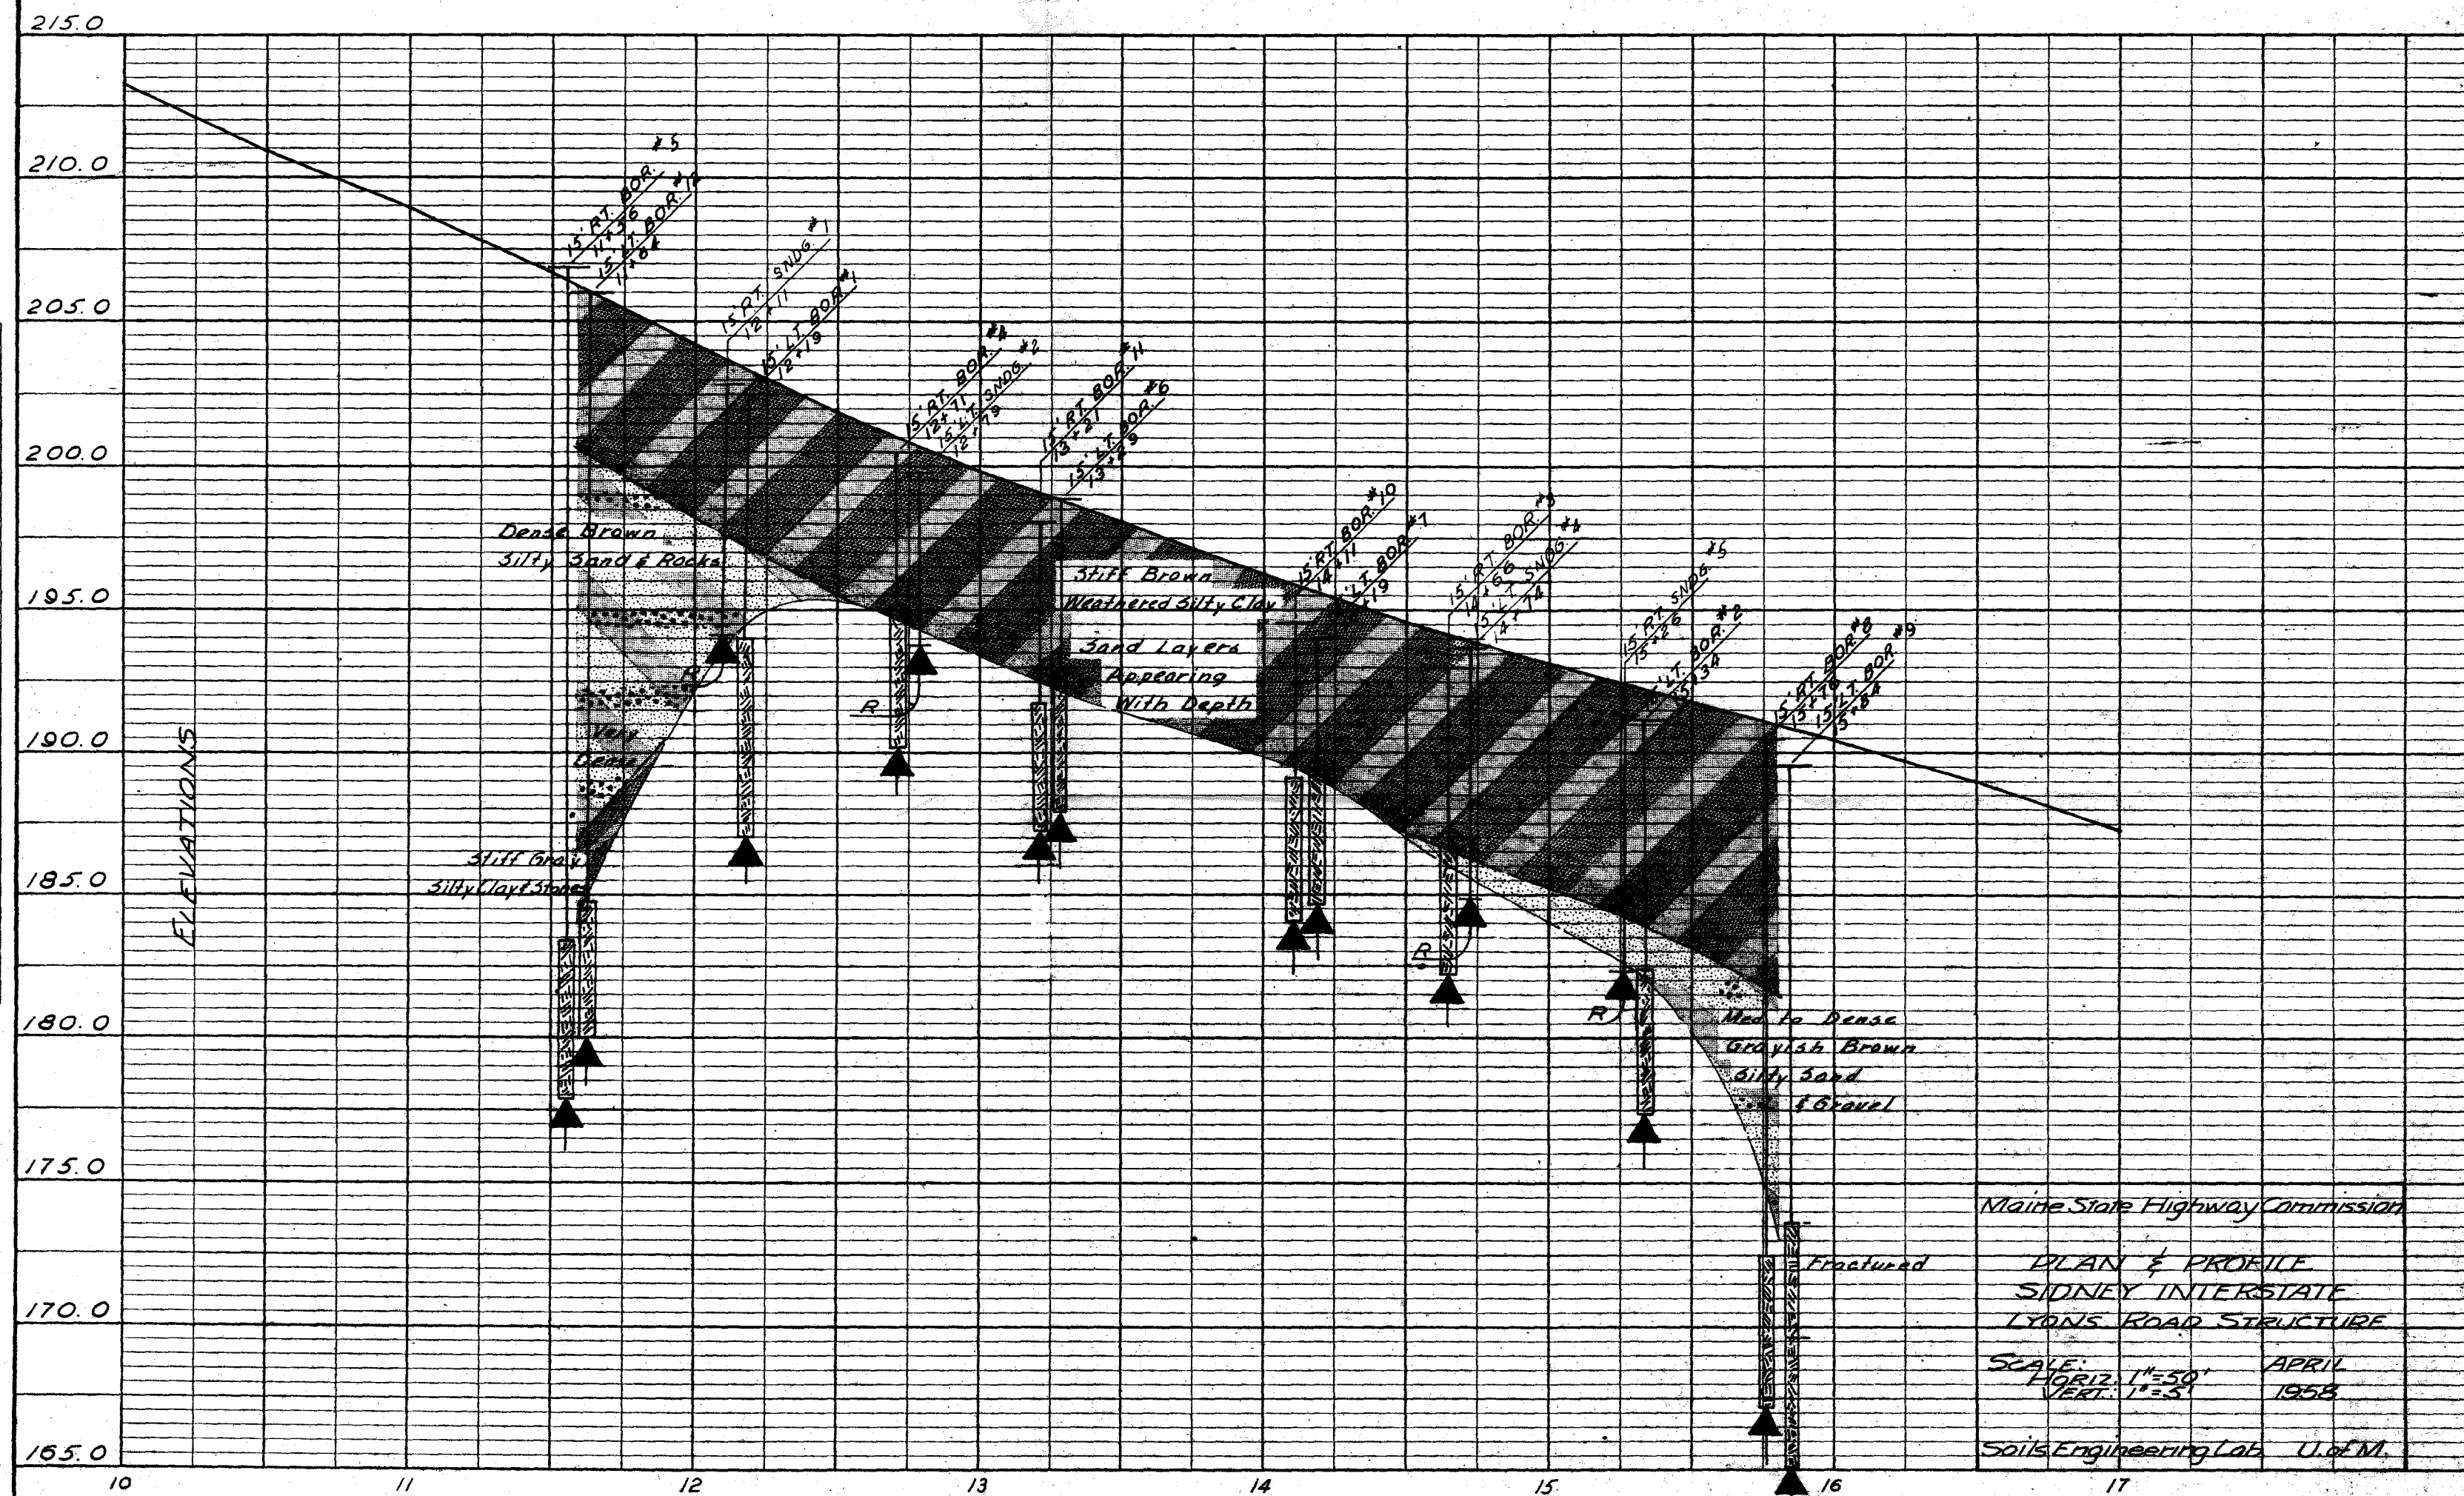
Maine State Highway Commission
PLAN & PROFILE
SIDNEY INTERSTATE
LYONS ROAD STRUCTURE
SCALE: HORIZ. 1"=50' VERT. 1"=5'
APRIL 1958
Soils Engineering Lab. U.M.N.

A rather shallow ledge surface (within ten (10) feet of the surface) was noted except at the two extreme abutments, one on the eastern end and the other on the westerly end. On these two (2) ends the ledge drops more than twenty (20) feet from the ground surface. The general shape of the ledge profile is that of a fold; that is, the ledge has been squeezed together. The squeezing causes a vertical alignment of the fine grained particles and as such, cleavage or breakage easily occurs. This is greatest at the ends

and was noted by poor recovery of the ledge cores. The ledge under the piers and middle abutments is, however, firm and should provide adequate support for direct contact pressures of the piers and abutments. Allowable bearing values for this ledge would be twenty to thirty (20-30) tons per square foot, with the lower range to be used on end bearing piles.

The overburden at the top of this fold is a firm weathered silty clay with the sand content increasing with depth. At either end, a layer of compact silty sand appears below which appears a hard pebbly silt. Because the weathered silty clay will consolidate slightly under additional loading, and also because of the proximity to a good ledge surface, it is recommended that the bridge substructures be supported directly on ledge and at the deeper end by end frictional piles driven through the fill or on spread footings placed in the dense silty sand and gravel.

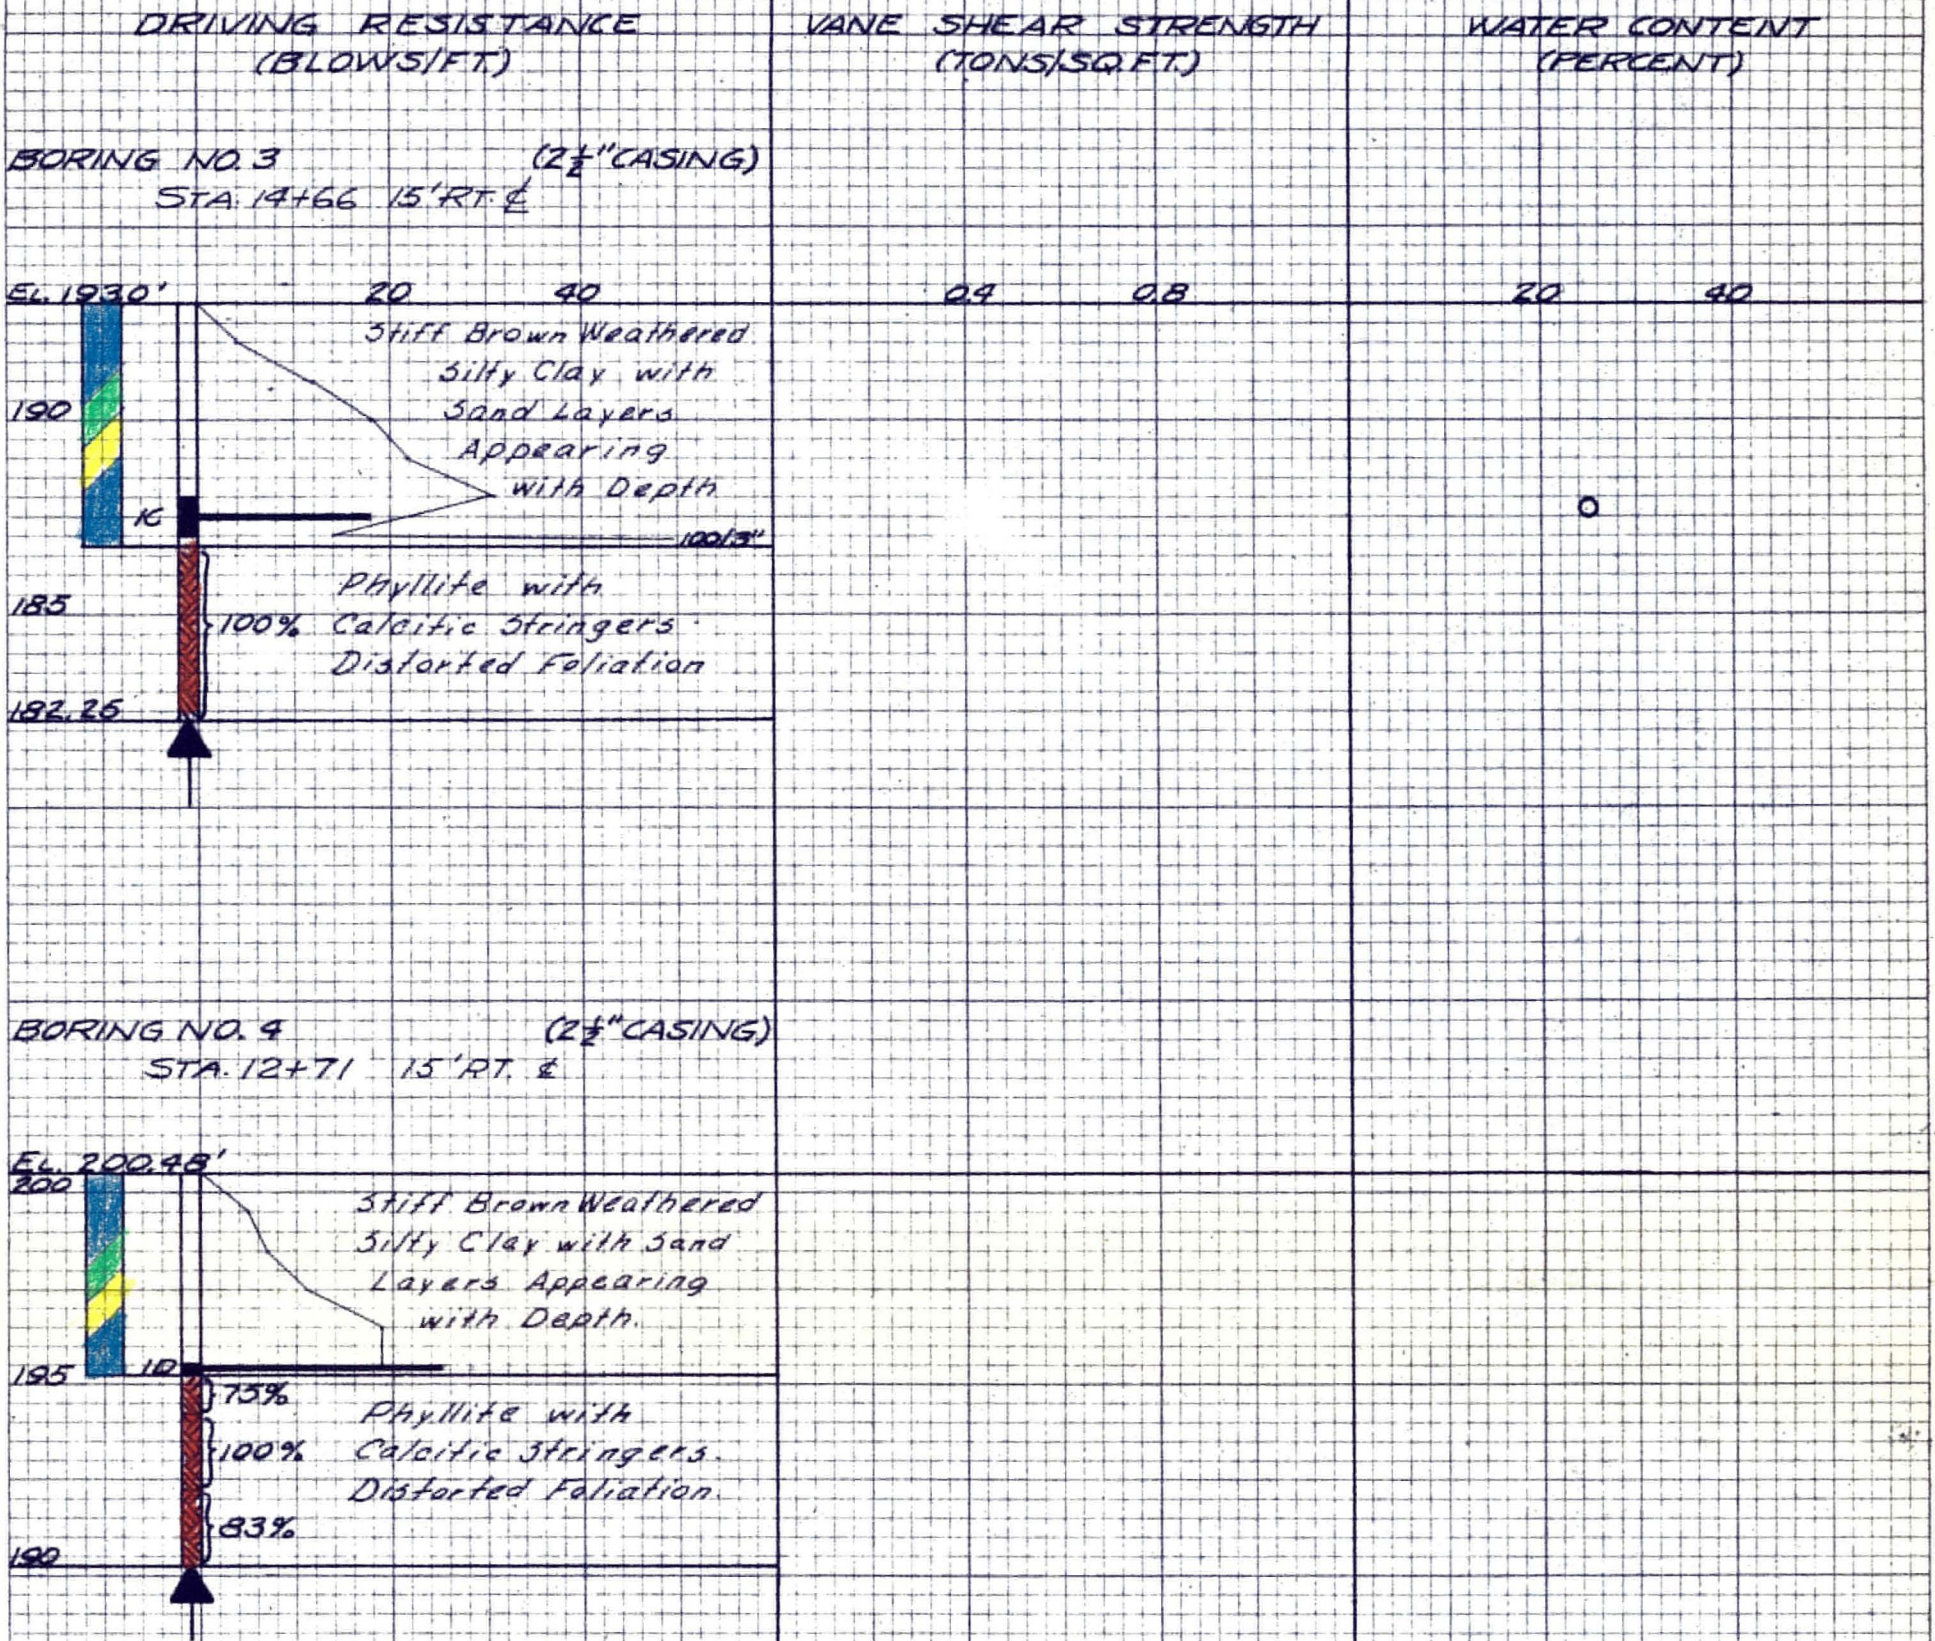
MAINE STATE HIGHWAY COMMISSION
DETAILED SOIL STRATIFICATION
&
CONSISTENCY DATA
BORINGS NO. 3 & 4
SIDNEY INTERSTATE
LYONS ROAD STRUCTURE
SCALE: 1" = 5' APR. 1958
SOILS ENGINEERING LAB UDEME

Pier No. 1. Boring 3 (Sheet 6) and the transverse profile (Sheet 2) shows the subsurface profile at the proposed location of Pier No. 2. Ledge was noted six (6) feet below the surface on the south end of the pier and a rod sounding at the northerly end encountered a refusal (believed to be the ledge surface) eight and one half ($8\frac{1}{2}$) feet below the surface. Since a footing should be placed five (5) feet below the surface, it is recommended that Pier No. 2 be directly supported on the ledge surface.

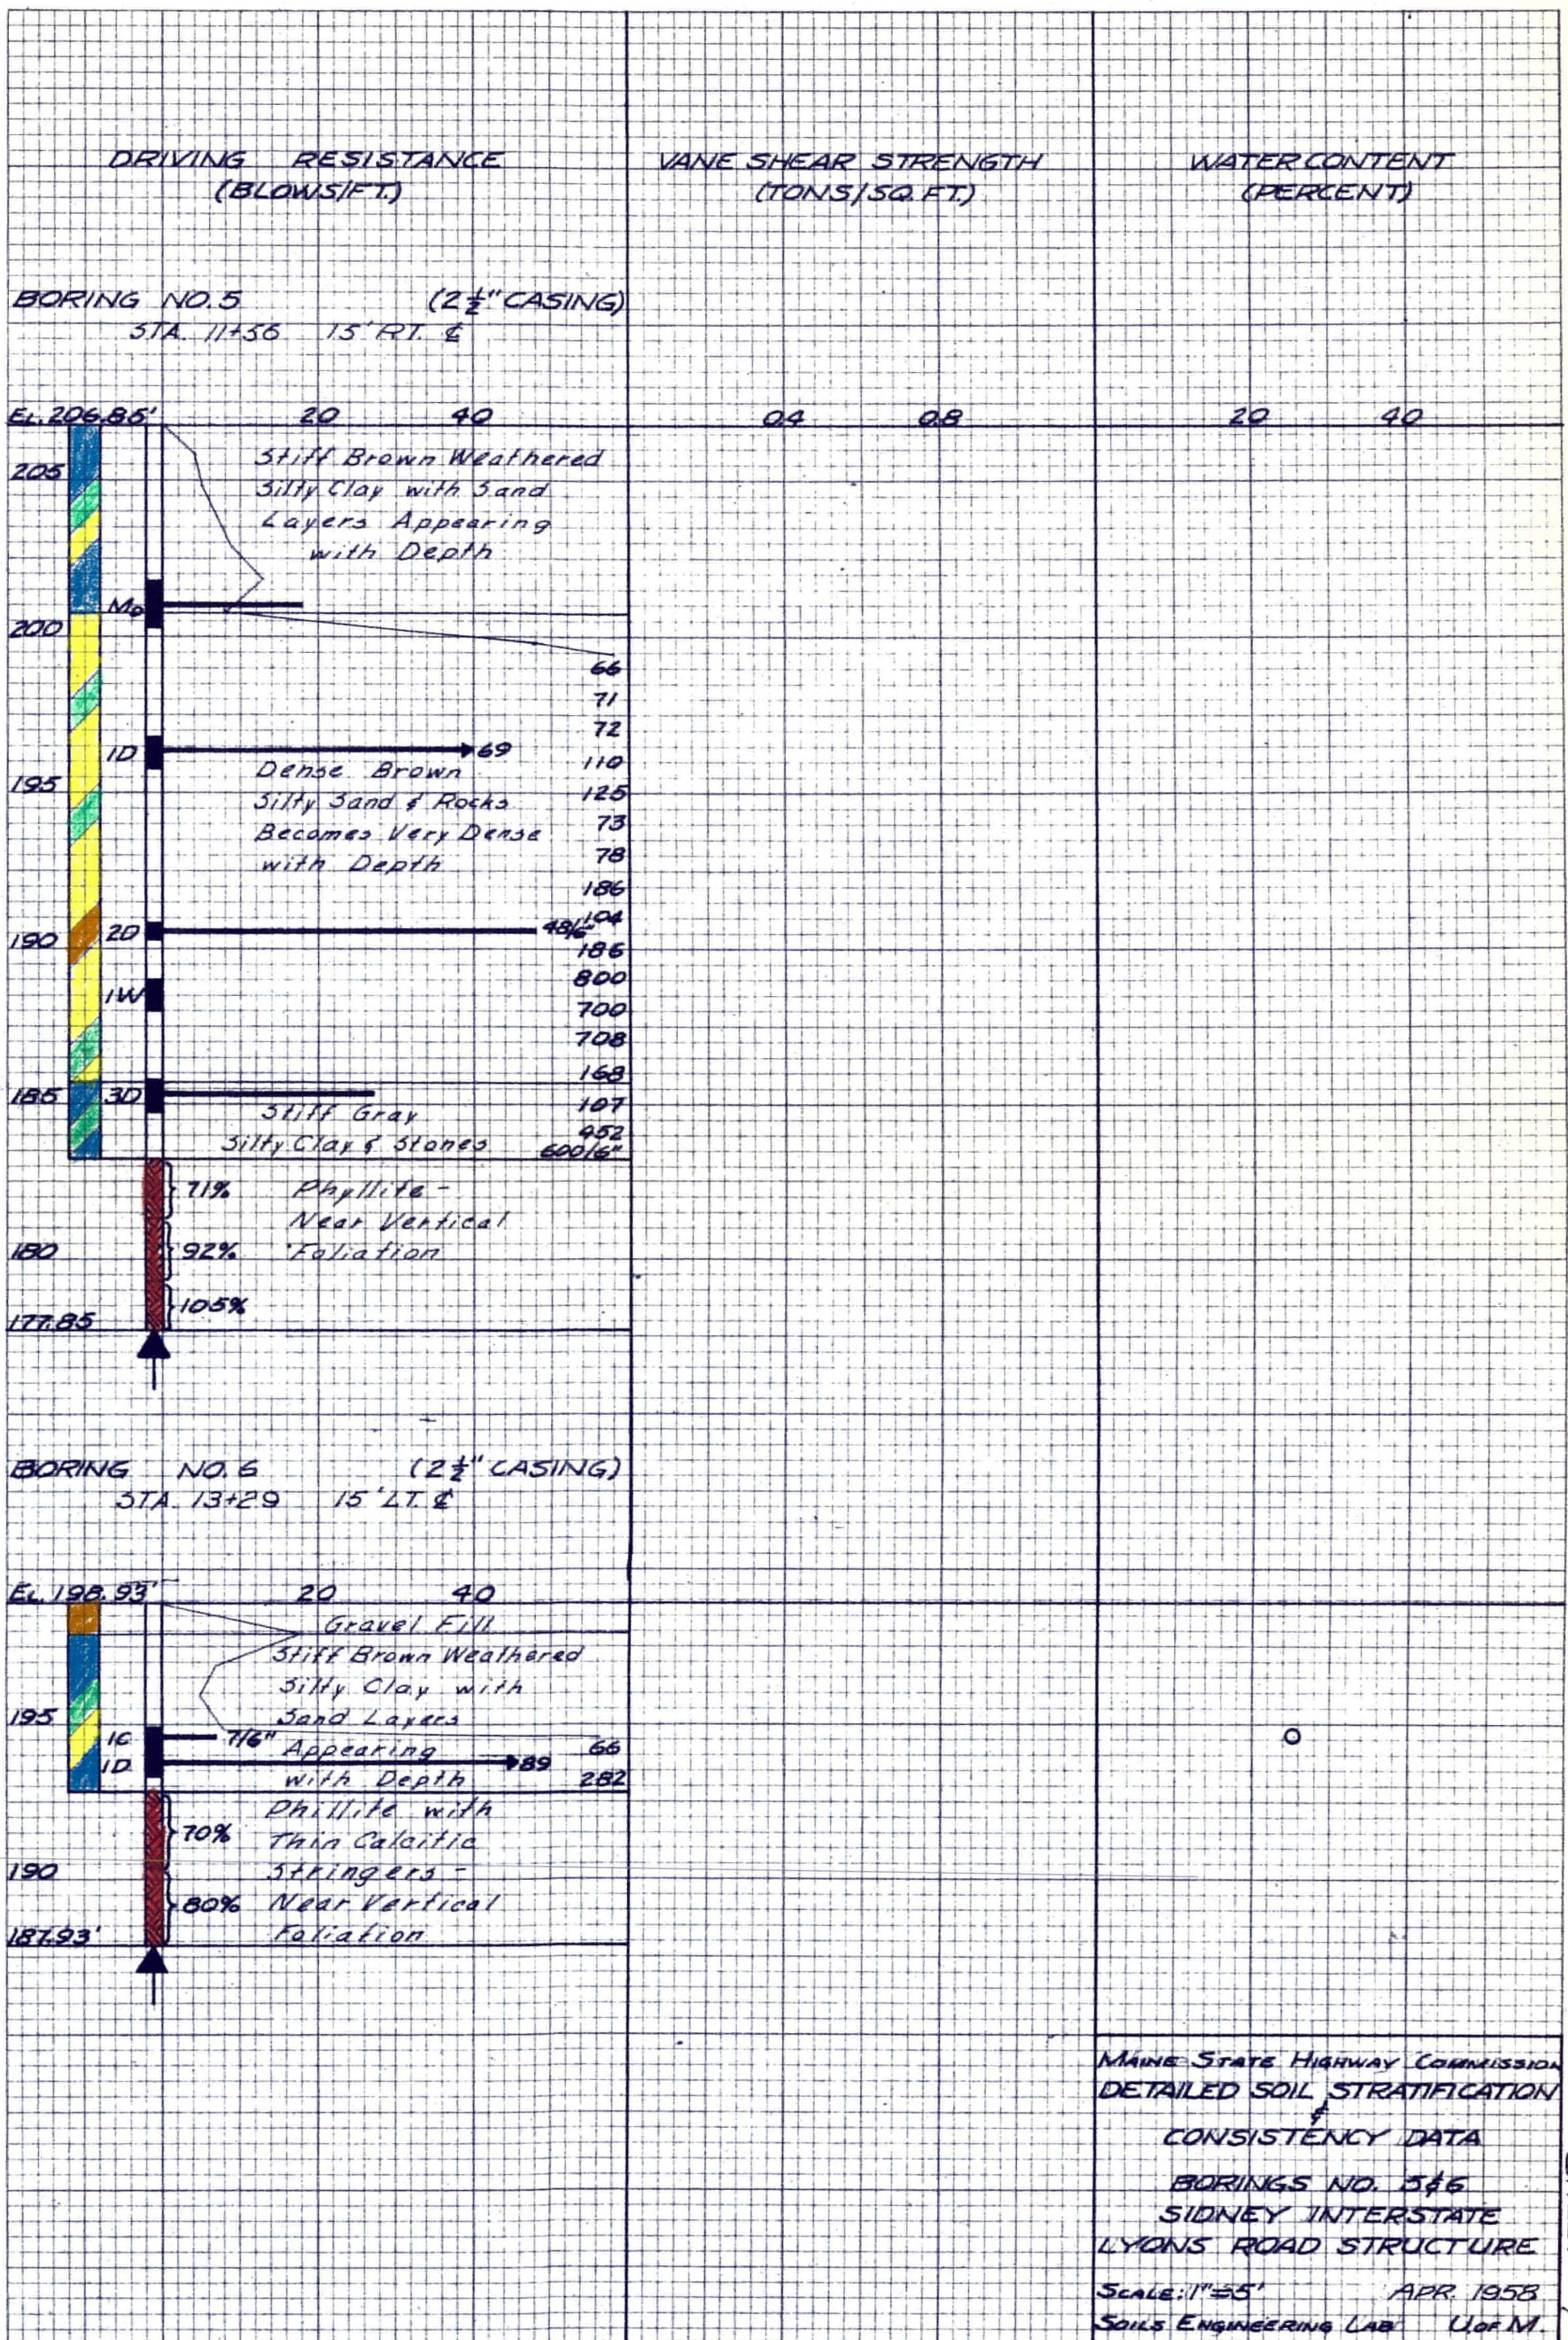
MAINE STATE HIGHWAY COMMISSION
DETAILED SOIL STRATIFICATION
CONSISTENCY DATA
BORINGS NO. 5 & 6
SIDNEY INTERSTATE
LYONS ROAD STRUCTURE
SCALE: 1" = 5' APR. 1958
SOILS ENGINEERING LAB. UOPM

Abutment No. 1 and Approach Fill. Borings 5 and 12 (Sheets 7 and 10) and transverse section (Sheet 2) show the existing soils profile under the proposed location of Abutment No. 1. If the abutment is constructed after the approach fill is made, it is recommended that the abutment be supported through the use of frictional piles. It is believed that piles may be driven to elevation 193. Jetting may be helpful in reaching this elevation. Because of the normal fluctuation of the ground water table, wooden piles are not recommended. Spread footings could be used provided the footing is placed in the dense silty sand and gravel layer, five (5) feet below the surface. A graph (Sheet 11) has been made showing the design pressures in relationship with the width of footing at the five (5) foot depth. The footing pressure could be increased 0.5 tons per square foot for each additional foot of depth below five (5) feet. The fill behind the abutment should perform satisfactorily

Abutment No. 2 and Fill. Borings 6 and 11 (Sheets 7 and 10) and the transverse profile (Sheet 2) show the soils profile at the proposed location of Abutment No. 2. As can be seen from the profile, the ledge surface was only six (6) feet below the surface. It is recommended that the abutment be supported directly on the ledge surface. If the fill is to be placed before the abutment is constructed, it is believed end bearing piles could be driven through the fill and to the ledge surface. Wooden piles are not recommended due to the fluctuation of the ground water table. The approach fill should be adequately supported by the stiff weathered silty clay. Good compaction in the fill is, however, a necessity.
