I-95-6(16)

TRAFTON ROAD STRUCTURE 58-5

**SUBSURFACE INVESTIGATION FOR
TRAFTON ROAD STRUCTURE
INTERSTATE HIGHWAY PROJECT
WATERVILLE, MAINE**

April 1958

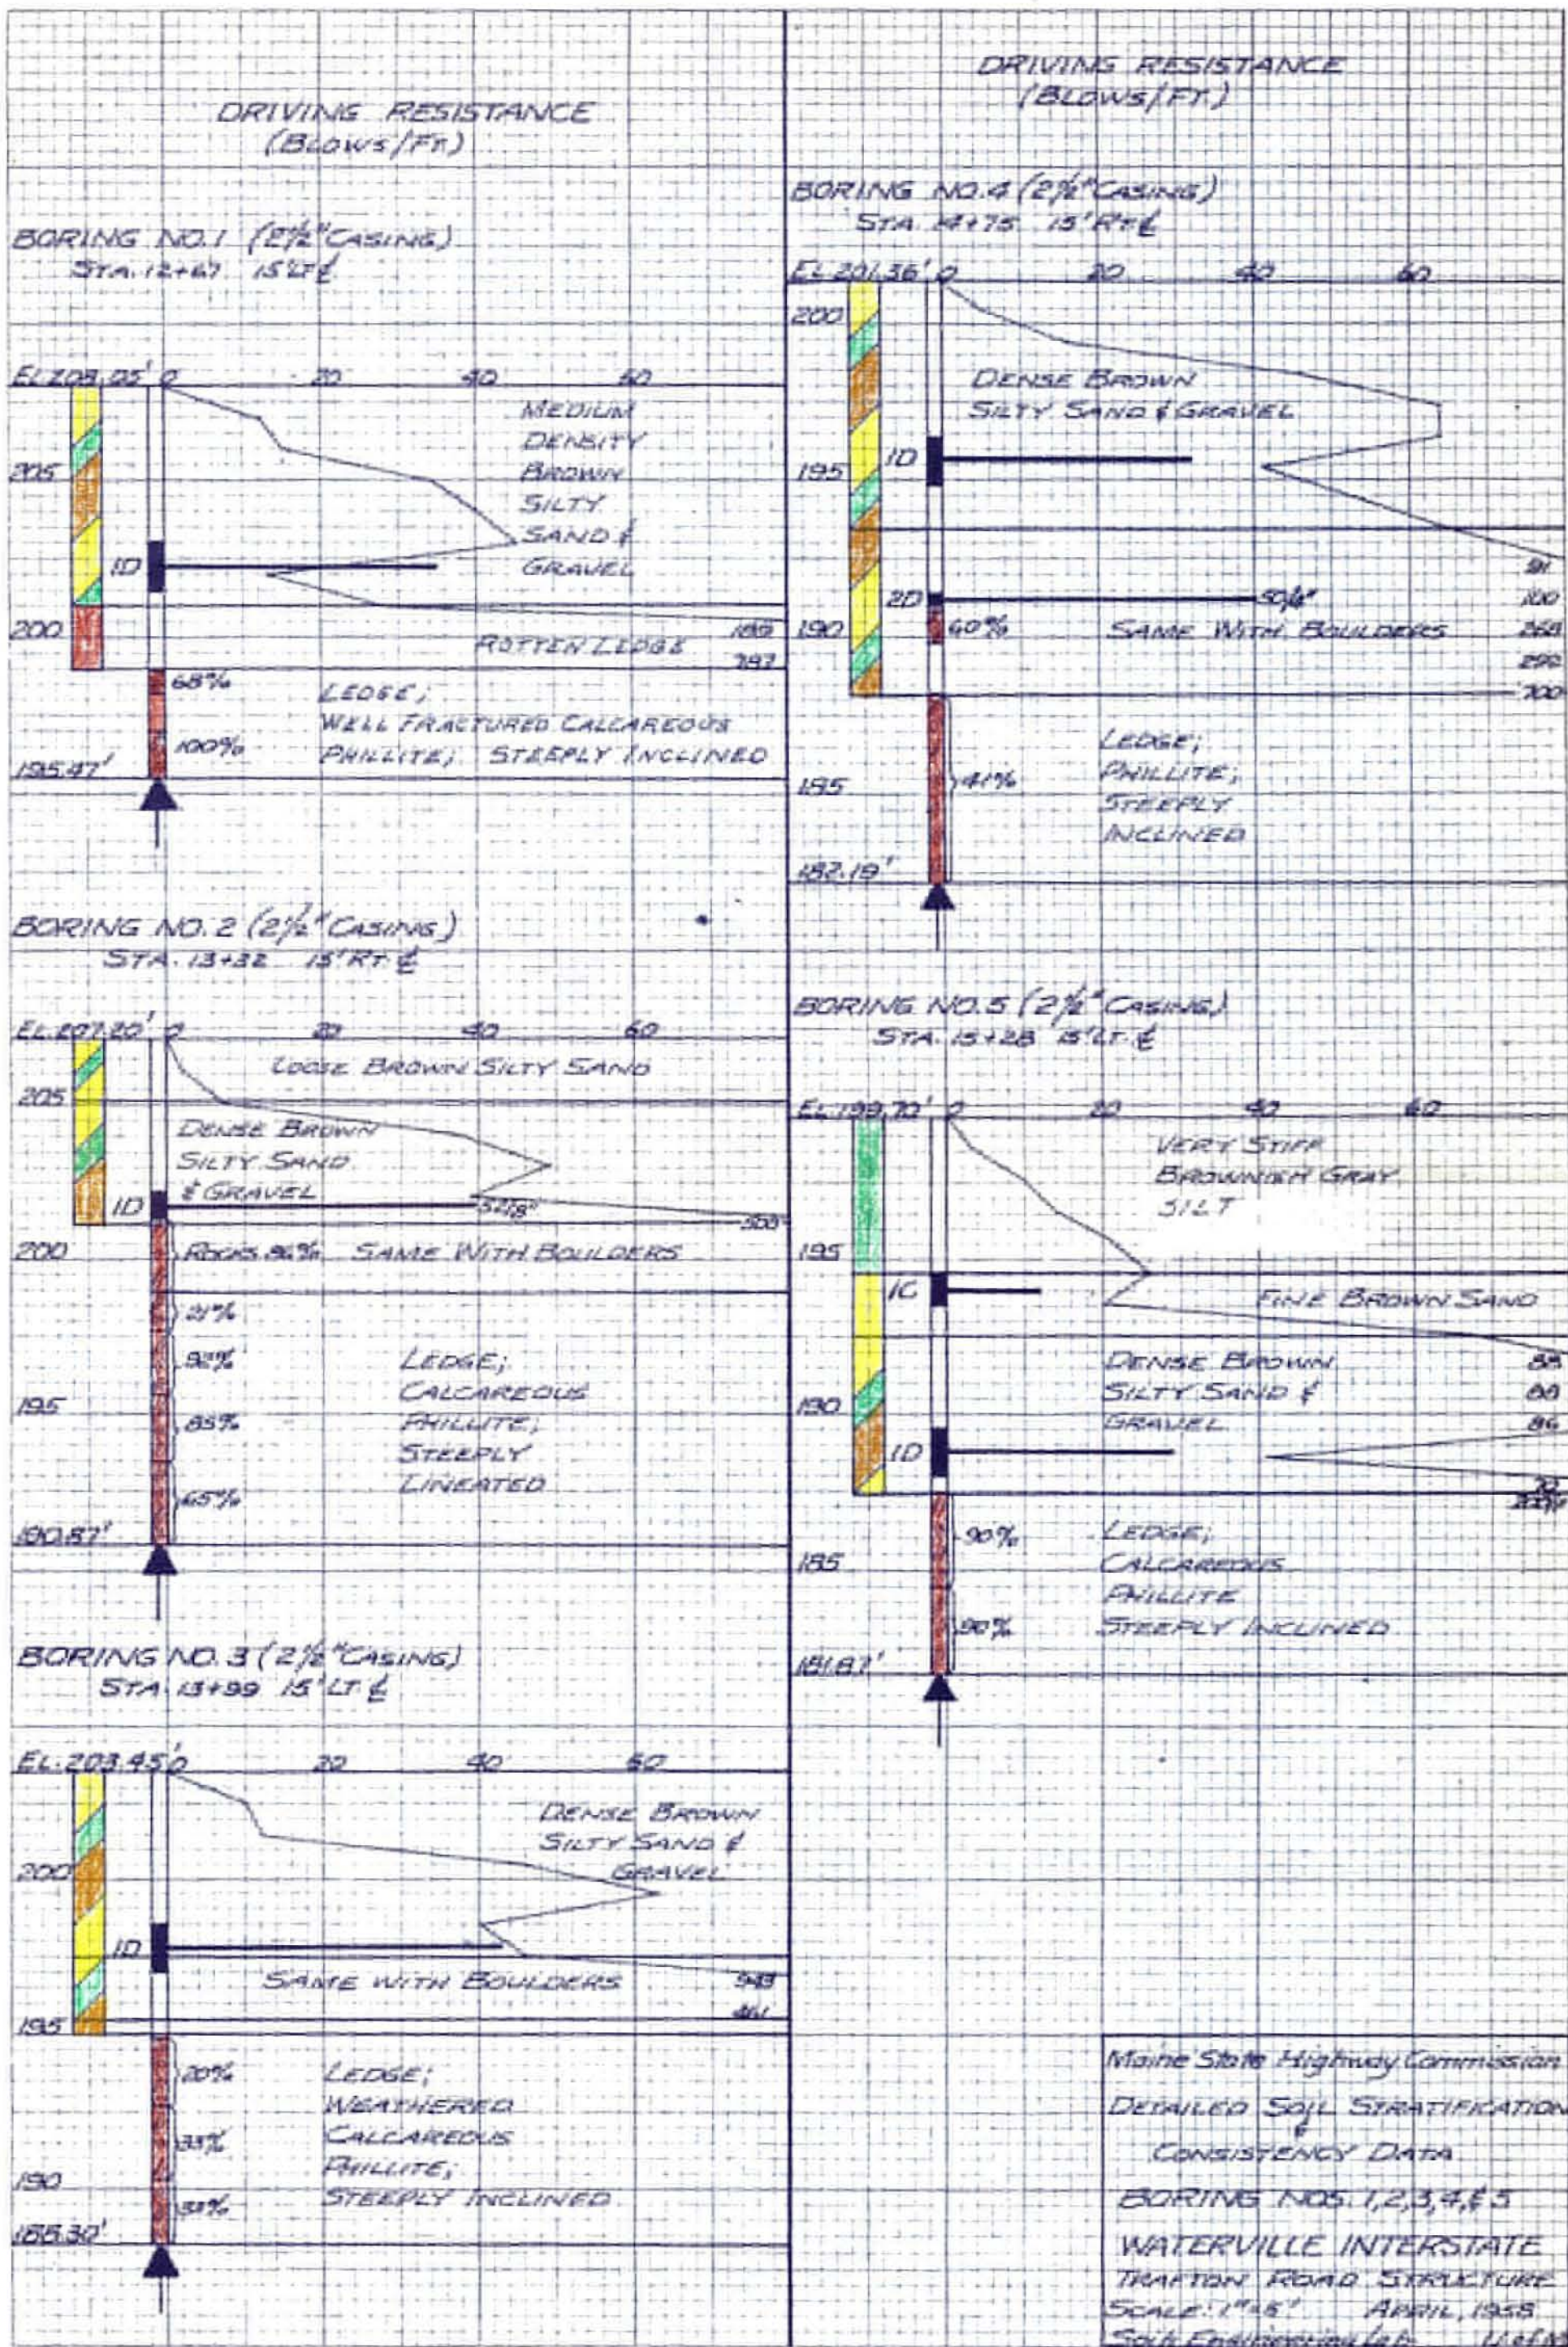
Pier No. 1. Boring 1 (Sheet 5) and the transverse sections on Sheet 3 show the existing soils at the proposed site of Pier No. 1. Since a poor recovery of ledge was made on Boring No. 1, a back hoe was used to dig a test pit.

The results of the test pit showed the ledge to be firm and solid at the south end of the pier and but four (4) feet below the surface. At the north end the ledge surface was noted six (6) feet below the surface and the back hoe was able to dig an additional four (4) feet into the ledge with little trouble. It is recommended that Pier No. 1 be supported on a firm ledge. This will probably entail removing at least three (3) feet of poor ledge on the north side and six (6) feet of sound ledge on the south end. This latter should be removed to provide a level surface and to prevent shearing of the ledge. If piles are used it is believed that they can be driven to the ledge surface.

Pier No. 2. Boring 2 (Sheet 5) and the transverse profile (Sheet 3) show the underlying soils at the proposed location of Pier No. 2. It is recommended that this pier be supported directly on ledge, six (6) feet below the surface. Test pits were made at either end of the pier. The observation of the ledge confirmed the high cleavage angle. It is recommended that two (2) feet of this ledge be removed before the footing is placed. If piles are used, it is believed they will be able to penetrate below elevation 202.

Pier No. 3. Boring 3 (Sheet 5) and the transverse profile (Sheet 3) show the underlying soils at the proposed site of Pier No. 3. A rod sounding was made at the opposite end of the pier to determine any dipping in the ledge surface. It is recommended that Pier No. 3 be supported directly on ledge. The ledge recovery on this boring was unusually low. No drops indicating fractures in the ledge were noted. An examination of the cores indicated that the low recovery was due to turning and wearing inside the core barrel during drilling which usually occurs with a soft rock. The test pits showed the high cleavage angles in the ledge. It is recommended that the top two (2) feet of ledge be removed before the footing is placed. The overburden

Pier No. 4. Boring 4 (Sheet 5) and the transverse section (Sheet 3) show the underlying soils conditions at Pier No. 4. A rod sounding was made at the opposite end of the pier to determine any dipping in the ledge surface. Since the ledge surface was noted thirteen (13) feet below the surface, spread footings might be more economical. A graph has been prepared (Sheet 7) relating the width of footing to design pressure when the footing is placed five (5) feet below the surface. If piles are used, it is believed they will be able to be driven to elevation 192.

Pier No. 5. Boring 5 (Sheet 5) and the transverse section (Sheet 3) show the underlying soils conditions at Pier No. 5. Ledge was noted twelve (12) feet below the surface at the northern end of the pier and a rod sounding at the south end encountered a refusal (believed to be ledge) eleven and one half (11½) feet below the surface. If spread footings are used they should be placed on or in the sand and gravel seven (7) feet below the surface. A graph (Sheet 8) has been drawn relating the width of footing to design pressures. If piles are used, it is believed they can be driven to the ledge surface (elevation 187).

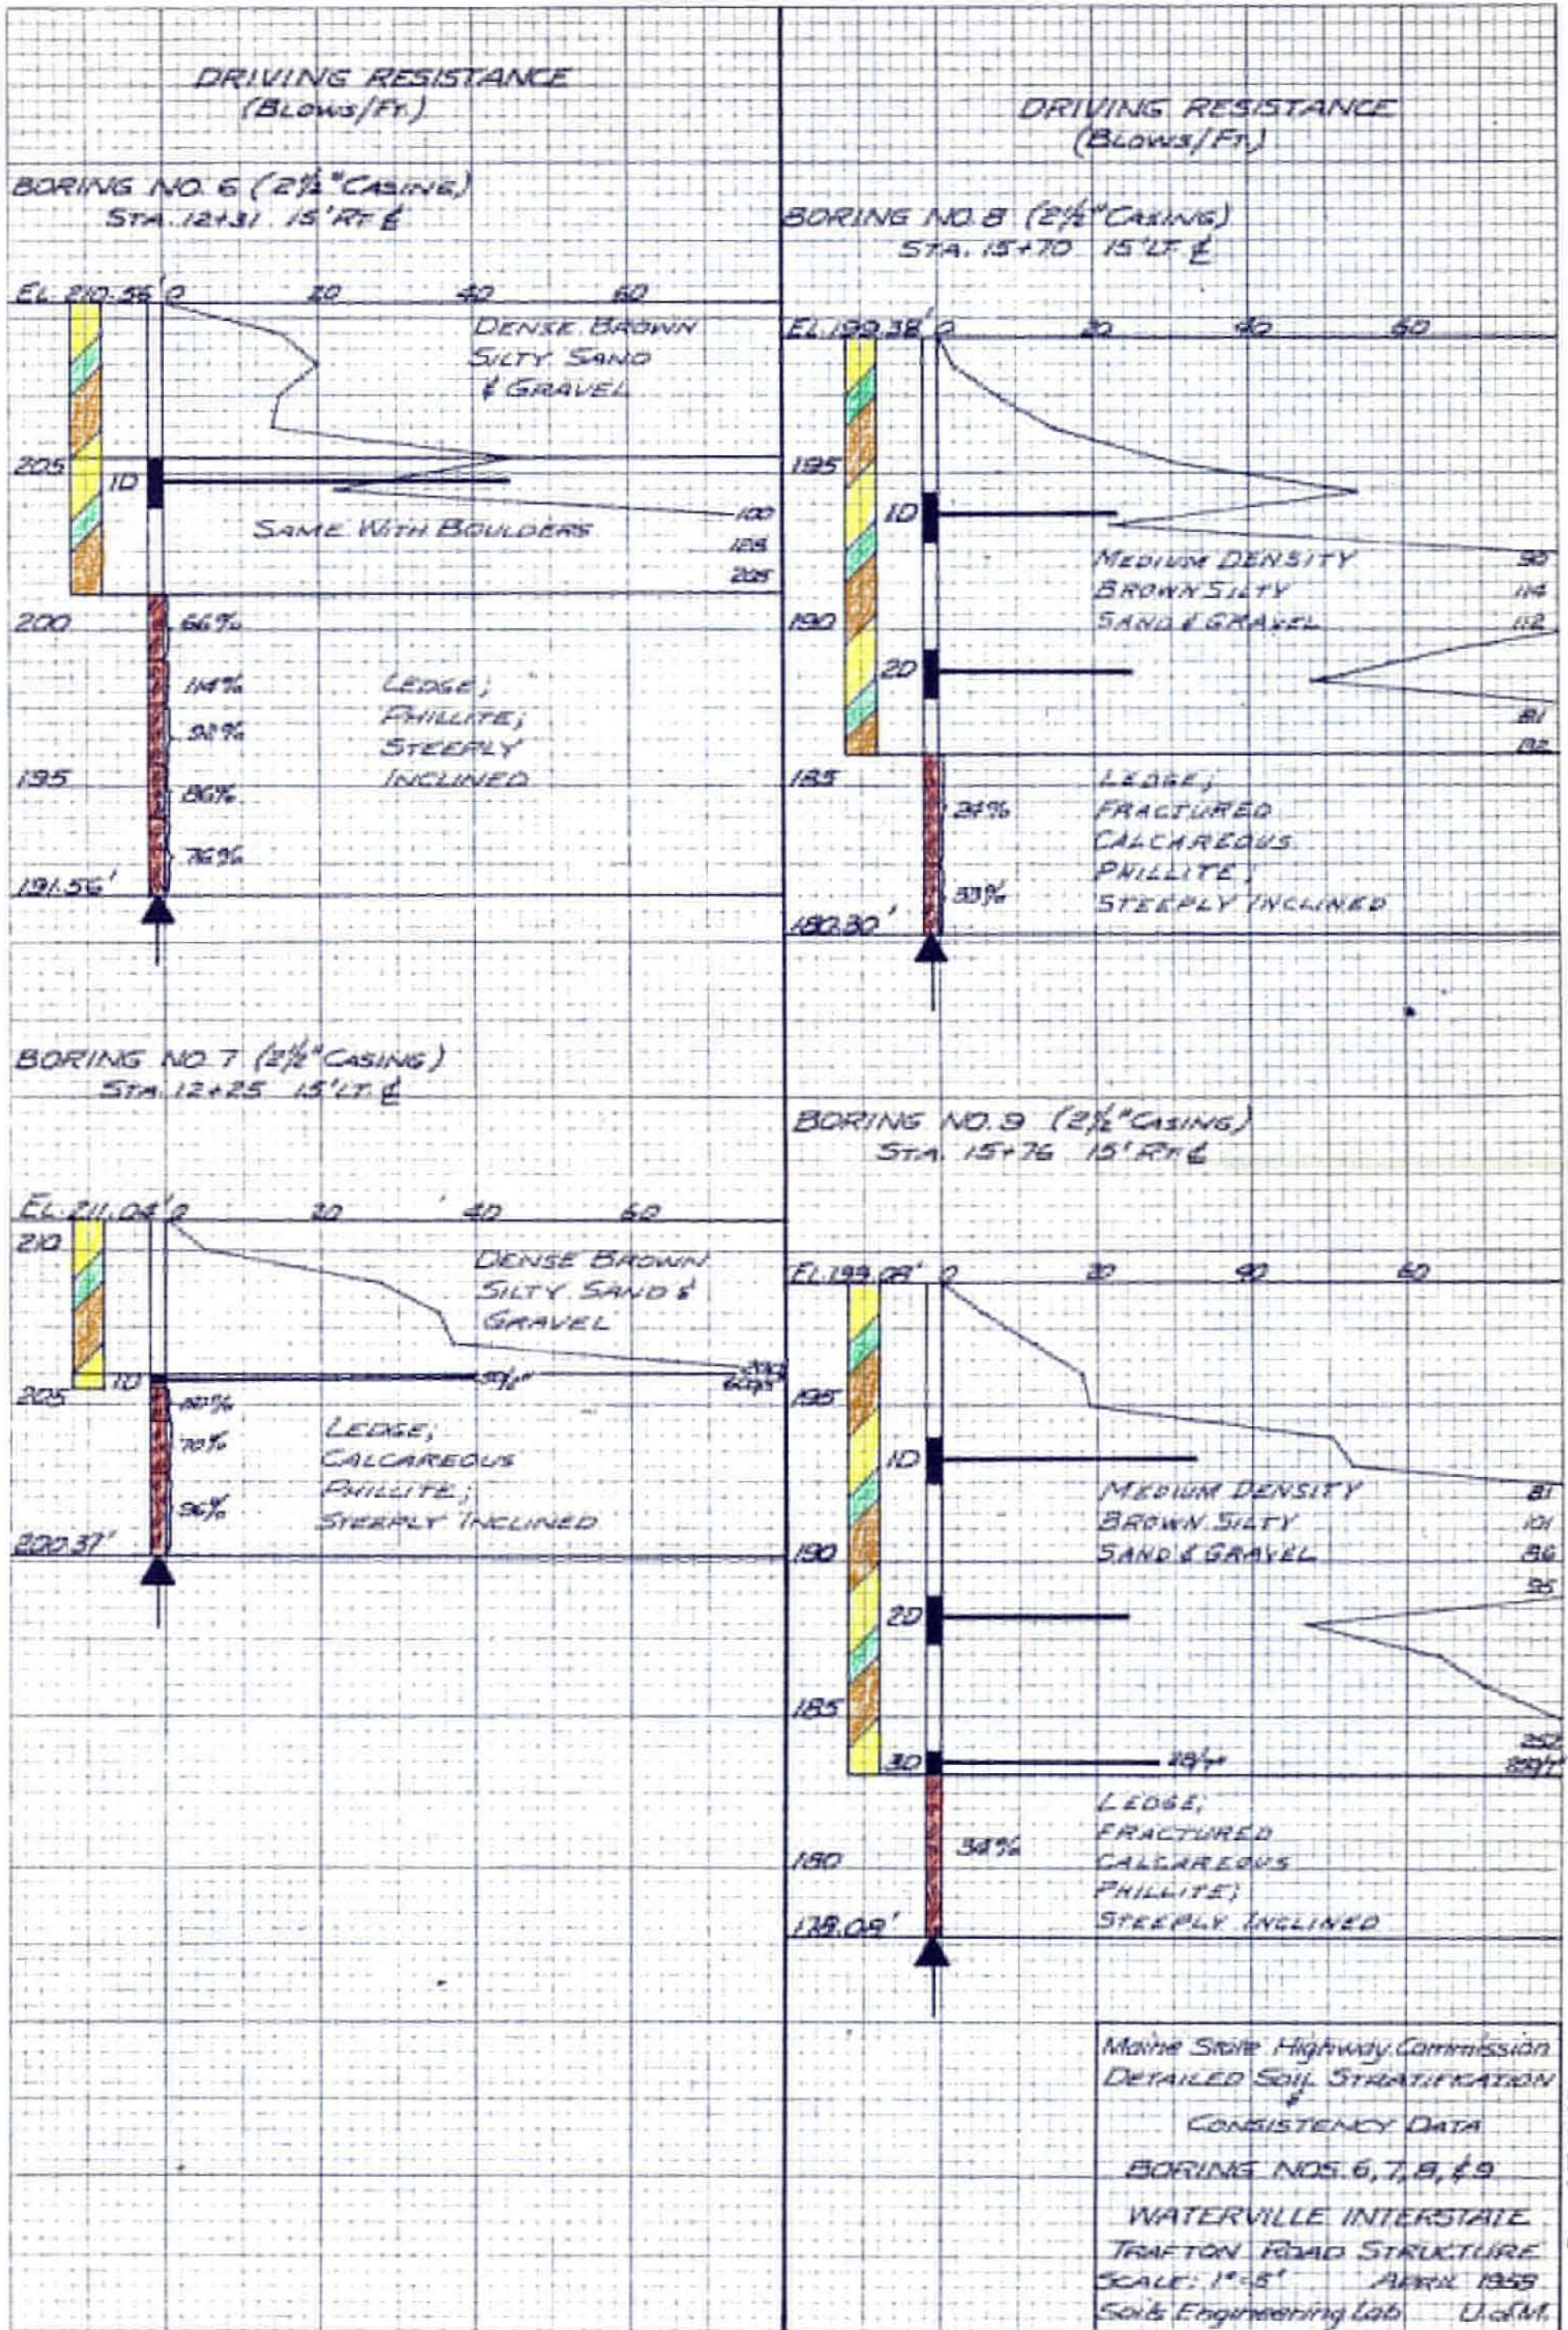
Abutment No. 1 and Western Approach Fill. Borings 6 and 7 (Sheet 6) and the transverse section on Sheet 3 show the underlying soils at the proposed site of Abutment No. 1. While spread footings placed five (5) feet below the surface could be used, it would take but another three (3) feet to place the structure directly on the ledge surface. If, however, the fill is constructed before the abutment is built, then piles would be recommended. It is believed piles should be able to be driven through the fill and to the ledge surface. The approach fill should be adequately supported by the existing soils, however, good compaction in the fill is a necessity.

Abutment No. 2 and Eastern Fill. Borings 8 and 9 (Sheet 6) and the transverse section (Sheet 3) show the existing soils under the proposed location of Abutment No. 2. The ledge surface was encountered approximately fifteen (15) feet below the ground surface. Since the underlying soils are in a medium to dense density, spread footings could be used. Design data is shown on Sheet 8. If the abutment is to be constructed after the fill is completed, then piles are recommended. It is believed that piles may be stopped in the vicinity of elevation 190, but with jetting, they may be able to reach the
