CHILDS ENGINEERING CORPORATION

Re: Fish Pier Inspection and Assessment Report

Fish Pier Inspection and Assessment Report

June 18, 2015

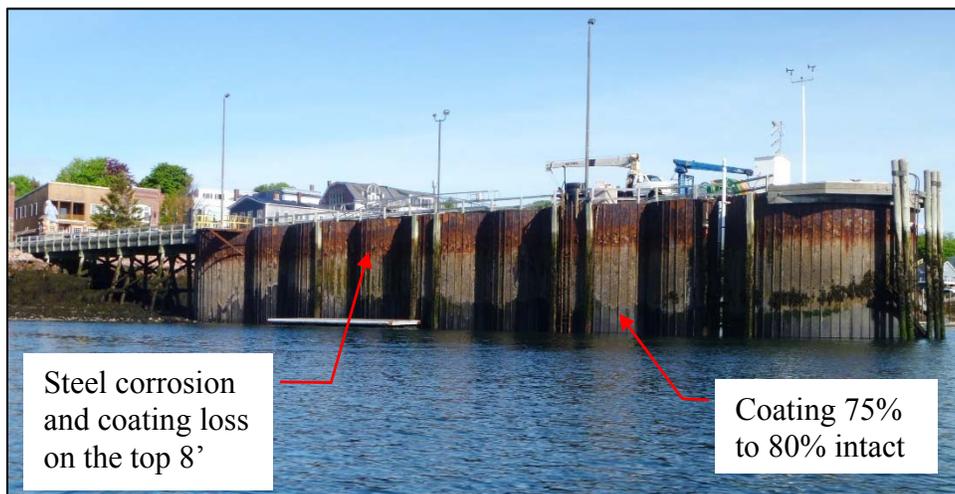
Photo 1 – Overall view of the south face sheet pile cells and vertical timber fenders.

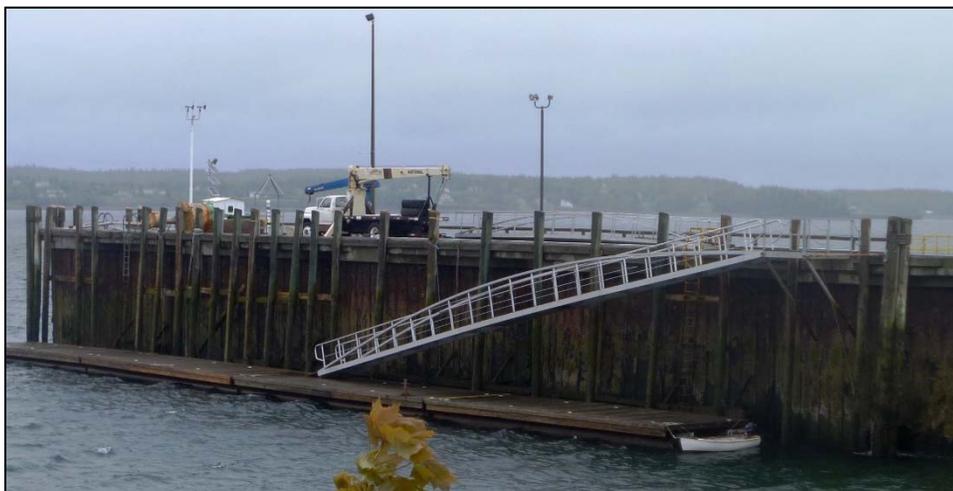
Photo 2 – Overall view of the north face of the pier with fender system and floating dock.

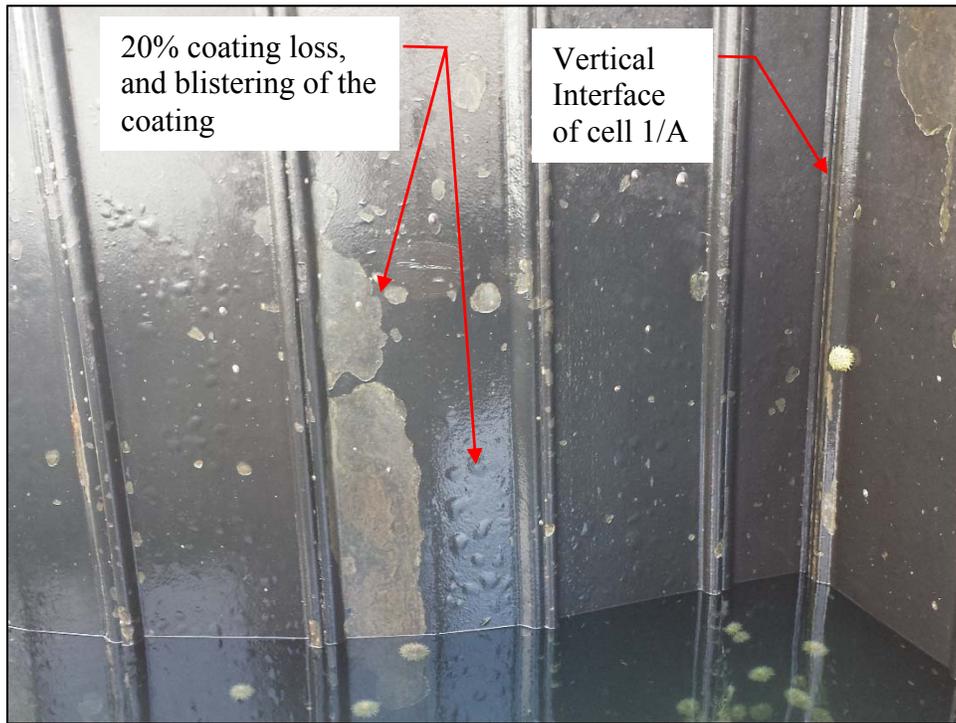
5% of the structure (below water). The majority of anodes are 100% depleted with loose and missing connection bolts. The coating within the tidal zone is approximately 75% intact, and at compromised coating locations the steel was found to be pitted with maximum depths of 1/8th inch. Also observed within the tidal zone is blistering of the coating indicating pending failure. Above high water, on the top 8 feet of the sheets, the coating is typically gone with moderate corrosion and scale found. Ultrasonic thickness measurements were taken at various depths and locations along the cells. Assuming an original 3/8 inch wall thickness from the referenced plans, readings yielded 72% to 100% of the steel sheet thickness remains, with the lower percentages on the top 8 feet.

Photo 3 – Interface of sheet pile cell 1/A on north face at low water.

Short term recommendations for repair and maintenance of the steel sheet piles include cleaning and recoating the steel from low water to the top of the sheets, and replacing the sacrificial anodes below water. From prior experience, we have had good luck using the following coating systems, provided the surfaces are prepared and the coatings are applied according to manufacturer recommendations:

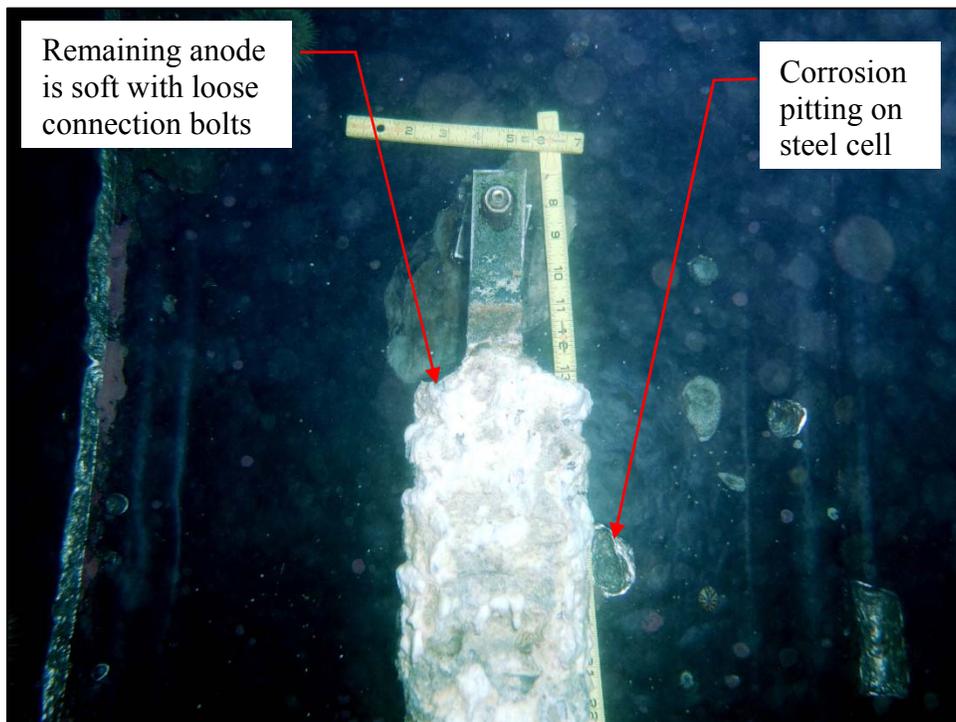
Photo 4 – Sacrificial anode on north face sheet pile, cell 2, below water.

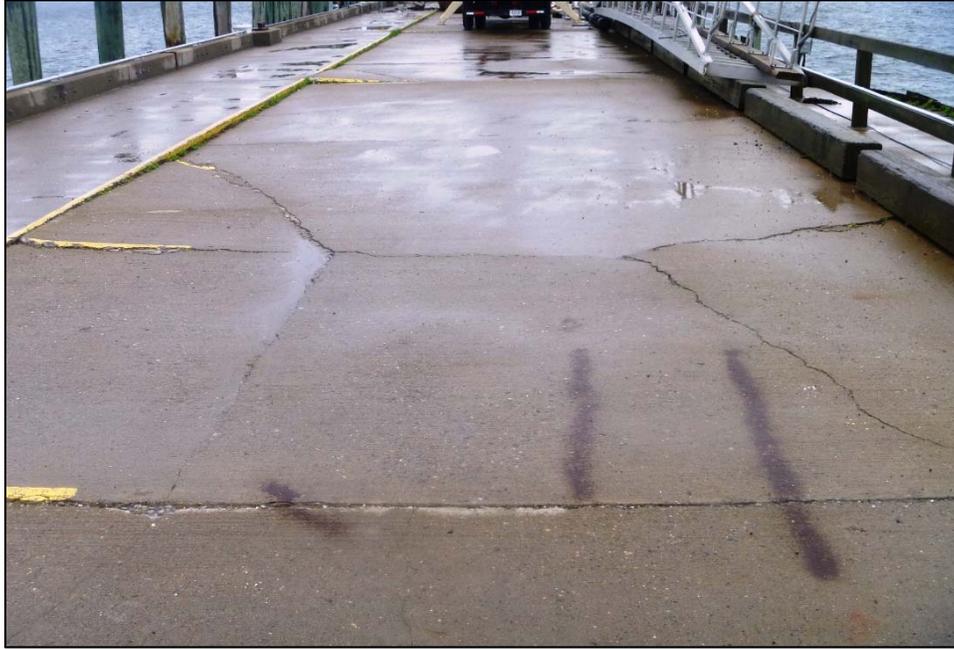
The southern deck has isolated locations of transverse and longitudinal cracking throughout with maximum crack widths of 1/8 inch wide. Settlement was also noted at crack locations and adjacent to the northern deck by as much as 3 inches. There is horizontal separation between the concrete deck and sheet pile measuring 1/2 to 1 inch wide with one isolated location of a 2 inch separation at the cell 1/A interface. The separation and cracking are due to settlement of the cell fill material. Although there is cracking and settlement present, this does not significantly reduce the intended structural capacity.

Photo 5 – Concrete deck looking east with settlement and cracking.

Long term recommendations include removing the existing concrete deck, placing a level compacted graded base, and installing a new reinforced concrete deck.

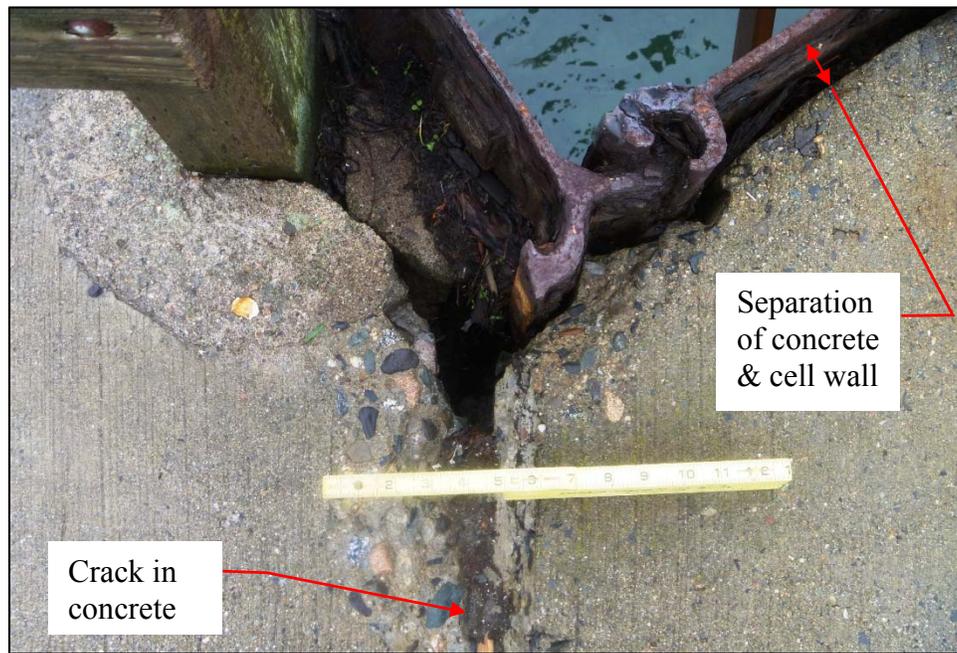
Photo 6 – Separation and cracking at cell 1/A interface, due to settlement.

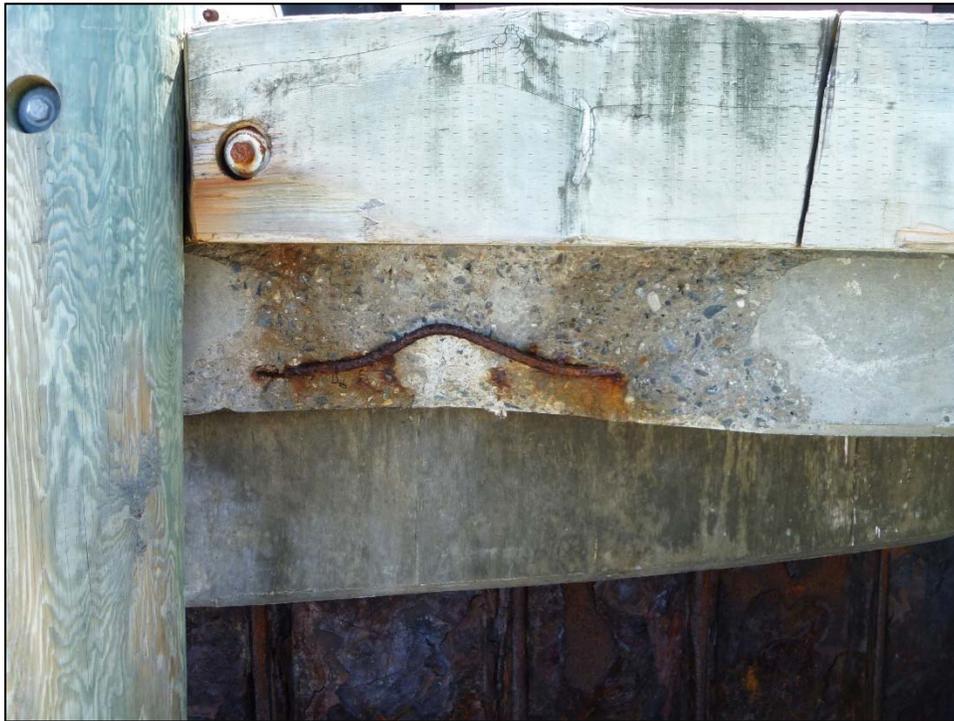
The northern portion of the deck is supported by the cells and does not exhibit settlement. The northern portion of the deck has hairline cracking throughout the underside edge of the deck, most likely from drying shrinkage cracks, which are not of concern. Cell 4 has a 3 square foot fracture spall with exposed reinforcing steel on the bottom corner below the timber chock.

Photo 7 – Concrete impact spall with exposed rebar below top chock on cell 4.

Short term recommendations for the concrete superstructure include repairs to the fracture spall due to the exposed reinforcing steel, which if left unrepaired will continue to corrode and increase the spall area. The concrete spall area should be chipped back to sound concrete and then cleaned with high pressure water. All corroded reinforcement should be cleaned, or replaced if significantly deteriorated, before new concrete is added. A marine grade concrete should then be installed.

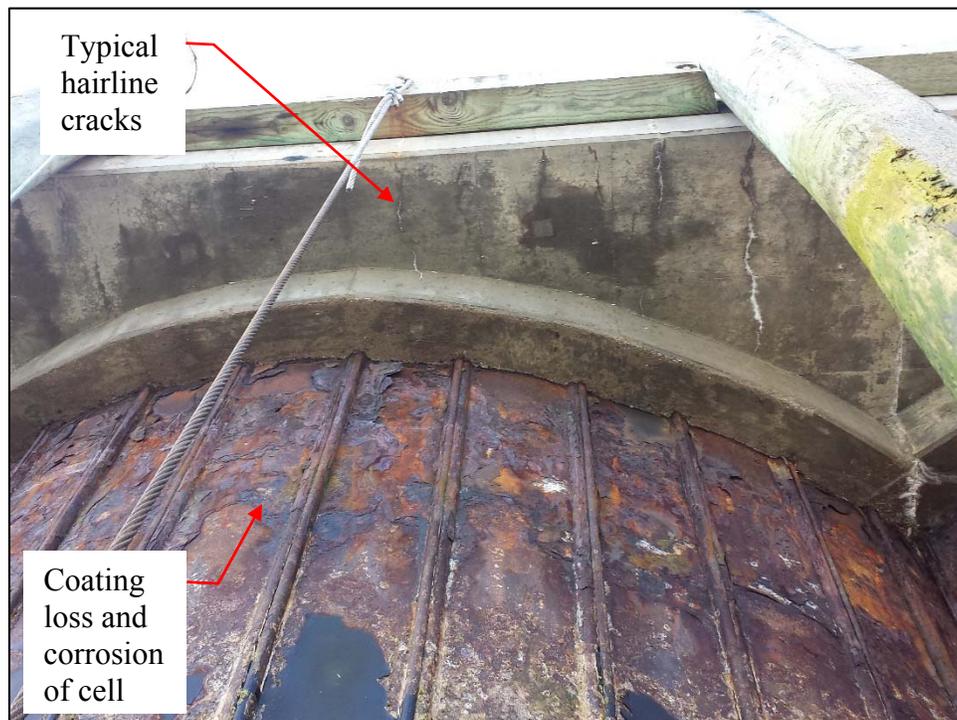
Photo 8 – Underside of concrete deck with typical hairline cracking.

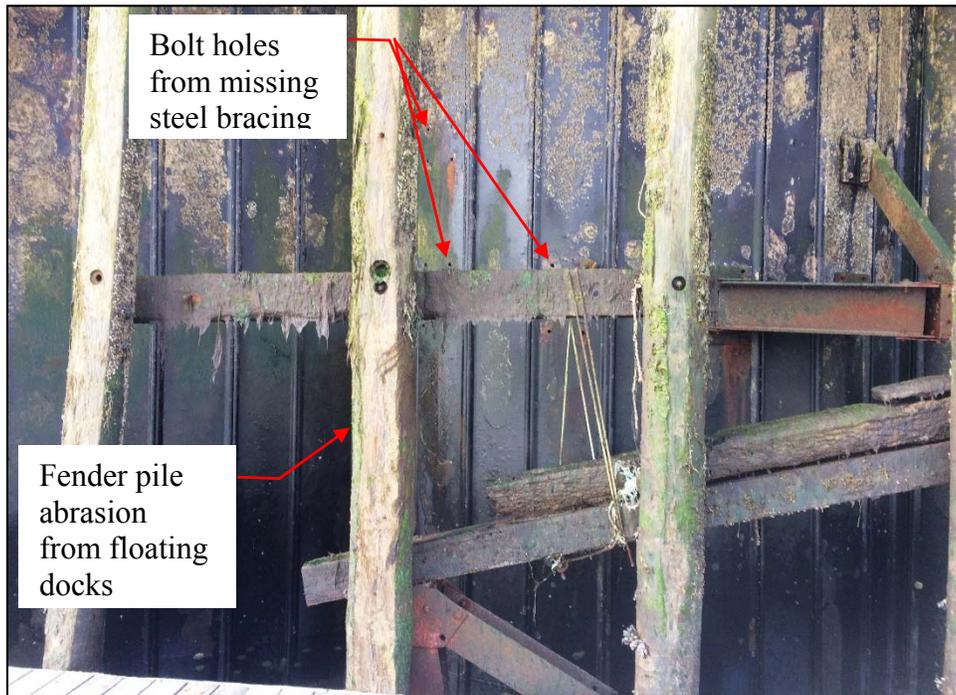
The fender system is in *poor* condition due to broken piles, and missing and broken bracing components at low water. The majority of timber fender piles are found to be in *satisfactory* condition with minor abrasion and ice damage in the tidal zone. Six of the piles have significant defects found including 3 broken piles, 1 missing pile, 1 pile with 20% section loss due to marine borer activity, and 2 piles with heavy abrasion and approximately 50% section loss. The low water bracing is made up of steel angles and beams with 100% coating loss, minor surface corrosion, and typically has failed bolted connections and missing components. There are loose connection bolts, missing steel bracing, and missing timber chocks and wales throughout. A few repairs have been made to replace the bolted connection with a welded connection at the steel sheet and are in *satisfactory* condition. Along the tops of the piles, approximately 50% have a fiberglass cap to protect the pile top from decay and the rest are missing.

Photo 9 – Low water bracing is typically in poor condition.

Short term recommendations are to replace the 6 damaged fender piles in-kind that are broken, missing, and heavily abraded, wrap the pile with marine borer to prevent further section loss, and to install protective covers on the pile tops. To prevent continued damage to the piles we recommended replacing the lower steel bracing system as well as the timber wale and chocks. The bracing should be redesigned with welded connections to facilitate installation. Typical replacement bracing would consist of 10 inch diameter thick walled steel pipe welded to 1/2 inch thick steel plates on either end. The end plate would then be welded to the sheet pile between knuckles and the opposite end plate would have timber wale and chocks bolted between piles. As an alternative consideration should be given to replacing timber fender system with a new system consisting of steel pipe piles, wales and chocks.

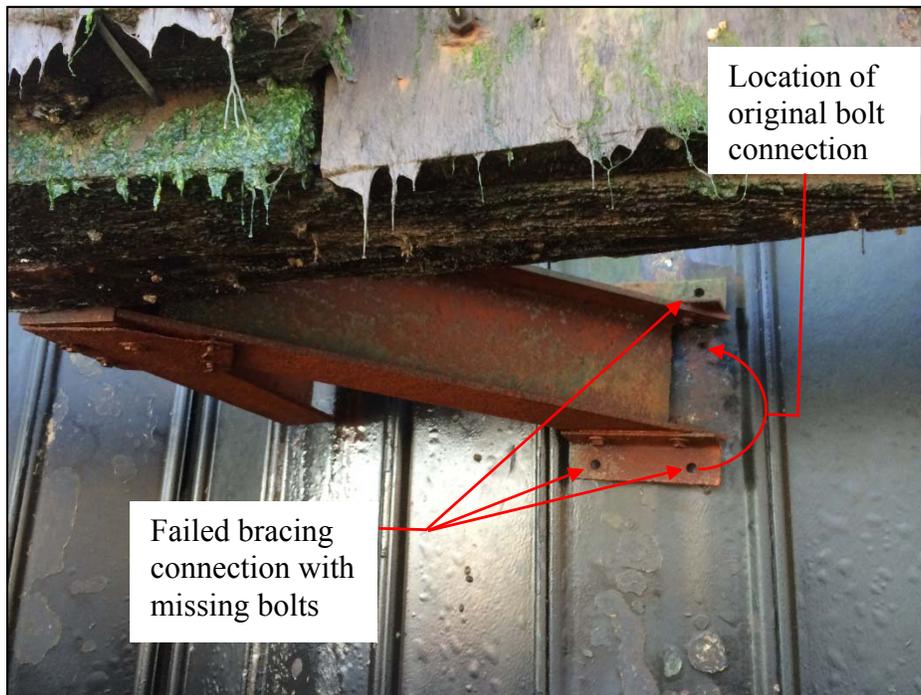
Photo 10 – Low water bracing with missing bolted connections to sheet pile cell.

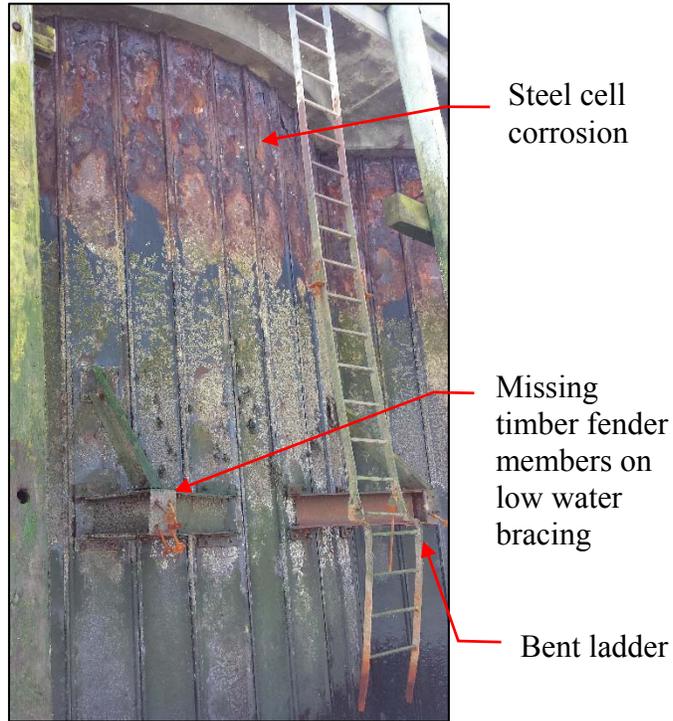
Photo 11 – Broken steel bracing with missing timber wale and damaged ladder.

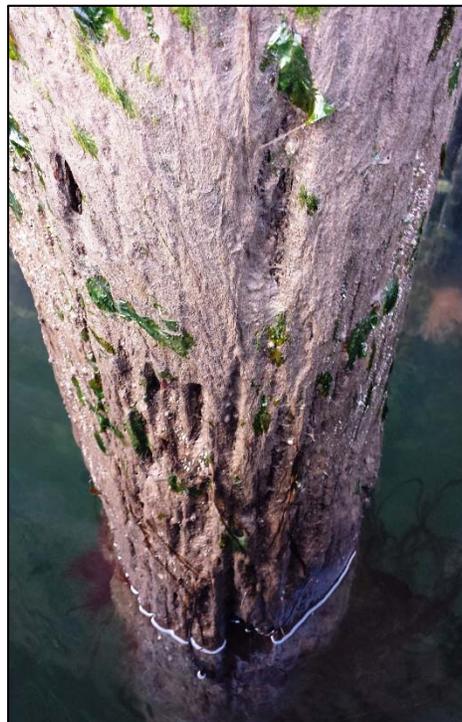
Photo 12 – Fender pile with marine borer activity and section loss.

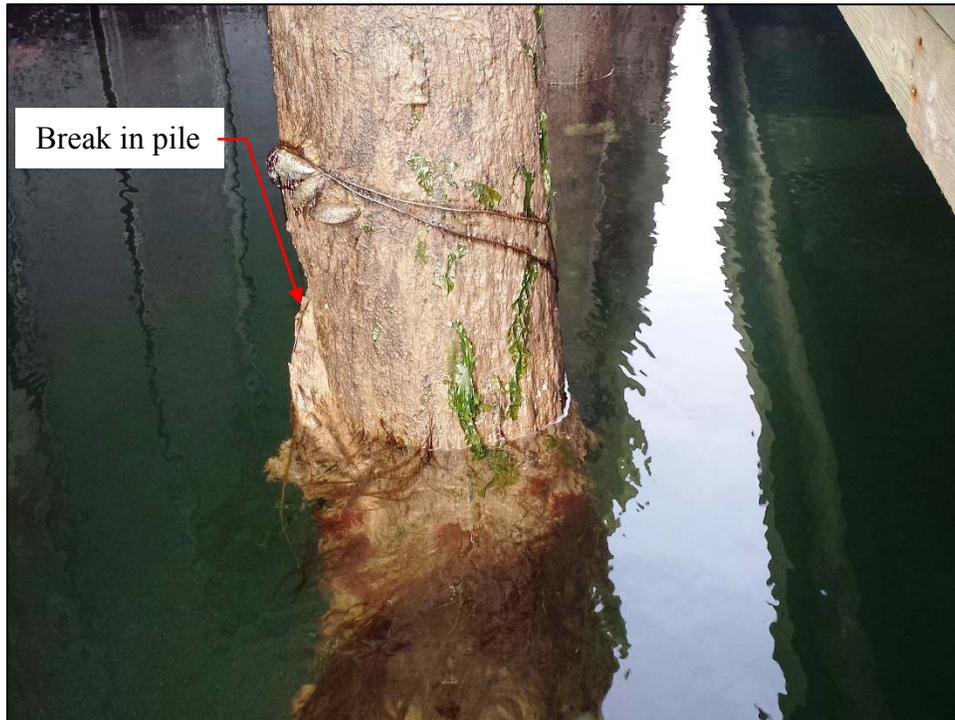
Photo 13 – Broken fender pile at low water.

A fully functional fender system performs the vital function of protecting the pier from berthing vessels. The fender piles are susceptible to breakage when vessels are berthed against them as they cannot resist the intended horizontal loads.

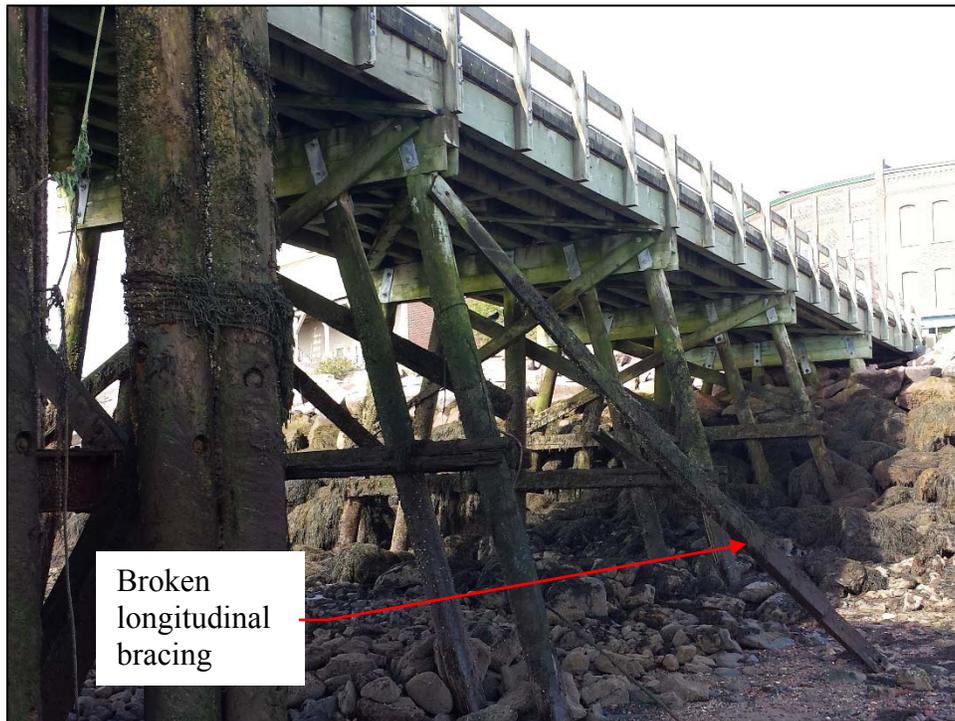
Photo 13 – Overall view of timber access pier below deck.

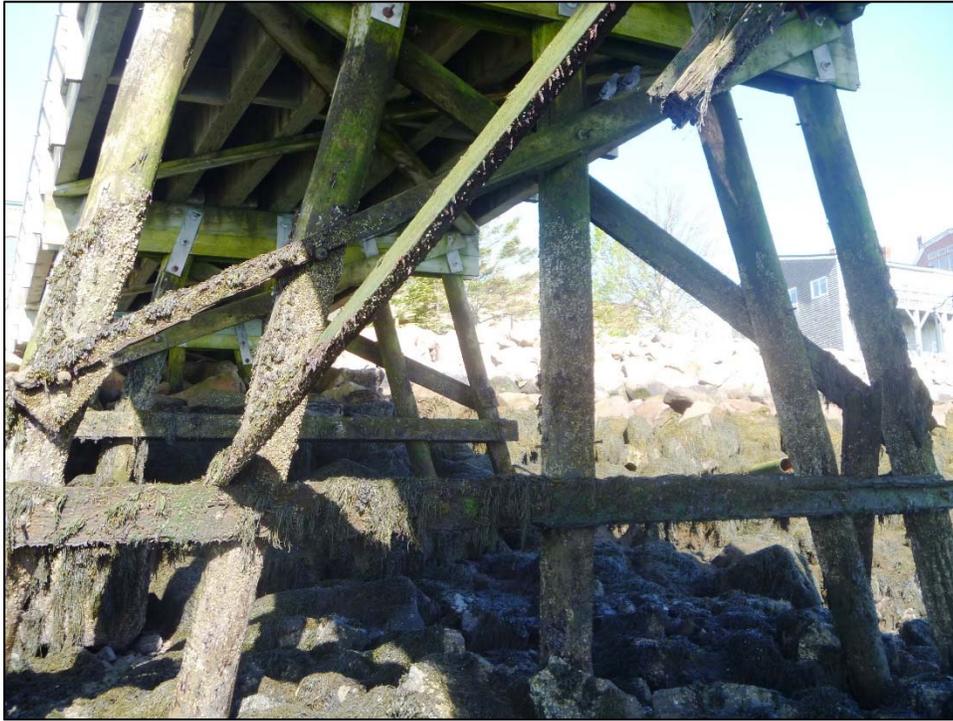
Photo 14 – Lower bracing with severe marine borer activity and fungal decay.

Short term recommendations for the access trestle include wrapping the timber pile with marine borer activity to prevent section loss, and replacing the deteriorated timber bracing, rail posts, and deck planks. There are no long term repairs recommended at this time. Although the above mentioned defects do not require a reduction in the certified load capacity, a repair schedule should be established.

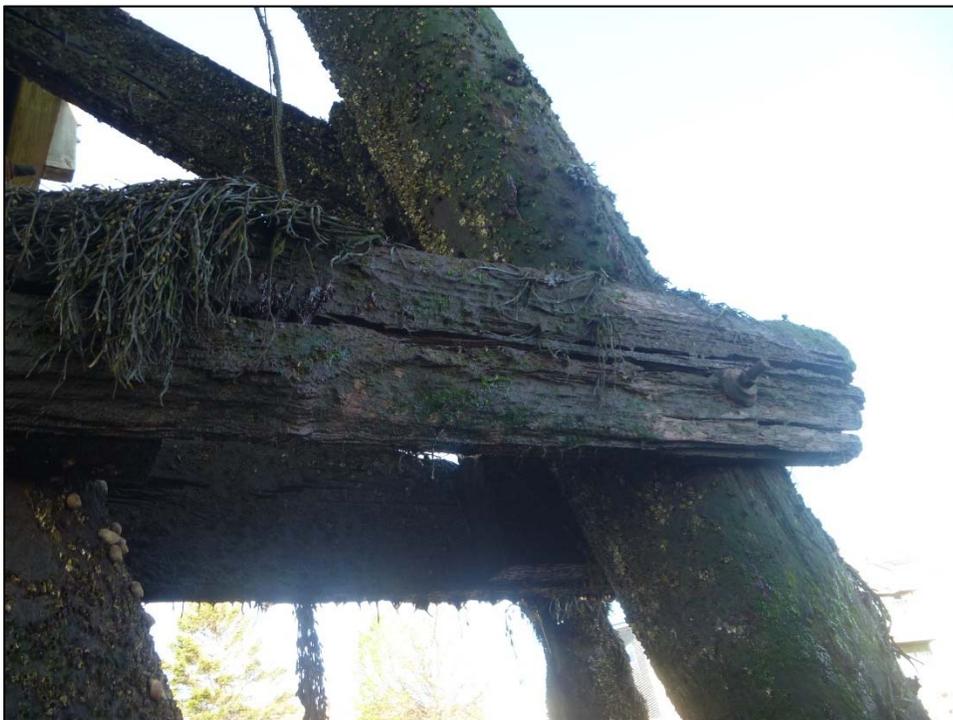
Photo 15 – Deteriorated lower transverse bracing with connection bolt in good condition.

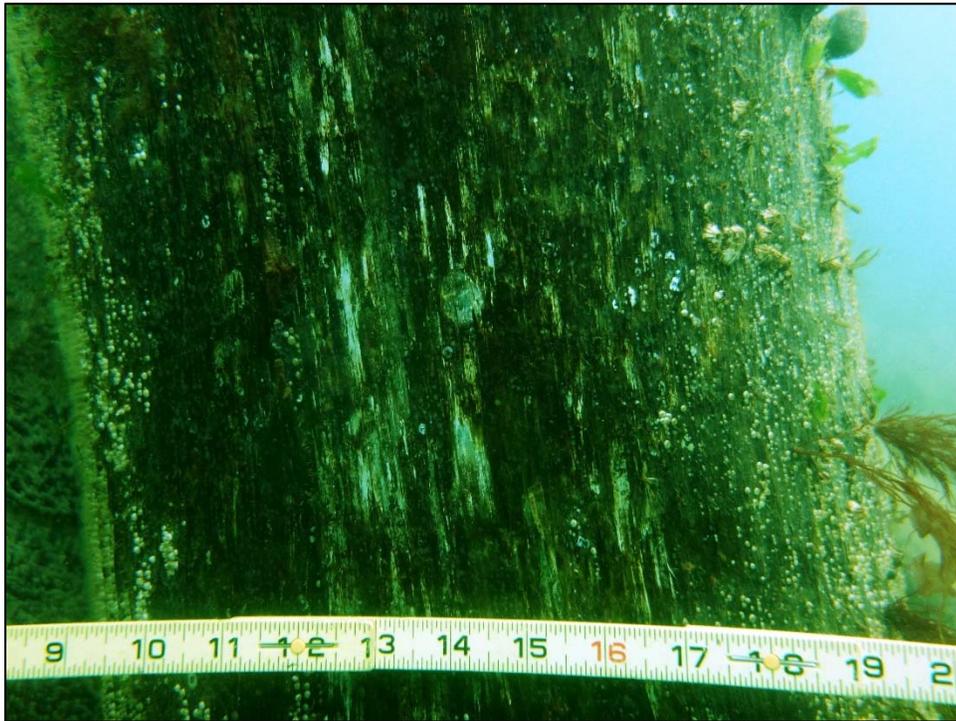
Photo 16 – Timber pile at bent 4 north below water in good condition.

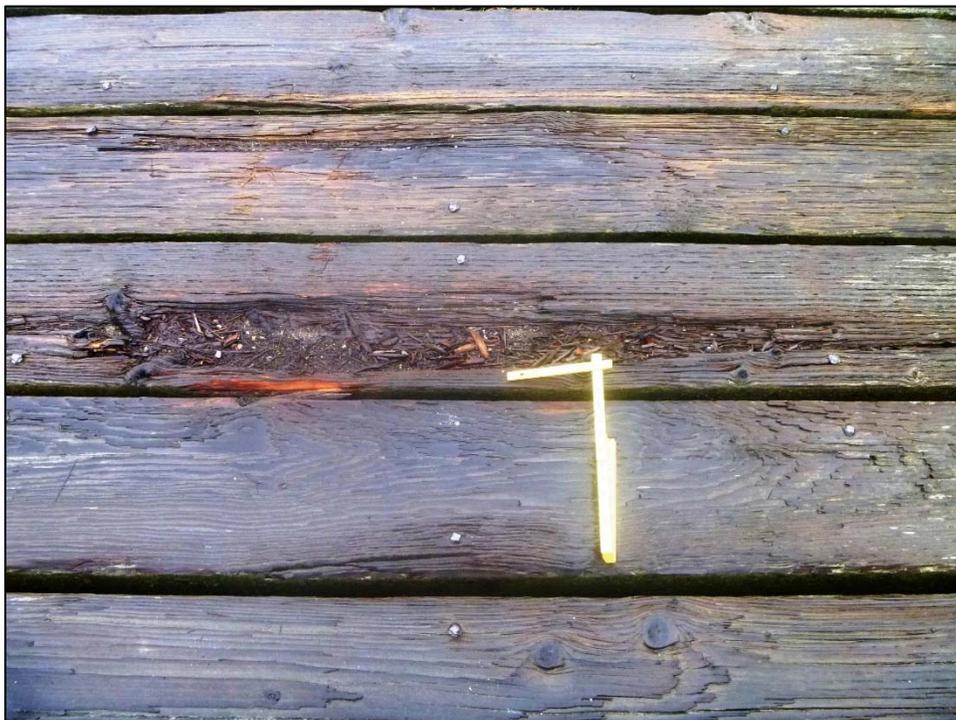
Above deck, the timber deck planks, wheel stops, and safety rails have minor defects including 5 locations of fungal decay on the tops of the rail posts measuring up to 6 inches deep, and 2 locations of fungal decay on the deck planks measuring 4 to 6 feet long and 3 inches deep. All connection hardware is in *good* condition with light surface corrosion located within the tidal zone.

Photo 17 – Timber deck plank with fungal decay.

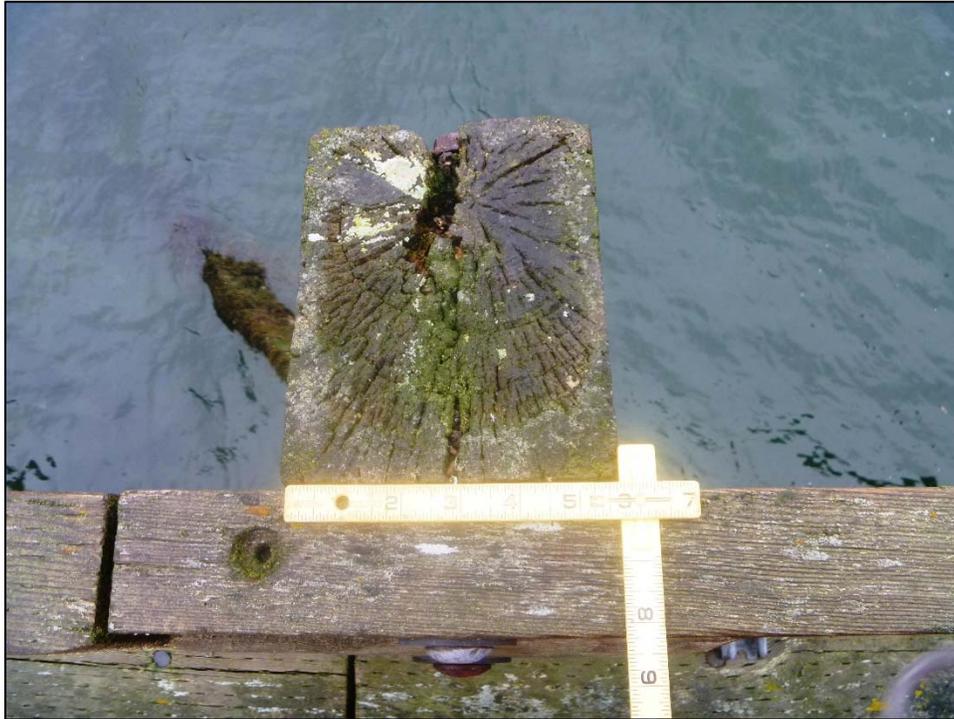
Photo 18 – Top of timber post with fungal decay 6 inches deep.
