## Appendix G

### Project Summaries

**Bridge #1461- Carries I-95 SB over Webb Road in Waterville.**

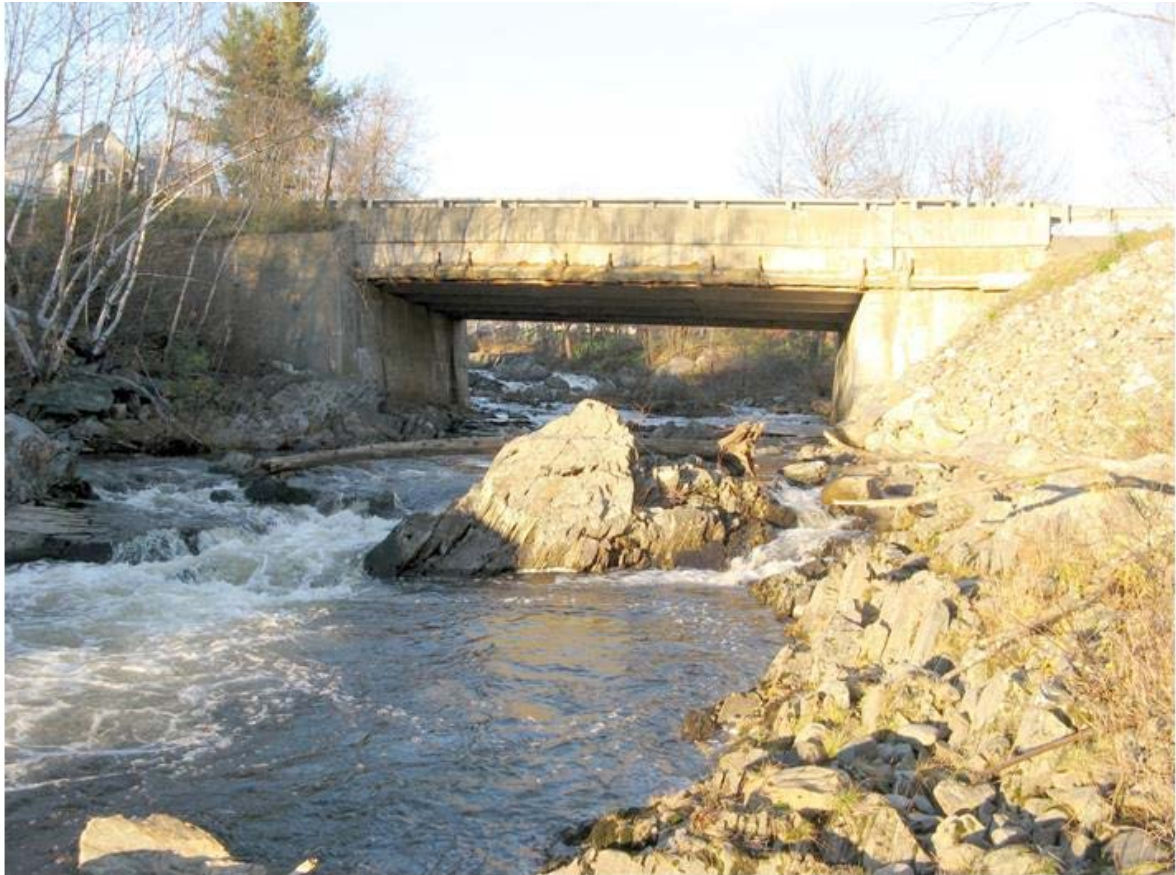
Looking upstream.

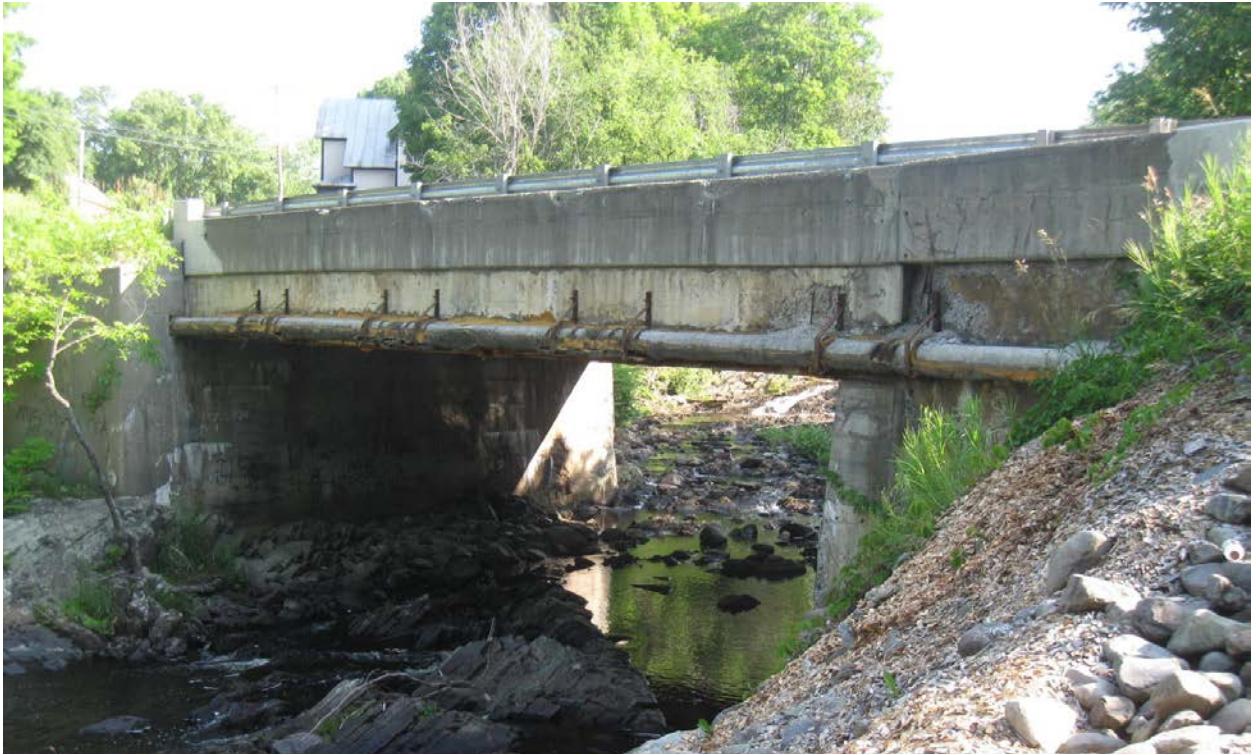
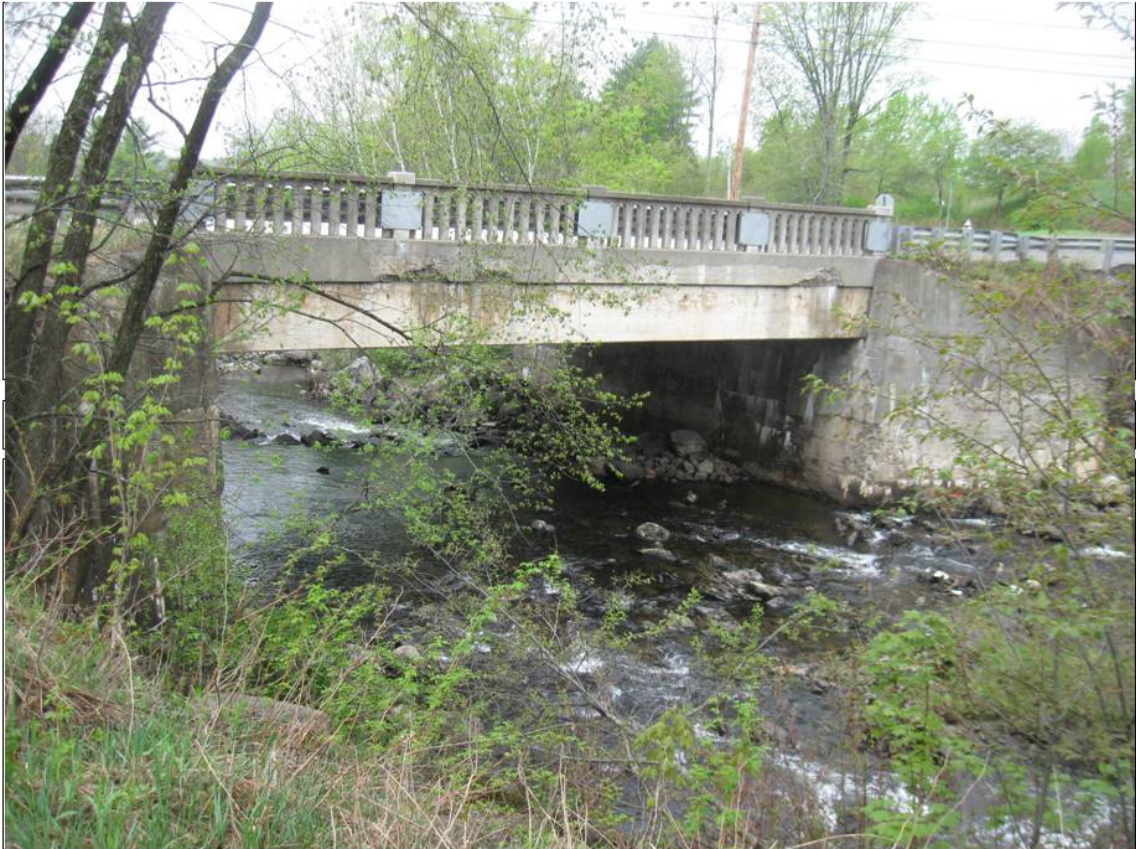
East side view

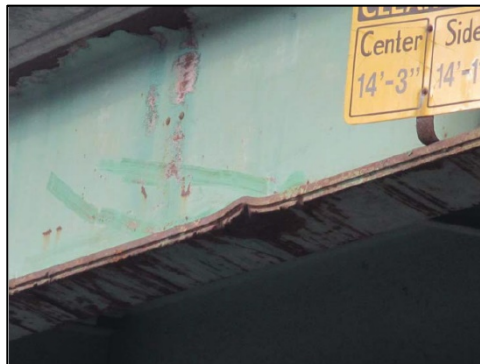
*Geometric Constraints* – a November 2017 bridge inspection evaluation reported impact damage to the two southerly facias girders of the center span. With Broadway being a main traffic artery for the city of Bangor, ME and the I-95 overpass providing substandard vertical clearance the likelihood of impact damage like this occurring is compounded. The 14 feet, 5 inches of vertical clearance provided is insufficient to support modern freight vehicles safely or efficiently, and currently requires large vehicles to detour away from the bridge, which places increased traffic demands on smaller roadways.

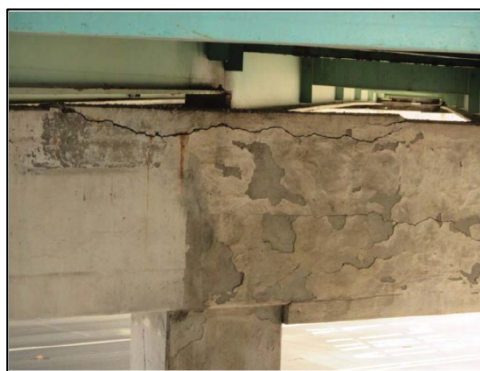
*Poor condition of structural members* – in general the steel girders have scattered surface paint failure and minor section loss at their ends; with the girders at pier joints experiencing extensive paint loss and rust. The concrete deck is in fair condition with scattered spalls, delaminations, cracking, exposed rebar, and efflorescence. Deck concrete at the pier joints has extensive cracking and spalling. The piers are in fair to poor condition with map cracking throughout the pier caps. Previous repairs are deteriorating/delaminating, and several cracks have formed directly under the bearings. Pier columns have scattered large areas of delaminations and vertical cracking. Overall the structure is functionally obsolete with advanced stages of deterioration that will require extensive rehabilitation or complete replacement soon.

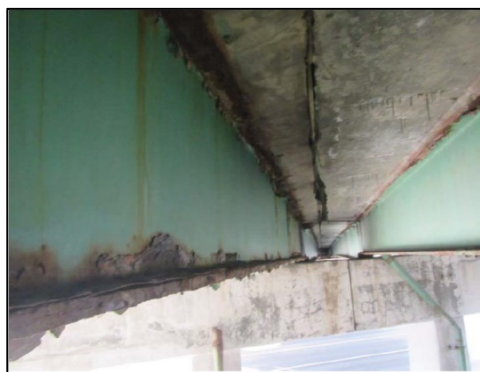
*Extensive Deteriorating Repairs and Retrofits* – the bridge has undergone numerous repairs over its 60-year service life. The original finger joint was replaced after 7 years, in 1967. In 1982 the bridge received a new concrete parapet and aluminum rail, as well as, new compression seals over both piers. There has been repair work done to both piers and abutments, assumed to be completed in the mid-1990s, which has since begun to deteriorate and delaminated.
