Maine Department of Transportation

Pavement Condition Report

BRUNSWICK EXECUTIVE AIRPORT (KBXM)

To assist individual airports to effectively maintain their pavement infrastructure and help improve airport pavement conditions statewide, the Maine Department of Transportation (MaineDOT) contracted with DuBois & King, Inc. (D&K) to provide pavement evaluation surveys at local airports. Assisting D&K on this effort was Applied Research Associates, Inc. (ARA). This report documents the pavement condition at Brunswick Executive Airport (BXM) in October 2018.

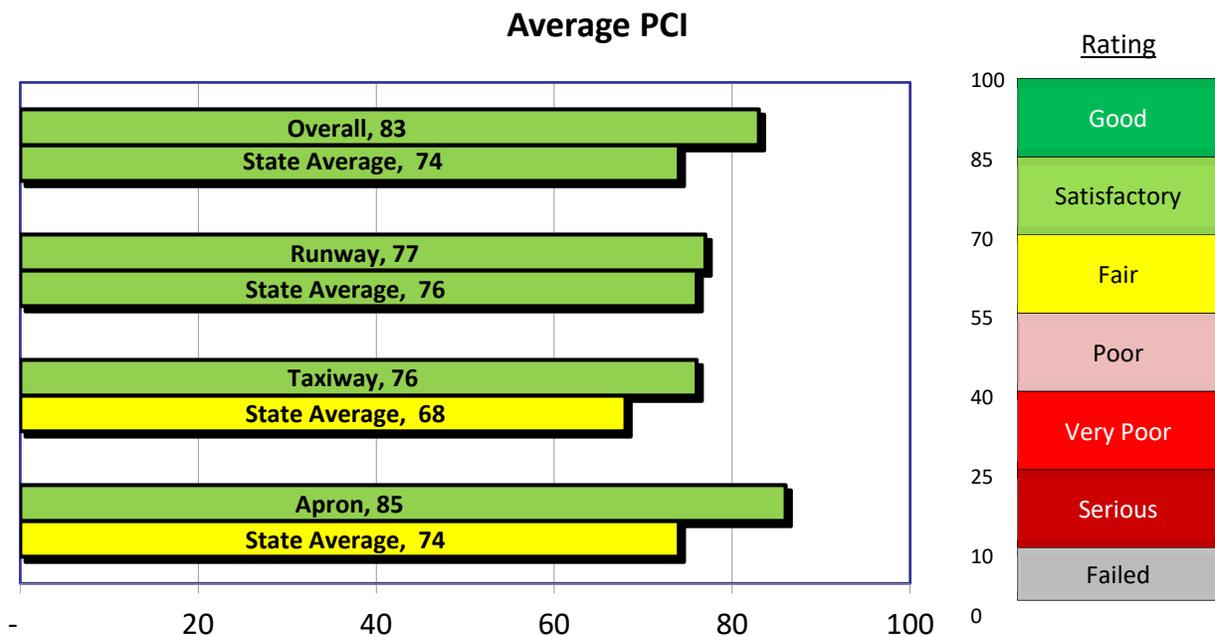
The average inspected Pavement Condition Index (PCI) for all the airfield pavements at BXM was 83. Runway 1-19 had an average inspected PCI of 77, which is above the MSL of 70. Taxiways had an average inspected PCI of 76, and aprons had an average inspected PCI of 85. A comparison of the average PCI values at BXM to the statewide average PCI values, by branch use, is shown in the figure below.

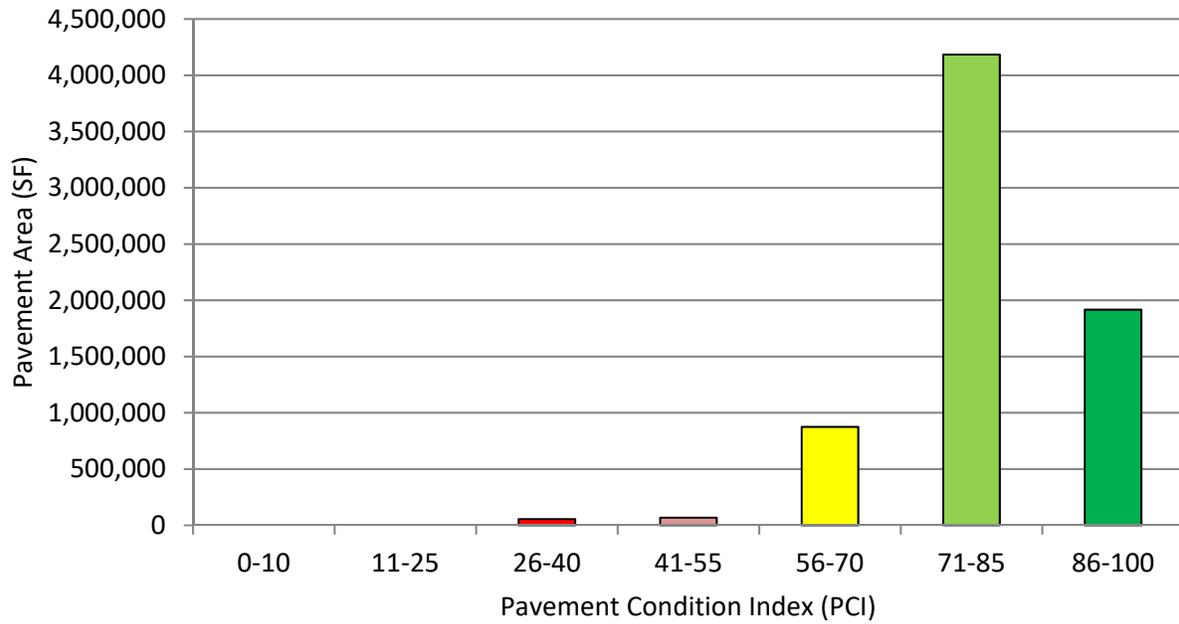
Figure 4. Condition distribution.

Figure 4 and Figure 5 present the overall PCI for BXM by area distribution and pavement use, respectively. Table 3 presents the PCI summary for each section at BXM, including the drop in PCI per year. Generally, pavement sections will deteriorate between 1 and 3 PCI points per year. Sections

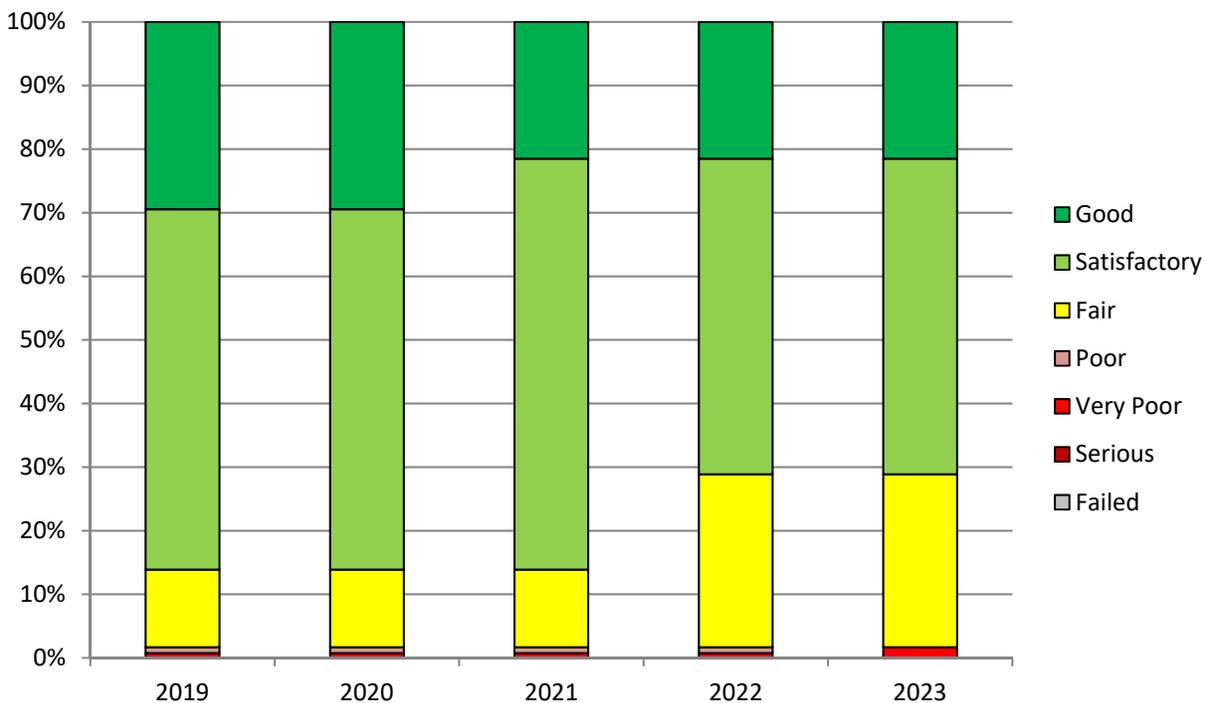
Figure 6. Projected PCI by percent area.

Figure 6 shows the projected PCI at BXM by percent area for the next 5 years assuming no maintenance or major repairs (overlays, reconstruction, etc.) are performed during that period. It shows how quickly the pavement network will deteriorate if no capital improvements are made. The corresponding projected PCI values for each pavement section are shown in Table 4.
