Maine Department of Transportation

Pavement Condition Report

WISCASSET MUNICIPAL AIRPORT (KIWI)

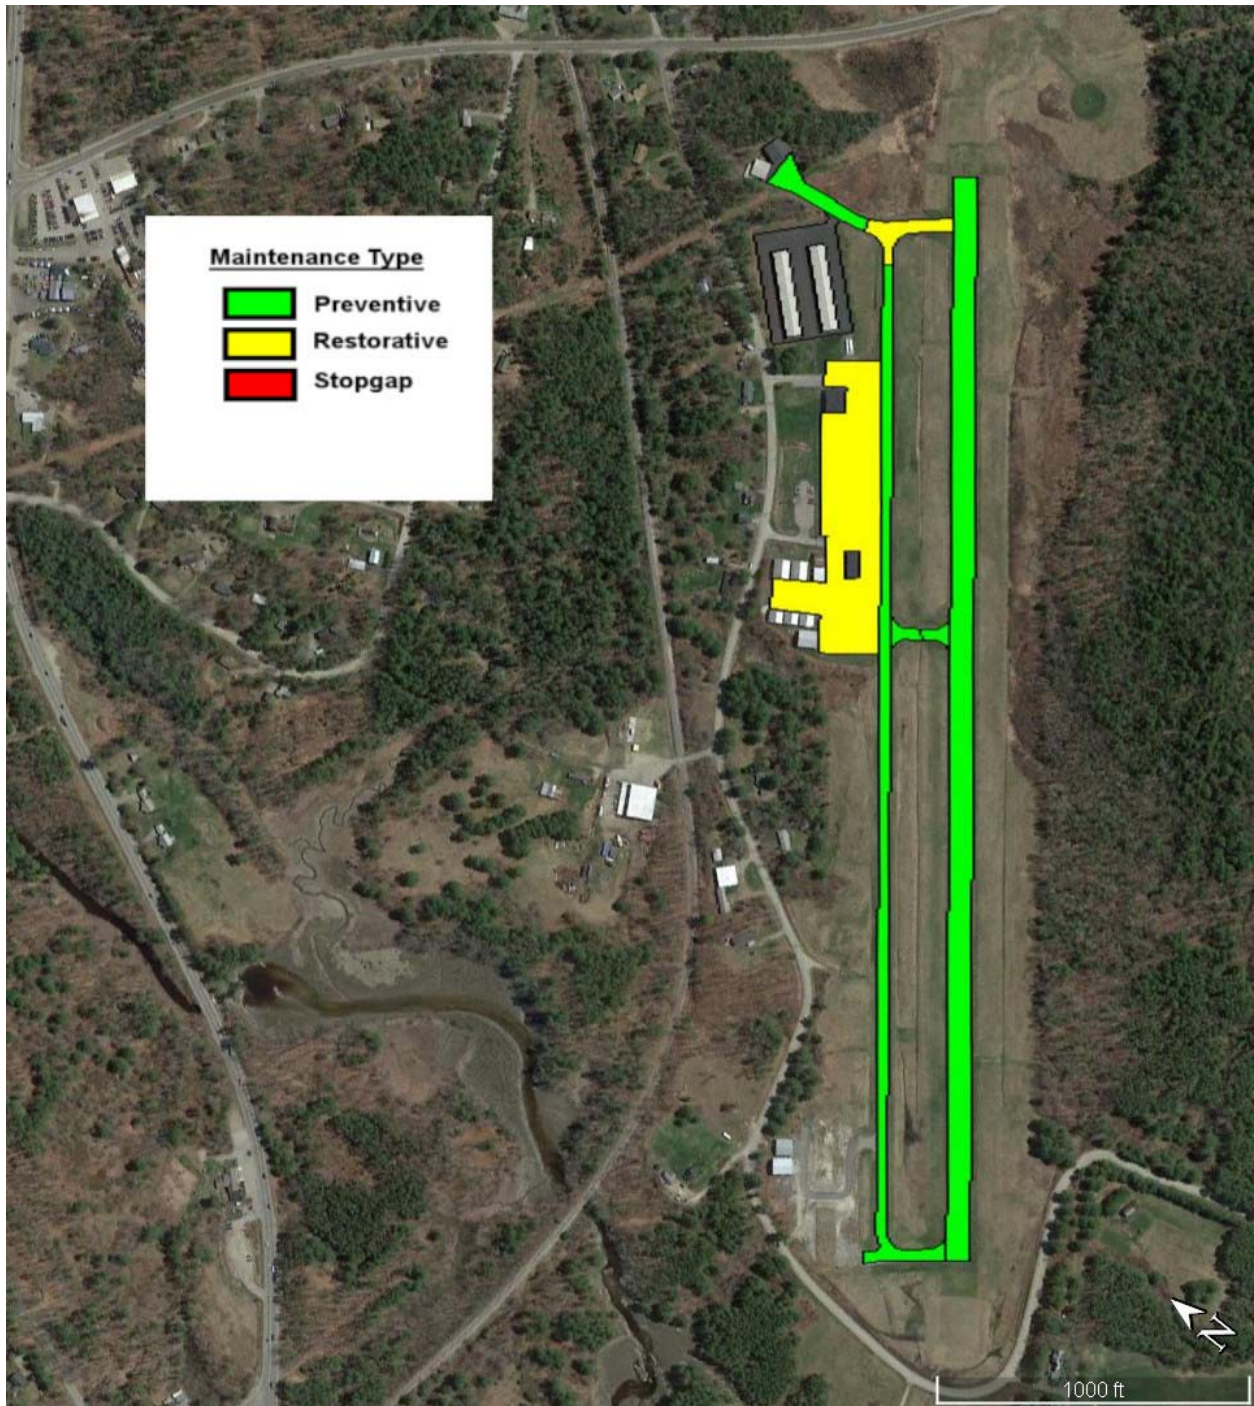
Figure 8. Maintenance type

Table 7 presents the summary of maintenance work quantities and estimated costs to apply the near term maintenance plan at IWI. The repair quantities are based on extrapolated distress quantities from PAVER using the 2018 PCI inspection and the maintenance policy matrix as defined in appendix E.

Branch	Section	Work Type	Quantity	Unit	Cost
APA	001	Crack Sealing - AC	1,622	Ft	\$2,238
APA	001	Patching - AC Deep	1,056	SqFt	\$19,613
APA	001	Surface Seal	1,049	SqFt	\$640
CTC	001	Crack Sealing - AC	4	Ft	\$5
CTC	002	Crack Sealing - AC	99	Ft	\$137
CTD	001	Crack Sealing - AC	52	Ft	\$72
CTD	001	Patching - AC Deep	14	SqFt	\$255
CTD	001	Patching - AC Shallow	38	SqFt	\$641
PTA	001	Crack Sealing - AC	14	Ft	\$20
RY725	001	Crack Sealing - AC	291	Ft	\$402
TLD	001	Crack Sealing - AC	240	Ft	\$331

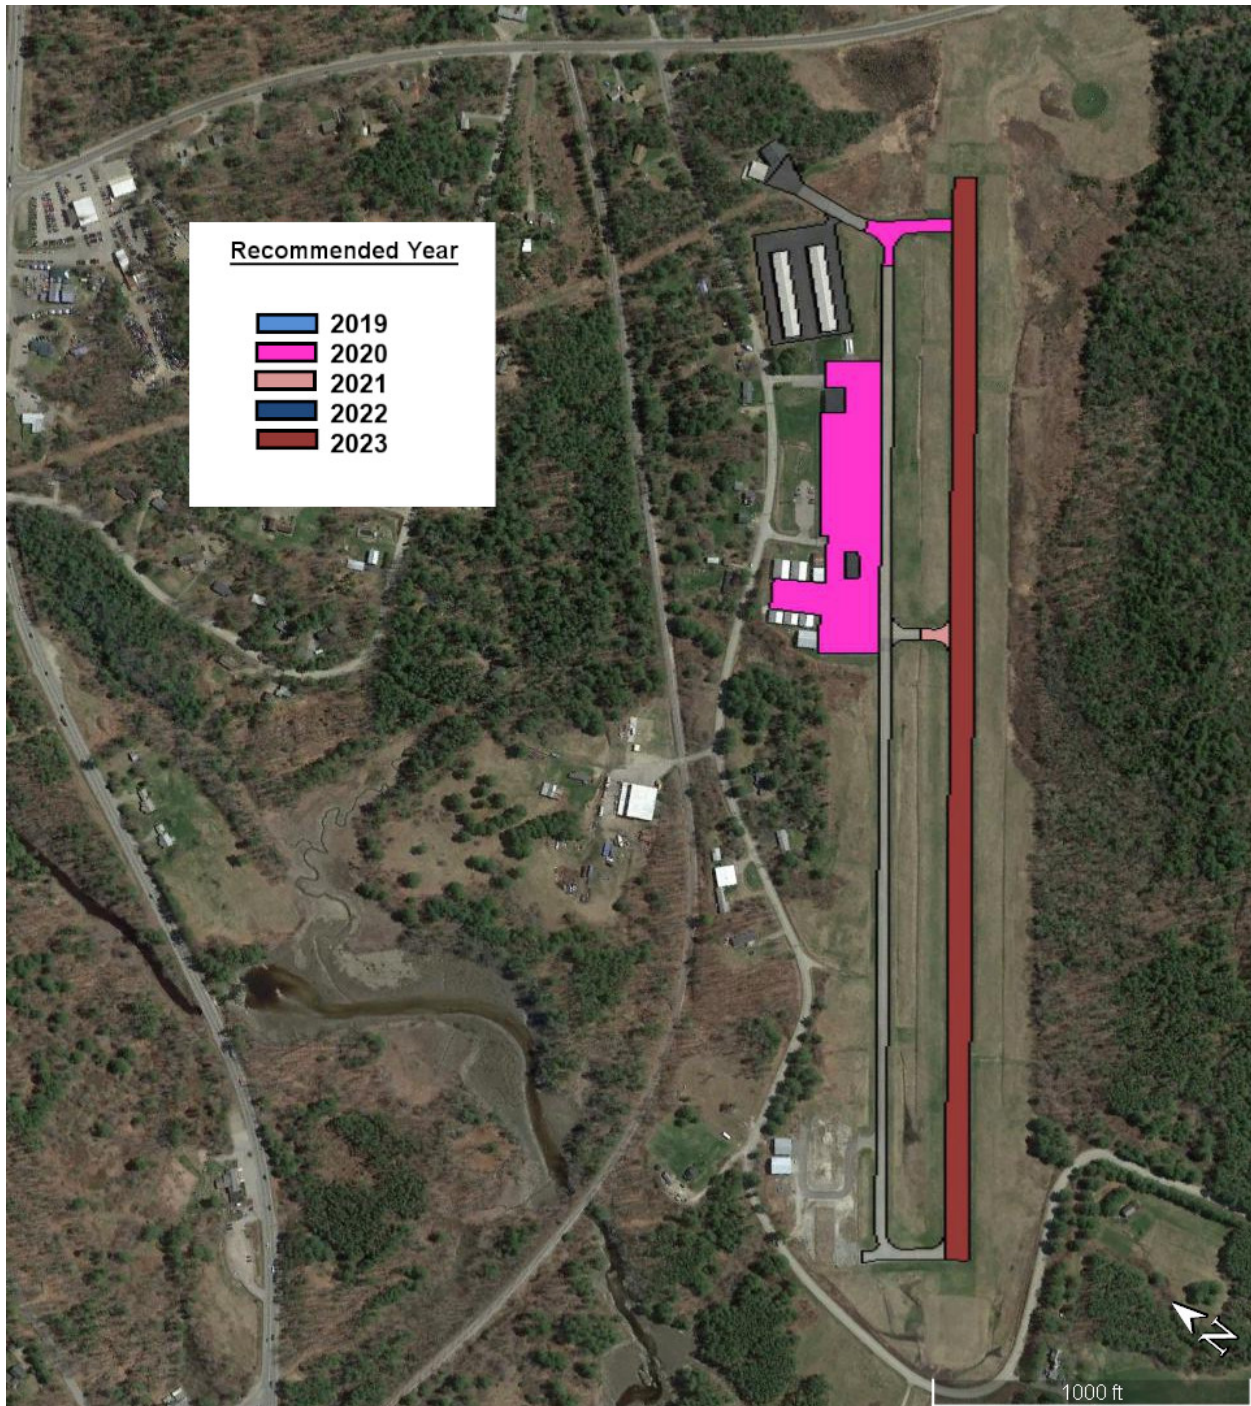
Figure 9. Major M&R

The pavement sections identified for major rehabilitation in Table 10 and shown in Figure 9 are at or are predicted to reach a condition level where major M&R should be considered. While the predicted rehabilitation timeline identifies specific sections and the general timing for the repair, more in-depth project-level studies will be needed to determine exactly how to fix each pavement (i.e. asphalt overlay, reconstruction, or some other repair alternative). Additionally, the airport may find it desirable to adjust the timing of projects to meet fiscal and operational constraints. For example, if the runway and several connector taxiways were forecast to reach the MSL in various years ranging from 2019-2023, it may be preferable to group these pavement sections into a single project.

Branch ID	Section ID	Year	Predicted PCI Before Rehab	Estimated Cost
APA	001	2020	62	\$482,750
CTD	001	2020	64	\$43,449
CTC	002	2021	69	\$12,237
RY725	001	2023	69	\$700,407
5-year Airport Total				\$1,238,844
