Pavement Condition Report

LORING INTERNATIONAL AIRPORT (ME 16)

LORING COMMERCE CENTRE

Submitted To:
Maine Department of Transportation
16 State House Station
Augusta, ME 04333

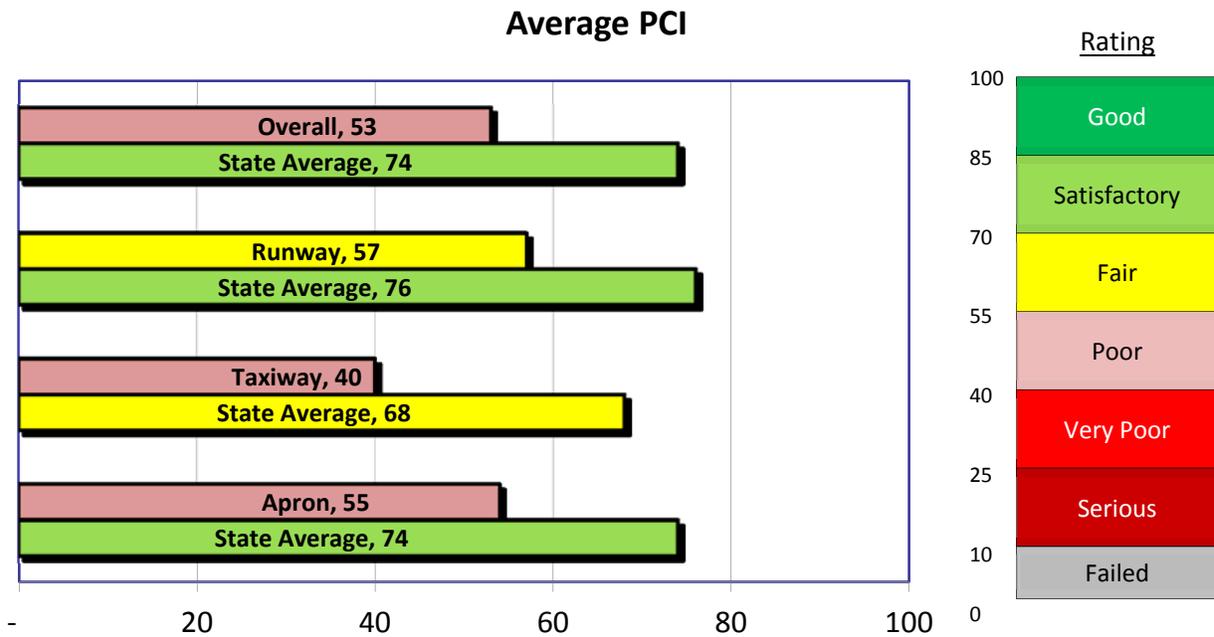
The average inspected Pavement Condition Index (PCI) for all the airfield pavements at LOR was 53. Runways had an average inspected PCI of 57, which is below the MSL of 70. Taxiways had an average inspected PCI of 40, and aprons had an average inspected PCI of 55. A comparison of the average PCI values at LOR to the statewide average PCI values, by branch use, is shown in the figure below.

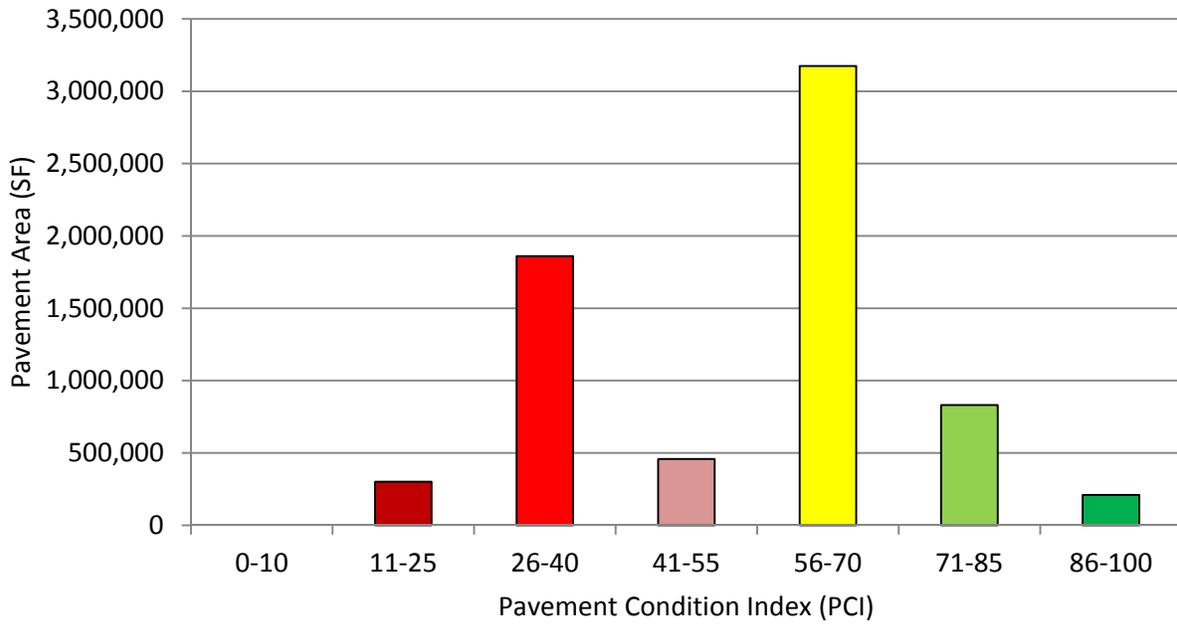
Figure 4. Condition distribution.

Figure 4 and Figure 5 present the overall PCI for LOR by area distribution and pavement use, respectively. Table 3 presents the PCI summary for each section at LOR, including the drop in PCI per year. Generally, pavement sections will deteriorate between 1 and 3 PCI points per year. Sections deteriorating at higher rates may need maintenance above the normal application rates and should be closely monitored in case major repairs become necessary earlier than expected.

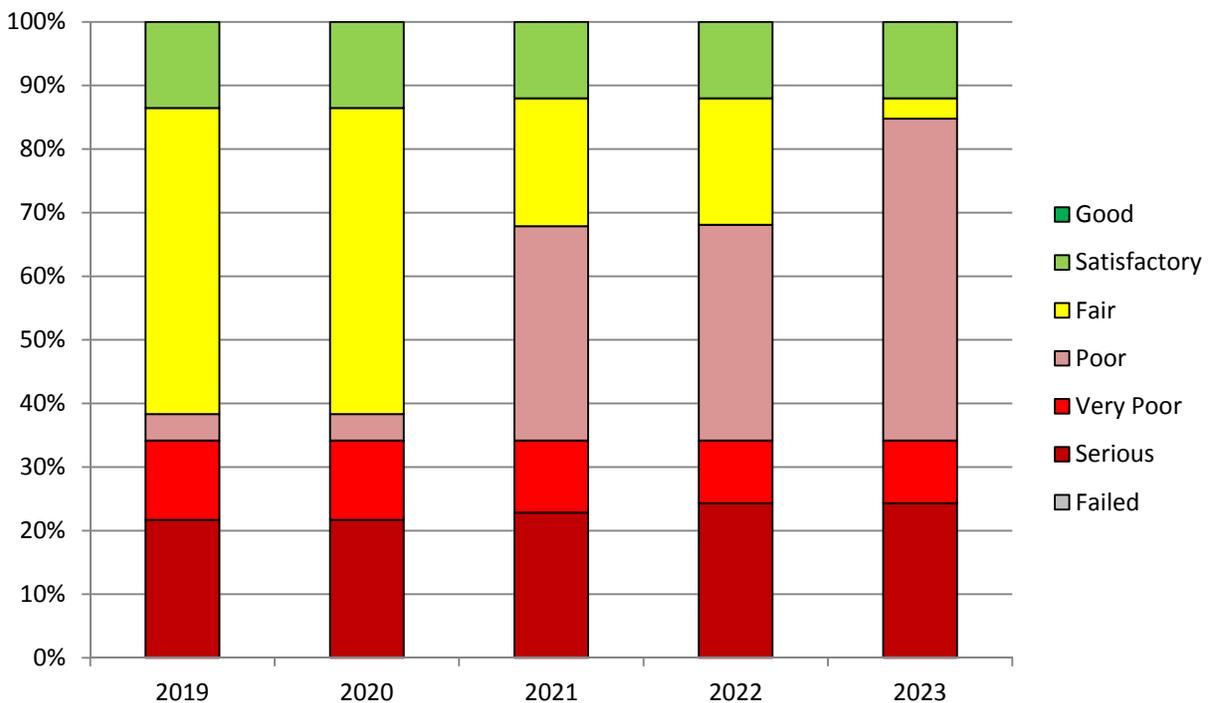
Figure 6. Projected PCI by percent area.

Figure 6 shows the projected PCI at LOR by percent area for the next 5 years assuming no maintenance or major repairs (overlays, reconstruction, etc.) are performed during that period. It shows how quickly the pavement network will deteriorate if no capital improvements are made. The corresponding projected PCI values for each pavement section are shown in Table 4.

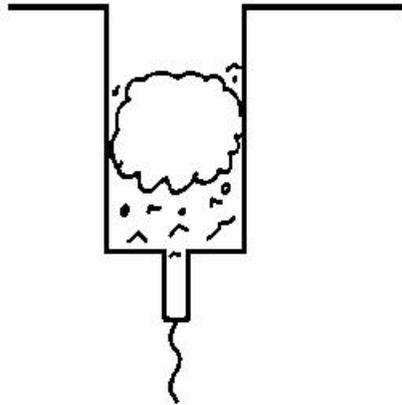
Typical joint with deficient sealant and a collection of debris & incompressibles.
