Maine Department of Transportation

Pavement Condition Report

LINCOLN REGIONAL AIRPORT (KLRG)

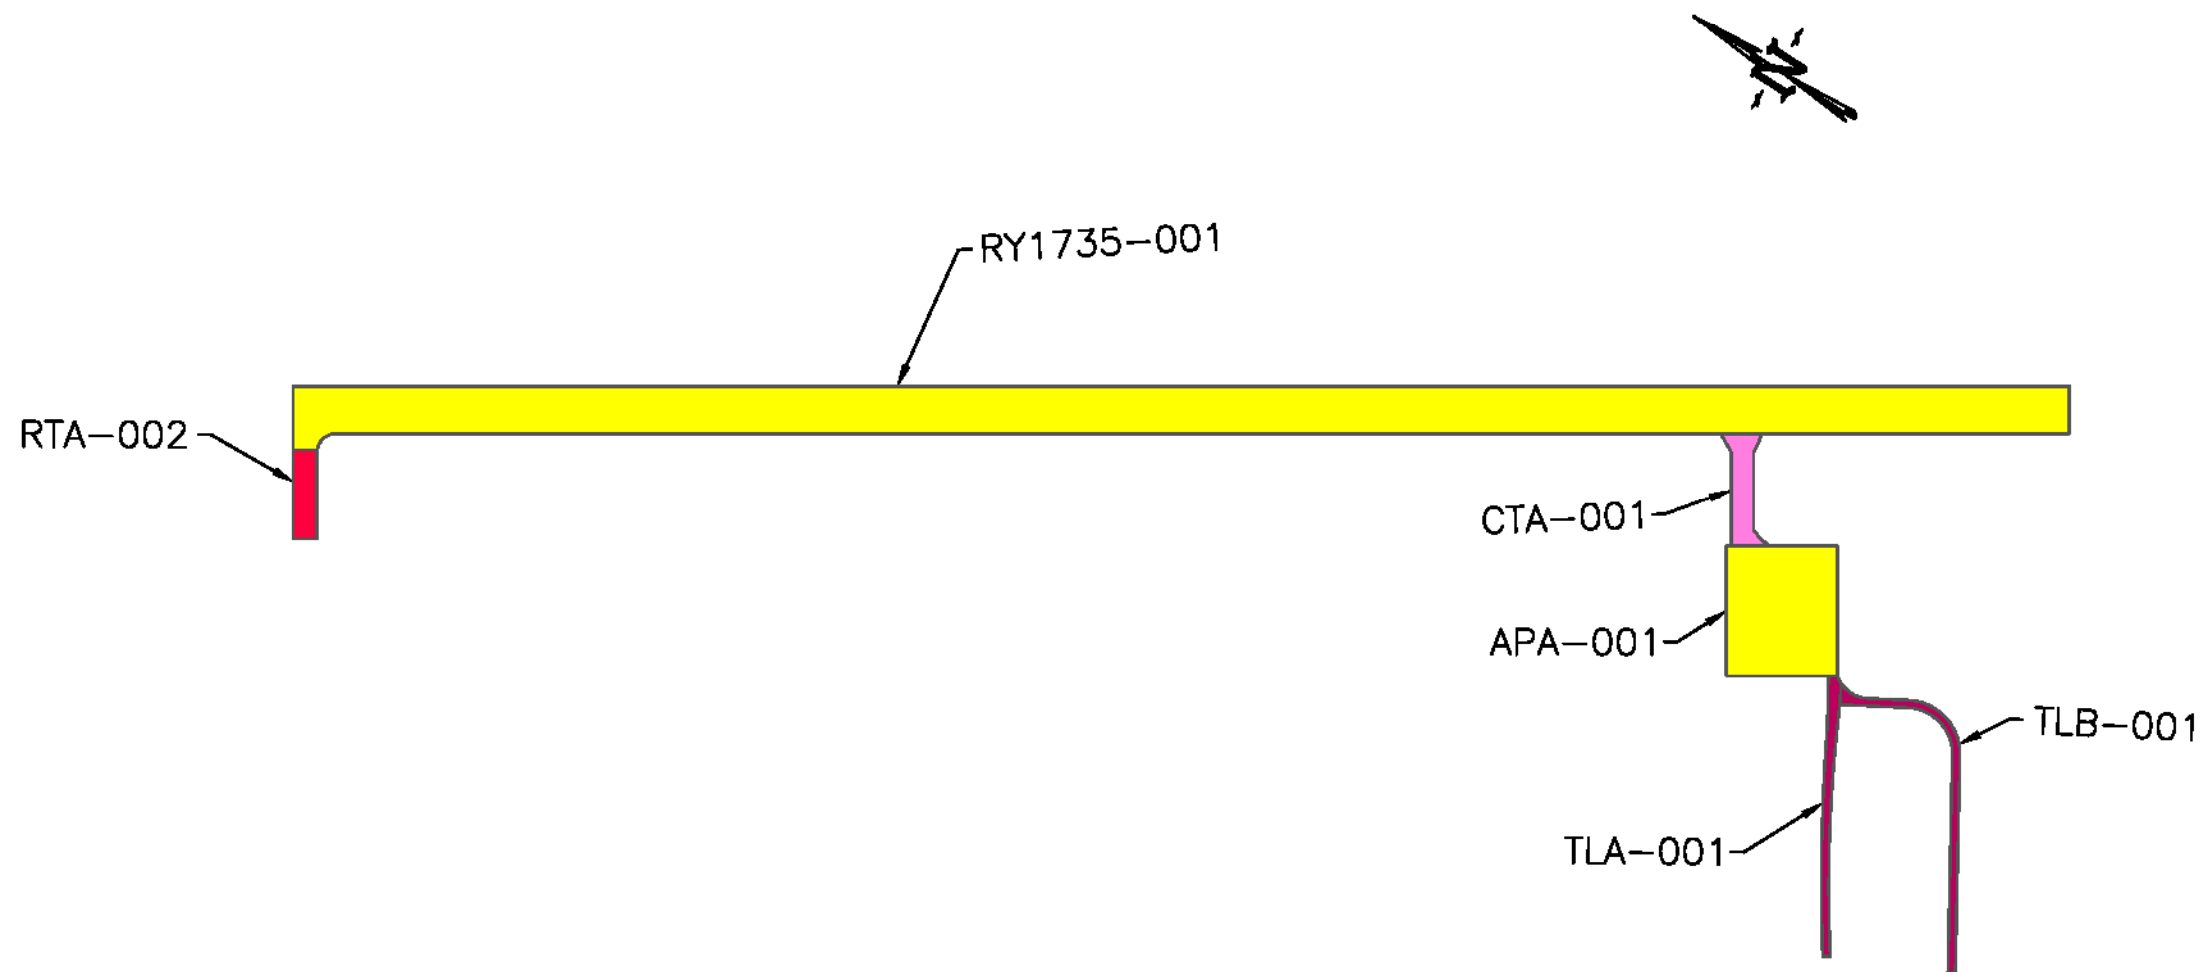
2018 Pavement Condition Map Lincoln Regional Airport (LRG)	
ENGINEER: BDA	DRAWN BY: MJP
DATE: Jul 2019	CTAF 122.8

The average inspected Pavement Condition Index (PCI) for all the airfield pavements at LRG was 62. Runway 17-35 had an average inspected PCI of 66, which is below the MSL of 70. Taxiways had an average inspected PCI of 44, taxilanes had an average inspected PCI of 22, and aprons had an average inspected PCI of 56. A comparison of the average PCI values at LRG to the statewide average PCI values, by branch use, is shown in the figure below.

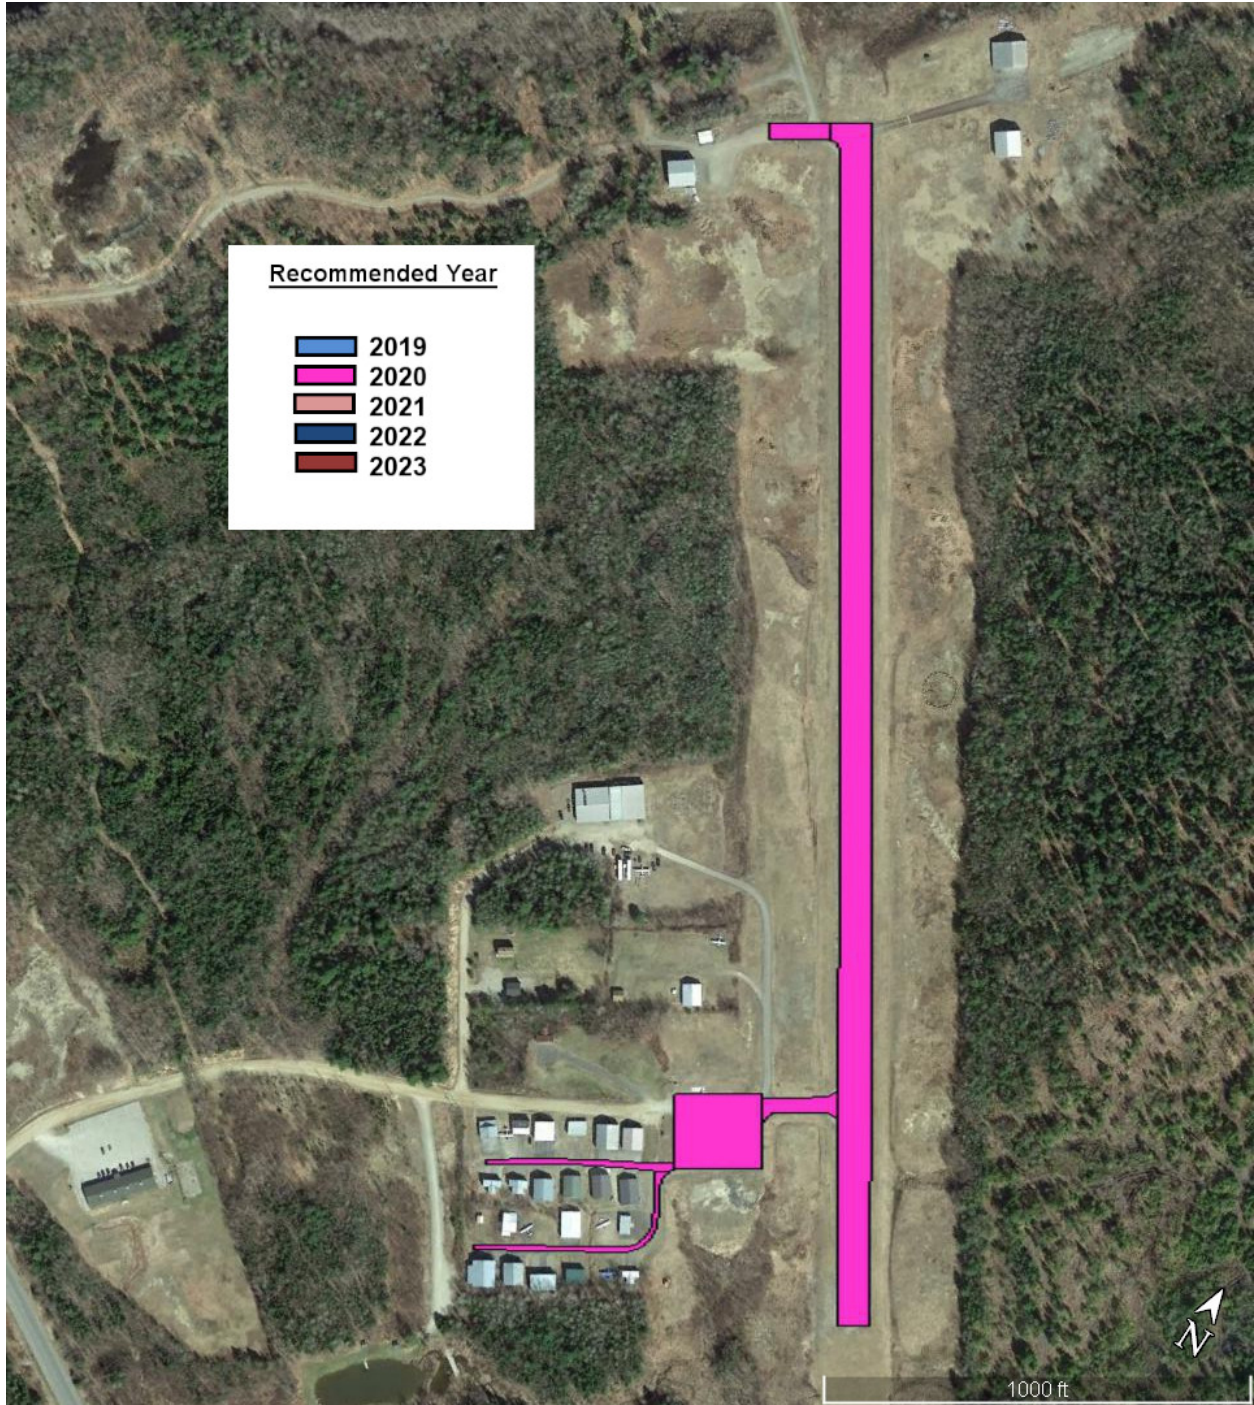
Figure 9. Major M&R

The pavement sections identified for major rehabilitation in Table 10 and shown in Figure 9 are at or are predicted to reach a condition level where major M&R should be considered. While the predicted rehabilitation timeline identifies specific sections and the general timing for the repair, more in-depth project-level studies will be needed to determine exactly how to fix each pavement (i.e. asphalt overlay, reconstruction, or some other repair alternative). Additionally, the airport may find it desirable to adjust the timing of projects to meet fiscal and operational constraints. For example, if the runway and several connector taxiways were forecast to reach the MSL in various years ranging from 2019-2023, it may be preferable to group these pavement sections into a single project.

Branch ID	Section ID	Year	Predicted PCI Before Rehab	Estimated Cost
APA	001	2020	52	\$729,288
CTA	001	2020	51	\$141,778
RTA	002	2020	26	\$109,138
RW1735	001	2020	62	\$581,335
TLA	001	2020	16	\$124,438
TLB	001	2020	19	\$145,858
5-year Airport Total				\$1,831,834

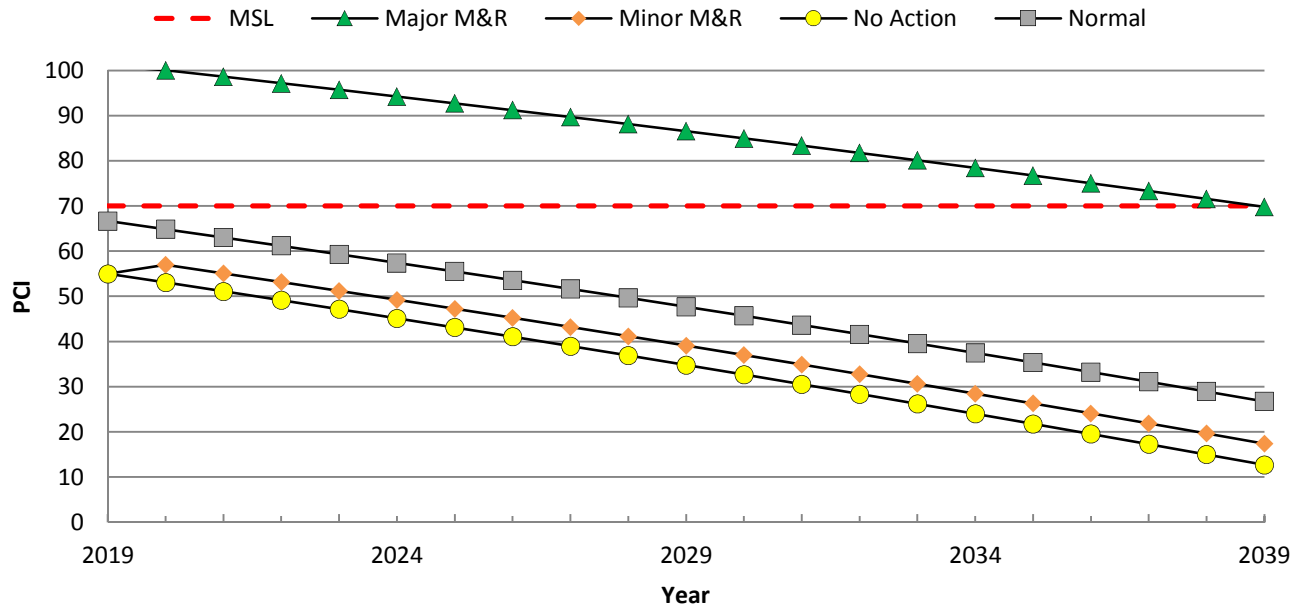
Section:	LRG::CTA::001
Description:	Connecting Taxiway A
PaveType:	AC
Area:	6,950
Built:	1/15/1998
Age:	21yr

M&R	Action	Year / Quantity	Cost (\$)	Ending PCI
Major	Major M&R	2020	141,778	100
Minor	All Minor	2020	5,403	57
1	Surface Seal	6910 SqFt	4,216	-
2	Patching - AC Shallow	69 SqFt	1,153	-
3	Crack Sealing - AC	25 Ft	34	-
4	-	-	-	-
5	-	-	-	-
6	-	-	-	-
7	-	-	-	-

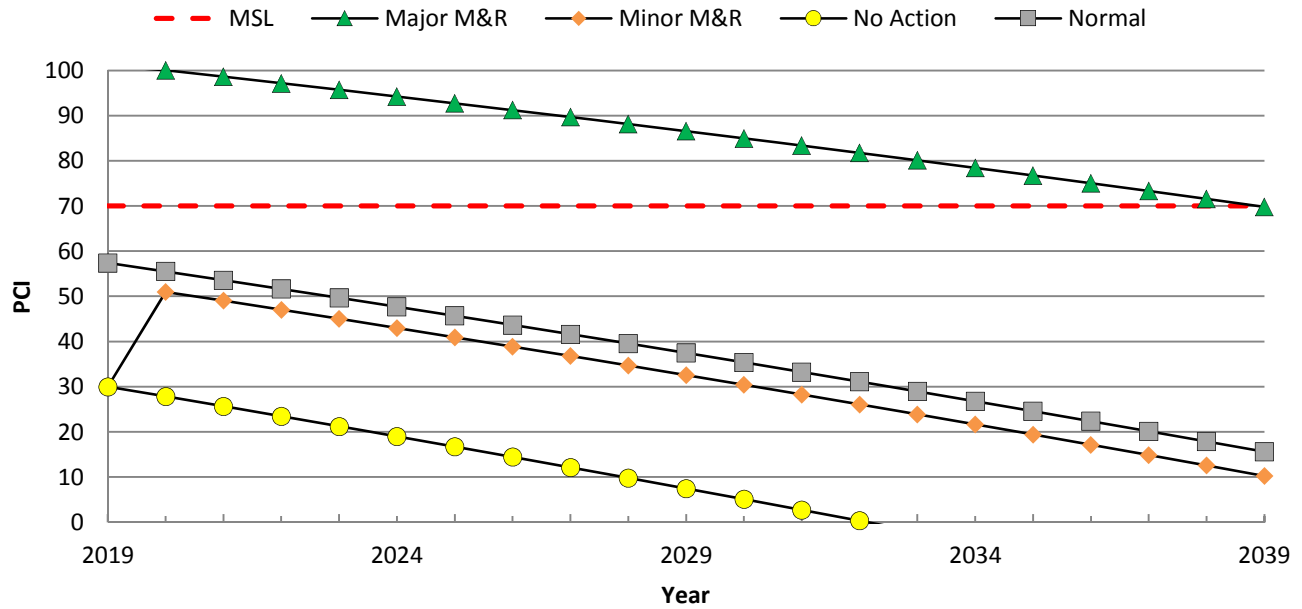
Section:	LRG::RTA::002
Description:	Runway Turnaround A
PaveType:	AC
Area:	5,350
Built:	1/15/1993
Age:	26yr

M&R	Action	Year / Quantity	Cost (\$)	Ending PCI
Major	Major M&R	2020	109,138	100
Minor	All Minor	2020	2,785	51
1	Surface Seal	2972 SqFt	1,813	-
2	Crack Sealing - AC	705 Ft	972	-
3	-	-	-	-
4	-	-	-	-
5	-	-	-	-
6	-	-	-	-
7	-	-	-	-

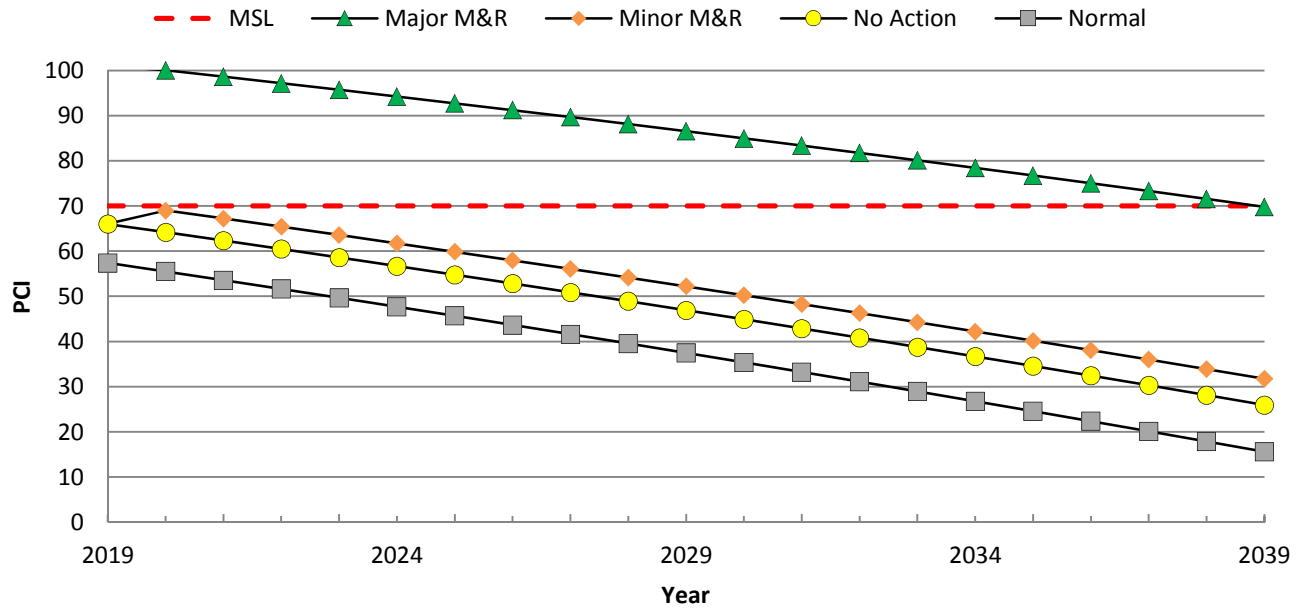
Section:	LRG::RW1735::001
Description:	Runway 17-35
PaveType:	AC
Area:	211,400
Built:	1/15/1993
Age:	26yr

M&R	Action	Year / Quantity	Cost (\$)	Ending PCI
Major	Major M&R	2020	581,335	100
Minor	All Minor	2020	11,575	69
1	Surface Seal	10066 SqFt	6,141	-
2	Crack Sealing - AC	3938 Ft	5,435	-
3	-	-	-	-
4	-	-	-	-
5	-	-	-	-
6	-	-	-	-
7	-	-	-	-

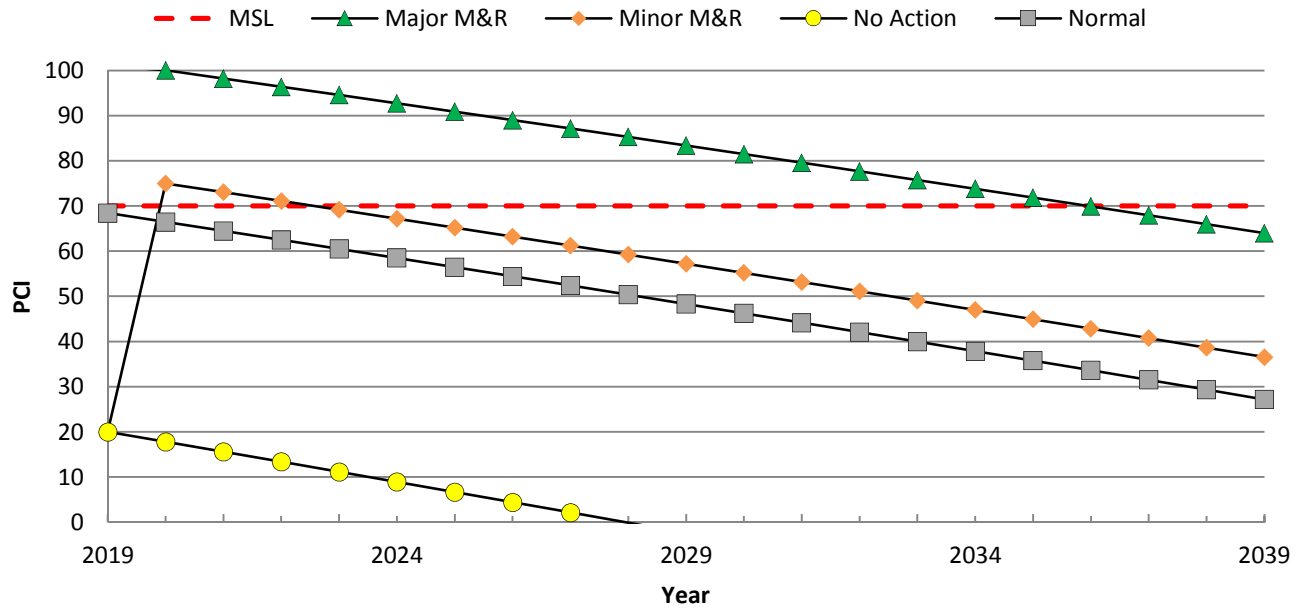
⁴ The higher than expected deterioration rate of 5.0 PCI/Yr for TLA-001 is primarily due to medium-and high-severity alligator cracking.

Section:	LRG::TLA::001
Description:	Taxilane A
PaveType:	AC
Area:	6,100
Built:	1/15/2002
Age:	17yr

M&R	Action	Year / Quantity	Cost (\$)	Ending PCI
Major	Major M&R	2020	124,438	100
Minor	All Minor	2020	16,742	75
1	Patching - AC Deep	762 SqFt	14,146	-
2	Patching - AC Shallow	155 SqFt	2,596	-
3	-	-	-	-
4	-	-	-	-
5	-	-	-	-
6	-	-	-	-
7	-	-	-	-

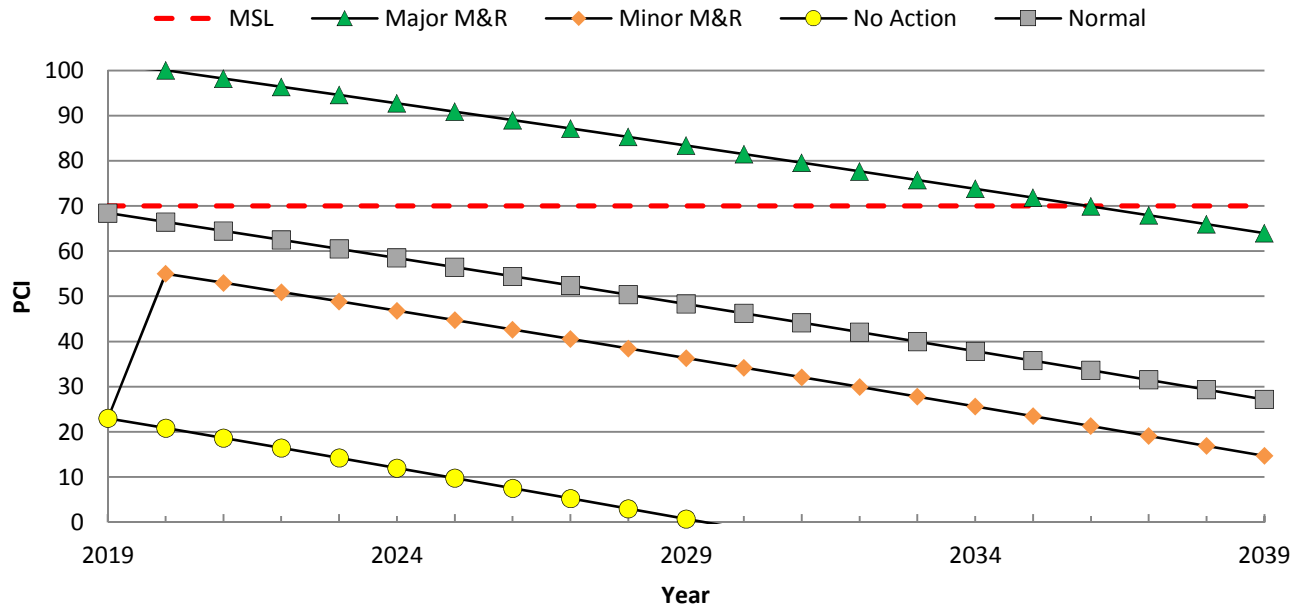
⁵ The higher than expected deterioration rate of 4.8 PCI/Yr for TLB-001 is primarily due to low-, medium-and high-severity alligator cracking.

Section:	LRG::TLB::001
Description:	Taxilane B
PaveType:	AC
Area:	7,150
Built:	1/15/2002
Age:	17yr

M&R	Action	Year / Quantity	Cost (\$)	Ending PCI
Major	Major M&R	2020	145,858	100
Minor	All Minor	2020	22,318	55
1	Patching - AC Deep	1028 SqFt	19,088	-
2	Patching - AC Shallow	193 SqFt	3,230	-
3	-	-	-	-
4	-	-	-	-
5	-	-	-	-
6	-	-	-	-
7	-	-	-	-
