Maine Department of Transportation

Pavement Condition Report

SANFORD SEACOAST REGIONAL AIRPORT (KSFM)

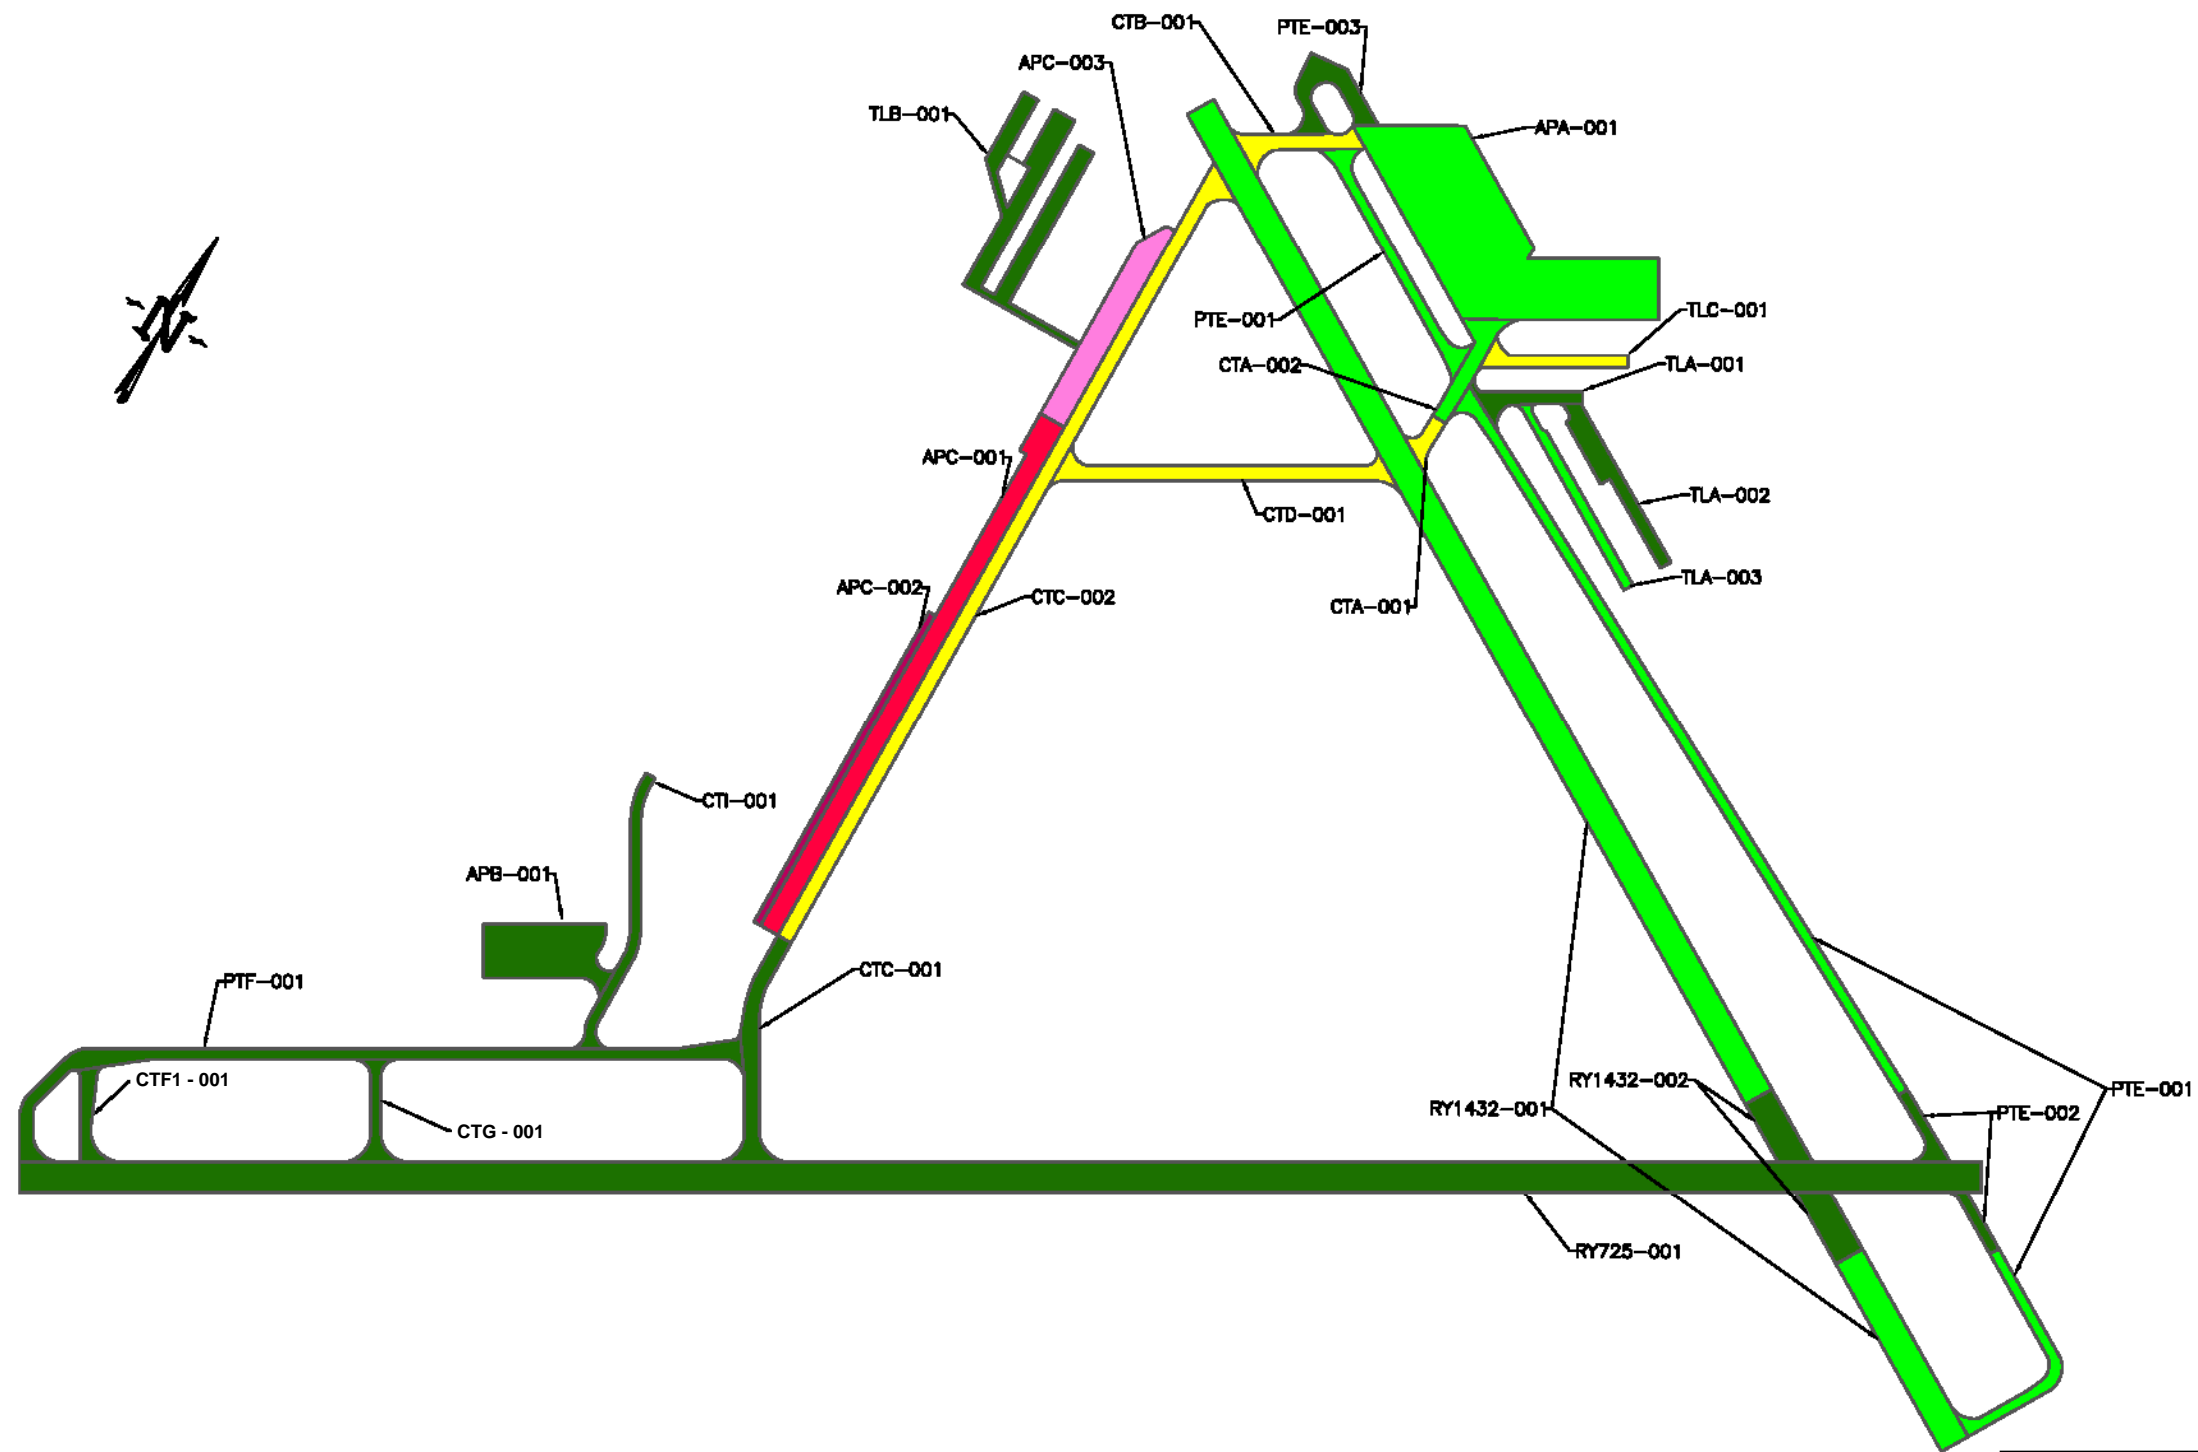
2018 Pavement Condition Map
Sanford Seacoast Regional Airport (SFM)

FAILED	SERIOUS	VERY POOR	POOR	FAIR	SATISFACTORY	GOOD	PCI INDEX
NS	0-10	11-25	26-40	41-55	56-70	71-85	86-100

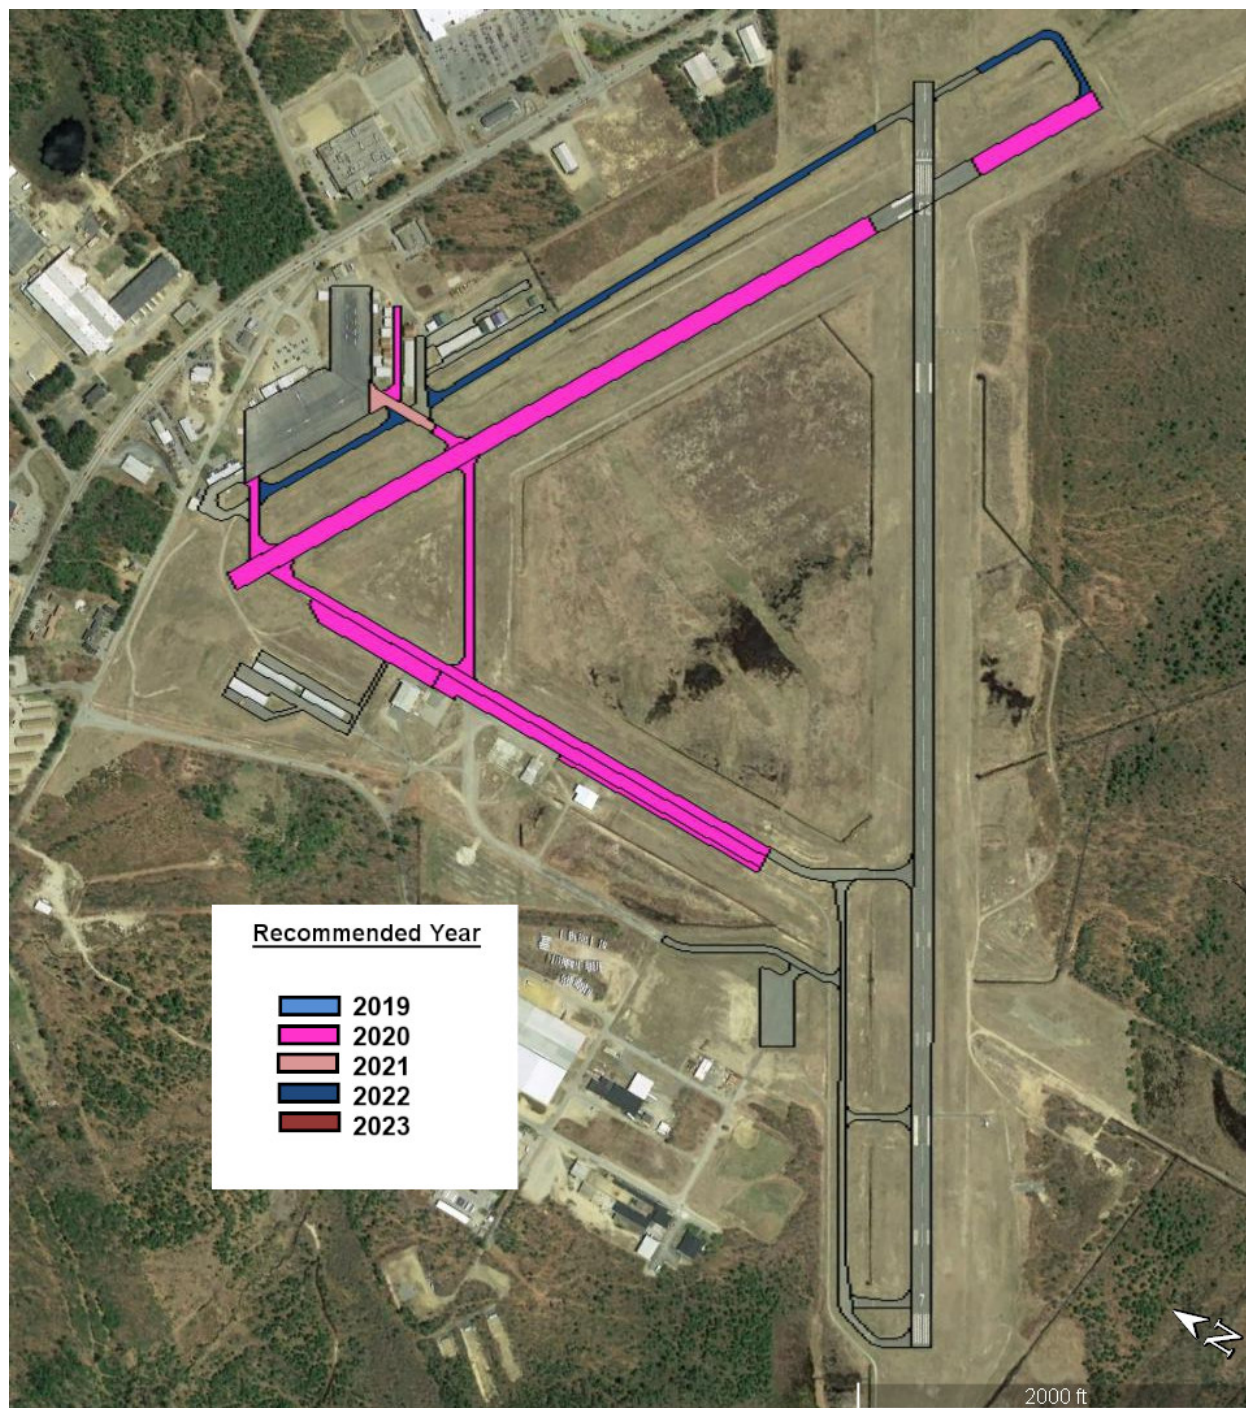
Figure 9. Major M&R

The pavement sections identified for major rehabilitation in Table 10 and shown in Figure 9 are at or are predicted to reach a condition level where major M&R should be considered. While the predicted rehabilitation timeline identifies specific sections and the general timing for the repair, more in-depth project-level studies will be needed to determine exactly how to fix each pavement (i.e. asphalt overlay, reconstruction, or some other repair alternative). Additionally, the airport may find it desirable to adjust the timing of projects to meet fiscal and operational constraints. For example, if the runway and several connector taxiways were forecast to reach the MSL in various years ranging from 2019-2023, it may be preferable to group these pavement sections into a single project.

Branch ID	Section ID	Year	Predicted PCI Before Rehab	Estimated Cost
APC	001	2020	31	\$2,544,856
APC	002	2020	11	\$611,990
APC	003	2020	37	\$1,318,837
CTA	001	2020	67	\$24,474
CTB	001	2020	65	\$66,136
CTC	002	2020	53	\$2,996,709
CTD	001	2020	60	\$1,193,400
RY1432	001	2020	68	\$1,208,869
TLC	001	2020	52	\$427,373
CTA	002	2021	69	\$64,761
PTE	001	2022	69	\$440,539
5-year Airport Total				\$10,897,944
