Maine Department of Transportation

Pavement Condition Report

Waterville Le Robert LaFleur Airport (WVL)

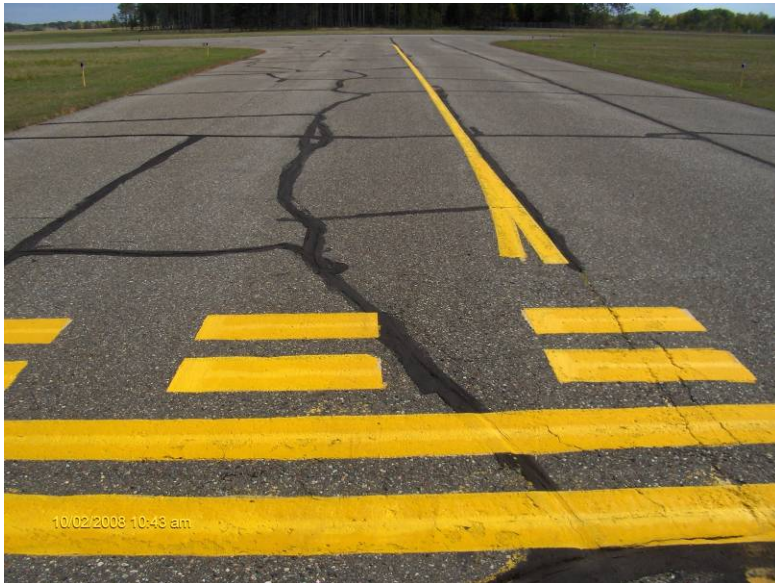
Example of Longitudinal and Transverse Cracking (L&T cracking)

Longitudinal and transverse cracks are caused by pavement aging, by construction, and by subsurface movement. Aging occurs as pavement loses some of its components to the atmosphere and becomes more brittle. Consistent application of pavement sealcoats can help to prevent the occurrence of age related cracks. Cracks will also develop along poorly constructed paving lane joints. Ensuring that joints are made when both sides are still hot, and near the same temperature, is one of the best ways to mitigate this potential problem. Seasonal movement caused by changes in moisture content or temperature differences can also cause pavement cracks. Asphalt pavement placed over a PCC pavement or cement stabilized base course may evidence reflective cracking from the underlying material. Longitudinal and transverse cracks are not caused by wheel loads, although traffic may worsen their condition.

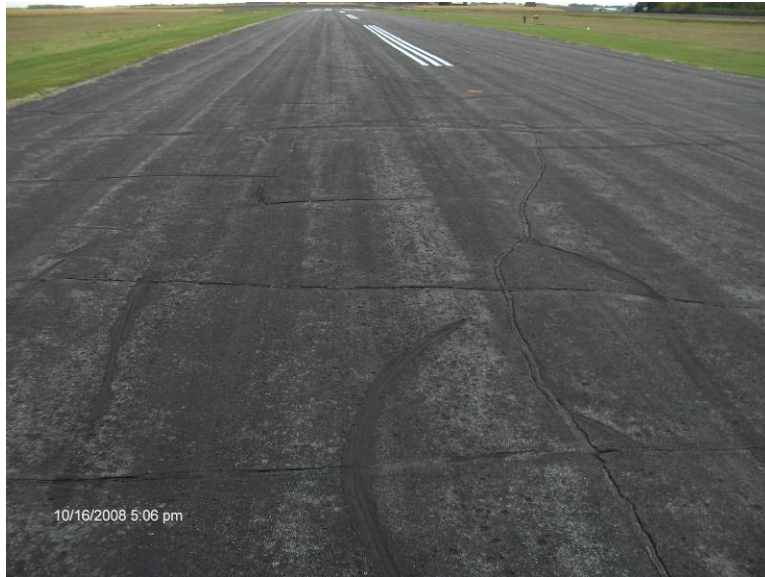
Example of Block Cracking

Block cracking is longitudinal and transverse cracking that has established a pattern of blocks ranging in size from 1ft x 1ft to 10ft x 10ft. This distress typically happens in older asphalt pavements and is an indication that the bituminous binder has lost most of its flexibility. The severity determination is basically determined by the crack width criteria defined for longitudinal and transverse cracking. Crack sealing typically is used to repair block cracking; however, the amount of required sealant can be extensive due to the high density of cracks.

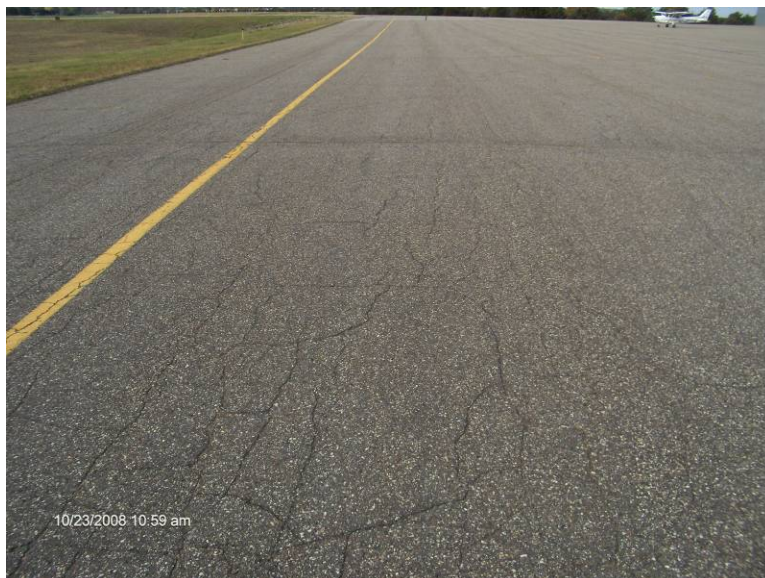
Example of Alligator Cracking

Alligator (or fatigue) cracks are a series of interconnected load-related cracks caused by fatigue of the asphalt surface. Alligator cracking is a significant structural distress and develops only in places subject to traffic loads. These cracks typically initiate at the bottom of the asphalt layer (where tensile strains

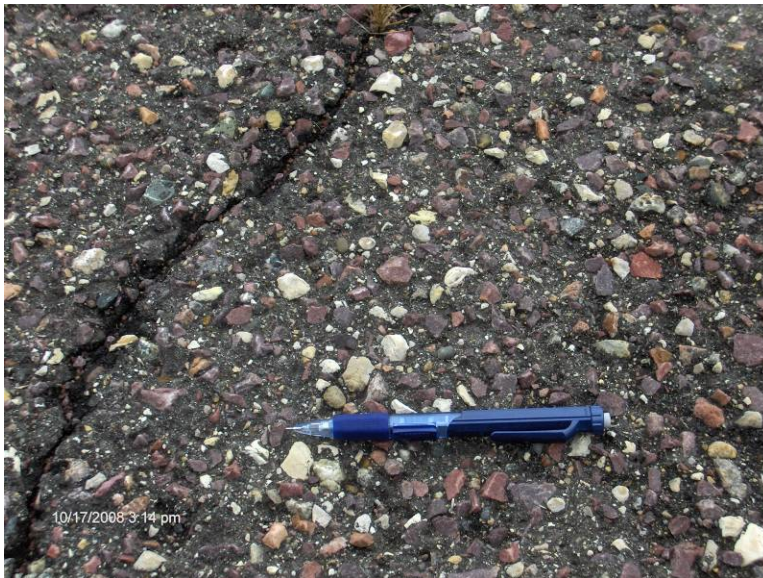
Example of Raveling/Weathering

Raveling and weathering are the wearing away of the pavement surface. Raveling is the condition where the mid- to large size aggregates are becoming dislodged; weathering is when the fine aggregate wears away exposing the edges of the larger aggregate. These distresses are usually evident over large areas and may occur together (pictured above) or separately. Raveling and weathering may indicate that the asphalt binder has hardened significantly.

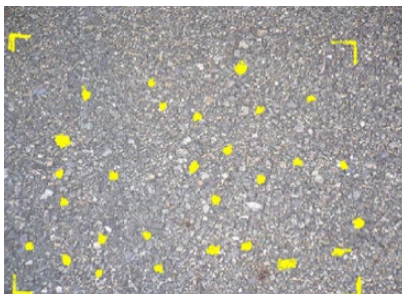
Raveling – At low severity, the number of missing coarse aggregates (> 3/8 inch) is between 5-20 missing/yd², medium severity (pictured below where the missing coarse aggregates have been dotted with yellow paint) is 21-40 missing/yd², and high severity is > 40 missing/yd².

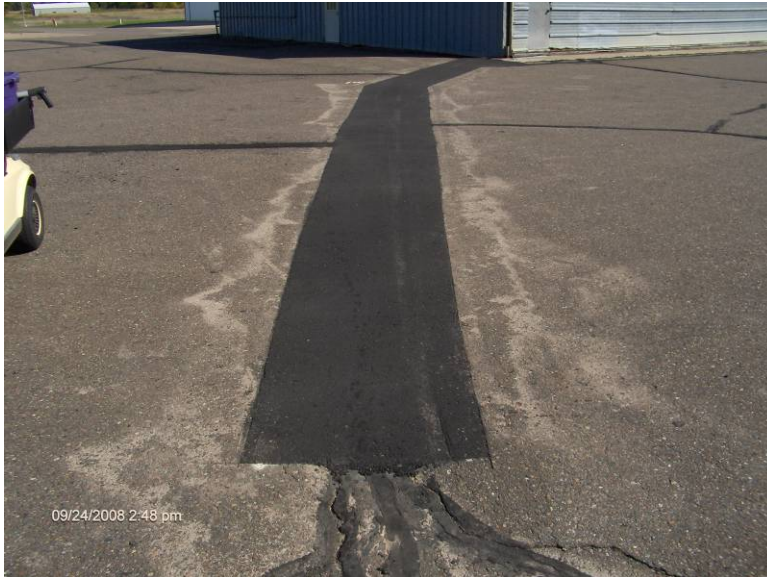
Example of Patching

Patched areas are defined when a portion of the original pavement is replaced with a material intended as a semi-permanent repair. A patch is documented as a defect because it is considered a break in the integrity of the pavement structure. Patches are constructed for a variety of reasons including utility repairs, correcting grade issues, and addressing a defect in the original pavement. The severity level of patches is determined by the amount of distress (i.e. cracking, depression, weathering/raveling, etc.) occurring within the limits of the patched area.

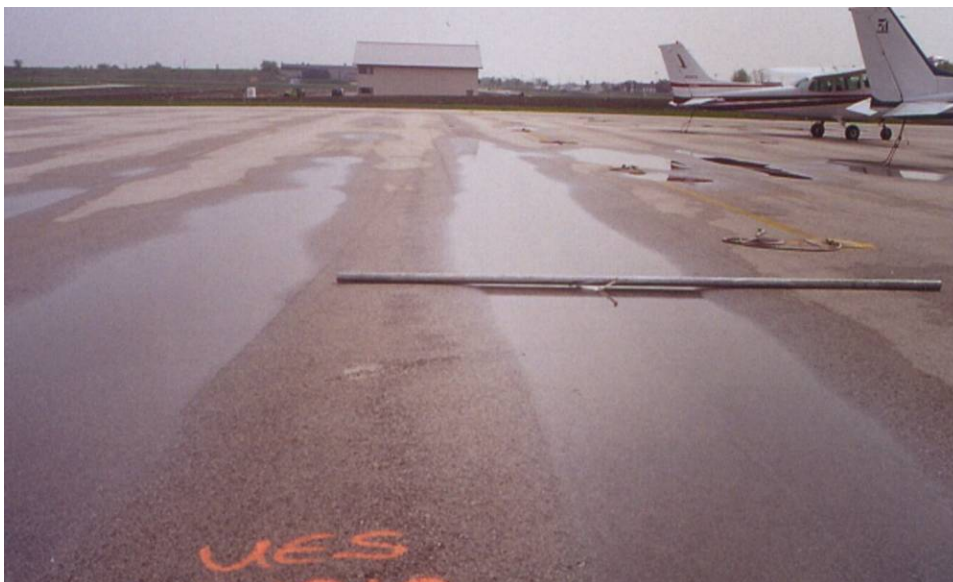
Example of Rutting

Ruts are localized, load related, areas of pavement having elevations lower than the surrounding sections. Rutting is due to base and subgrade consolidation, caused by excessive wheel loads or poor compaction. Ruts indicate structural failure, and can cause hydroplaning. At low severity, ruts have an

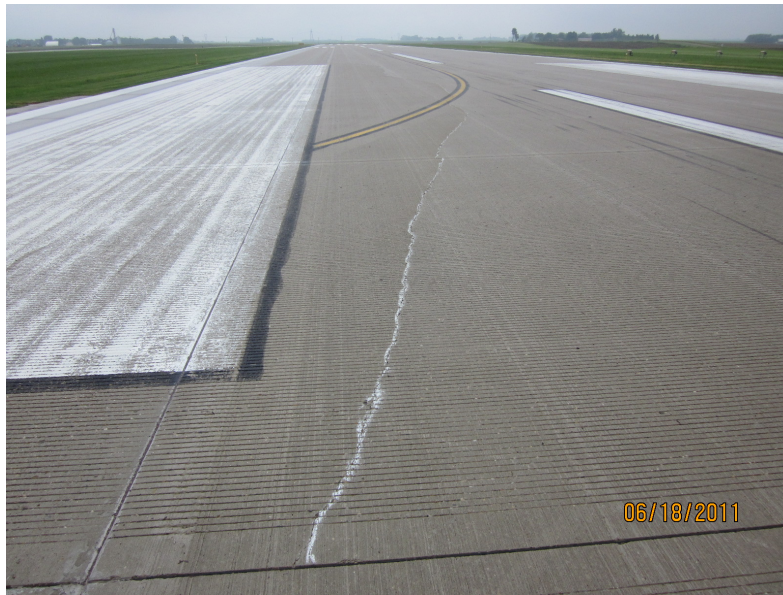
Example of Longitudinal, Transverse, and Diagonal Cracking

LTD cracking is most often a result of externally applied loads and/or constrained temperature deformations. External loads cause LTD cracking through flexure. Temperature changes on restrained slabs will result in stresses due to friction or curling. When any of these stresses exceed the strength of the slab, cracking will occur. LTD cracking is recorded at low, medium, or high severity, depending on the width of crack opening and degree of deterioration. At low severity, the crack is less than 1/8th inch wide with little spalling and no corrective action is indicated. At medium severity, LTD cracks can be up to 1 inch wide with moderate spalling, and should be repaired and sealed using procedures similar to joint sealing. At high severity, cracks exceed 1 inch in width and may be severely spalled. High-severity LTD cracking is evidence of serious load failure of the slab, and correction may require patching or slab replacement. If the distress occurs in several adjacent slabs at medium or high severity, major rehabilitation of that pavement area is indicated.

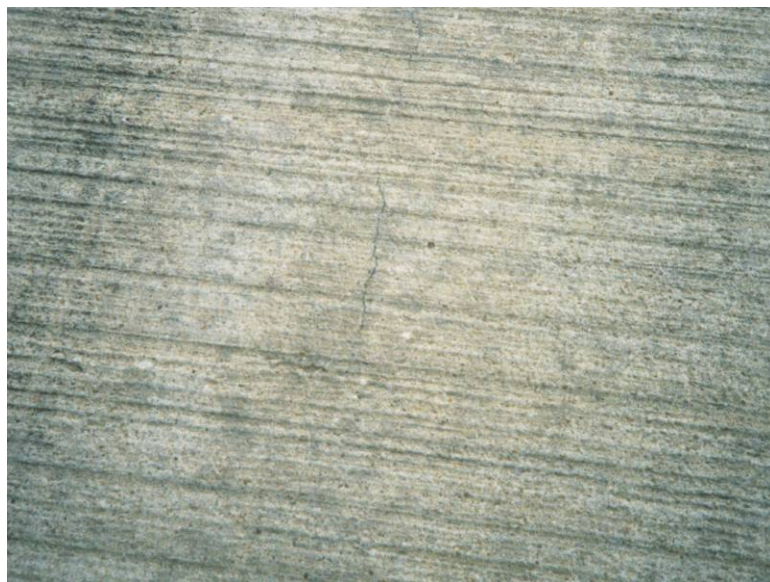
Example of Shrinkage Cracking

Shrinkage cracks are small, nonworking (no spalling along edge) cracks that are visible at the surface but do not penetrate through the full depth of concrete. Shrinkage cracks most commonly occur shortly after construction due to concrete shrinkage during the curing process. Shrinkage cracks are usually so small that they are not visible until staining or material loss at crack edges begins to take place. Shrinkage cracks do not represent a structural weakness, and no corrective action is prescribed.

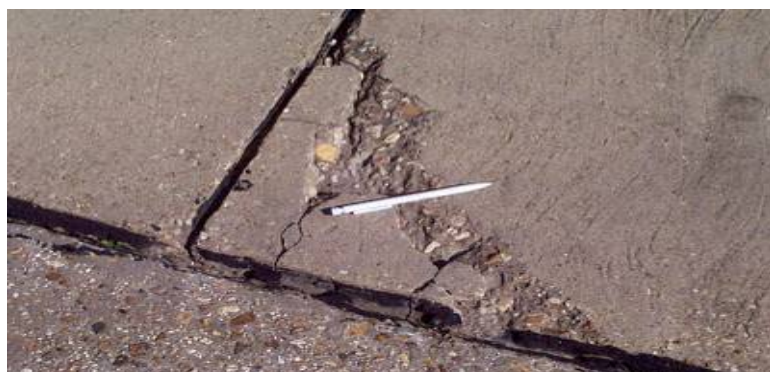
Example of Joint and Corner Spalling

Spalls at slab joints and corners are caused by excessive internal stress in the pavement. Spalls occur when these stresses exceed the shear strength of the concrete. Spalling usually results from thermal expansion during warm or hot weather. As slabs expand, they push against one another at joints. If the joints are filled with incompressibles, such as sand, or if adjacent slabs offset slightly, stresses can become severe, causing spalls. Spalling can be reduced significantly by conscientious maintenance of joint sealant.

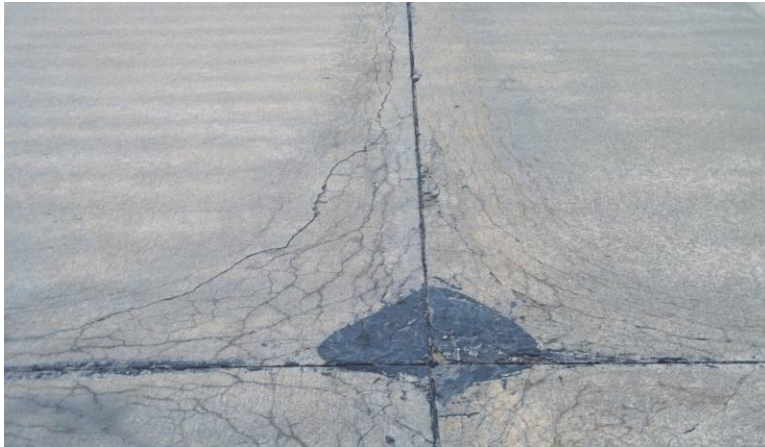
Example of Durability Cracking

Durability cracking (D-cracking) is caused by environmental factors, the most common of which is freezing/thawing. It usually appears as a pattern of hairline cracks running parallel to a joint or crack, or in a corner, where water tends to collect. This type of cracking eventually leads to disintegration of the pavement, creating FOD potential. At low severity, D-cracking is evident, but no disintegration has occurred. As the distress advances to medium severity, the distress pattern is evident over a significant area of the slab, and some disintegration and FOD potential exists. High severity durability cracking is evidenced by extensive cracking with loose and missing pieces and significant FOD potential.

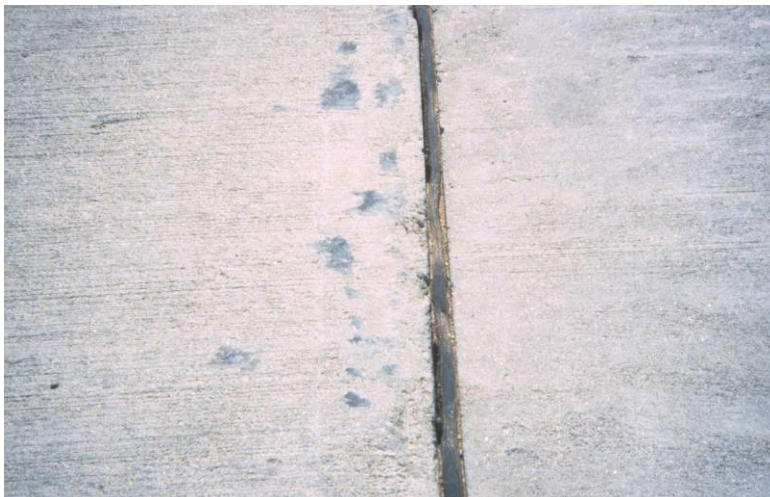
Example of Joint Seal Damage

Joint seal damage is recorded at three severities: low, medium, and high. When joint sealant is in perfect condition (no damage), it is not a distress. At low severity, at least 10 percent of the sealant is debonded but still in contact with the joint edges (i.e., joint sealant is in serviceable condition but should
