Highway Bridge Inspection Report

**I-95 SB / EMERSON MILLS RD
I-95 SOUTHBOUND
over
B&A RR & EMERSON MILL RD**

Inspection Date: 06/21/2018

Inspection Type(s): Routine

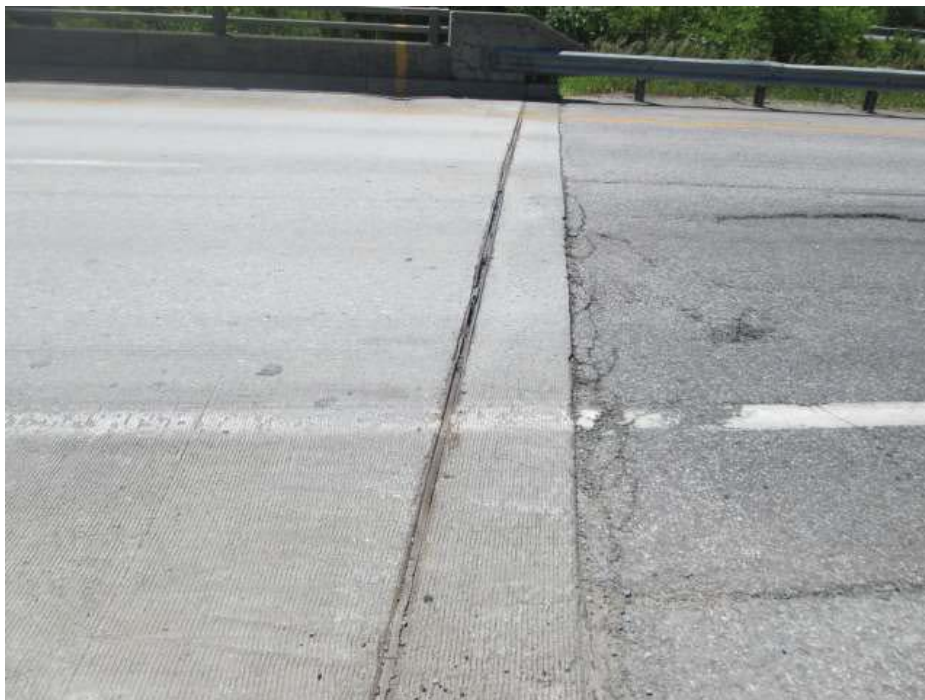
PHOTO 2

Description west joint

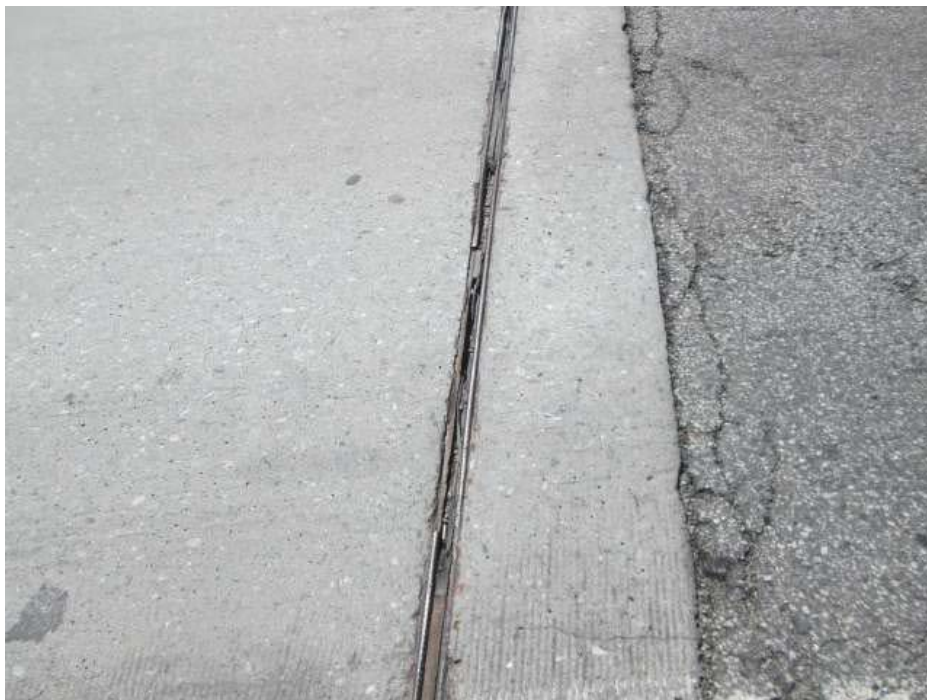
PHOTO 3

1 SF area of delaminated concrete over travel lanes chipped out. All joints in fair to poor condition, have allowed leakage causing beam end paint loss and moderate/heavy rust. Concrete under steel joint armor has extensive spalling throughout all joints. Reinforcing steel bars were welded onto joint armor to raise them to grade. Many welds have broken. Westerly joint rebar has broken away and is slapping/pinging when traffic passes over. Numerous aluminum posts have plow damage ranging from minor to heavy. Concrete barrier has moderate cracking and light staining. See photos.

Description leaking west joint seal

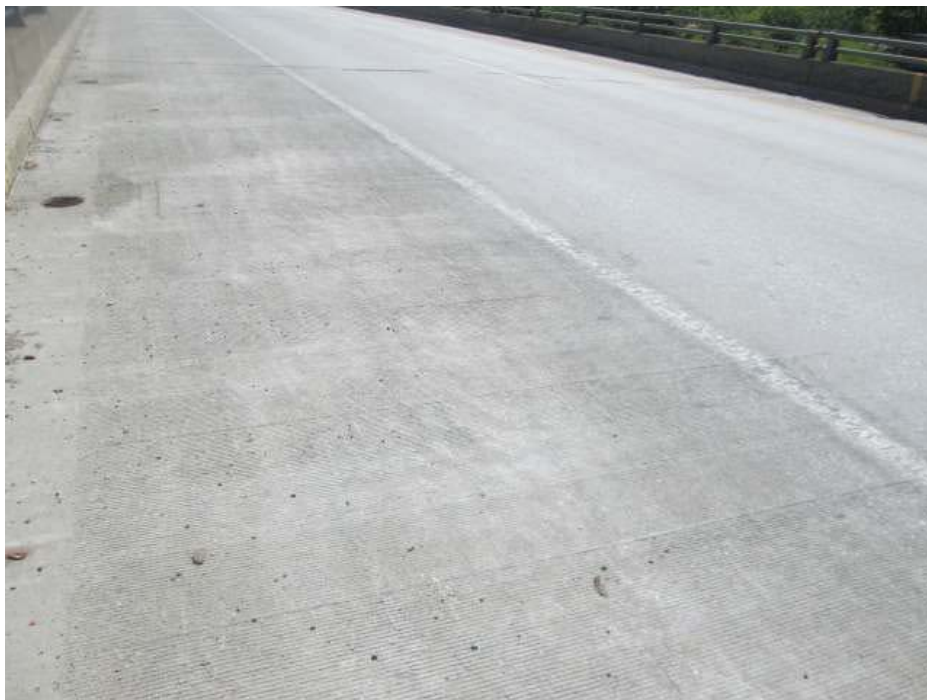
PHOTO 4

Concrete wearing surface with heavy wear in wheel paths and complete loss of tining in travel lanes. Not chain dragged do to traffic conditions, but no nested cracking, potholes or delaminated concrete noted.

Description wearing surface view

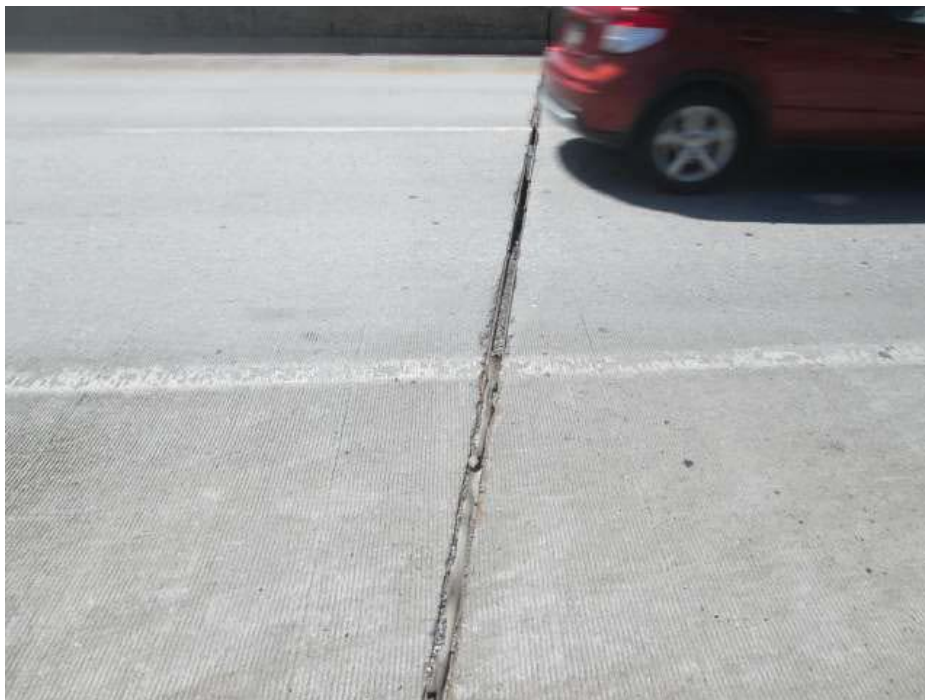
PHOTO 5

Description pier joint

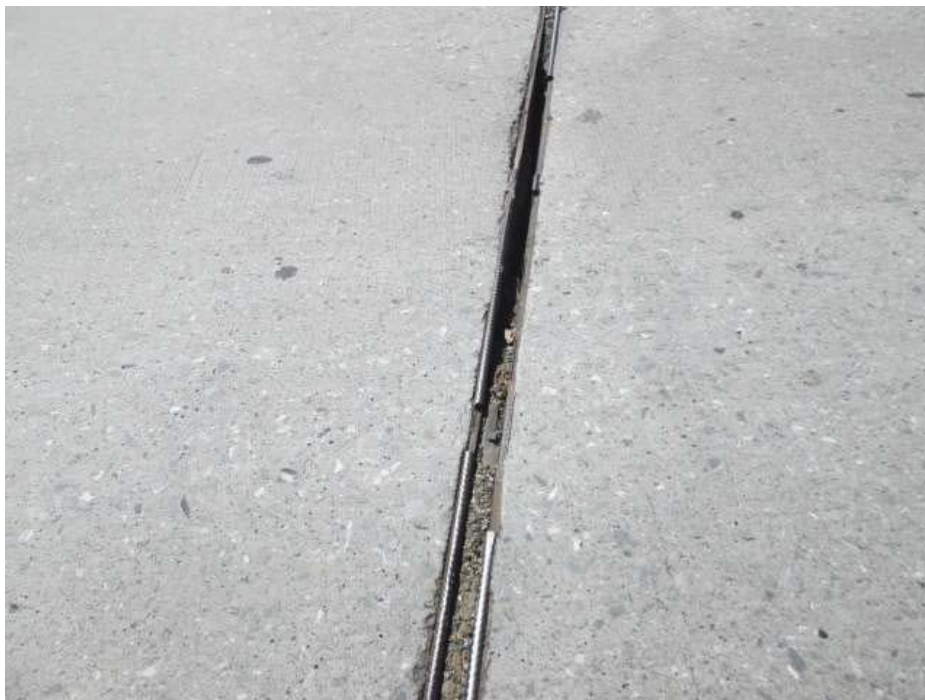
PHOTO 6

Description leaking pier joint

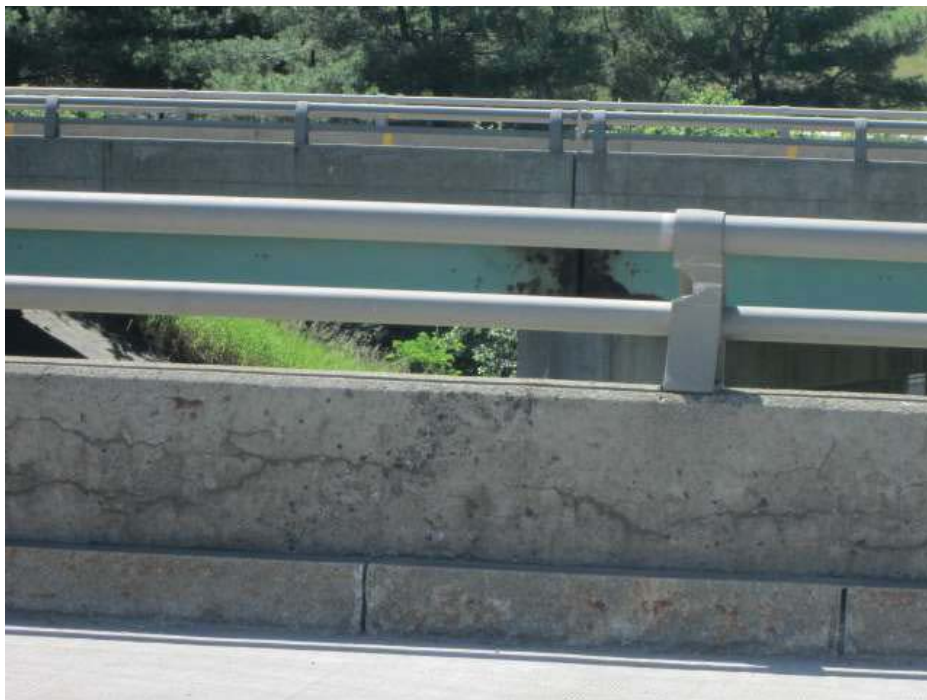
PHOTO 7

Description rail post plow damage

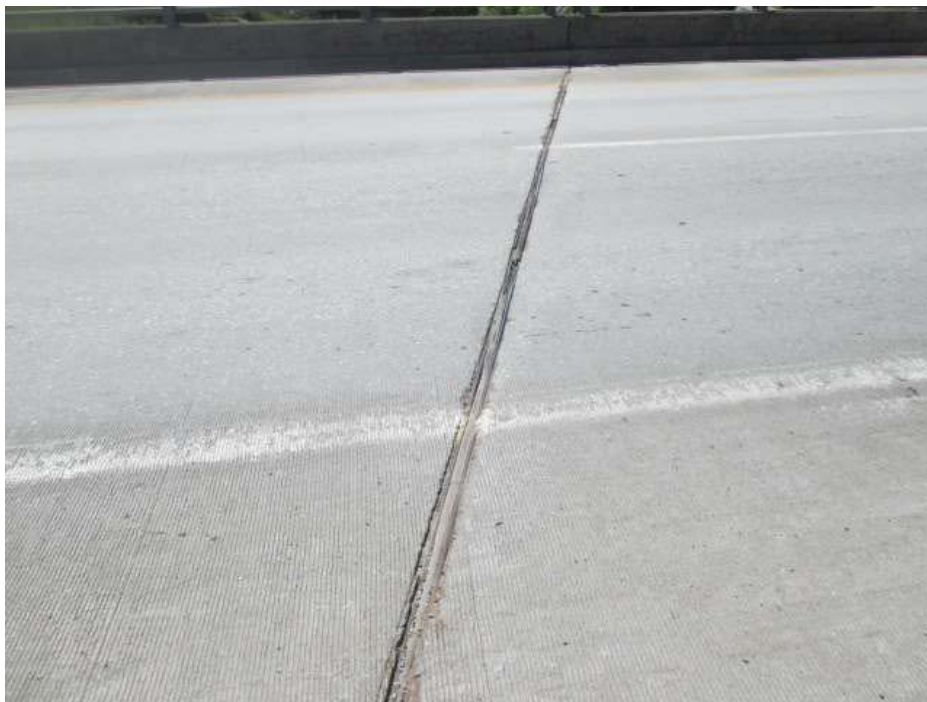
PHOTO 8

Description pier joint

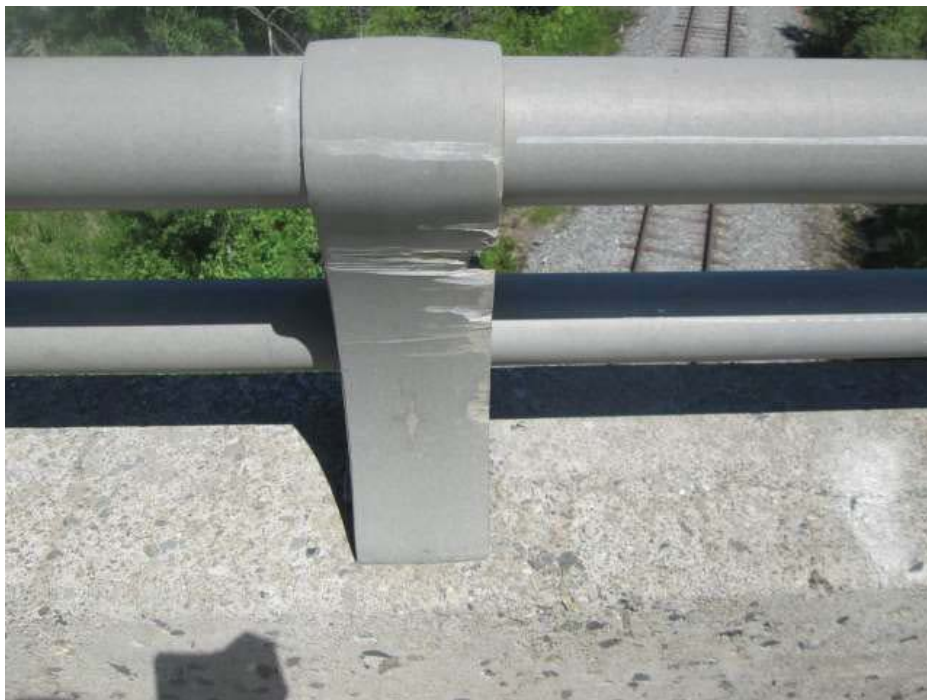
PHOTO 9

Description minor rail post damage

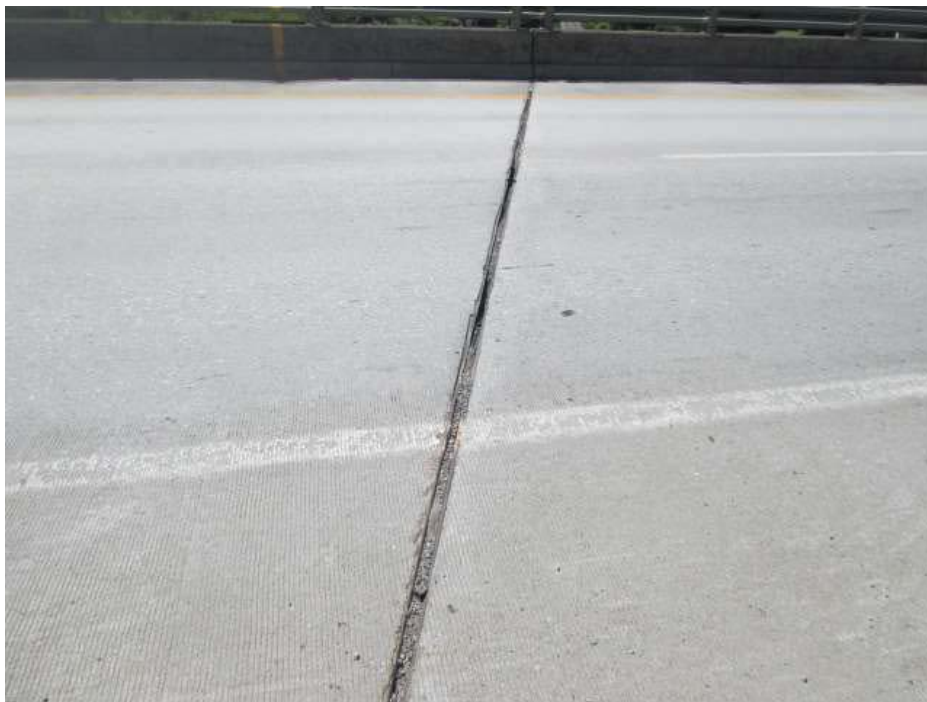
PHOTO 10

Description pier joint

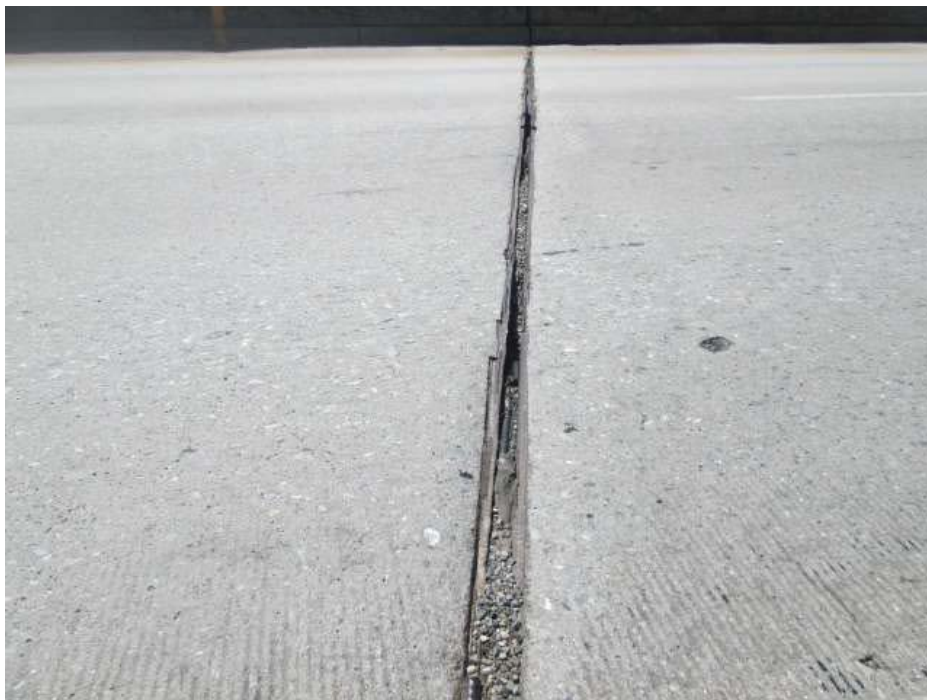
PHOTO 11

Description failed seal east pier joint

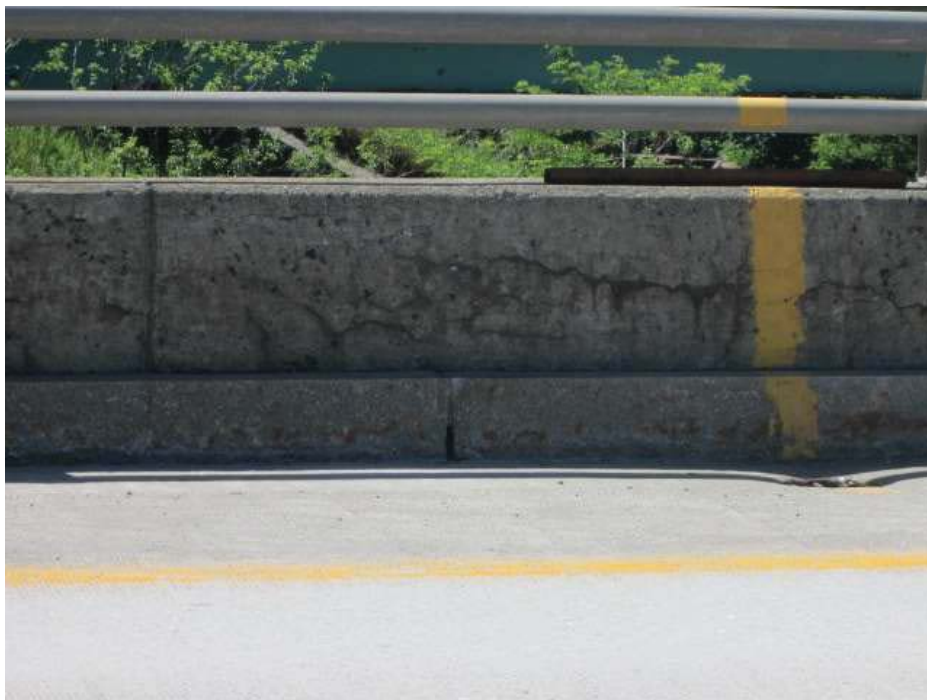
PHOTO 12

Description piece of debris laying on concrete rail

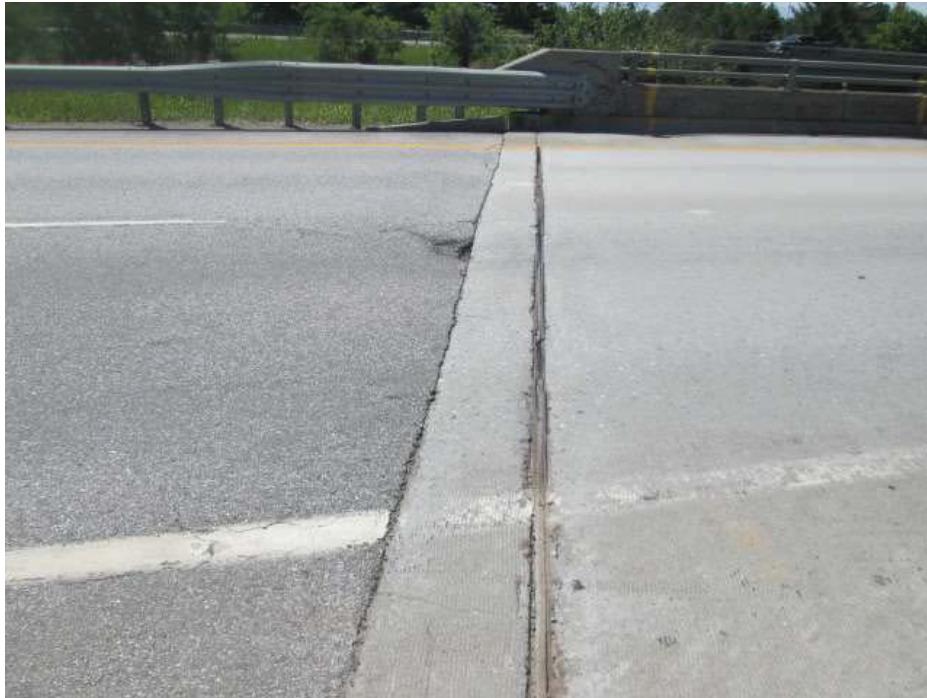
PHOTO 13

Description east joint

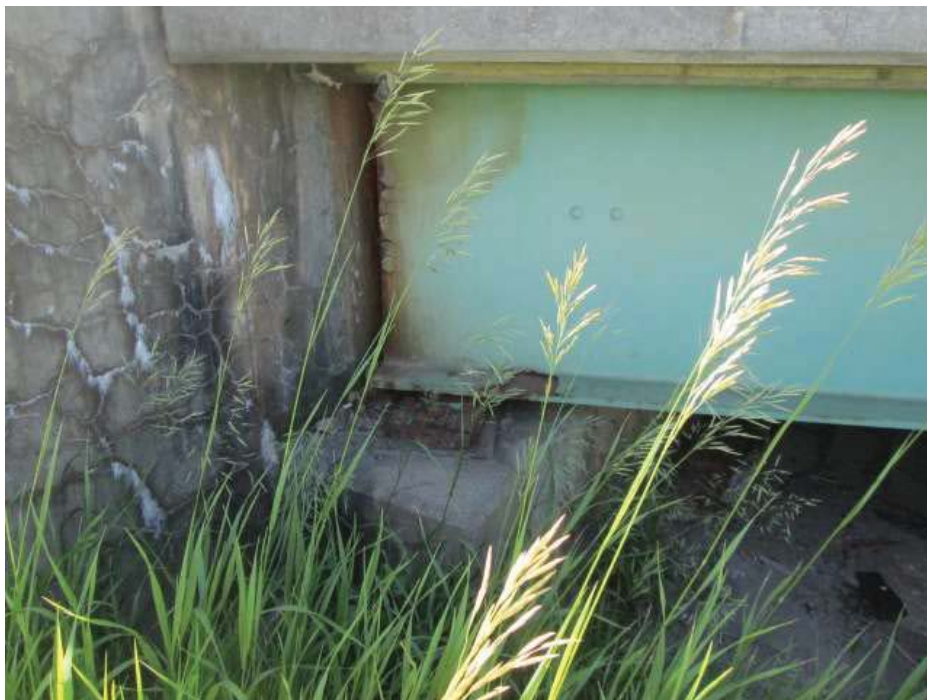
PHOTO 15

Approximately 20% overall paint system distress with sheet failure at south exterior girders and minor paint system distress on interior girders. The last 1'-2' of each girder and joint seal diaphragms, have paint loss and scaling rust from leaking joints above.

Description east beam end

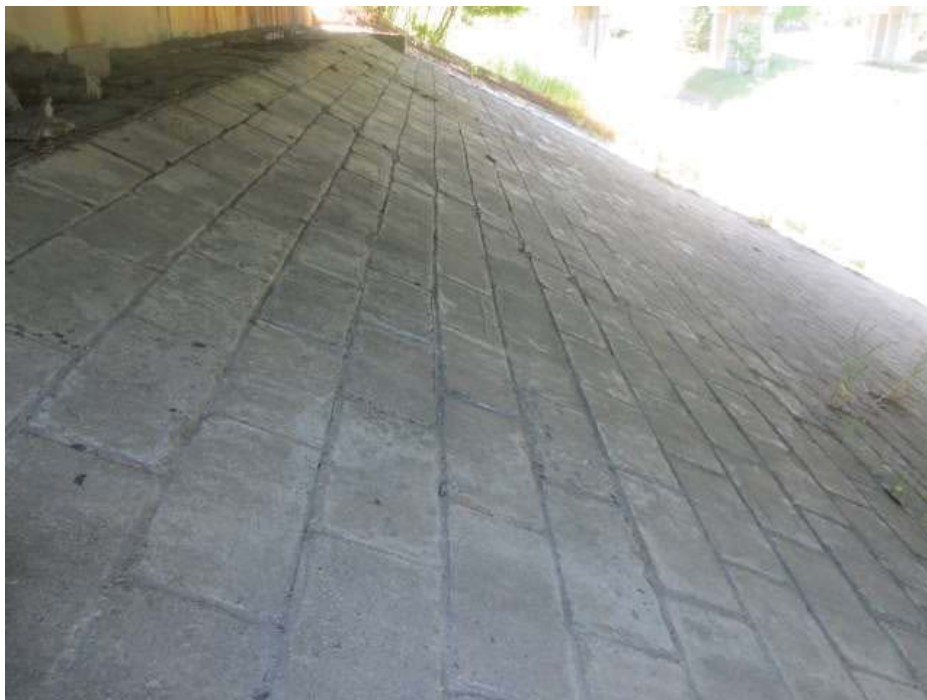
PHOTO 16

Description east abutment slope pavement

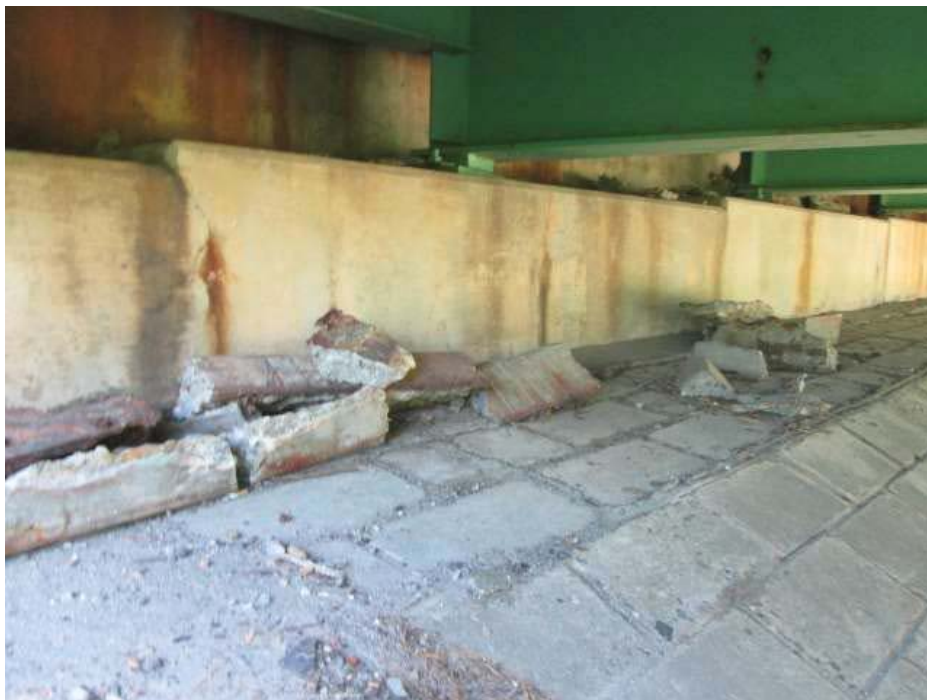
PHOTO 17

Description haunch concrete laying on east slope pavement

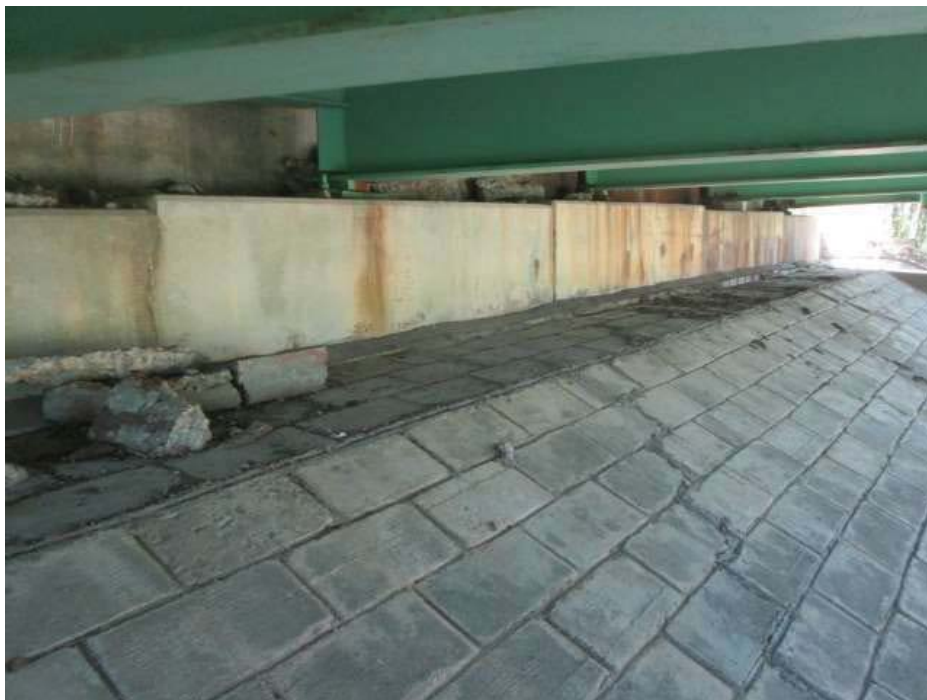
PHOTO 18

The center pier cap has cracking underside and has a 5 SF delamination with two layers of exposed re-steel. Re-steel heavily rusted. Easterly abutment backwall has heavy rust staining from leaking joints and partial rust staining and cracking of breastwall (photo). Westerly abutment has minor/sporadic hairline cracking.

Description east abutment

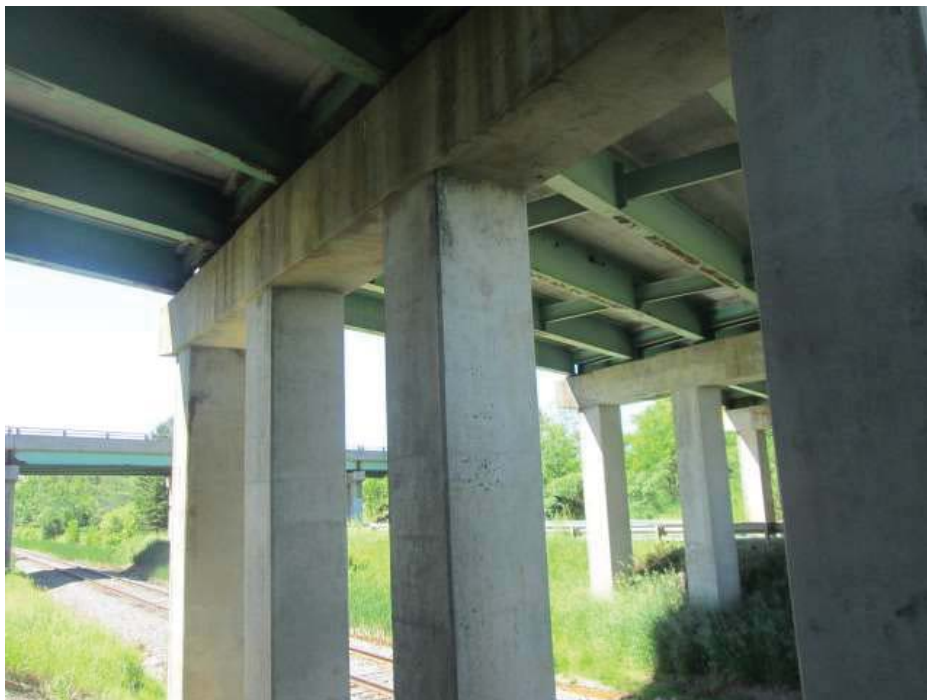
PHOTO 19

Description east pier

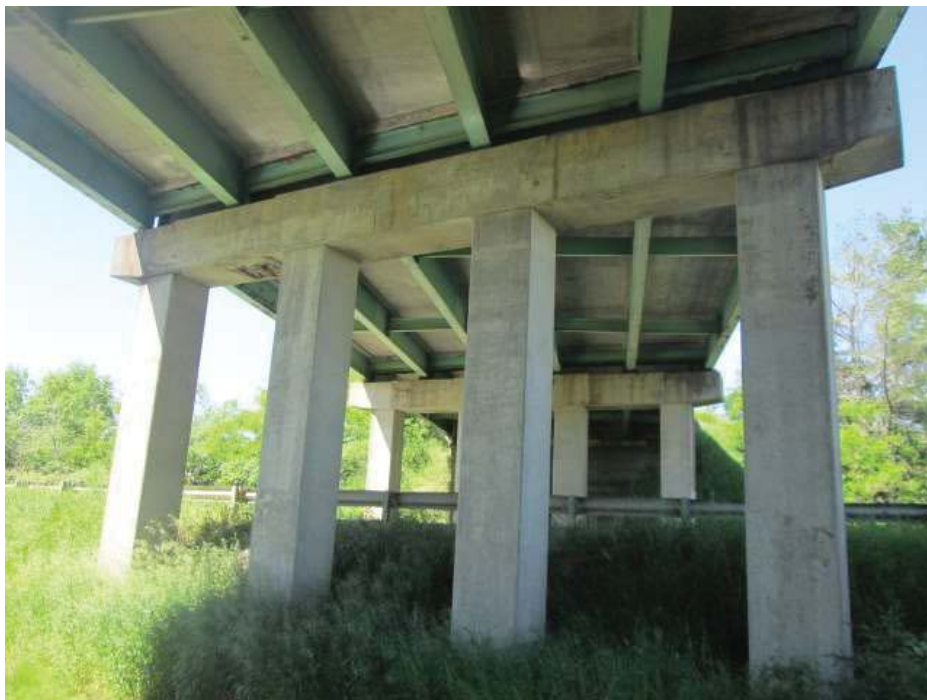
PHOTO 22

Description Center pier view

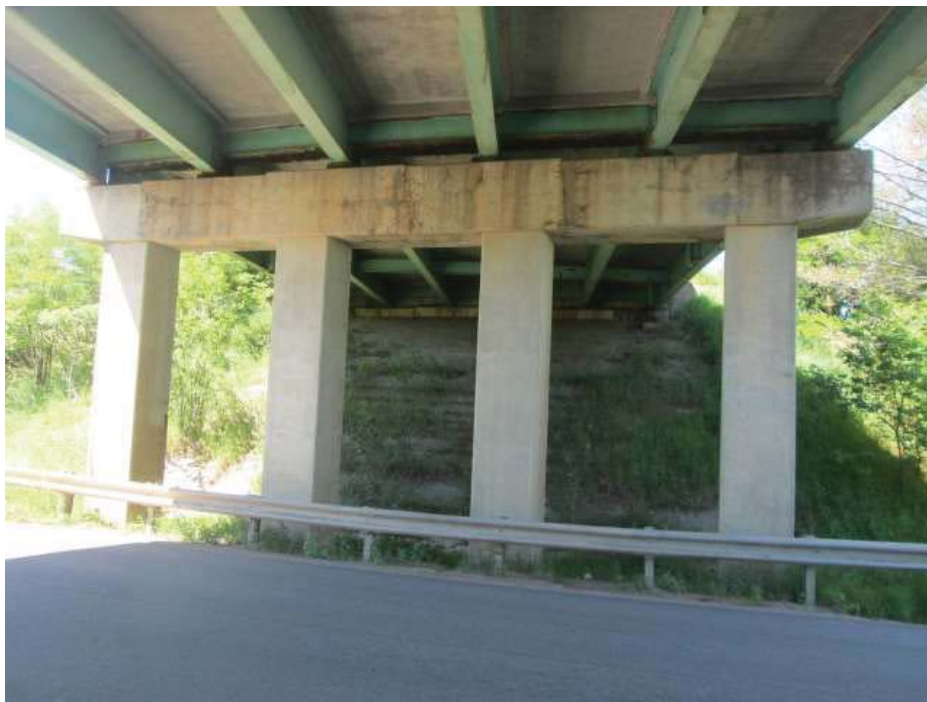
PHOTO 24

Description west pier

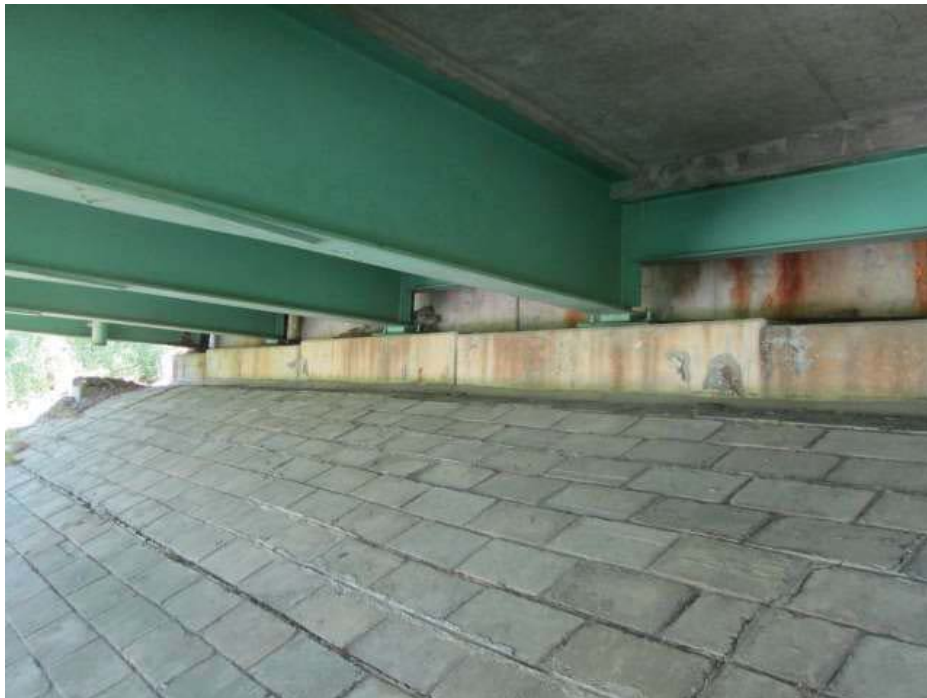
PHOTO 26

Description west abutment

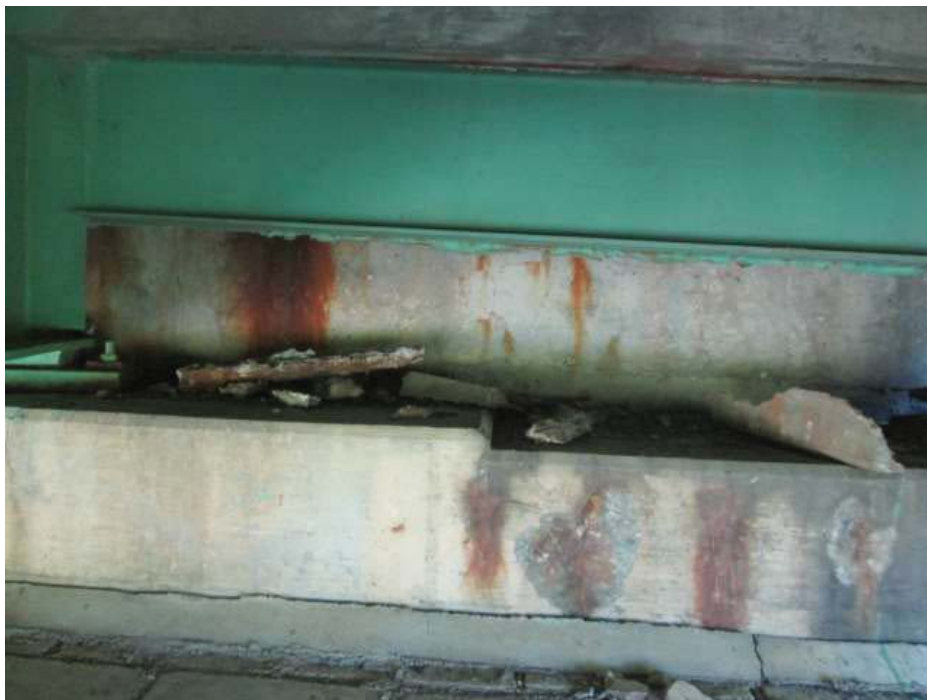
PHOTO 27

Description debris on bridge seat staining abutment

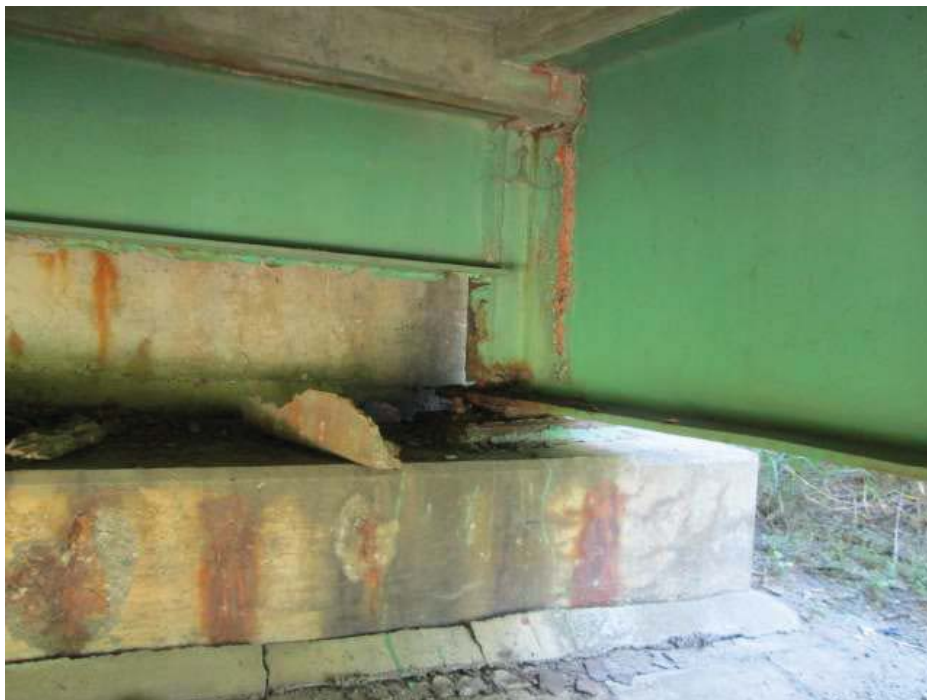
PHOTO 28

Description west abutment beam end

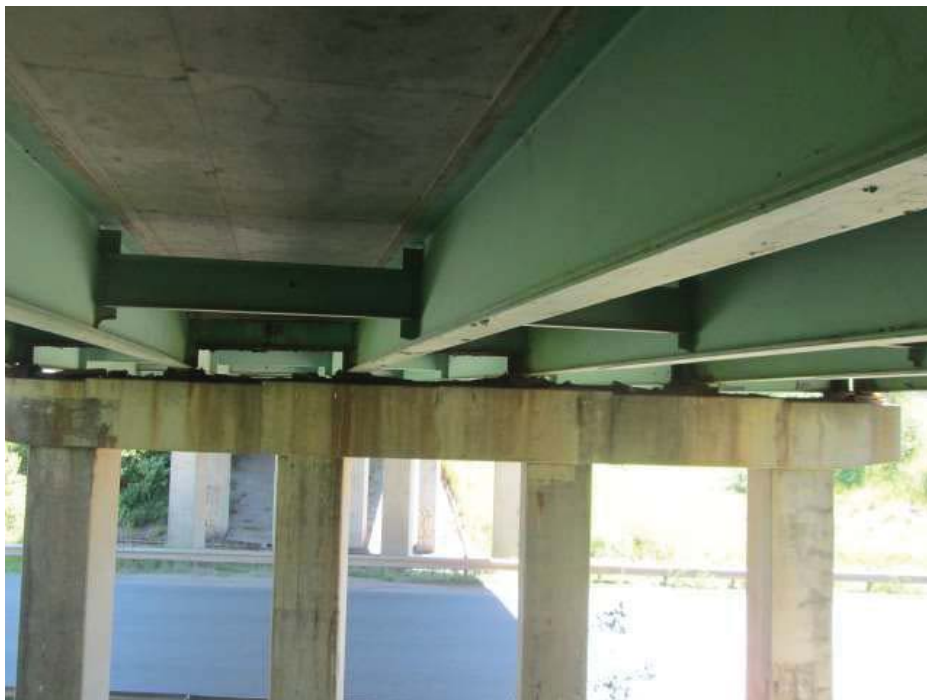
PHOTO 30

Description debris on west pier bridge seat

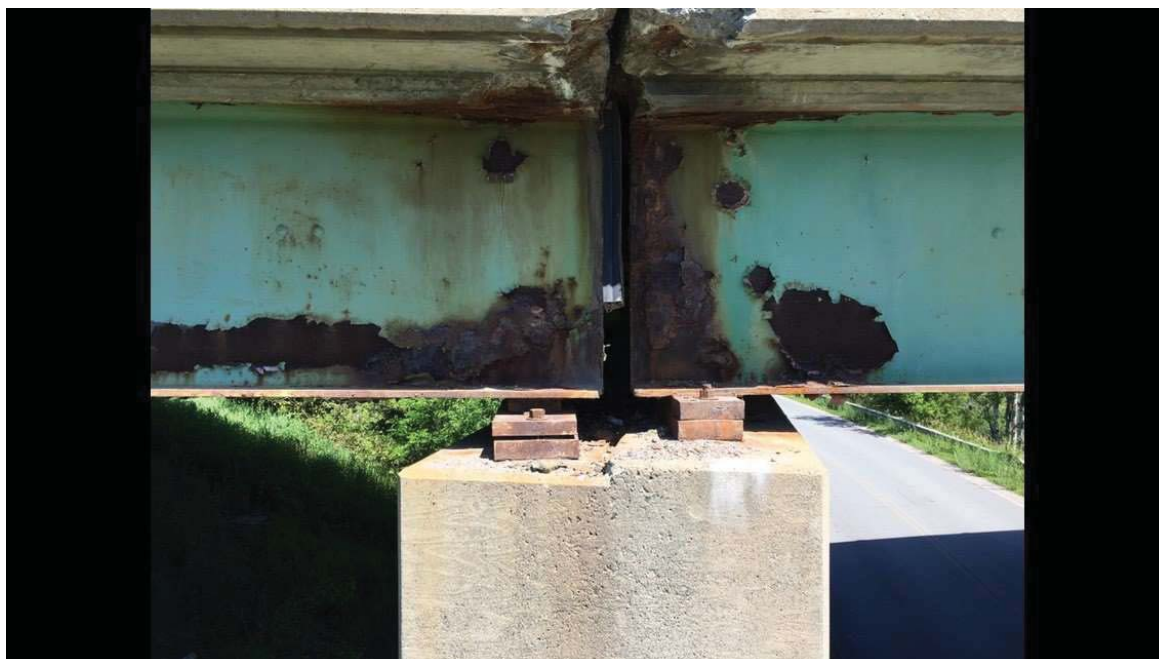
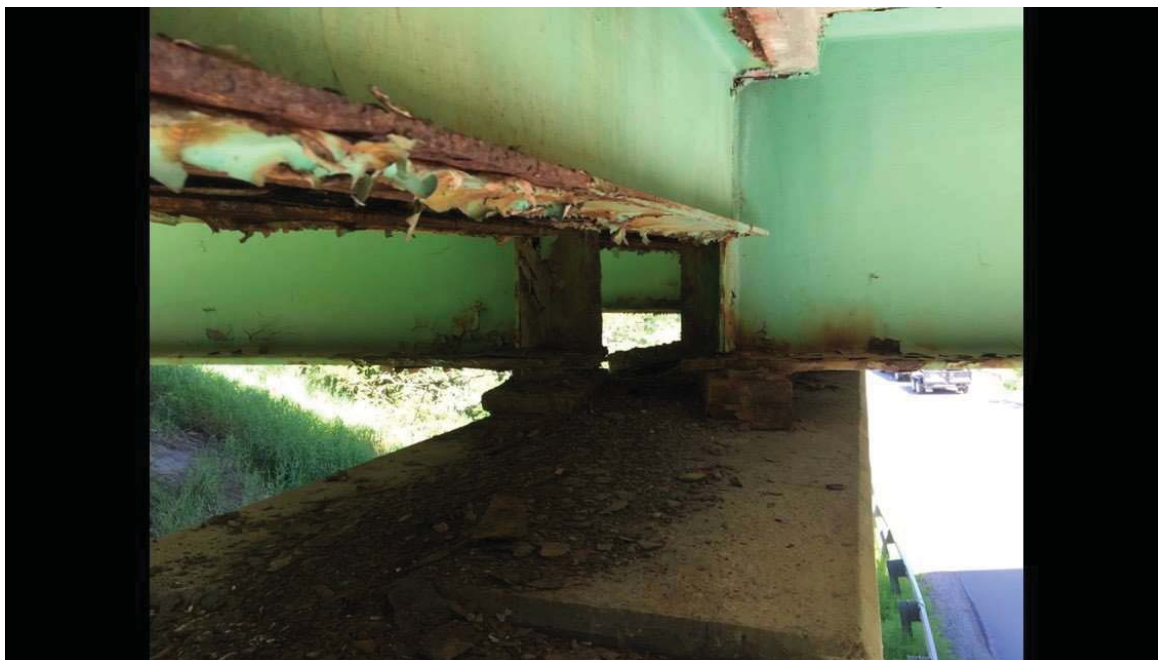
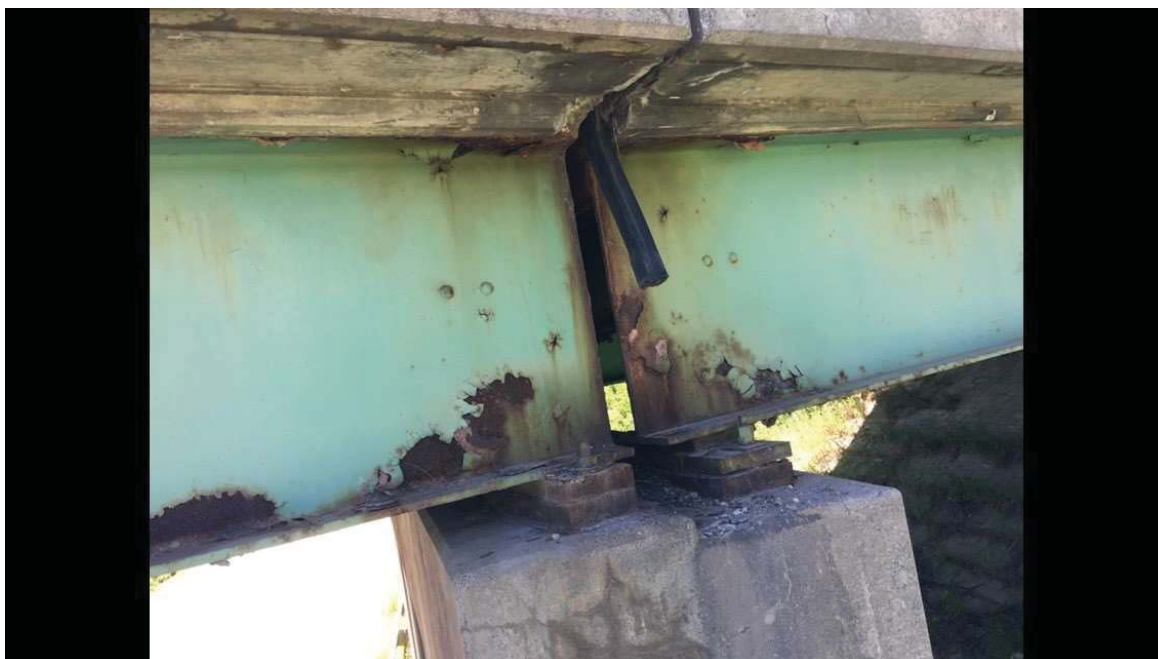
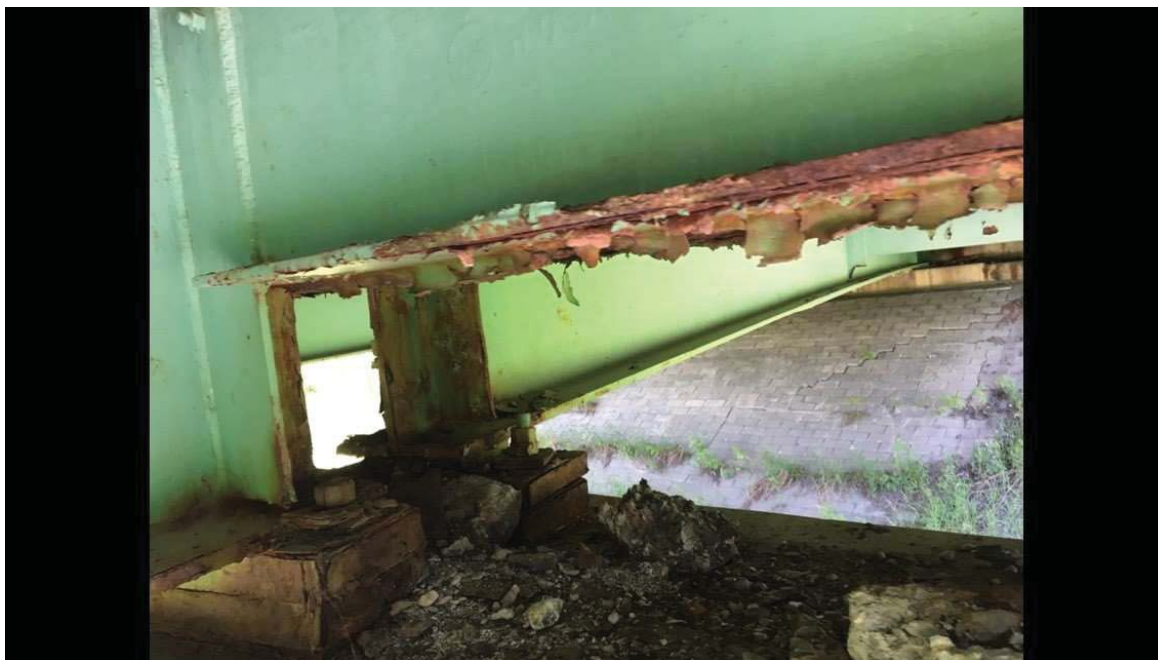
Pier columns have minor to moderate vertical cracking/map cracking w/staining, small areas of delamination. Minor to moderate pier cap cracking w/staining on the center and easterly piers.

Description west pier

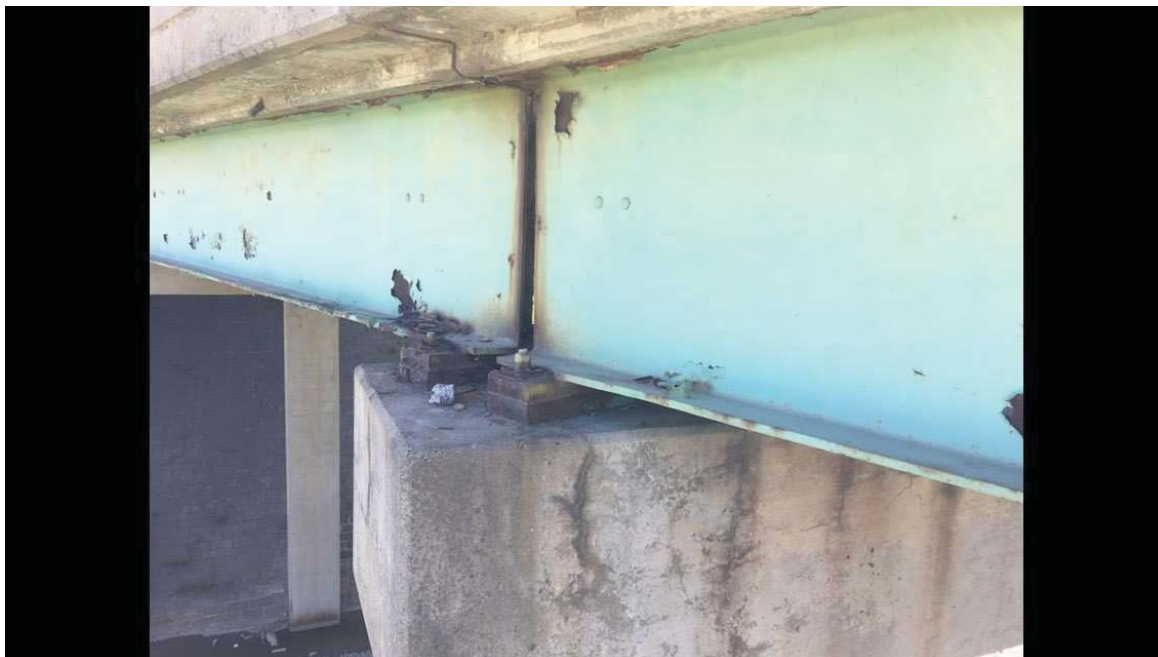
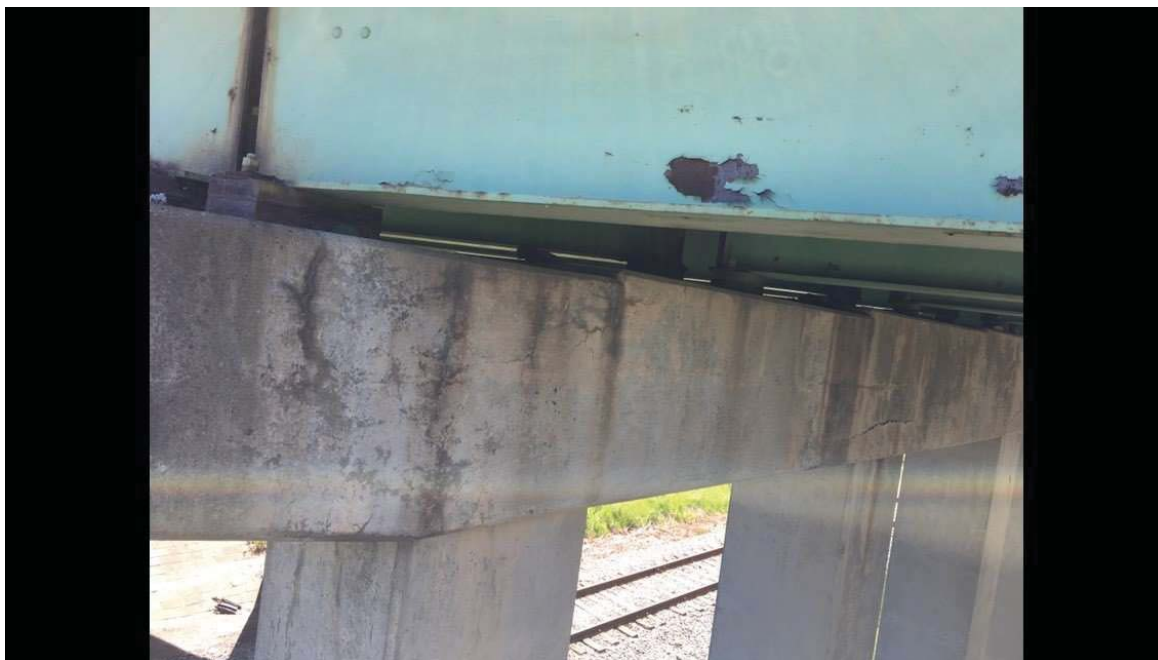
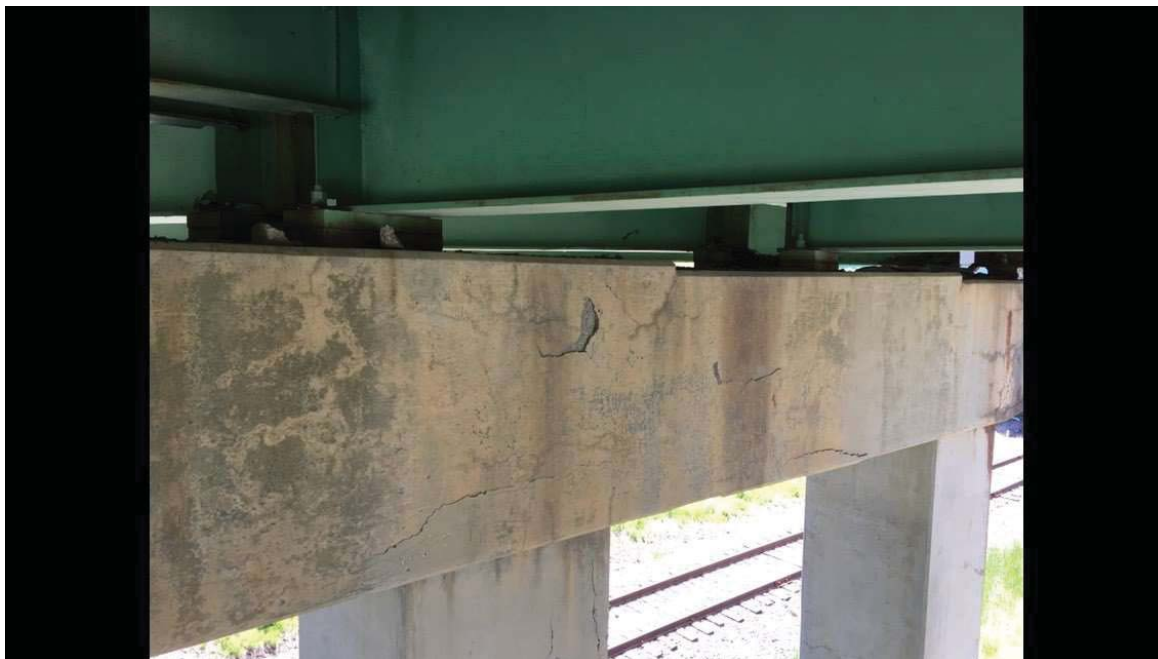
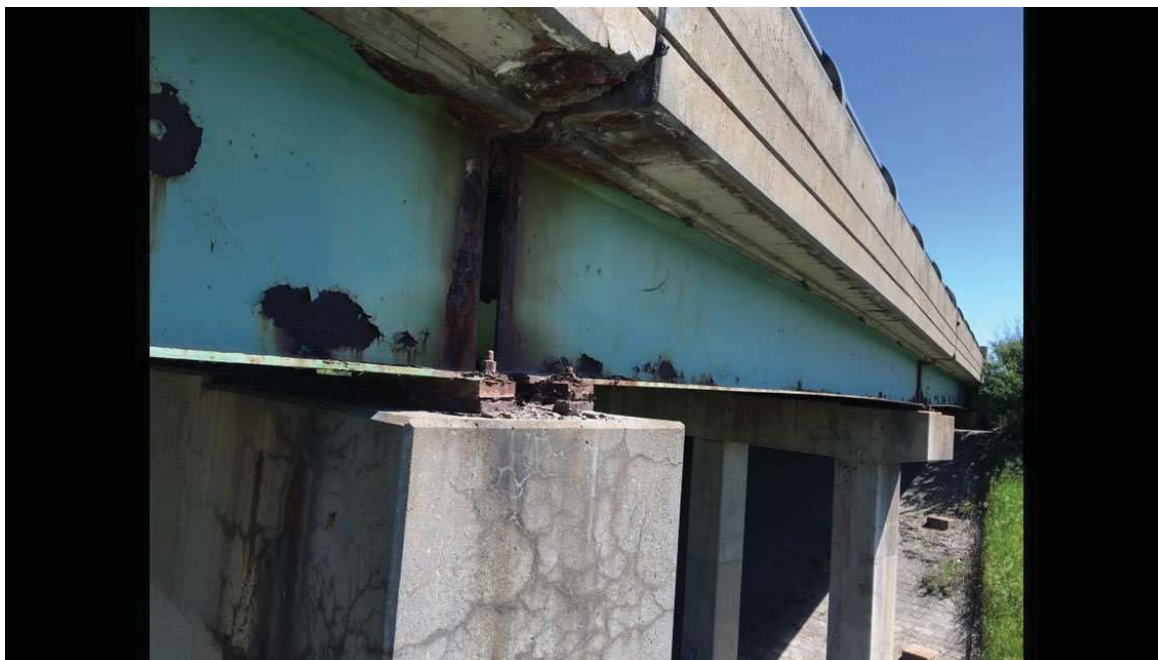
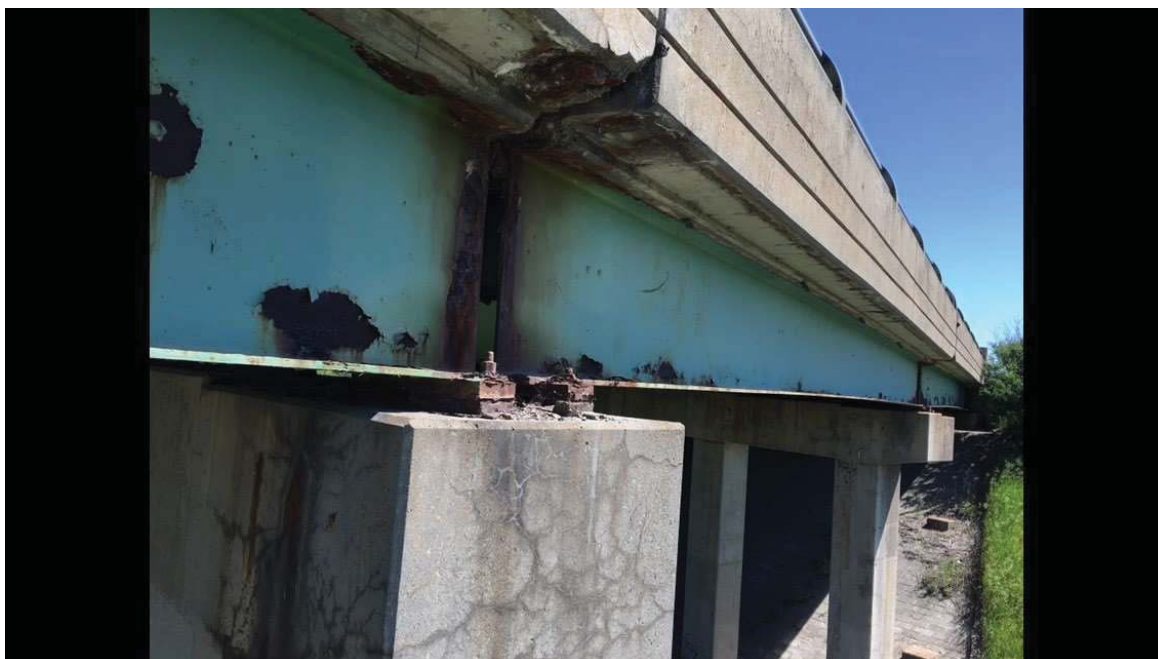
Description center pier
