Highway Bridge Inspection Report

**I-95 SB / EMERSON MILLS RD
I-95 SOUTHBOUND
over
B&A RR & EMERSON MILL RD**

Inspection Date: 06/21/2018

Inspection Type(s): Routine

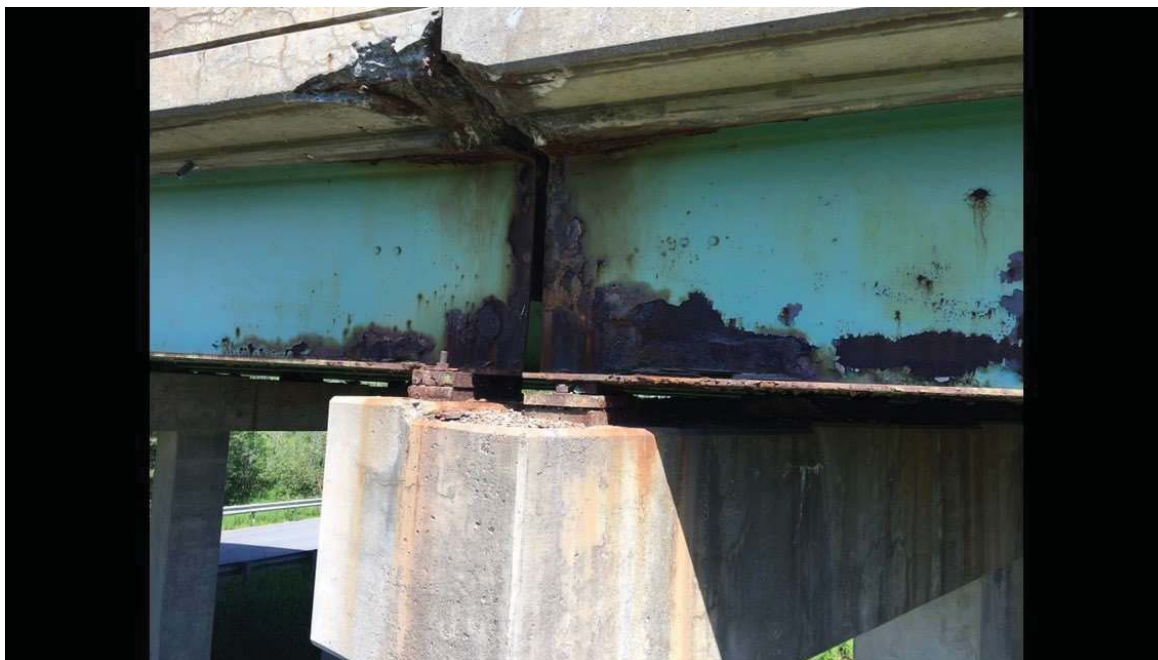
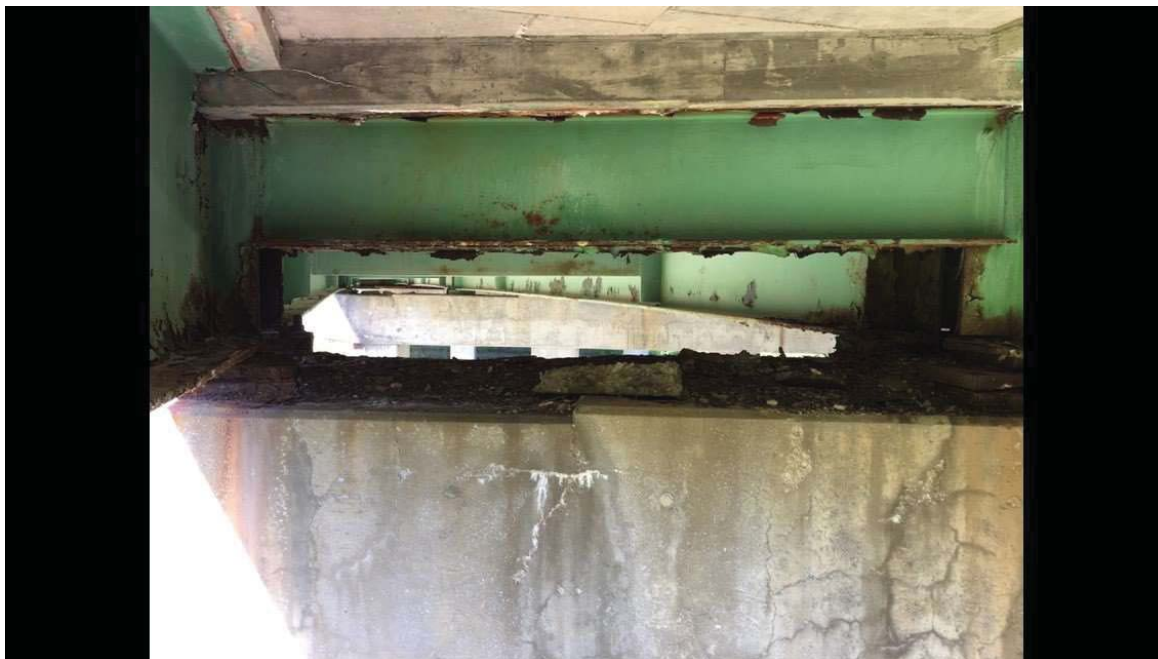
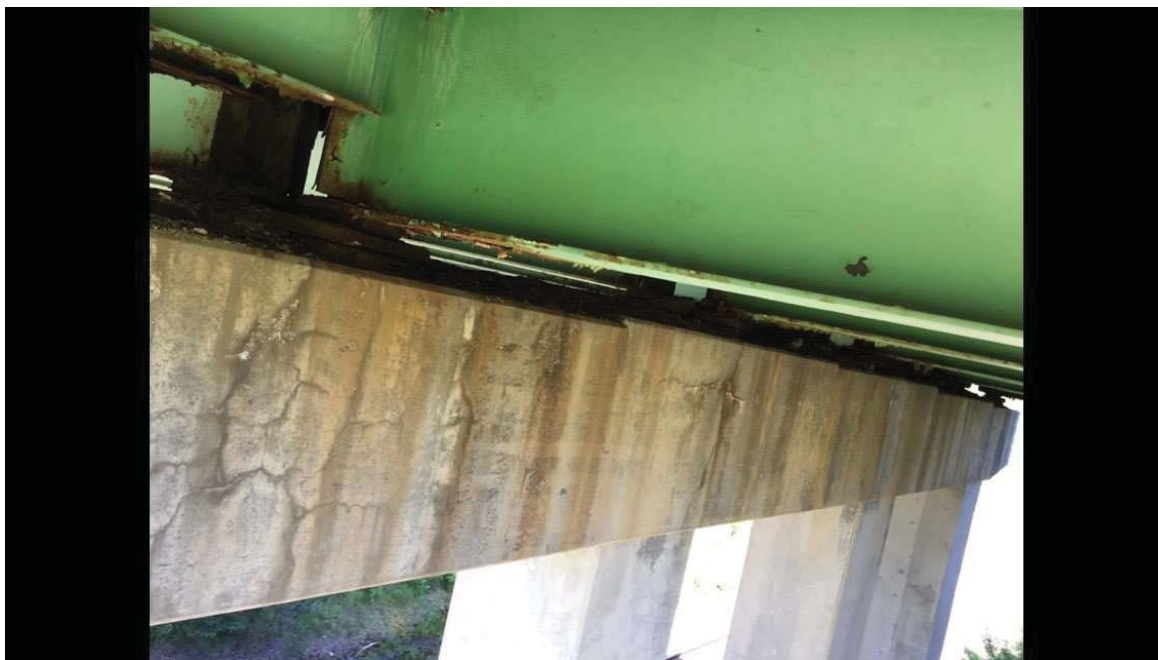
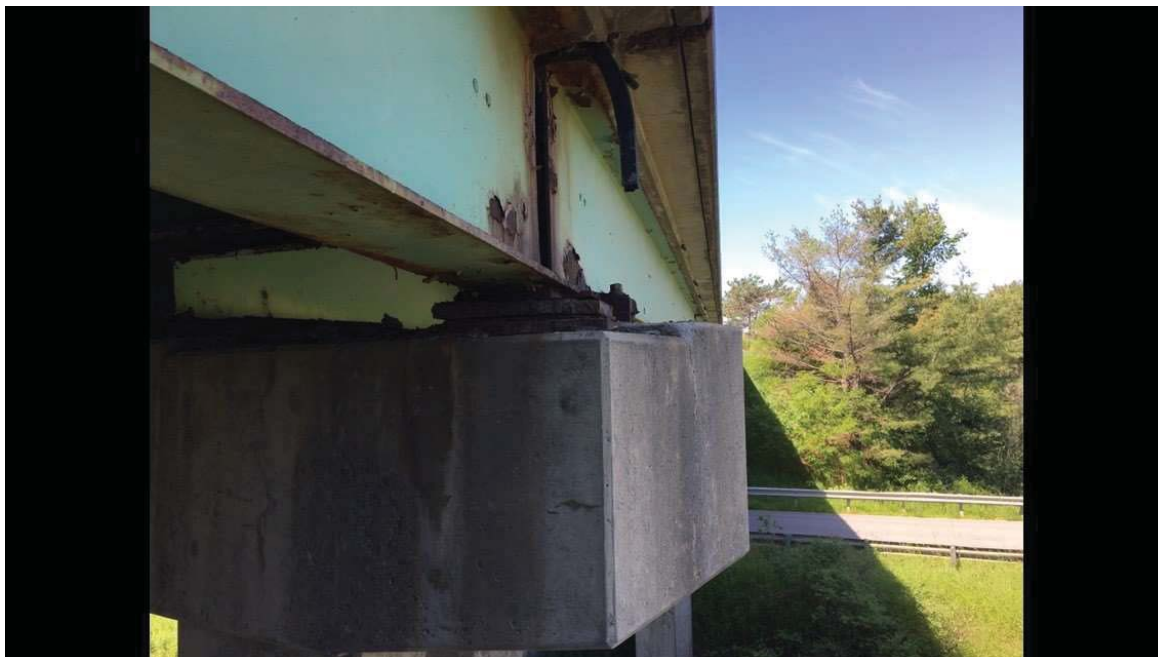
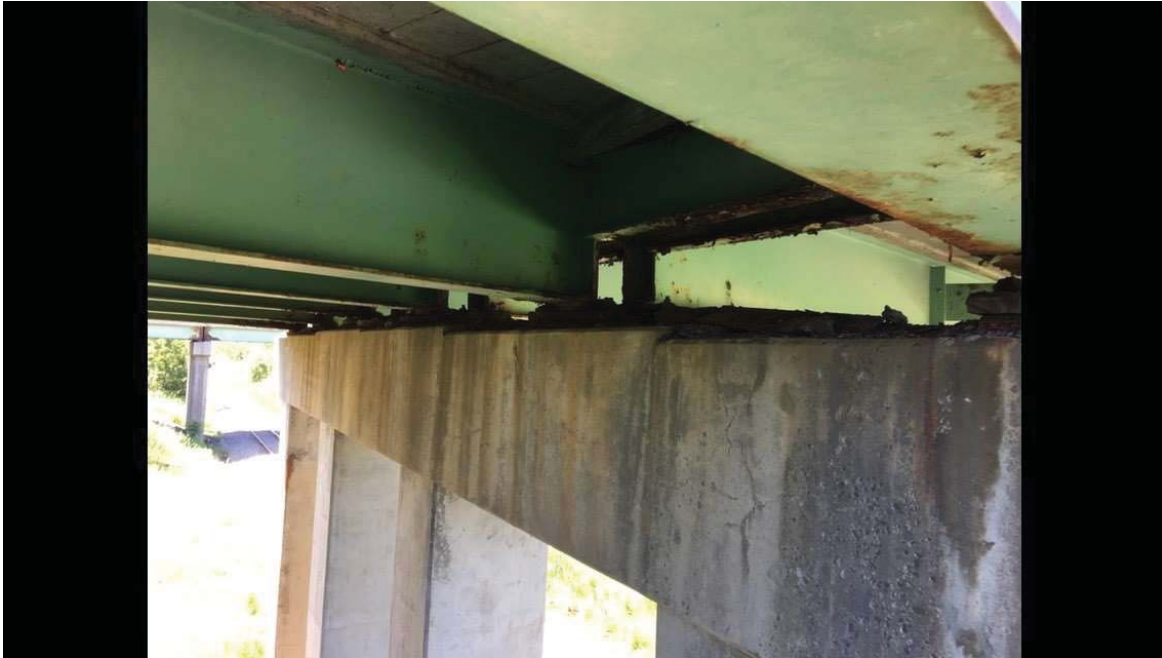
Pier columns have minor to moderate vertical cracking/map cracking w/staining, small areas of delamination. Minor to moderate pier cap cracking w/staining on the center and easterly piers.

Description east pier
