Highway Bridge Inspection Report

**I95 SB / SOUADABSCOOK EAST
I-95 SB
over
SOUADABSCOOK STREAM**

Asset Code: 1431

Inspection Date: 04/06/2017

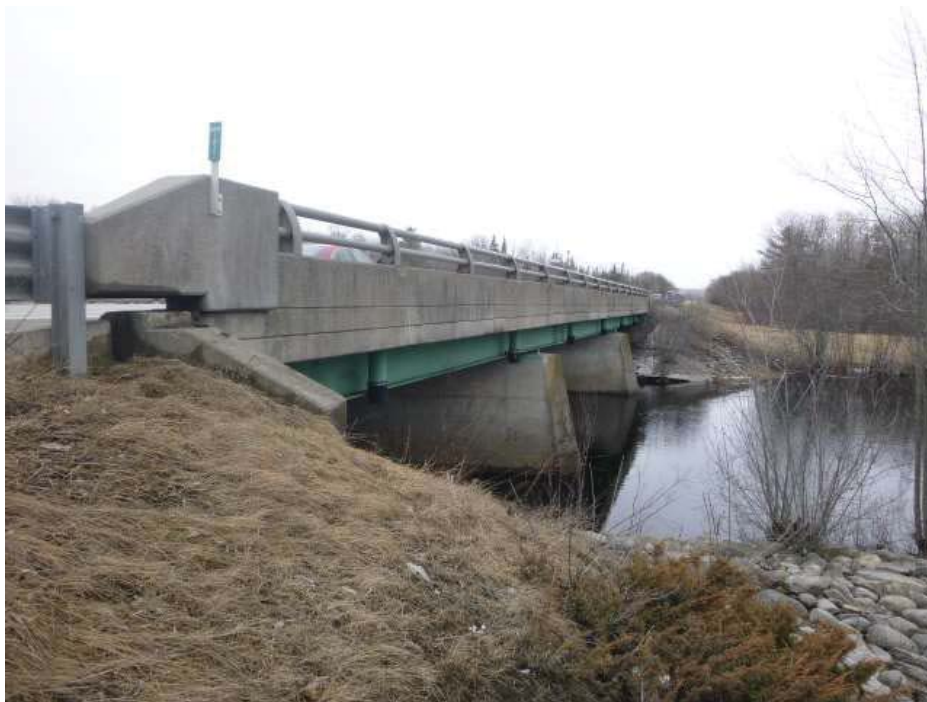
PHOTO 2
Description Up stream end, looking South

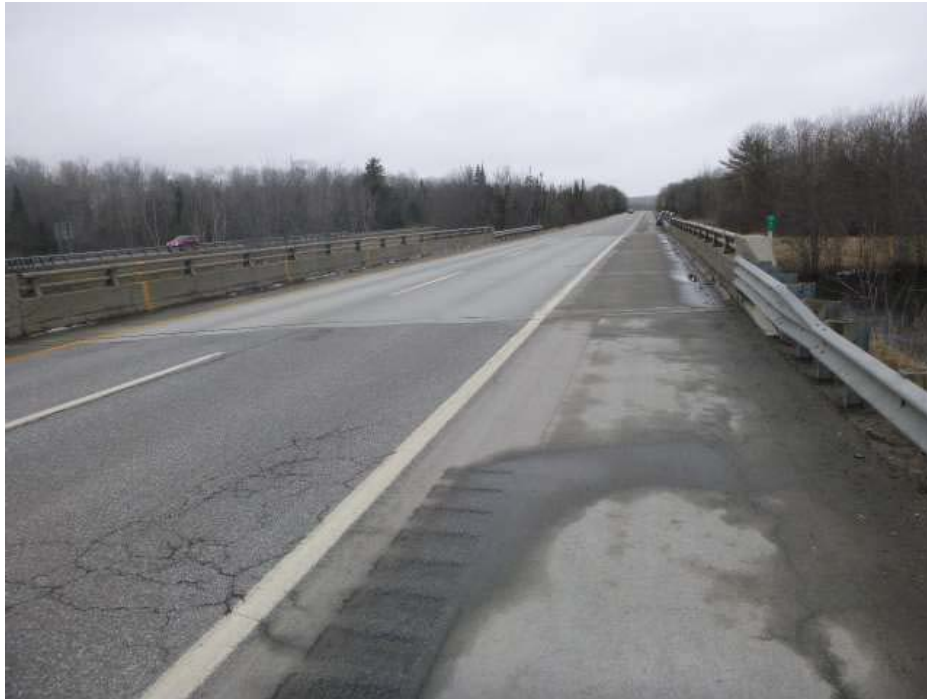
PHOTO 3

Description Roadway looking South

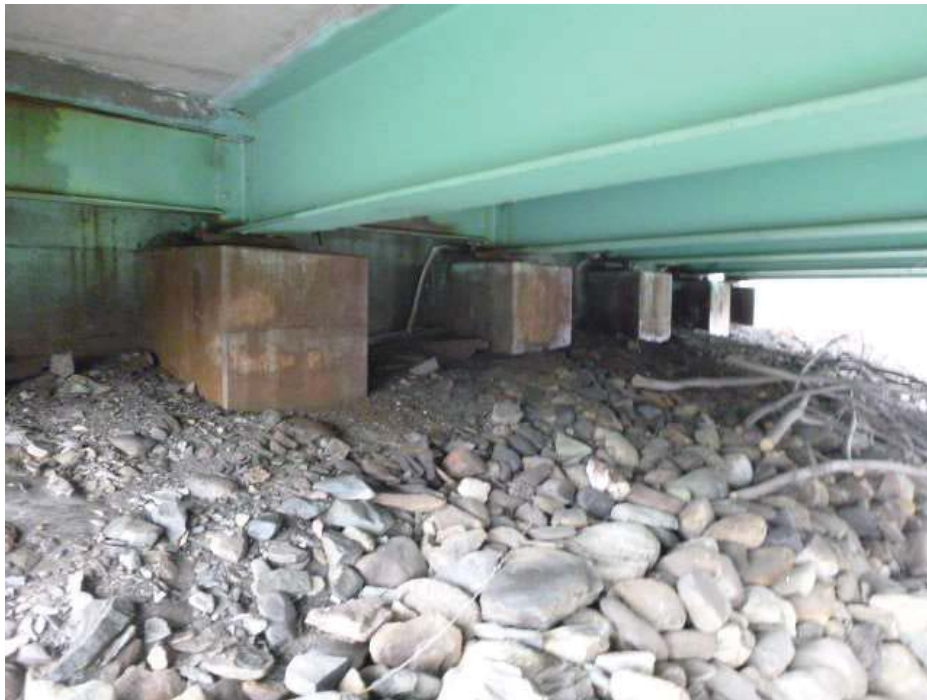
PHOTO 4

Both of the abutments have pedestal bearing blocks that have moderate to isolated heavy cracking. Back wall has isolated moderate cracking areas with exposed re-steel. Footings exposed on piers, but plans and U/W Inspection in 2003 noted piers were founded on exposed ledge. See the latest U/W Inspection for additional details and sketch.

Description North abutment

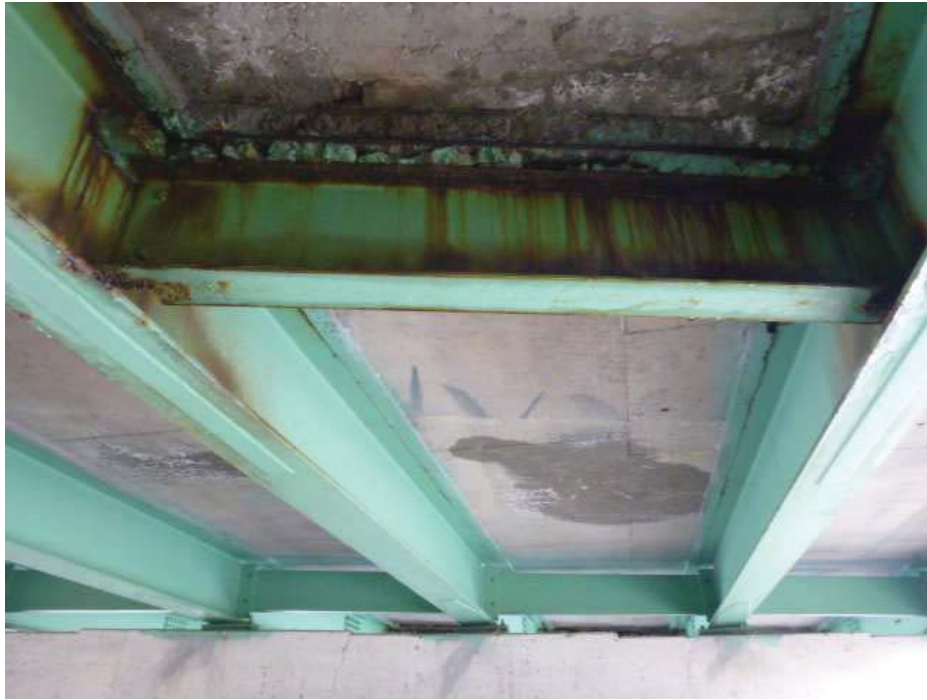
PHOTO 5

Description Bottom of the deck, North span

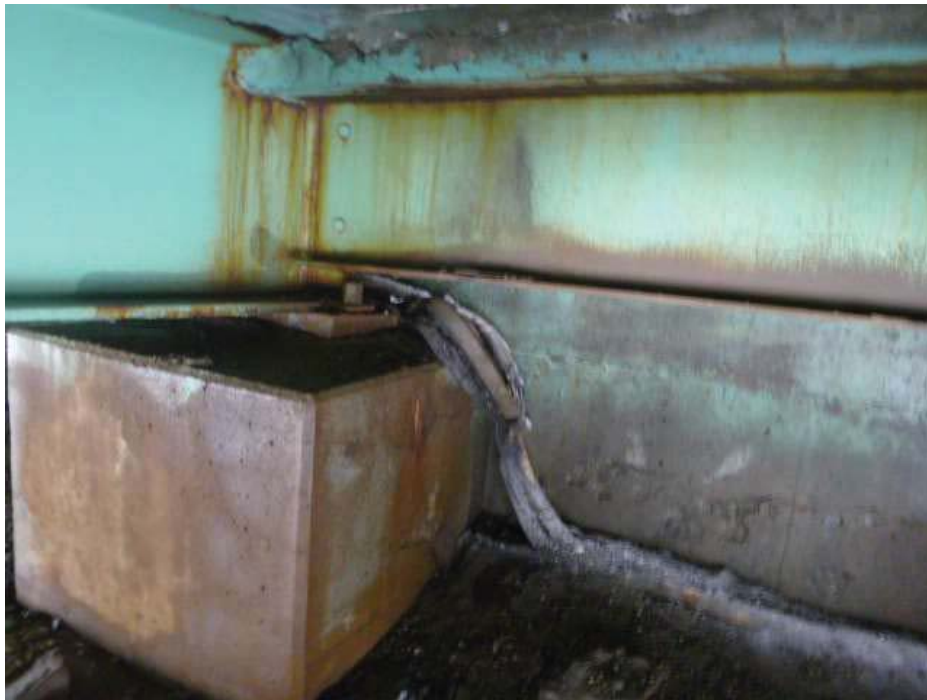
PHOTO 6

Description North beam end

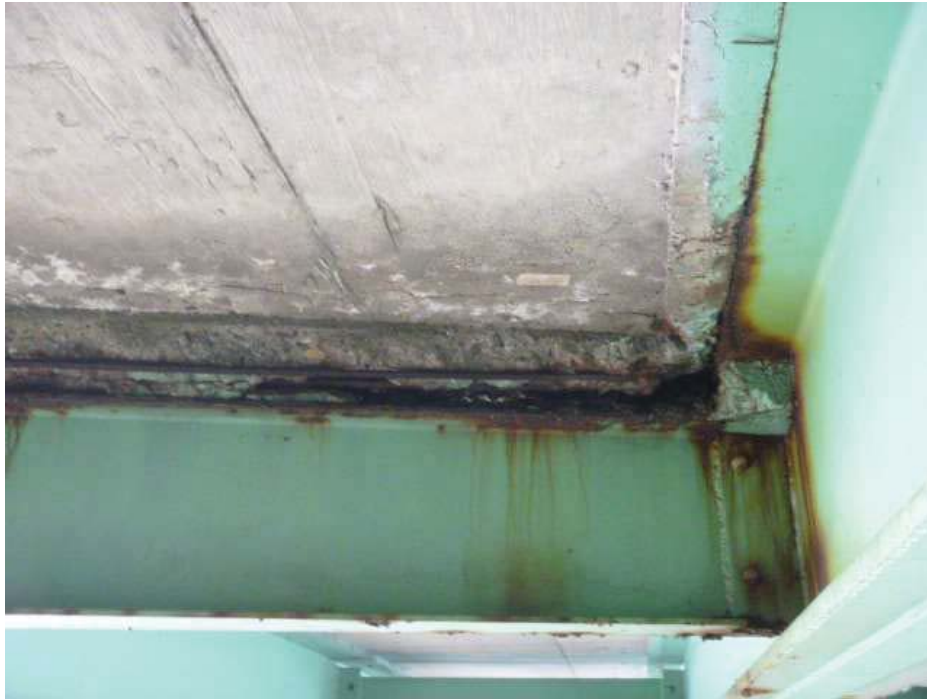
PHOTO 7

Description Daylight from cold joint in deck above, North span

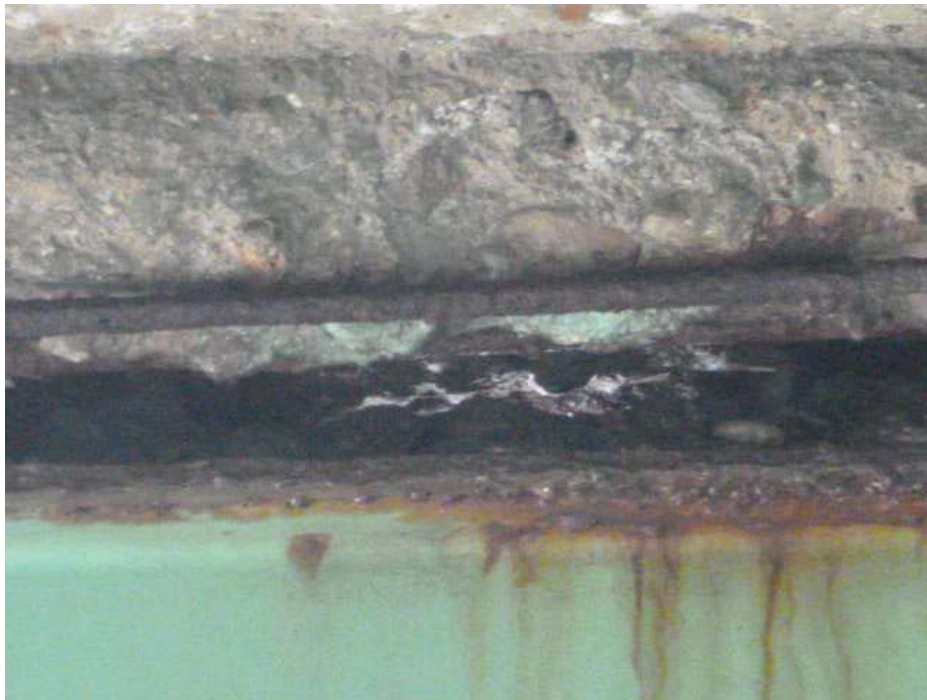
PHOTO 8

Description Daylight from cold joint in deck above, North span

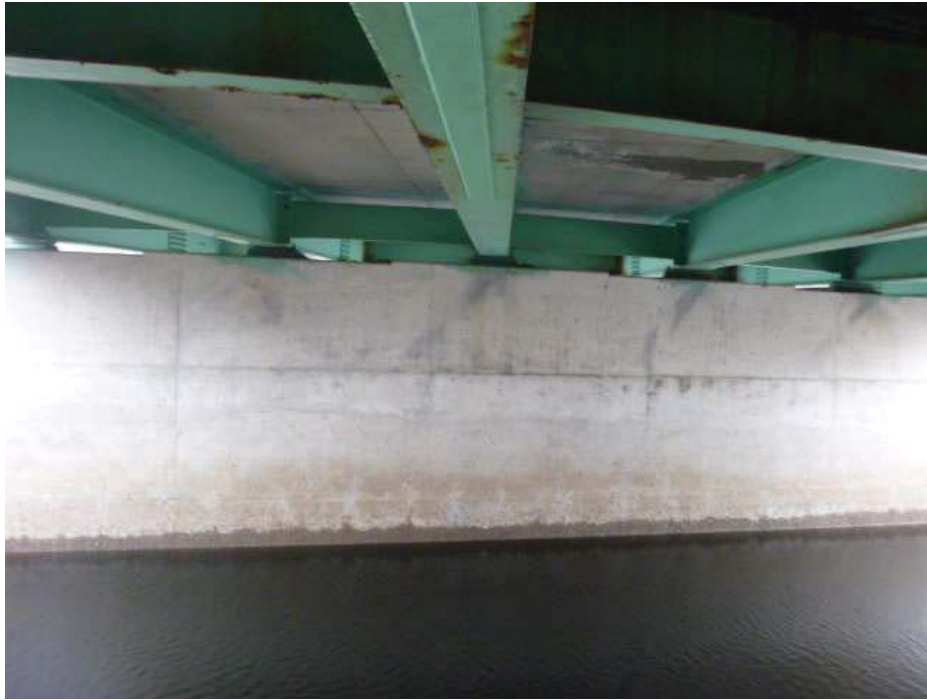
PHOTO 9

Description Looking South at the North pier

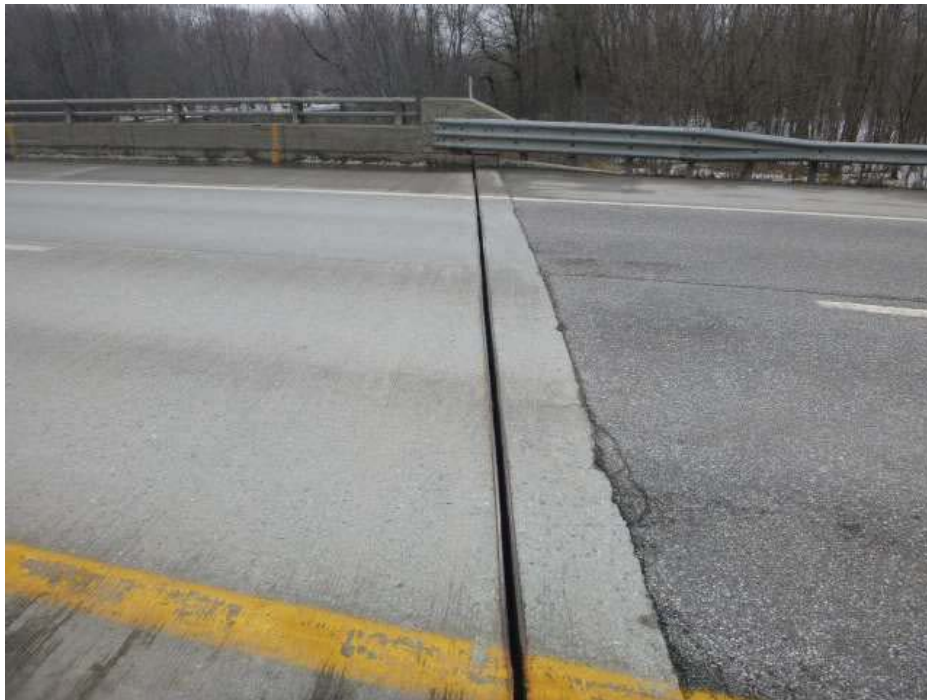
PHOTO 10

Both joint seals are missing and surrounding headers have been pounded with extensively spalled concrete and exposed re-steel. Frequent areas of delaminated concrete on the bottom of the deck, but the only areas that have spalled are in the haunch areas above the diaphragms and headers. These haunch areas have fully exposed re-steel, loose broken concrete and section loss to some of the diaphragm top flanges. Haunch area at the North end above the diaphragms has spalled and has sunlight coming thru from cold joint above, see photo. All of the aluminum rail posts have minor to heavy damage. The up stream rail has 90% of the posts damaged from minor to isolated heavy damage with a detached rail, see photos.

Description North deck joint without a seal

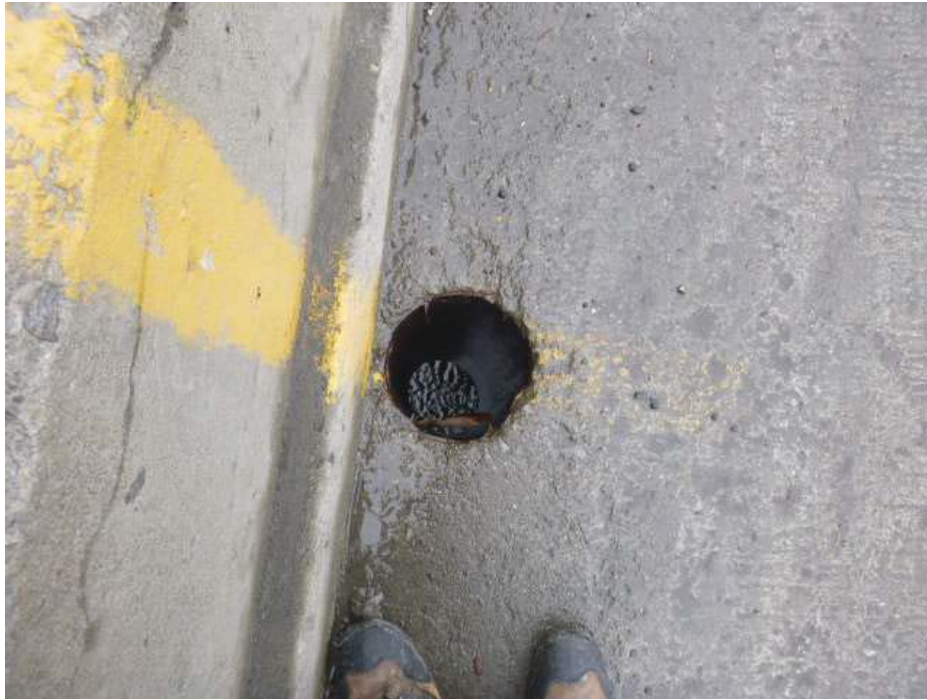
PHOTO 11

Description Deck drain without a grate

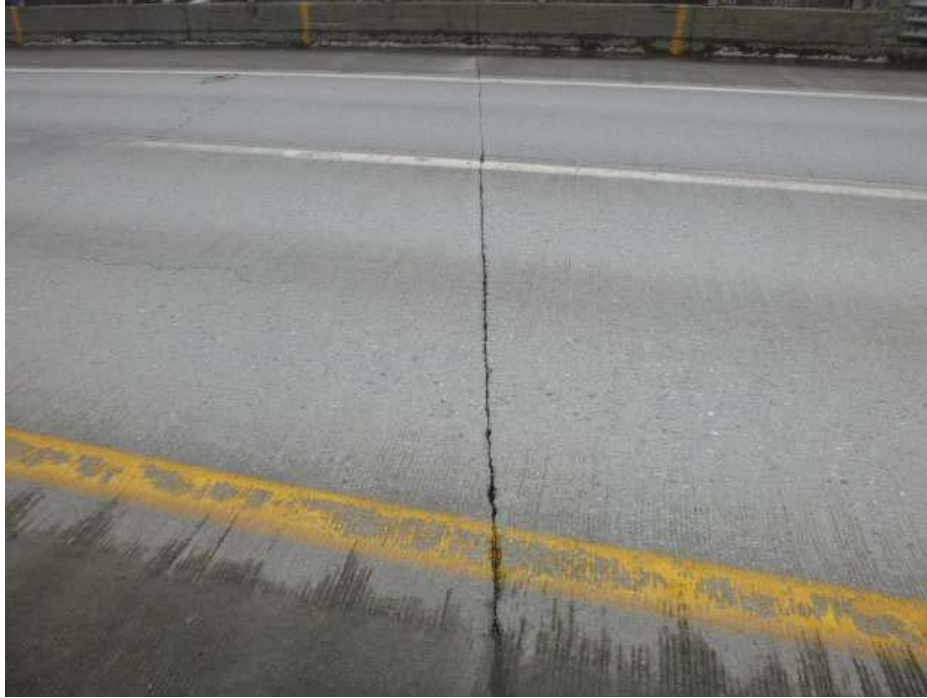
PHOTO 13

Heavy traffic prevented chain dragging of deck. Recommend off-season chaining of deck when traffic is less. Concrete wearing surface has frequent transverse cracking and an isolated pothole <1 SF in size with loose concrete pieces.

Description Wearing surface

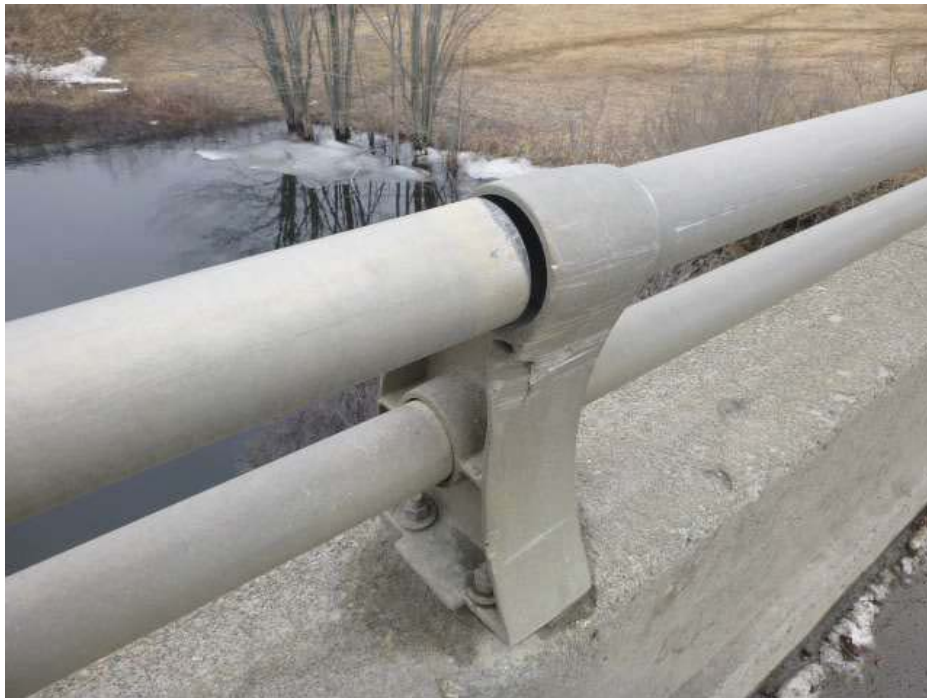
PHOTO 14

Description Rail not attached, up stream end

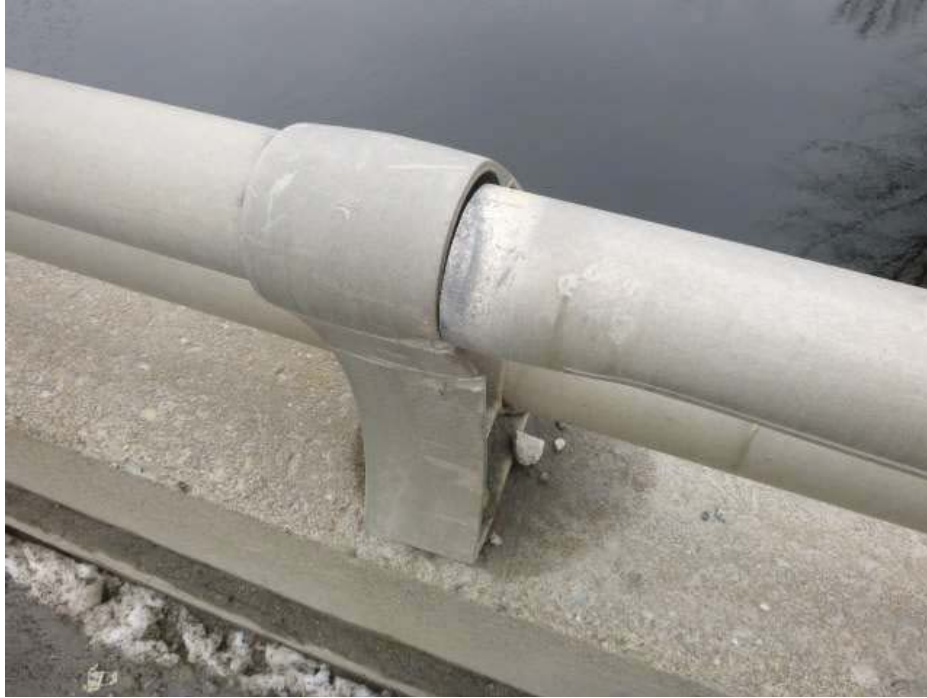
PHOTO 15

Description Rail not attached, up stream end

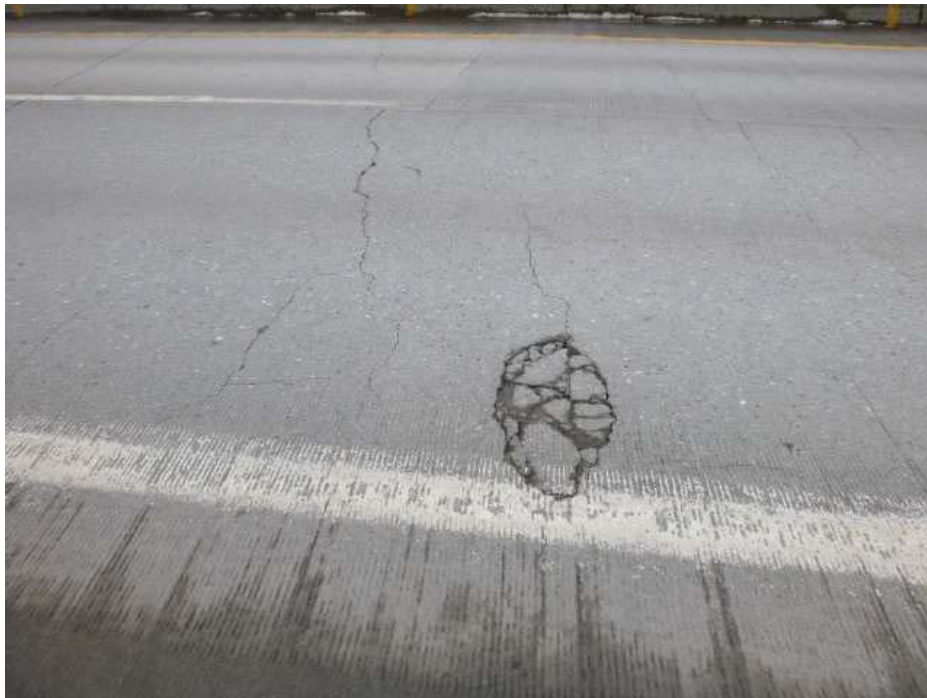
PHOTO 16

Description Nested cracking in the wearing surface

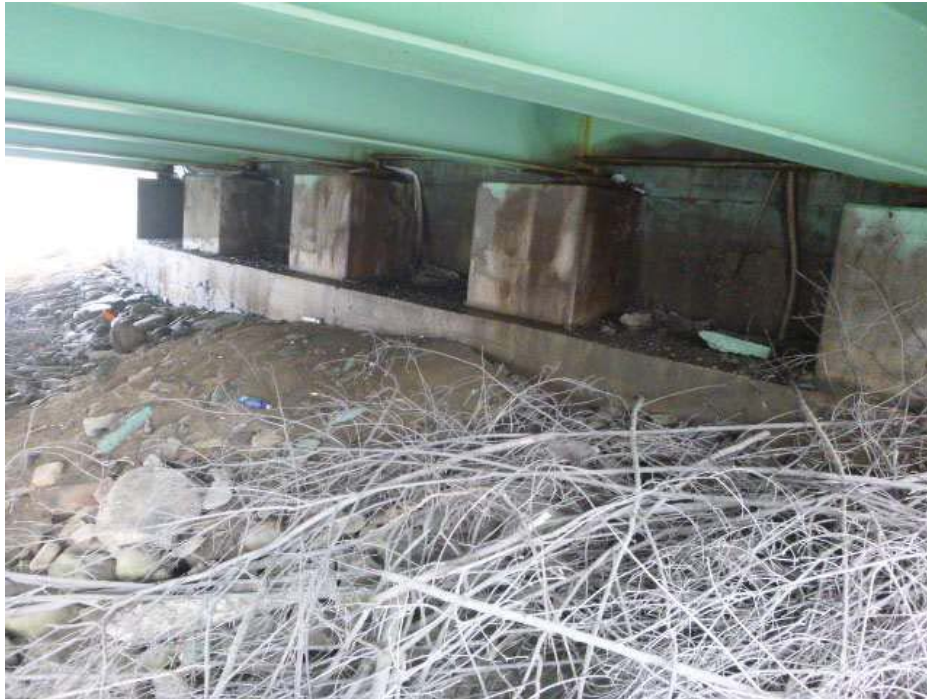
PHOTO 17

Description South abutment and beam ends

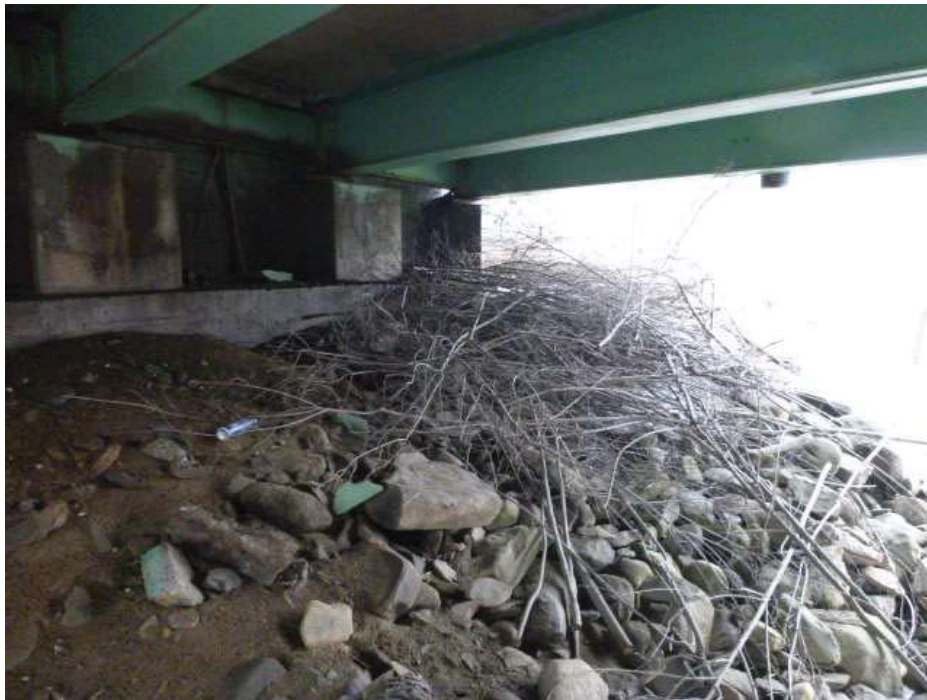
PHOTO 18

Description South abutment

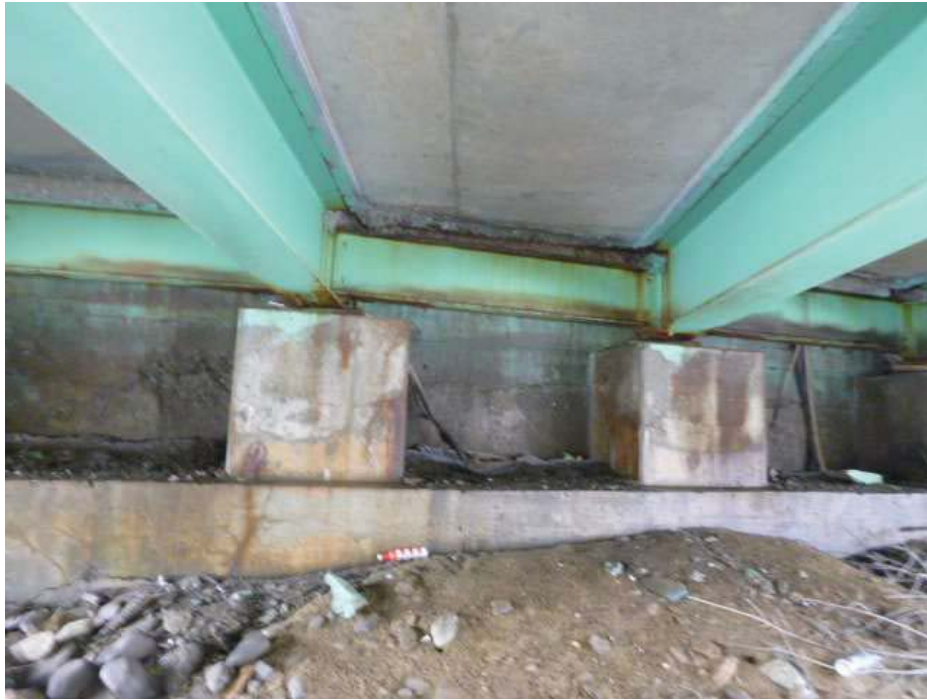
PHOTO 19

Description South beam ends

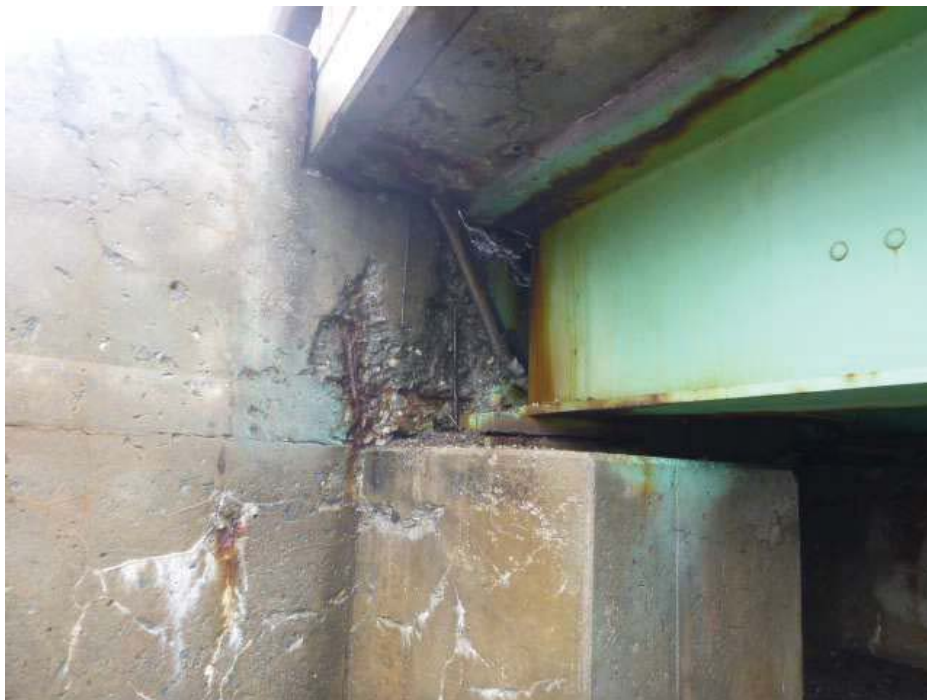
PHOTO 20

Description Spalled soffit above the SE beam end
