Highway Bridge Inspection Report

**I95 SB / SOUADABSCOOK CENTER
I 95 SB
over
SOUADABSCOOK STREAM**

Asset Code: 1432

Inspection Date: 04/06/2017

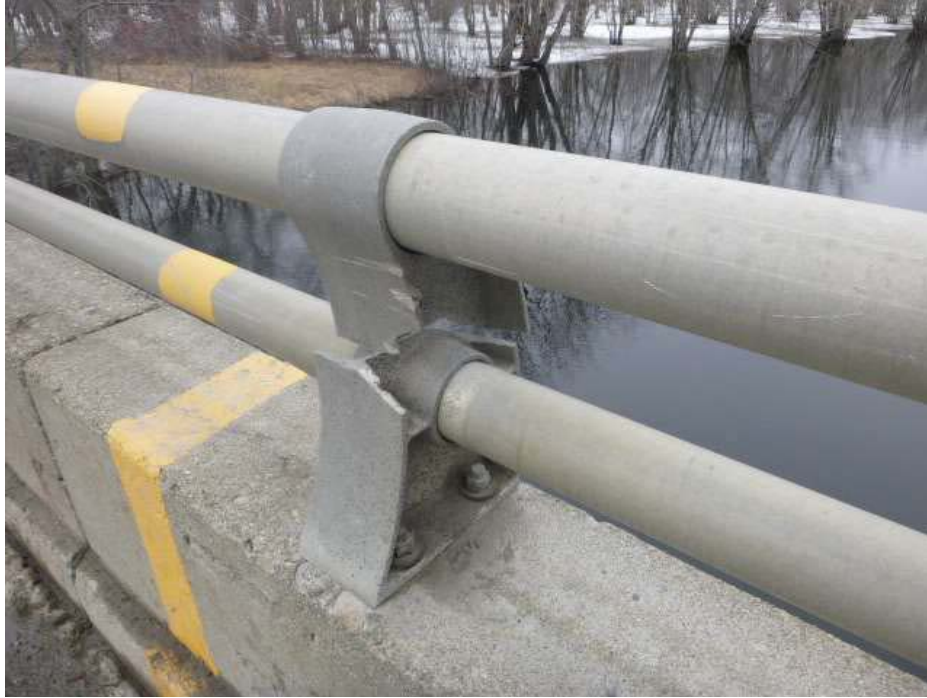
PHOTO 1

Deck rehab in 2007 included deck patches, sections of curb and end posts and bearing pedestals. Bridge rail on the down stream side has multiple gouged rail posts, broken posts that involve at least one bolt, a completely severed post and a torn rail, see photos.

Description Completely severed bridge rail post

Type	Work Item	Priority	Notes
Maintenance	Stabilize Substructure	3	Grout Bag
Maintenance	Repair Bridge Rail		Multiple rail and post issues
Maintenance	Reset Bearings		North abutment center bearing is bouncing

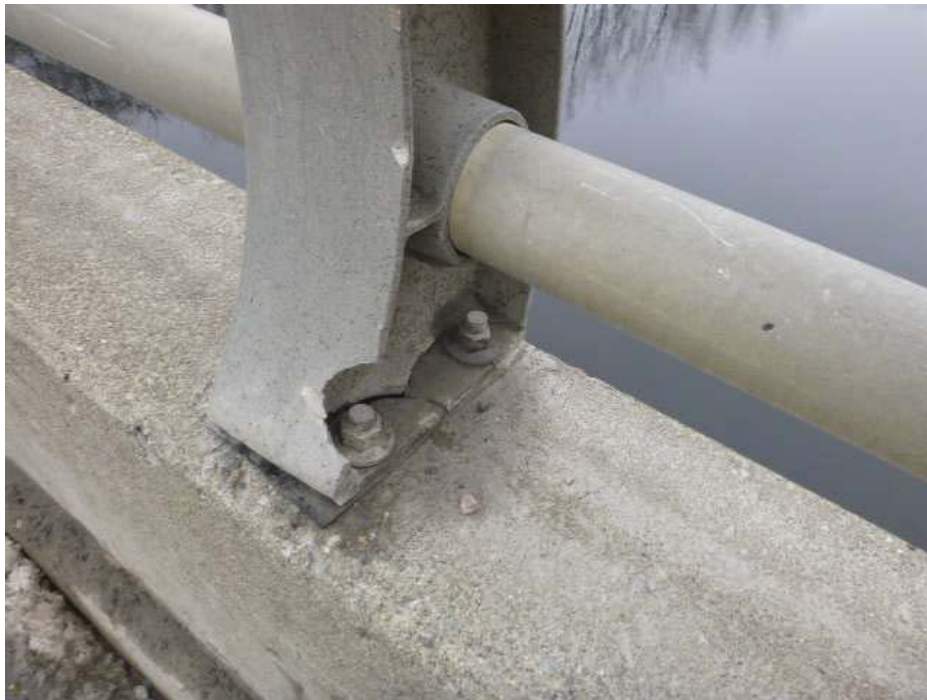
PHOTO 2

Description Bridge rail post damage with broken base

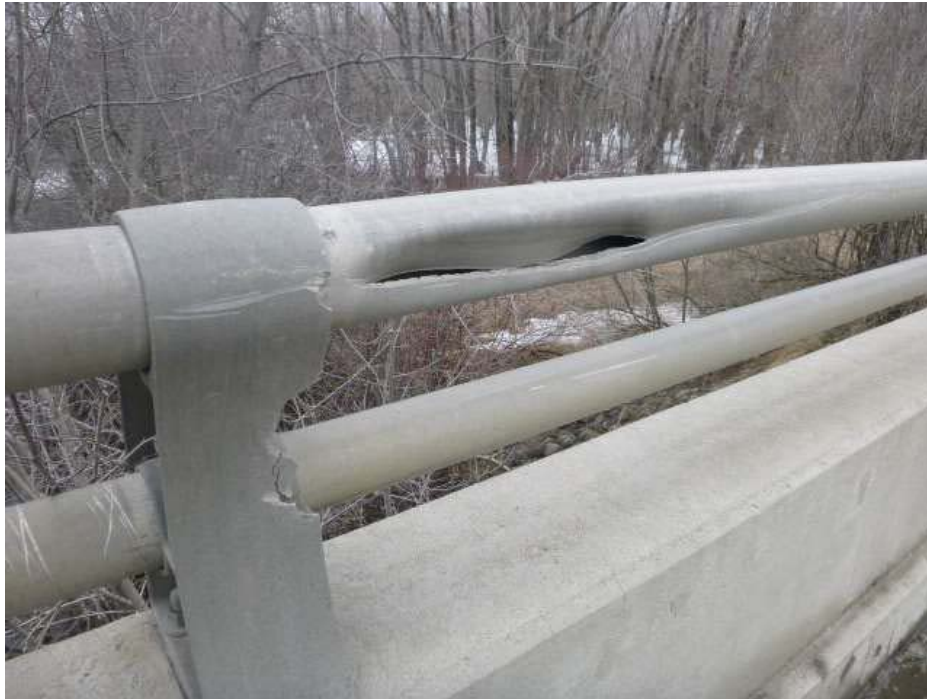
PHOTO 3

Description Split in bridge rail

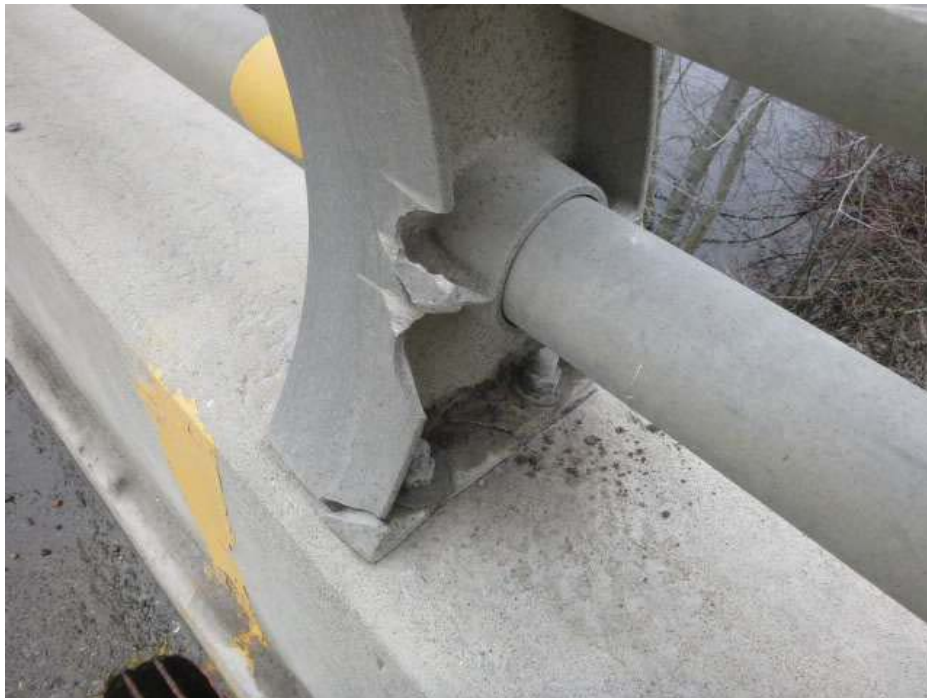
PHOTO 4

Description Bridge rail post broken

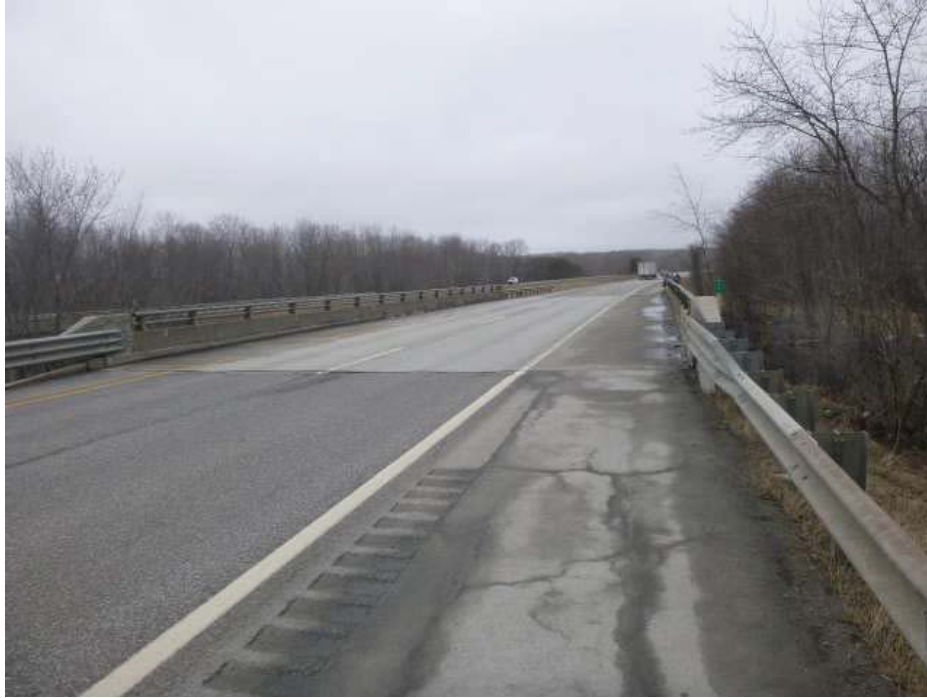
PHOTO 5

Approach bituminous settlement with nested cracking at both ends of the bridge. Concrete wearing surface has loss of tining in the wheel path areas. Minor transverse cracking. Nested cracking and minor settlement at the South approach pavement, see photo. Half of the aluminum bridge posts have plow damage (up stream end) the remainder are in good condition.

Description Roadway looking South

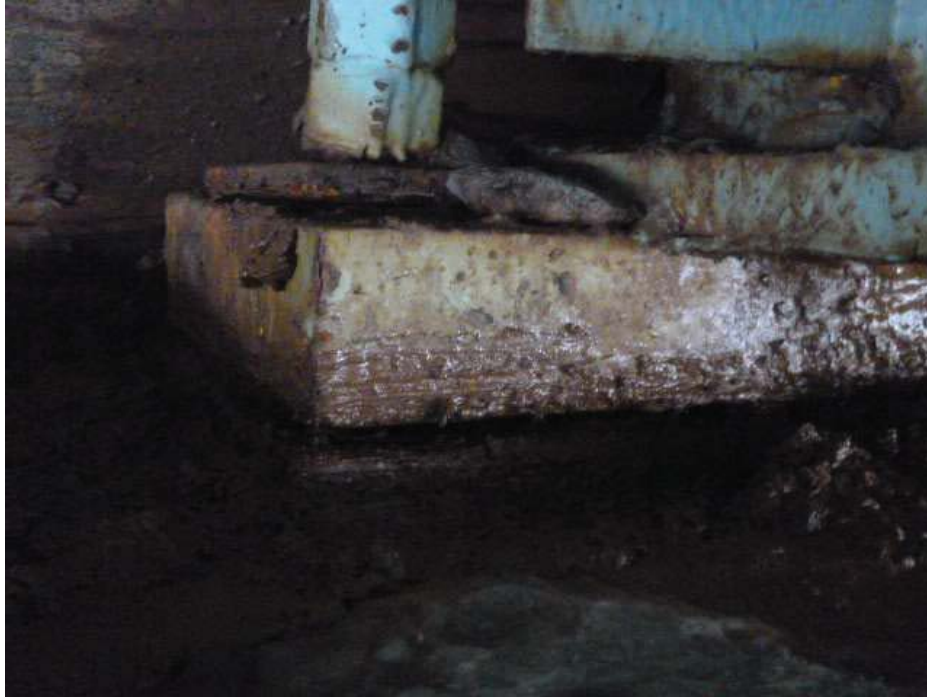
PHOTO 11

North abutment center bearing is not bearing on the masonry plate and bouncing 1/4", see photo. Possibilities for this issue include abutment settlement or excessive pack rust under the remaining bearings. Painted steel girders are in good condition with moderate paint deterioration.

Description Center bearing, North end, is not bearing on the masonry plate and bounces 1/4" when live load is applied
