# Highway Bridge Inspection Report

**I95 SB / SOUADABSCOOK WEST  
I 95 SB  
over  
SOUADABSCOOK STREAM**

**Asset Code:** 1433

**Inspection Date:** 04/06/2017

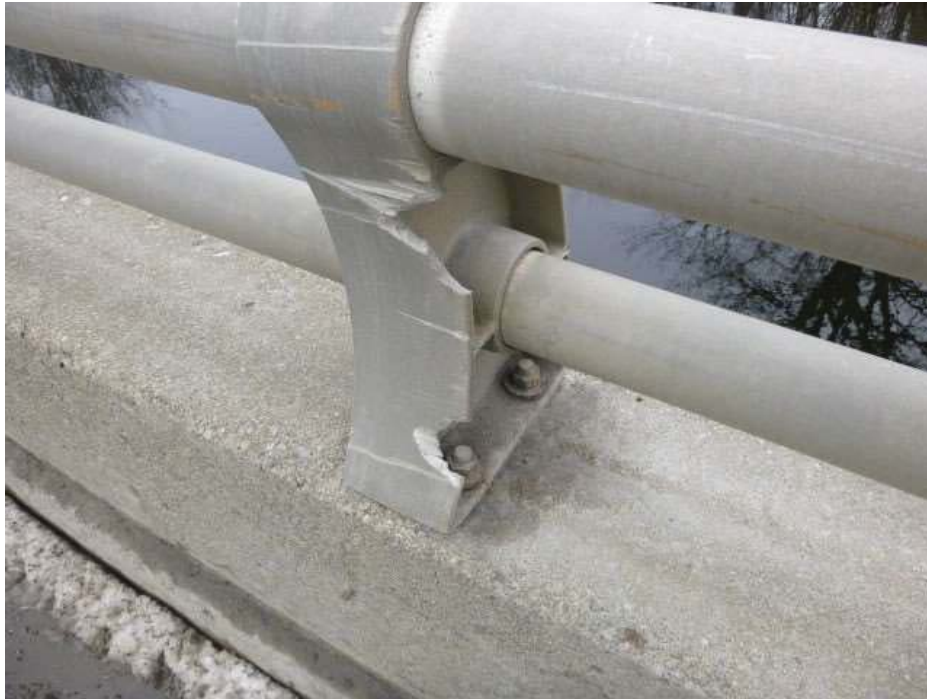
PHOTO 1

Description Section loss on up stream posts

Type	Work Item	Priority	Notes
Maintenance	Stabilize Substructure	3	Grout Bag
Maintenance	Rehab Substructure		North abutment bearing blocks
Maintenance	Seal Joint		install joint seals
Maintenance	Repair Deck		Deck to superstructure attachment
Maintenance	Repair Bridge Rail		Detached rails and broken posts

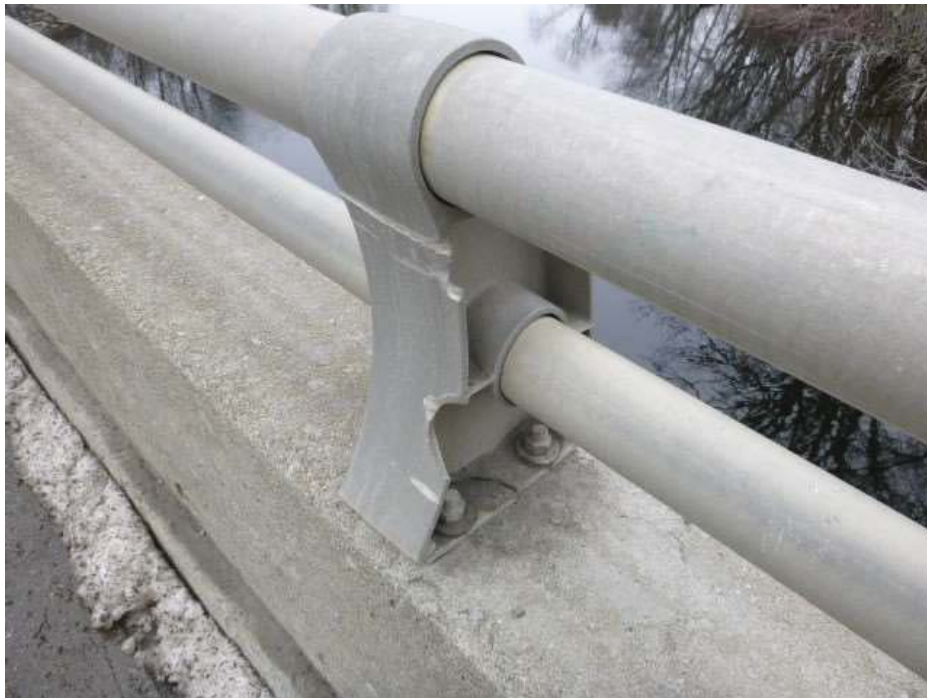
PHOTO 2

Description Three rail posts with section loss on up stream end and two posts with cracked bases

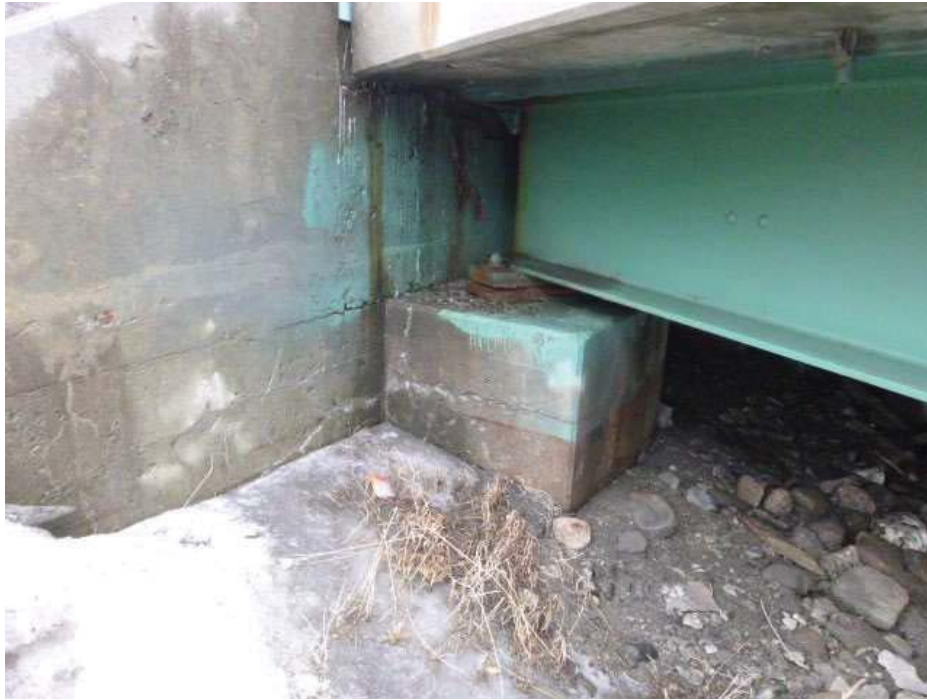
PHOTO 5

Painted steel girders are in overall fair condition, but beam ends (bearings have been) have not been treated and there are no joint seals above.

Description NW beam end

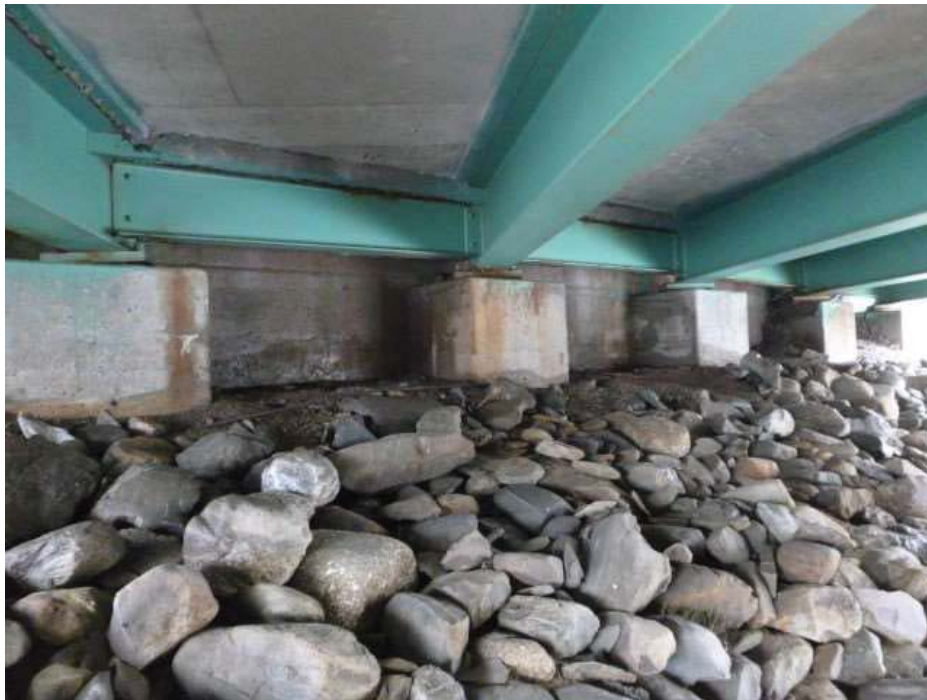
PHOTO 6

Substructure is rated a 5, but isolated areas such as the North abutment bearing block cracking and spalling with exposed re-steel lean towards a 4. Both of the piers are in satisfactory condition. Abutments and wings have extensive cracking and staining, see photos. No seals in the deck joints above. See most recent dive report for channel and pier details. Previous undefined concrete wall element of 14' has been included in the abutment element total.

Description North abutment

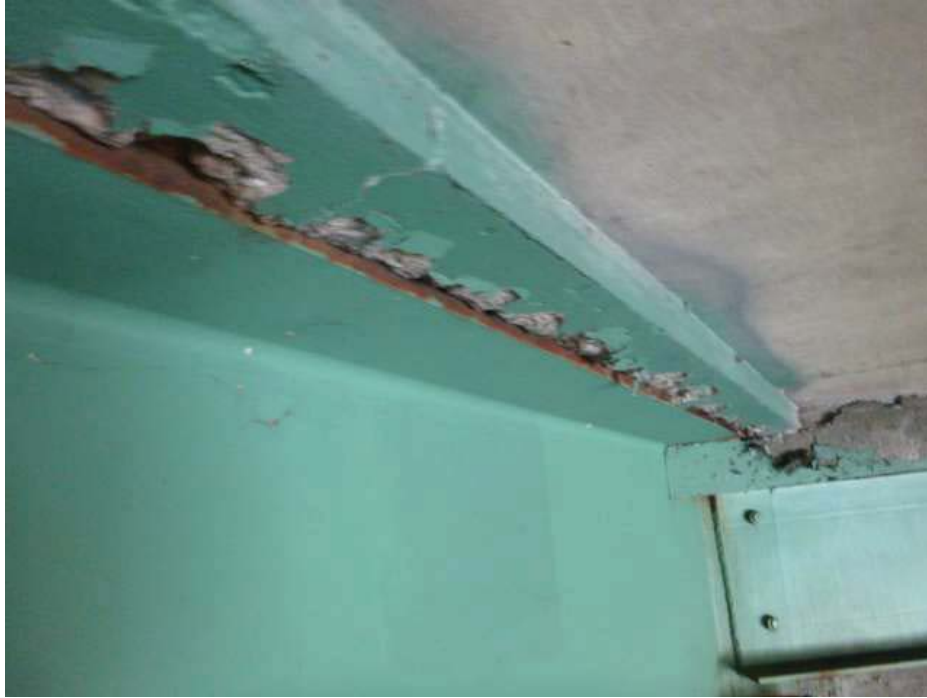
PHOTO 7

The deck has separated from the superstructure at the North abutment. Deck flexes independently of the superstructure when live loads are applied. This can be seen on the top flange, North abutment, middle beam end area. Areas of delaminated and spalled concrete. Haunches above diaphragms have spalled with fully exposed re-steel and fallen re-steel, see photos. Both joints are missing seals.

Description separation between deck and superstructure at the North abutment. Deck flexes independently of steel when traffic load is applied

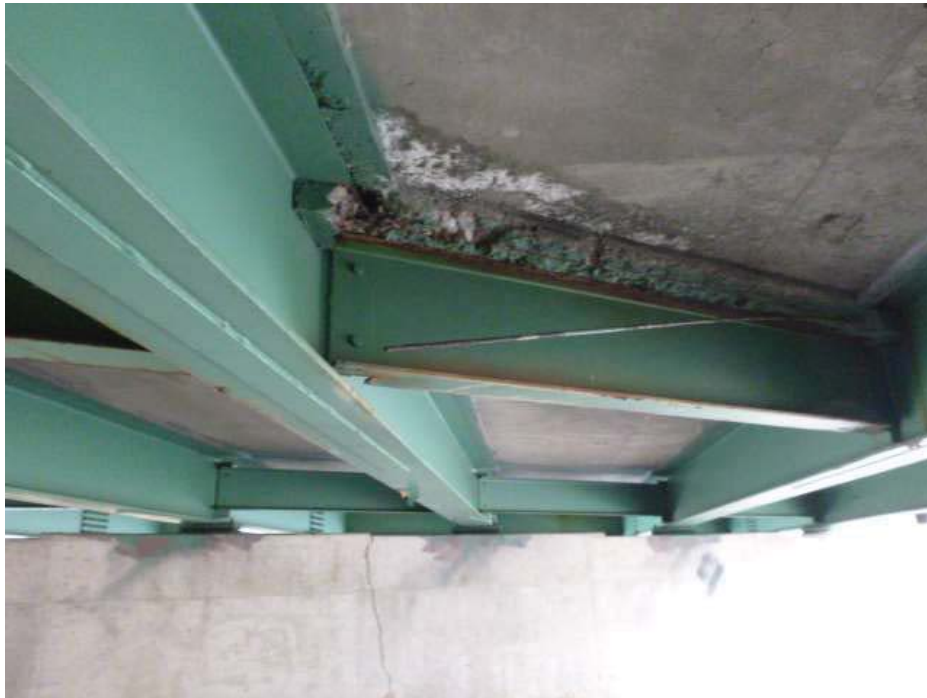
PHOTO 8

Description Spalled haunches, North end

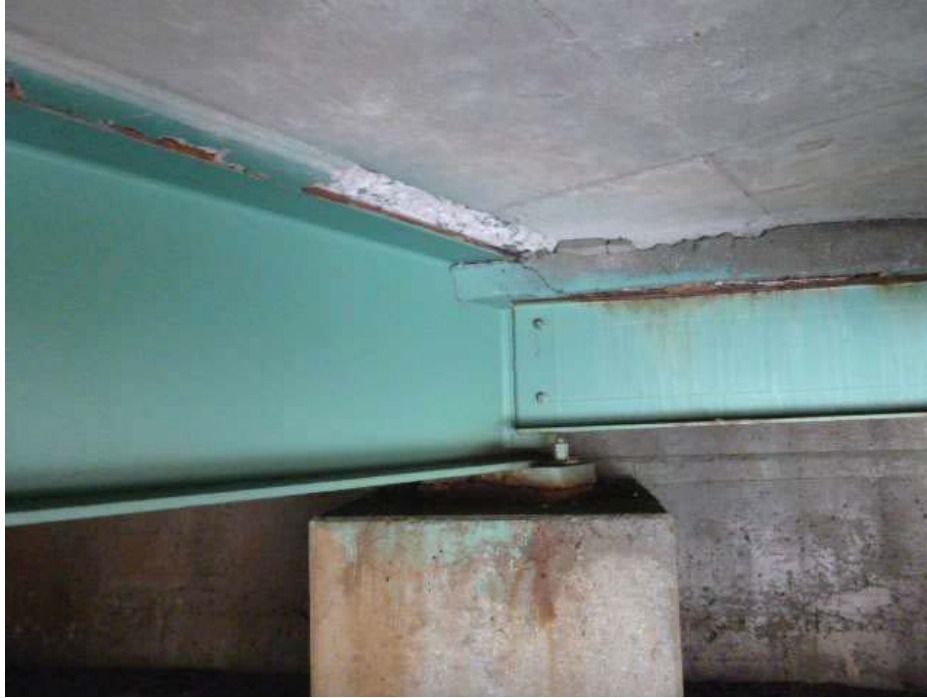
PHOTO 9

Description North abutment beam end

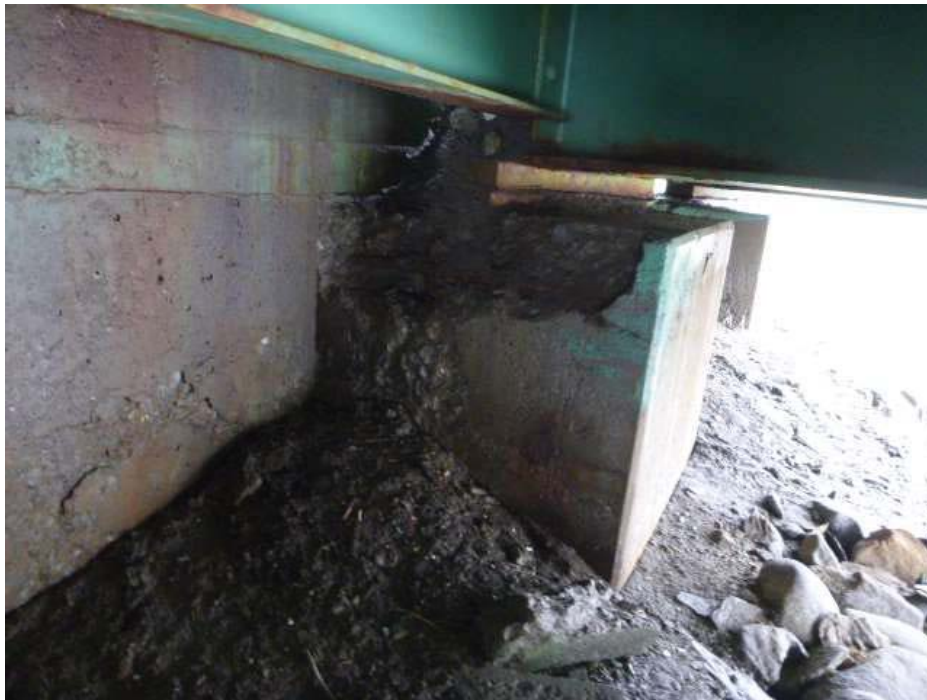
PHOTO 10

Description Spalled bearing block with exposed re-steel, North abutment, No seal above in deck joint

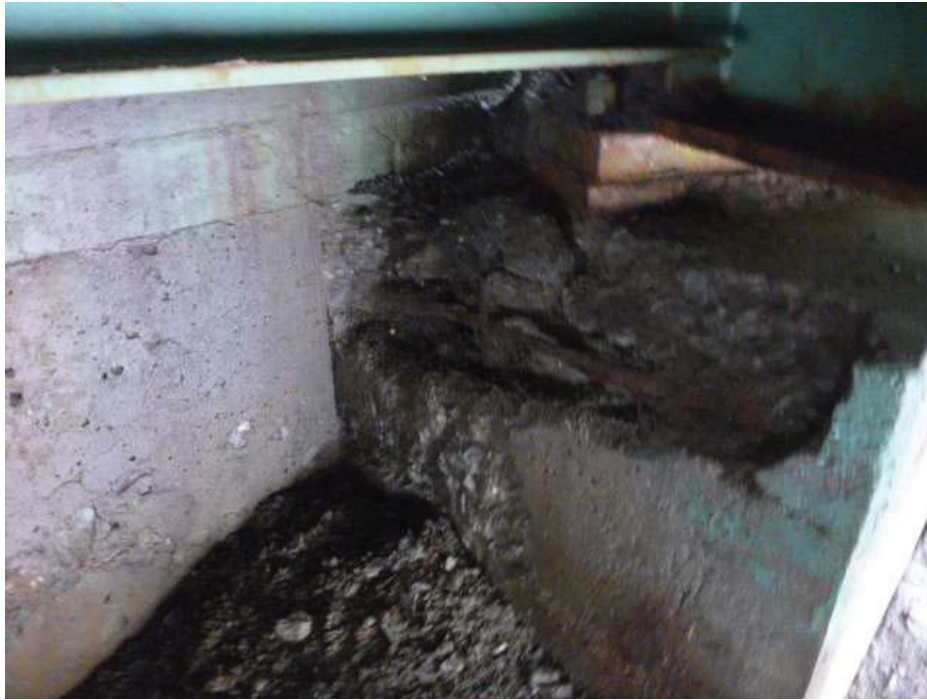
PHOTO 11

Description Spalled bearing block with exposed re-steel, North abutment

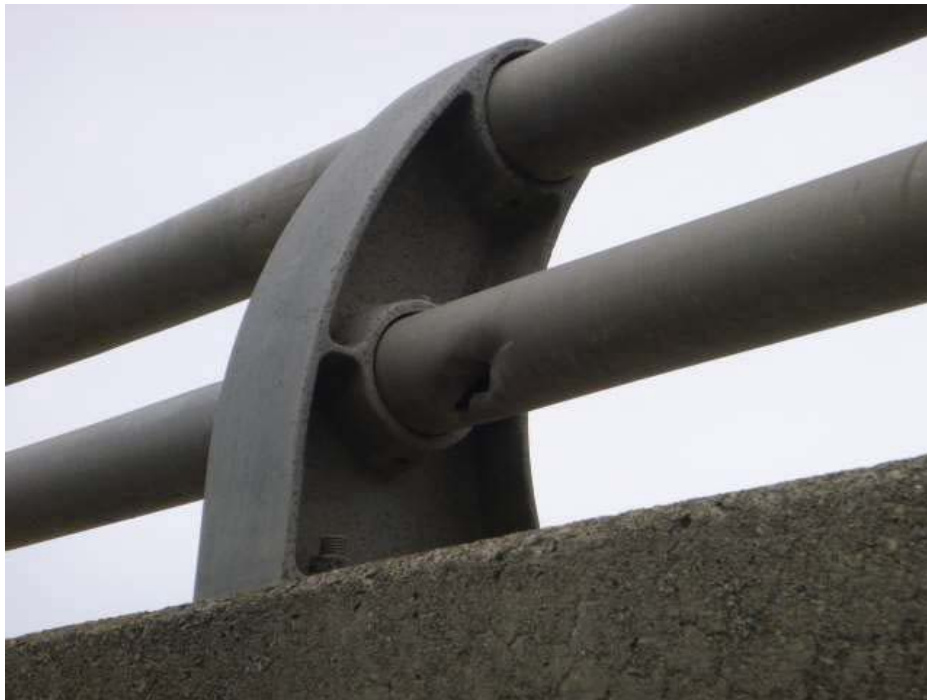
PHOTO 12

Description Torn rail, down stream side, exterior

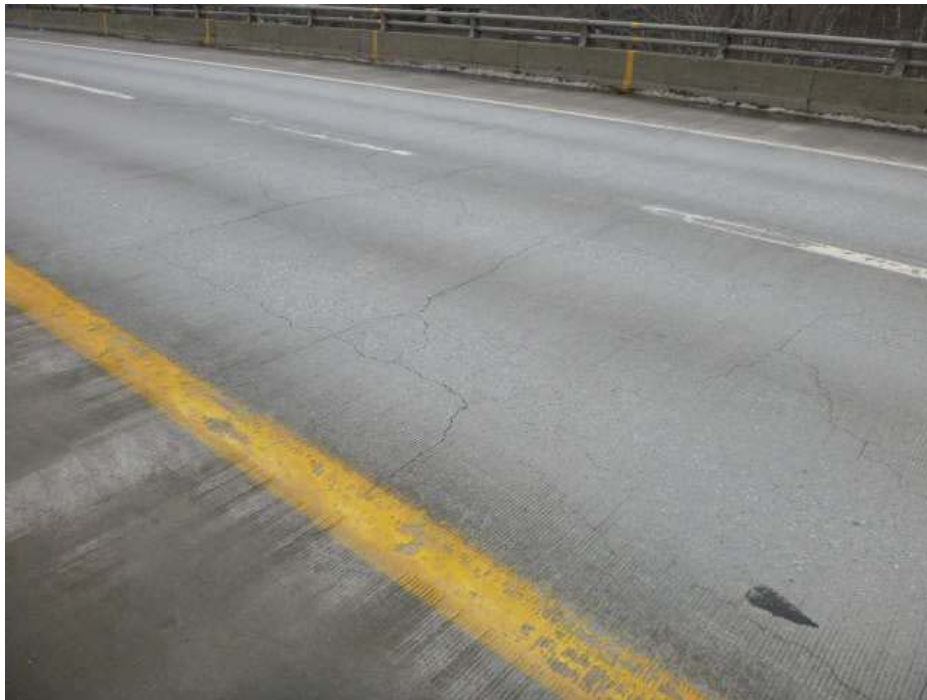
PHOTO 14

Worn concrete wearing surface in wheel path areas. Scattered cracking of the wearing surface.

Description Cracking of concrete wearing surface

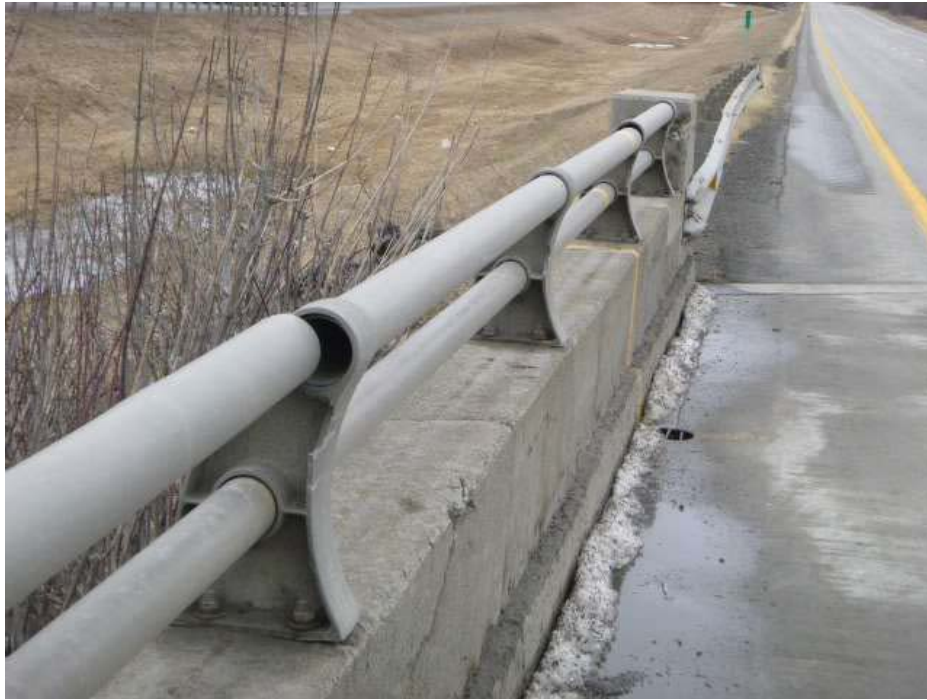
PHOTO 15

Description Two disconnected rails on the down stream side, 2nd and 4th sections

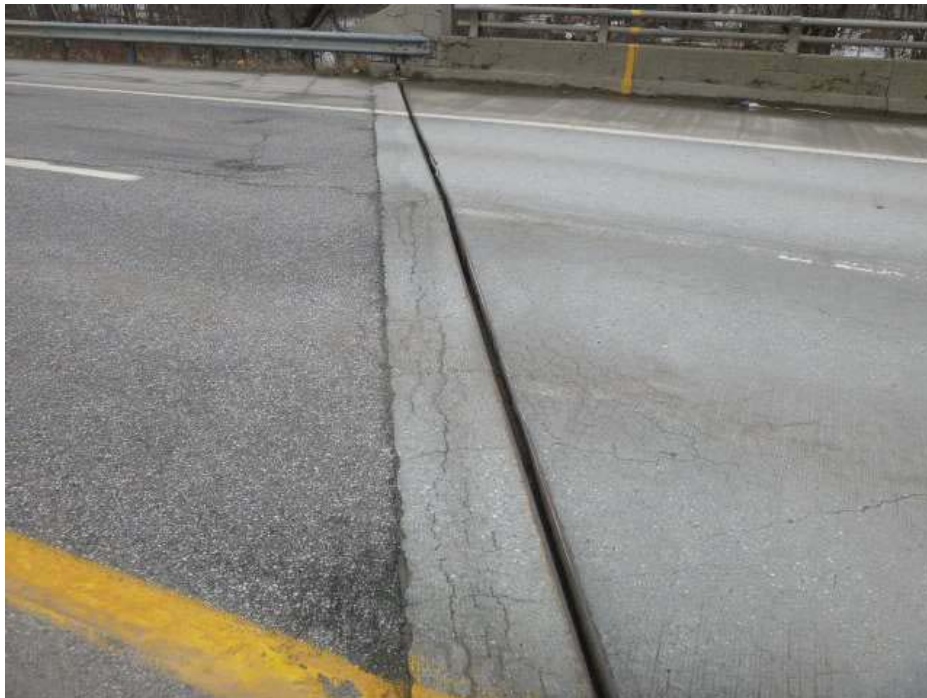
PHOTO 16

Description South deck joint with no seal
