Highway Bridge Inspection Report

**SOUADABSCOOK EAST NB
I 95 NB
over
SOUADABSCOOK STREAM**

Inspection Date: 09/13/2018

Structure Number: 5949

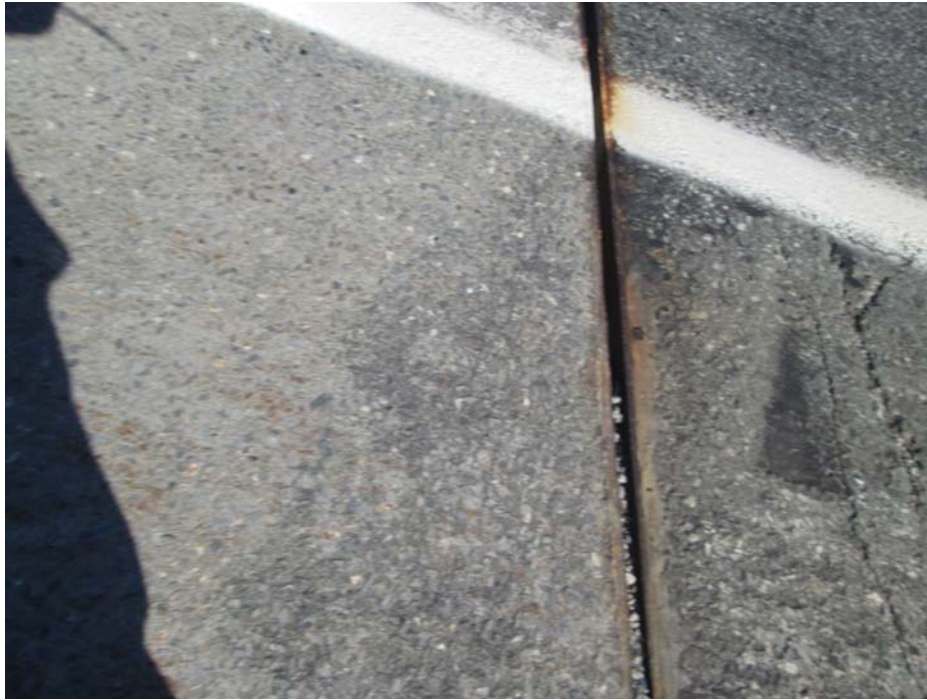
PHOTO 3

Bottom of deck has spalling at blocking and joint areas and large areas of staining.
The West joint seal has failed and is leaking.
There are 3+ post on both the up and down stream ends that have either missing nuts or damaged.

Description North Joint - Seal Pushed down

Type	Work Item	Priority	Notes
Maintenance	Paint		Beam ends
Maintenance	Coat Beam Ends		
Maintenance	Repair Bridge Rail		
Preservation	Seal Joint

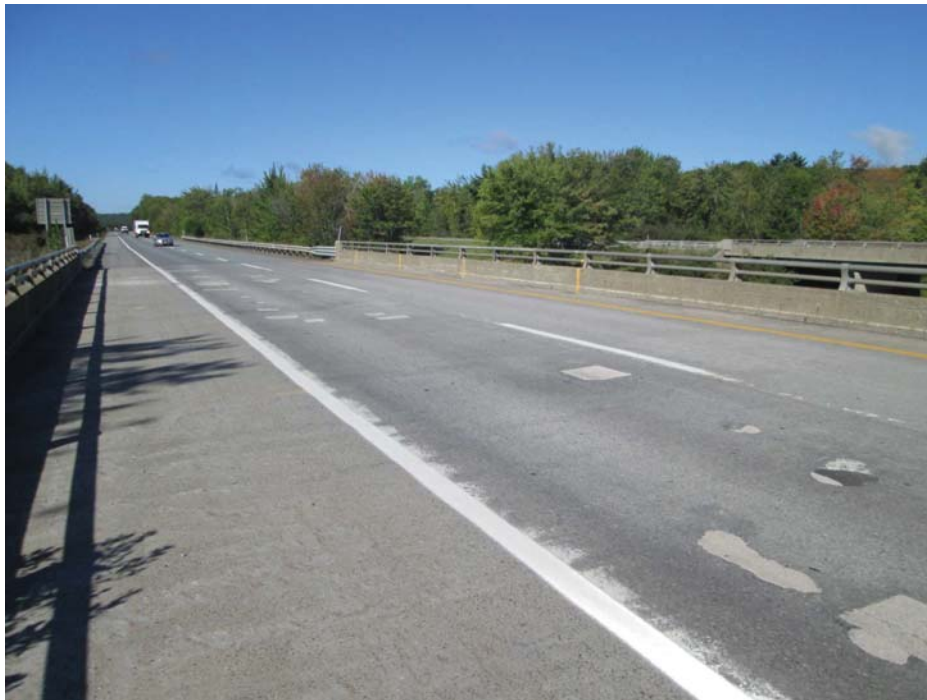
PHOTO 4

Did not chain wearing surface due to heavy traffic, but observed approximately 25% cracking and multiple patched areas. Isolated transverse cracking.

Description Concrete Wearing Surface - Frequent patching

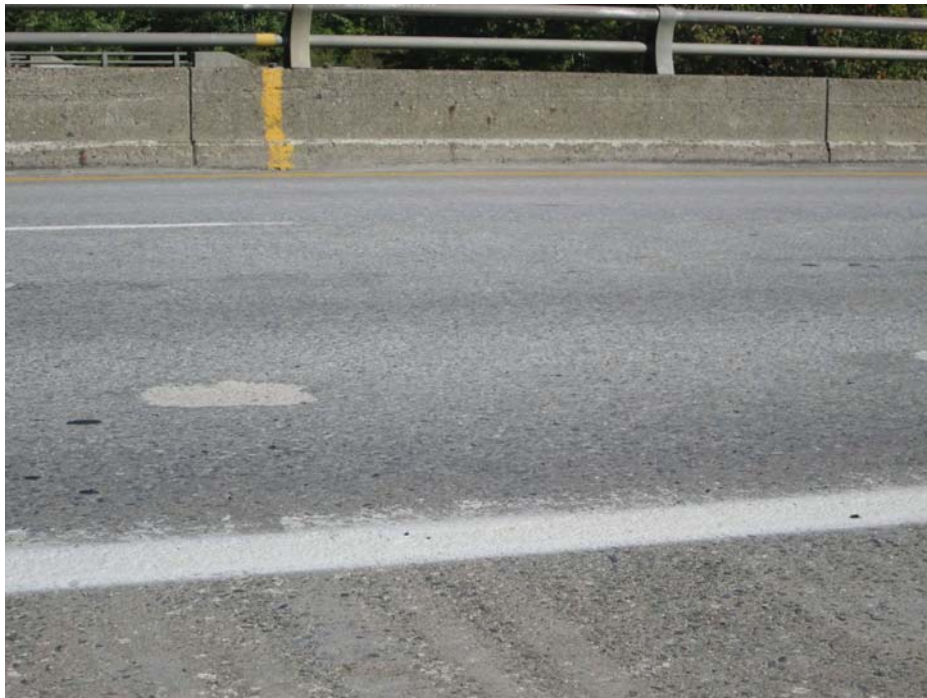
PHOTO 6

Description Concrete Wearing Surface - Moderate rutting

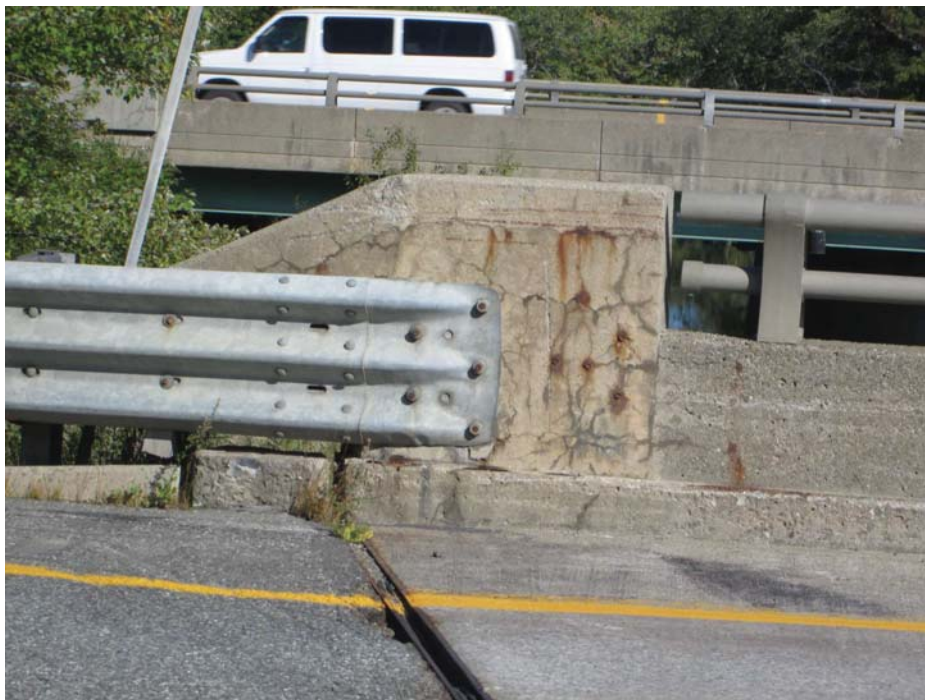
PHOTO 8

Description SW End Post - Moderate Cracking

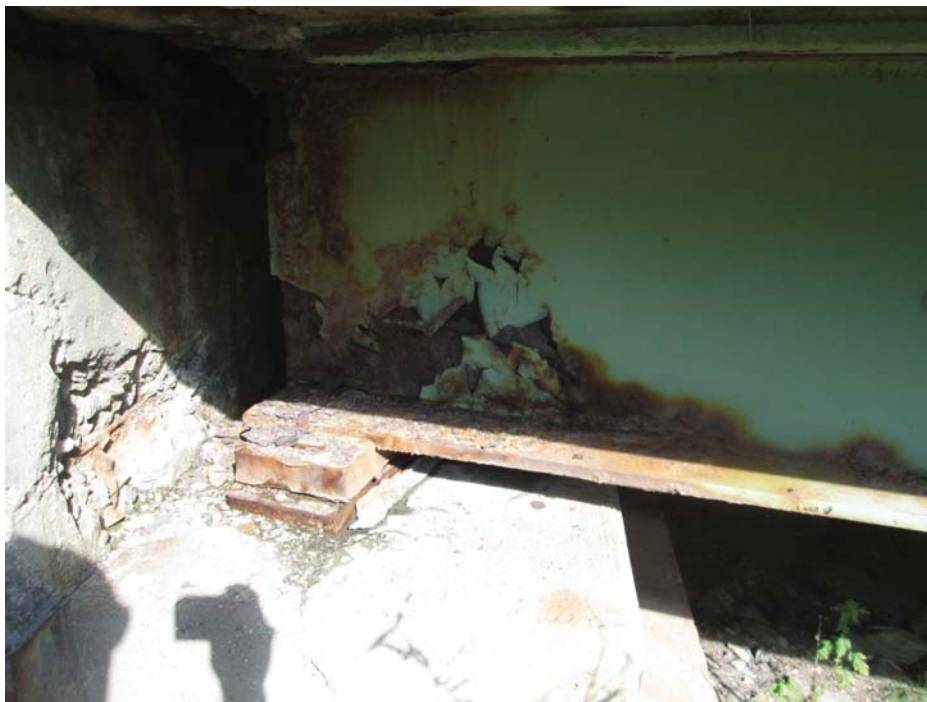
PHOTO 10

Approximately 25% paint system distress with moderate rusting at exterior beam end areas.
Several bearing anchor bolts are missing.

Description SE beam End and Bearing - Anchor bolts gone

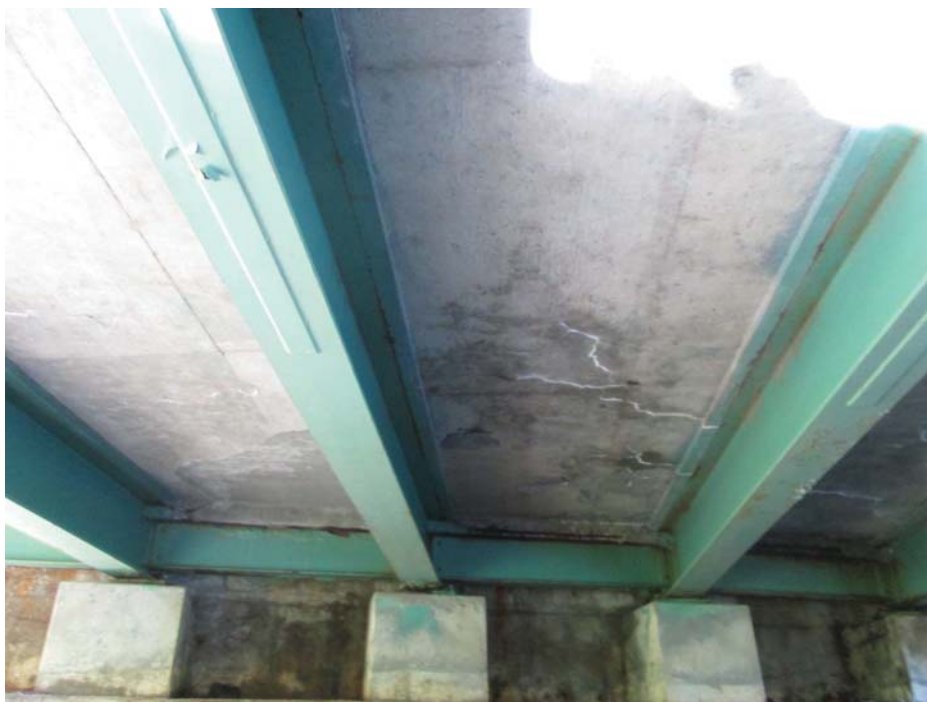
PHOTO 12

Description Deck View - South Span - patching - cracking with efflo

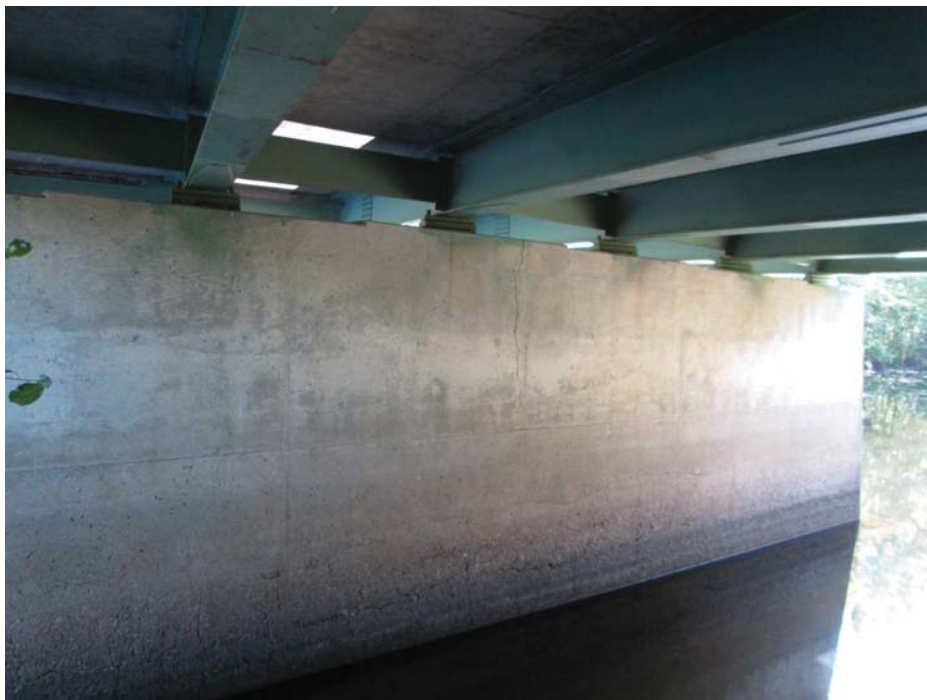
PHOTO 13

See 2015 dive report for substructure and channel details.
Exposed pier footings founded on ledge with no undermine.
Moderate cracking, staining and scaling of abutment bridge seats & back-walls.
West pier has a full height crack that is 1/8" wide at the top down to fine cracking at the bottom, and is unchanged.

Description South Pier Moderate cracks

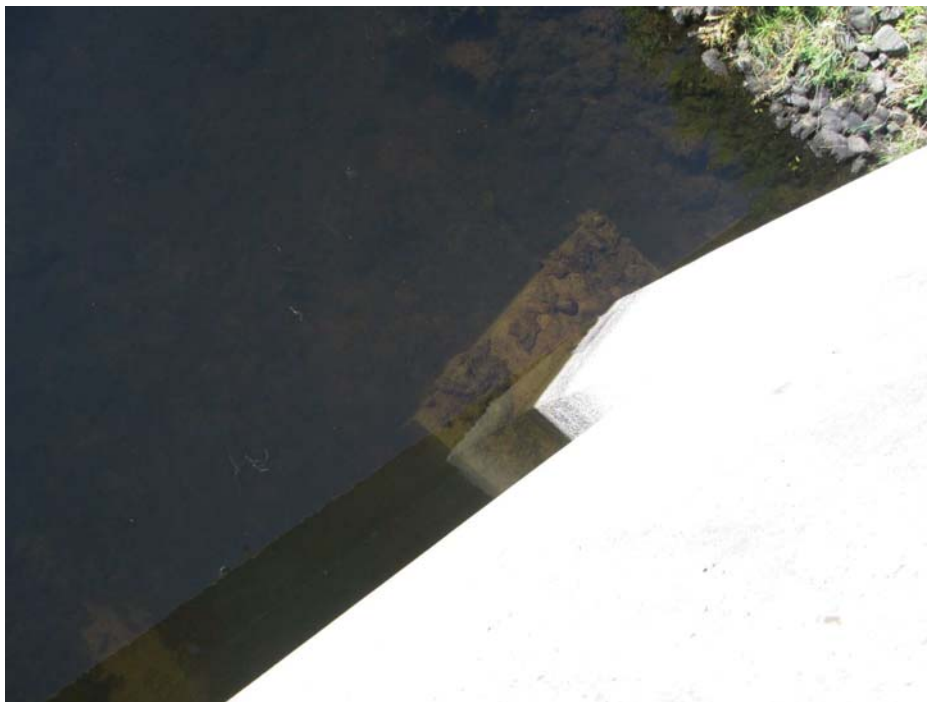
PHOTO 14

2 piers on ledge in good condition. Inspected with SB bridge.
No significant change in exposed footing.
Piers on ledge per plans.
2011: No major changes. Exposed footing similar to previous report.
2015: Exposed footings.
Lft pier exposed 8'.
Right pier exposed 7'.
No changes.

Description South Pier Footing - exposed

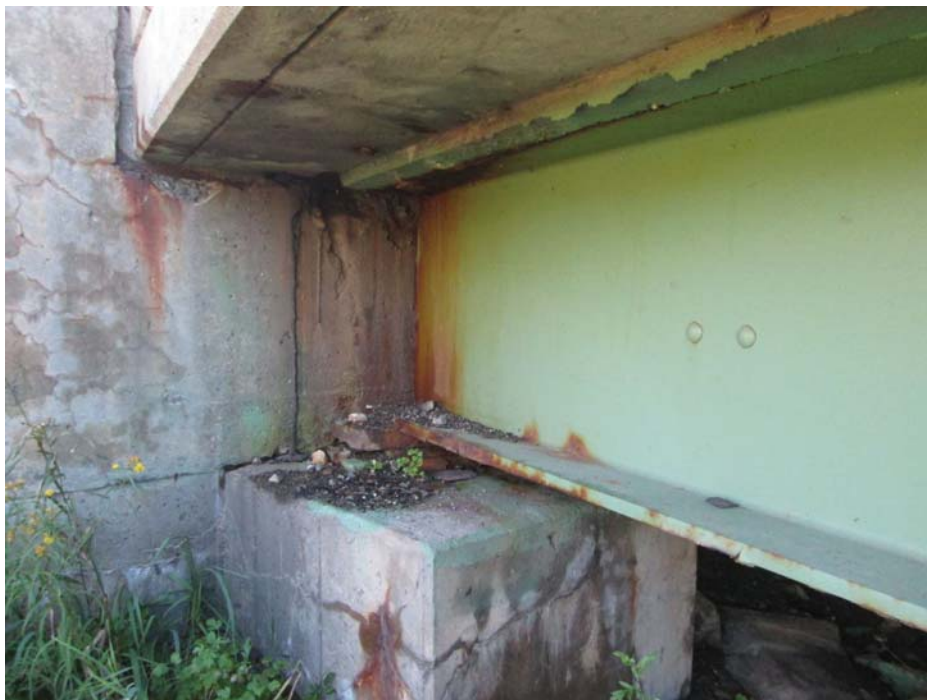
PHOTO 17

Description North Abutment - NW Beam End and Bearing View - All North Anchor bolts gone

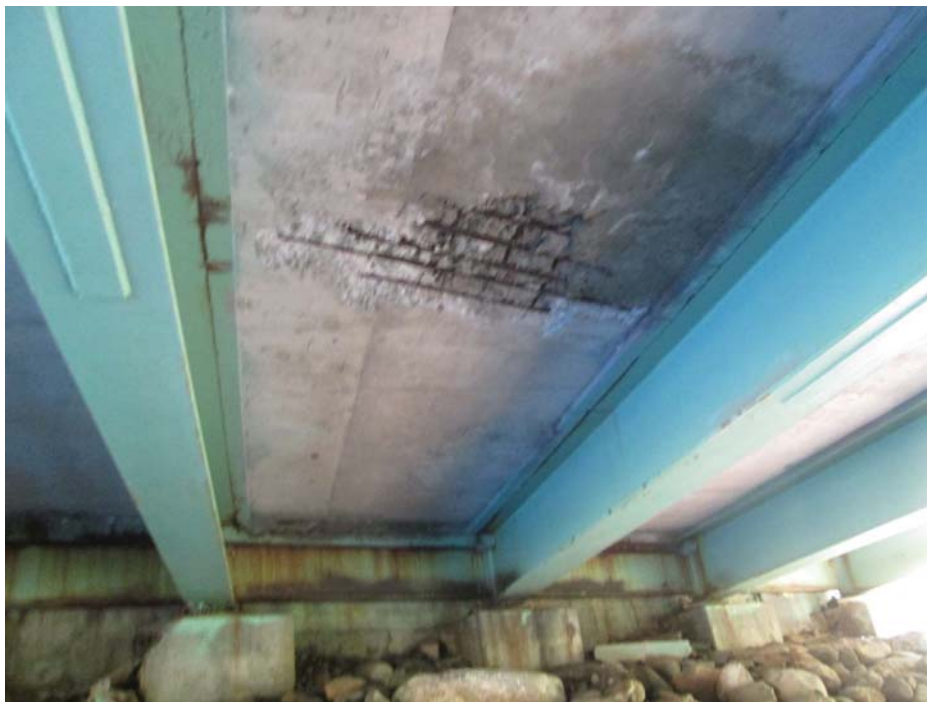
PHOTO 19

Description Deck View - North Span - Spall with exposed rebar

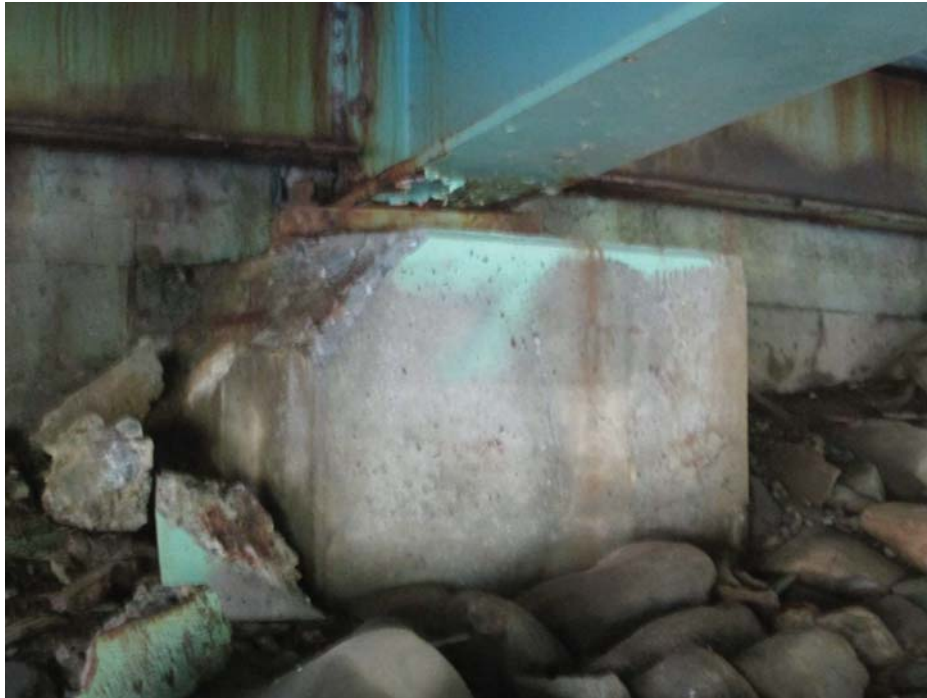
PHOTO 20

Description North Abutment - Interior Pedestal Spall
