# Highway Bridge Inspection Report

**SOUADABSCOOK CENTER NB  
95 NB  
over  
SOUADABSCOOK STREAM**

**Inspection Date:** 09/13/2018

**Structure Number:** 5950

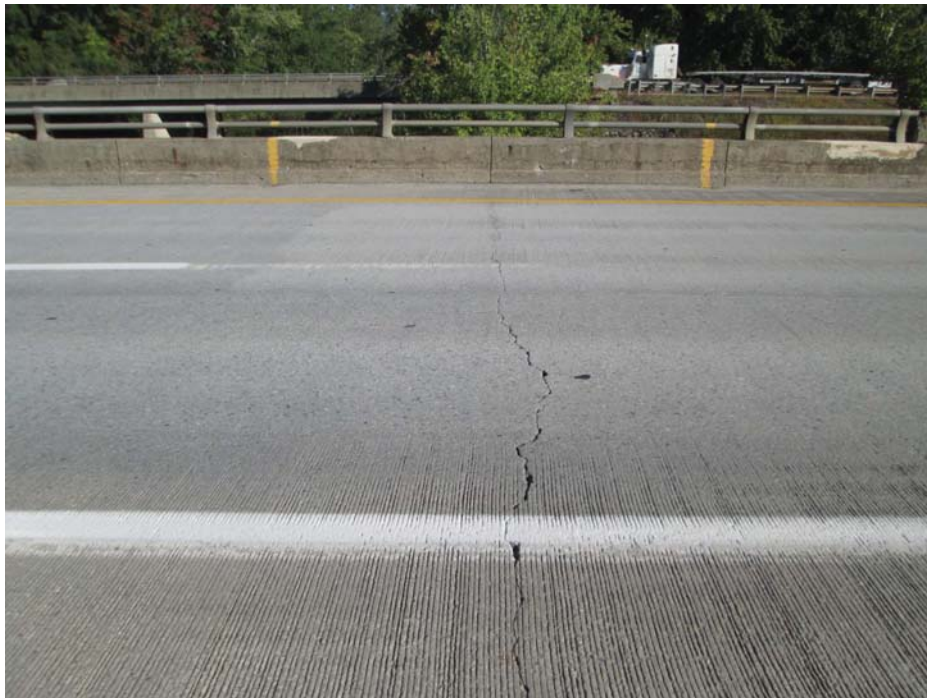
PHOTO 4

Did not chain wearing surface due to heavy traffic, but observed approximately 25% cracking, patched areas. Concrete wearing surface has 3 transverse cracks near center and 1/3rd of the way from each abutment.

Description Concrete Wearing Surface - Crack

Type	Work Item	Priority	Notes
Maintenance	Stabilize Substructure		Grout Bag
Maintenance	Repair Deck		
Preservation	Replace Wearing Surface

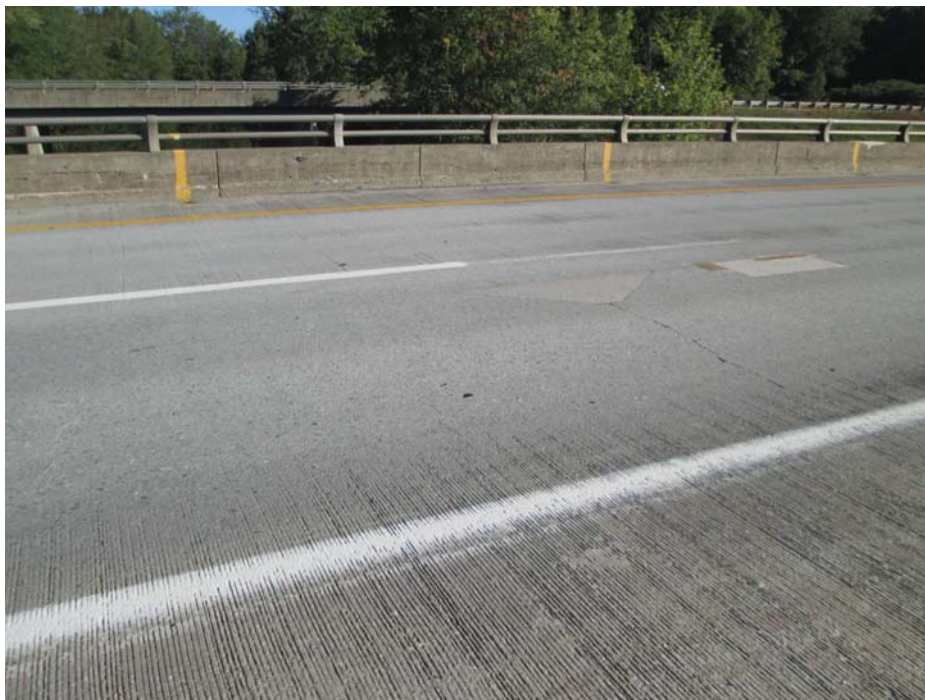
PHOTO 5

Description Concrete Wearing Surface - Many Patches - cracking

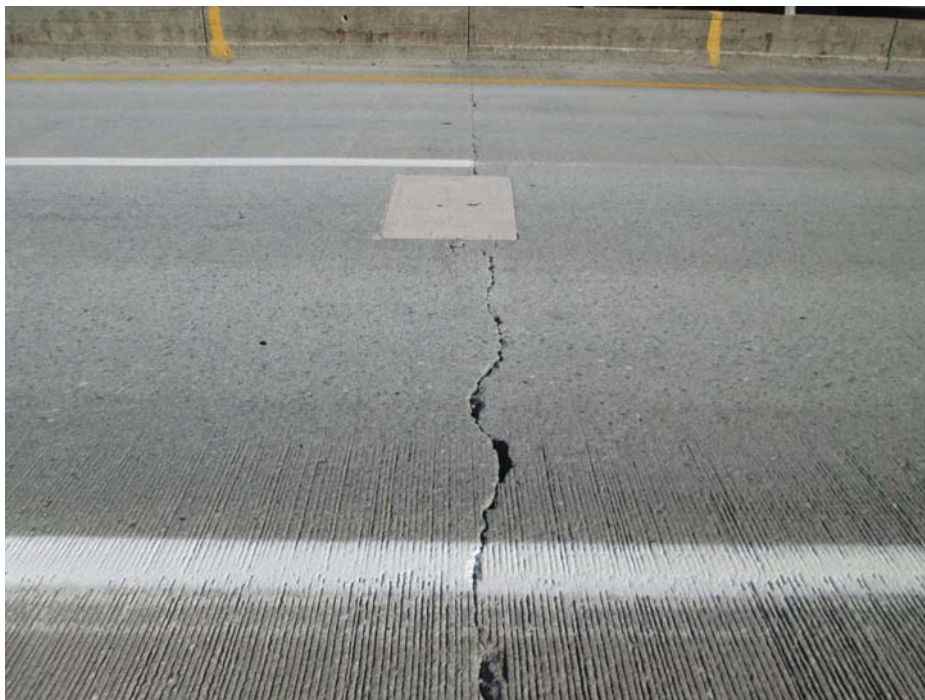
PHOTO 6

Description Concrete Wearing Surface - Patch and Heavy Crack - South

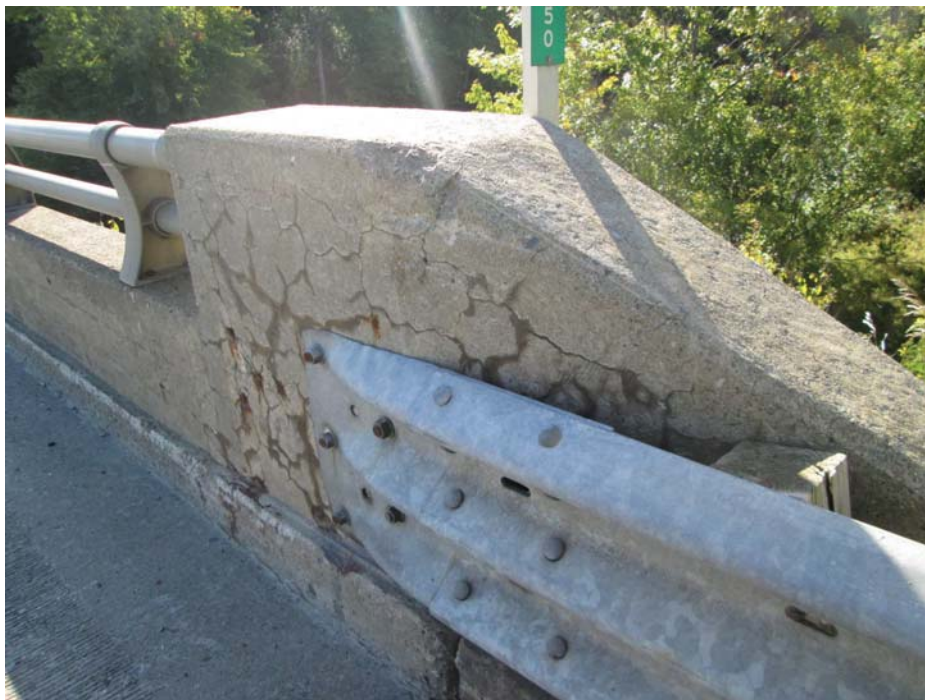
PHOTO 8

Description SE end post - moderate map cracking

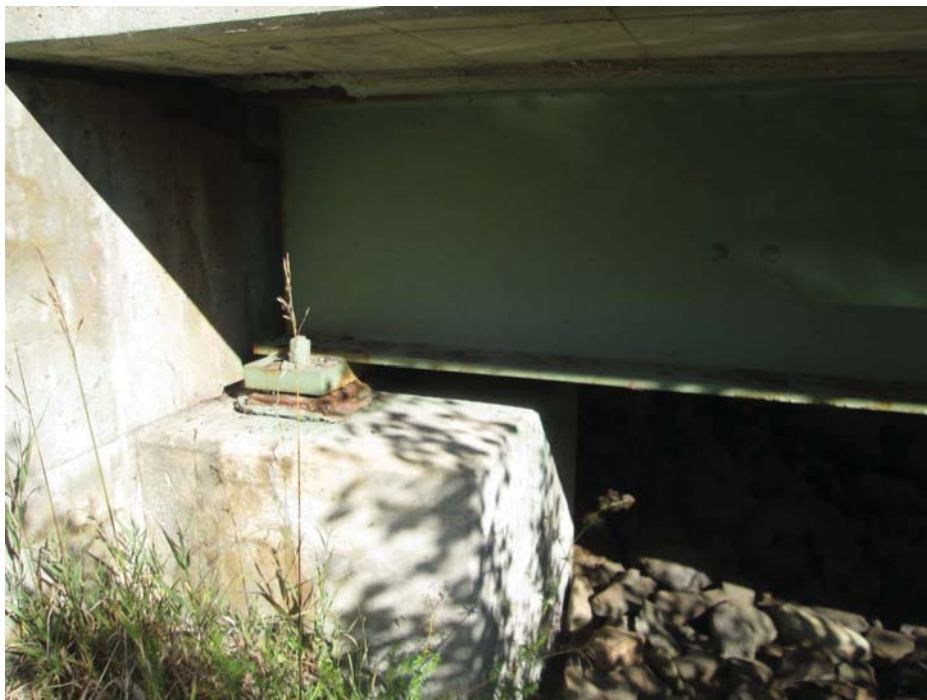
PHOTO 10

Approximately 15% paint system distress with moderate rusting at beam end exterior bearing areas.  
Anchor bolts are missing.  
Bearings have 50%+ Paint loss for bearings under joints.  
Deck and deck are not integral at the East end, see deck note above.

Description SE Beam end and Bearing View

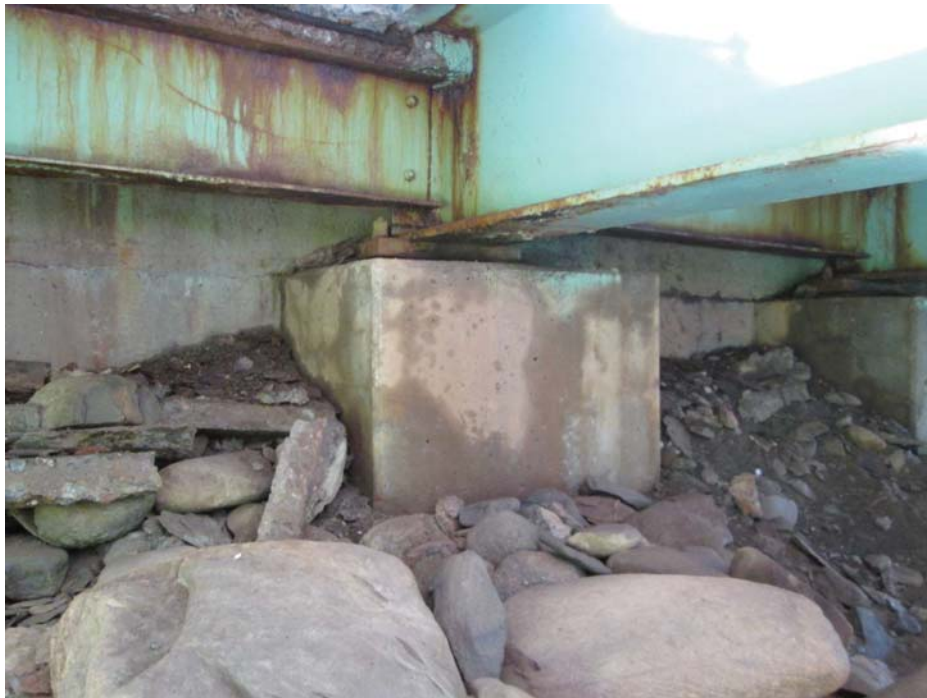
PHOTO 12

Moderate cracking and staining of back-wall areas.  
Pedestals have moderate cracking, spalled edges and staining.  
Concrete piers are in satisfactory condition.

Description South Interior Pedestal and Bearing View

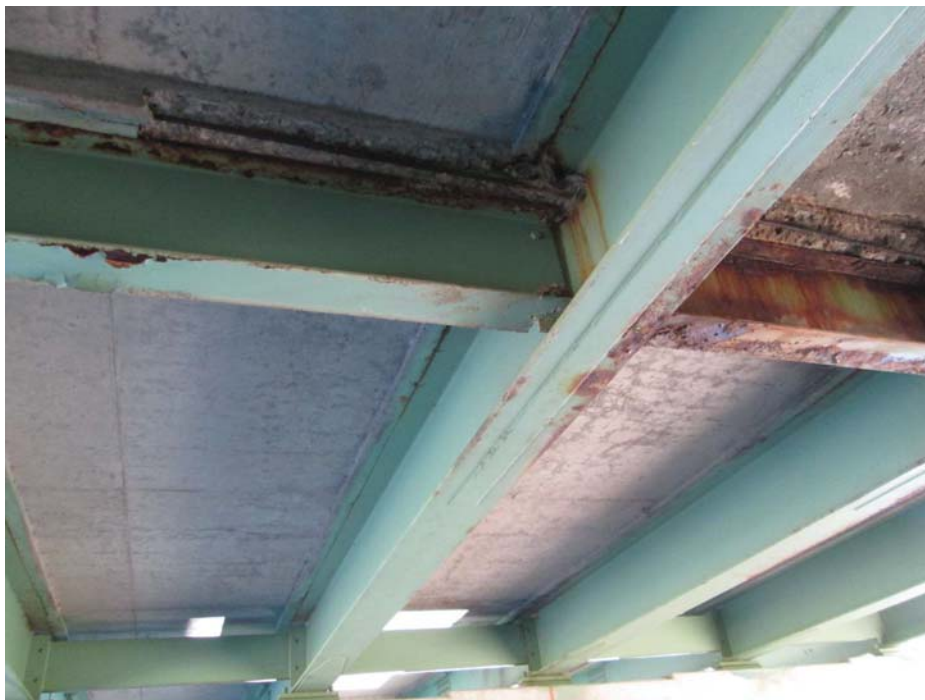
PHOTO 13

Extensive areas of spalled concrete with exposed re-steel on bottom of joint header.  
Bottom of deck has heavy spalling with exposed re-steel at deck blocking areas and a high percentage of staining bottom of deck.  
Seals are intact, but have signs of moderate to heavy leakage.  
Note - deck at the East end was noted moving separately from the steel girders when large trucks passed over. Area noted was near center only a few feet out from the East abutment, top flange.  
4-5 posts are damaged and/or missing nuts on both the up and down stream ends of the bridge.  
Repair sink hole just behind the back wall, NW corner

Description Deck View - South Span

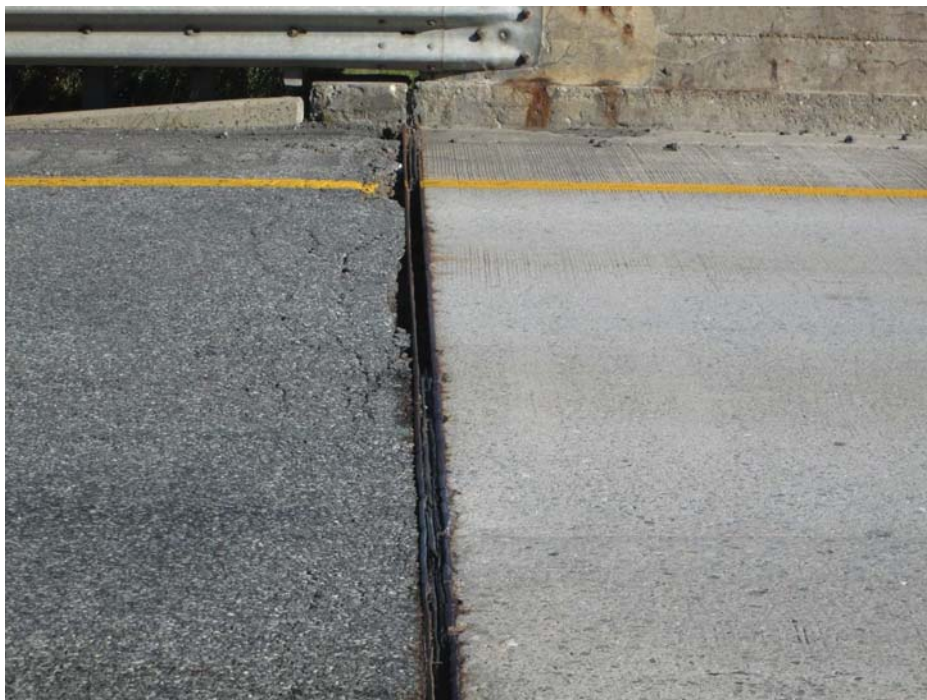
PHOTO 16

Deck has separated from the superstructure at the East end of the bridge. Independent movement can be seen a few feet out from the center of the East abutment, top flange/deck, when a large truck passes over.

Description South Joint - West Side - banging

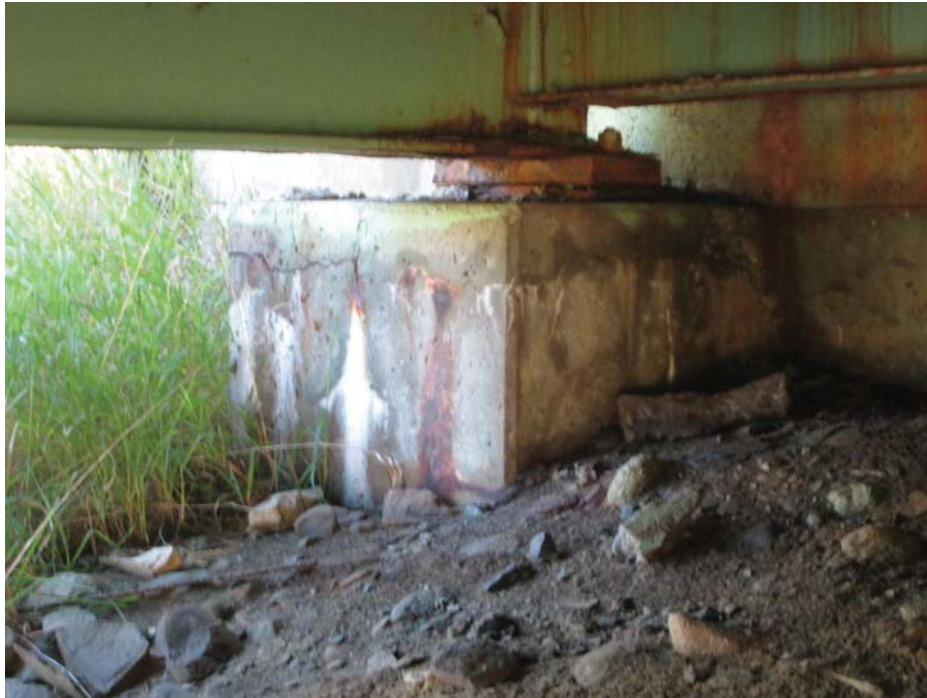
PHOTO 20

Description NW Bearing Pedestal View
