Highway Bridge Inspection Report

**SOUADABSCOOK WEST NB
95 NB
over
SOUADABSCOOK STR**

Inspection Date: 09/13/2018

Structure Number: 5951

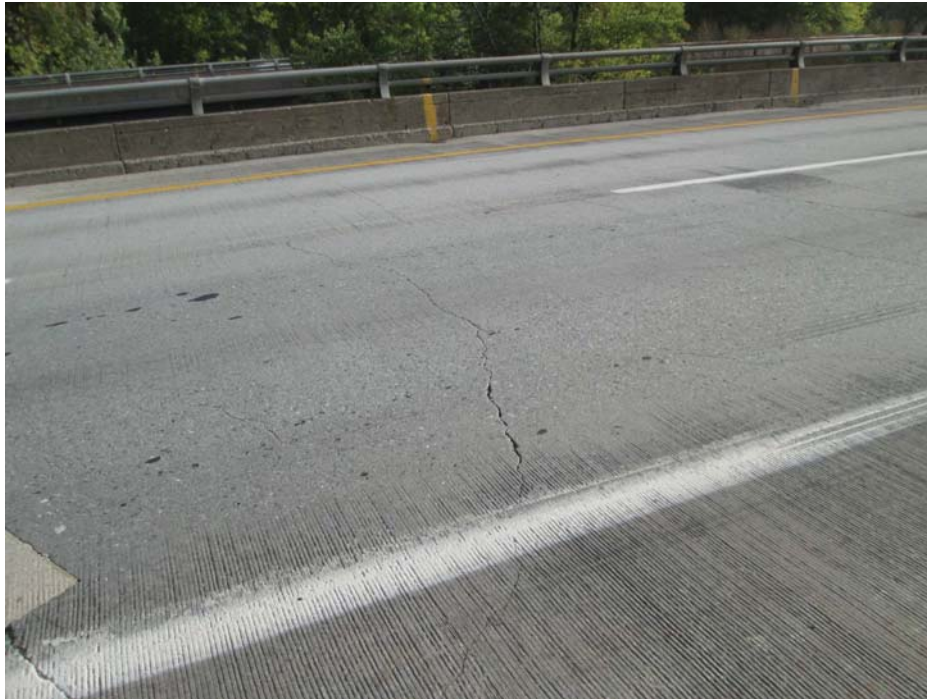
PHOTO 3

Did not chain wearing surface due to high traffic volume, but observed approximately 50% scattered heavy cracking, wear, small forming potholes and patched area to concrete.

Description Concrete Wearing Surface - moderate cracking

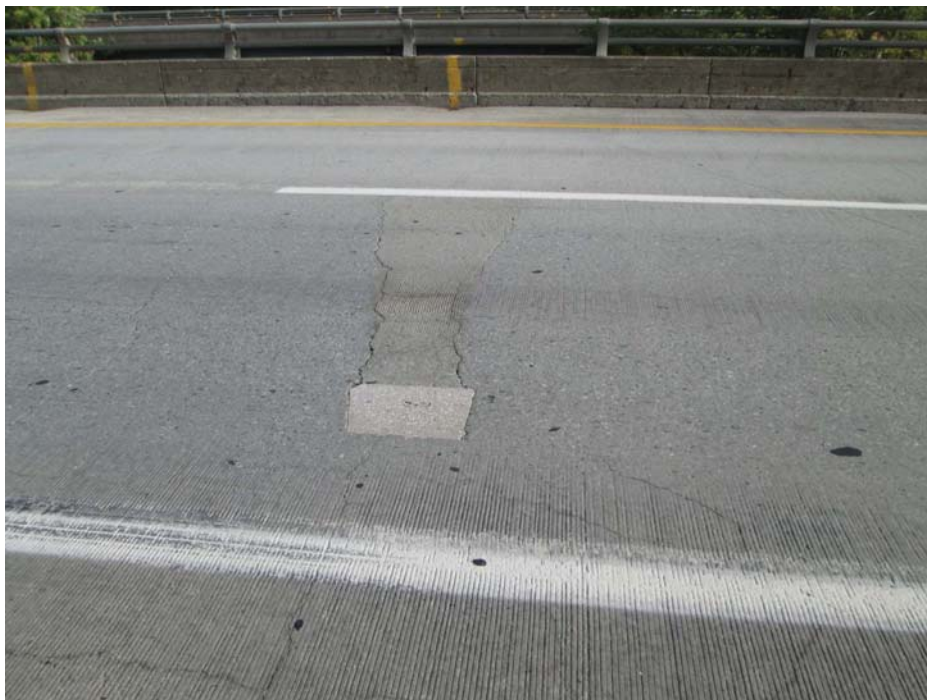
PHOTO 5

Description Wearing Surface - Patches and cracking

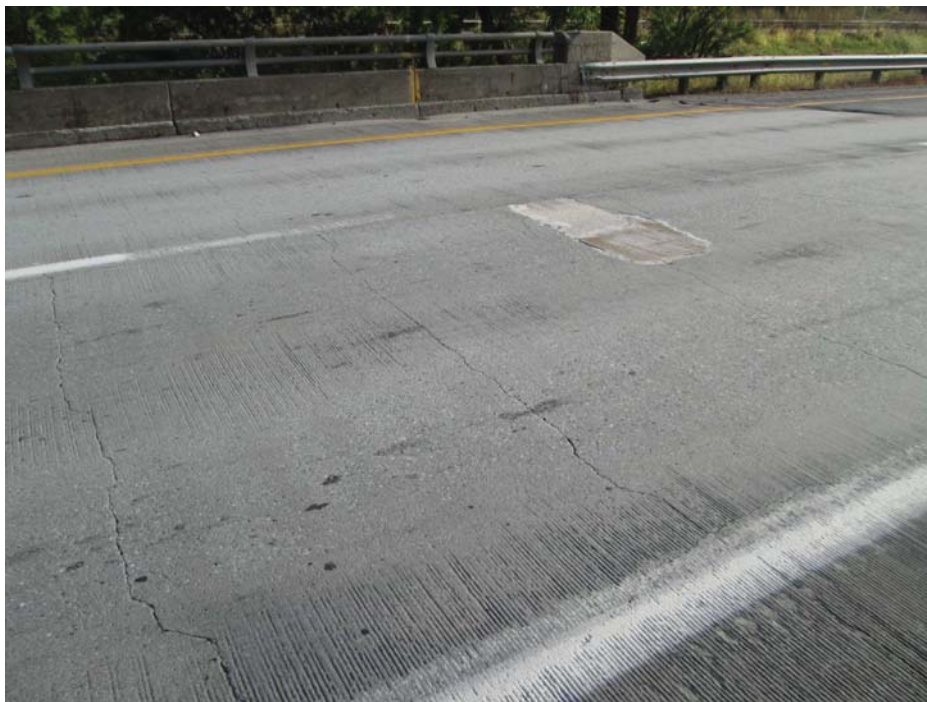
PHOTO 6

Description Concrete Wearing Surface -North - patching - cracks

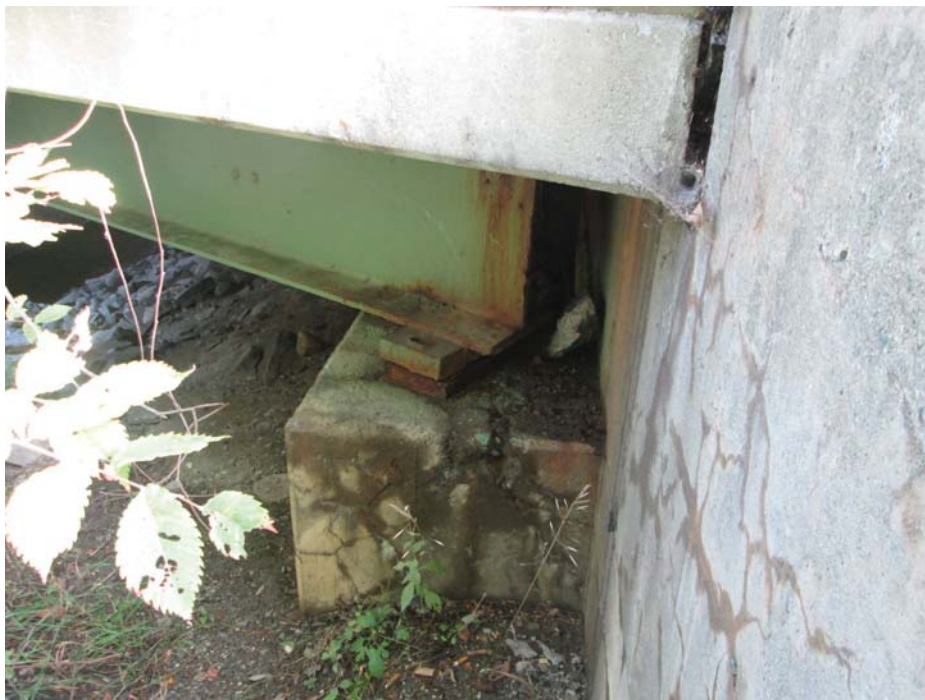
PHOTO 8

Paint loss at beam ends and bearings from leaking joints.

Description NE Beam End and Bearing View

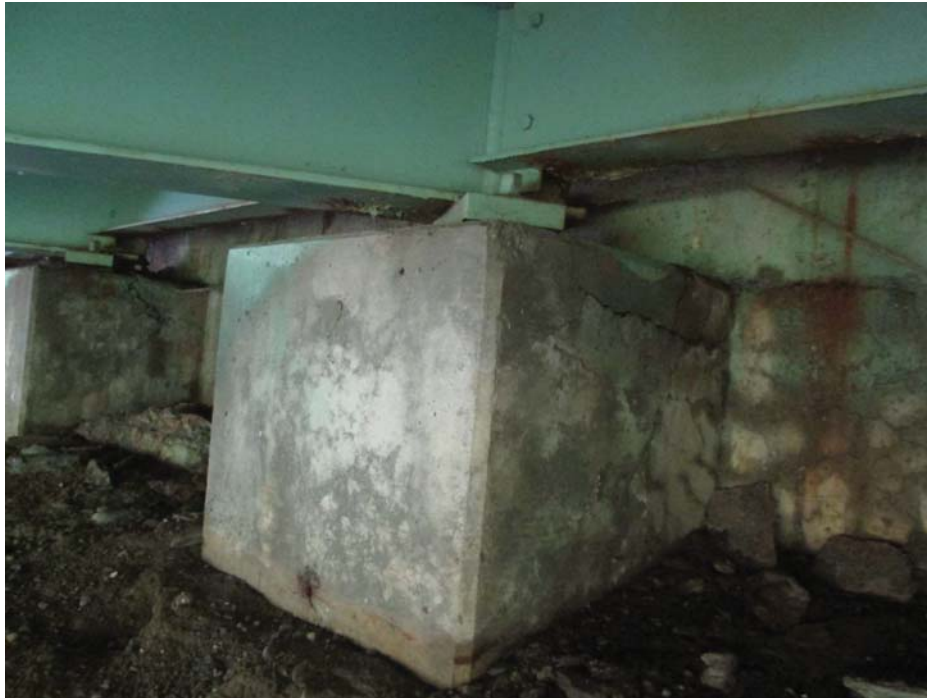
PHOTO 11

Description East Interior Pedestal - Cracking - typical

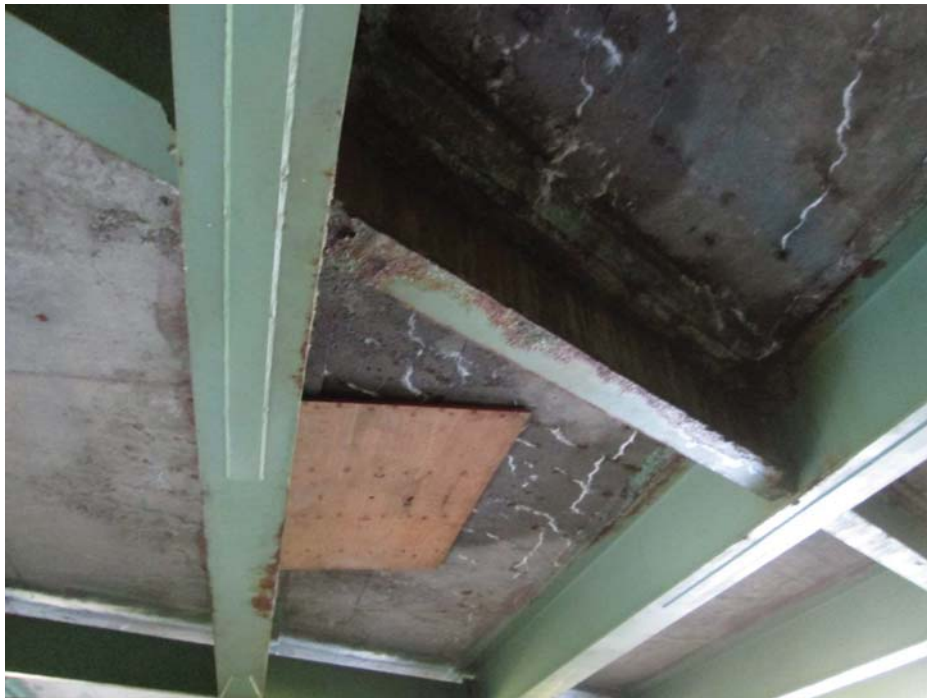
PHOTO 12

Bottom of deck has a high percentage of blocking spalling, small delams and heavy cracking/ stained areas.

Description Deck View - North span - large patch - staining and efflo

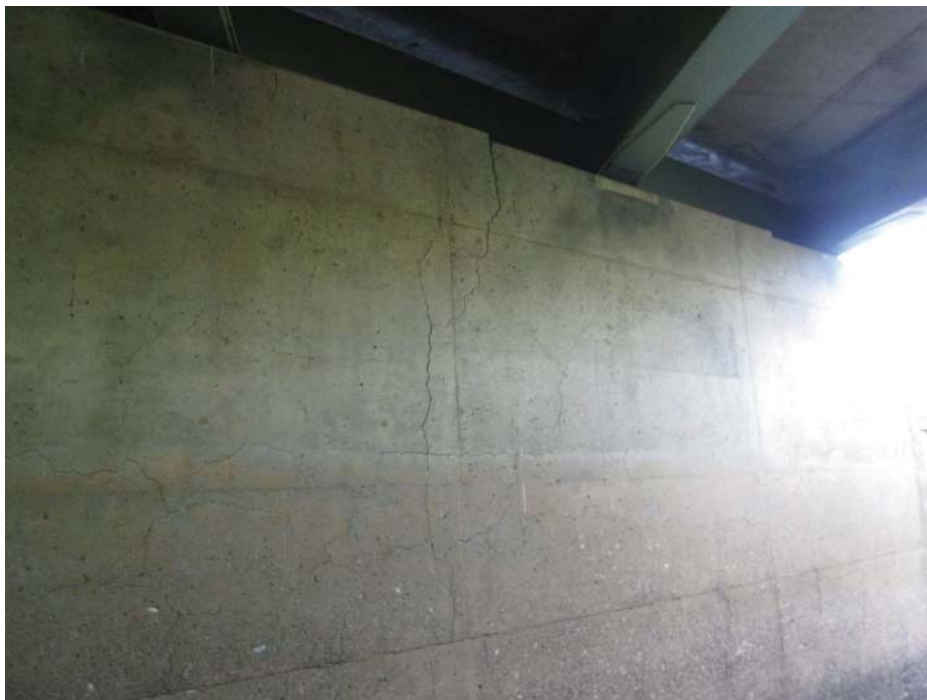
PHOTO 13

Description North Pier - Moderate Cracking

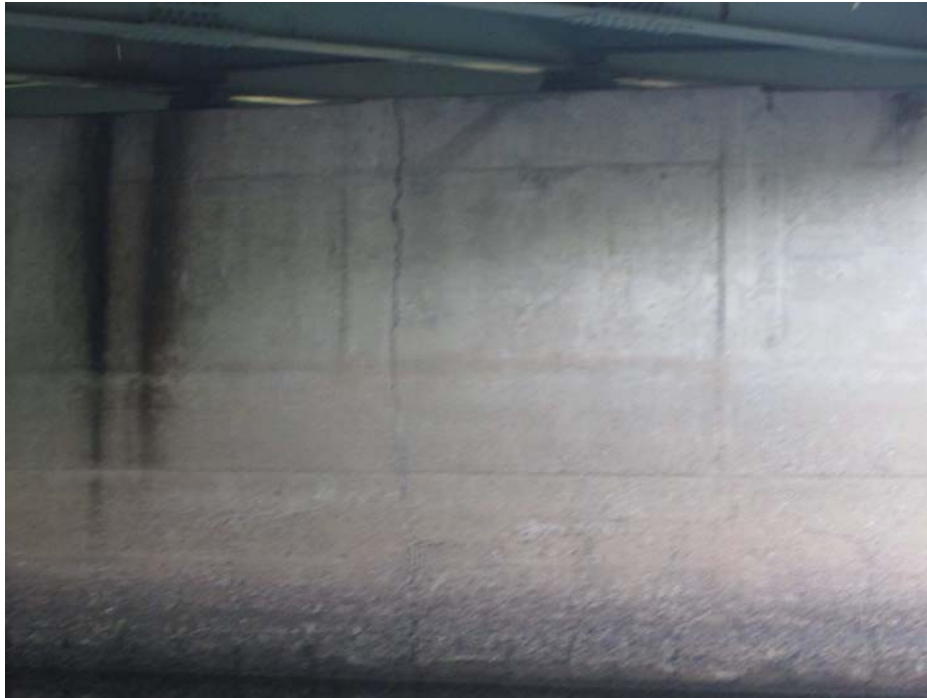
PHOTO 15

Description South Pier - Full height Crack - North Side

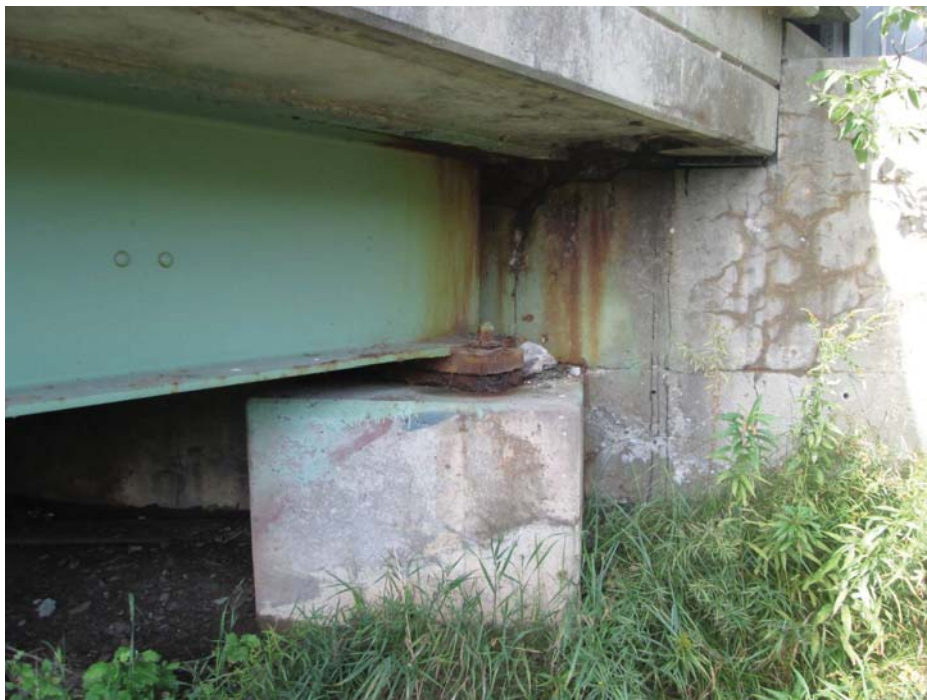
PHOTO 17

Description SW Beam end and Bearing View

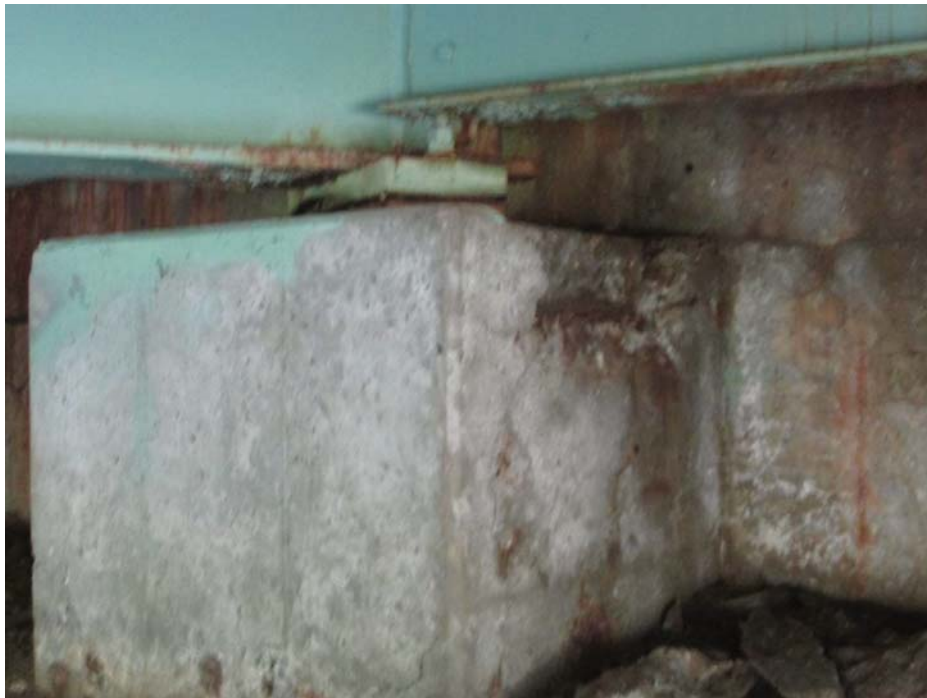
PHOTO 19

The joint headers, multiple bearing blocks and deck haunches have spalled concrete with exposed re-steel.

Description South Abutment - Internal Bearing Pedestal - Spall

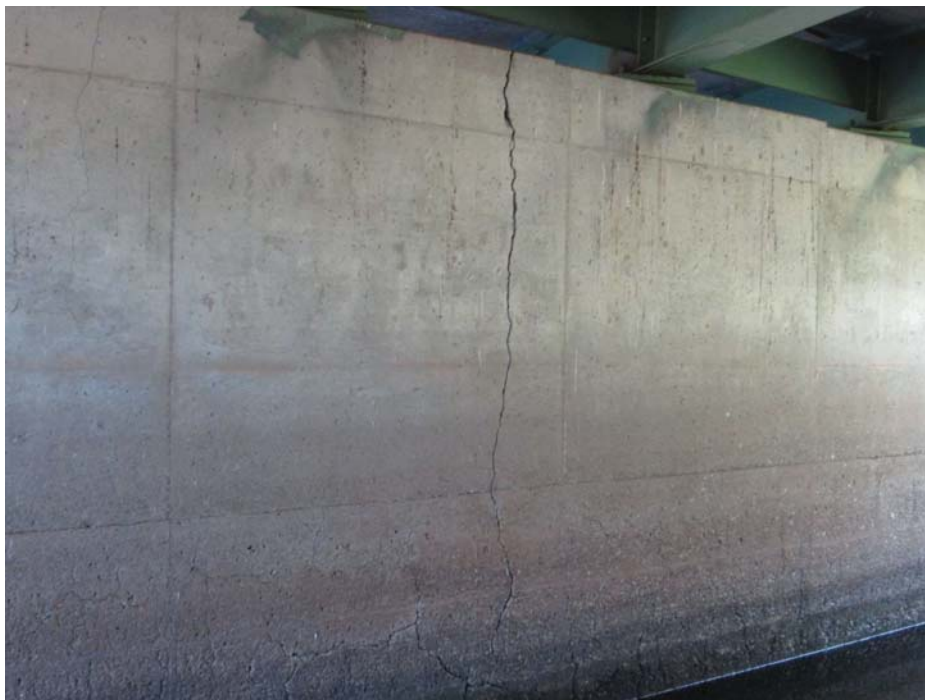
PHOTO 20

Description South Pier - Full Height Crack - South Side

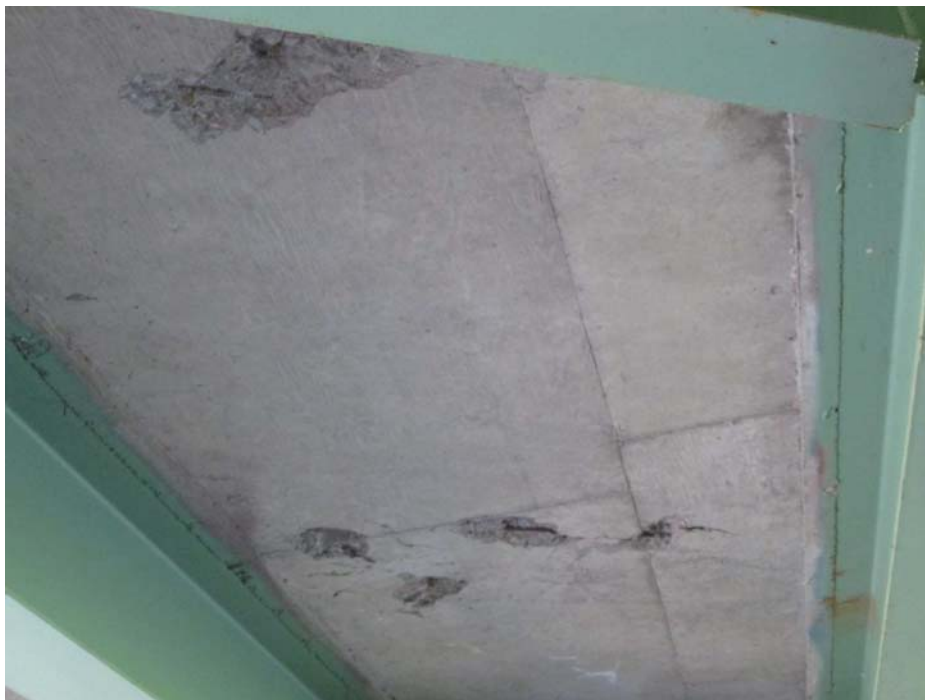
PHOTO 21

Description Deck View - South Span - Scattered Spalls

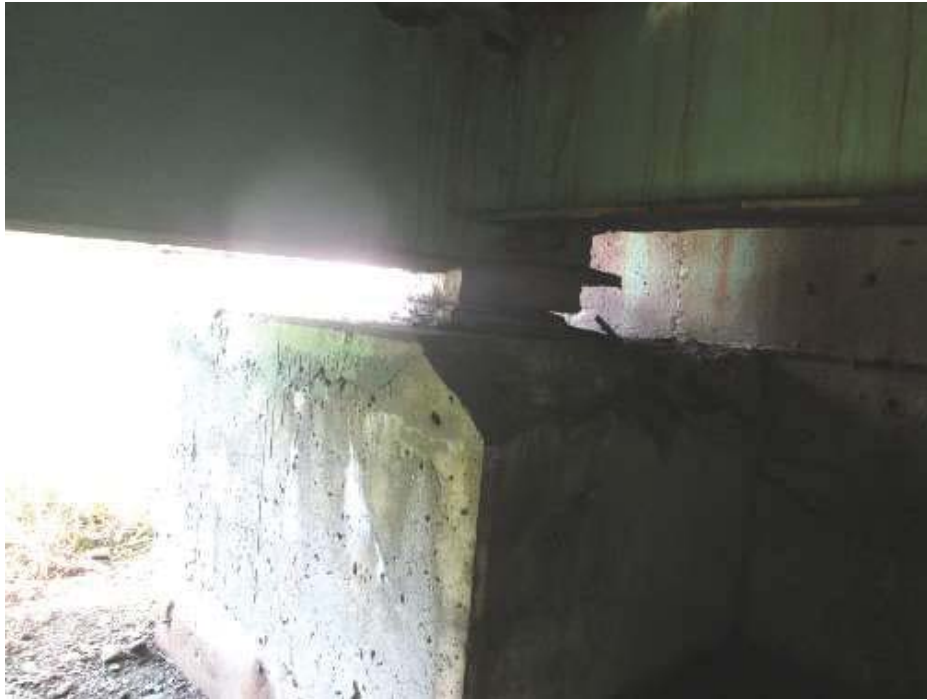
PHOTO 22

Description SE Bearing Pedestal - Spall
