Highway Bridge Inspection Report

**I-95 NB/EMERSON MILLS RD
I-95 NORTHBOUND
over
B&ARR,EMERSON MILL RD**

Inspection Date: 06/21/2018

Inspection Type(s): Routine

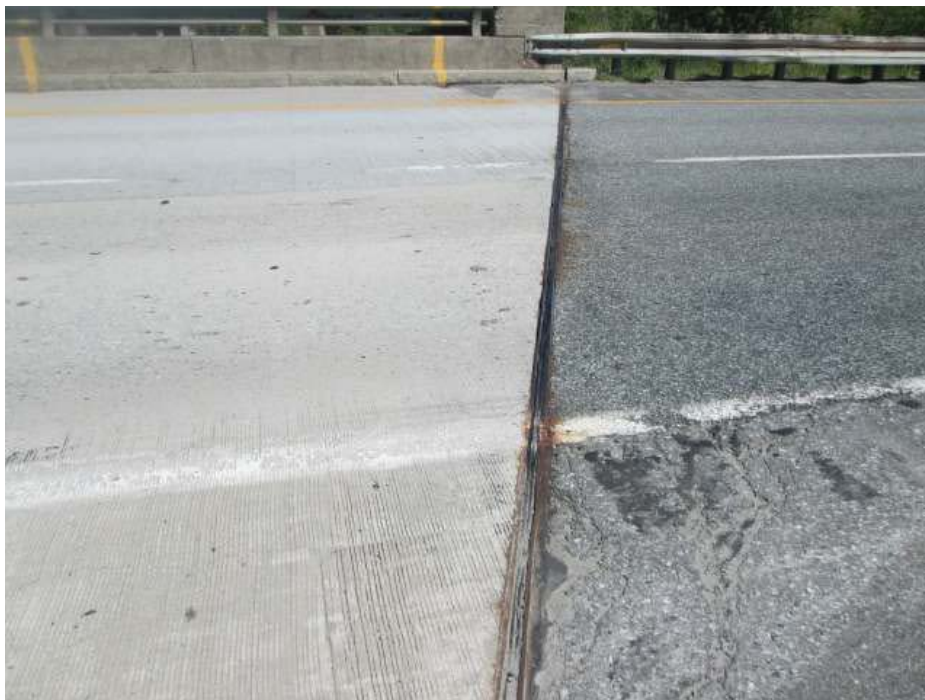
PHOTO 2

Description east joint

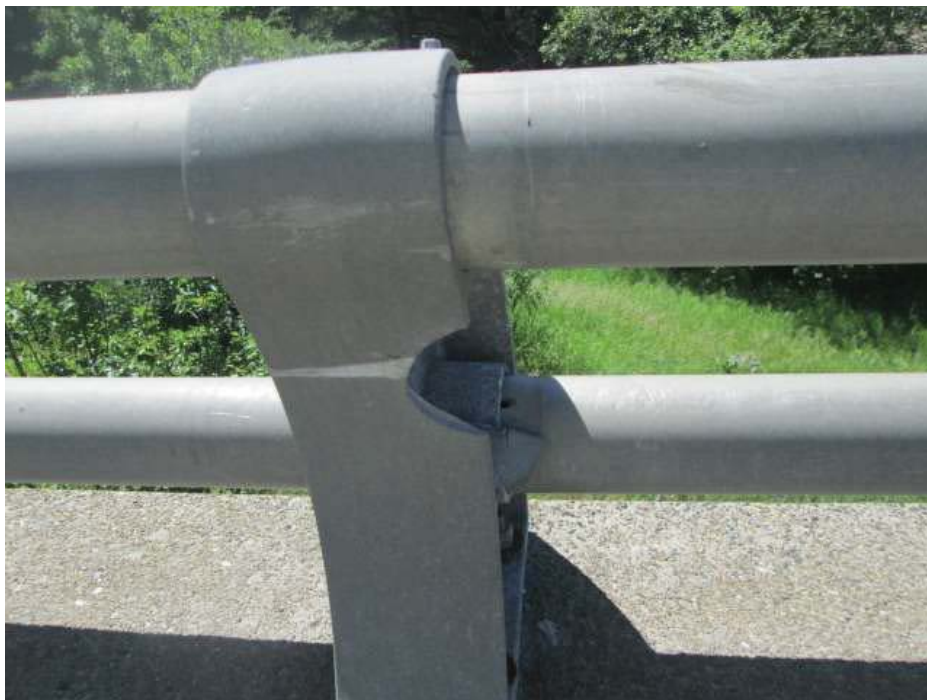
PHOTO 3

Scattered delamination of underside of deck including one spa. All the joints have minor or past leakage but four appear to be in relatively good condition. Seal over easterly pier is failing & leaking, joint armor has minor steel damage. This effectively leaking joint seal has lead to most, if not all of the haunch spalling and now sitting on the pier cap below. May be very little support for deck in this area. One dislodged portion of rail at south side. aluminum posts have plow damage ranging from minor to having chips in bottom flanges. Concrete portion of railing has scattered light map cracking. All four end posts have minor to moderate map cracking w/staining.

Description Damaged post (worst of 6)

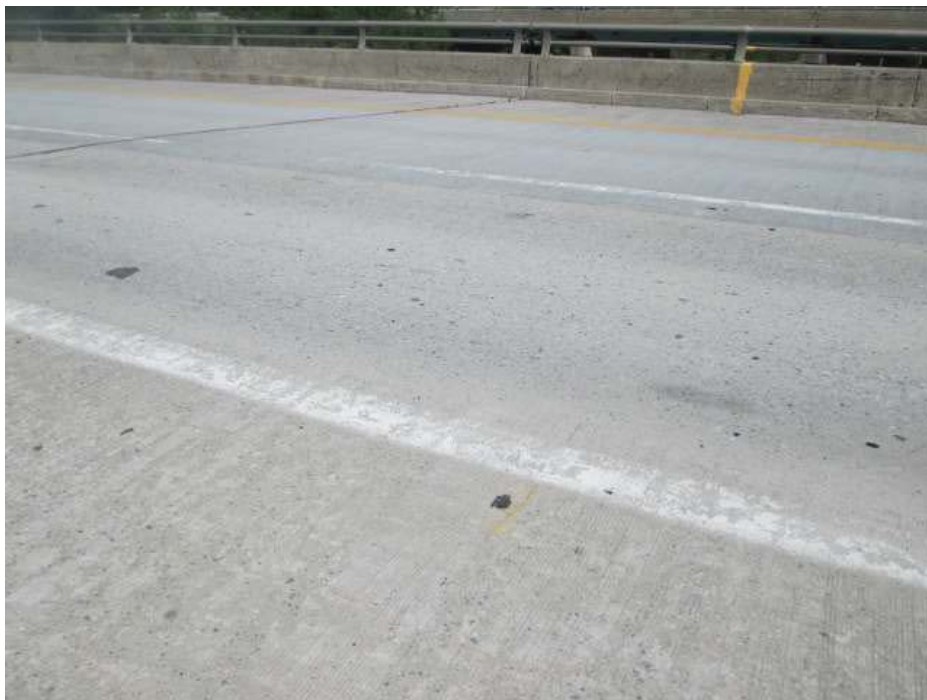
PHOTO 4

Concrete wearing surface with heavy wear in wheel paths and complete loss of tining in travel lanes. Was not chain dragged do to traffic conditions, but no nested cracking, potholes or delaminated concrete noted.

Description wearing surface view

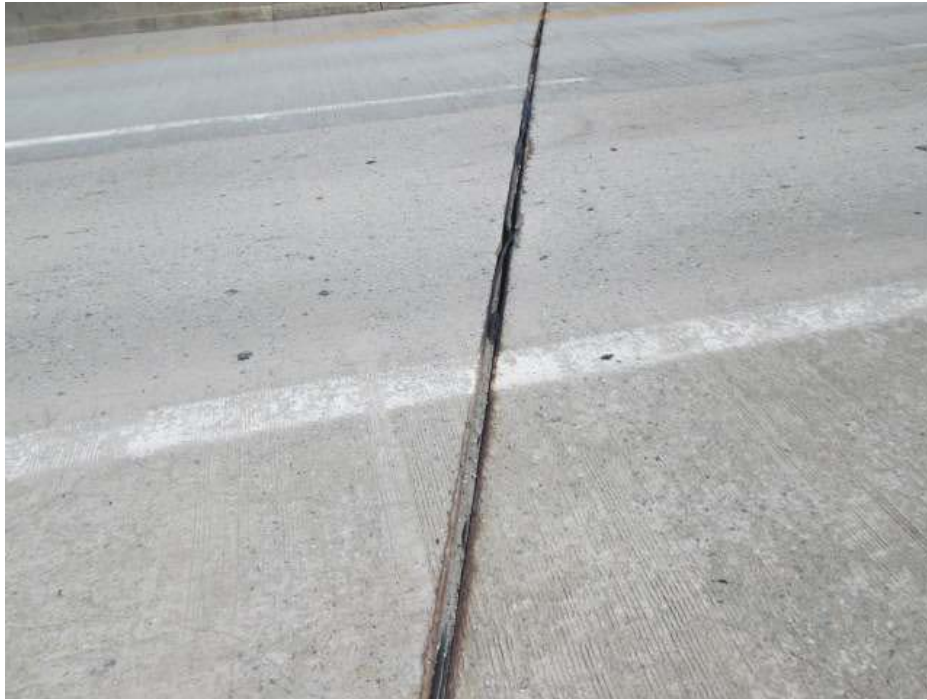
PHOTO 5

Description pier joint

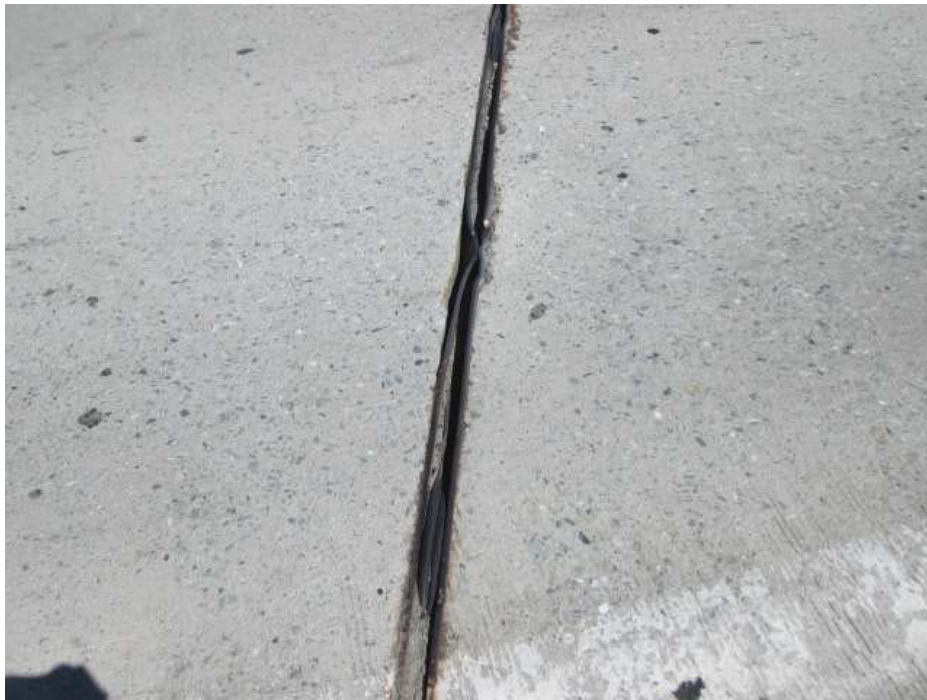
PHOTO 6

Description failing seal pier joint

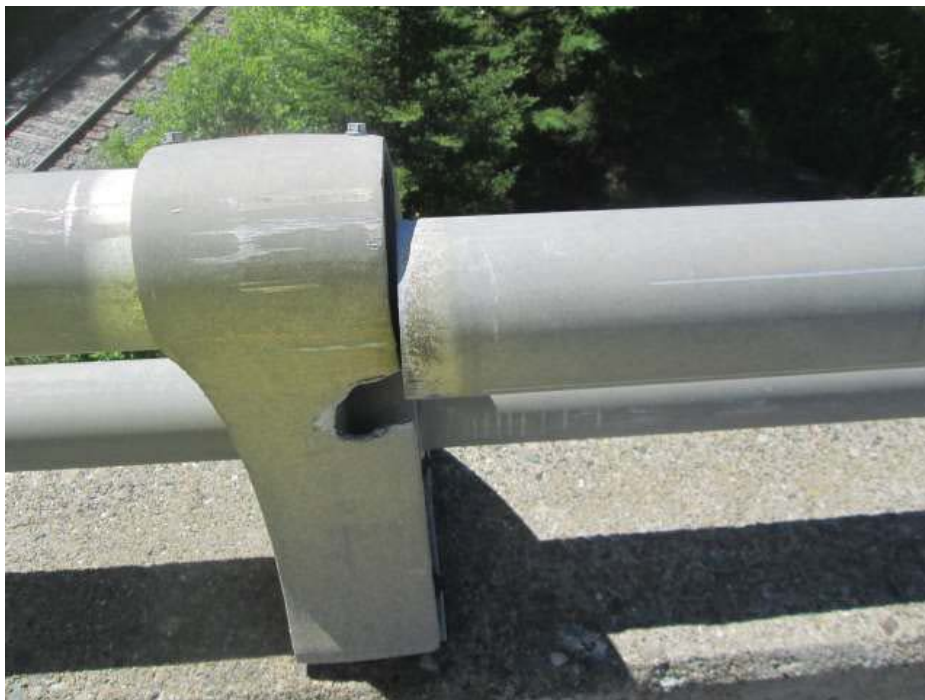
PHOTO 7

Description Dislodged rail section south side

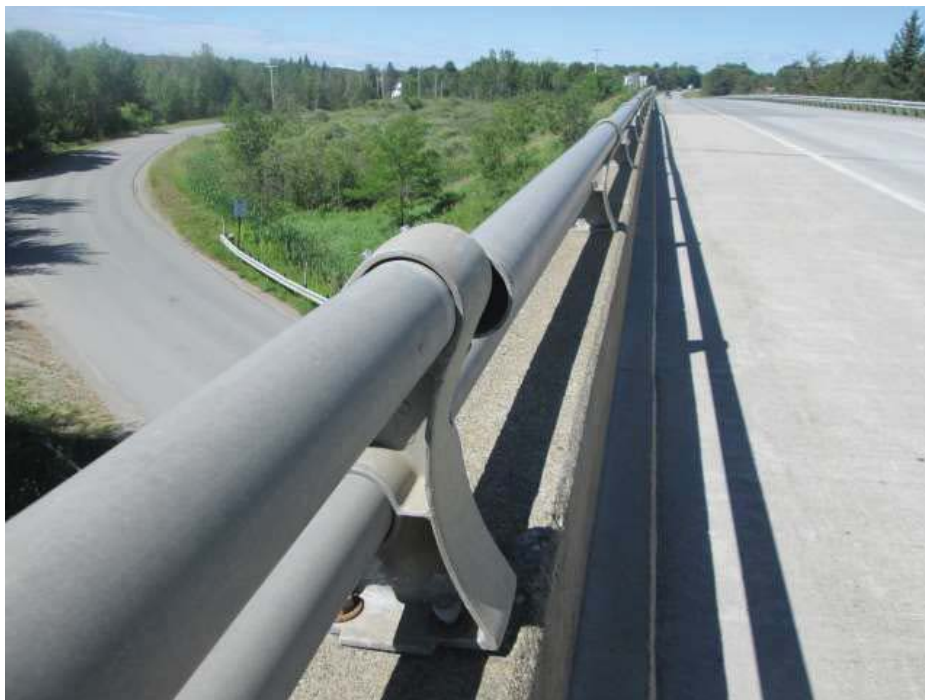
PHOTO 8

Description Dislodged rail section south side

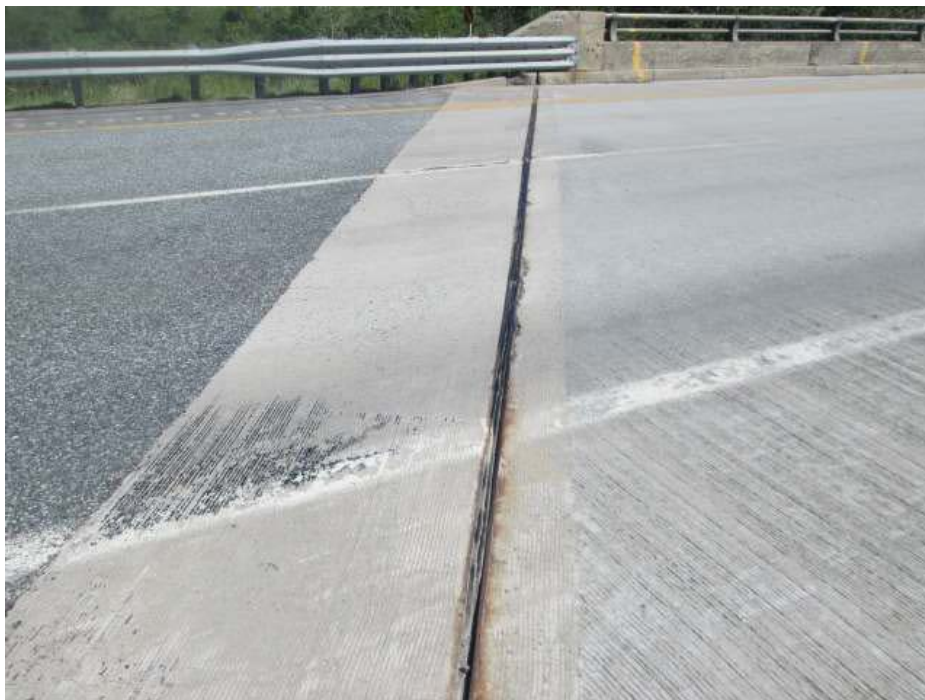
PHOTO 9

Description west joint

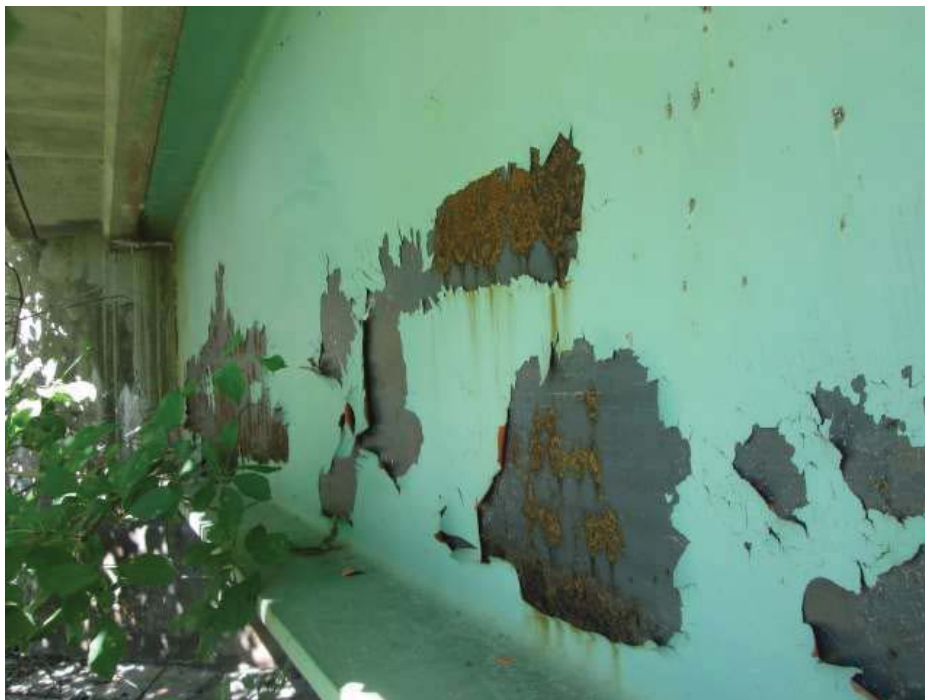
PHOTO 10

Approximately 20% overall paint system distress with sheet failure at south exterior girders, minor paint system distress on the interior girders. The last 1'-2' of each girder has paint loss and scaling rust from previous or currently leaking joints. Some section loss of bottom flange. The bearings at the westerly abutment have multiple missing anchor bolts, bearing and masonry plates are misaligned for at least half.

Description paint sheet failure exterior girder

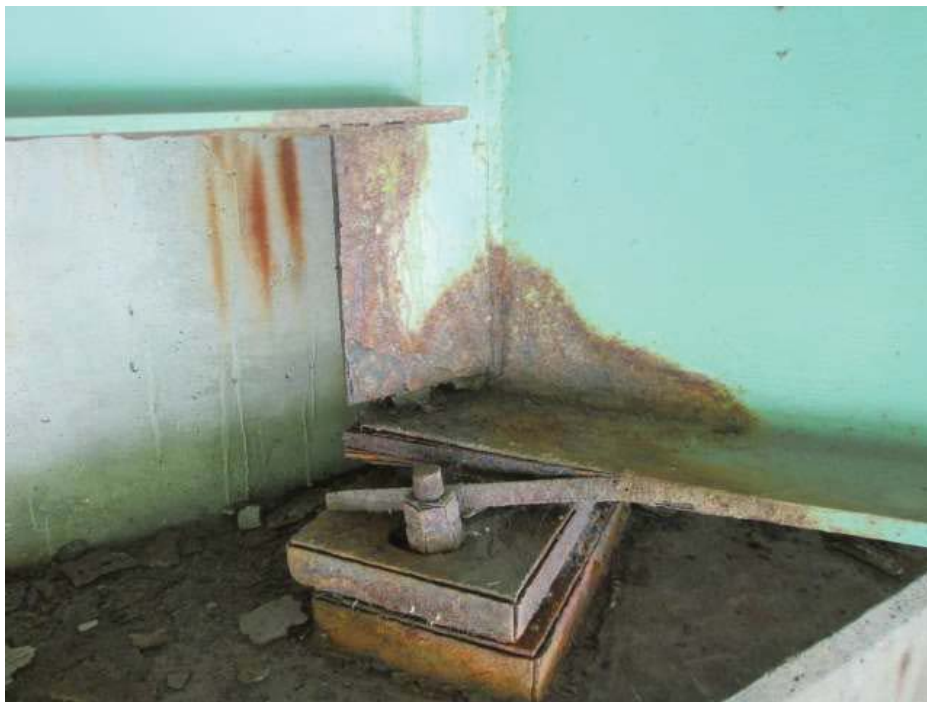
PHOTO 12

Description west abutment beam end / bearing area

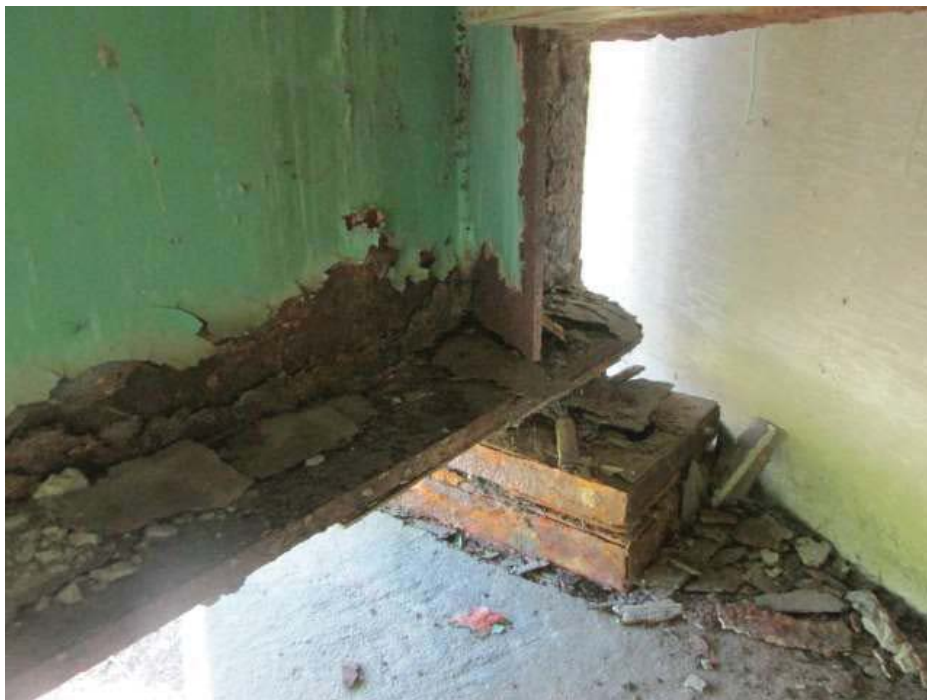
PHOTO 13

Description west abutment beam end / bearing area

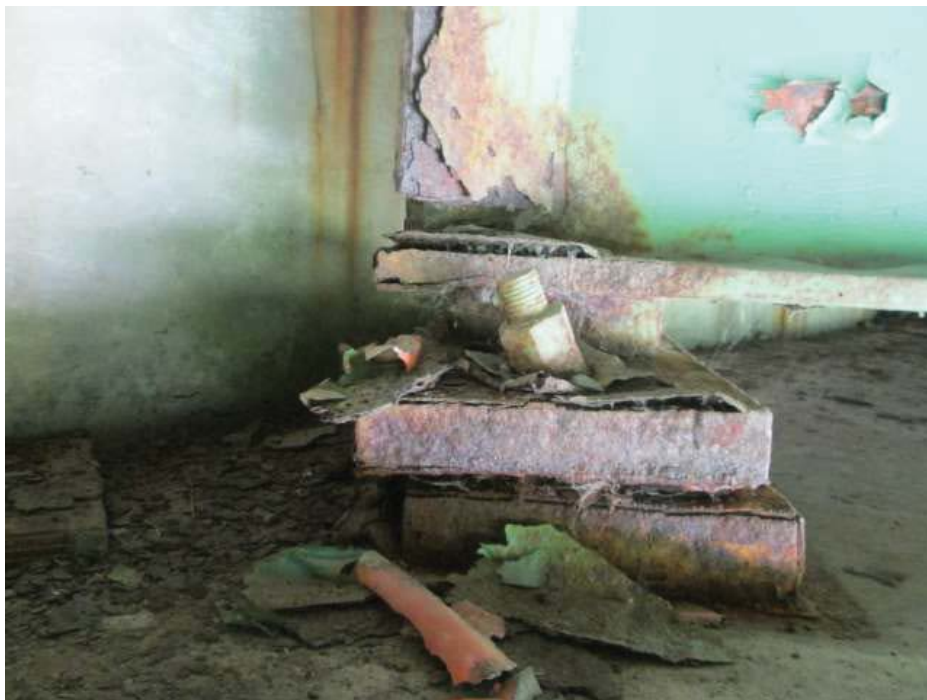
PHOTO 15

Description offset bearing with bent anchor bolts west abutment

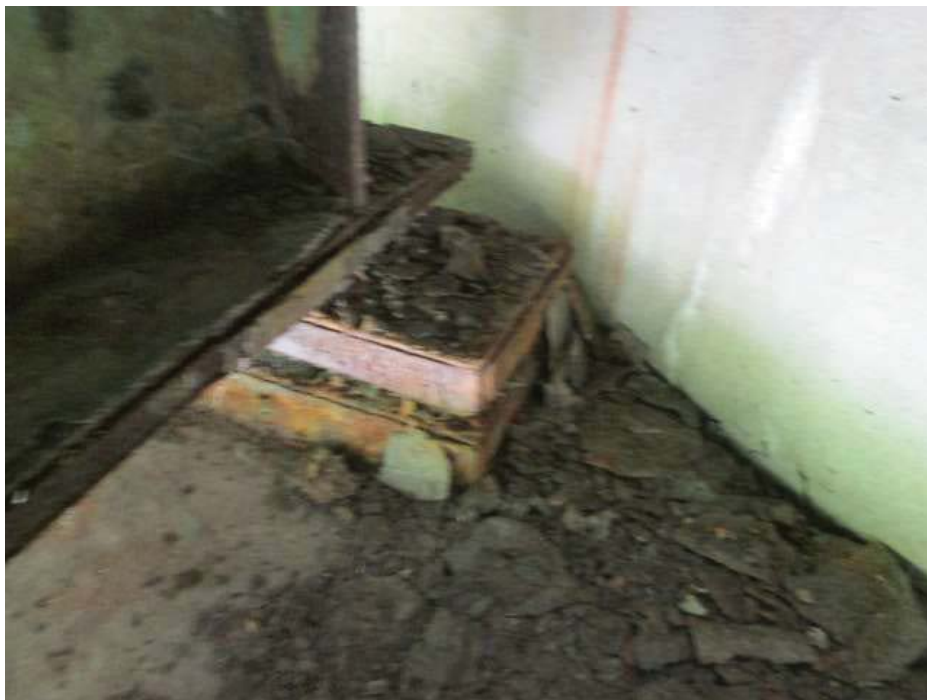
PHOTO 16

Description west abutment beam end missing anchor bolts

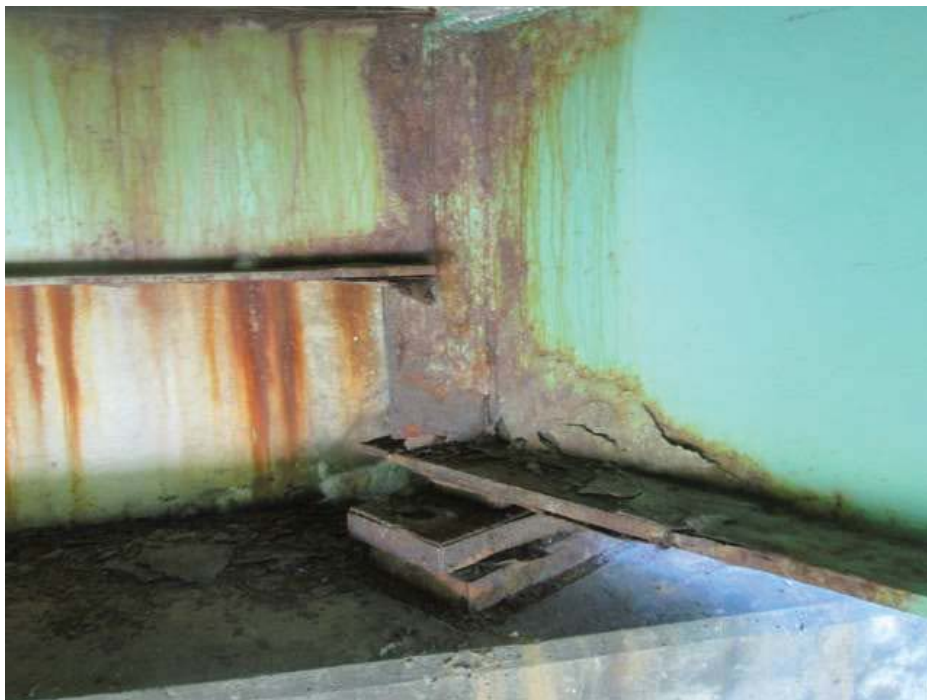
PHOTO 17

Description west abutment beam end / bearing area

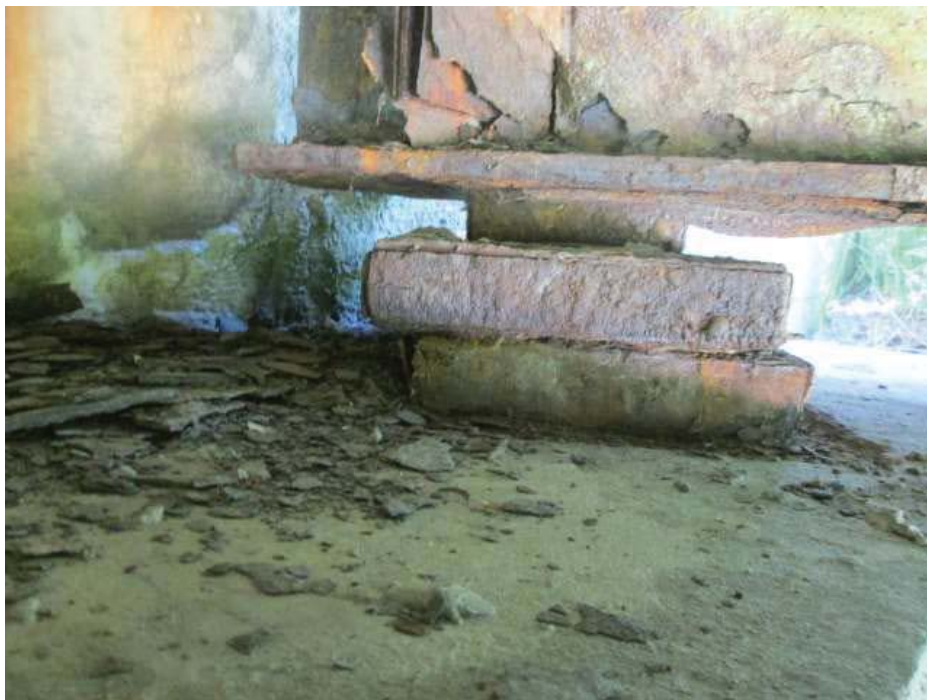
PHOTO 18

Description west abutment beam end / bearing area

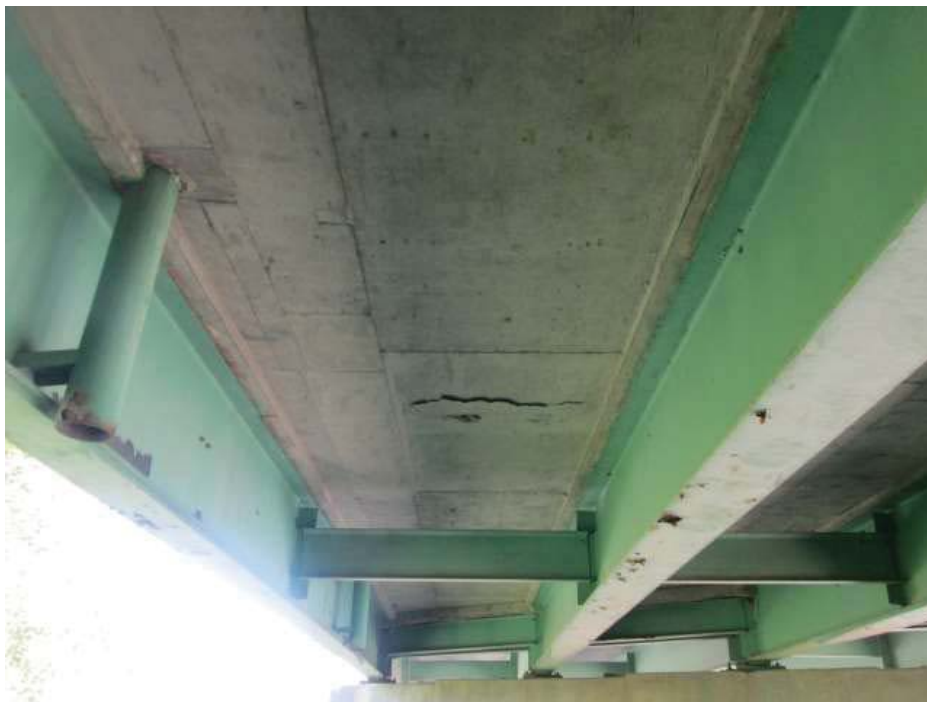
PHOTO 20

Description deck delam west span

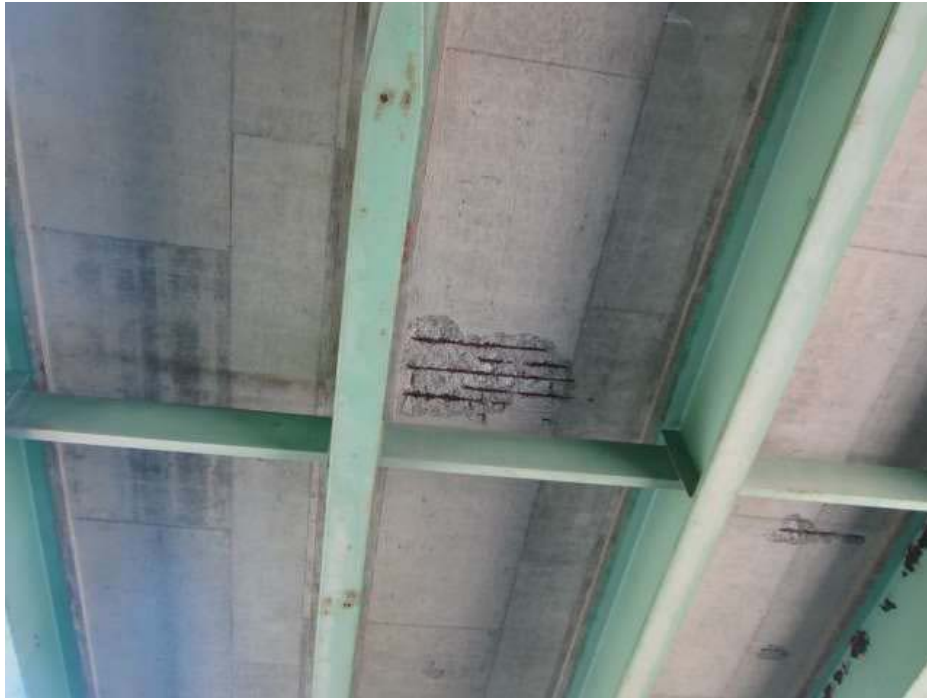
PHOTO 23

Description chipped put delam 2nd west span

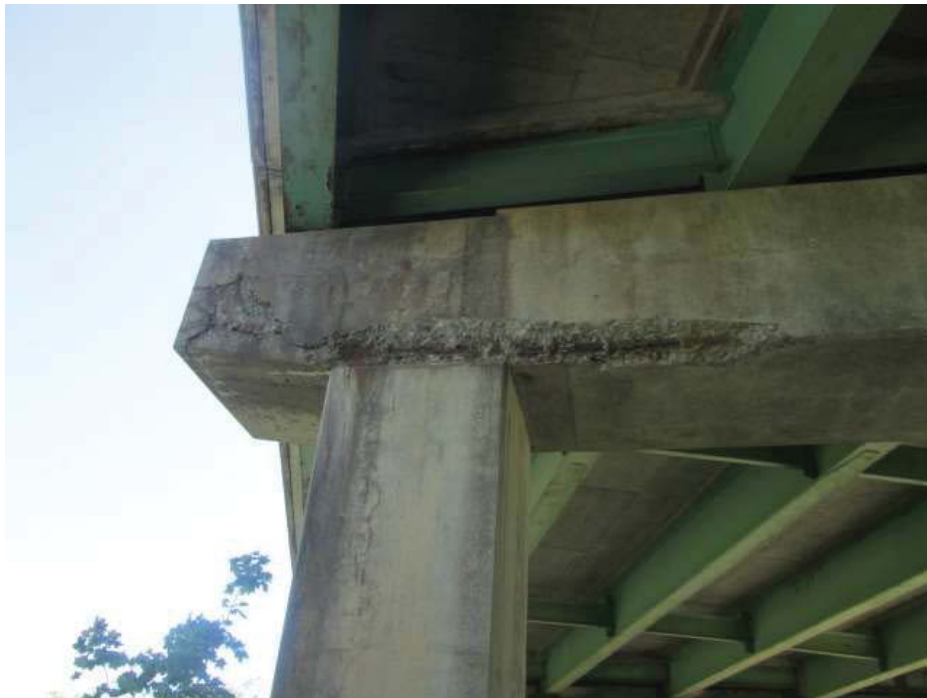
PHOTO 24

Concrete columns have minor to moderate, vertical and map, cracking and staining with small areas of delamination . Pier cap cracking, delaminating and spalling on the center and easterly piers. Abutment backwalls have isolated minor cracking, moderate to heavy horizontal cracking and staining of bridge seats scattered throughout. Wingwalls all generally covered with map cracking/staining.

Description scaling center pier

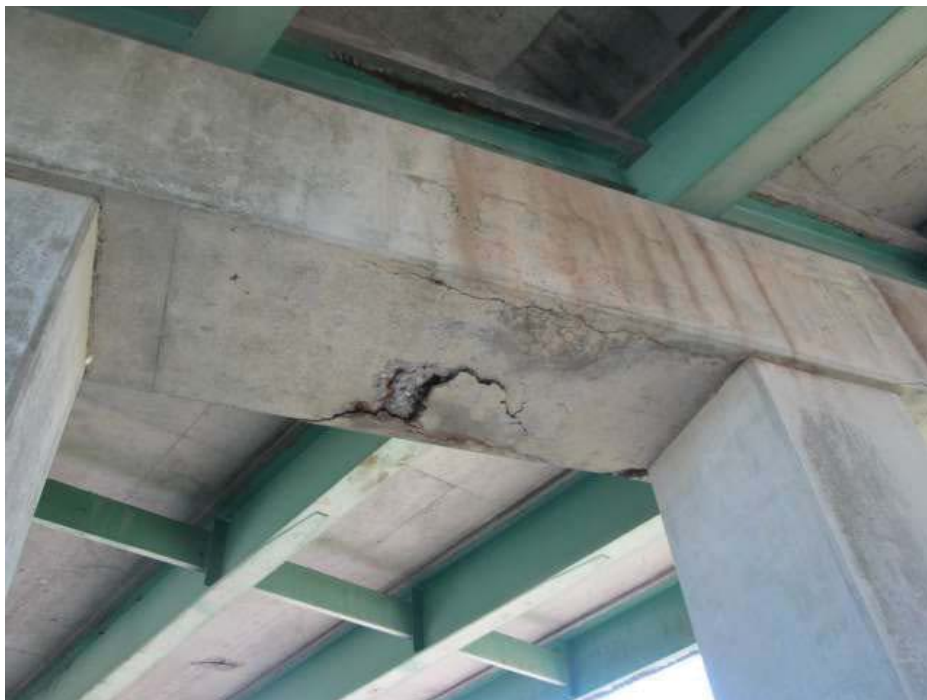
PHOTO 25

Description delams center pier

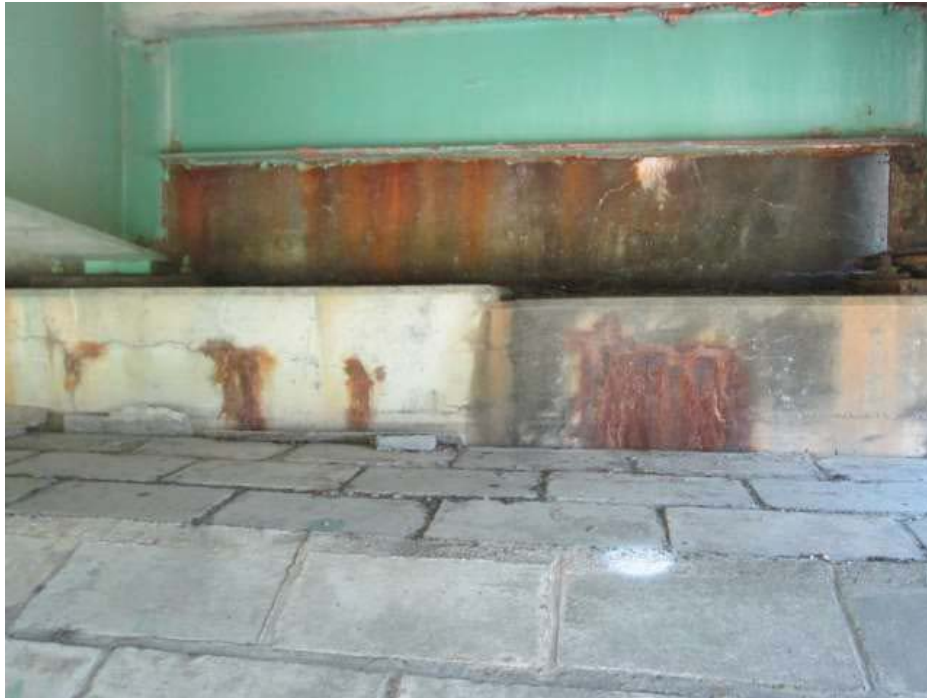
PHOTO 29

Description east abutment breastwall cracking

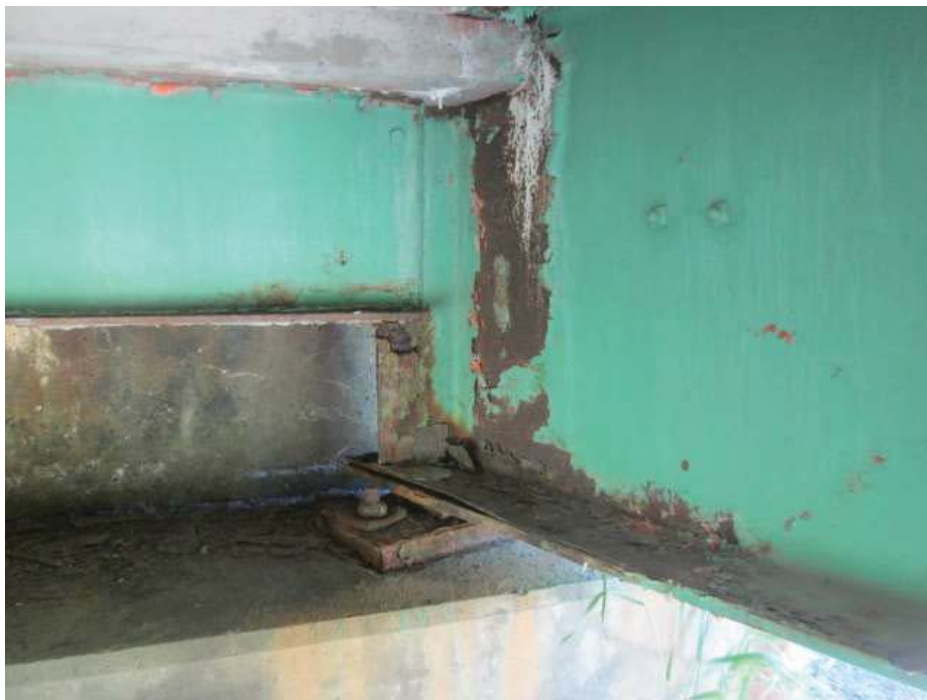
PHOTO 30

Description East abutment beam end

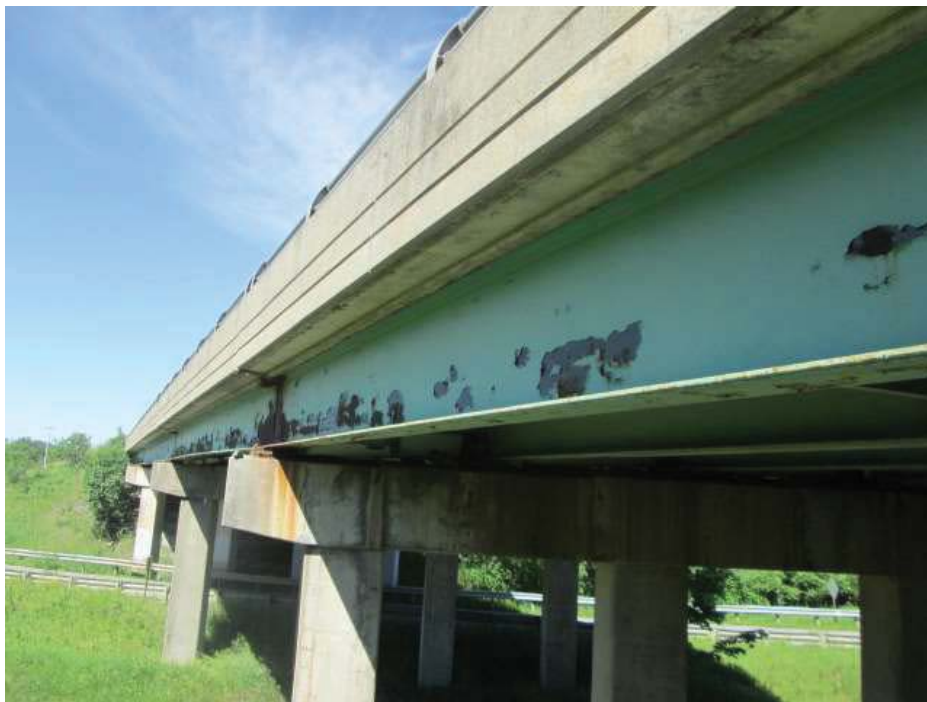
PHOTO 32

Description south side view paint system failures
