Highway Bridge Inspection Report

COLD BROOK ROAD/I-95
COLD BROOK ROAD
over
I-95

Asset Code: 5970

Inspection Date: 12/18/2017

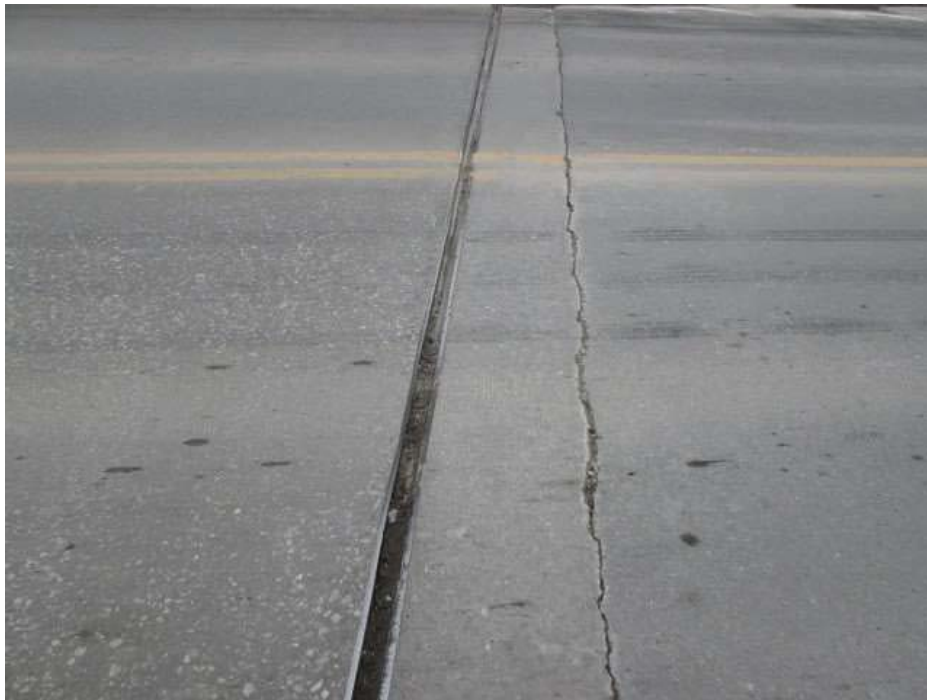
PHOTO 2

Bottom of the deck is in very good condition with no issues noted. No areas of spalled or delaminated concrete over the travel lanes. rail covered with snow at this time. Joints have minor tearing. No signage or light poles are attached to the bridge.

Description south joint

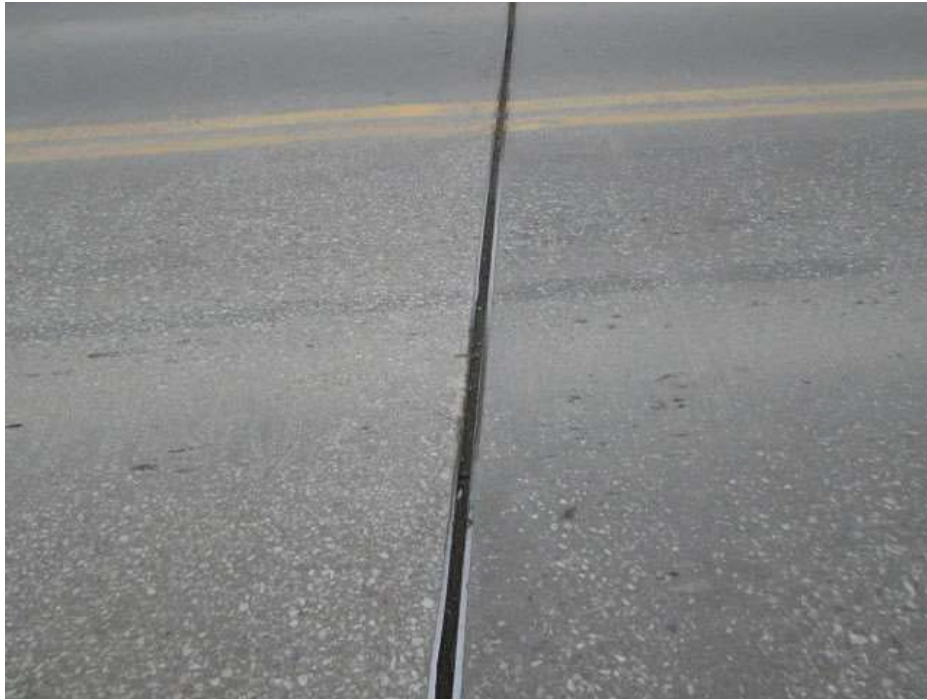
PHOTO 3

Description typical of pier joint

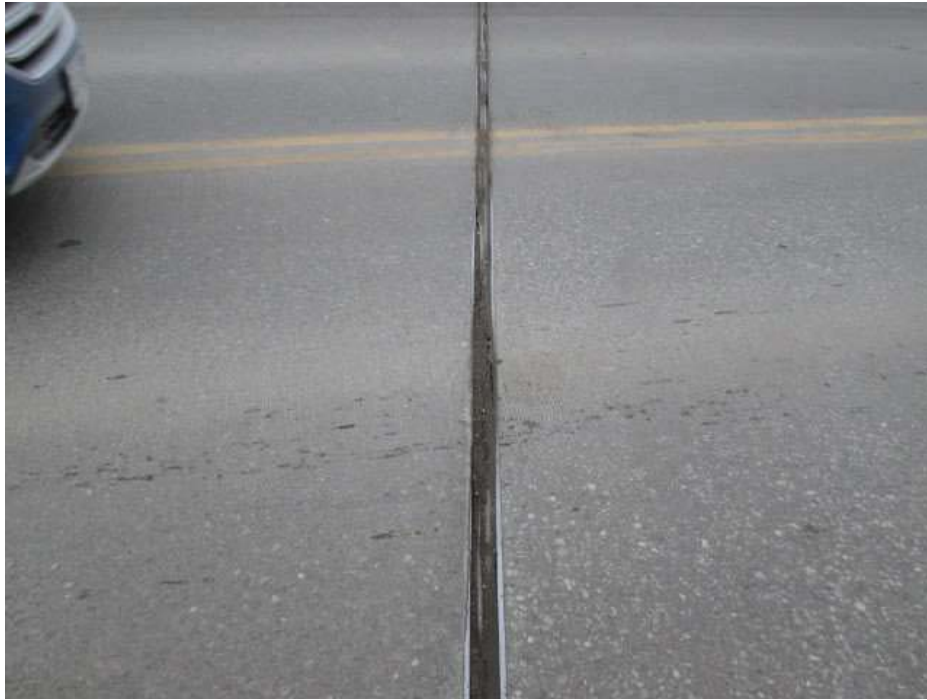
PHOTO 5

Description typical of pier joint

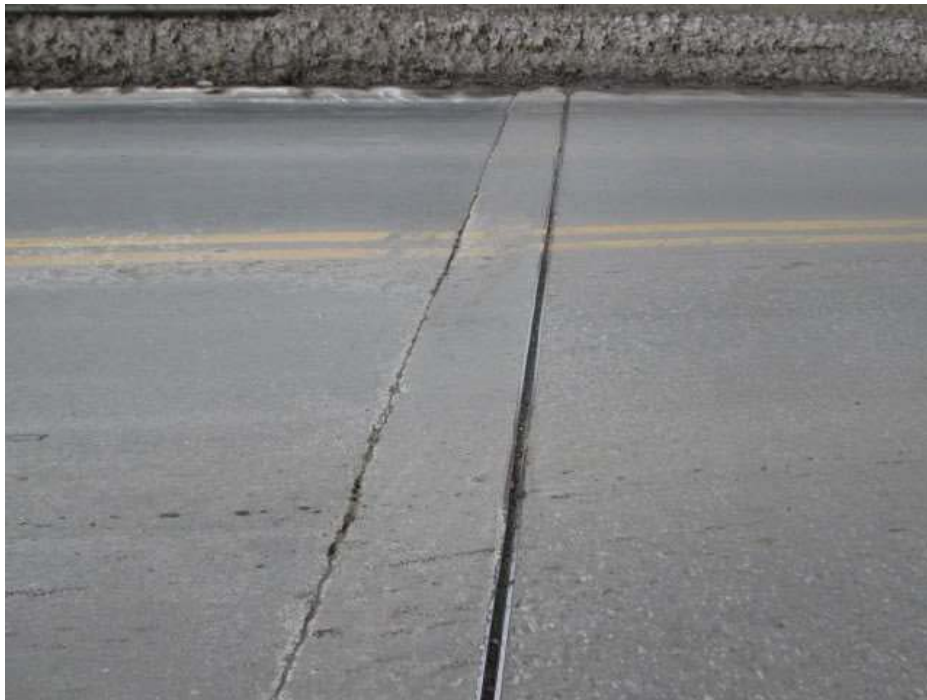
PHOTO 6

Description typical of pier joint

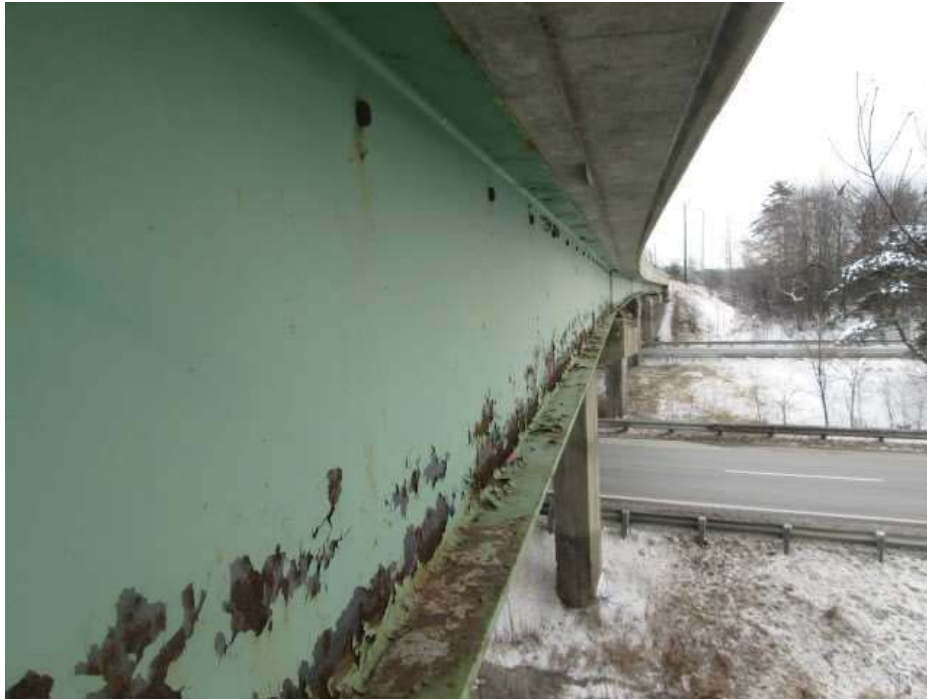
PHOTO 9

Painted steel girders have 15% paint distress to the exterior girders and the bottom flanges of the interior girders and girder ends. No measurable section loss noted.

Description paint failures westgirder

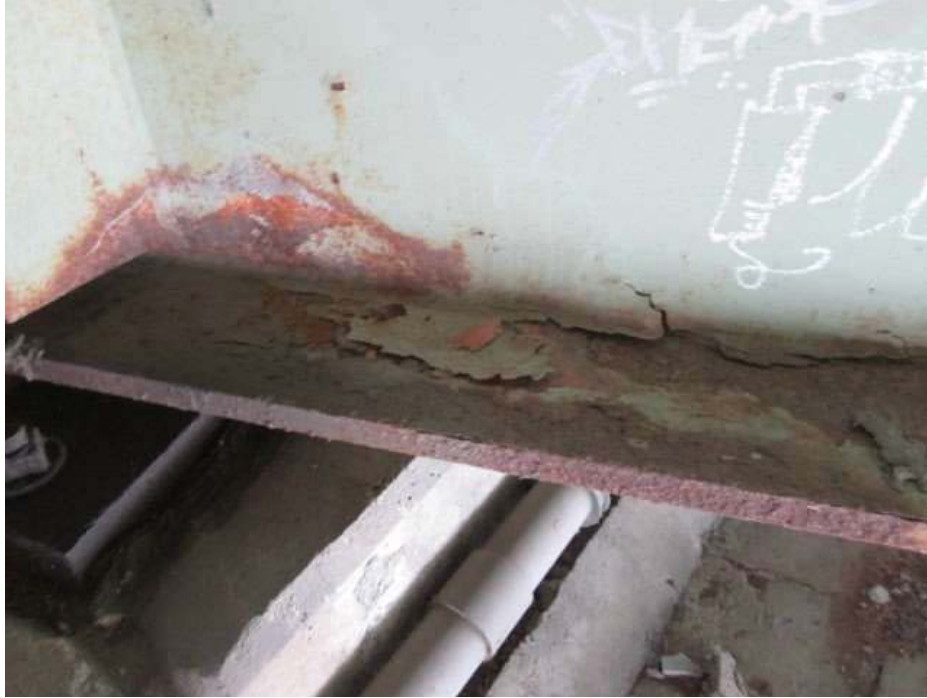
PHOTO 13

Description paint failures north abutment beam ends

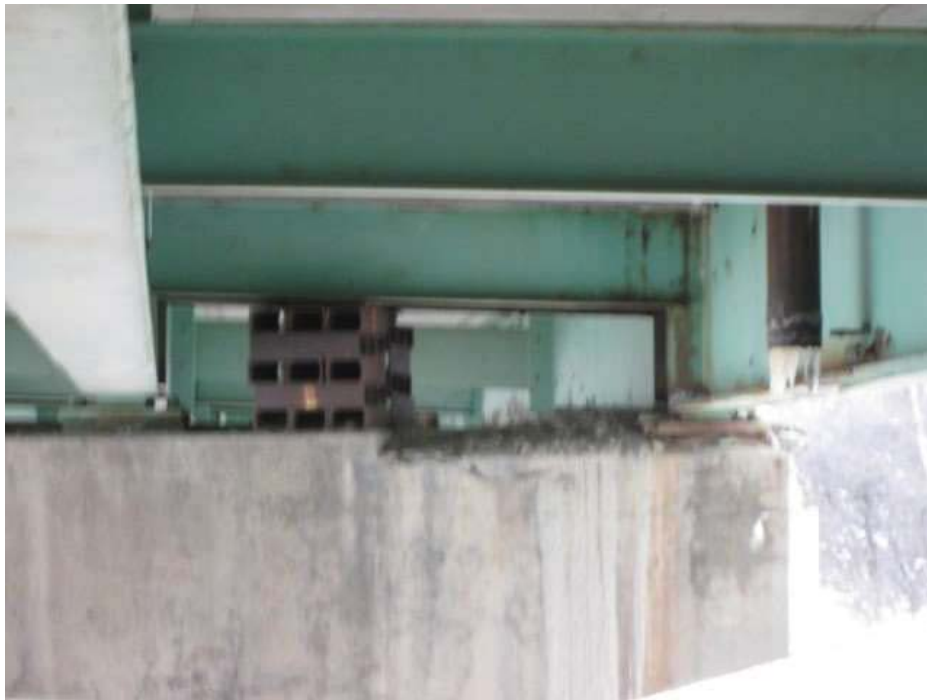
PHOTO 14

Concrete abutments have minor cracking and rust staining. Three out of four pier caps have serious section loss under the west exterior bearings, which have required blocking, see photos. Several of the columns have been rehabbed, but several have large areas of delaminated and cracked concrete.

Description blocking at NW pier

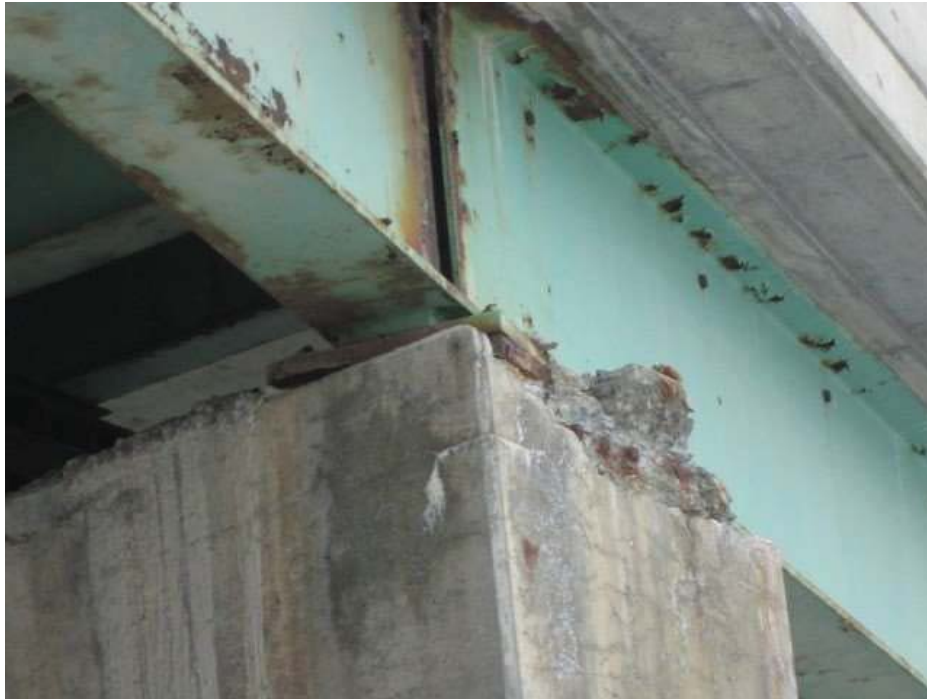
PHOTO 19

Description Spalling nw pier cap

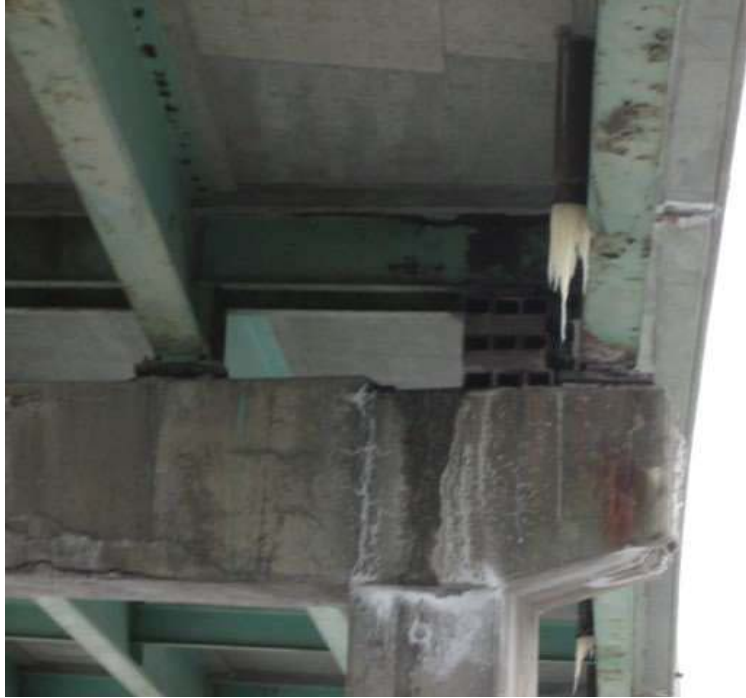
PHOTO 21

Description Blocking at nw pier cap

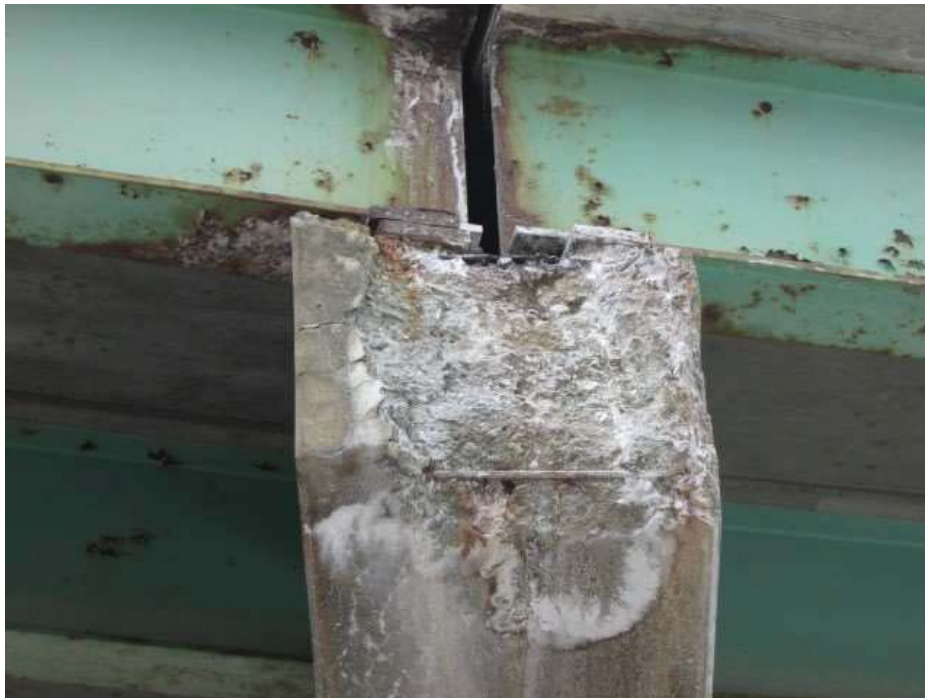
PHOTO 22

Description NW pier cap

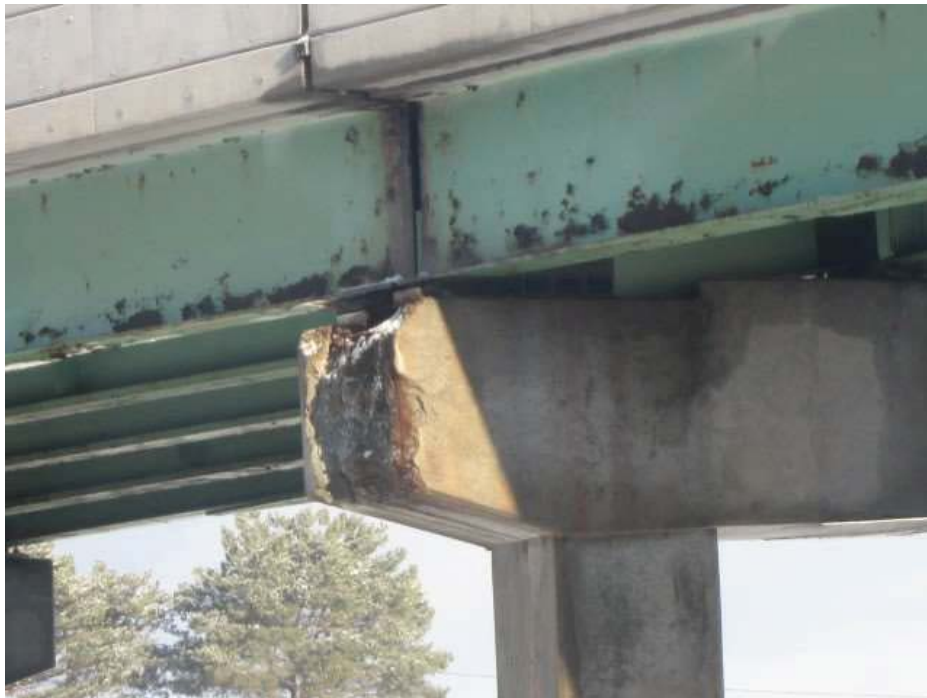
PHOTO 24

Description Deteriorated south pier cap

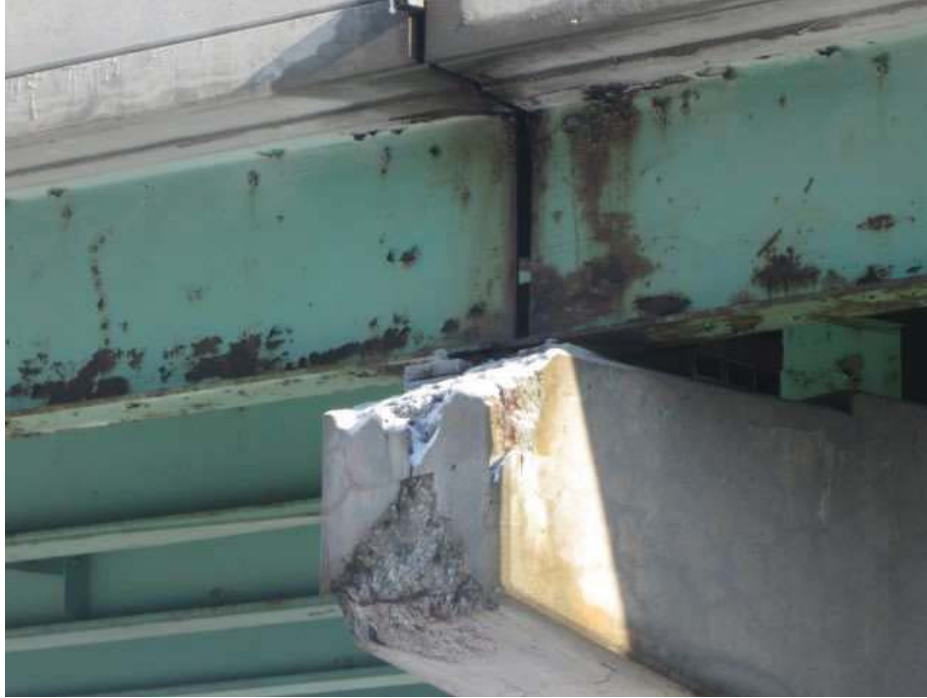
PHOTO 25

Description Typical beam end piers
