Highway Bridge Inspection Report

**I-95 SB / EMERSON MILLS RD
I-95 SOUTHBOUND
over
B&A RR & EMERSON MILL RD**

Asset Code: 1430

Inspection Date: 09/08/2016

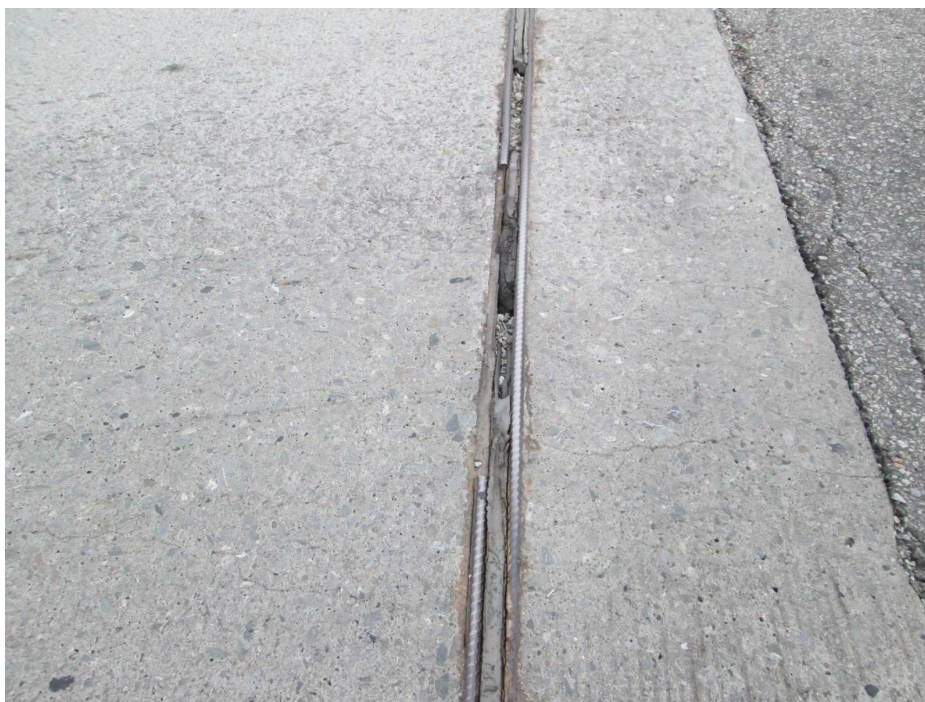
PHOTO 2

1 SF area of delaminated concrete over travel lanes (photo)that should be chipped out. All joints in fair to poor condition, have allowed leakage causing beam end paint loss and moderate/heavy rust. Concrete under steel joint armor has extensive spalling throughout all joints. Reinforcing steel bars were welded onto joint armor to raise them to grade. Many welds have broken. Westerly joint rebar has broken away and is slapping/pinging when traffic passes over. Should be repaired immediately! Numerous aluminum posts have plow damage ranging from minor to heavy. Concrete barrier has moderate cracking and light staining. See photos.

Description South joint damaged & failed

Type	Work Item	Priority	Notes
Maintenance	Repair Joint		Repair deteriorated and damaged joints
Safety	Repair Bridge Rail		repair damaged upper rail posts
Maintenance	Repair Deck		Replace deck
Preservation	Paint		Paint job
Maintenance	Rehab Substructure		Repair lower pier caps

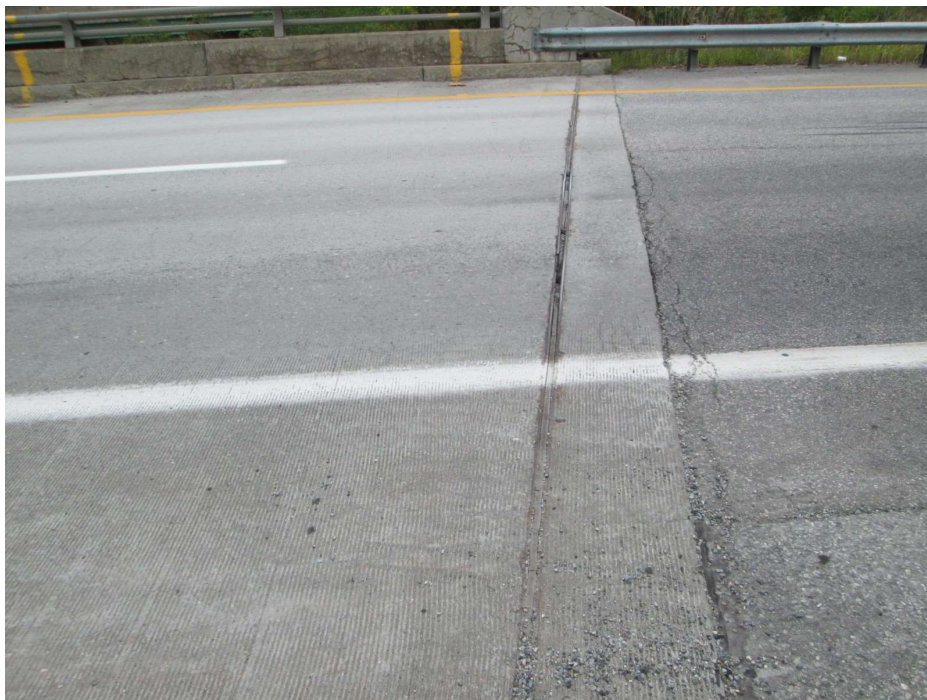
PHOTO 3

Description South joint

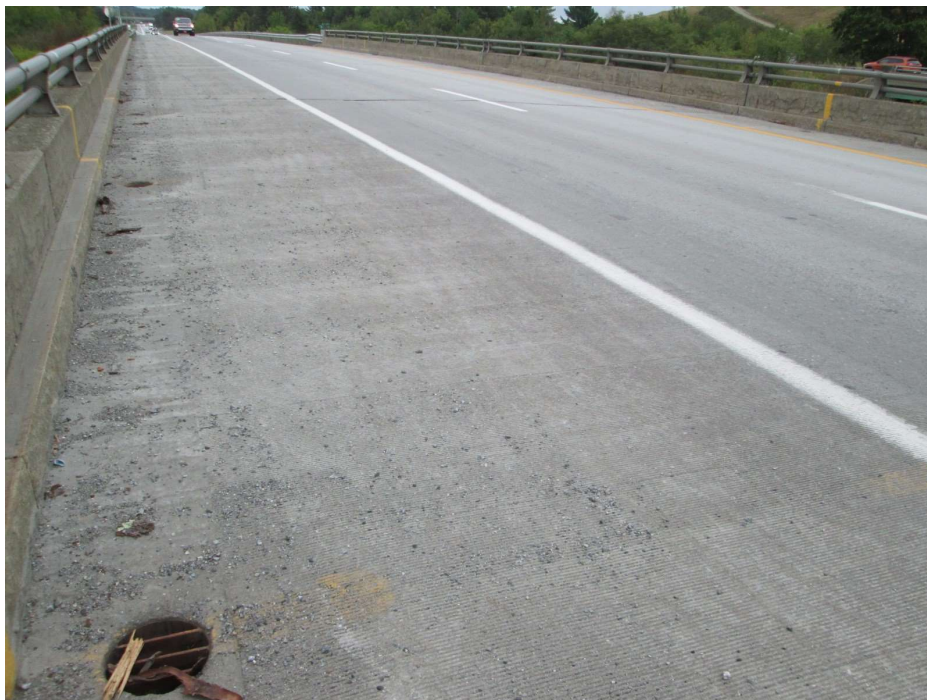
PHOTO 4

Concrete wearing surface with heavy wear in wheel paths and complete loss of tining in travel lanes. Not chain dragged do to traffic conditions, but no nested cracking, potholes or delaminated concrete noted.

Description Wearing surface view

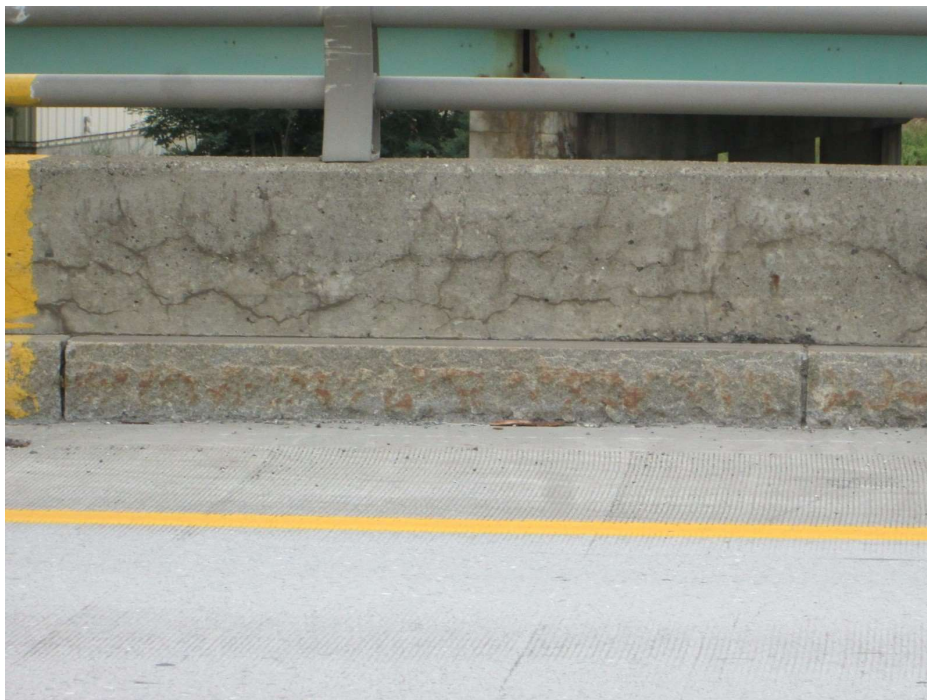
PHOTO 5

Description typical cracking of barrier rail

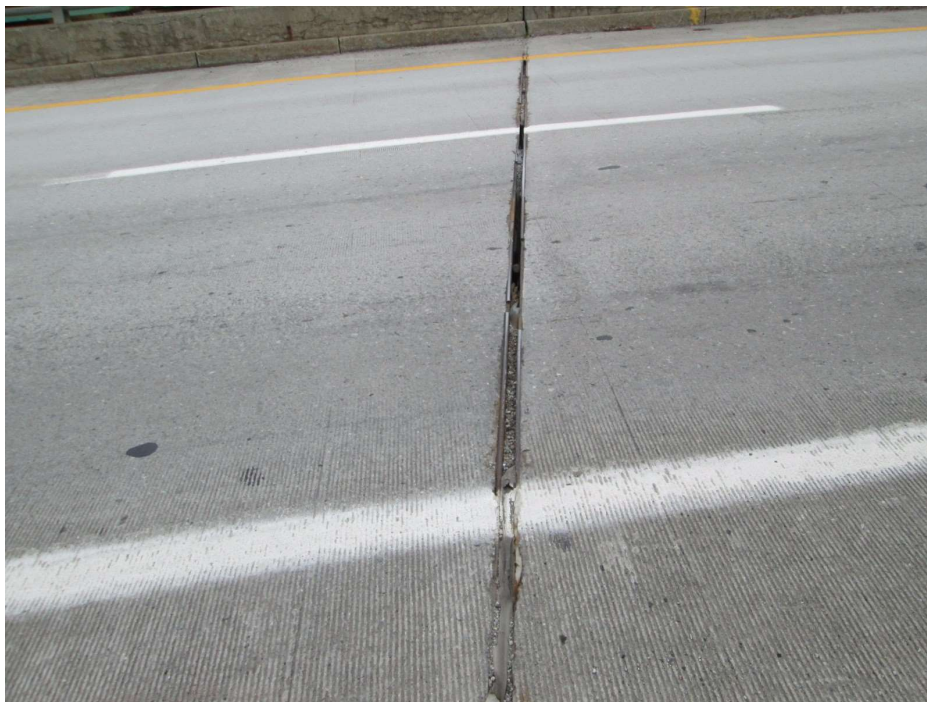
PHOTO 6

Description Failed pier joint seal

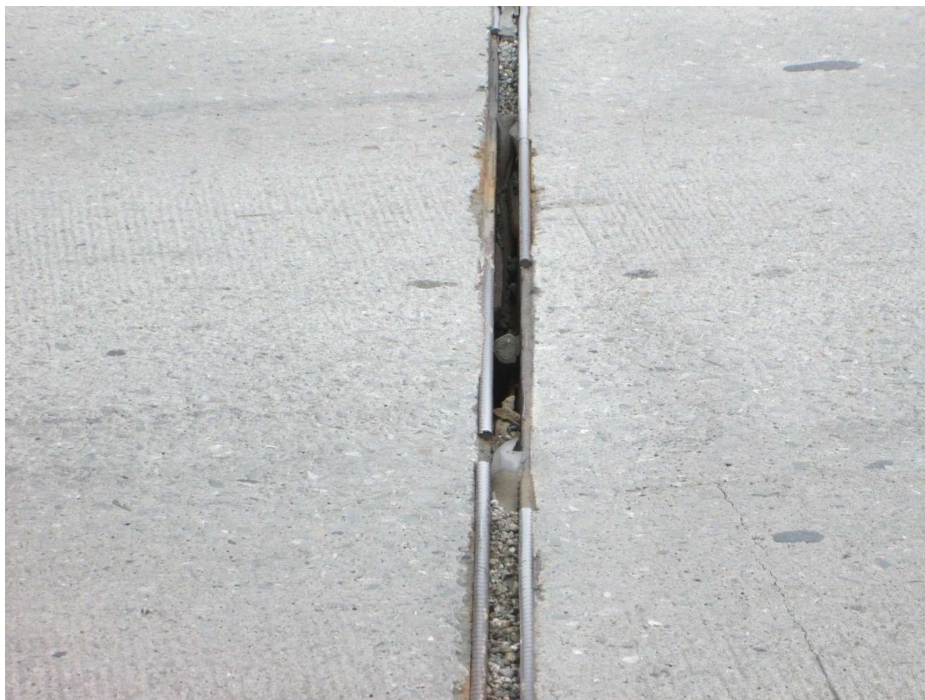
PHOTO 7

Description Failing pier joint seal

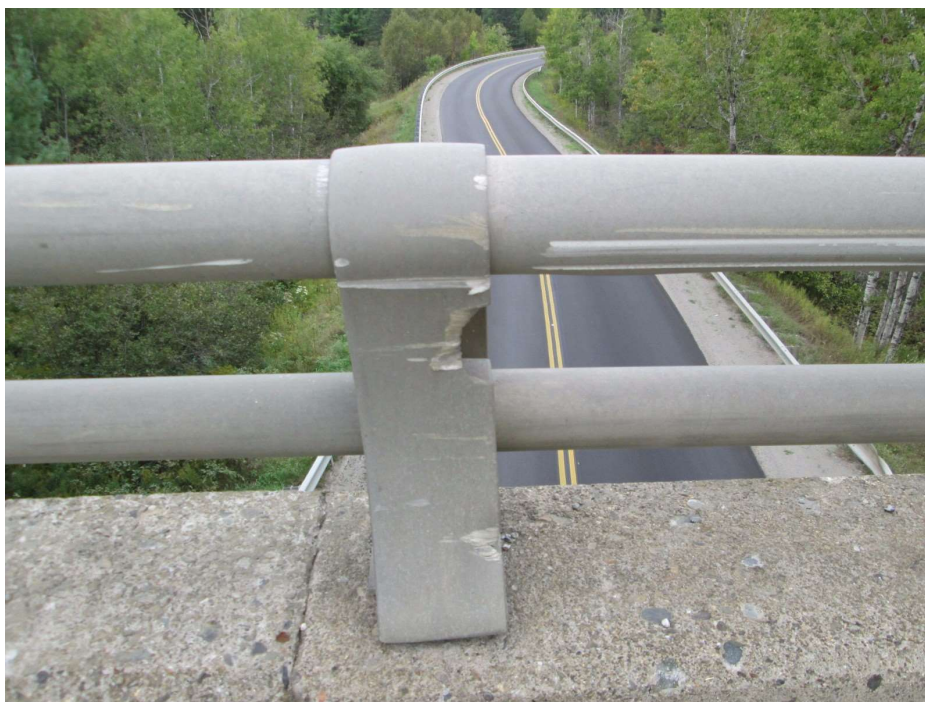
PHOTO 8

Description Damaged aluminum rail post

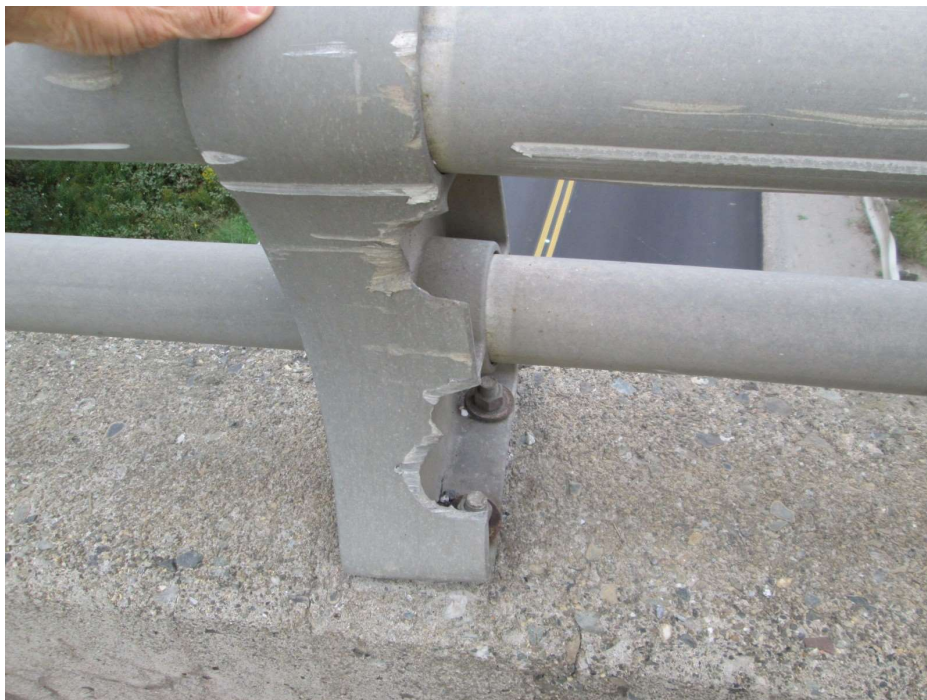
PHOTO 9

Description Damaged rail post flanges

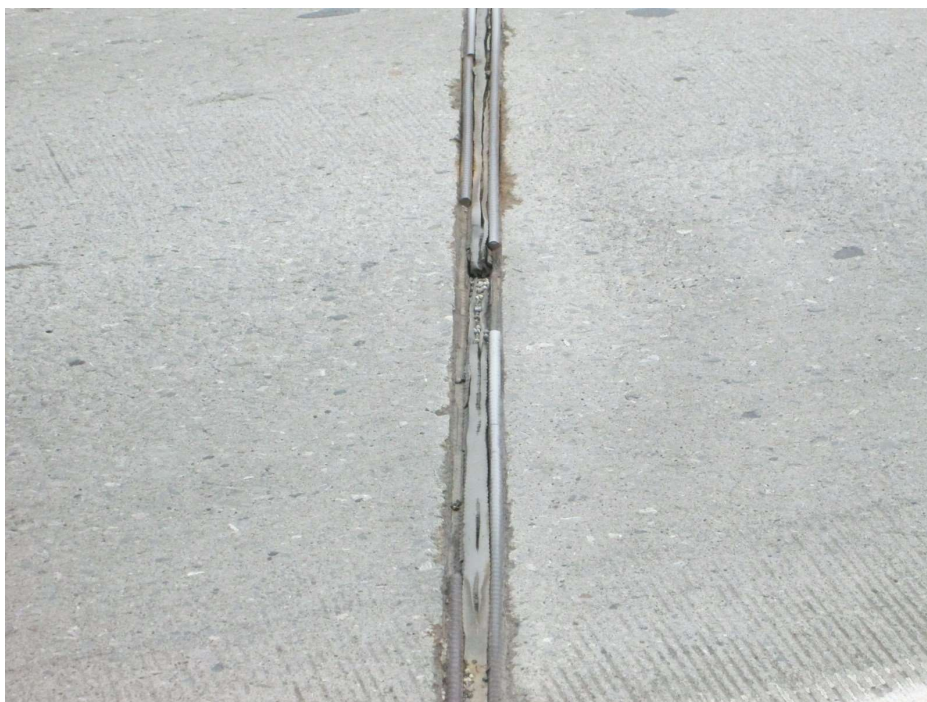
PHOTO 10

Description banged up joint armor

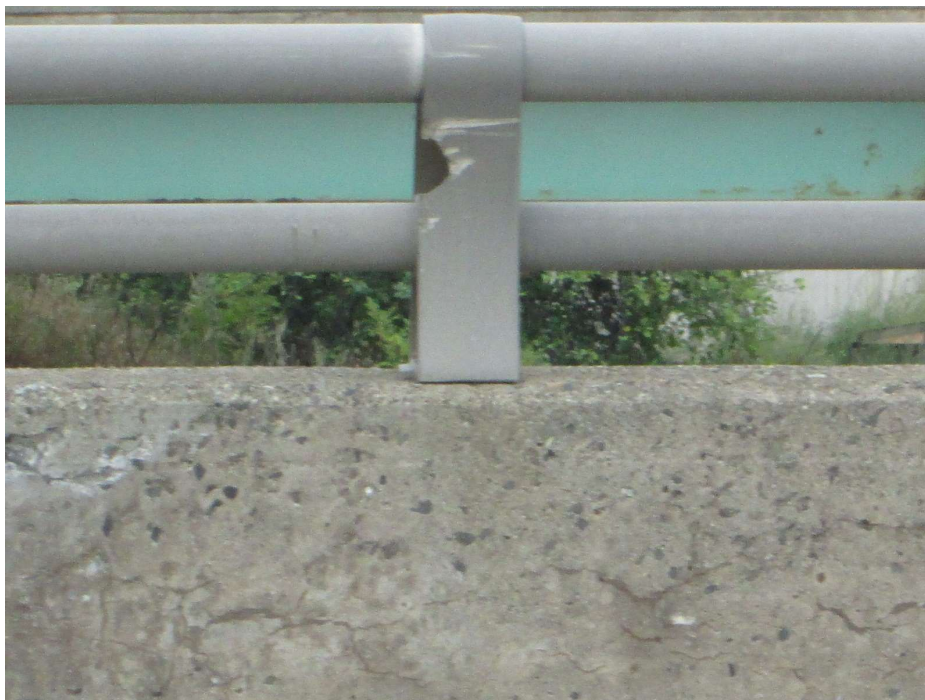
PHOTO 11

Description damaged rail post flanges

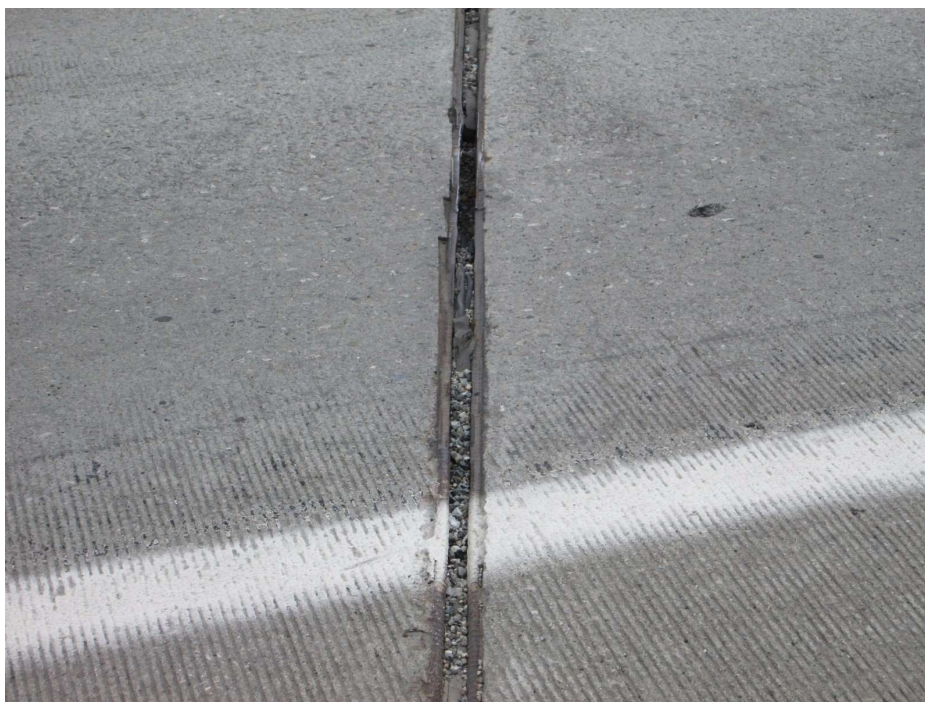
PHOTO 12

Description failing pier joint seal

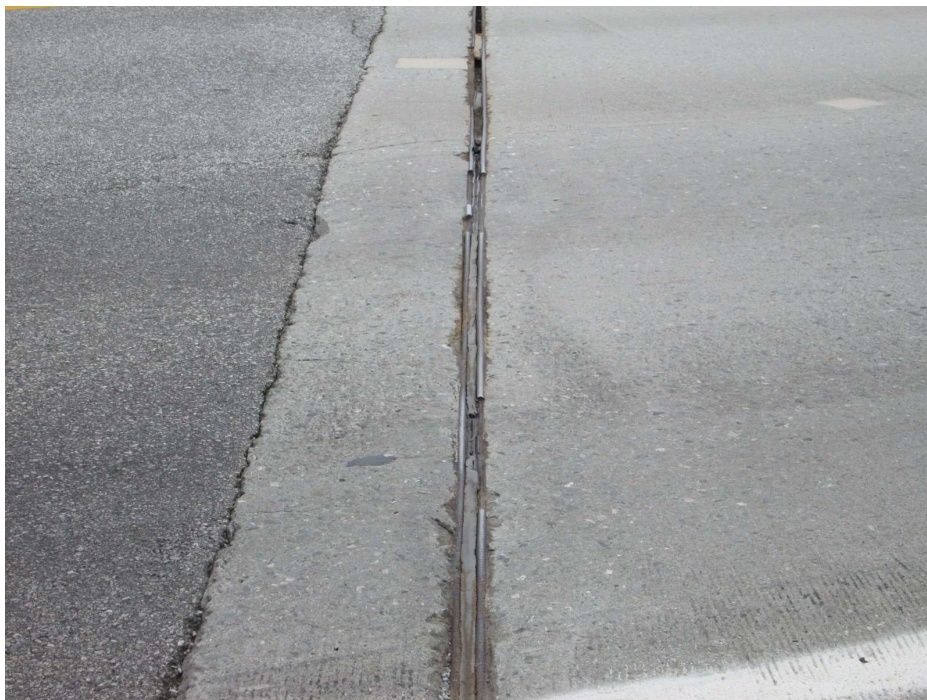
PHOTO 13

Description North end failing seal/ damaged armor

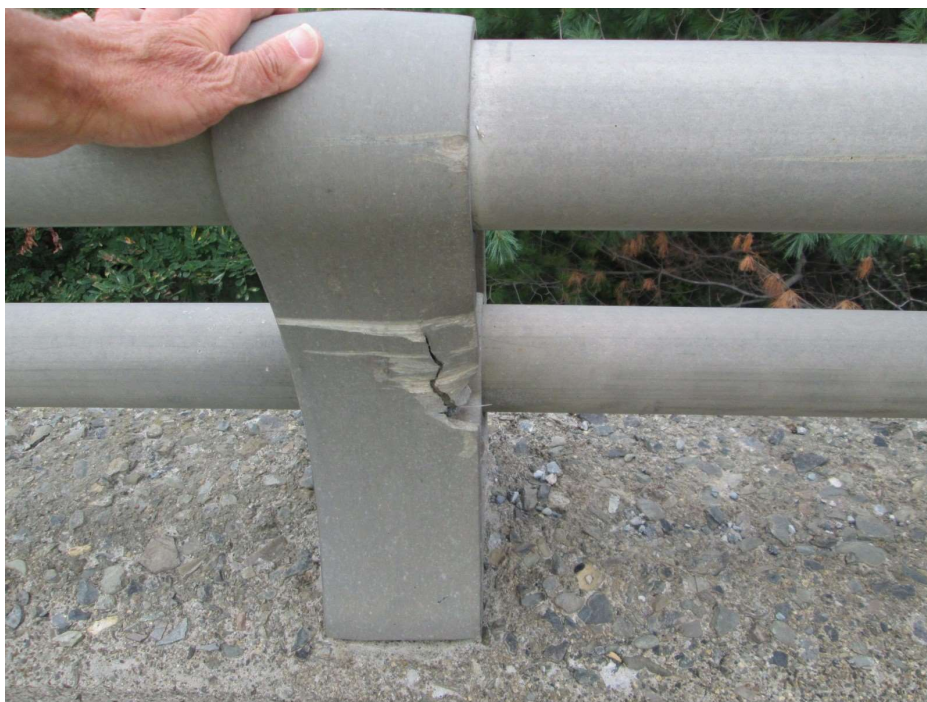
PHOTO 14

Description Another damaged rail post

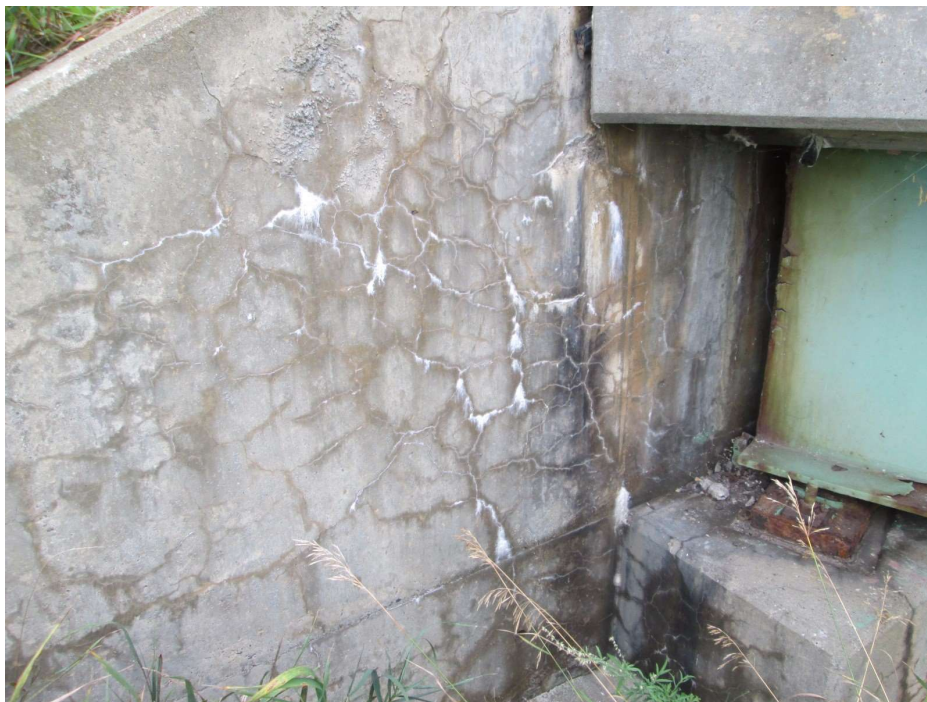
PHOTO 16

Description Cracking & staining wing wall

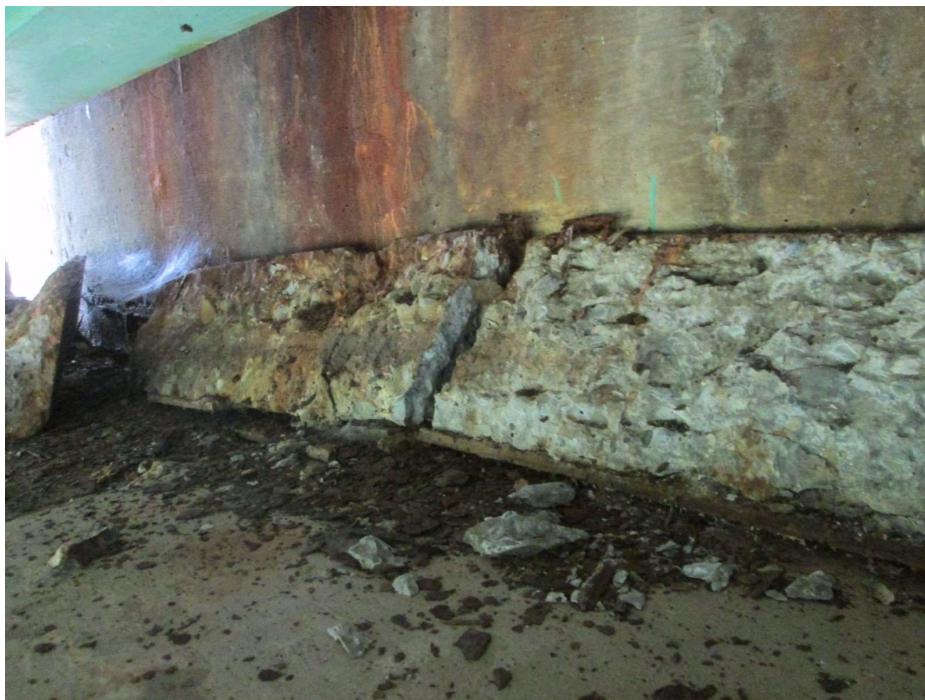
PHOTO 19

Description Spalling joint haunch concrete on north abutment

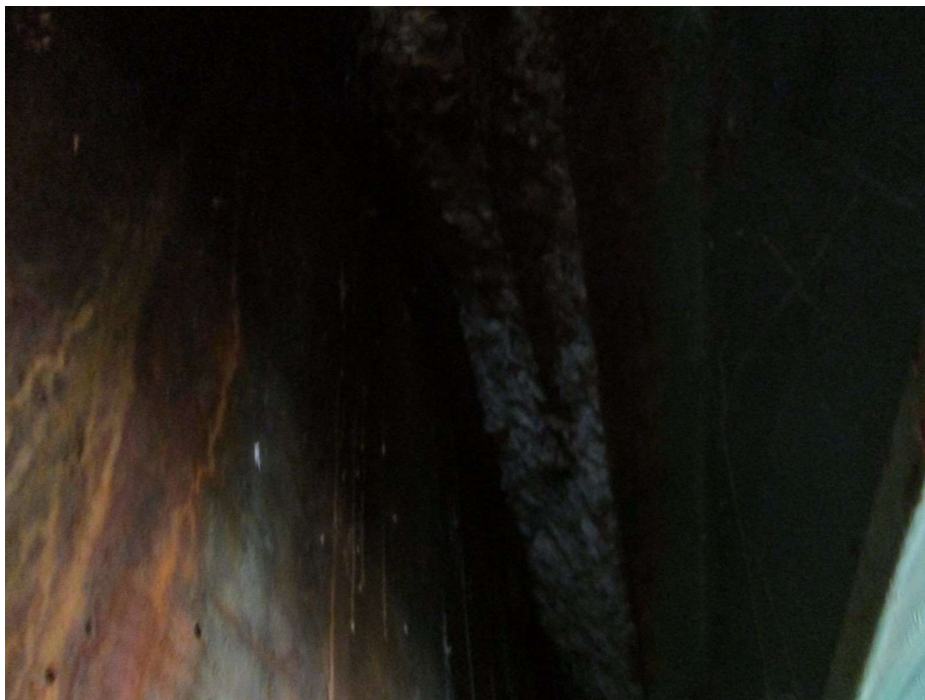
PHOTO 20

Description Spalling joint haunch over north abutment

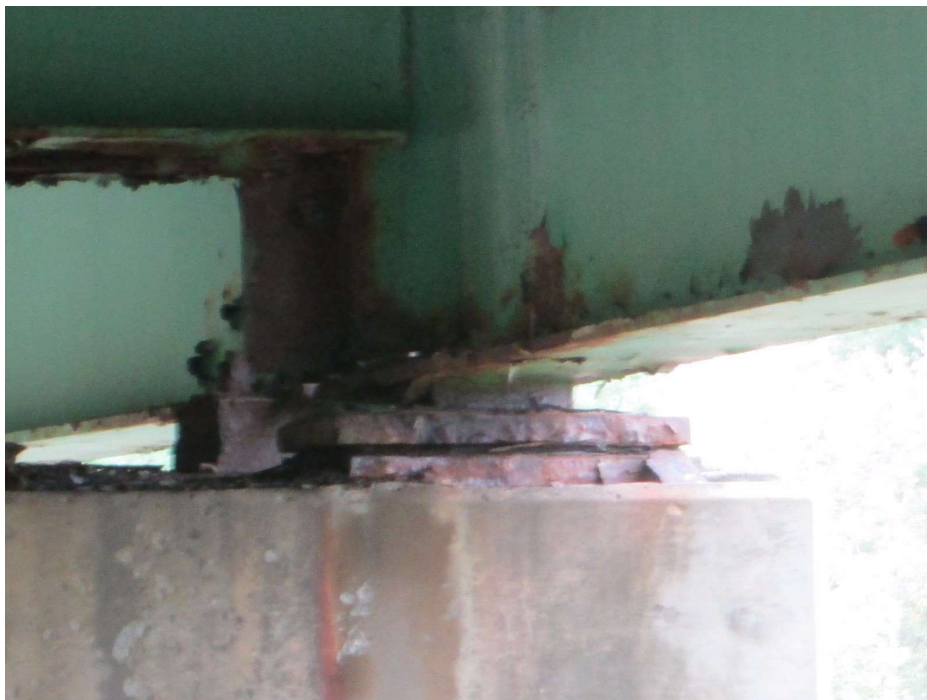
PHOTO 22

Description Heavy rusting of pier beaqrings

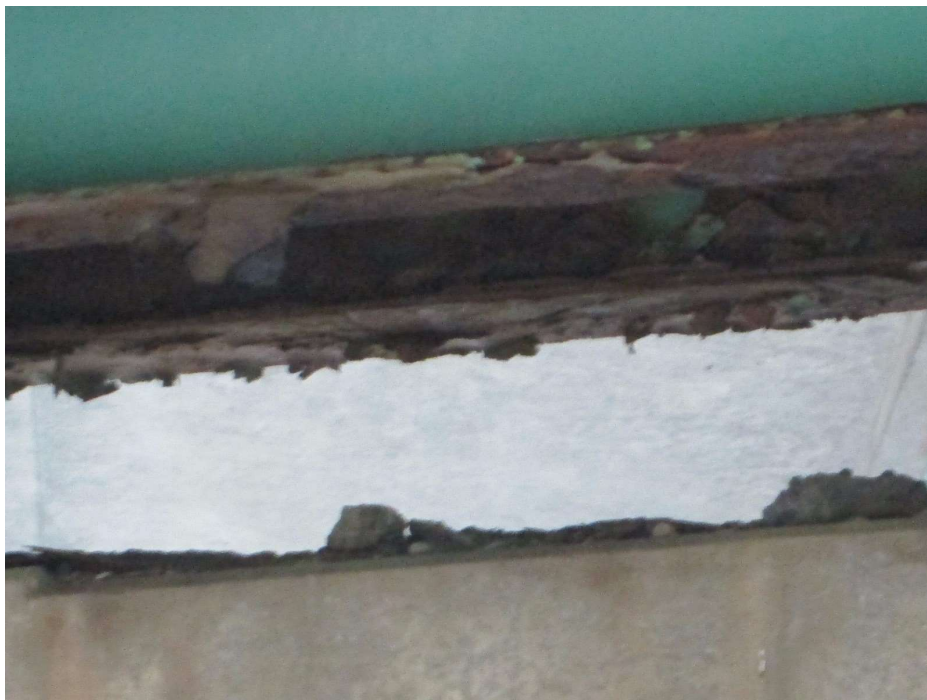
PHOTO 23

Approximately 15% overall paint system distress with sheet failure at south exterior girders and minor paint system distress on interior girders. The last 1'-2' of each girder and joint seal diaphragms, have paint loss and scaling rust from leaking joints above.

Description Rusty pier diaphragms

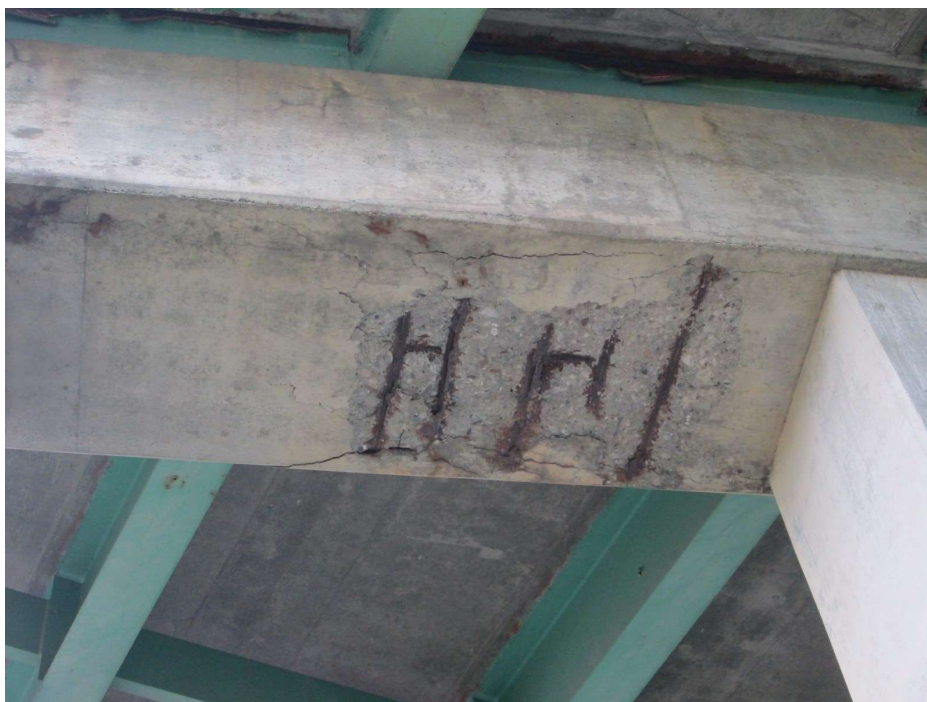
PHOTO 28

Pier columns have minor to moderate vertical cracking/map cracking w/staining, small areas of delamination. Minor to moderate pier cap cracking w/staining on the center and easterly piers. The center pier cap has cracking underside and has a 5 SF delamination with two layers of exposed re-steel. Re-steel heavily rusted. Easterly abutment backwall has heavy rust staining from leaking joints and partial rust staining and cracking of breastwall (photo). Westerly abutment has minor/sporadic hairline cracking.

Description Spalling with exposed re-steel bottom of pier cap

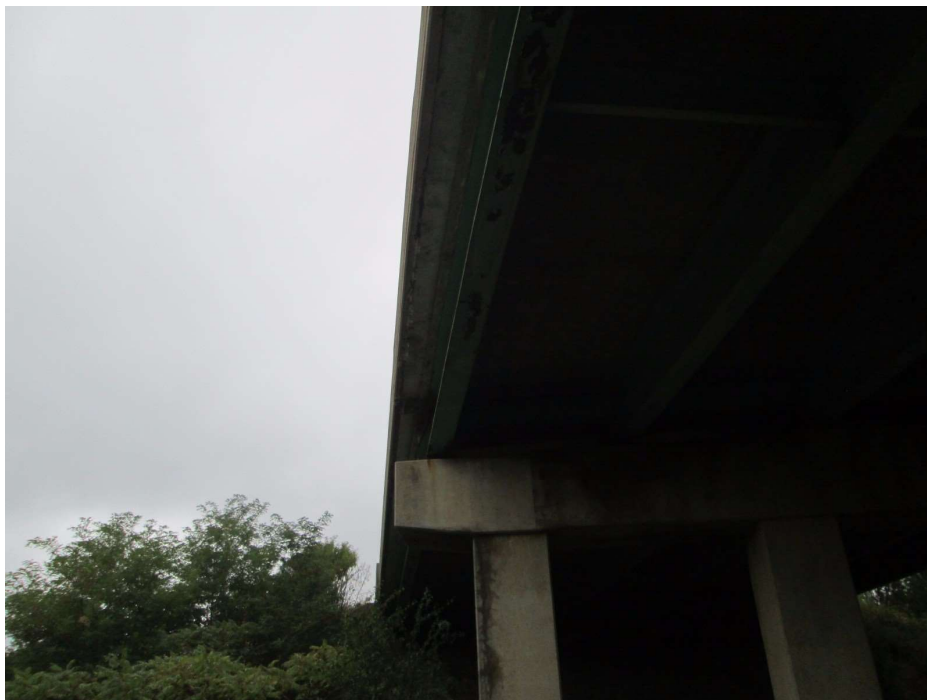
PHOTO 31

Description Scaling fascia

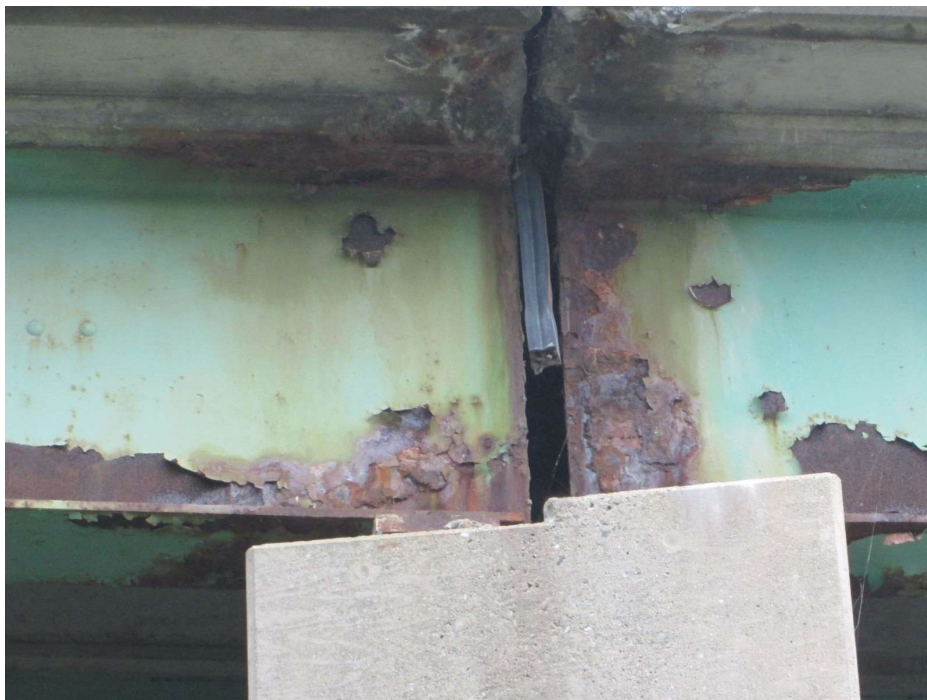
PHOTO 36

Description Deterioration of beam ends at piers
