# Highway Bridge Inspection Report

**I-95 NB/EMERSON MILLS RD  
I-95 NORTHBOUND  
over  
B&ARR,EMERSON MILL RD**

**Asset Code:** 5969

**Inspection Date:** 09/08/2016

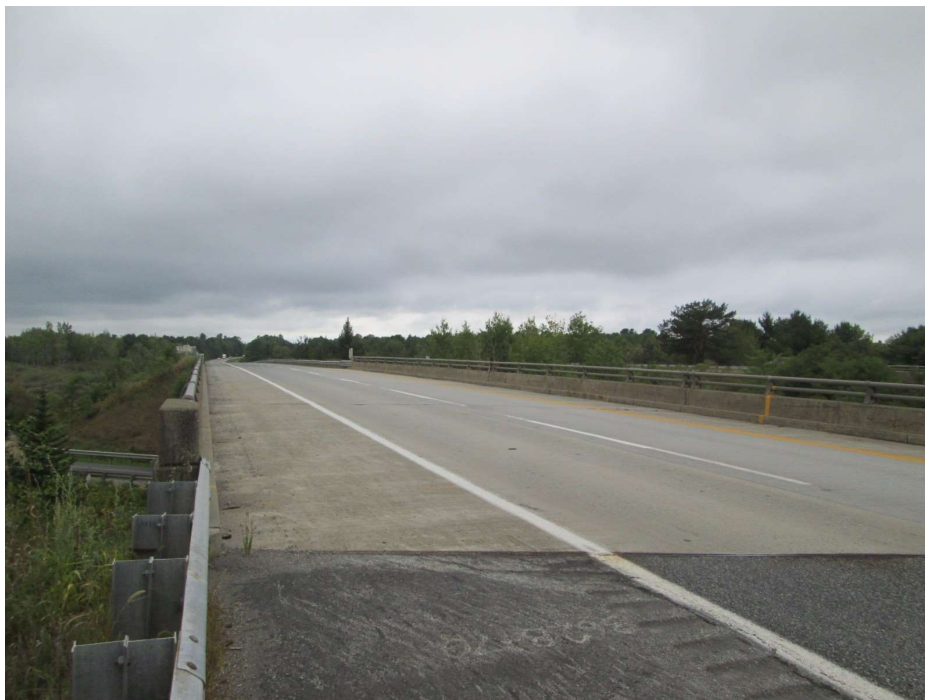
PHOTO 1

Description Roadway looking south

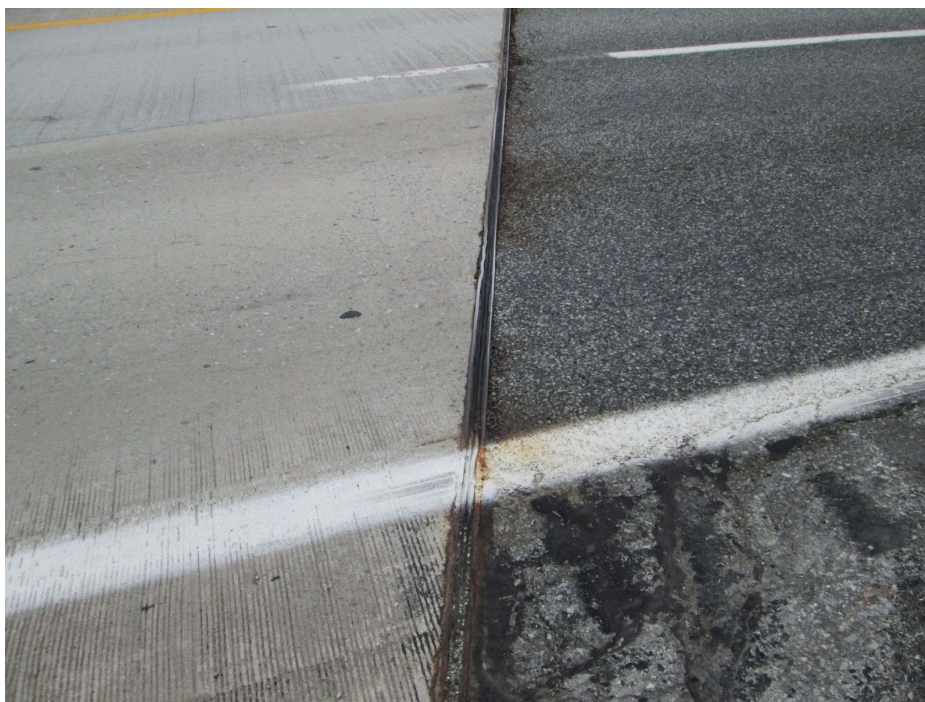
PHOTO 2

Description North joint

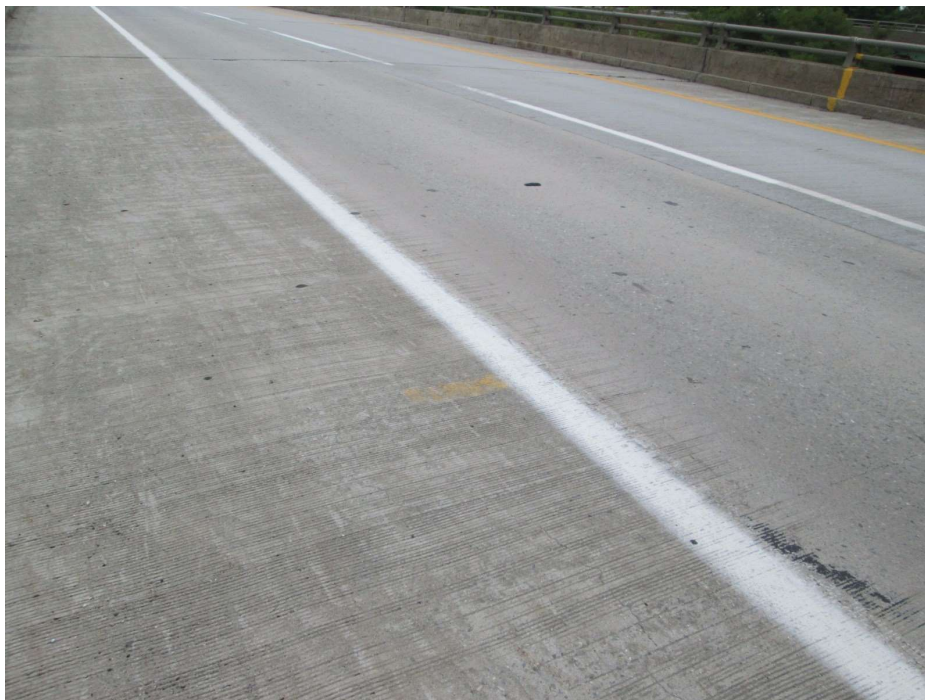
PHOTO 3

Concrete wearing surface with heavy wear in wheel paths and complete loss of tining in travel lanes. Was not chain dragged do to traffic conditions, but no nested cracking, potholes or delaminated concrete noted.

Description    Wearing surface view

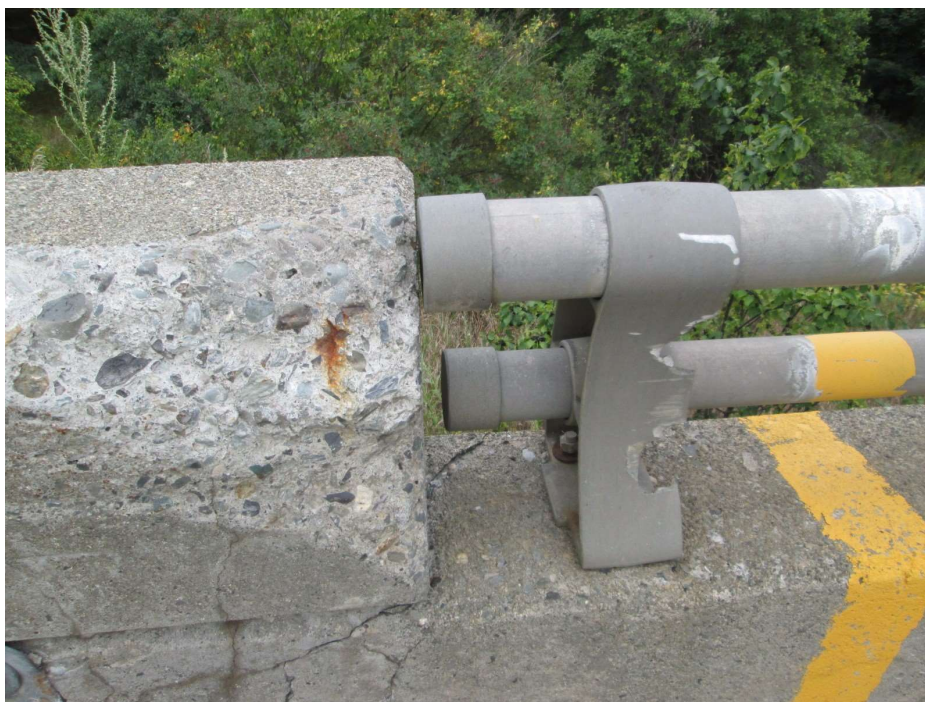
PHOTO 4

Description    Scaling rail end post

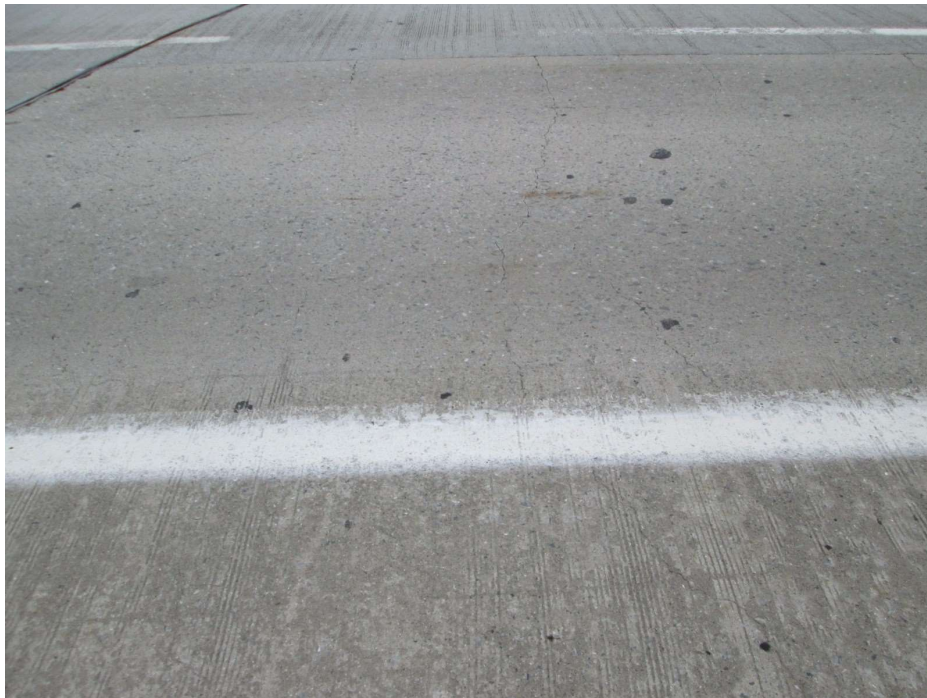
PHOTO 6

Description      Wearing surface view

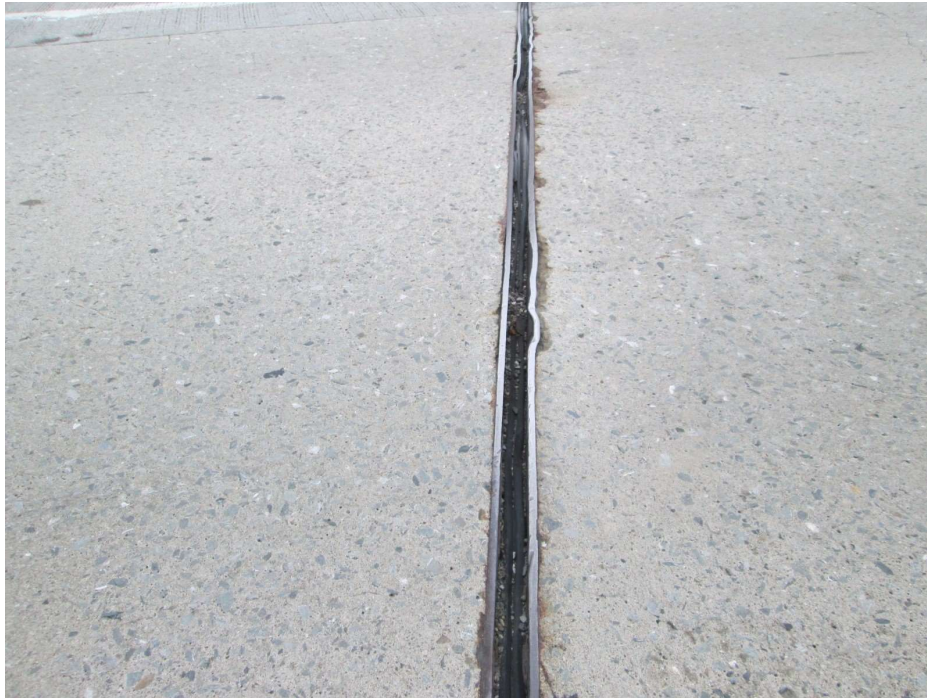
PHOTO 7

Scattered delamination of underside of deck including one spall (photo). All the joints have minor or past leakage but four appear to be in relatively good condition. Seal over easterly pier is failing & leaking, joint armor has minor steel damage. This effectively leaking joint seal has lead to most, if not all of the haunch spalling and now sitting on the pier cap below. May be very little support for deck in this area. All of the aluminum posts have plow damage ranging from minor to having only one anchor bolt and heavy damage. . Concrete portion of railing has scattered light map cracking. All four end posts have minor to moderate map cracking w/staining.

Description Failing joint seal & damaged armor over pier

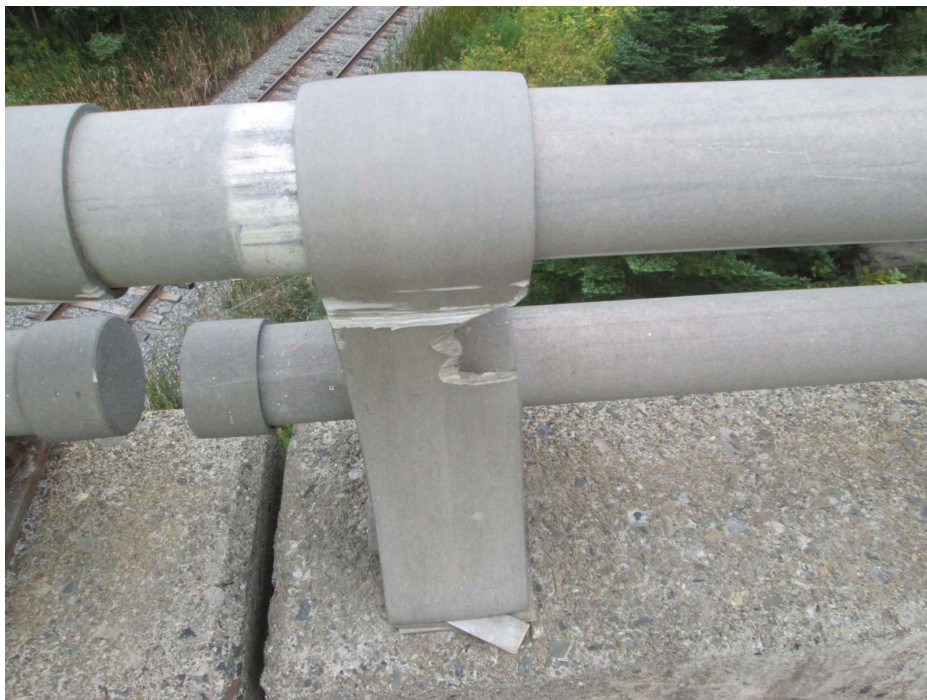
PHOTO 8

Description Damaged rail post

Type	Work Item	Priority	Notes
Safety	Repair Bridge Rail		Repair damaged rail posts
Maintenance	Rehab Substructure		Pier rehab as needed
Preservation	Paint		Future paint job
Maintenance	Reset Bearings		Replace missing anchor bolts rehab

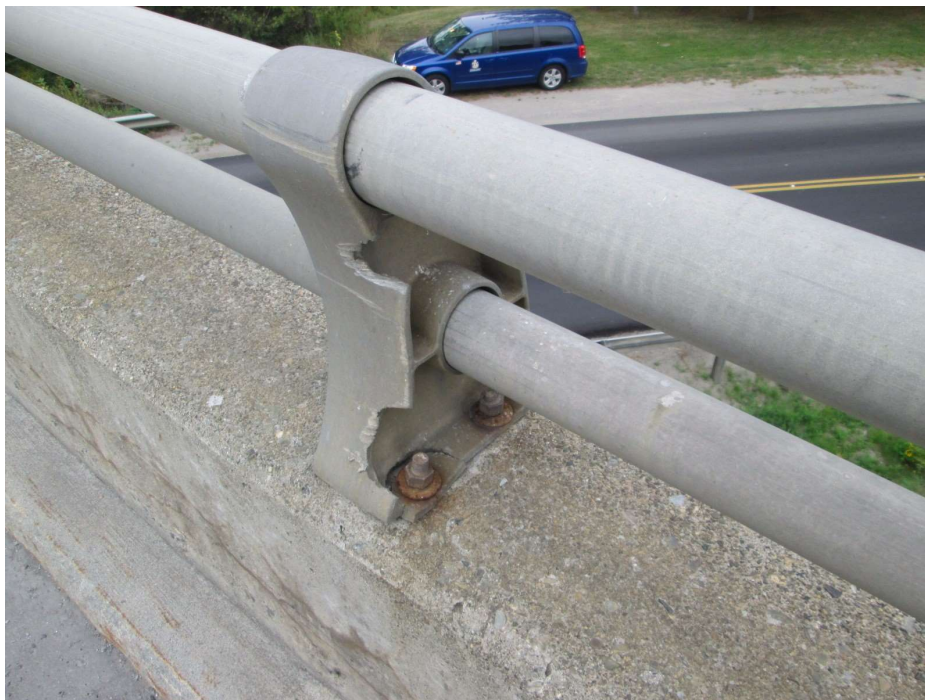
PHOTO 9

Description Damaged rail post

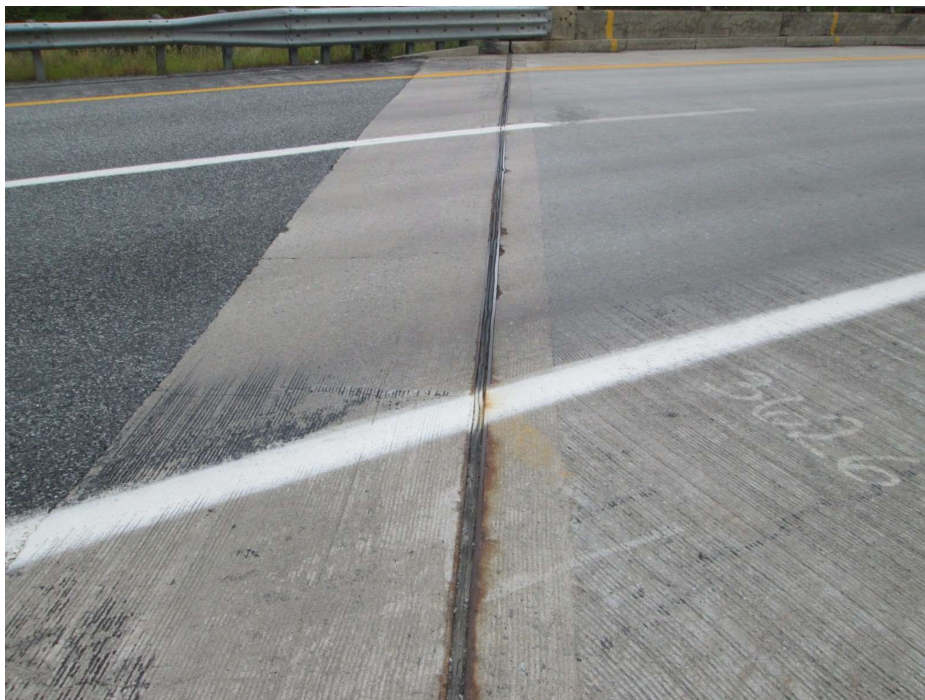
PHOTO 10

Description South end joint

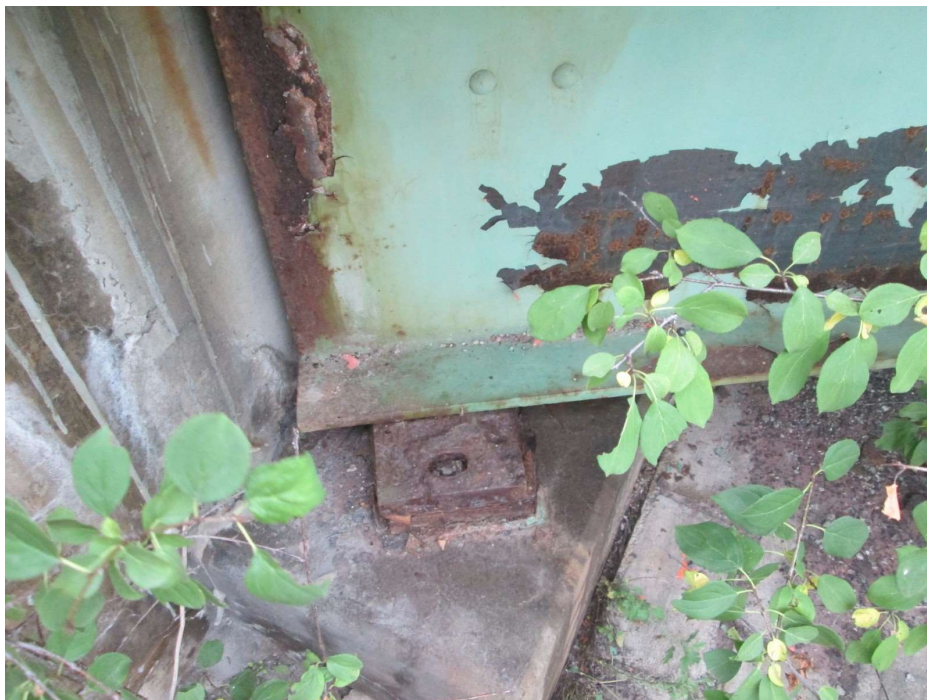
PHOTO 11

Approximately 15% overall paint system distress with sheet failure at south exterior girders, minor paint system distress on the interior girders. The last 1'-2' of each girder has paint loss and scaling rust from previous or currently leaking joints. Some section loss of bottom flange (photo). The bearings at the westerly abutment have multiple missing anchor bolts, bearing and masonry plates are misaligned for at least half.

Description Missing anchor bolt at SE abutment bearing

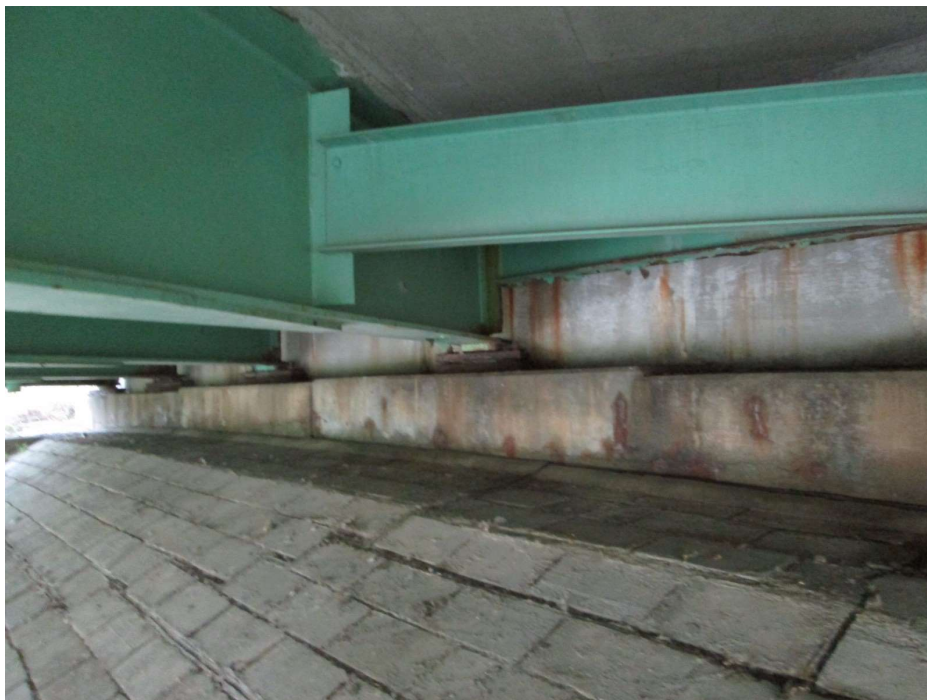
PHOTO 12

Description south abutment

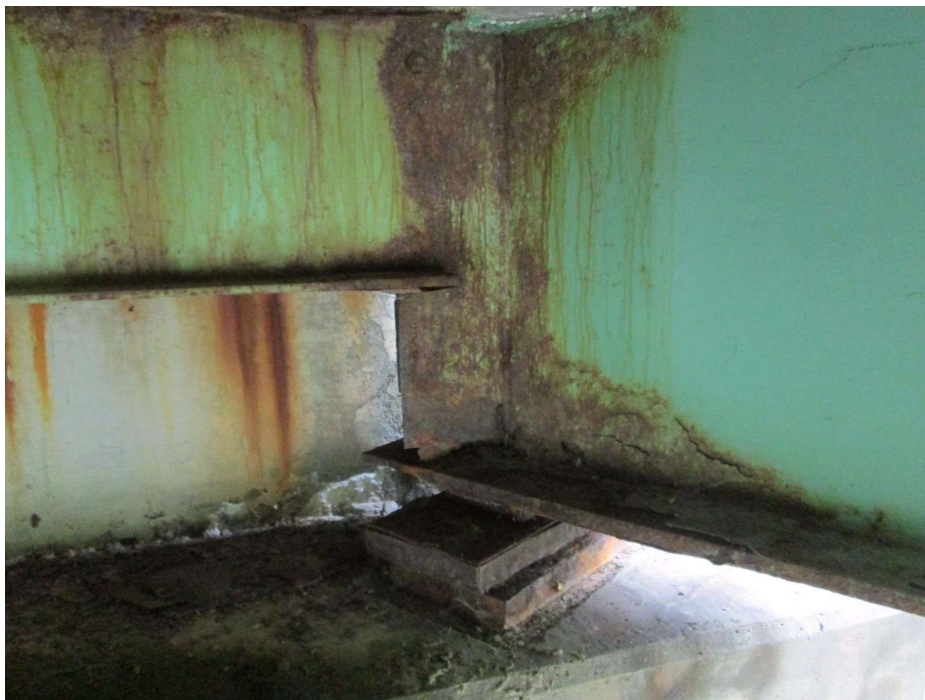
PHOTO 13

Description Interior bearing deterioration & missing anchor bolt

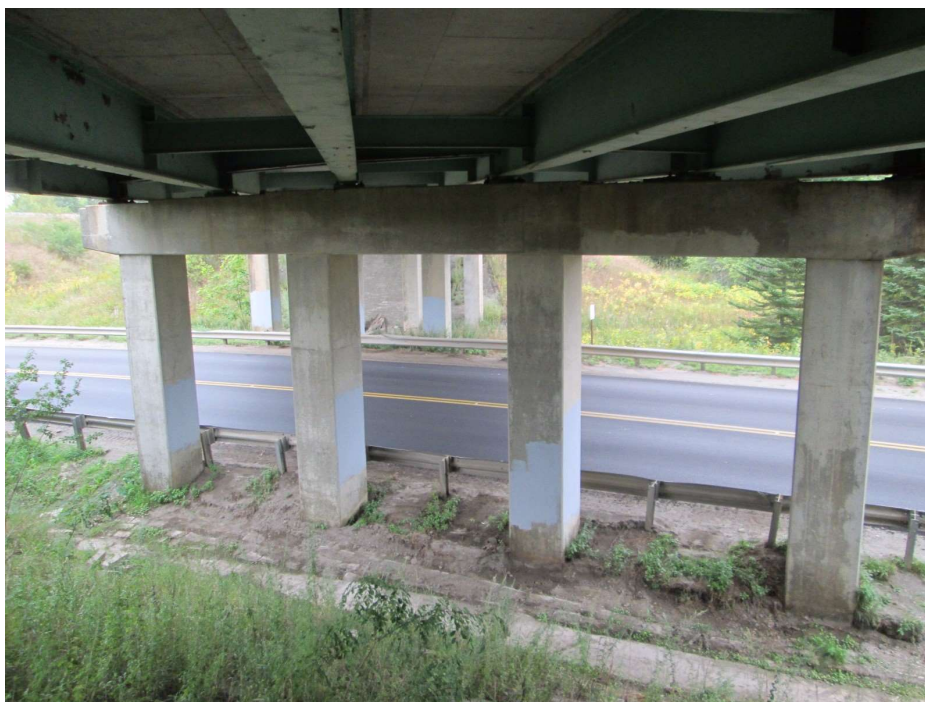
PHOTO 14

Description pier view south face

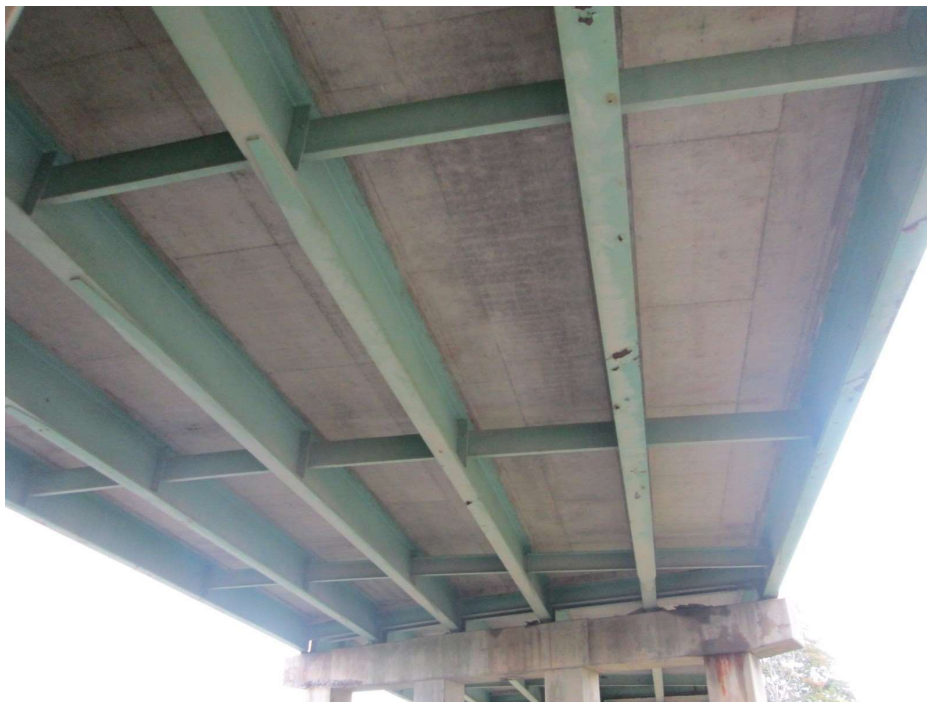
PHOTO 15

Description South span view

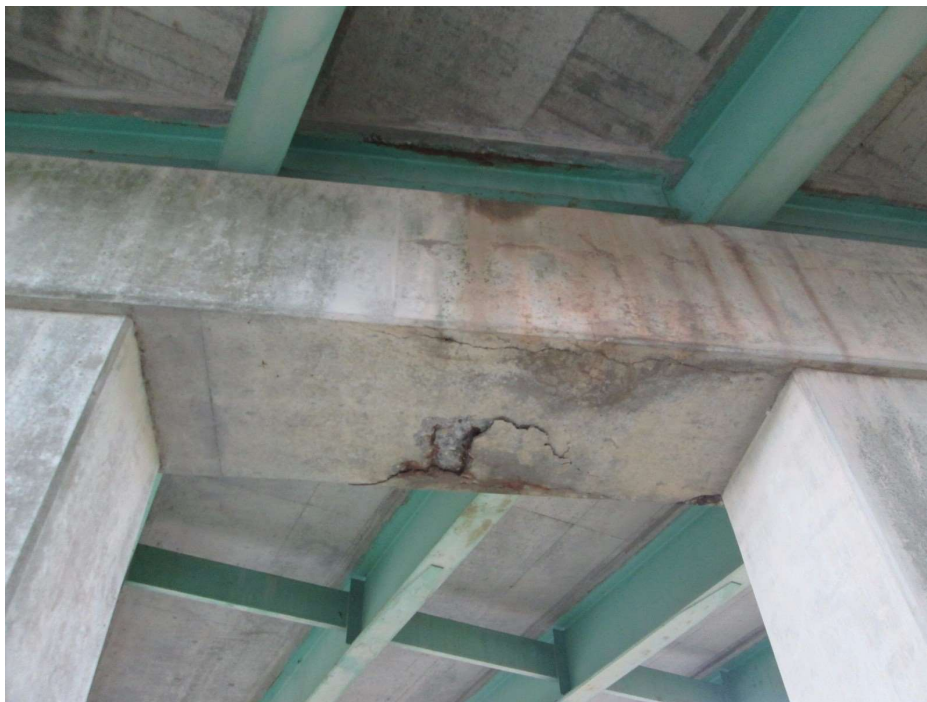
PHOTO 16

Concrete columns have minor to moderate, vertical and map, cracking and staining with small areas of delamination . Pier cap cracking, delaminating and spalling on the center and easterly piers. Abutment backwalls have isolated minor cracking, moderate to heavy horizontal cracking and staining of bridge seats scattered throughout. Wingwalls all generally covered with map cracking/staining.

Description Spall with exposed re-steel pier cap top & bottom

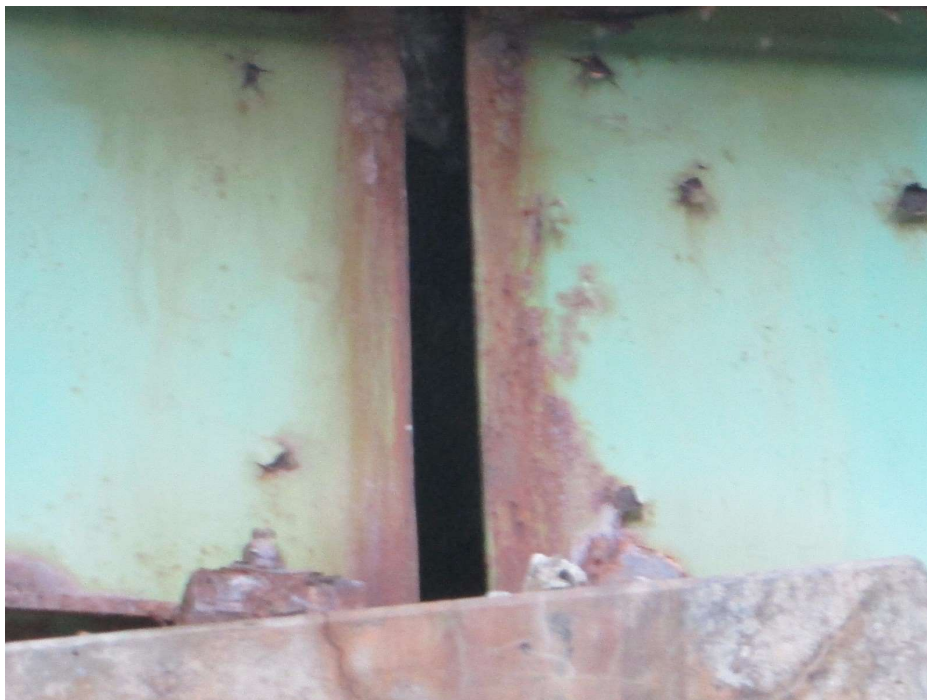
PHOTO 18

Description pier beam ends

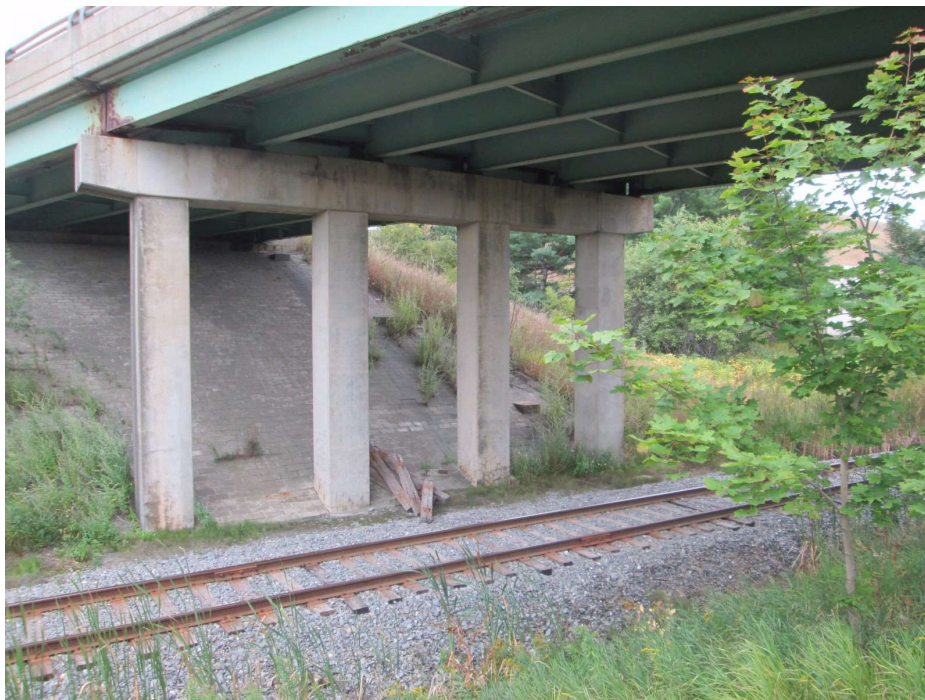
PHOTO 19

Description north pier

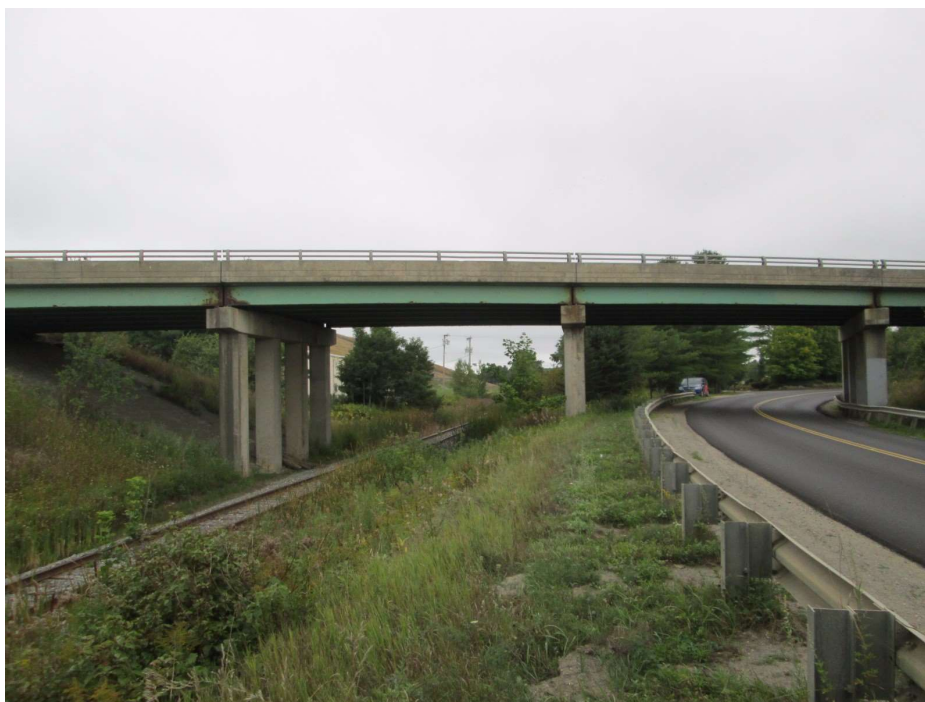
PHOTO 20

Description West side view

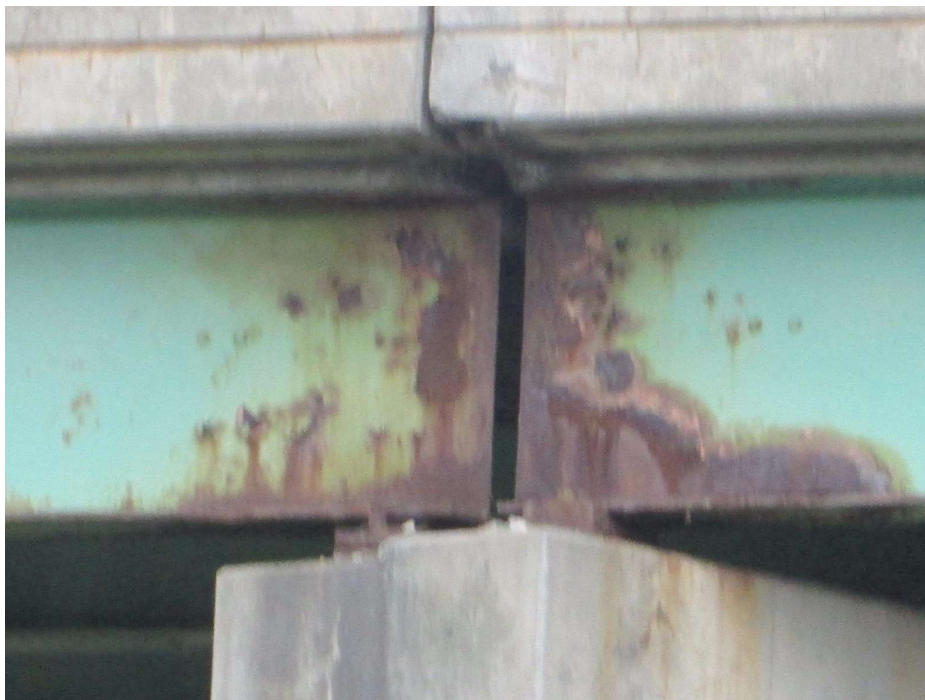
PHOTO 21

Description Deteriorated pier beam ends

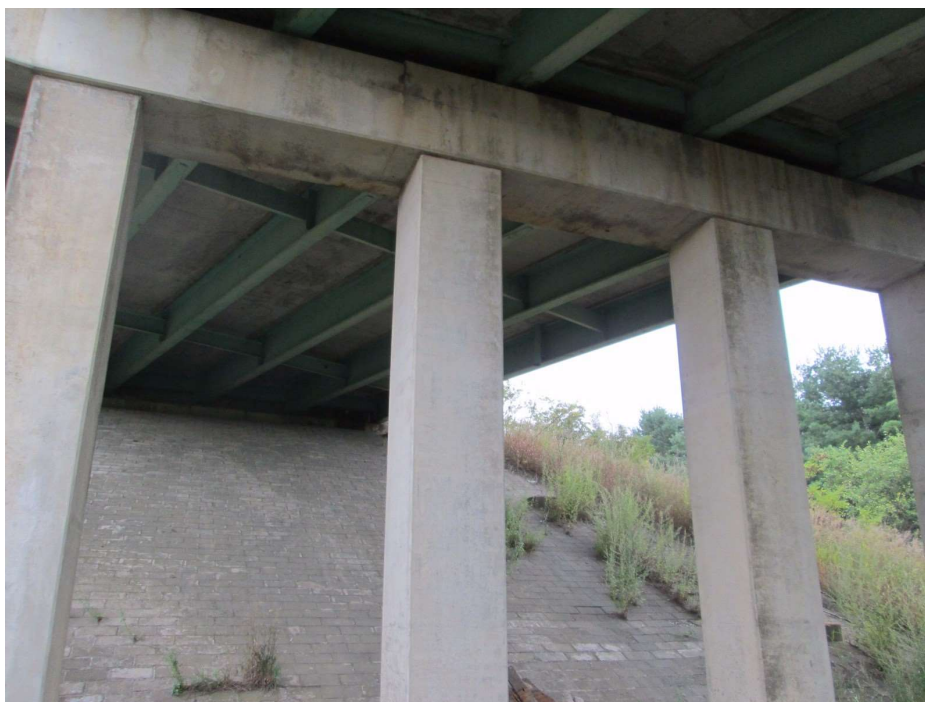
PHOTO 22

Description north pier

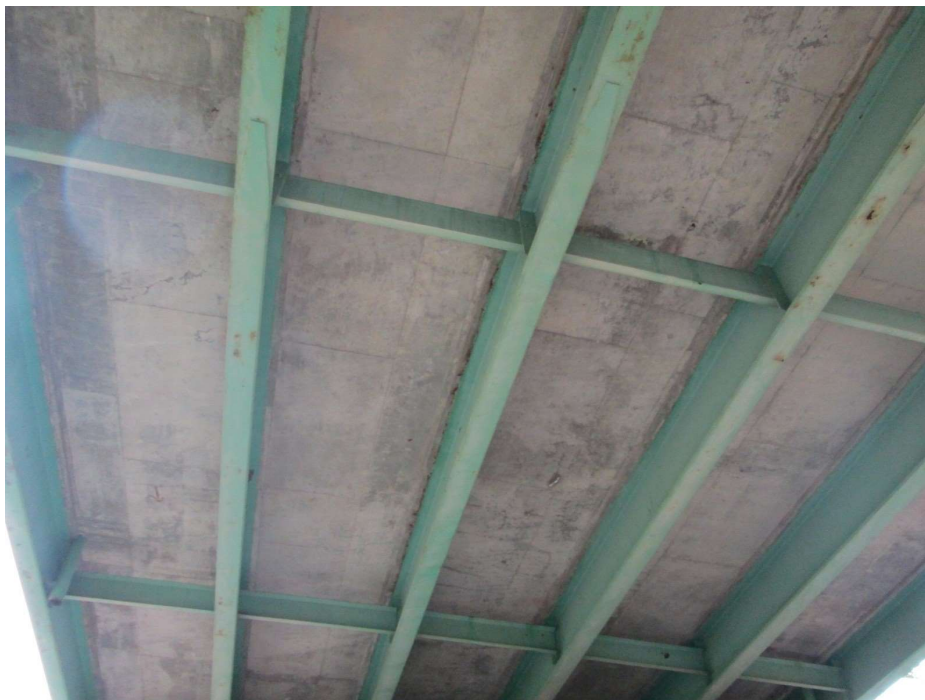
PHOTO 23

Description span view

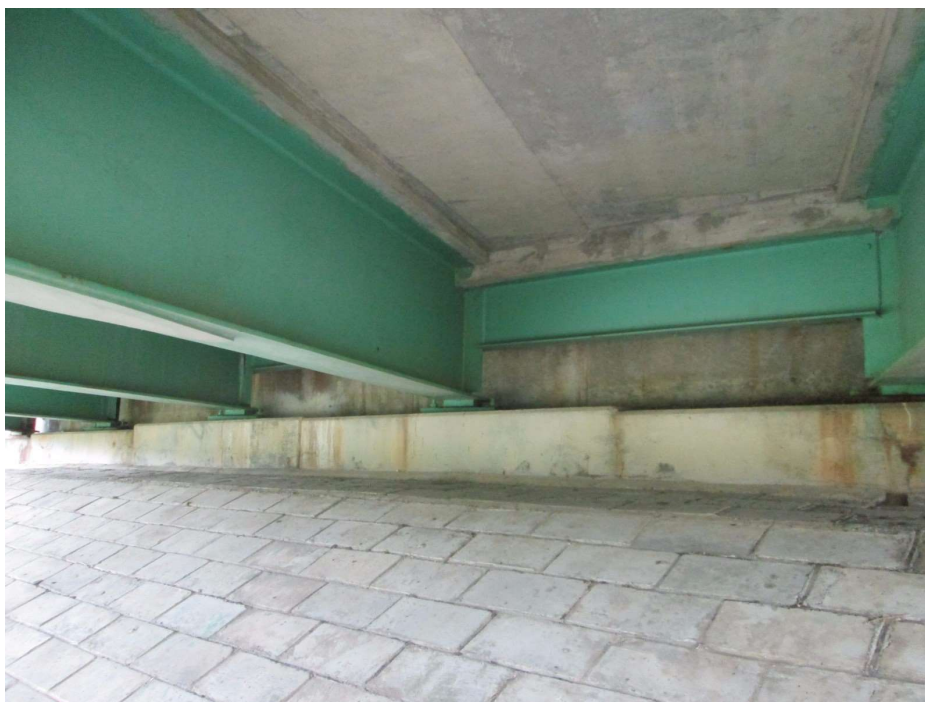
PHOTO 24

Description North abutment

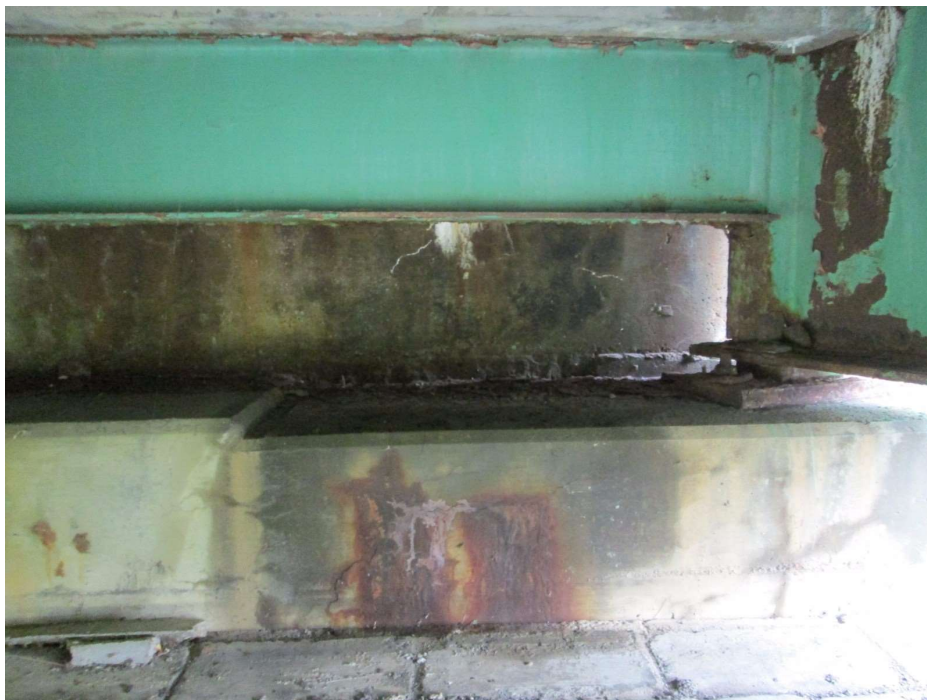
PHOTO 25

Description Staining backwall and bridge seat north end

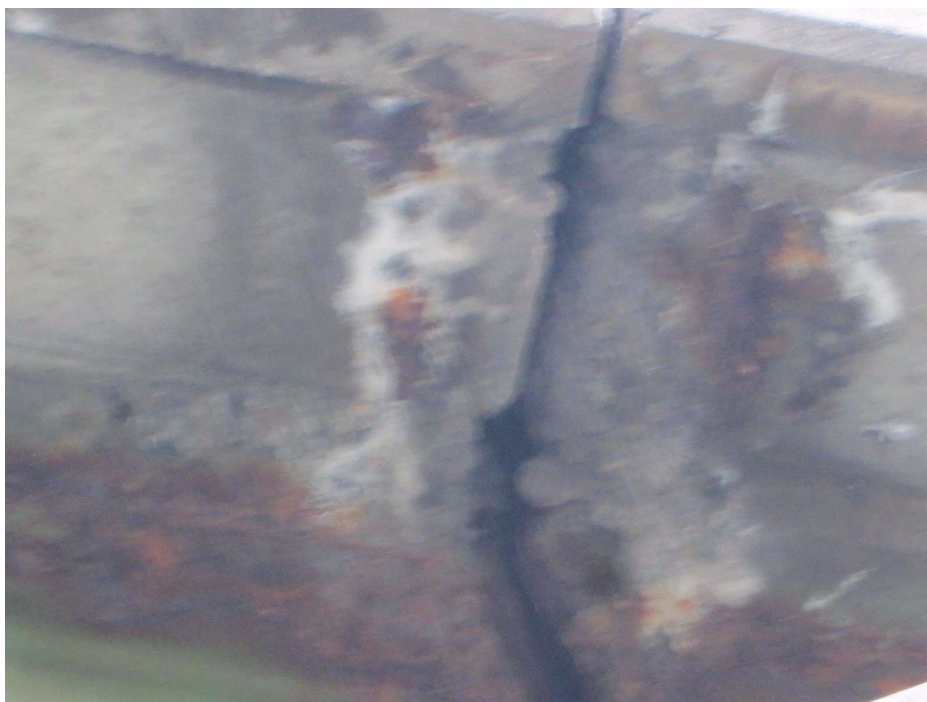
PHOTO 26

Description Cracking & staining fascia at north joint
