Highway Bridge Inspection Report

**SOUADABSCOOK CENTER NB
95 NB
over
SOUADABSCOOK STREAM**

Inspection Date: 05/07/2015

Inspection Type(s): Routine

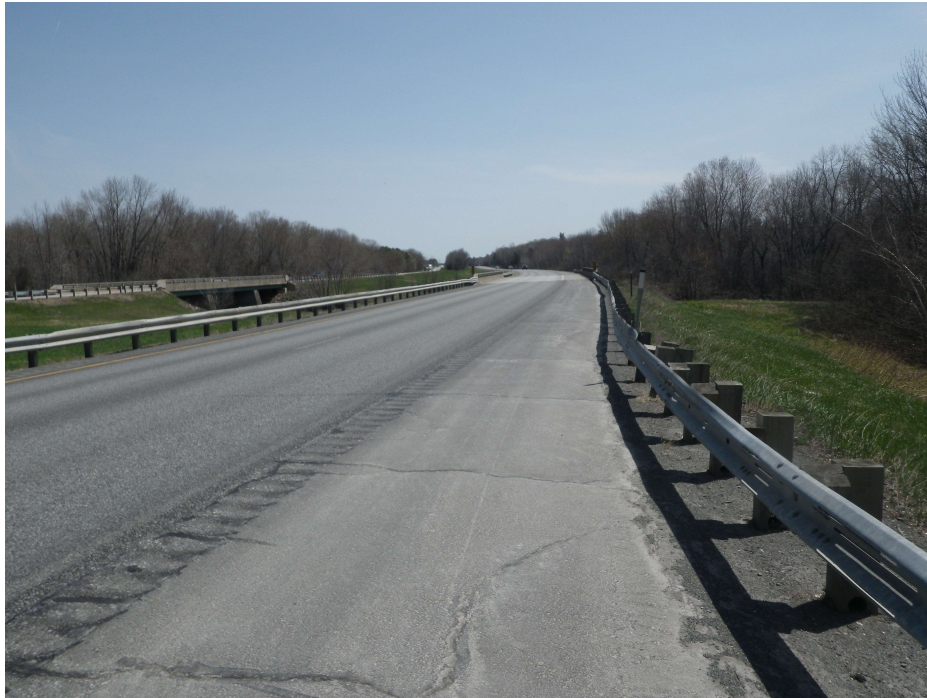
PHOTO 1

Description Roadway looking East

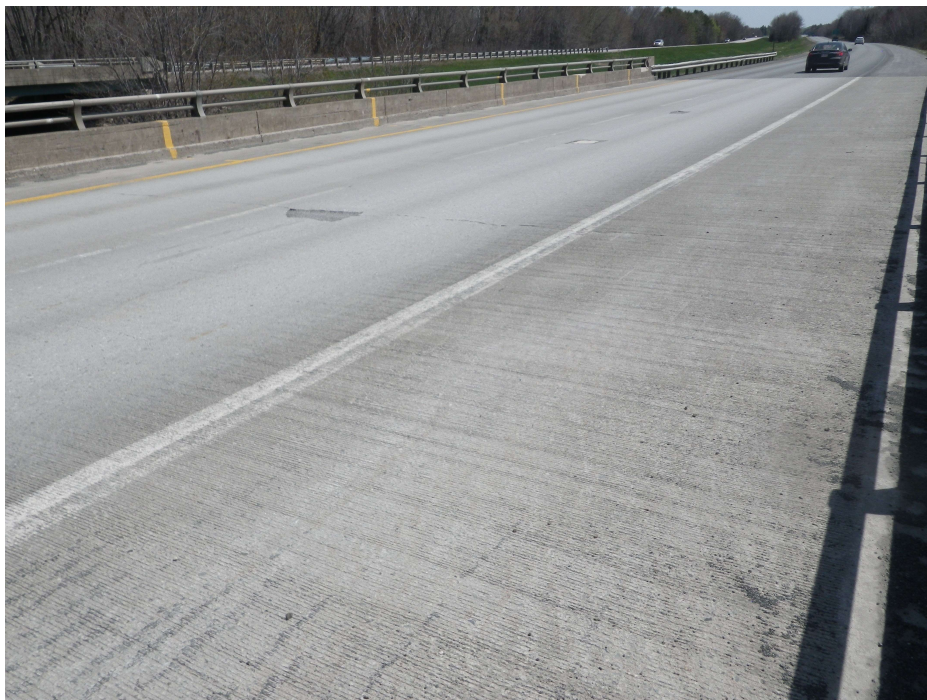
PHOTO 2

Did not chain wearing surface due to heavy traffic, but observed approximately 25% cracking, patched areas. Bottom of deck has heavy spalling with exposed re-steel at deck blocking areas and a high percentage of staining bottom of deck. Concrete wearing surface has 3 transverse cracks near center and 1/3rd of the way from each abutment, see photo.

Description General view of concrete wearing surface

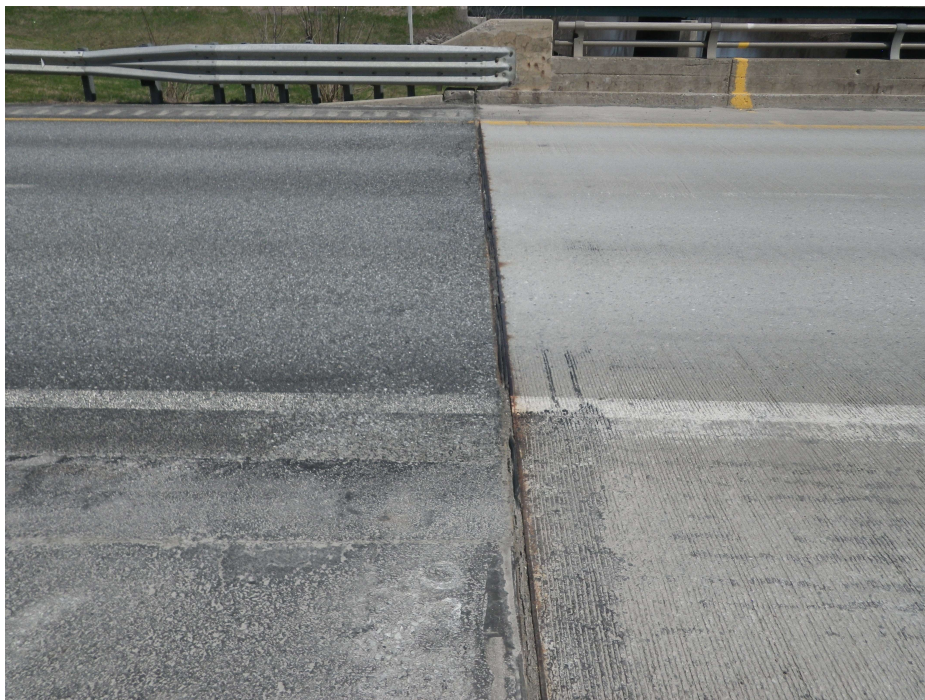
PHOTO 3

Extensive areas of spalled concrete with exposed re-steel on bottom of joint header. Staining areas on the bottom of the deck. Seals are intact, but have signs of moderate to heavy leakage. Joint haunch areas have spalling.

Description West joint seal

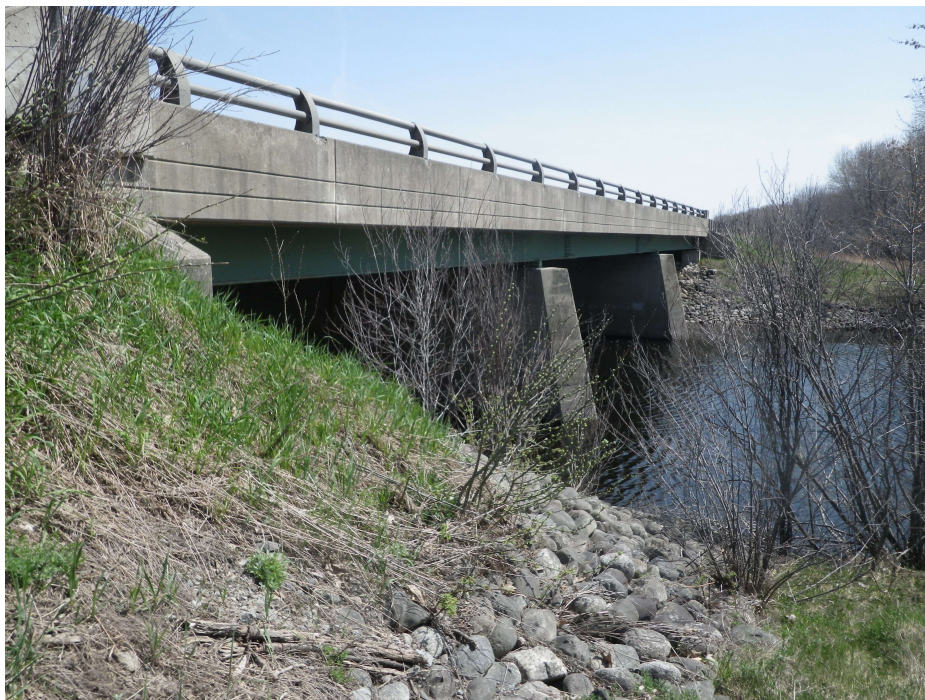
PHOTO 4

Description Up stream end

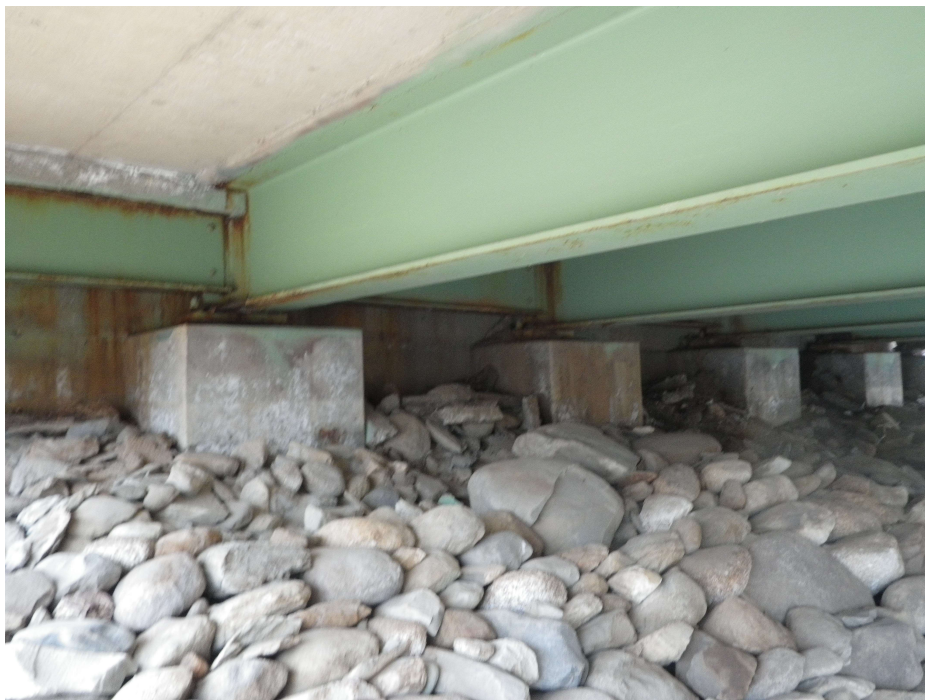
PHOTO 5

Moderate cracking and staining of back-wall areas. Pedestals have moderate cracking and staining.

Description West abutment

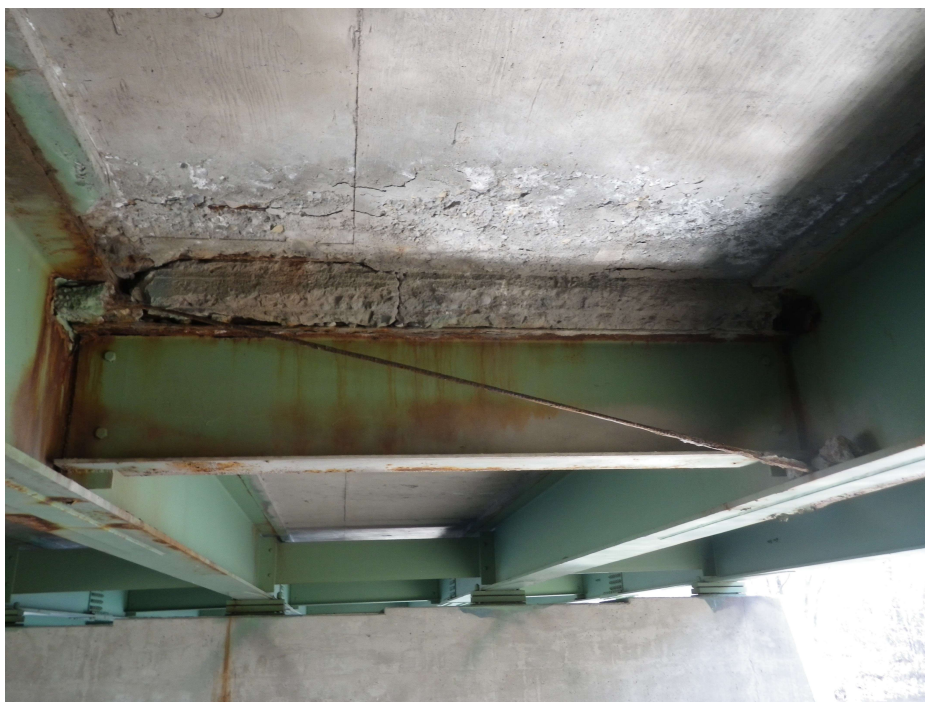
PHOTO 6

Description Spalled haunches with exposed re-steel, West end

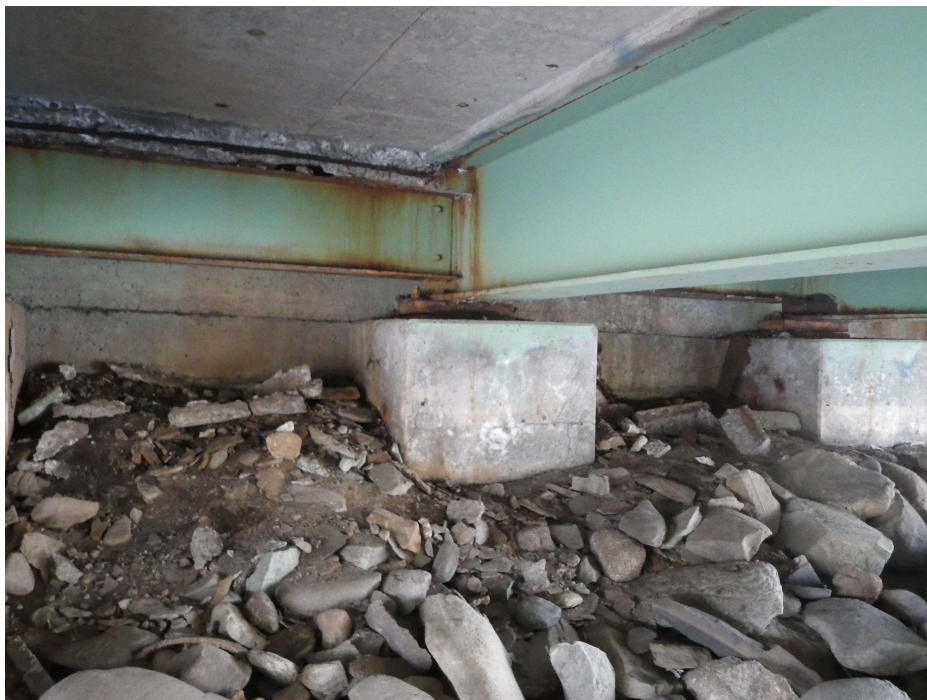
PHOTO 7

Description Spalled joint header, typical of East and West joint

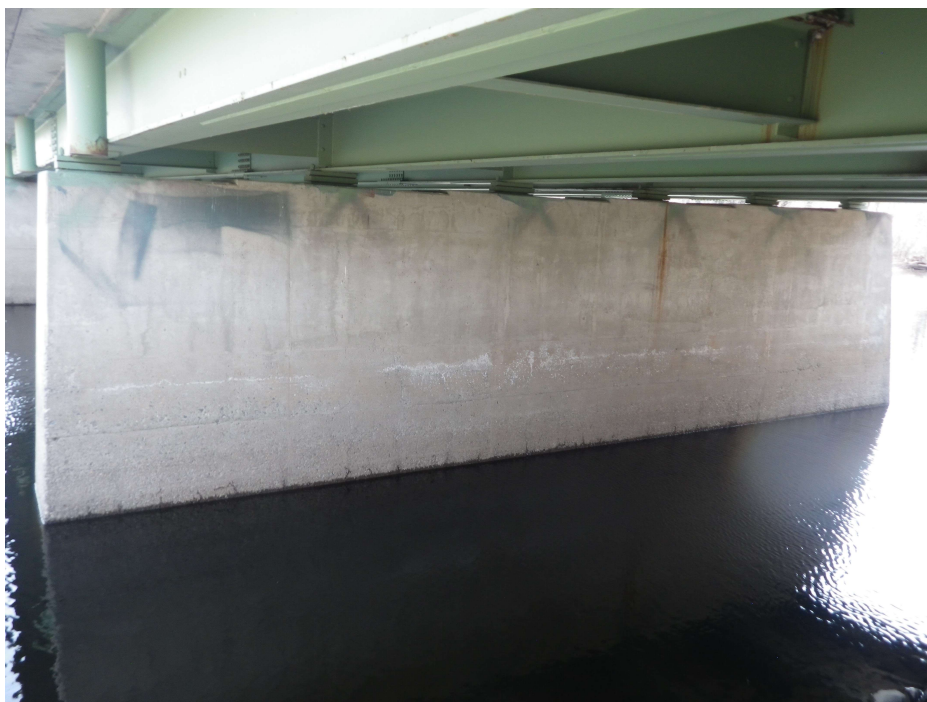
PHOTO 8

Description West side of the West pier

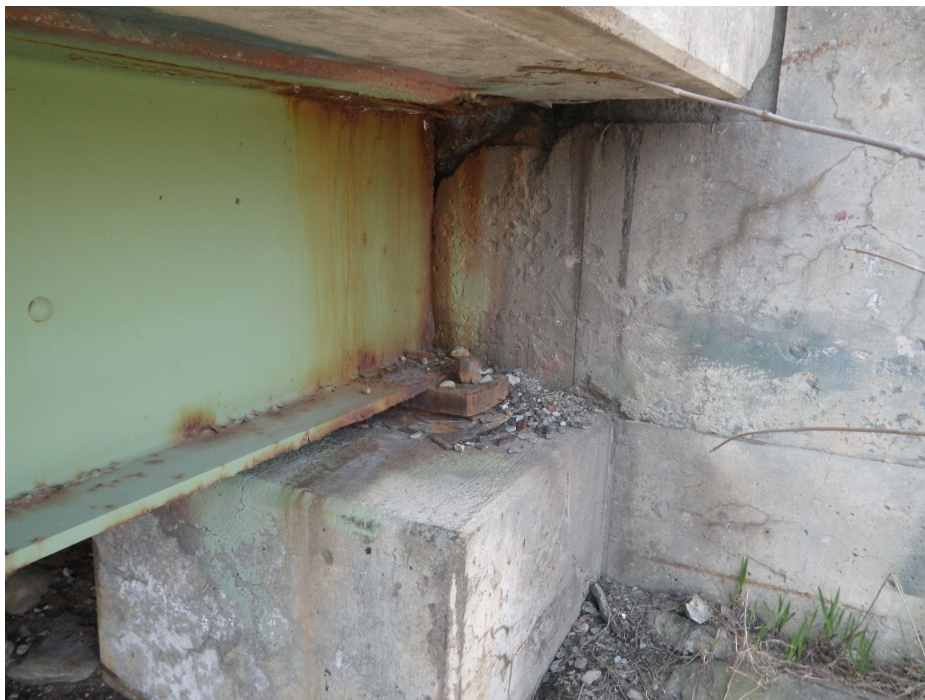
PHOTO 9

Approximately 15% paint system distress with moderate rusting at beam end exterior bearing areas. Anchor bolts are missing. Bearings have 50%+ Paint loss for bearings under joints.

Description Exterior bearing and beam end, West end

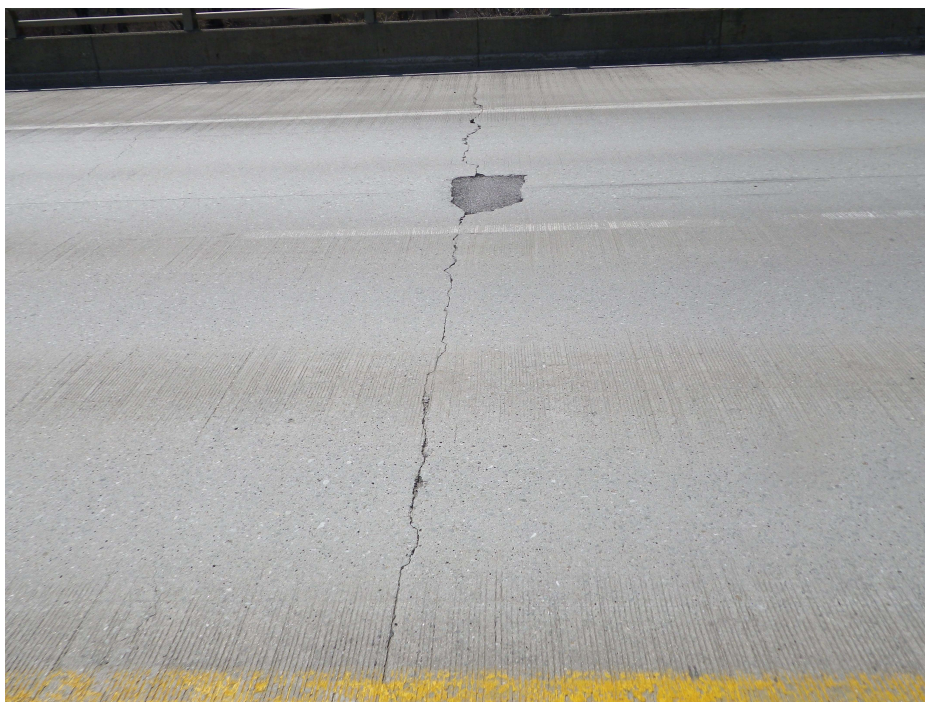
PHOTO 10

Description Transverse deck cracking, worst of three

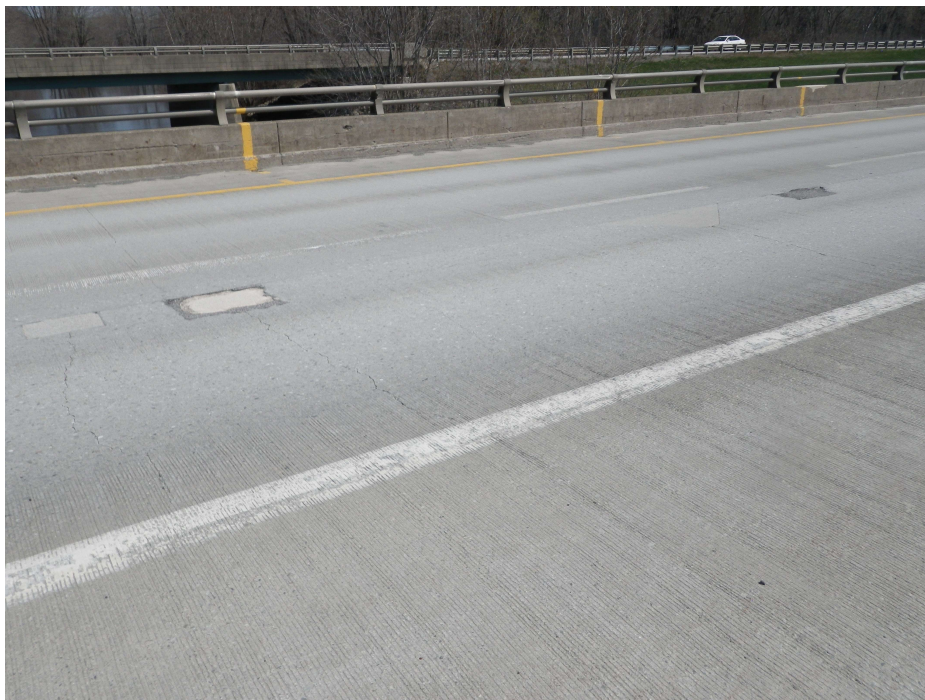
PHOTO 11

Description General view of patched concrete wearing surface

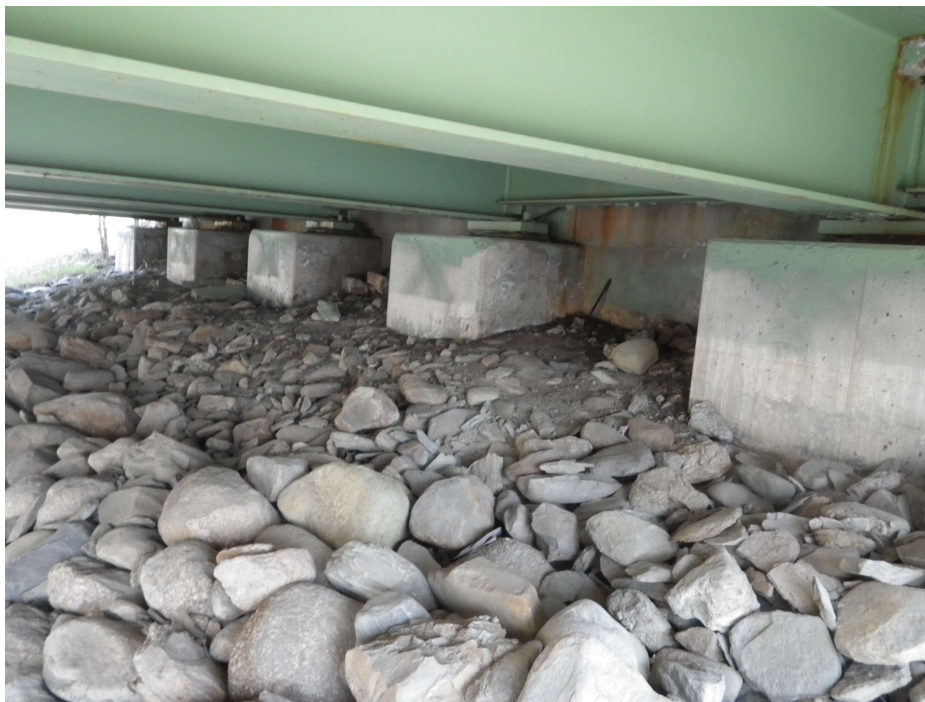
PHOTO 12

Description East abutment

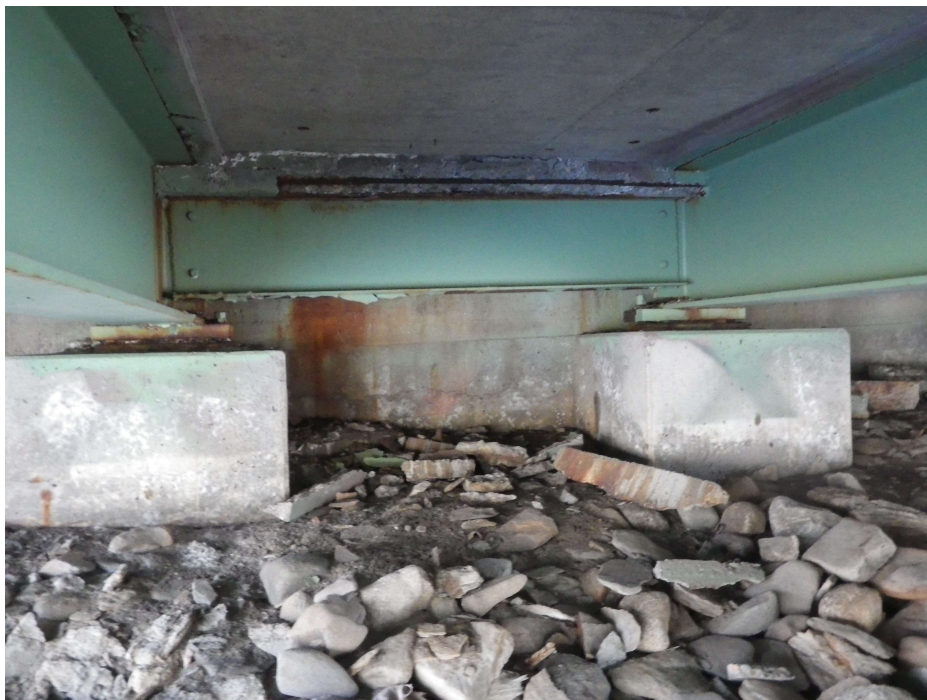
PHOTO 13

Description Spalled joint header, East end

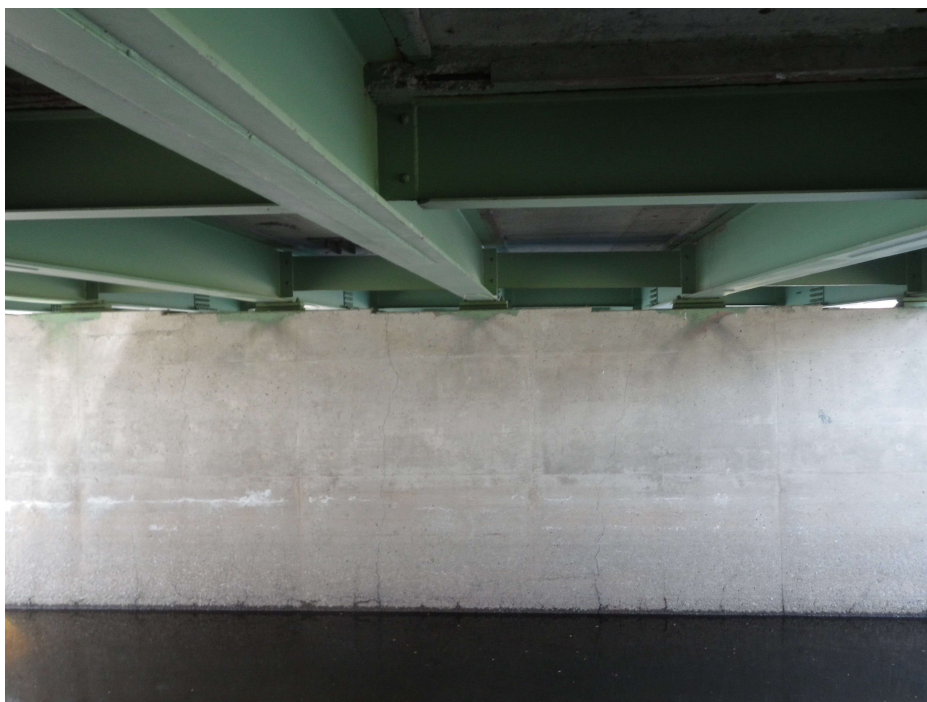
PHOTO 14

Description East side of East pier

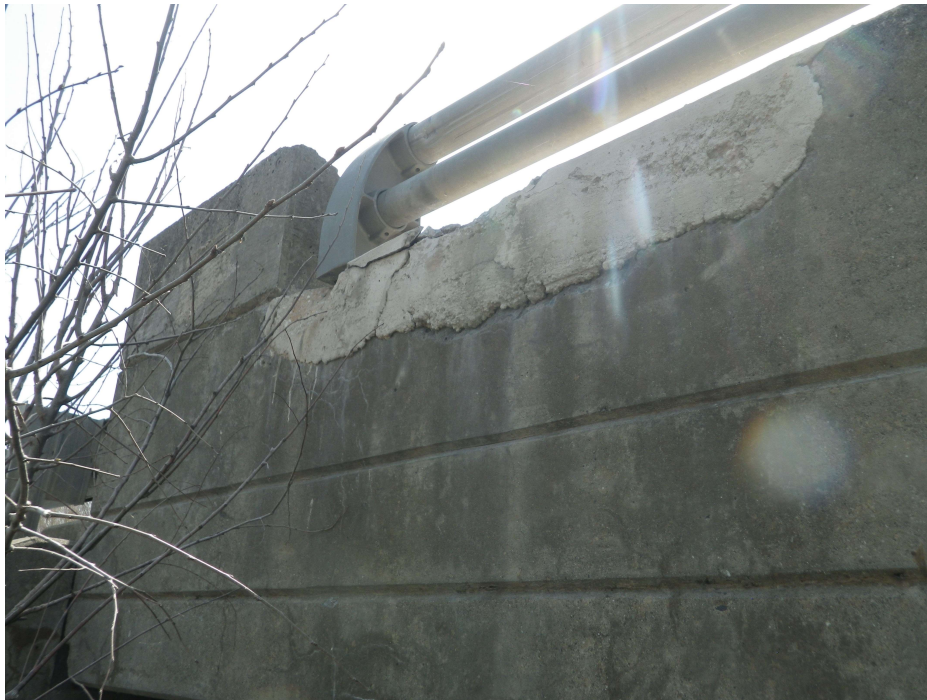
PHOTO 15

Description Patched concrete

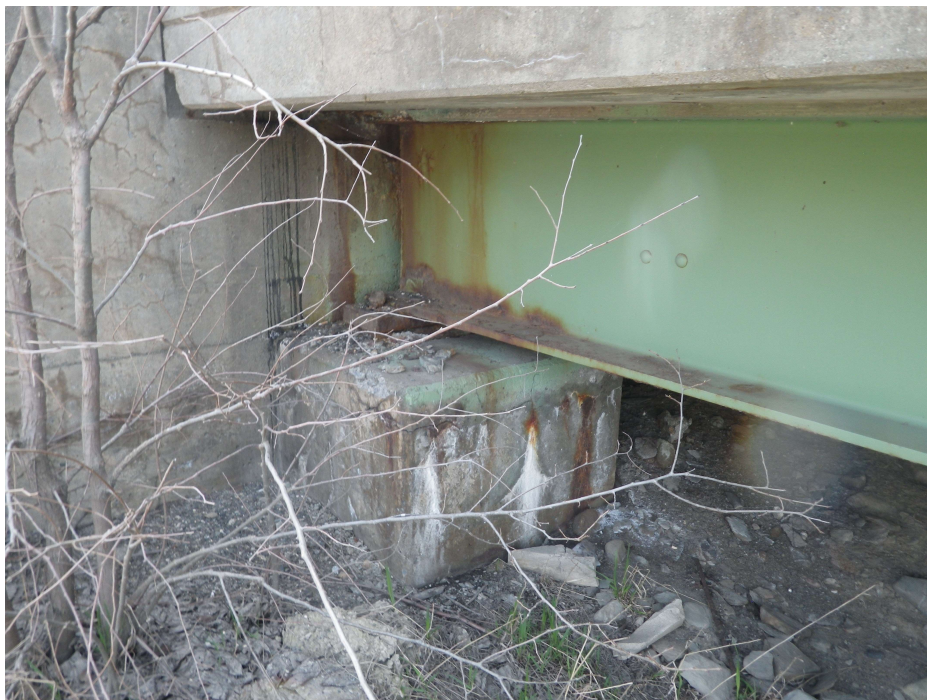
PHOTO 16

Description Exterior beam end

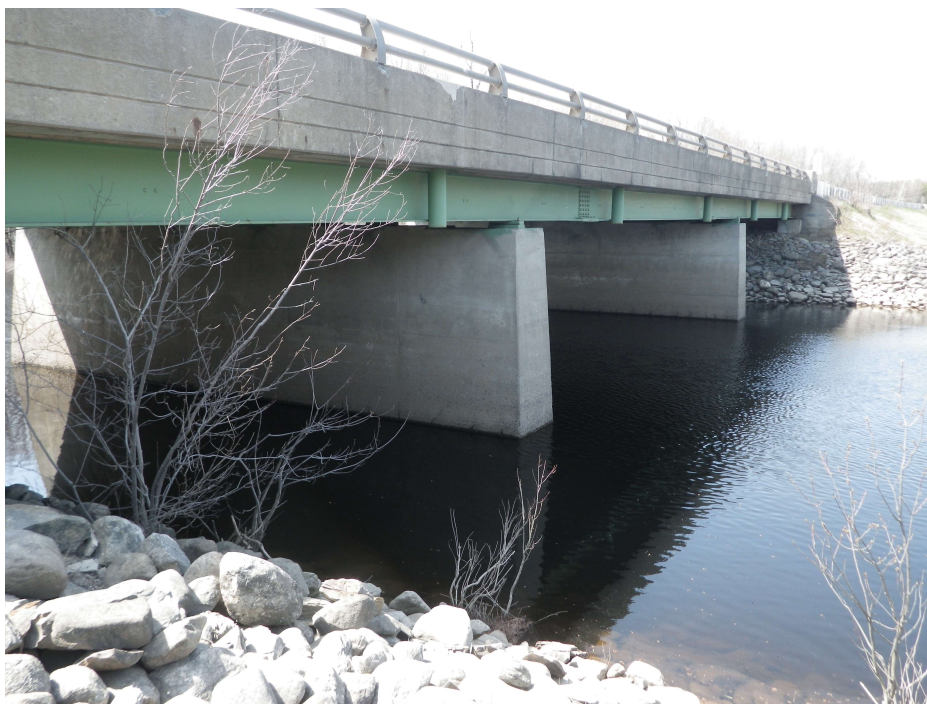
PHOTO 17

Description Down stream end

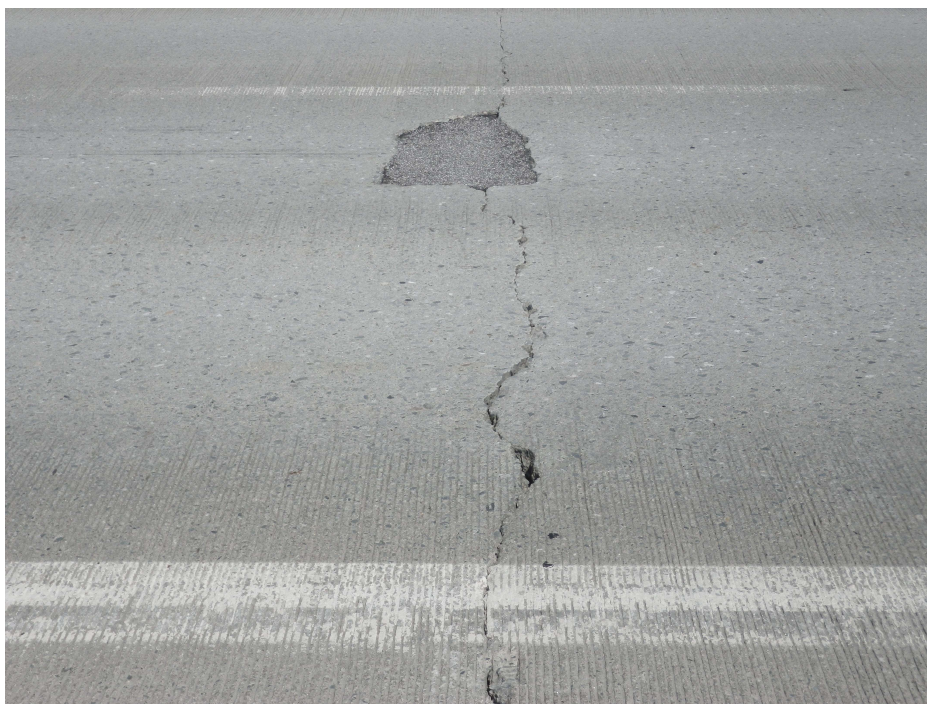
PHOTO 18

Description Transverse deck cracking

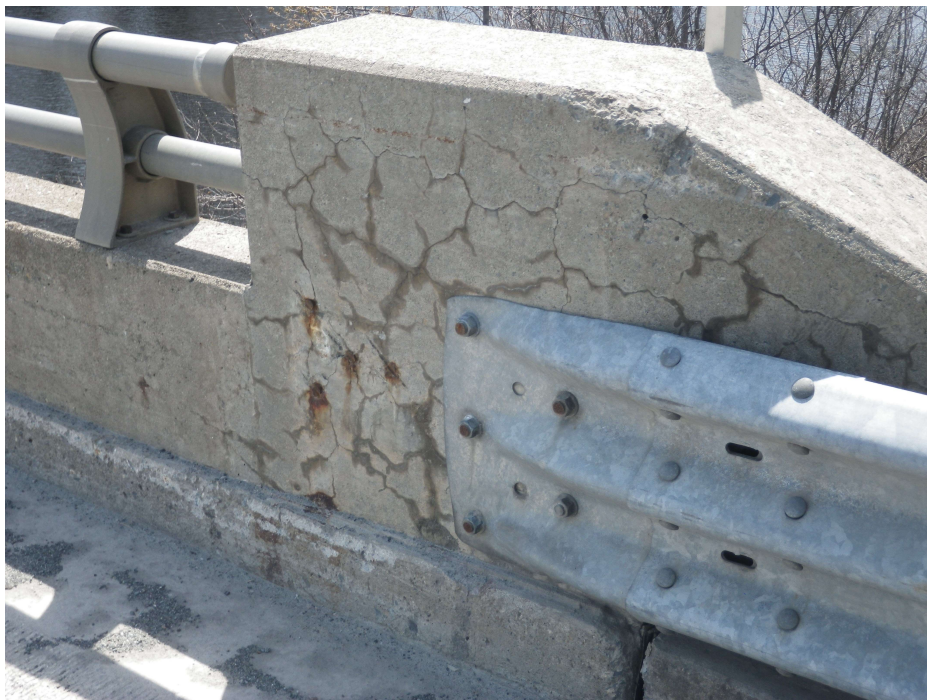
PHOTO 19

Description End post map cracking
