Highway Bridge Inspection Report

SOUADABSCOOK CENTER NB

Inspection Date: 09/01/2015

Inspection Type(s): Underwater

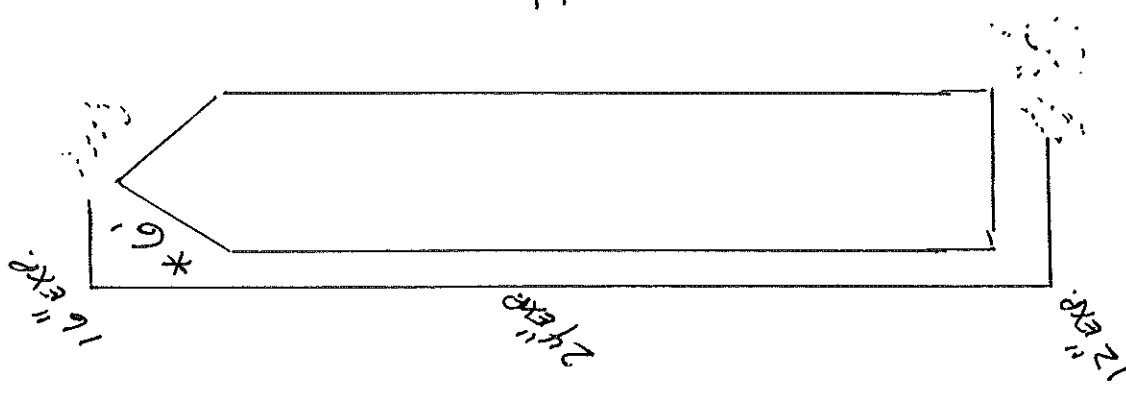
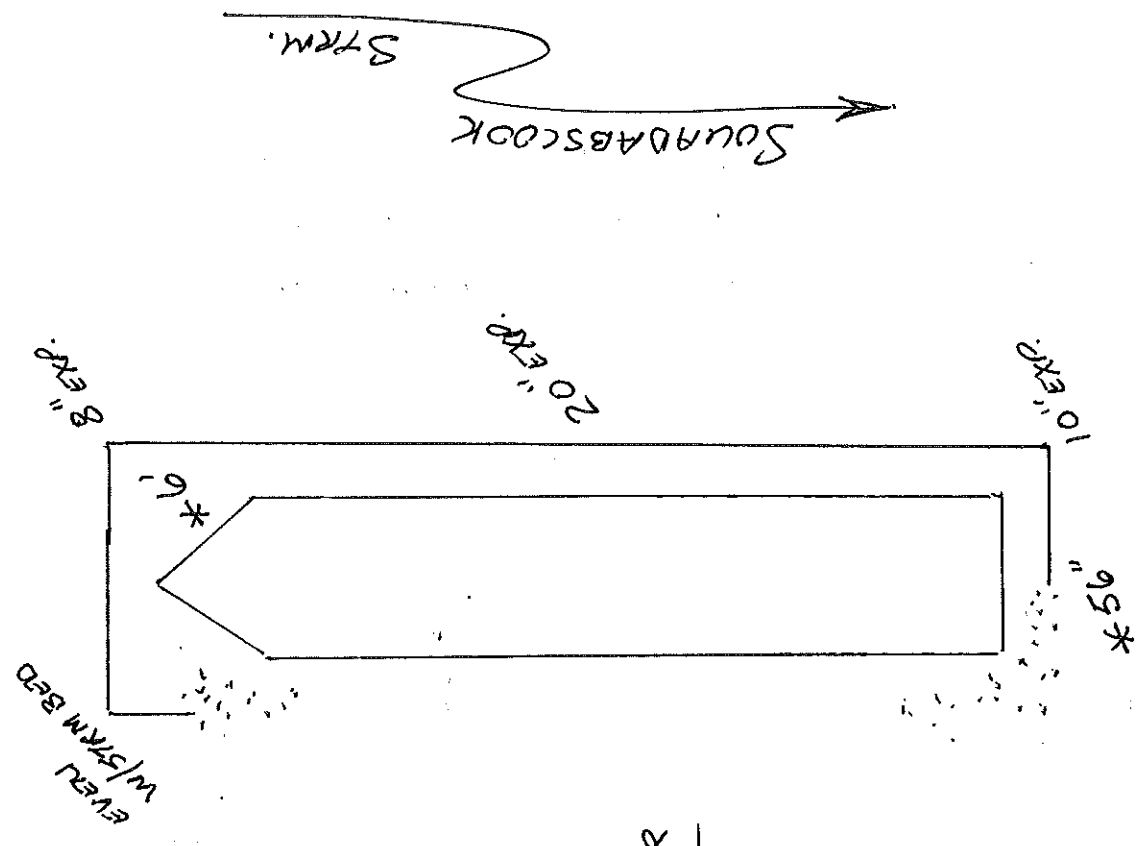
5950 HAMPDEN SQUADABSCOOK CENTER I-95NB 09-01-15

2 mass concrete piers. Both of the footings are exposed on the channel side. Concrete was in good condition. According to plans footings are 6'-6" in height and shown to be sitting on piles. 2007: Right footing exposed 0" to 10". Left footing exposed 0" to 17". 2011: Right footing exposed up to 10" max. Left footing exposed up to 24" max. Ratings remain same. Footings on piles. 2015: Right footing exposed up to 20" Left footing exposed up to 24". Ratings remain same.

* = WATER DEPTH EXP. = EXPOSED FOOTING

Type	Work Item	Priority	Notes
Maintenance	Stabilize Substructure	3	Grout Bag
