Highway Bridge Inspection Report

**SOUADABSCOOK EAST NB
I 95 NB
over
SOUADABSCOOK STREAM**

Inspection Date: 05/07/2015

Inspection Type(s): Routine

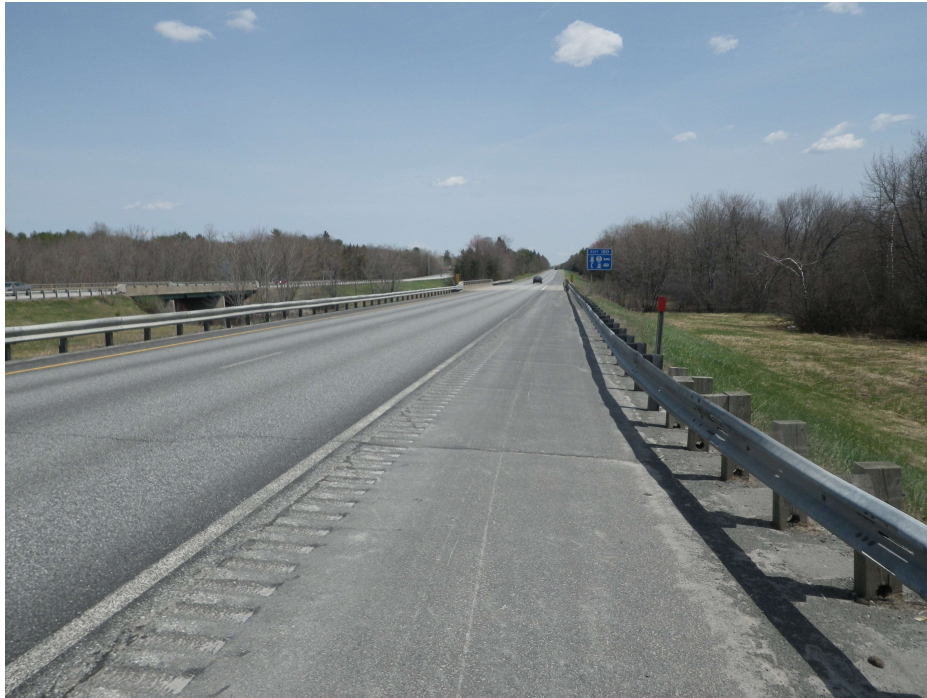
PHOTO 1

Description Roadway looking East

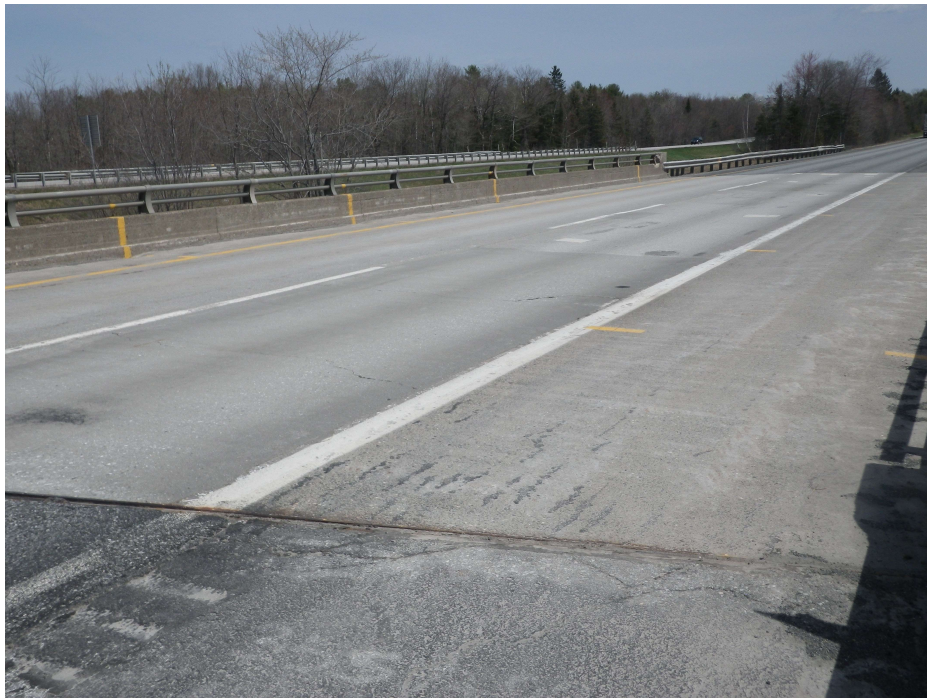
PHOTO 2

Did not chain wearing surface due to heavy traffic, but observed approximately 25% cracking and patched areas. Isolated transverse cracking.

Description General view of concrete wearing surface

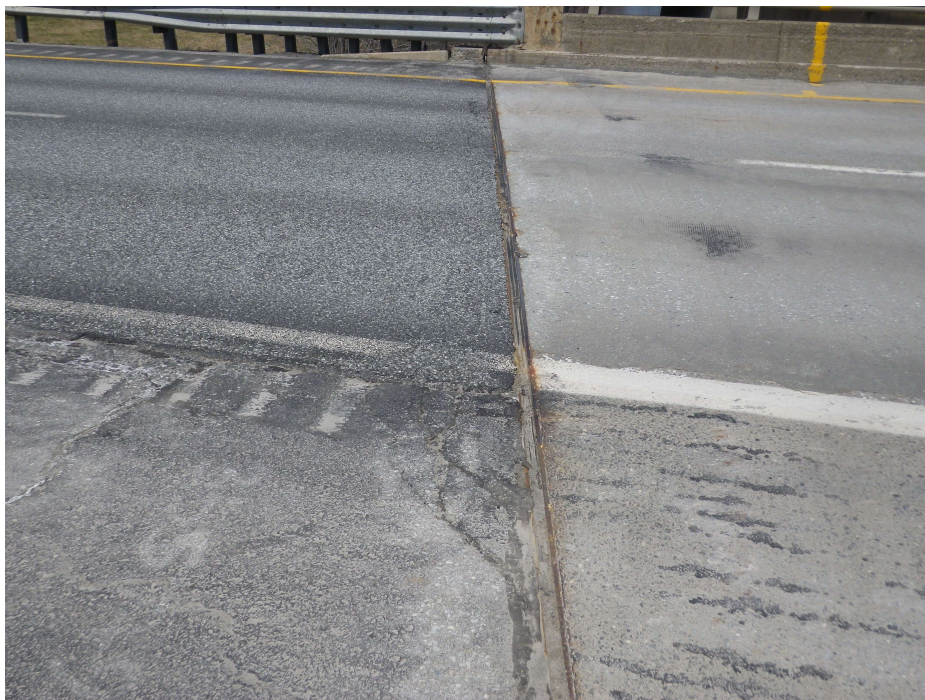
PHOTO 3

Description West joint

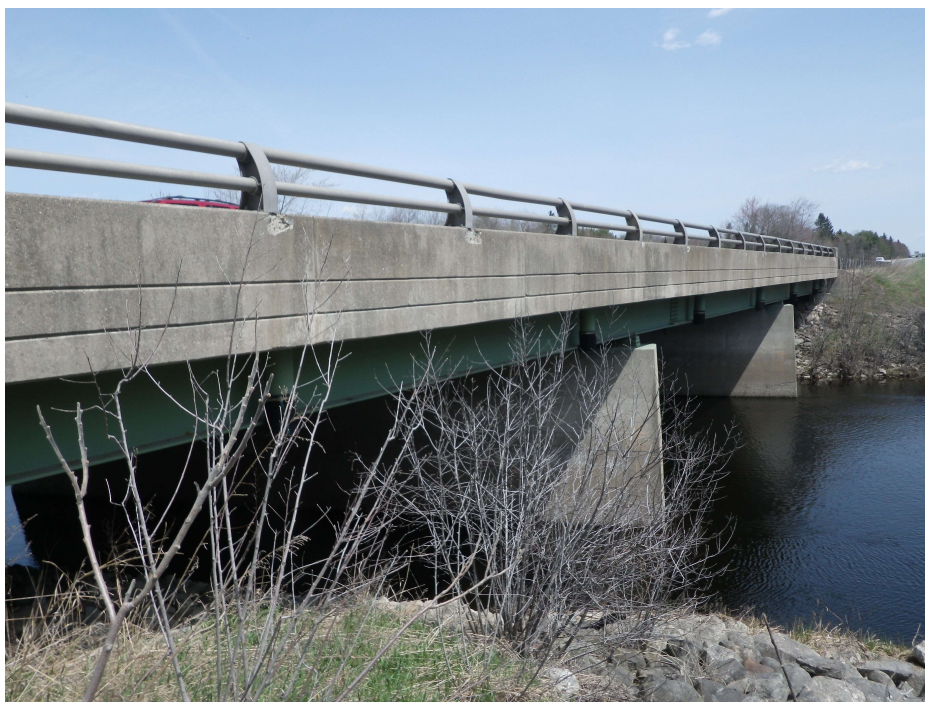
PHOTO 4

Description Down stream end

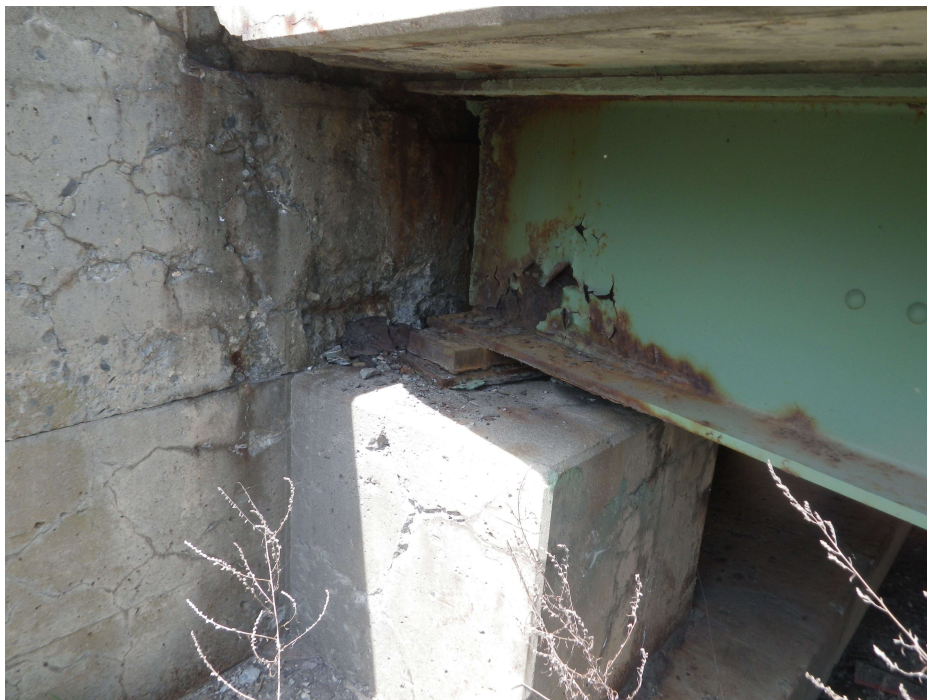
PHOTO 5

Approximately 25% paint system distress with moderate rusting at exterior beam end areas (see photos). Recommend painting of beam ends & repairs to damaged bridge rail bars & posts. Several bearing anchor bolts are missing.

Description Exterior bearing, back wall and beam end deterioration, West end

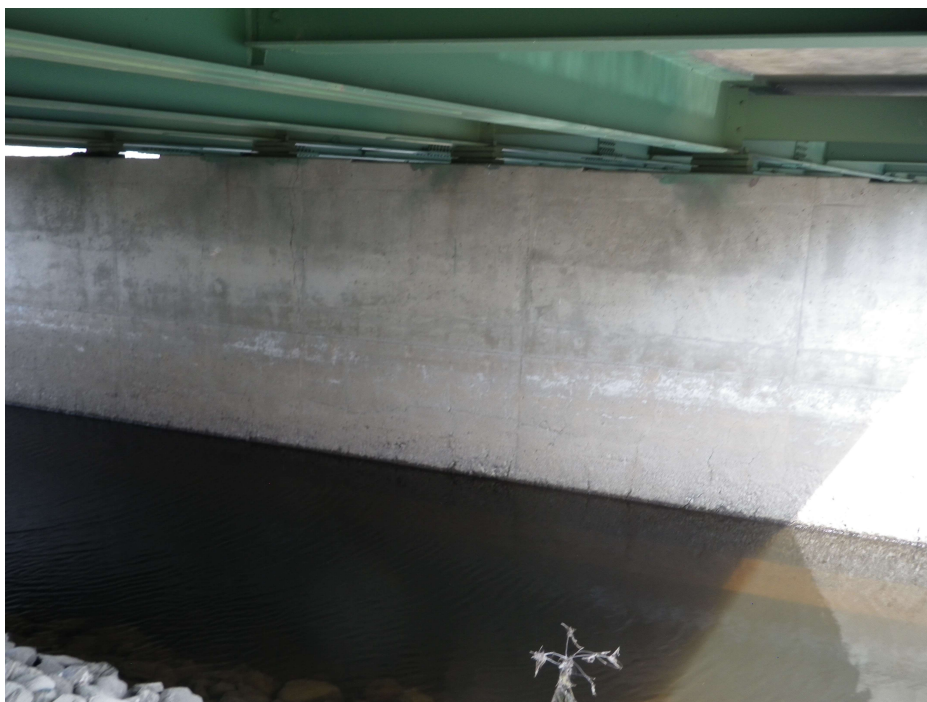
PHOTO 6

Description West side of the West pier

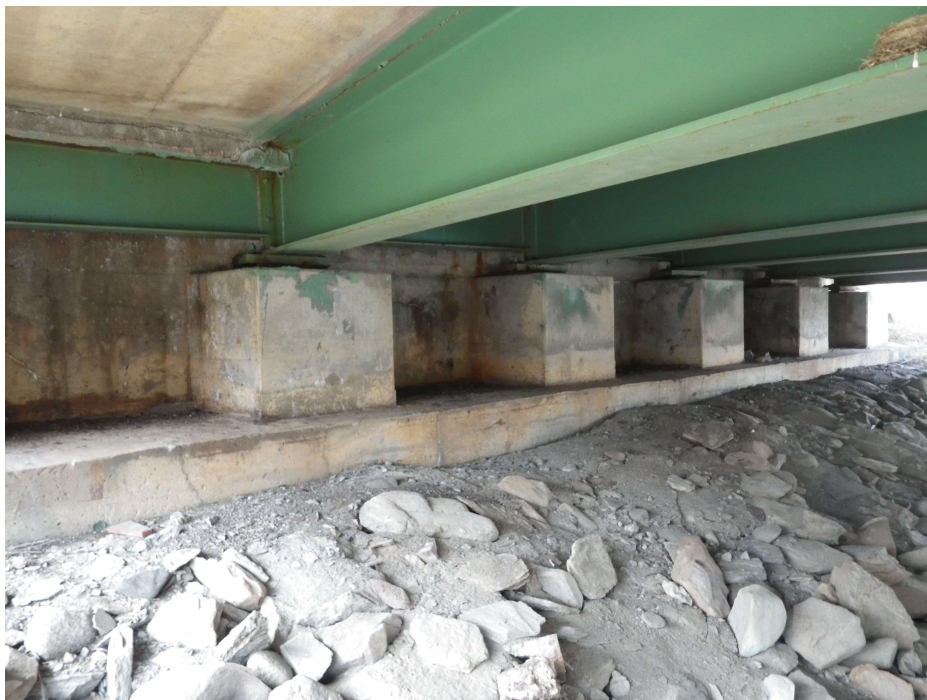
PHOTO 7

Description West abutment

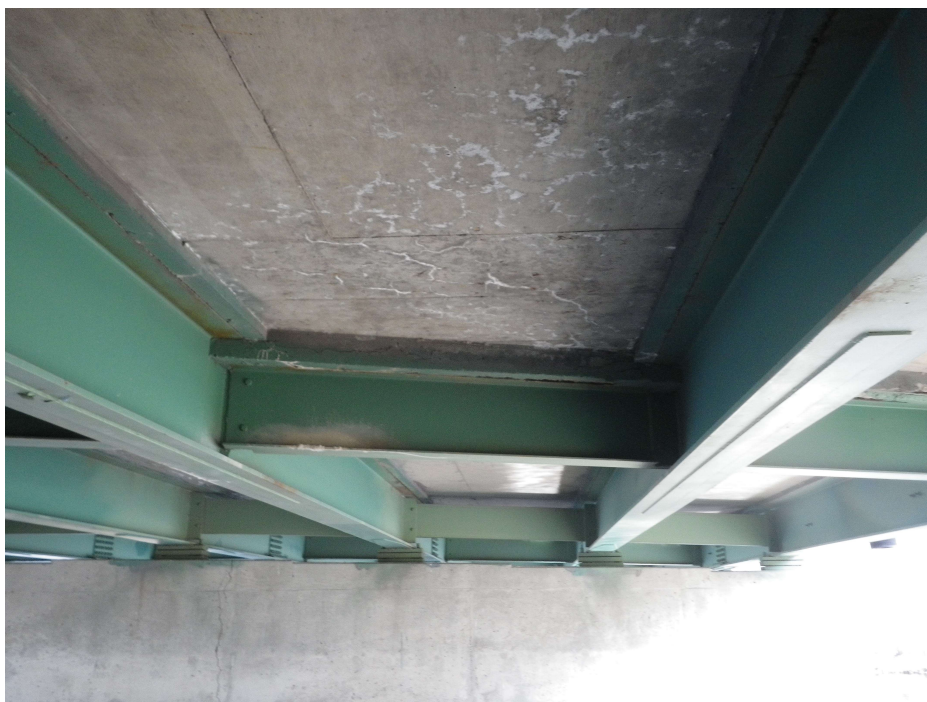
PHOTO 8

Bottom of deck has spalling at blocking and joint areas and large areas of staining. Approximately 20% complete seal failure with additional leakage.

Description Bottom of the deck, West end

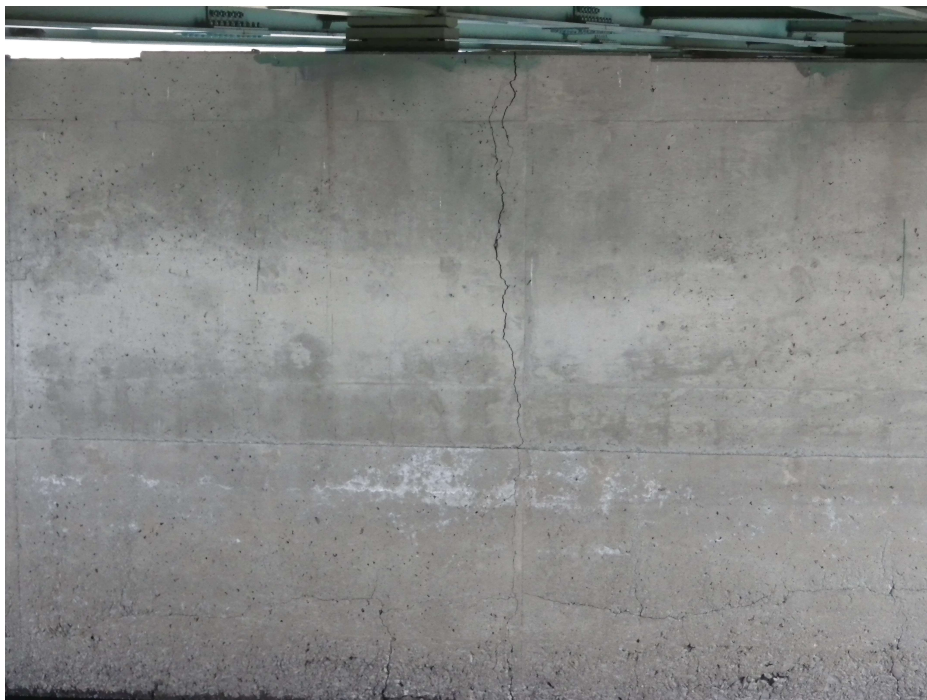
PHOTO 9

See 2011 dive report for substructure and channel details. Moderate cracking, staining and scaling of abutment bridge seats & back-walls. West pier has a full height crack that is 1/8" wide at the top down to fine cracking at the bottom.

Description Crack at center of West pier, West side, 1/8" wide at top

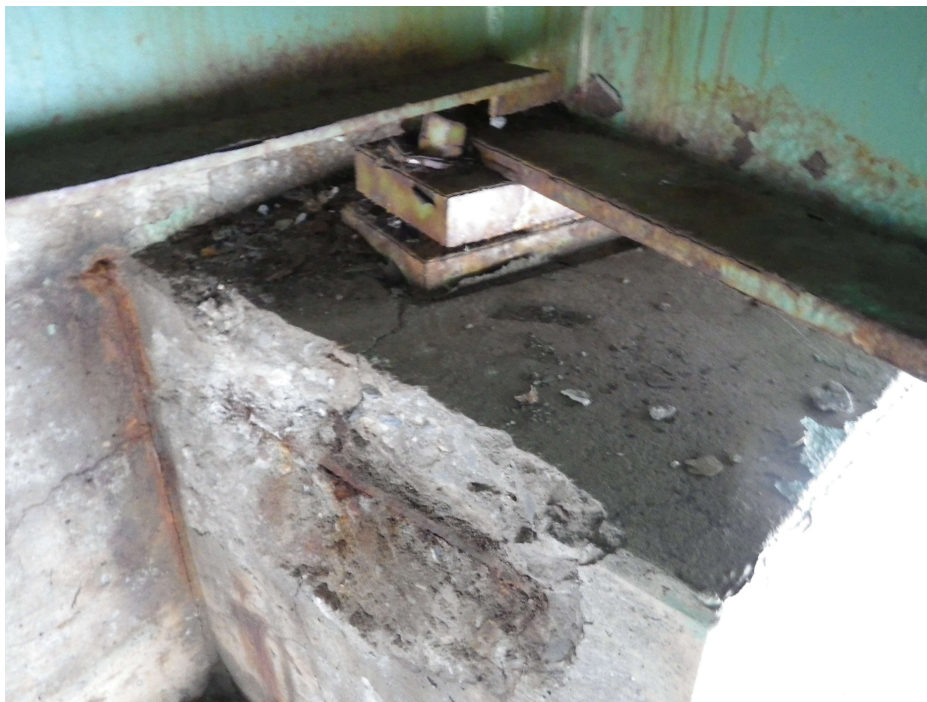
PHOTO 10

Description Spalled West abutment bearing block with crack

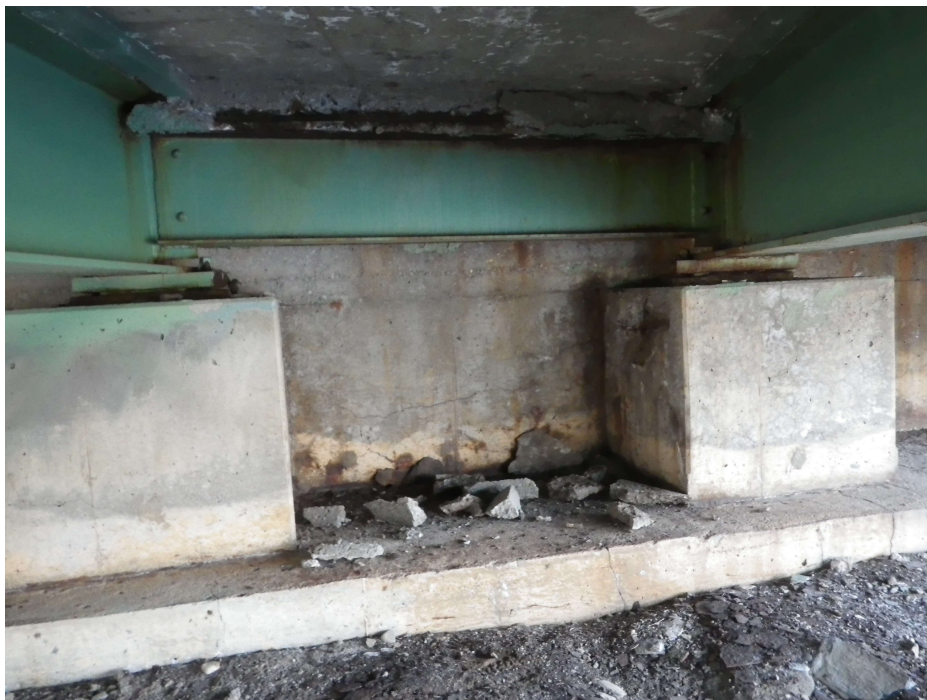
PHOTO 11

Description Spalled joint header, typical of both East and West ends

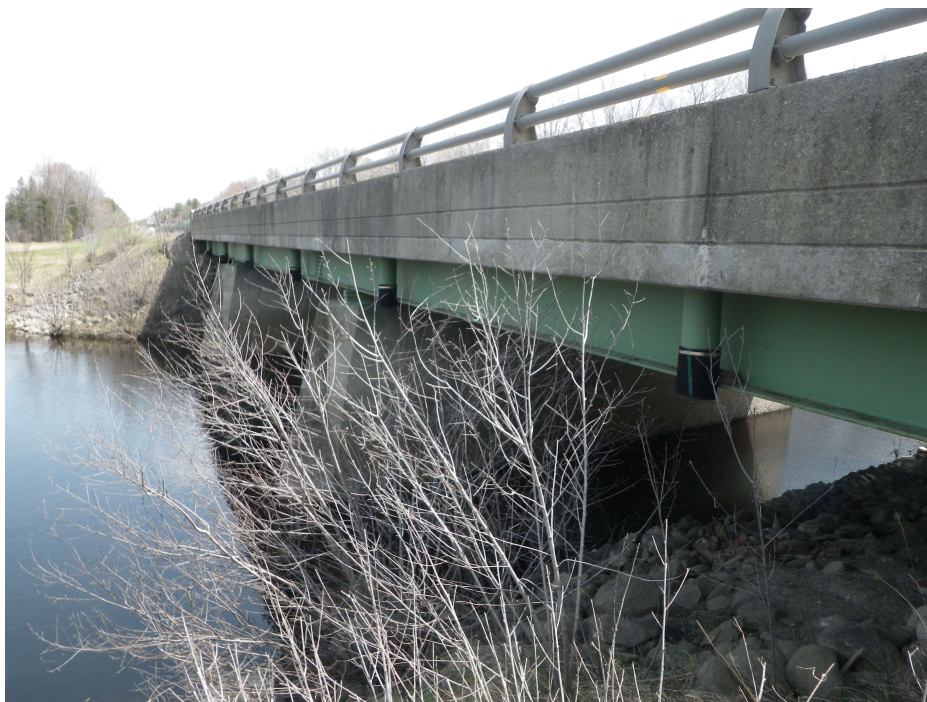
PHOTO 12

Description Up stream end

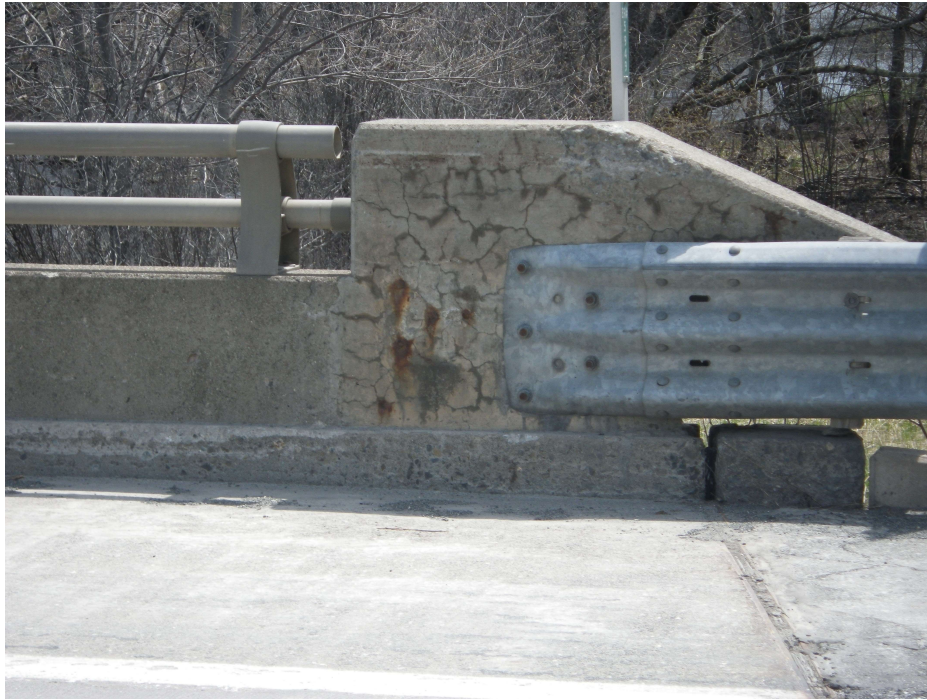
PHOTO 13

Description Map cracking of end posts

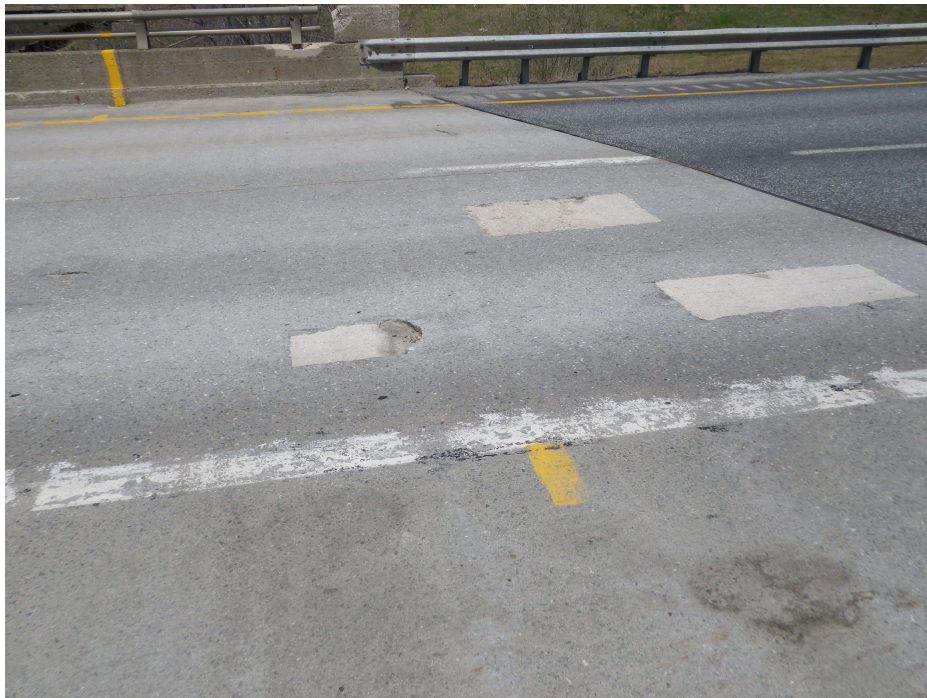
PHOTO 14

Description Patching of wearing surface

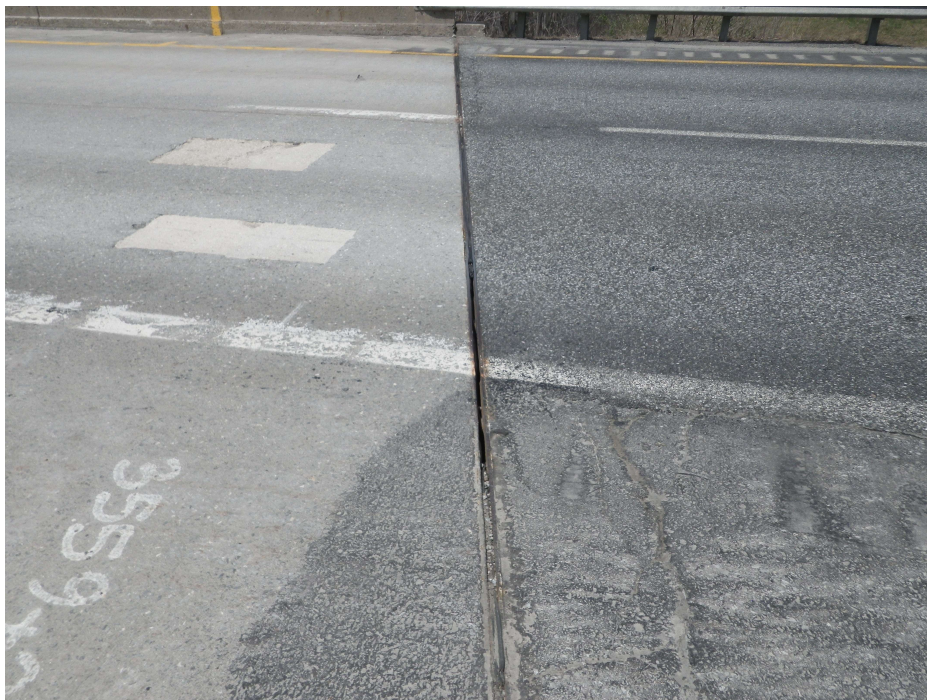
PHOTO 15

Description Failed East joint

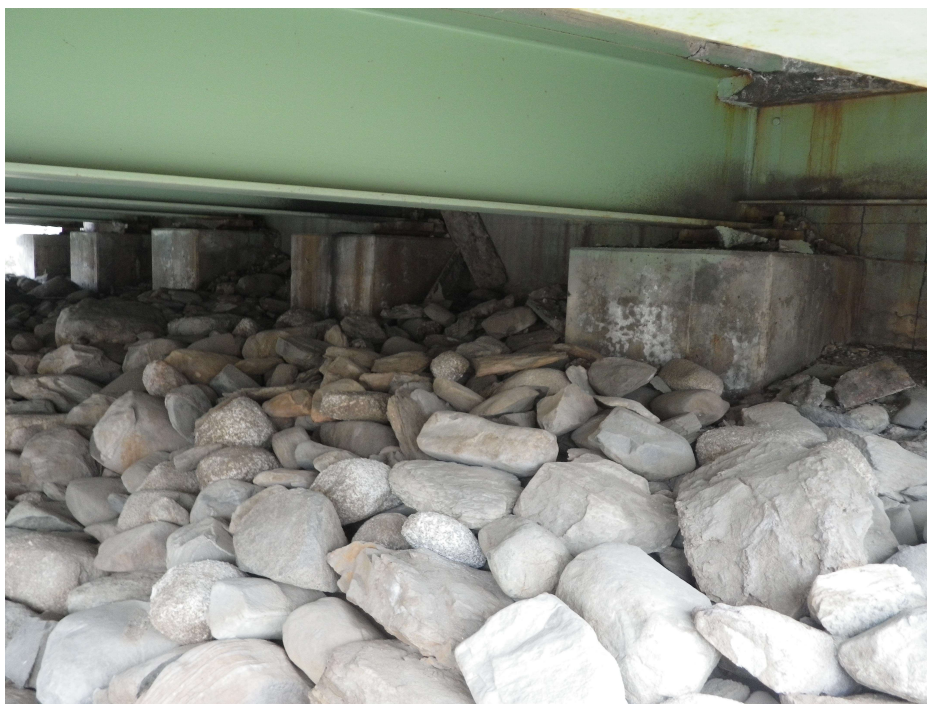
PHOTO 16

Description East abutment

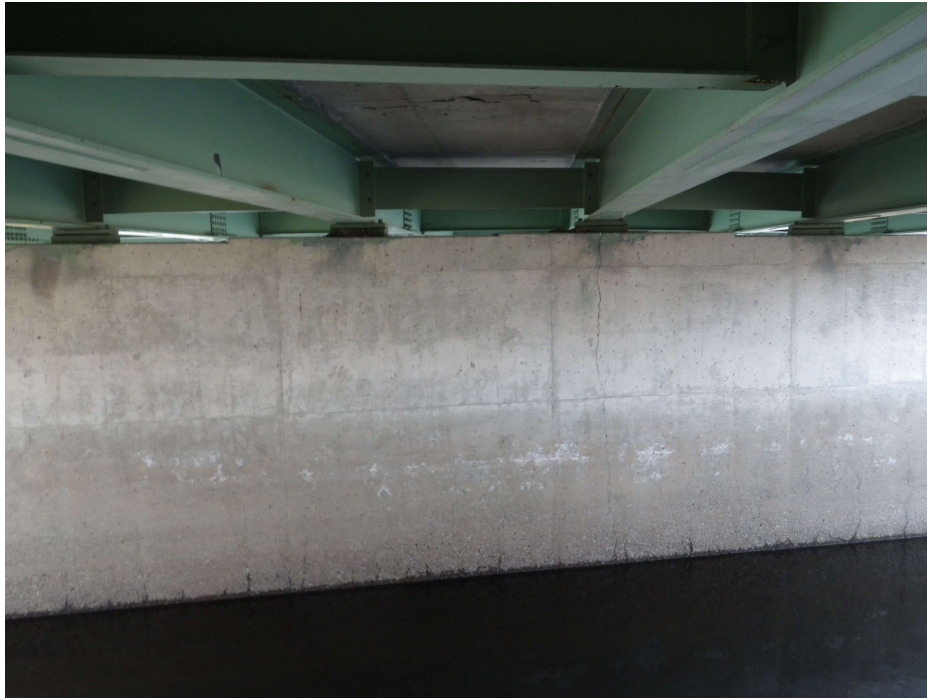
PHOTO 17

Description East side of East pier

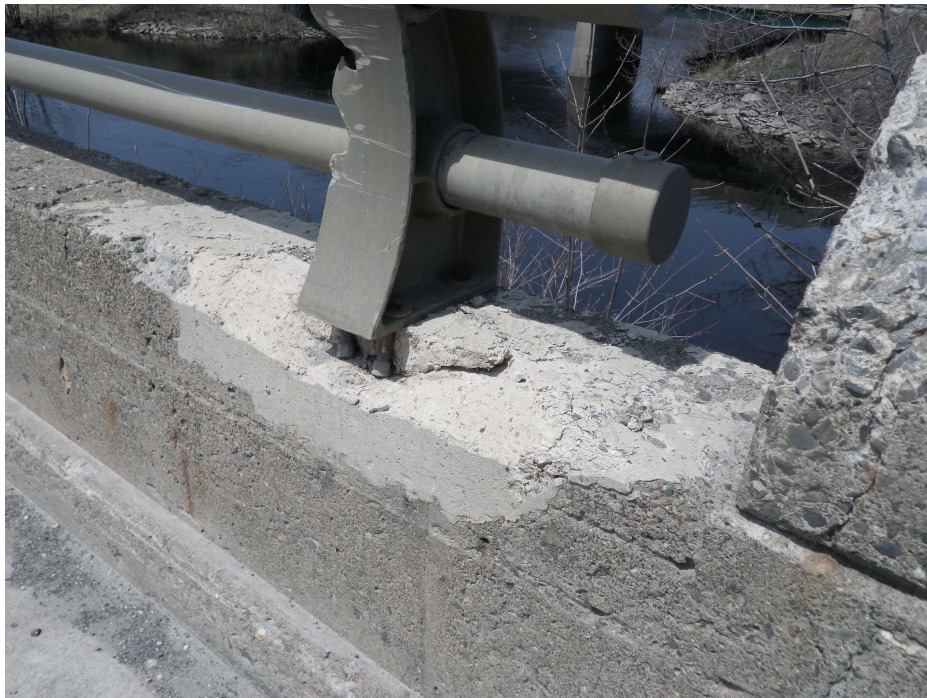
PHOTO 18

Description Spalled patch
