# **Highway Bridge Inspection Report**

**SOUADABSCOOK EAST NB**

**I 95 NB**

**SOUADABSCOOK STREAM**

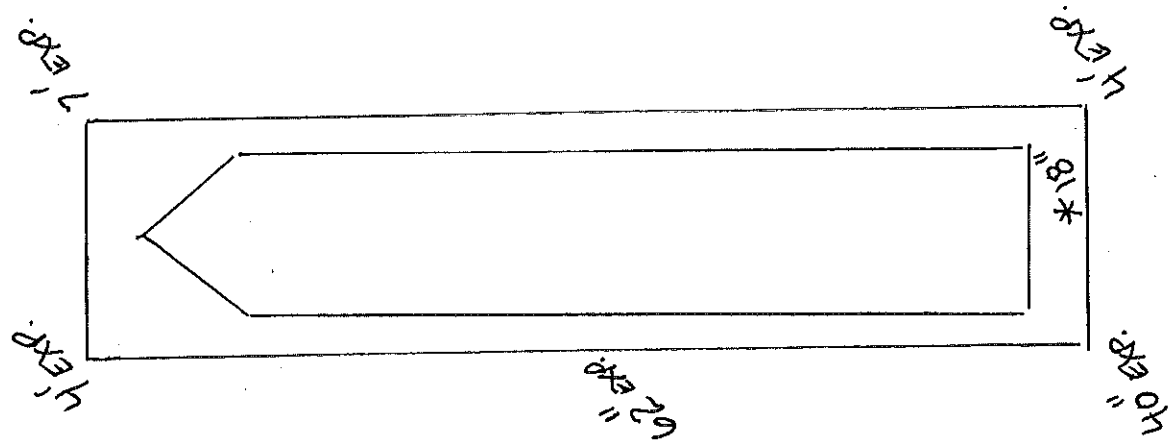
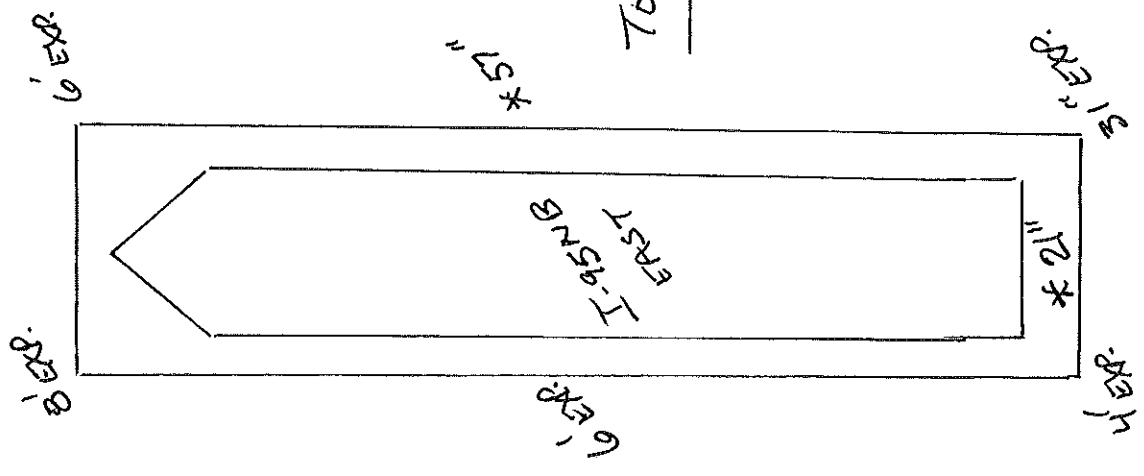
2 piers on ledge in good condition. Inspected with SB bridge. No significant change in exposed footing. Piers on ledge per plans. 2011: No major changes. Exposed footing similar to previous report. 2015: Exposed footings. Lft pier exposed 8'. Right pier exposed 7'. No changes.

\* = WATER DEPTH  
 EXP. = EXPOSED FOOTING
