Highway Bridge Inspection Report

**SOUADABSCOOK WEST NB
95 NB
over
SOUADABSCOOK STR**

Inspection Date: 05/07/2015

Structure Number: 5951

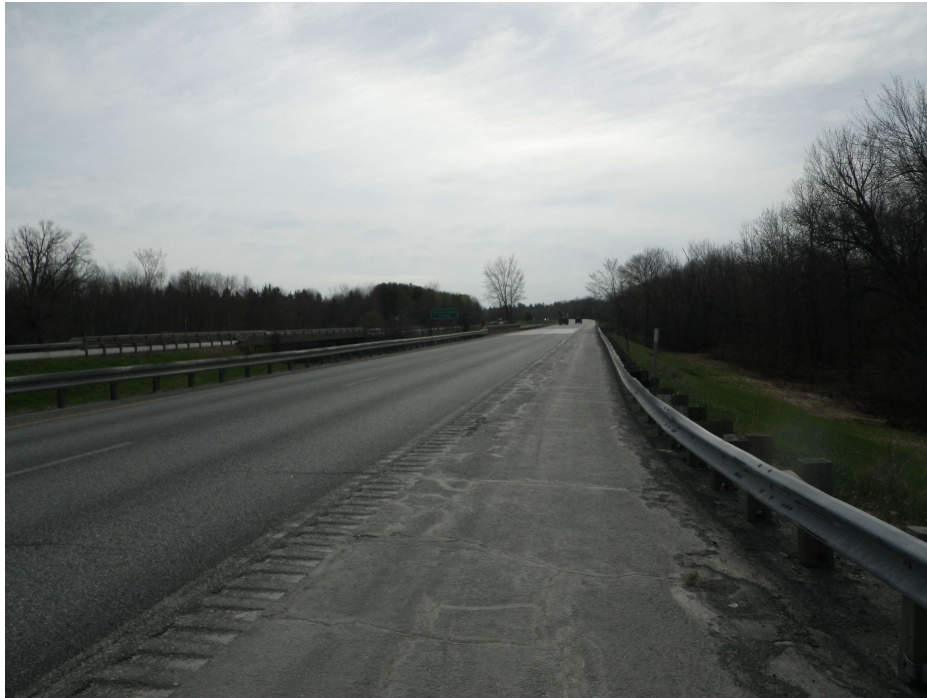
PHOTO 1

Description Roadway looking North

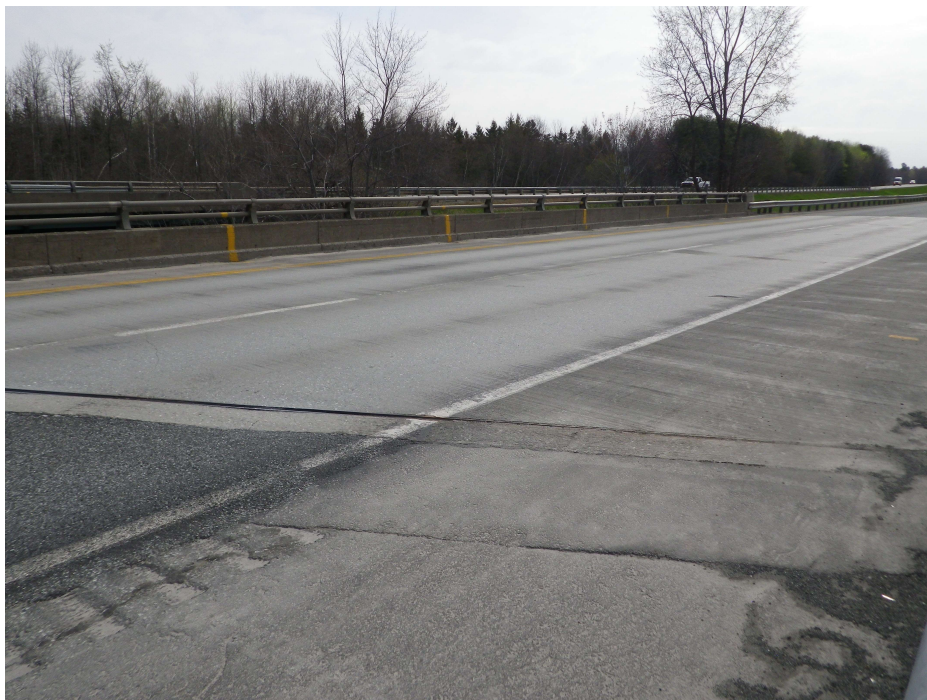
PHOTO 2

Did not chain wearing surface due to high traffic volume, but observed approximately 50% scattered heavy cracking, wear, small subsidence potholes and patched area to concrete.

Description General view of concrete wearing surface

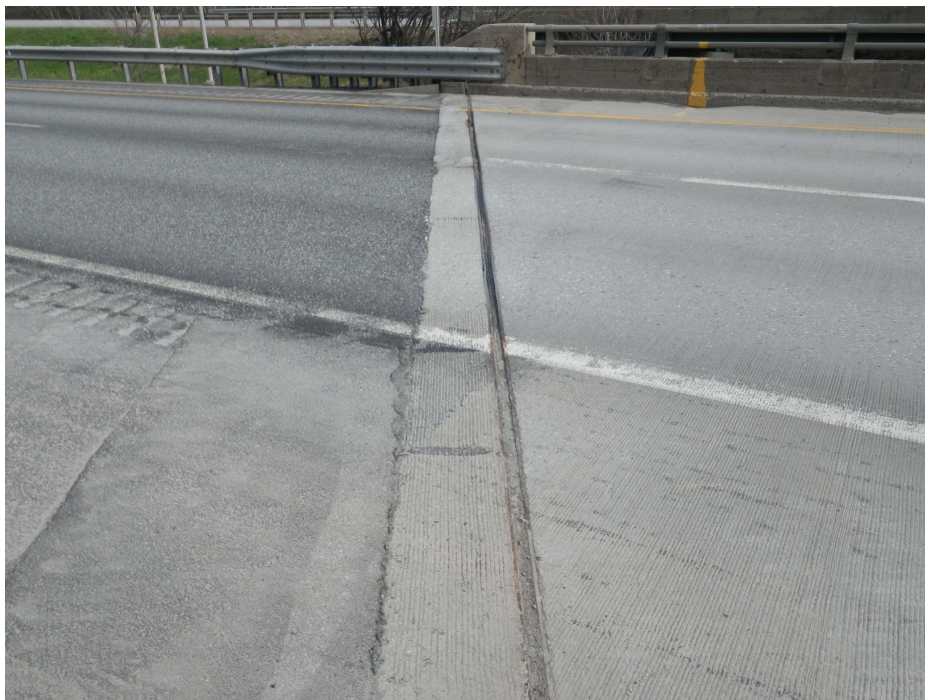
PHOTO 3

Description West joint

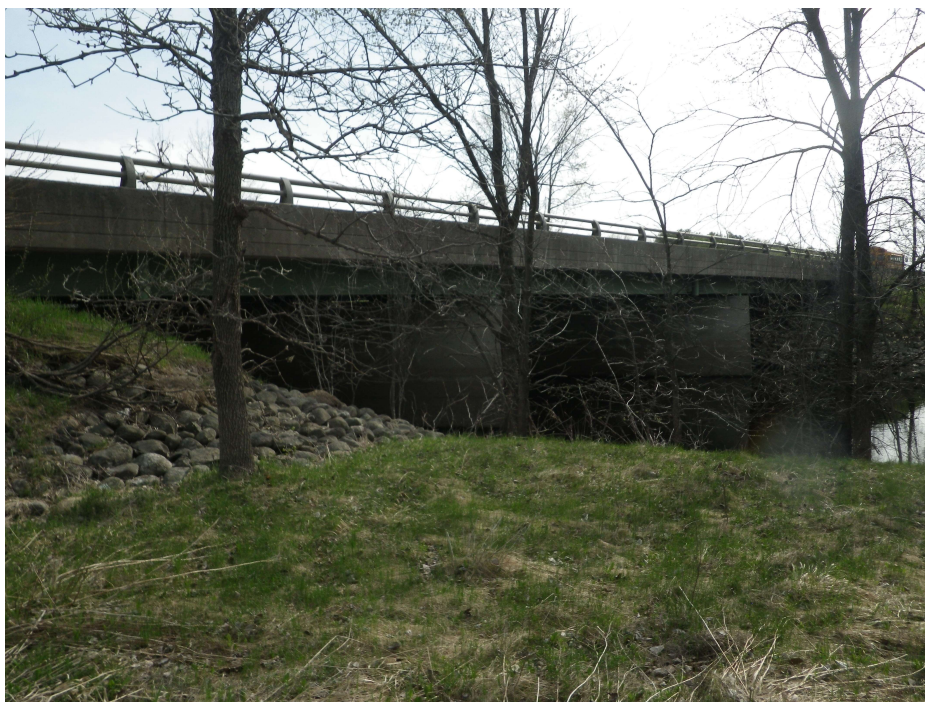
PHOTO 4

Description Down stream end

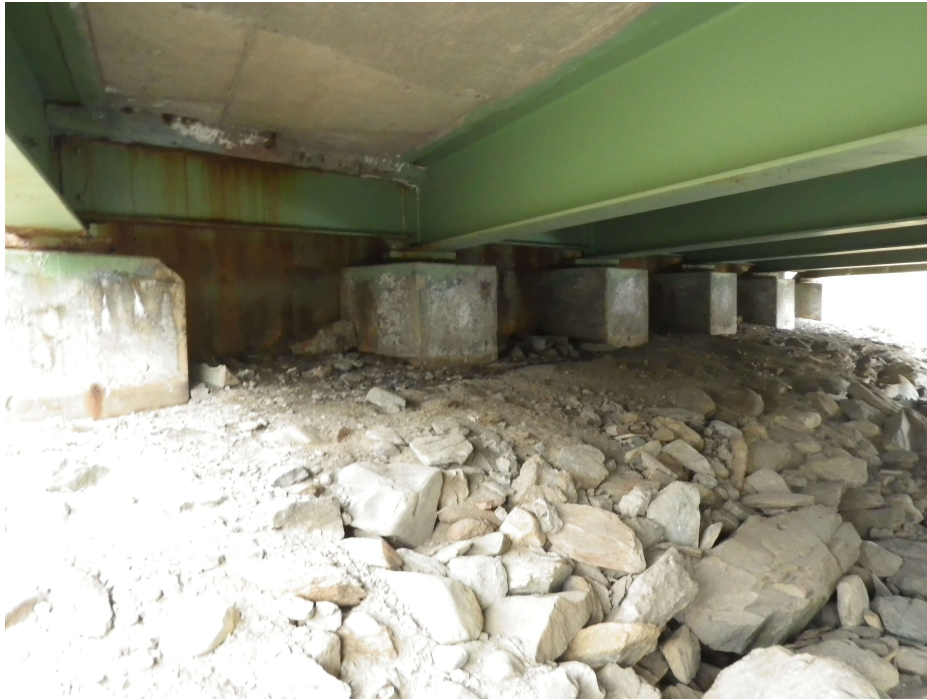
PHOTO 5

Description West abutment

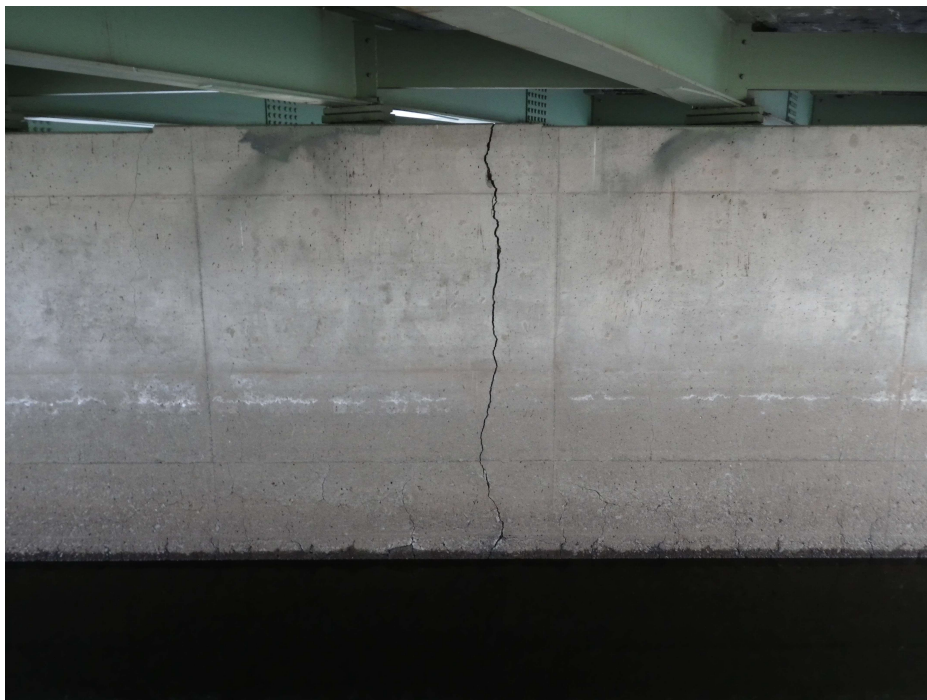
PHOTO 6

Crack in west side of the west pier was approx. 1/8" - 1/4" at the top and 1/16" - 1/8" at the bottom in 2011. Could not get within arms length, but 20' away I estimate the crack to be 3/8" wide at the top. There is a crack near the center on the East side of the East pier that is 1/8" wide at the top and is only fine cracking by the time it reaches halfway down the pier. The back walls of both abutments have heavy rust staining and minor to moderate cracking.

2007 - MEASURE AND MONITOR VERTICAL PIER CRACK - BWF 2015 - Slight change in West abutment crack from 1/4" wide at top to 3/8".

Description Full height crack in West pier

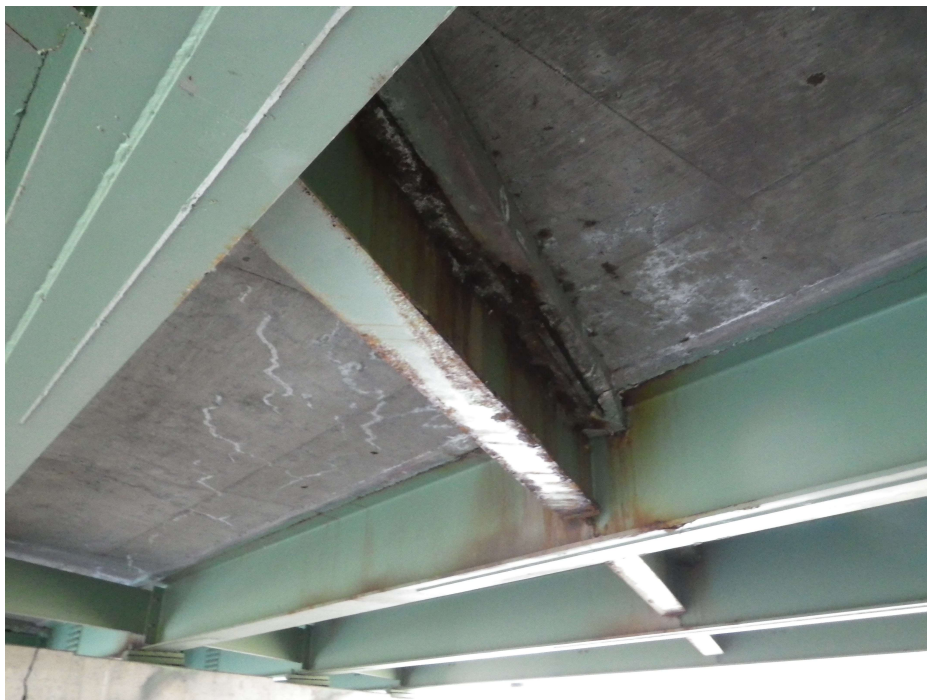
Paint loss at beam ends and bearings from leaking joints. The diaphragms have paint loss and scaling rust from the leaking deck above. Approximately 15% paint system distress with moderate/ heavy rusting at exterior beam end areas (see photos)

PHOTO 7 Condition
Description Leaking deck with steel deterioration below

Type	Work Item	Priority	Notes
Maintenance	Rehab Substructure	2	Rehab bearing blocks
Maintenance	Paint	2	Paint beam ends

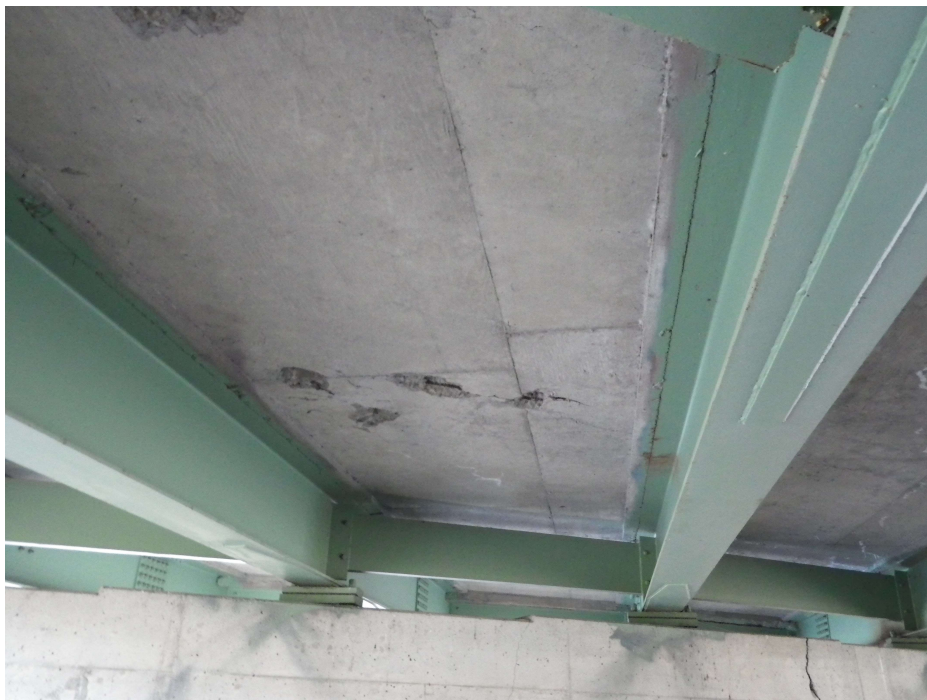
Moderate cracking & staining to both fascia bays and ends of interior bays. Worst areas toward deck ends. Bottom of deck has a high percentage of blocking spalling, small delams and heavy cracking/ stained areas. Largest concern at this time is the large percentage of cracking to both the concrete wearing surface and bottom of the deck. The bottom of the joint haunches are in poor condition with 50%+ spalled and exposed re-steel.

PHOTO 8
Description Spalled areas on bottom of deck, West end

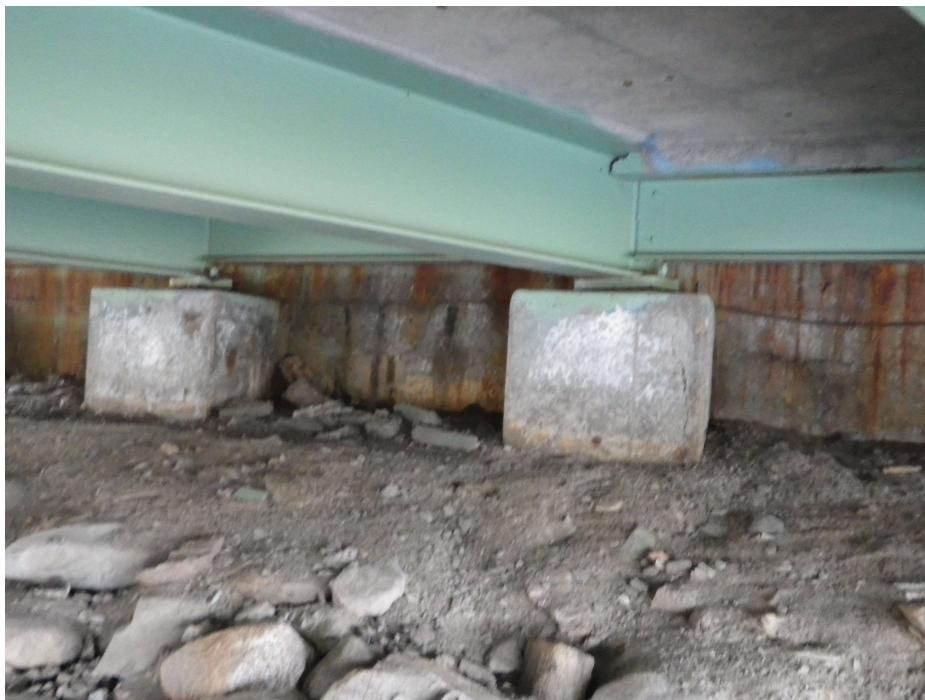
PHOTO 9

Description Back-wall staining

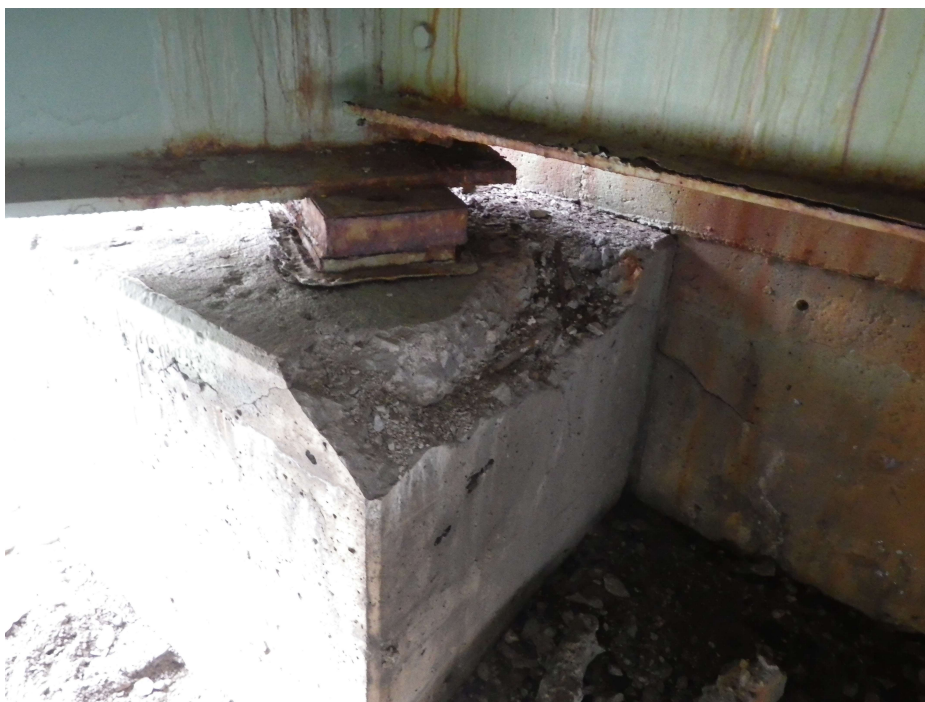
PHOTO 10

Description Exterior, West abutment, bearing block deterioration

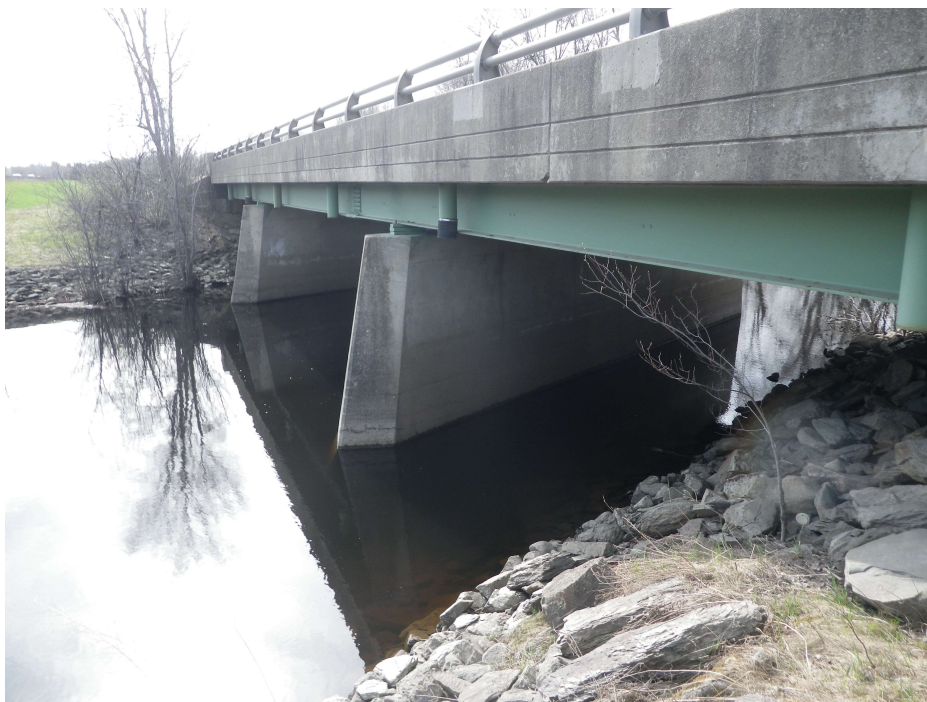
PHOTO 11

Description Up stream end

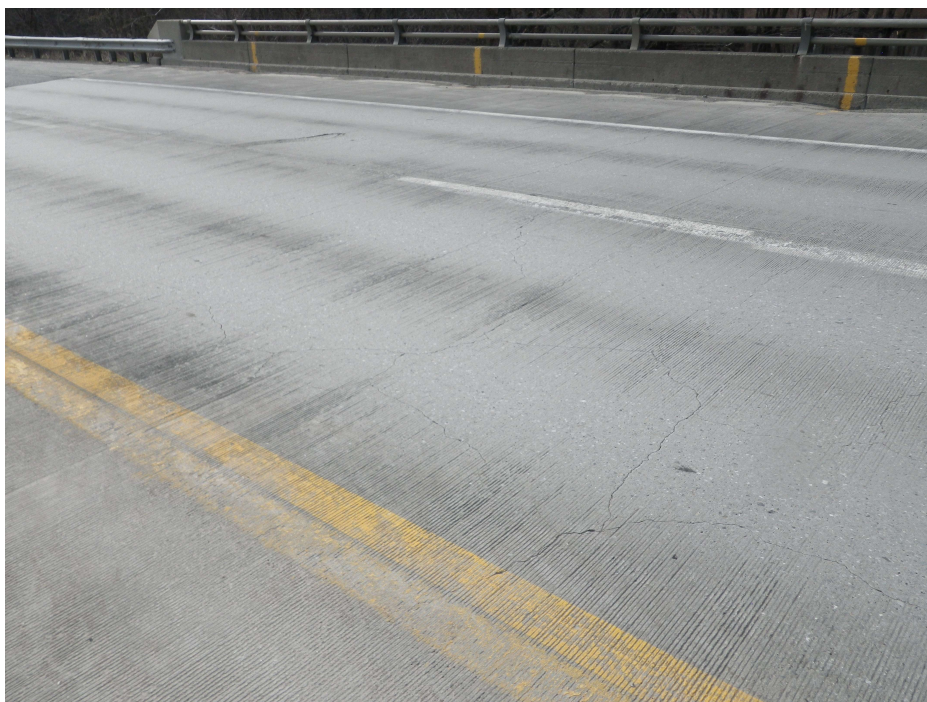
PHOTO 12

Description Wearing surface cracking

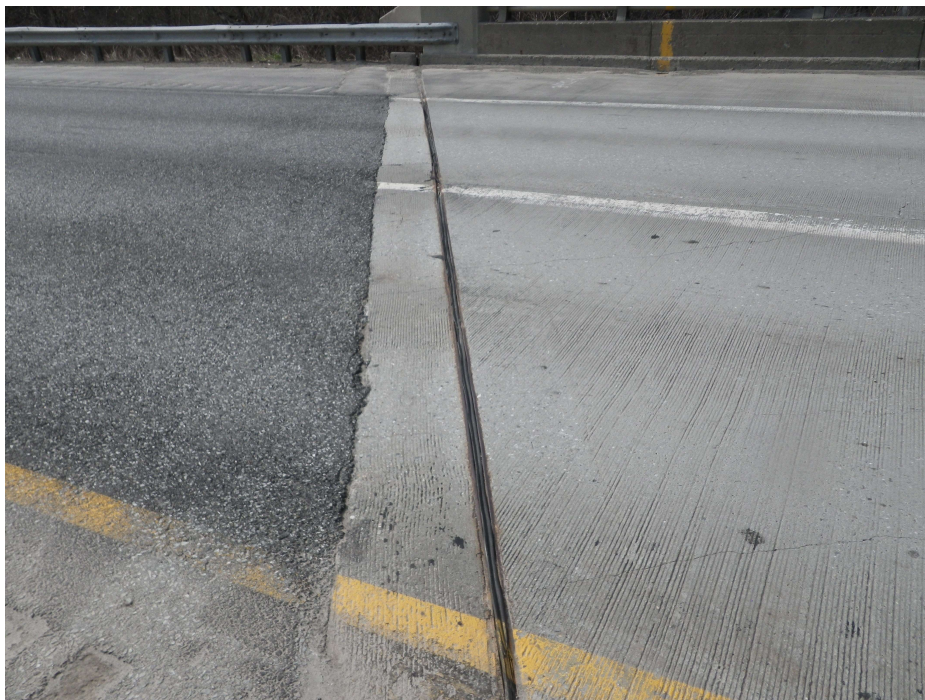
PHOTO 13

Description East deck joint

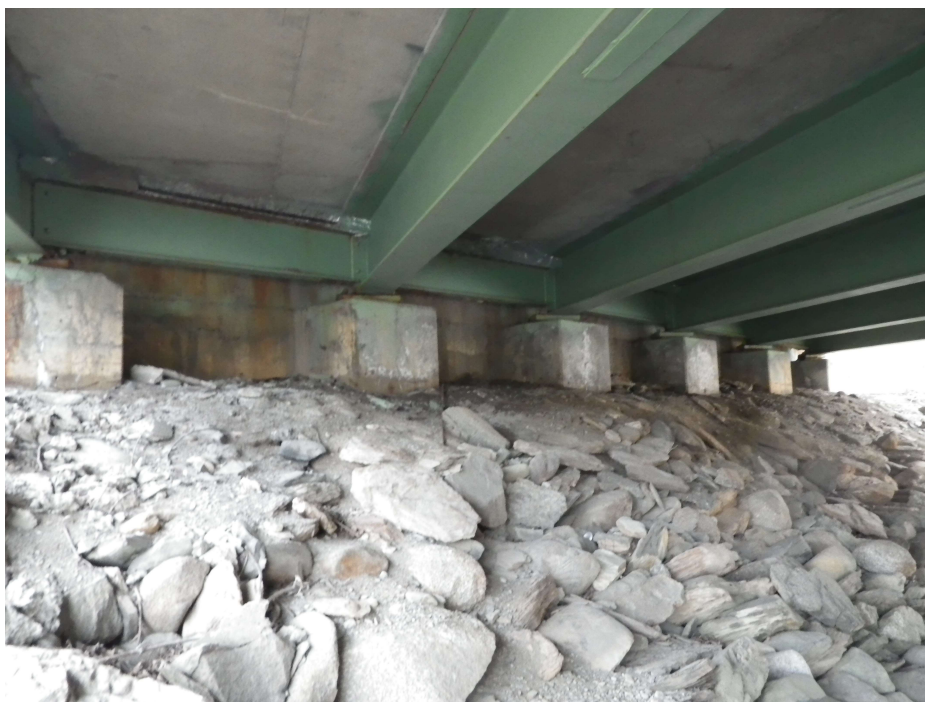
PHOTO 14

Description East abutment

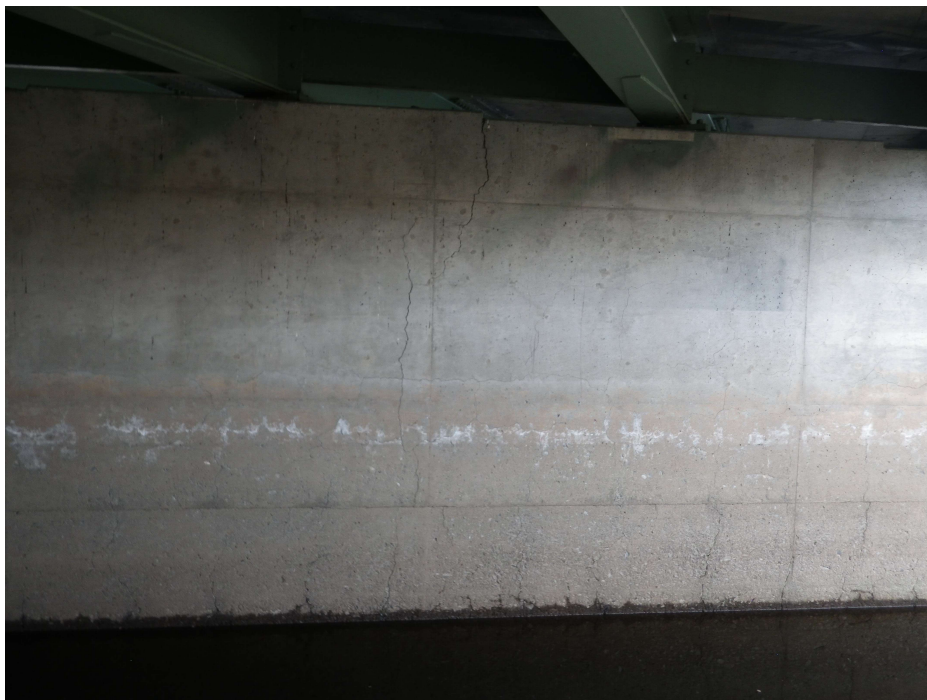
PHOTO 15

Description East pier fine cracking

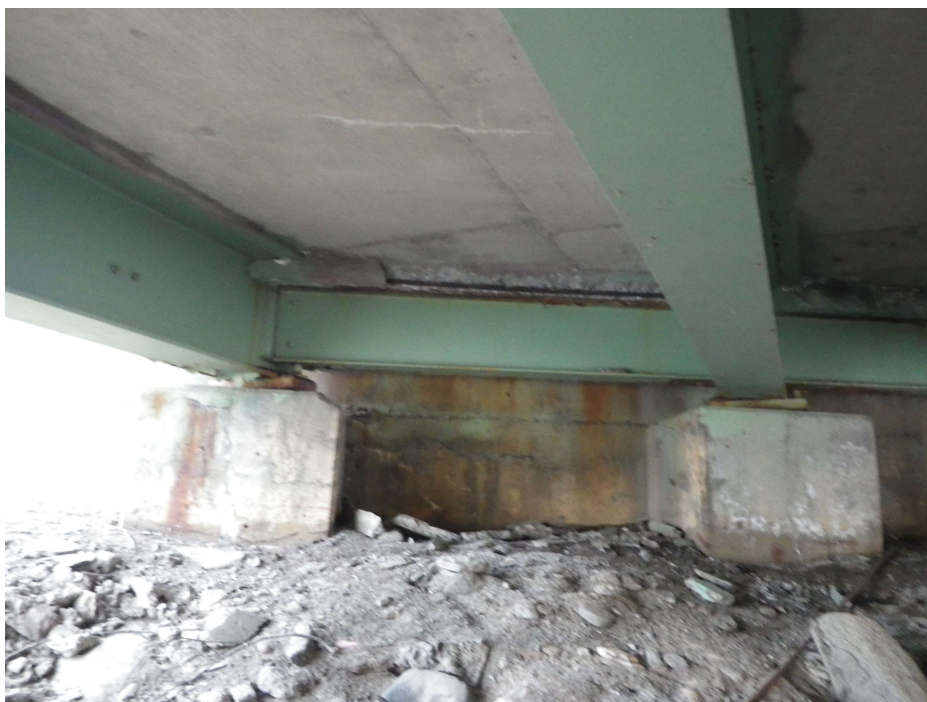
PHOTO 16

Description East abutment back wall

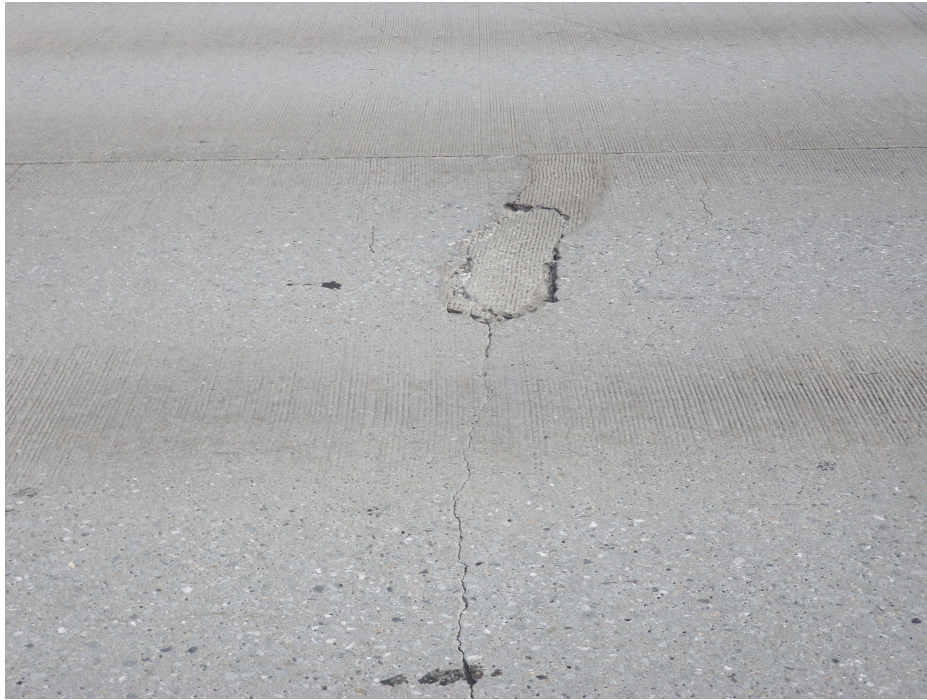
PHOTO 17 Condition
Description Area of delaminated concrete in wearing surface
