Highway Bridge Inspection Report

SOUADABSCOOK WEST NB

Inspection Date: 09/01/2015

Inspection Type(s): Underwater

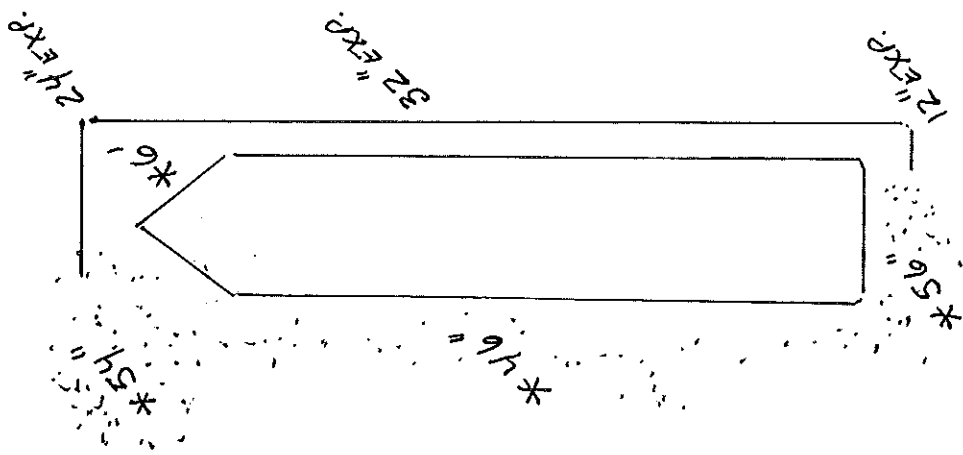
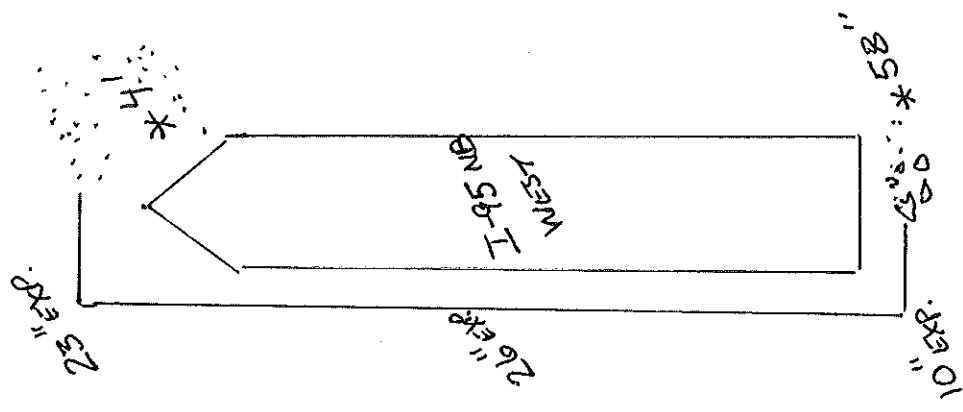
SOUADABSCOOK WEST I-95 NB 09-045

2 mass concrete piers. Concrete is in good condition. According to plans, footings are 6'-6" in height and are on piles. 2007: No changes, right pier footing 0" to 13", left footing exposed 0" to 25". All pier footing exposure is on channel side. 2011: No major changes to pier footing exposure. Rt. pier footing exposed up to 26". Lft. pier footing exposed up to 25". No changes to ratings. 2015: Right pier footing exposed up to 32" max. Left pier footing exposed up to 26" max. No major changes in condition.
