Preliminary Design Report

Frank J. Wood #2016

Brunswick-Topsham, Maine

August 4, 2017

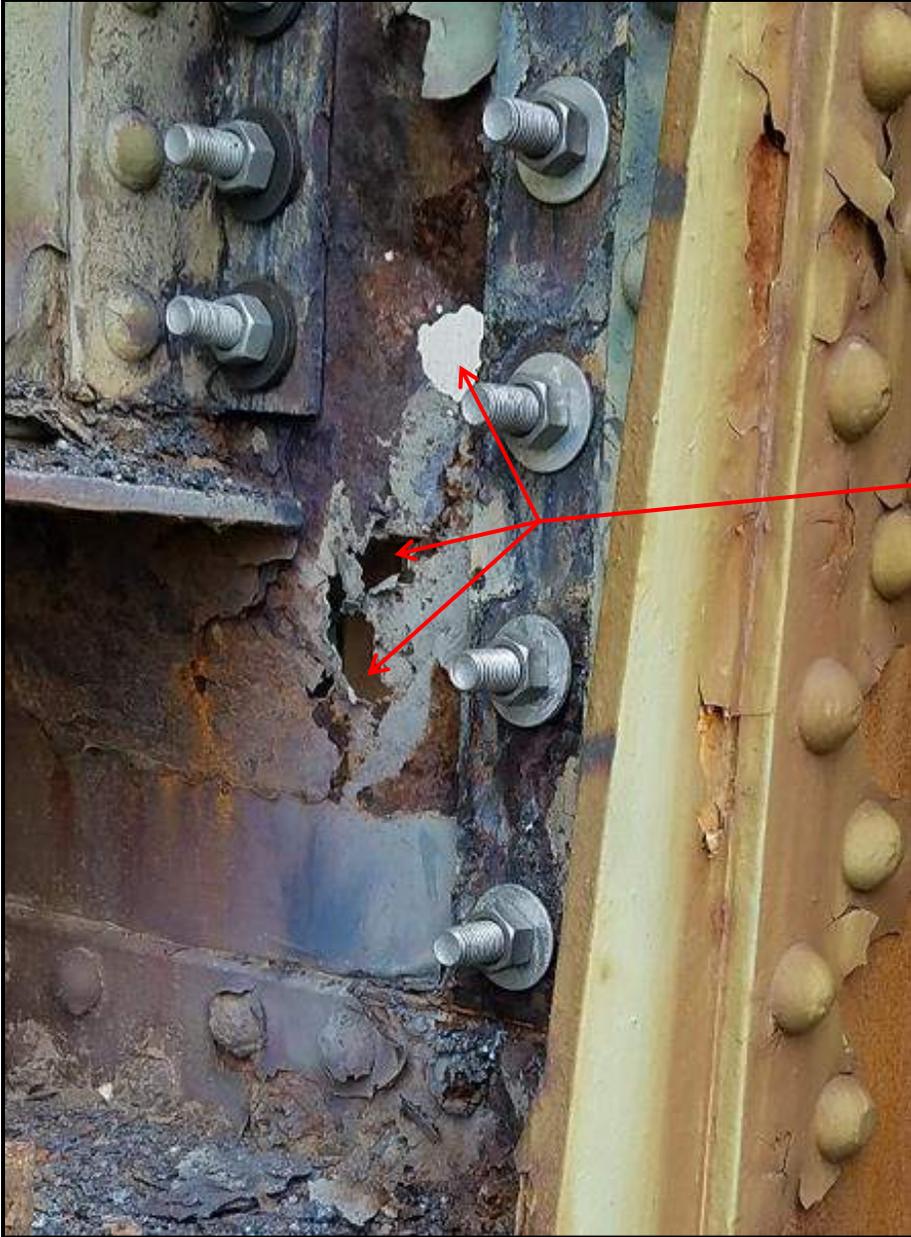
Floorbeam 7 was in the worst condition.

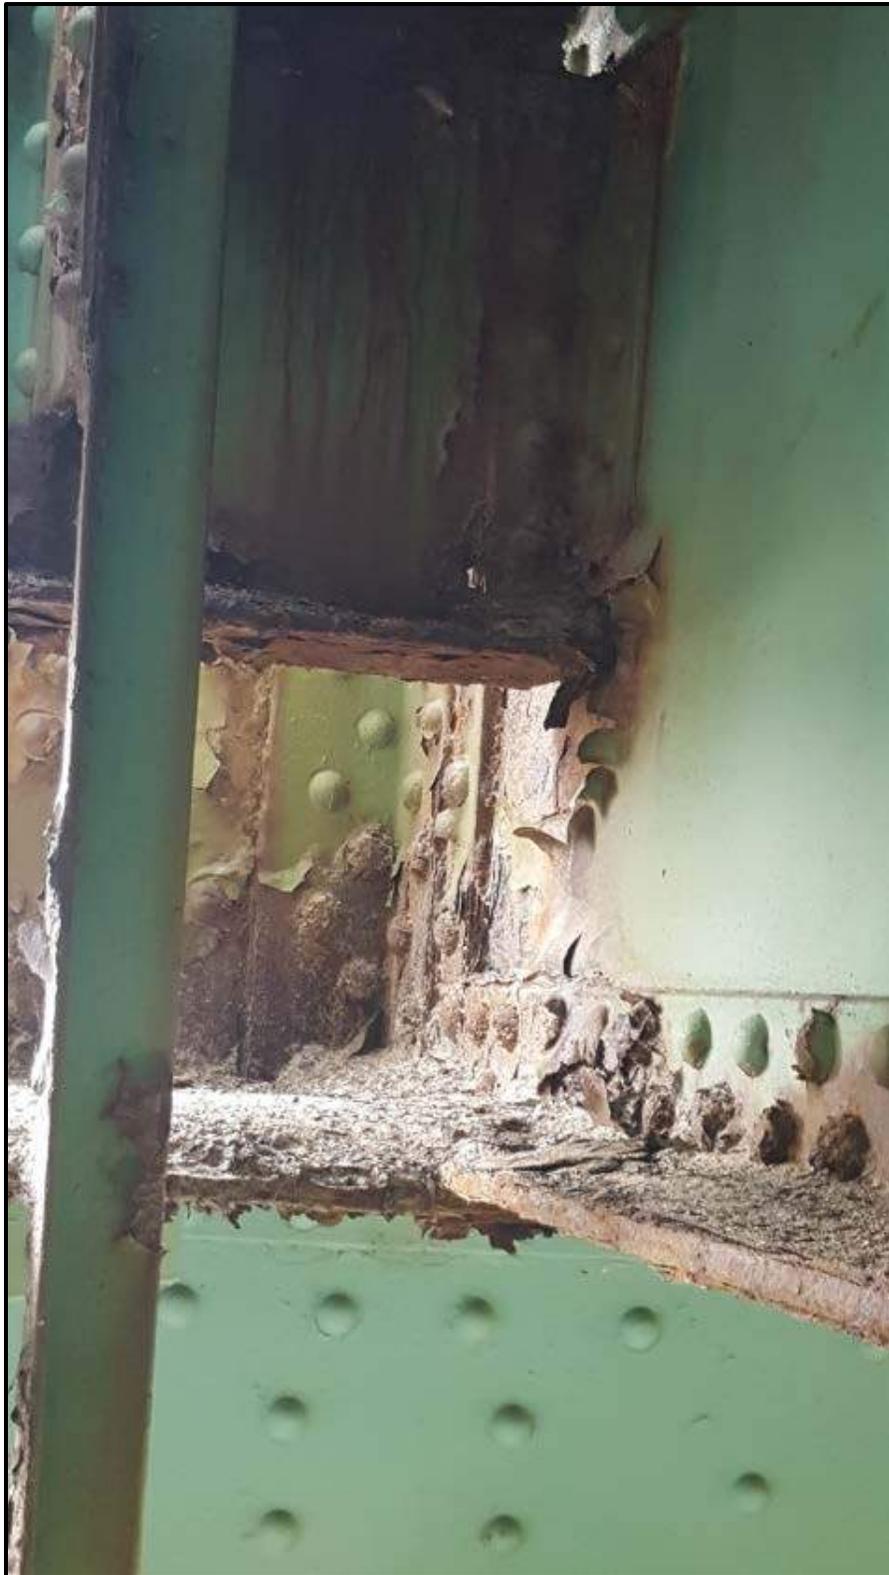
Photo A12 – Stringer 8, Roadway Truss @ Floorbeam 2 has section loss revealing a web hole.

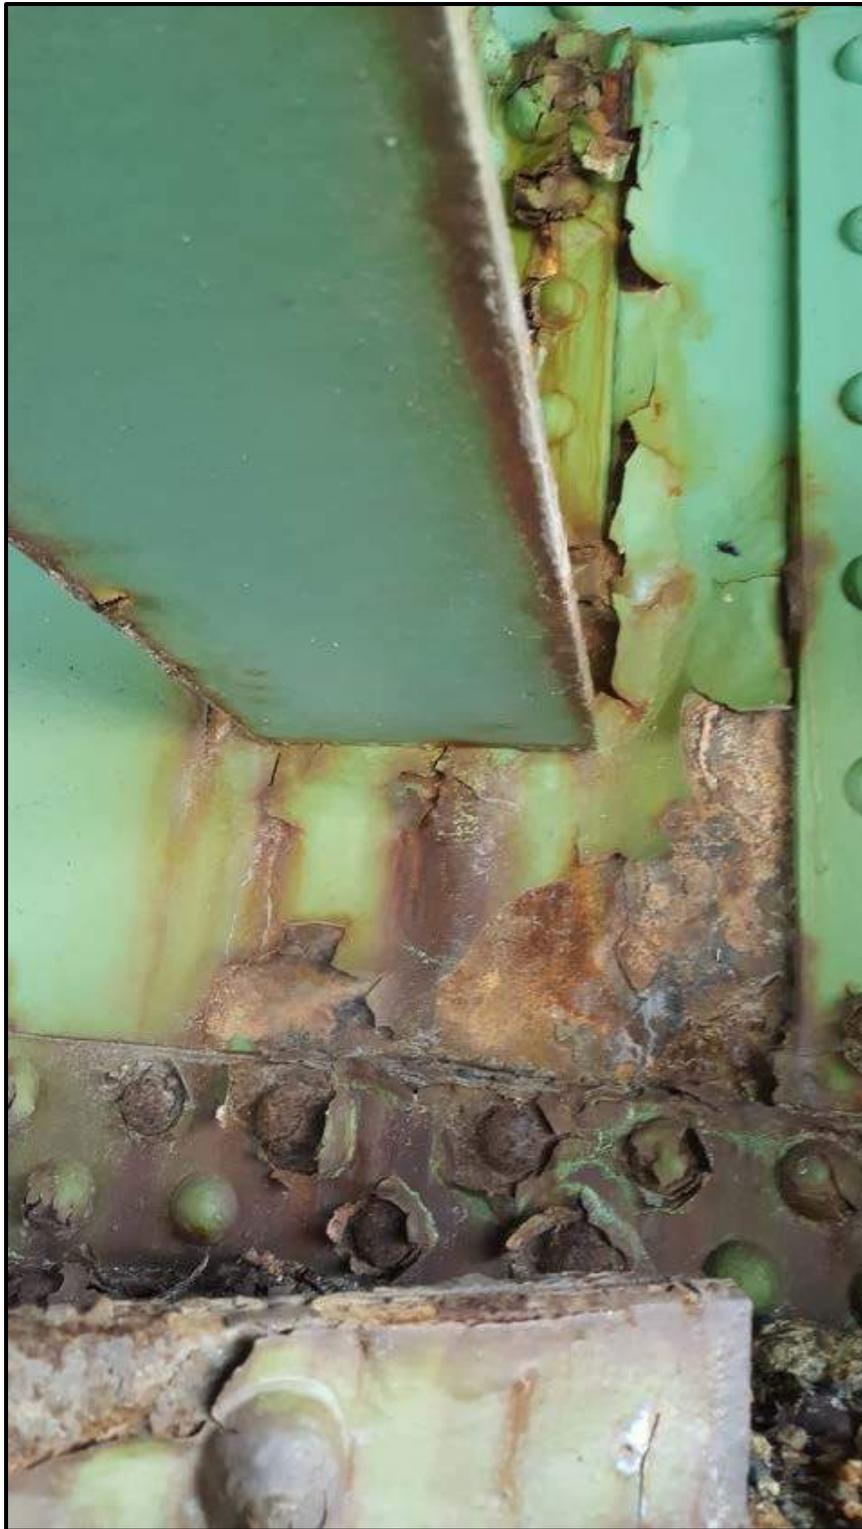
Photo A13 – Looking at the condition of north end of Stringer 8 attached to Floorbeam 3.

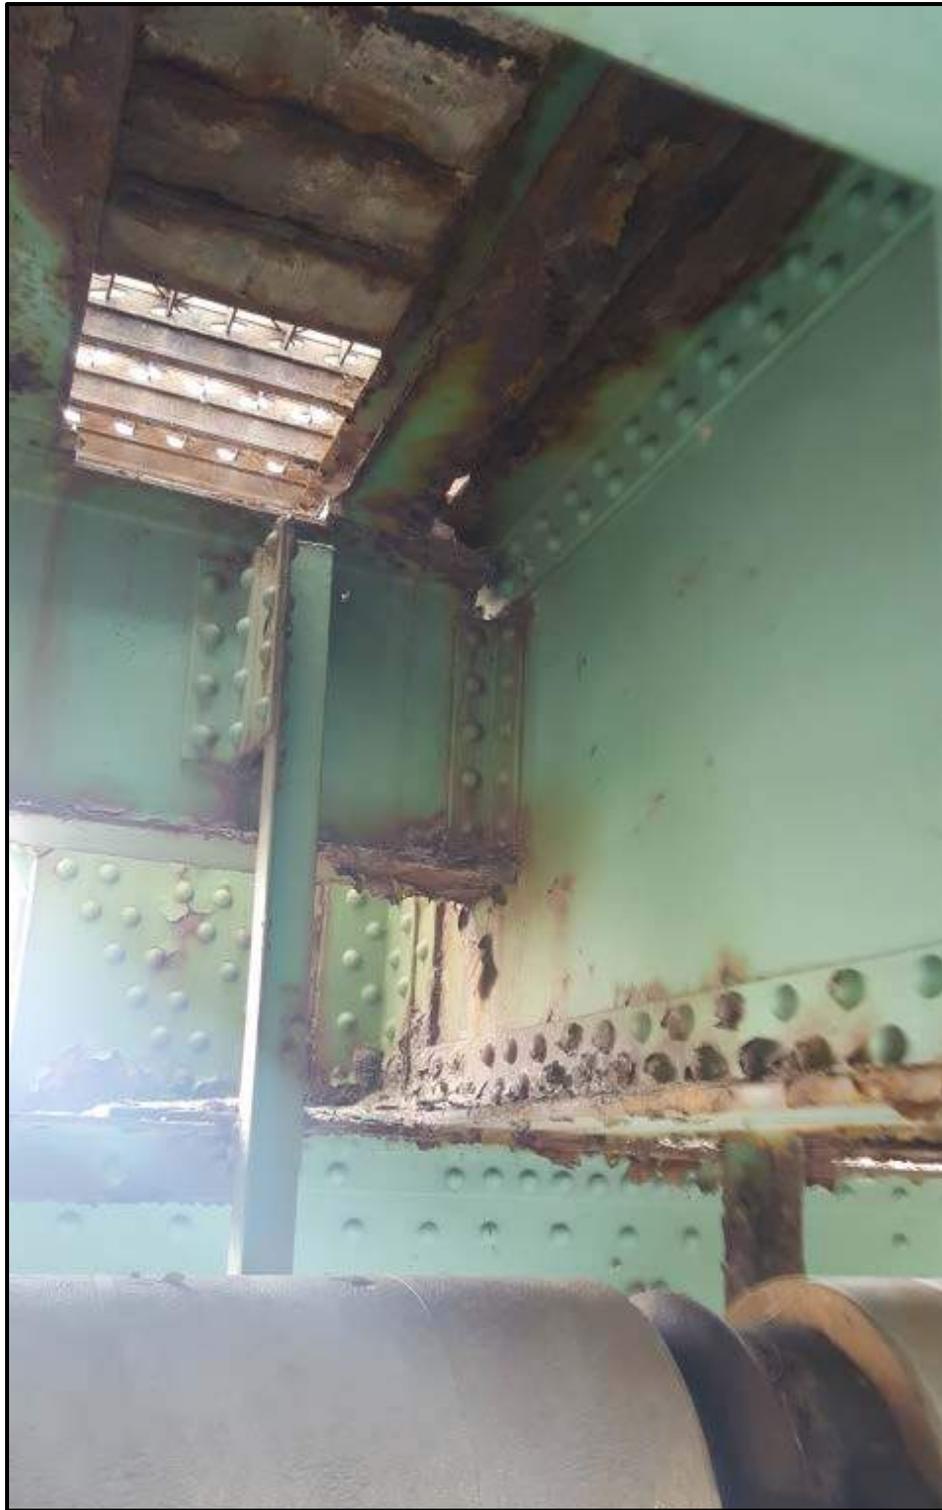
Photo A14 – Stringer 8 connection to Floorbeam 6, Roadside Truss, may warrant a reattachment repair within 5 years. Similar connection conditions @ Stringer 3 to Floorbeams 6 and 7.

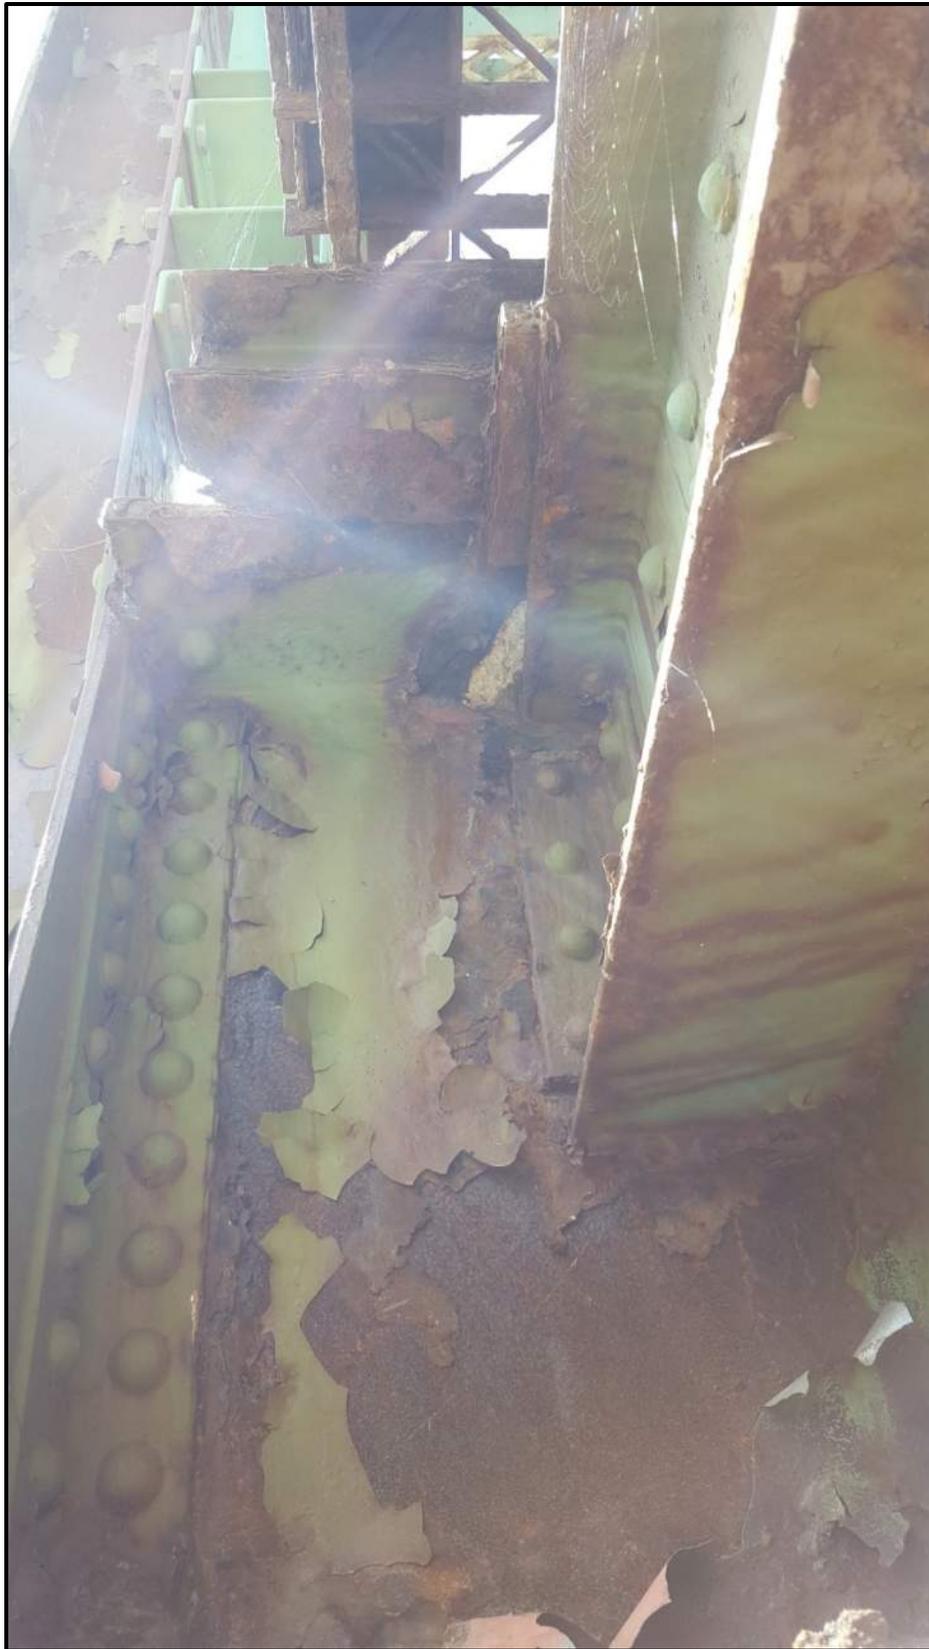
Photo A15 – Stringer 8 connection to Floorbeam 1 showing active corrosion.

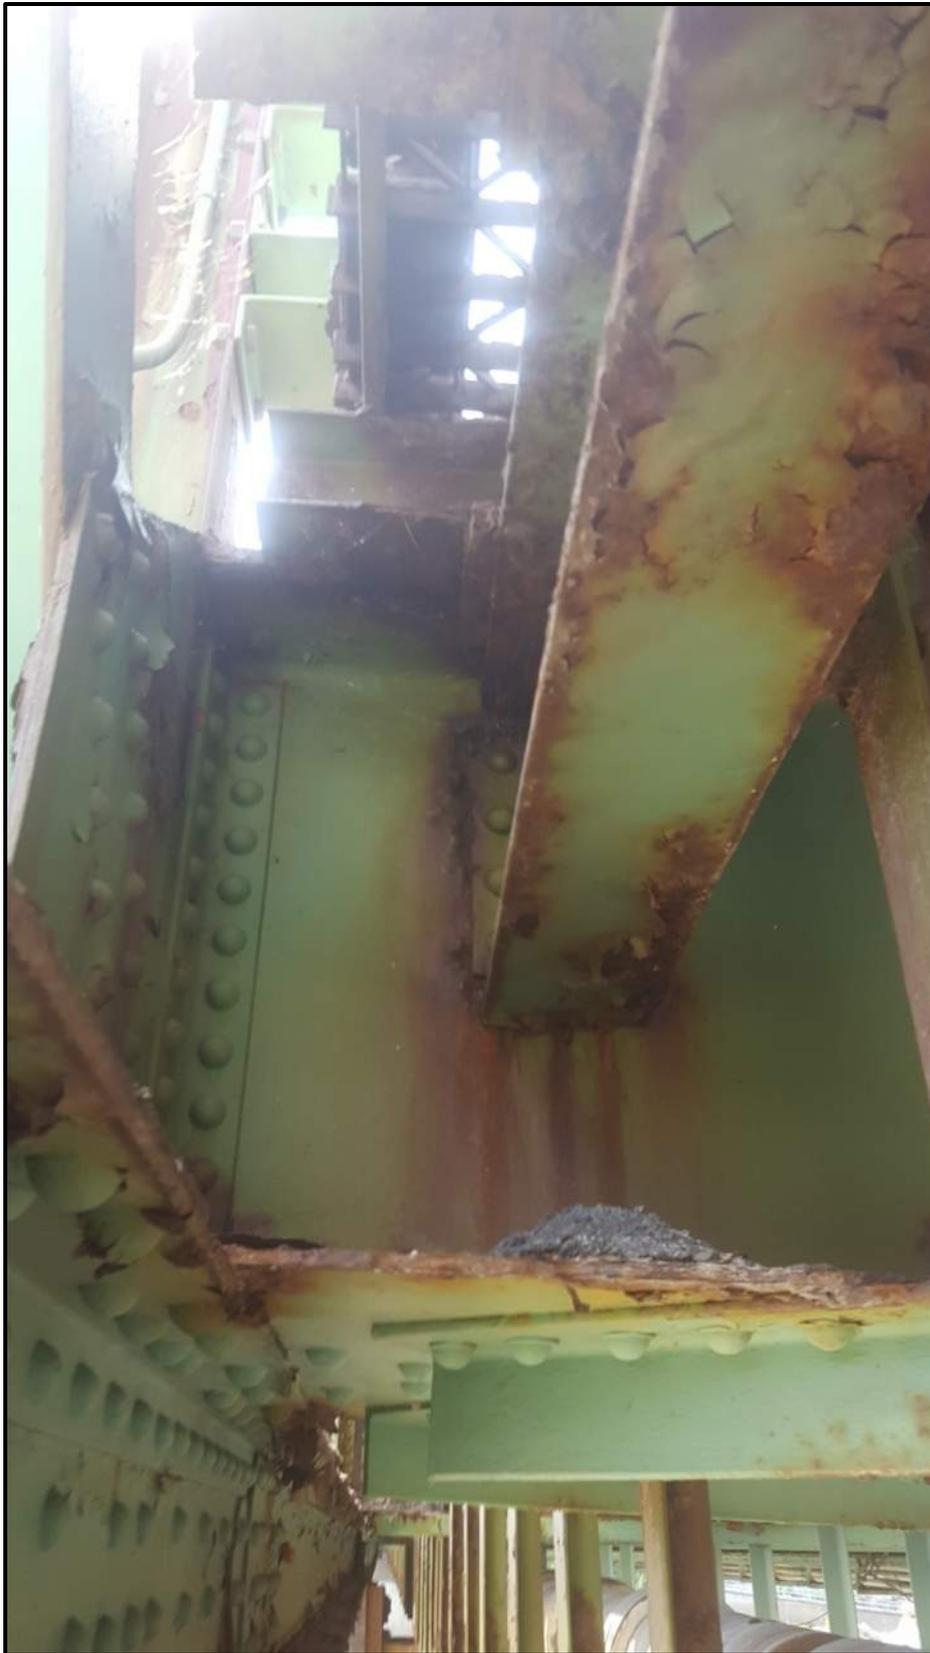
Photo A16 – Stringer 8 connection to Floorbeam 2 will likely need repair within 5 years.

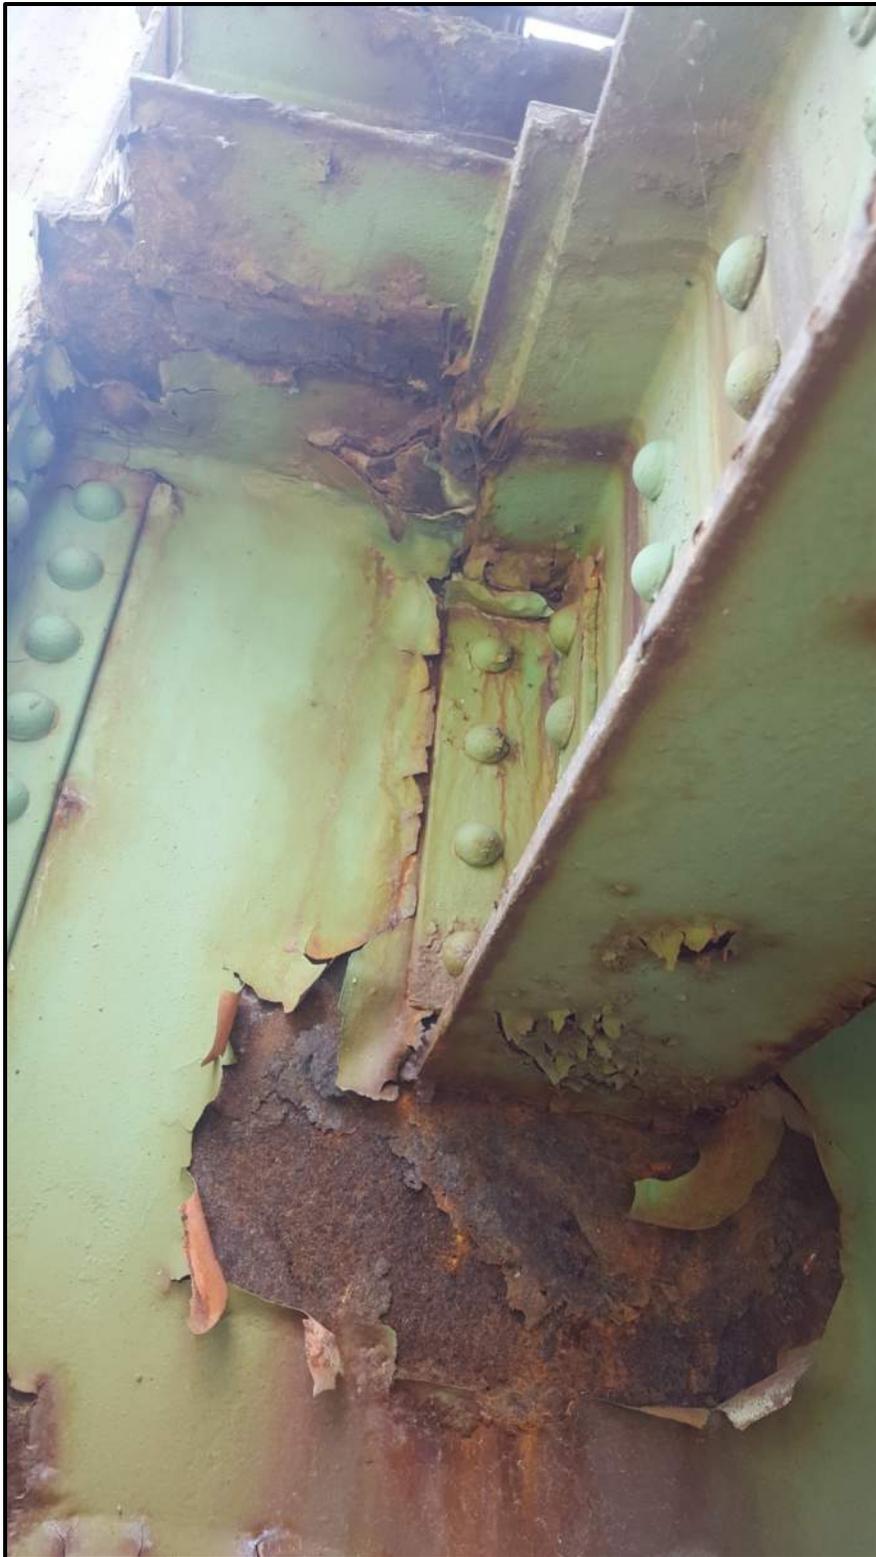
Photo A17 – Stringer 8 connection to Floorbeam 5 shows active corrosion.

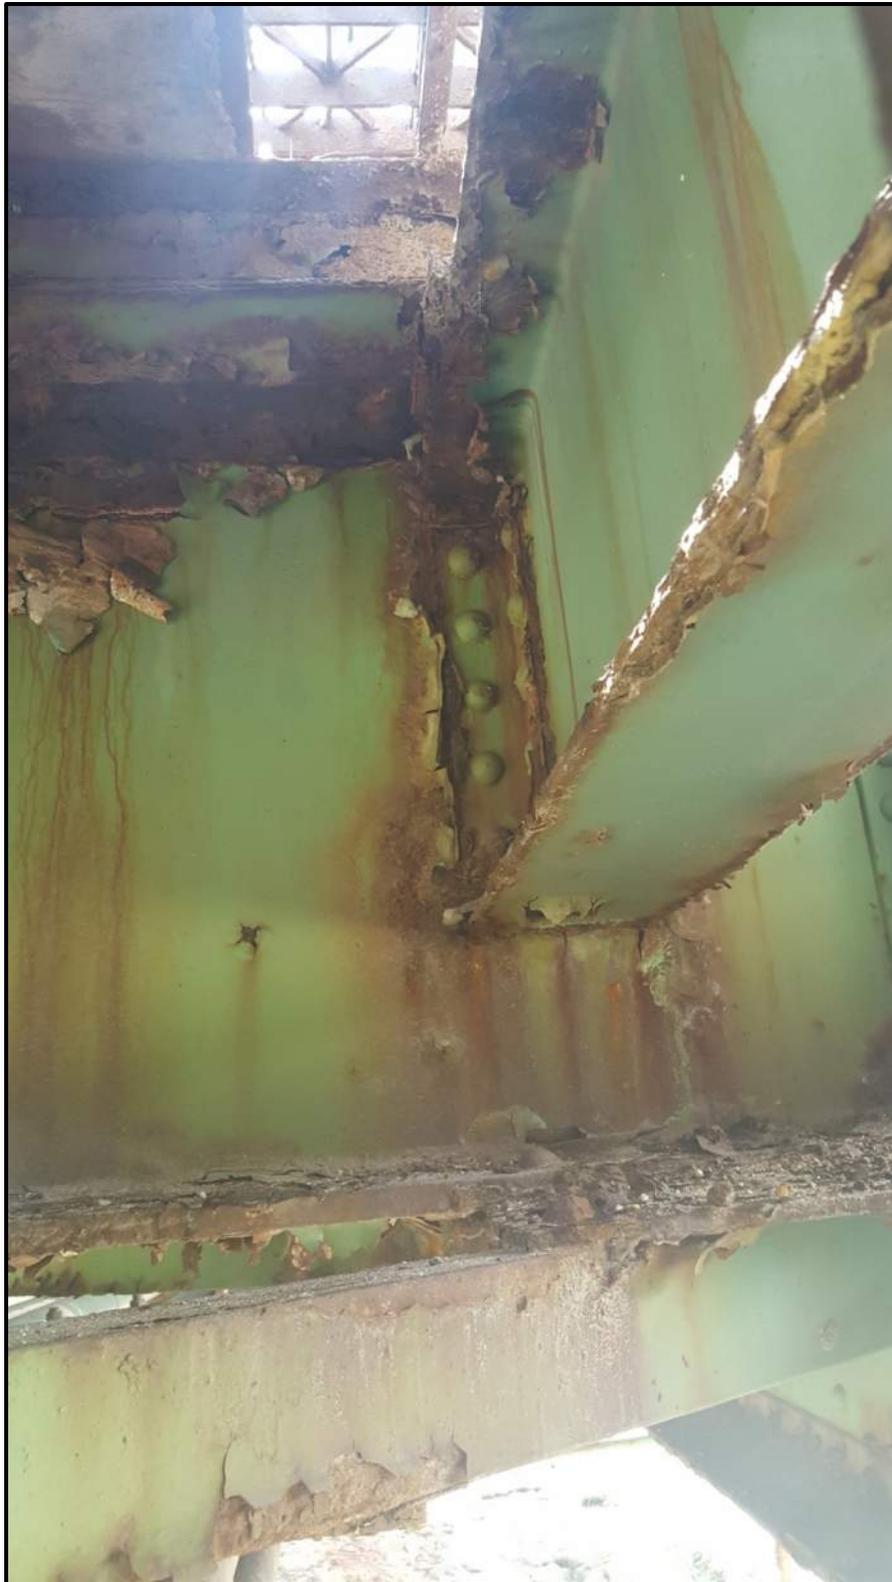
Photo A18 - Stringer 8 connection to Floorbeam 6. Stringer 3 connection similar condition.

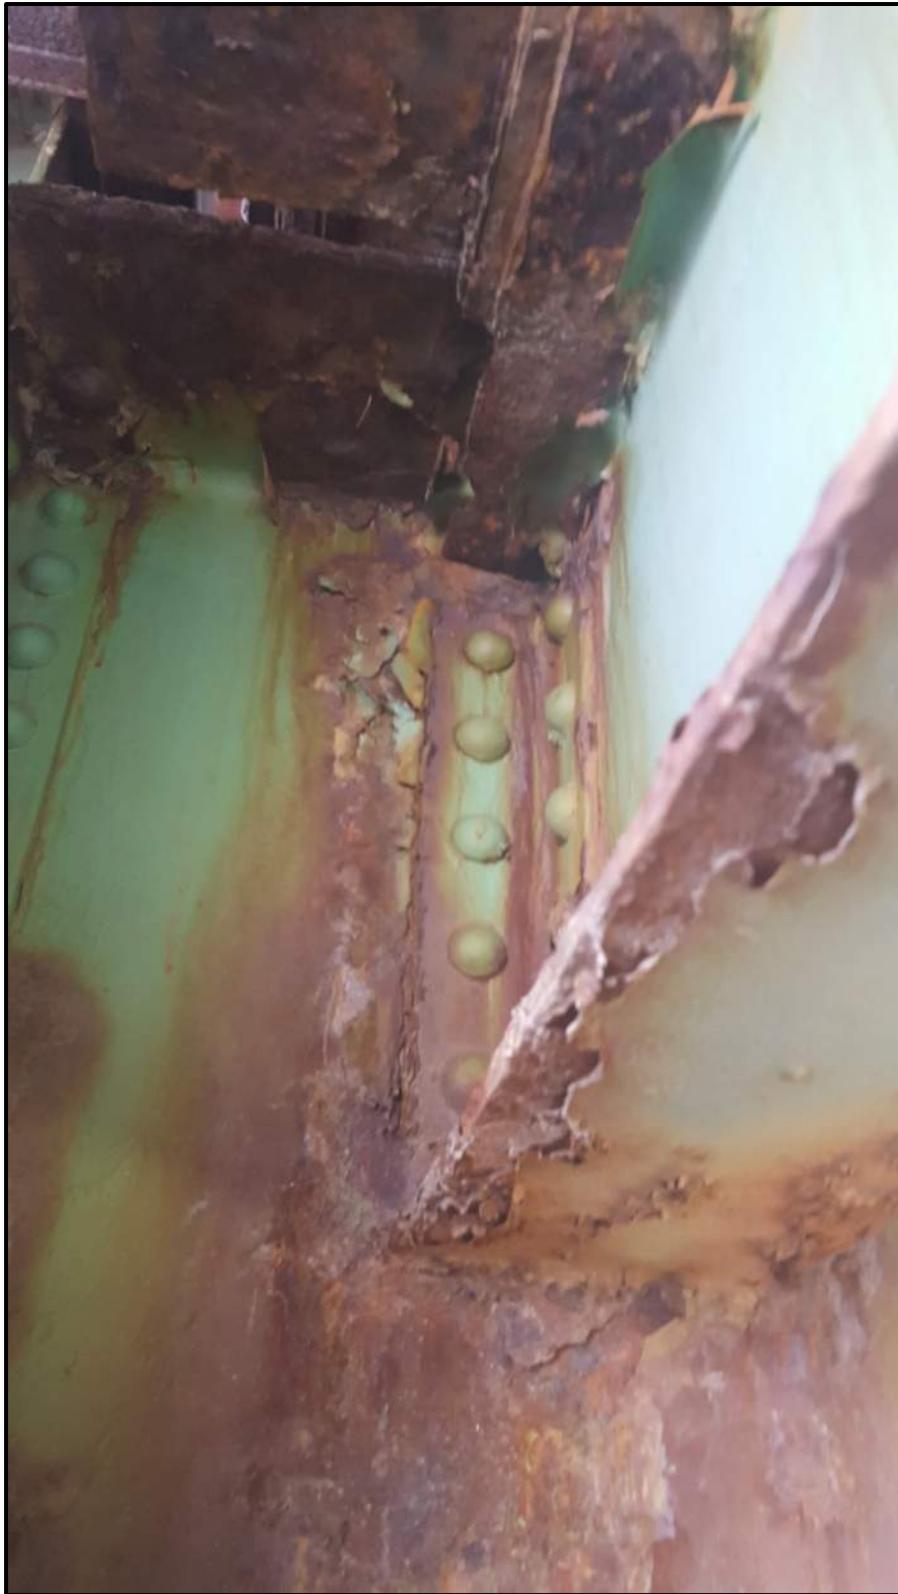
Photo A19 – Stringer 8 connection to Floorbeam 6 will likely require repairs within 5 years.

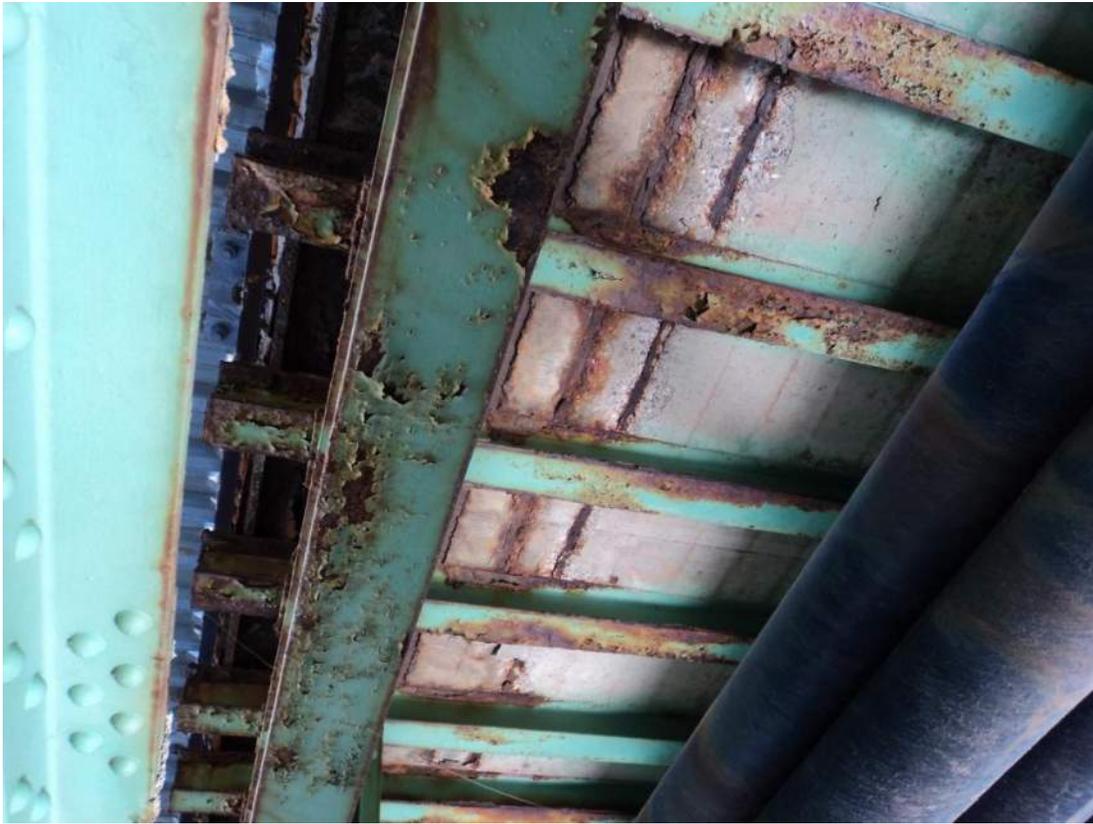
Photo 5 –Along outer edges of deck at S3 and S8 exposed main longitudinal grid deck bars were visible and exhibited active corrosion. Looking north in Span 1 along S3.

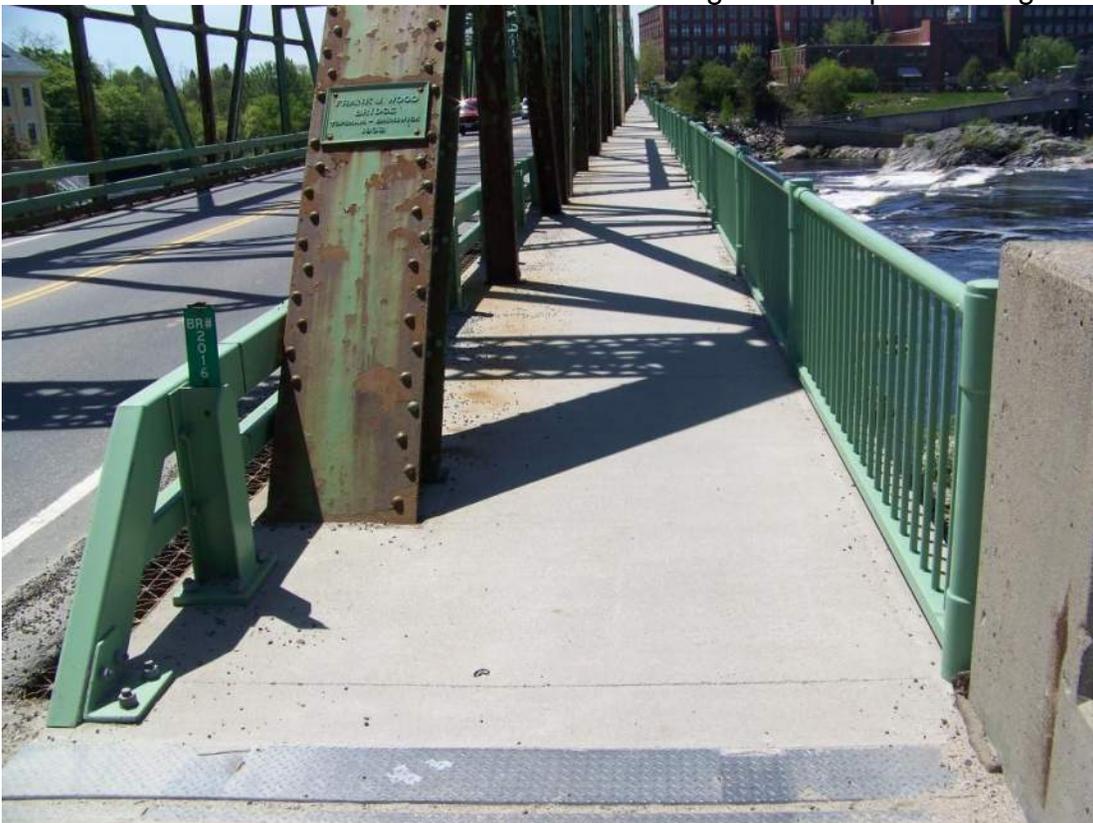
Photo 6 – The concrete curbs and sidewalk on the west side of the bridge are in good condition having been rehabbed relatively recently. Looking south from north abutment.

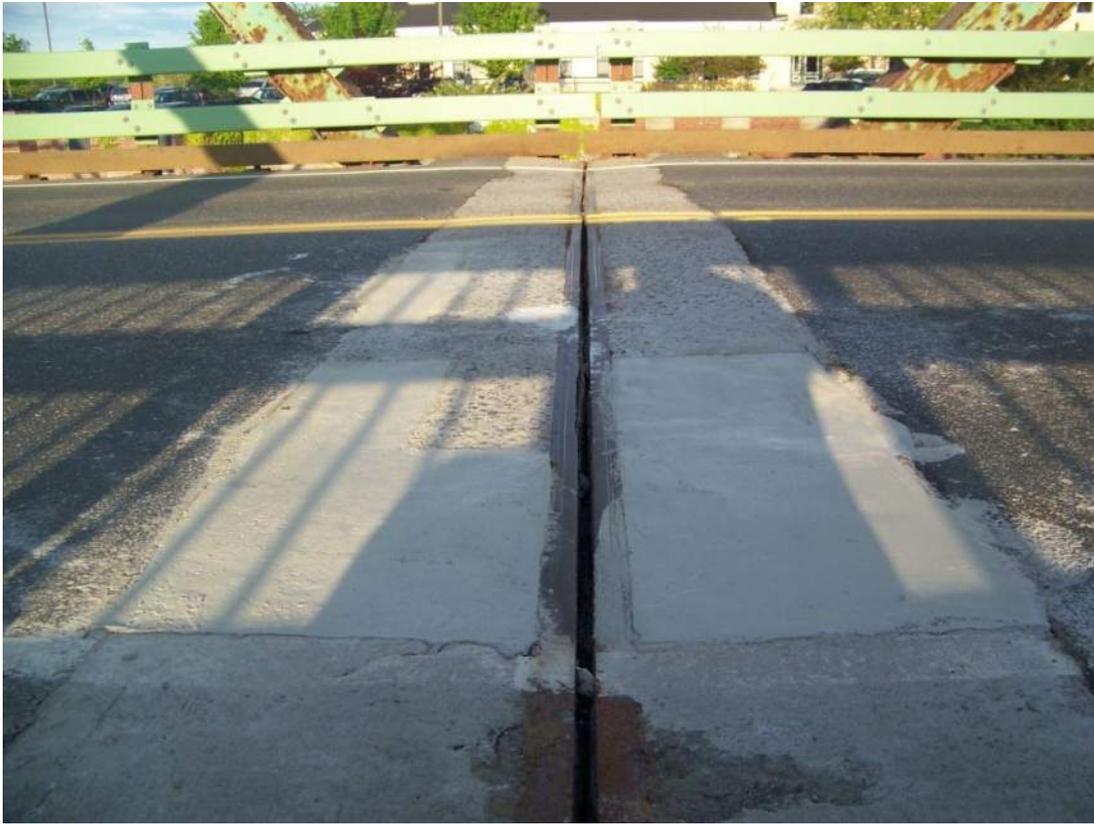
Photo 9 – The north pier strip seal type deck joint has three quick-setting concrete patch repairs placed during the lane closures implemented for the inspection. Looking east.

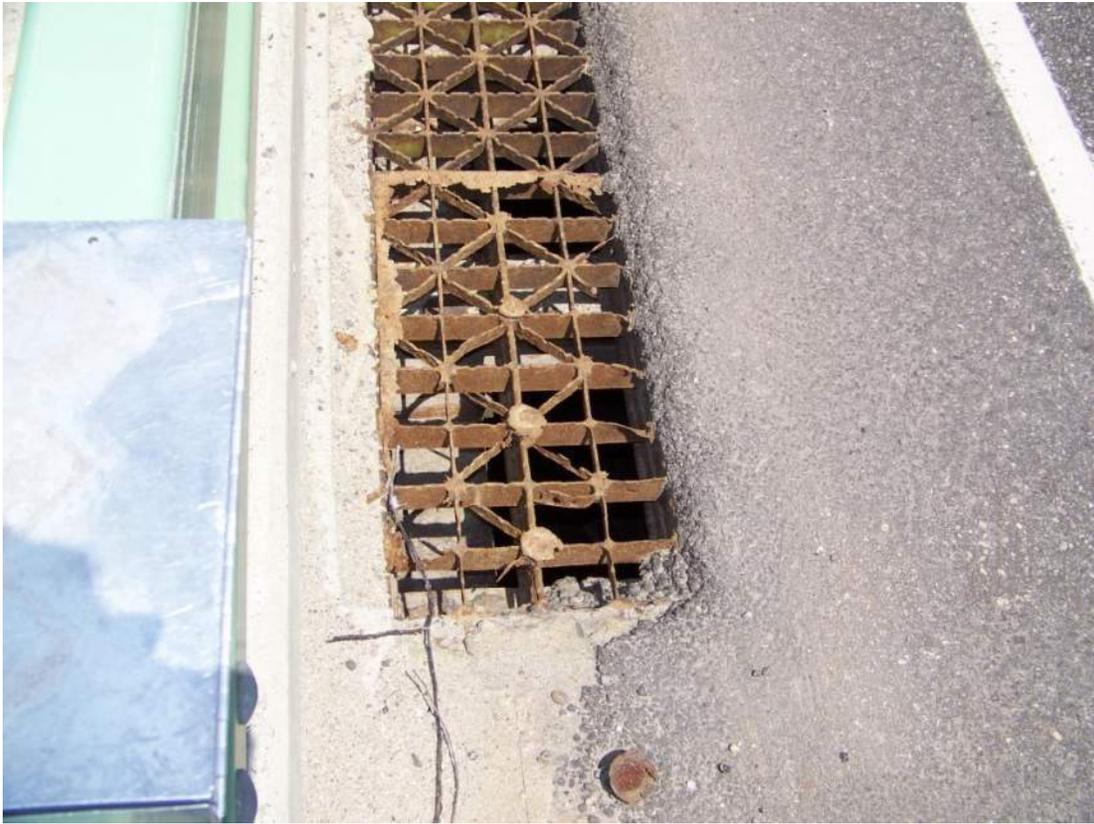
Photo 11 – Several damaged, perforated, and failed secondary distribution bars were observed in open grid gutter drainage strips. Looking north along west curb near Pier 2.

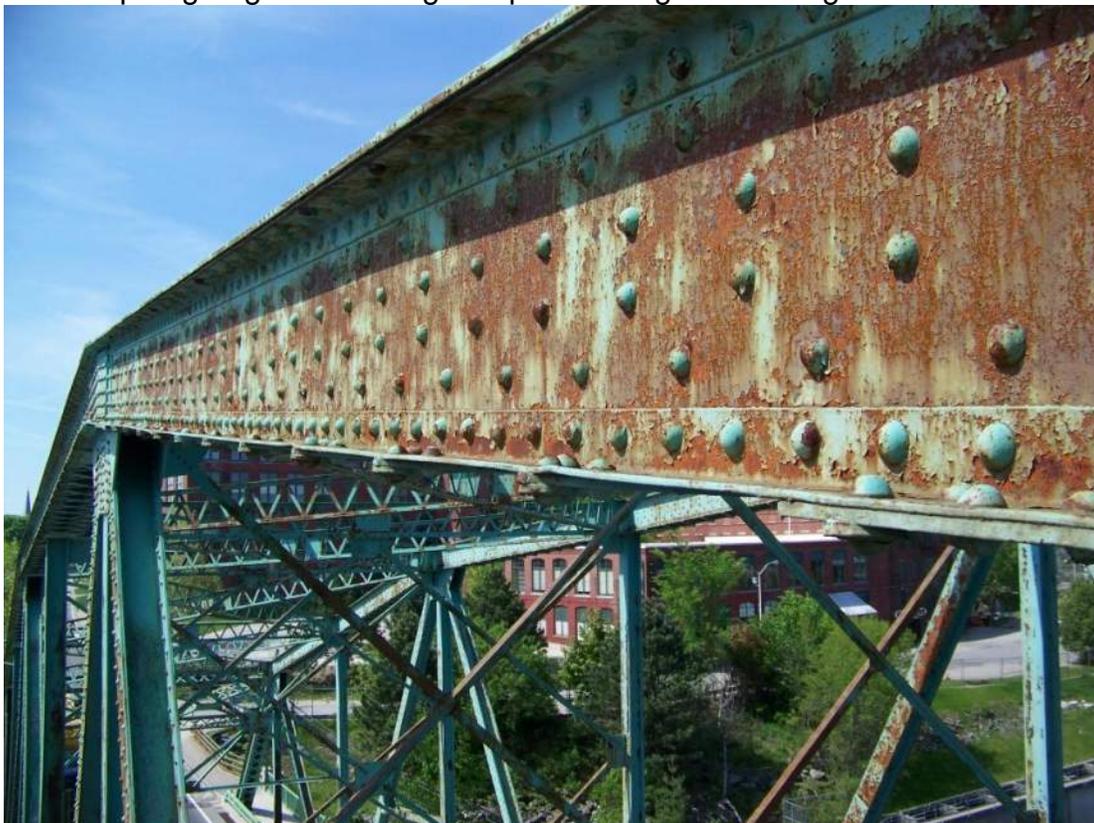
Photo 12 – Paint system is failed over more than 40% of exterior surfaces of upper chords with significant and widespread areas of missing paint and active corrosion.

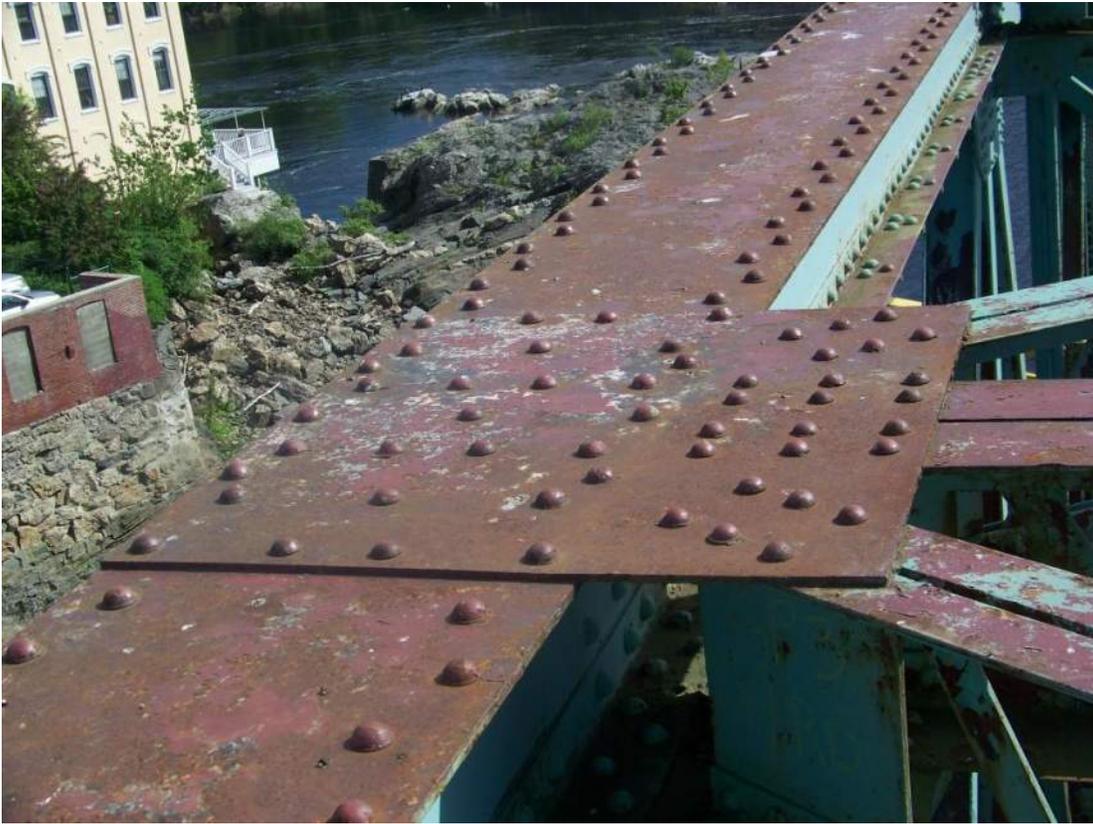
Photo 13 – Paint system is failed over more than 40% of exterior surfaces of upper chords with significant and widespread areas of missing paint and active corrosion.

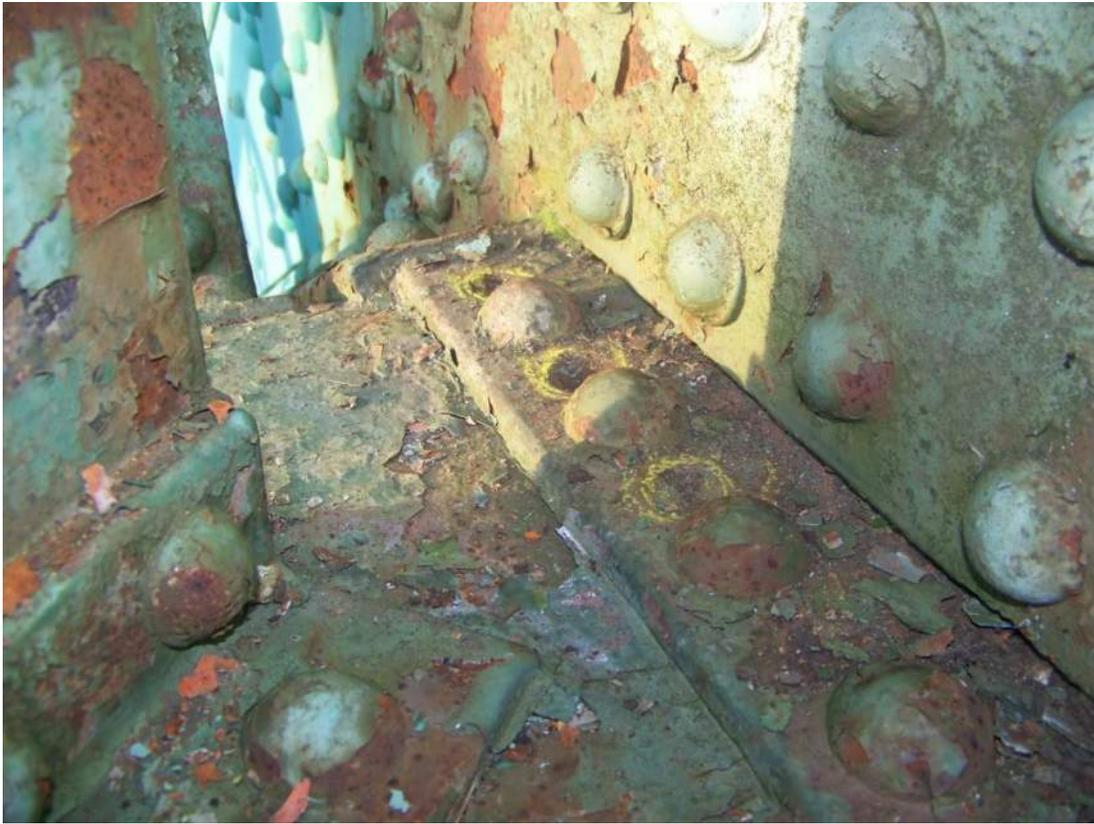
Photo 15 – Three additional mis-drilled rivet holes interspersed with the rivet holes were observed at the Span 2 roadway truss U9 west side channel lower angle. Looking north.

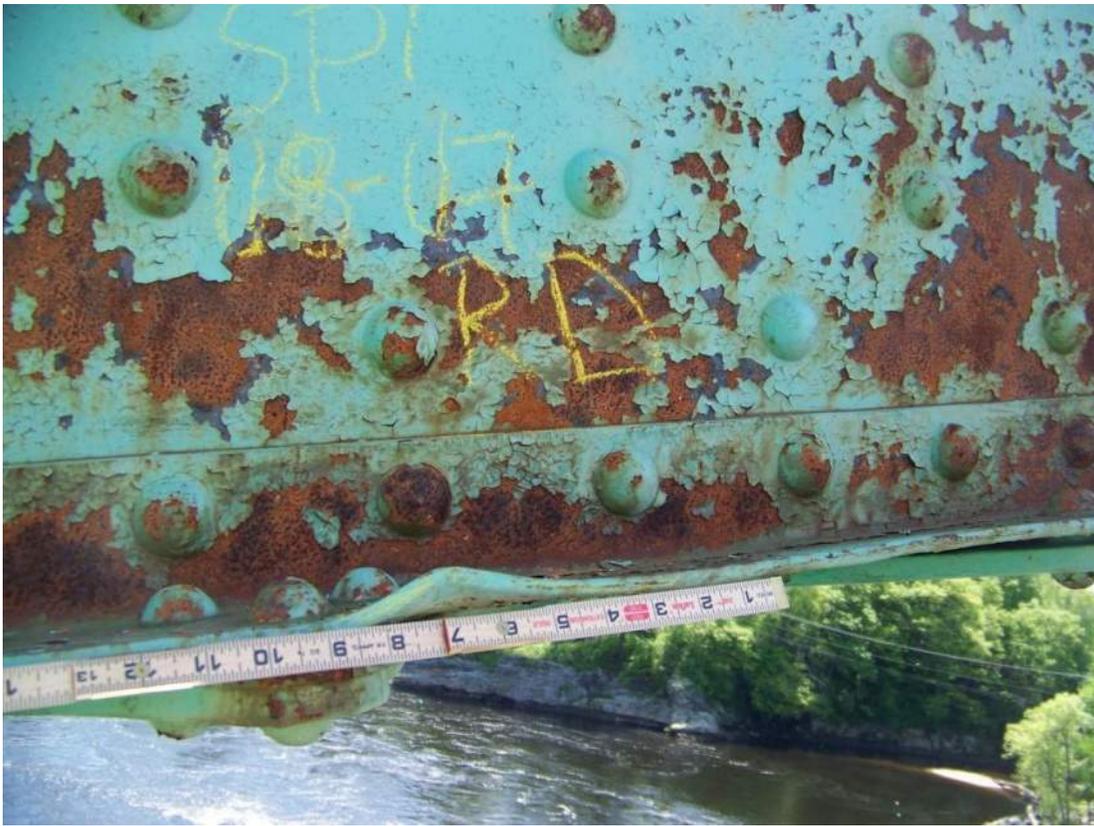
Photo 17 – Minor localized bends in flange angles with up to 5/8 inch vertical deflection of flange tip were observed at a few locations. View at Span 1 U7-U8 sidewalk truss.

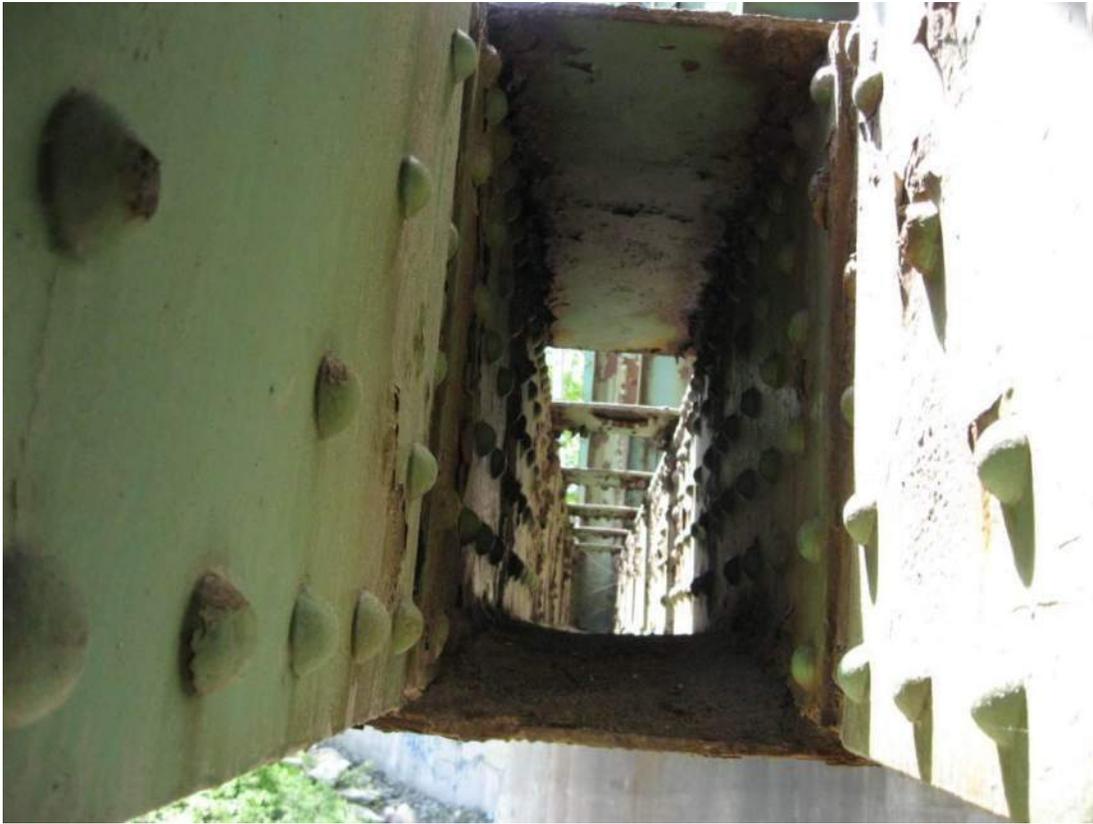
Photo 19 – Heavy debris accumulations up to four inches deep were observed on the top of the lower chord bottom plate near the Span 1 roadway truss L2 splice region.

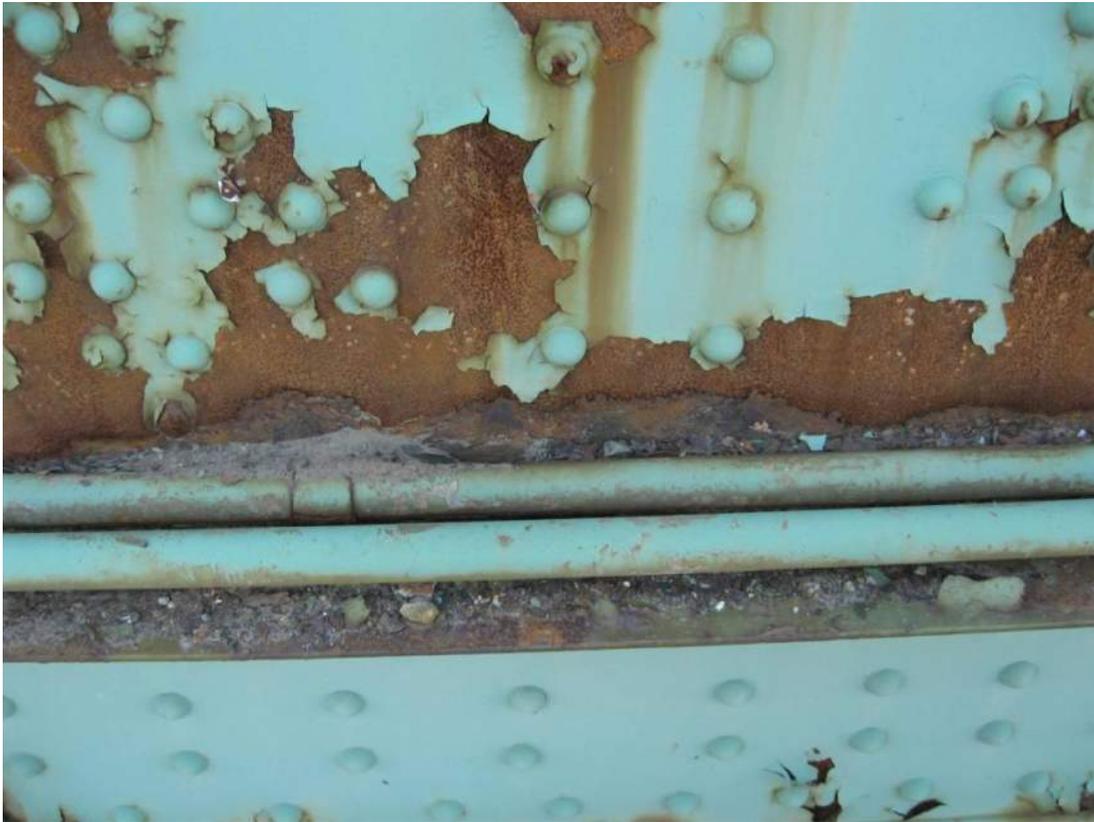
Photo 21 –In Span 1 roadway truss L4 joint minor exfoliated rusting was noted over 3” of outboard gusset plate due to moisture and dirt accumulation caused by the conduits.

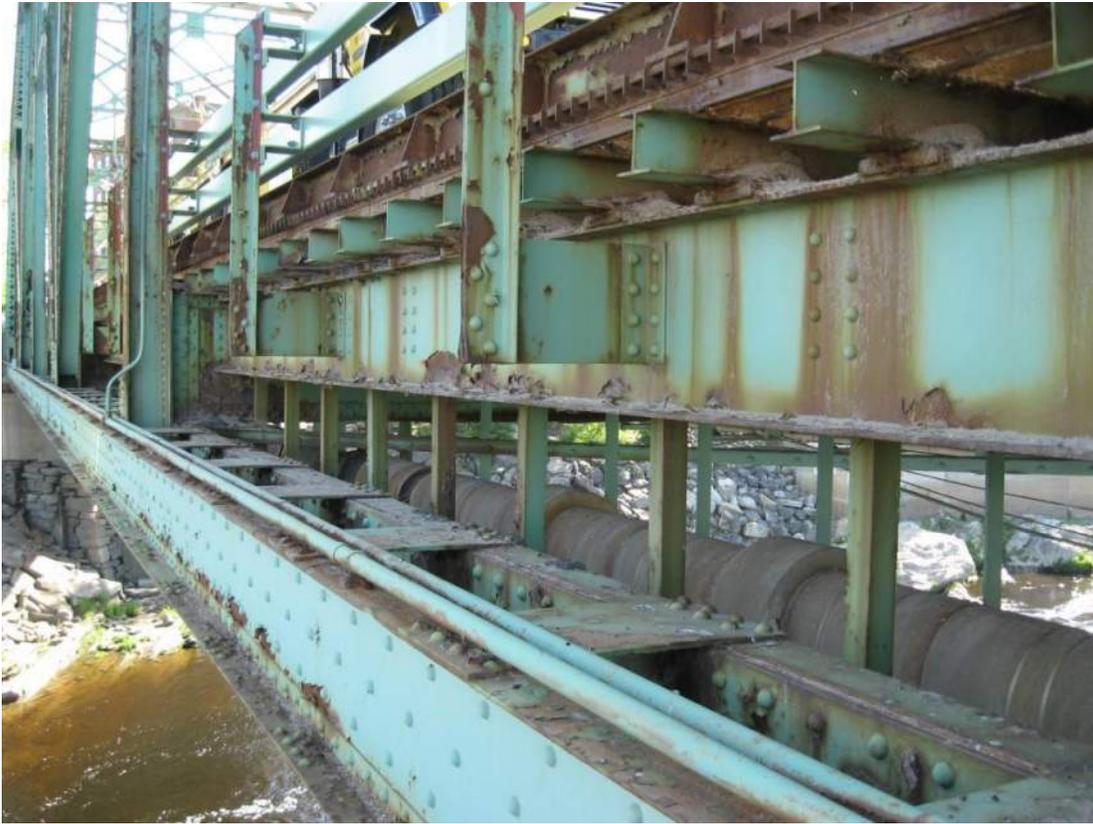
Photo 23 – The roadway truss lower chord top face exhibits poor paint condition with missing paint and active corrosion typical throughout bridge. View of Span 1 L5-L6.
