Preliminary Design Report

Frank J. Wood #2016

Brunswick-Topsham, Maine

August 4, 2017

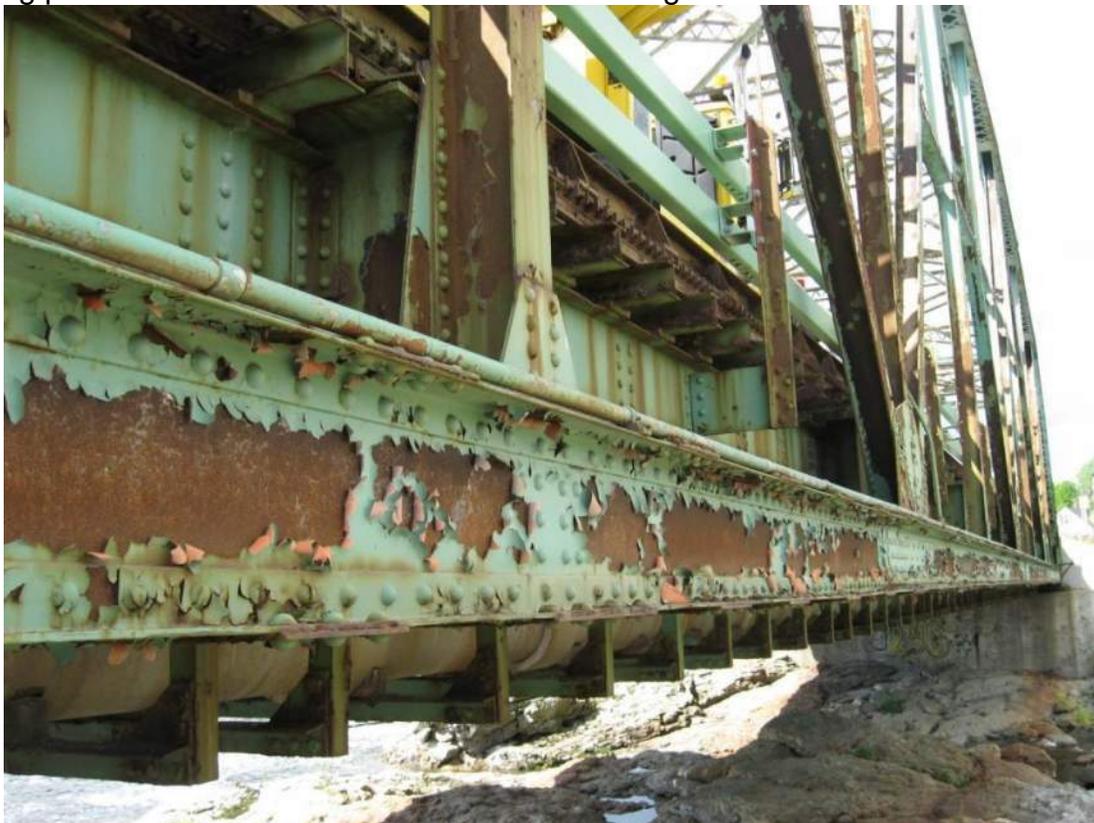
Photo 26 – In Span 3 the entire length of the east face of the roadway truss has severe paint failure with active corrosion. Looking north toward north abutment.

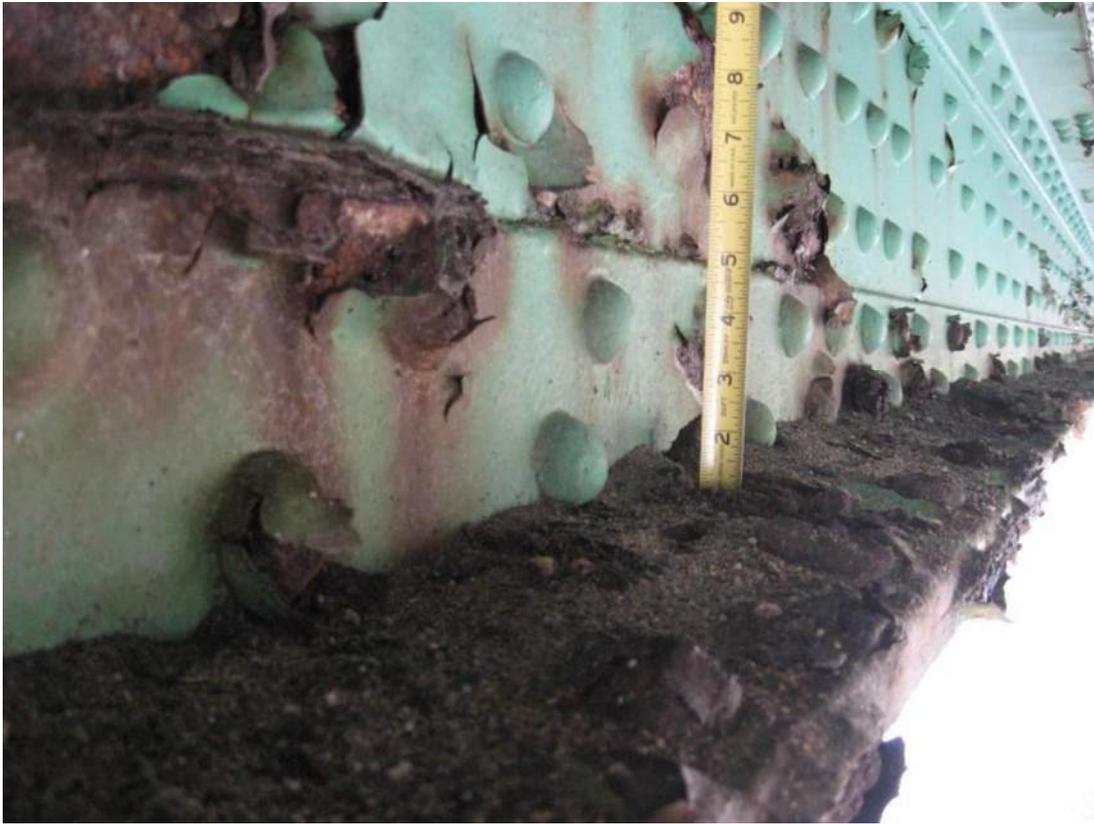
Photo 27 – Span 2 sidewalk truss lower chord east face has debris accumulations up to an inch deep over top of bottom flange of side channel for at least half of the span length.

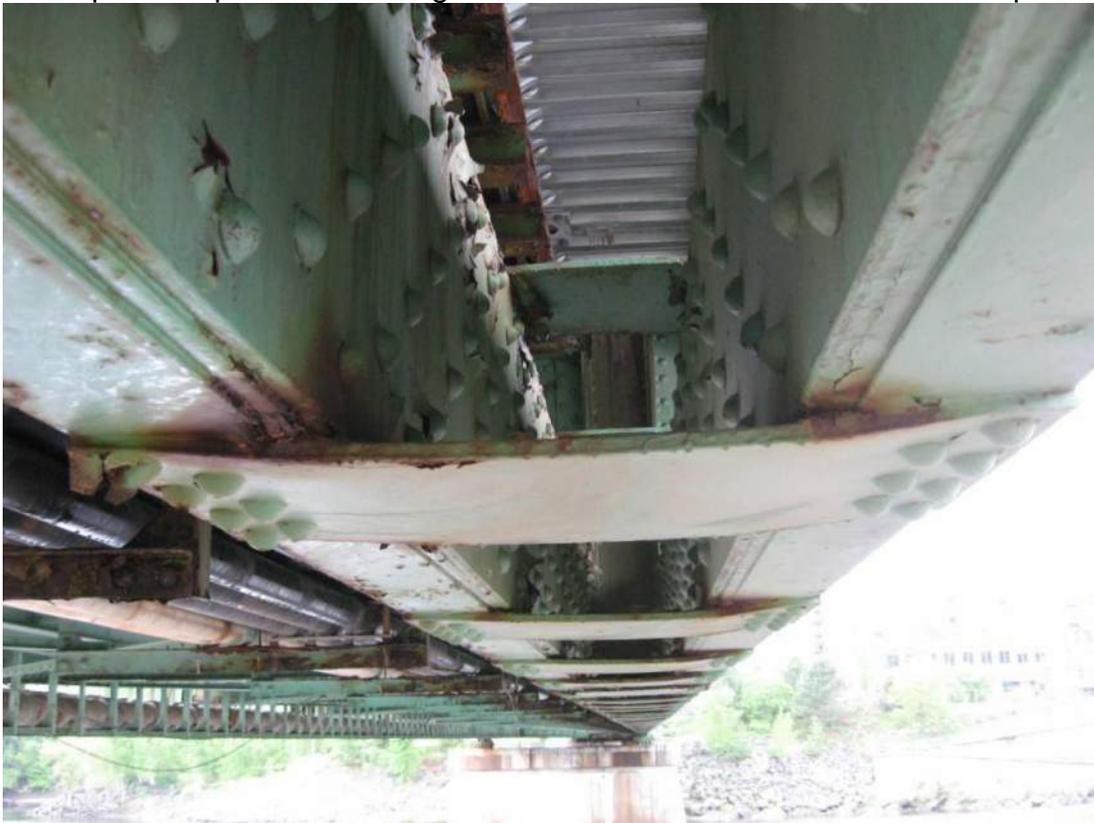
6. Replace the lattice plates of the bottom chord, which are severely bowed due to pack rust. See Figure 12.

Photo 28 – Span 2 sidewalk truss lower chord bottom face tie plates bowed downward due to pack rust at the interfaces with the bottom of the lower chord side channels.

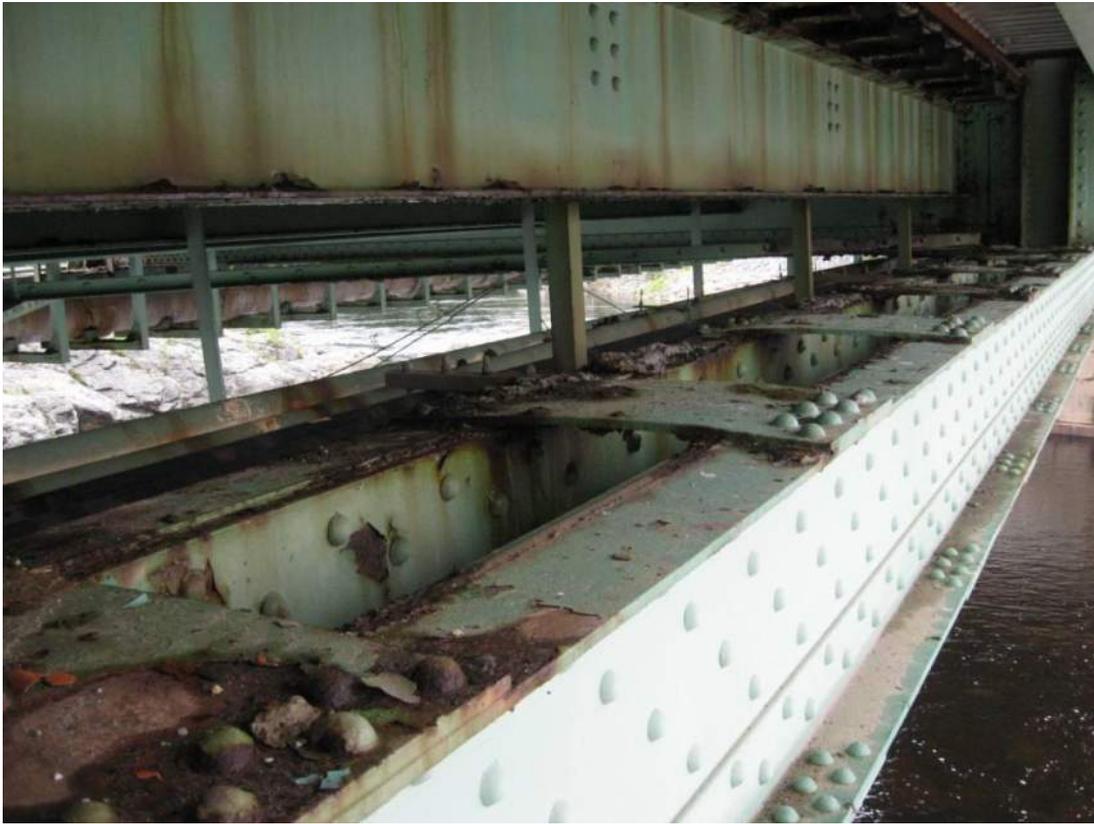
Photo 29– Top face tie plates are similarly bowed in the upward direction due to pack rust at the interfaces with the top of the lower chord side channels.

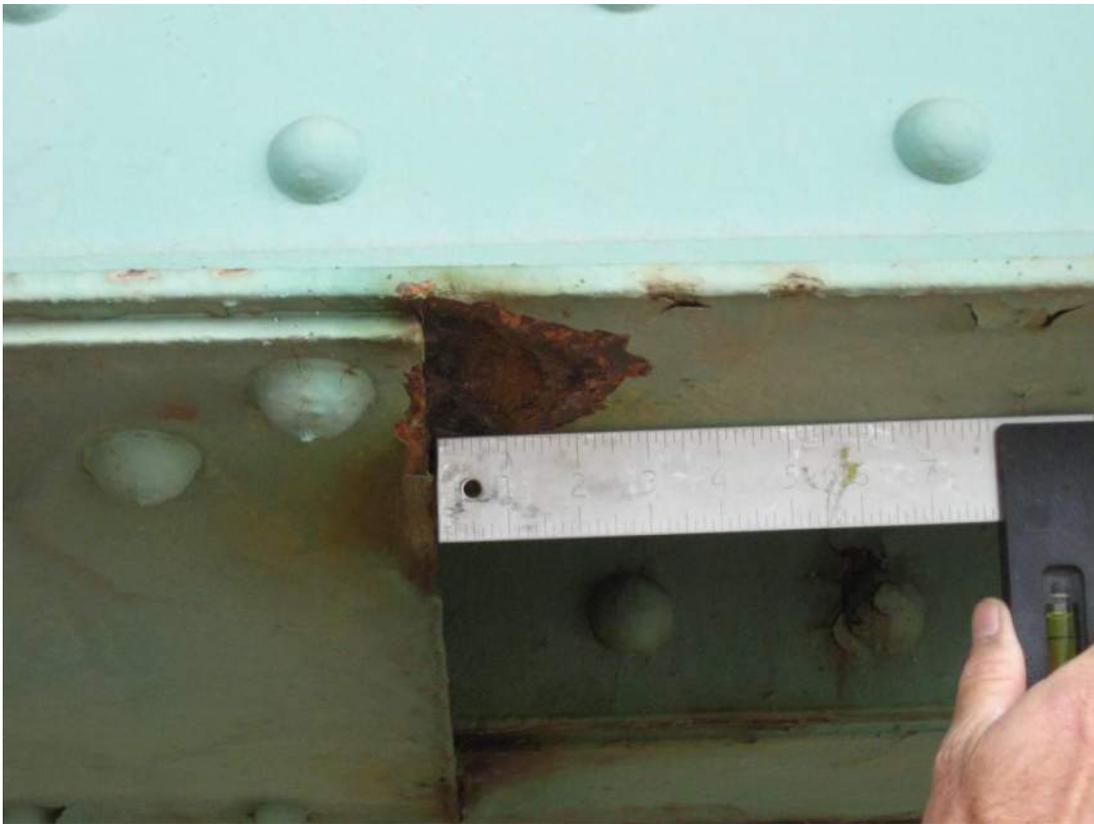
Photo 31– Zone of 1/8 inch deep by 3 inch wide section loss to Span 3 L4-L5 sidewalk truss outboard side channel located at corner of first tie plate south of center splice.

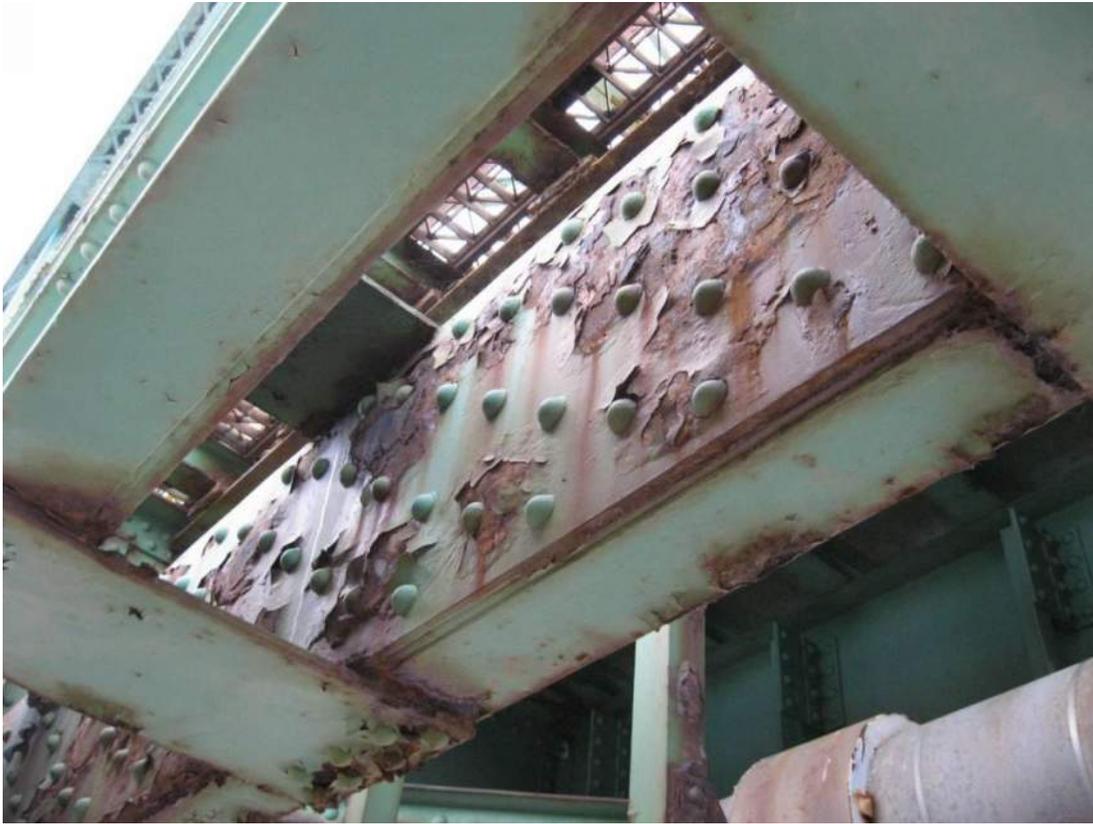
Photo 33– Interior vertical side channels of Span 3 roadway truss L3-L4 exhibit areas of failed paint, active corrosion, and raised expansive exfoliation similar to pack rust.

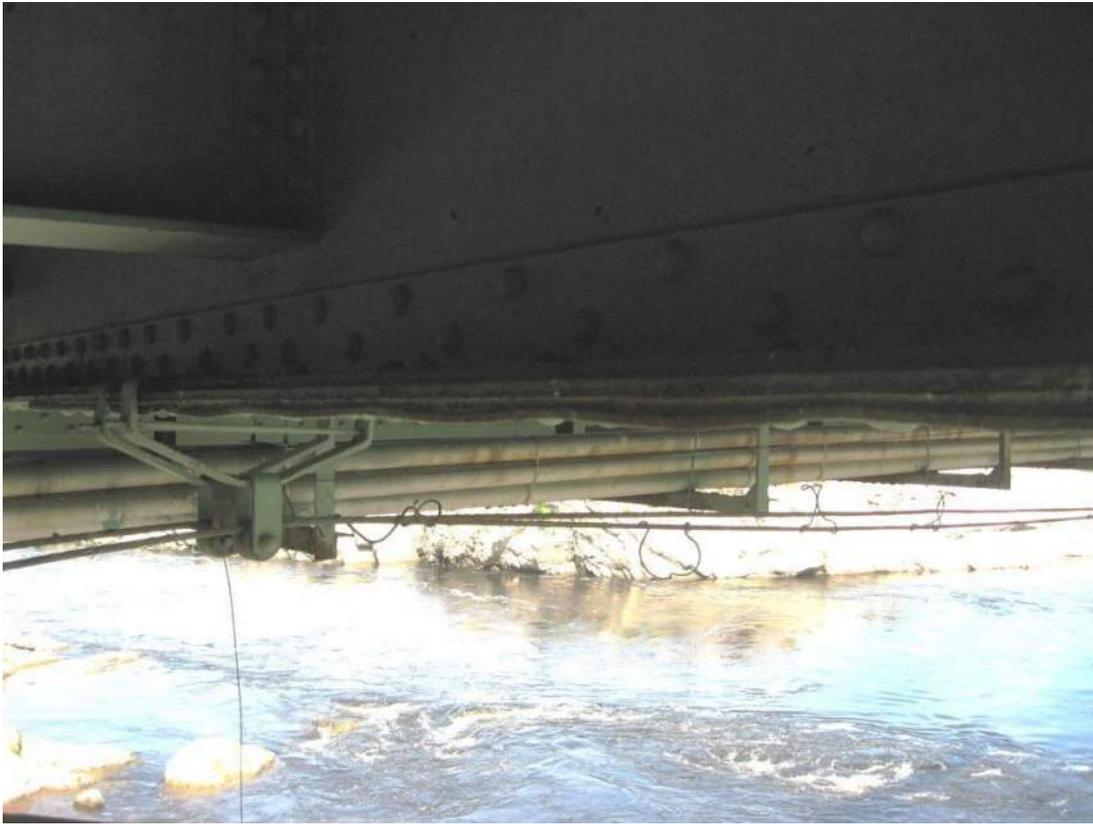
Photo 39– Previously arrested pack rust was observed in the Span 1 FB1 floorbeam between the bottom flange cover plate and the edges of the bottom flange angles.

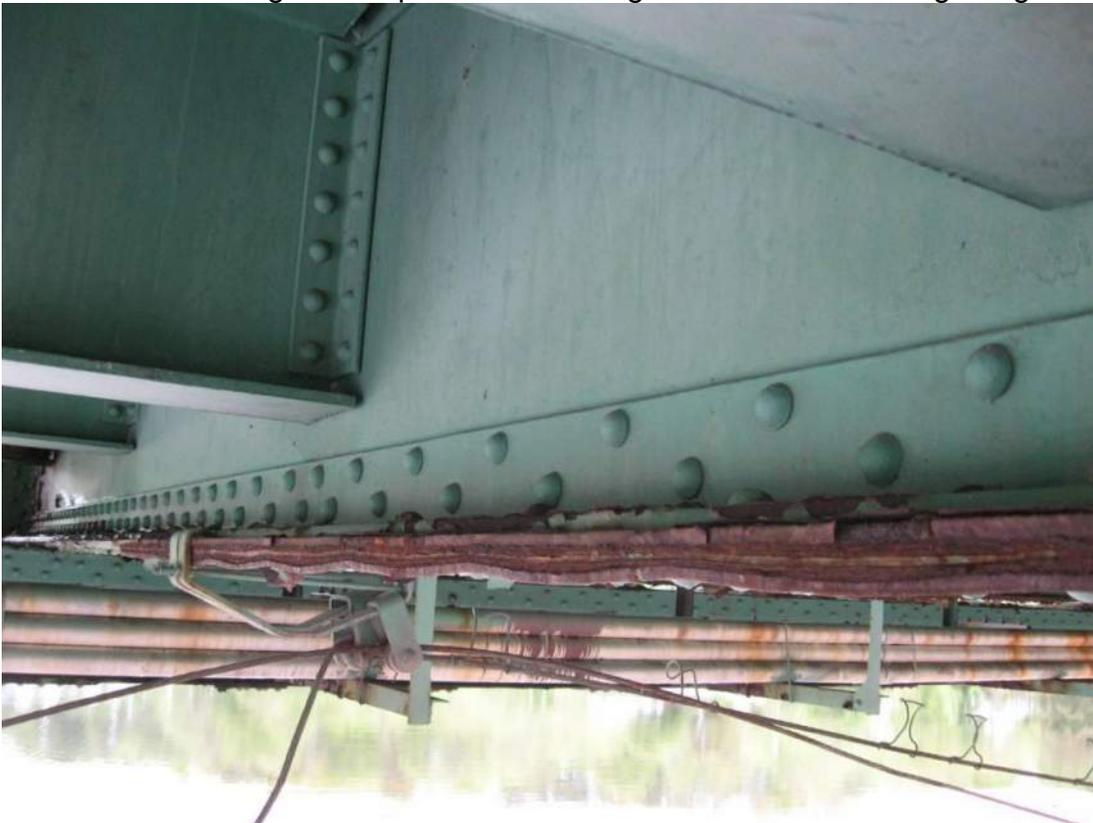
Photo 40 – An active pack rust condition was noted in the Span 2 FB5 floorbeam between S5 and S6.

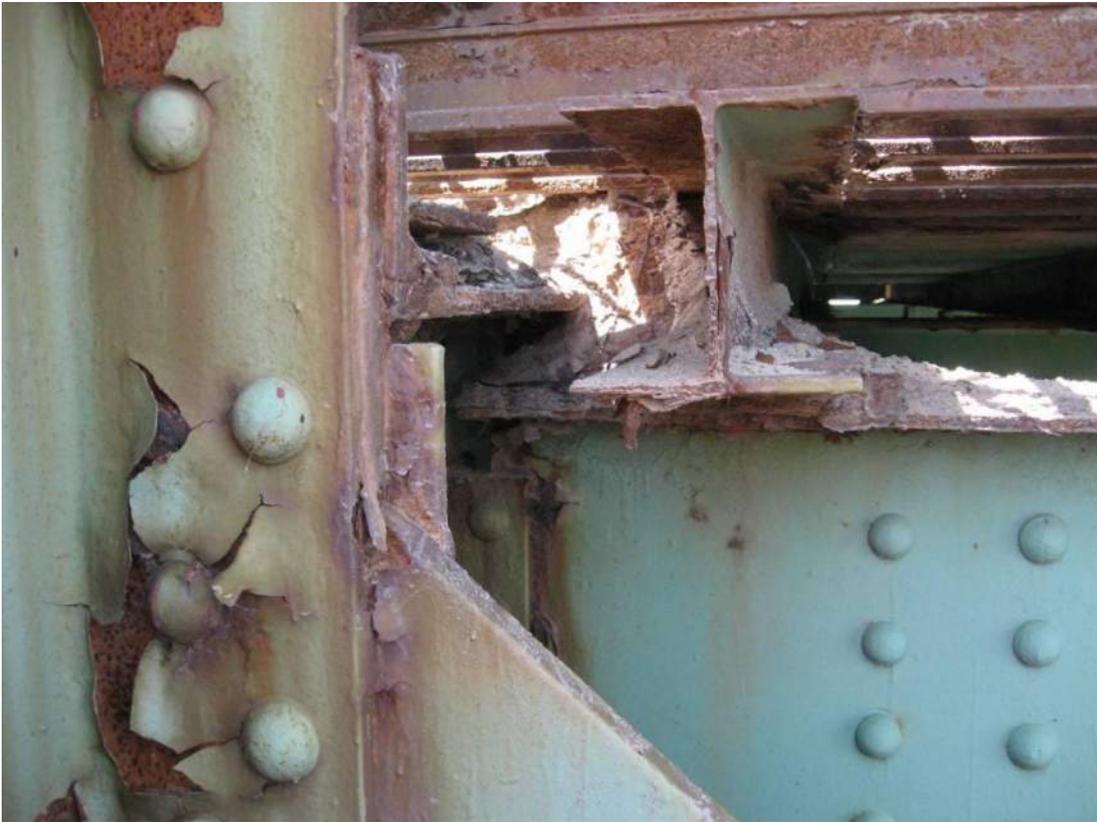
Photo 41– Span 1 FB2 has heavy debris accumulation from 4 to 6 inches deep on the top of the floorbeam flange. View looking west at roadway truss.

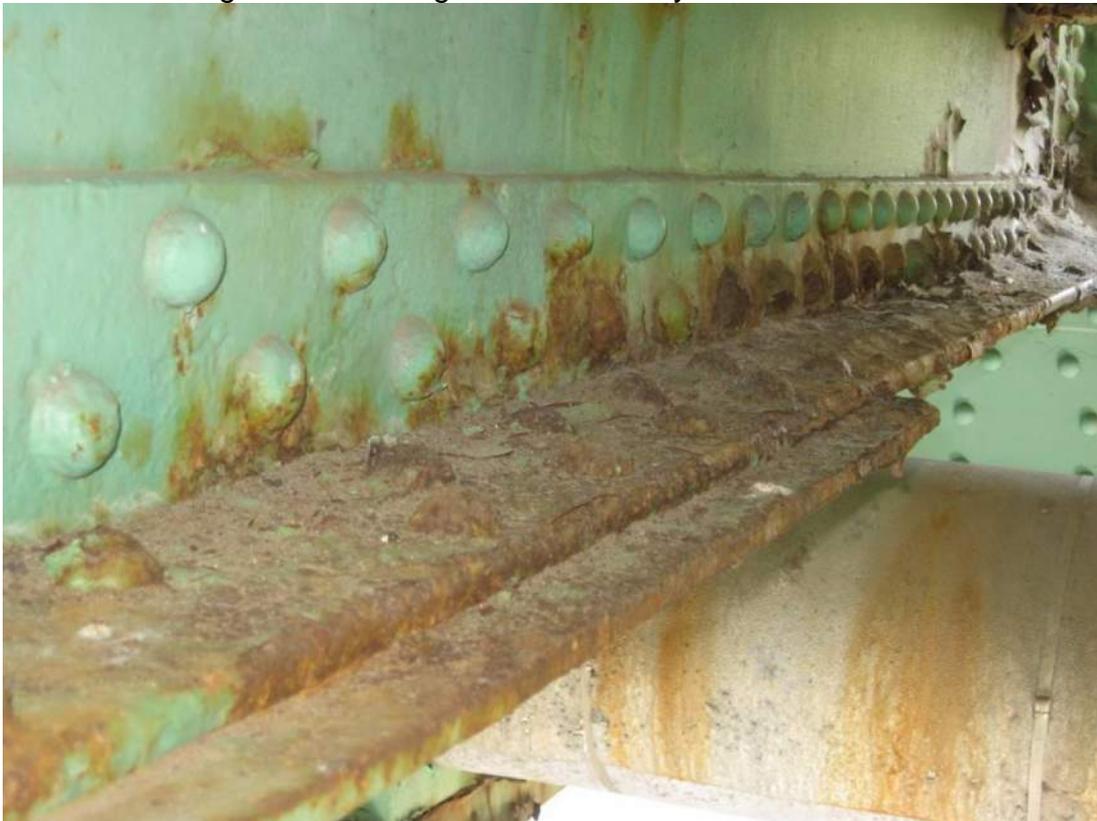
Photo 42 – Span 1 FB3 has moderate active corrosion to the bottom flange on the south side of the web between S6 and S8. View looking east.

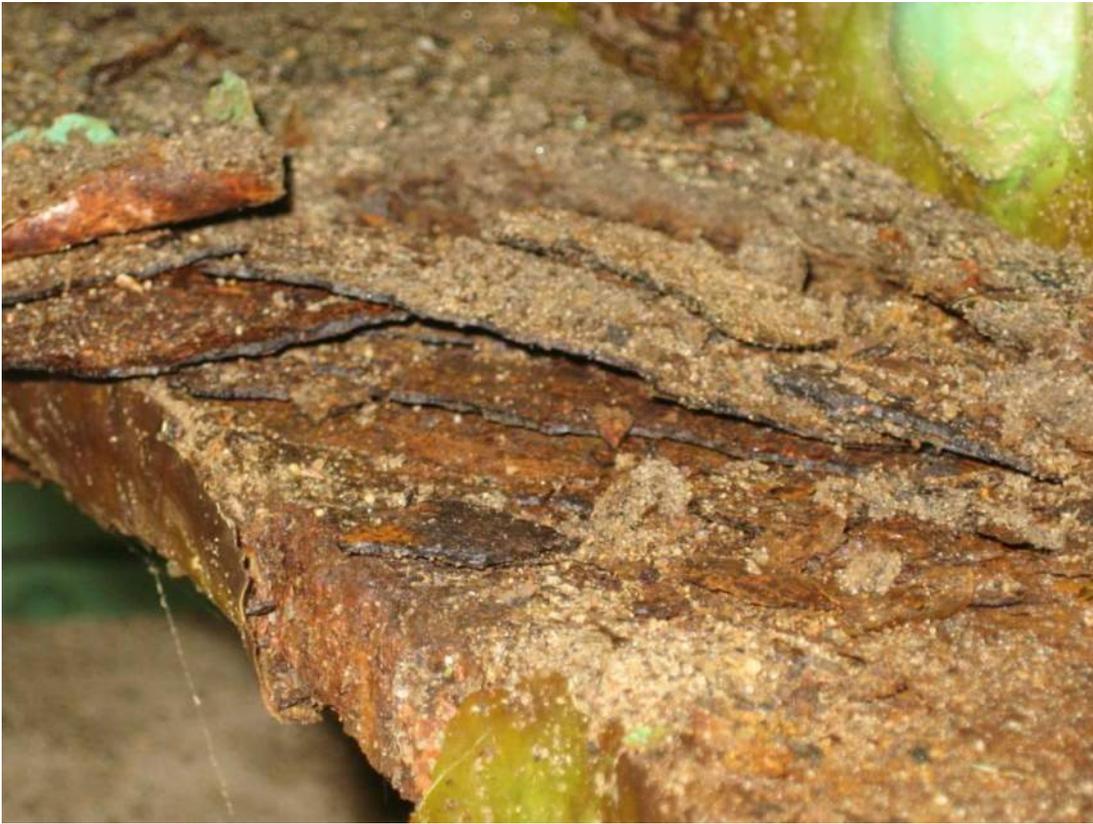
Photo 45– Span 2 FB8 has significant active corrosion and delamination to top of bottom flange angle on north side of web between S6 and S8 with up to 1/8 inch section loss.

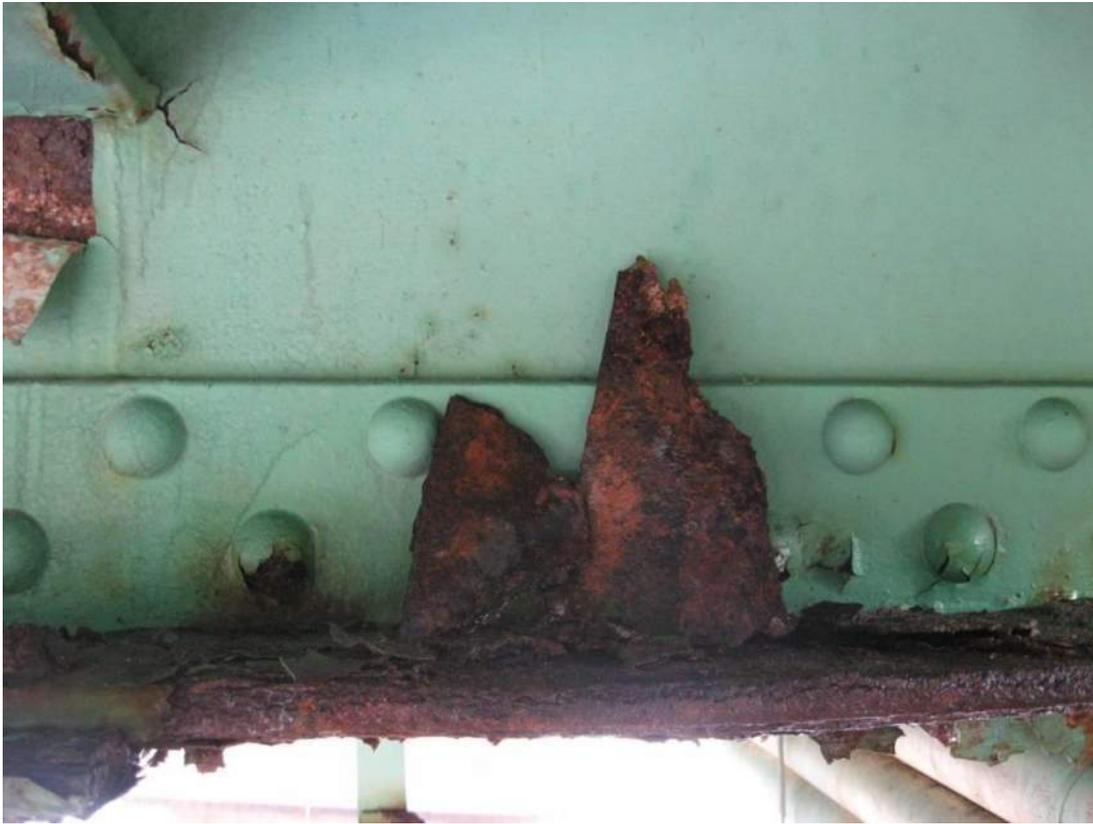
Photo 47– Span 2 FB4 has a 4” wide by 8” long zone of active corrosion/ delamination with 1/8” section loss to top of bottom flange on north side of web at 2 feet west of S4.

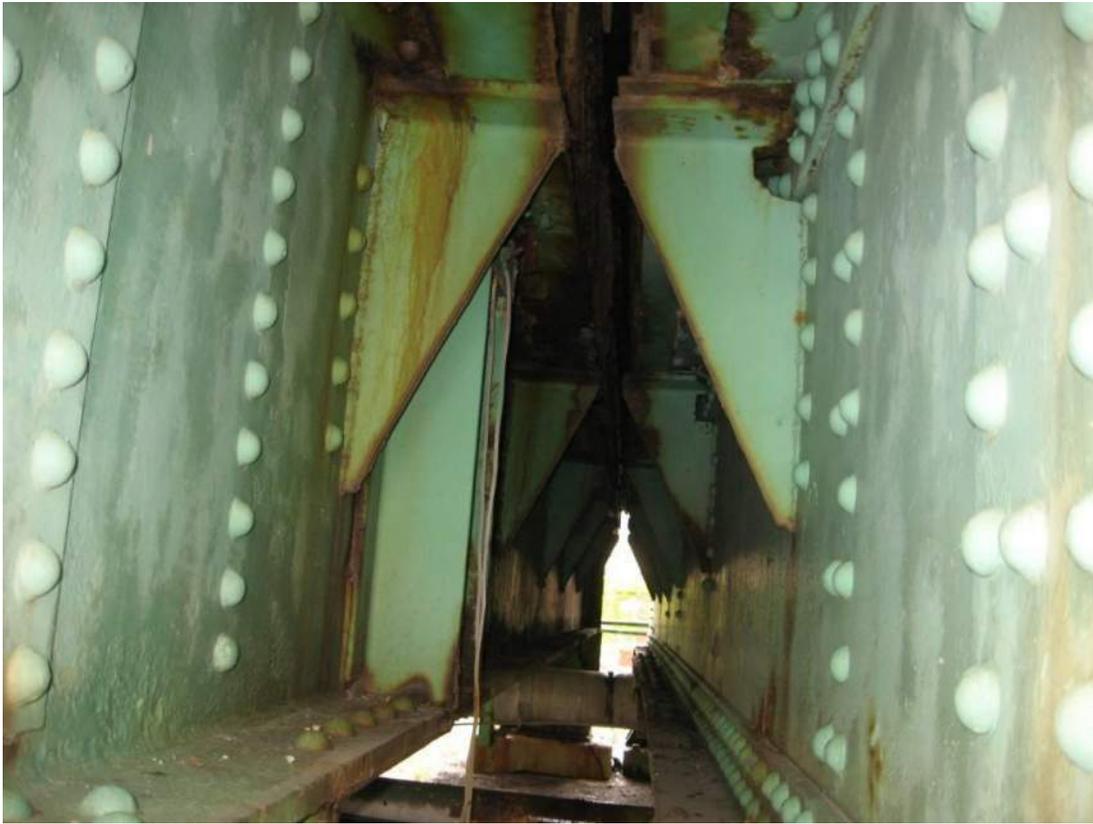
Photo 49– Partial height welded stiffeners on face of web below deck joint also observed at Pier 2 for the Span 2 and 3 end floorbeams (fatigue-sensitive details in FCM's).

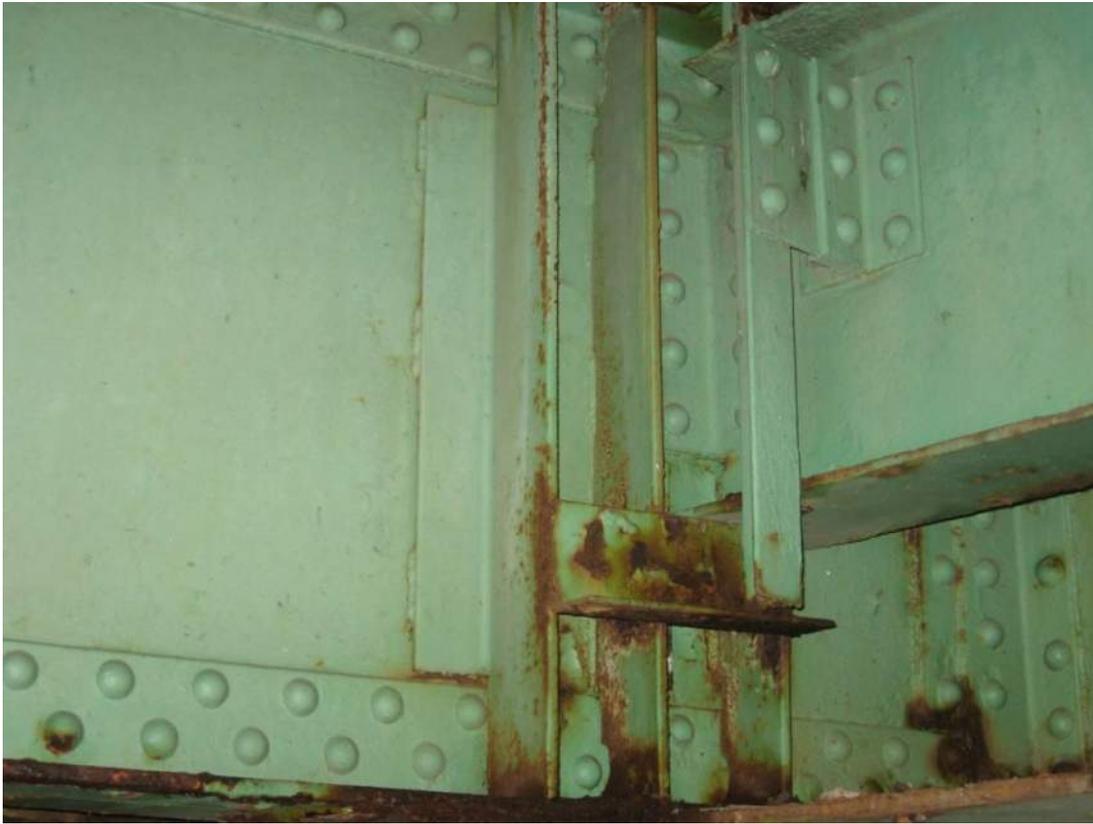
Photo 51– Full height welded jacking stiffeners were also noted on north face of Span 2 and 3 FB0 webs (on face opposite deck joint) at sidewalk and roadway truss ends.

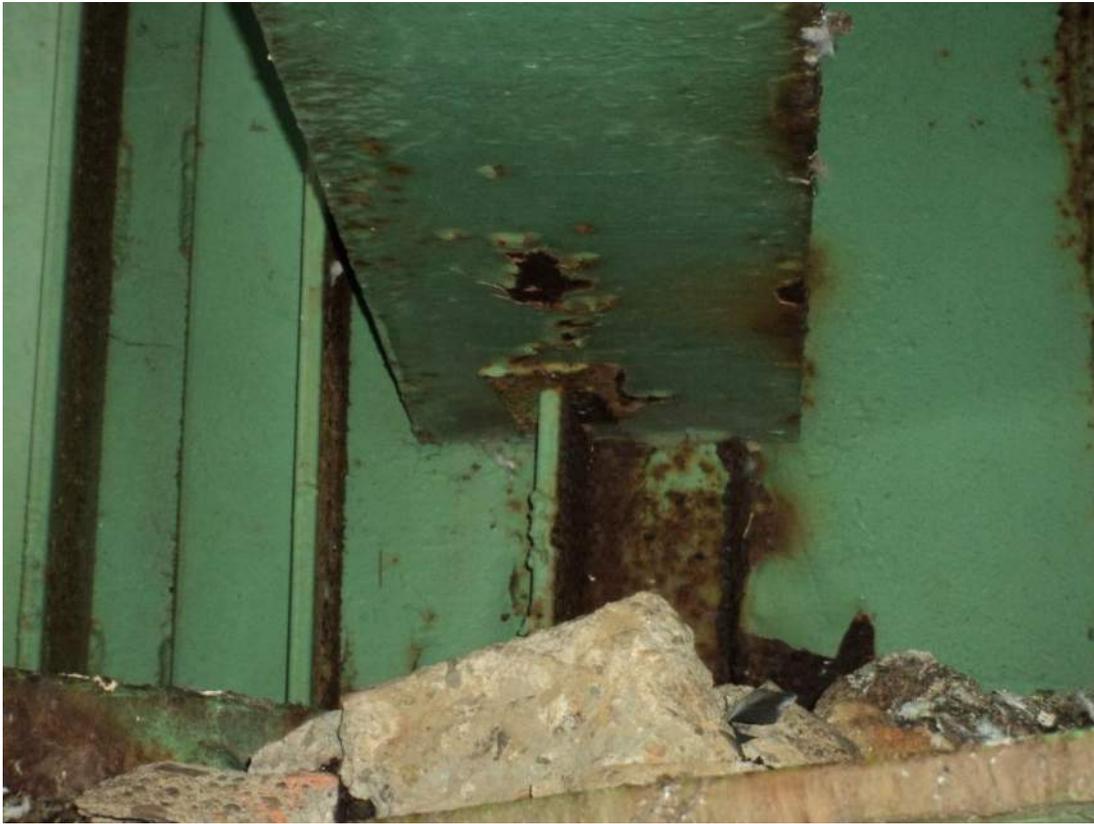
Photo 53– The north face of the Span 1 end floorbeam FB0 has a welded plate stringer bearing stiffener below S3 which constitutes a fatigue-sensitive detail in a FCM.

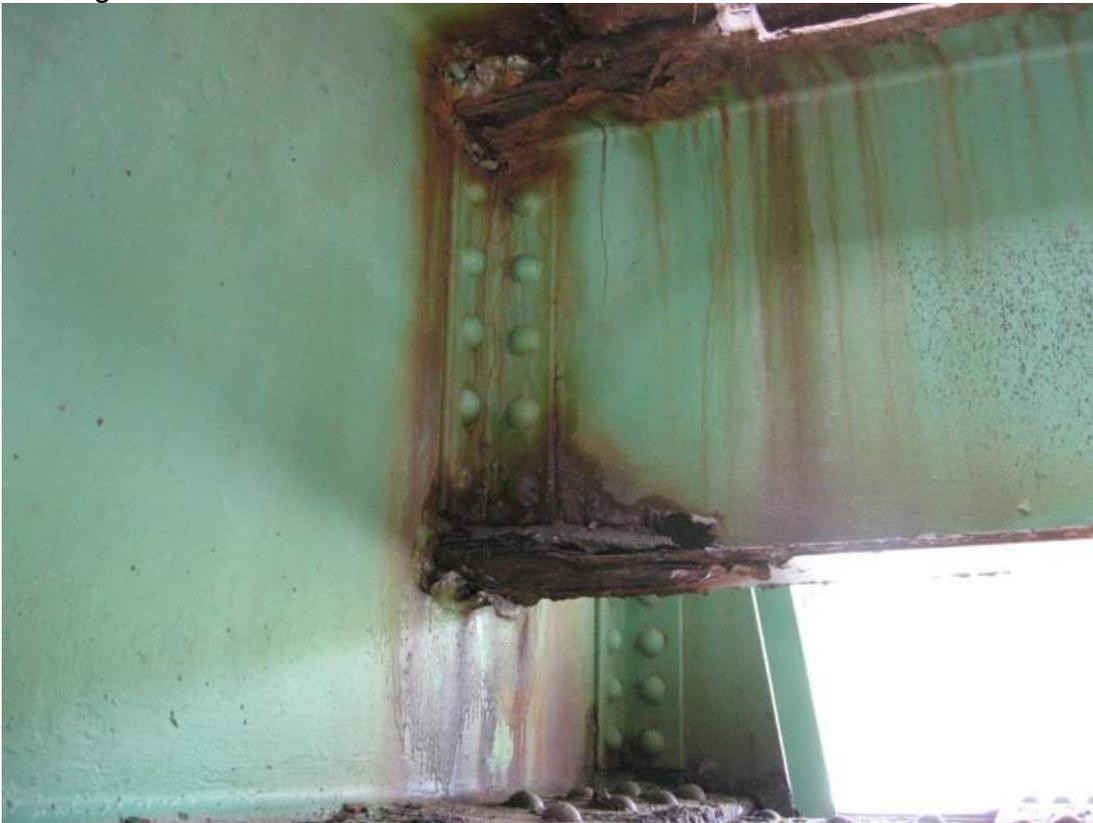
Photo 56 – Stringer S3 has pack rust on bottom flange and bottom of web at connection to north face of Span 3 FB3. Similar conditions noted at three other S3 stringer ends.

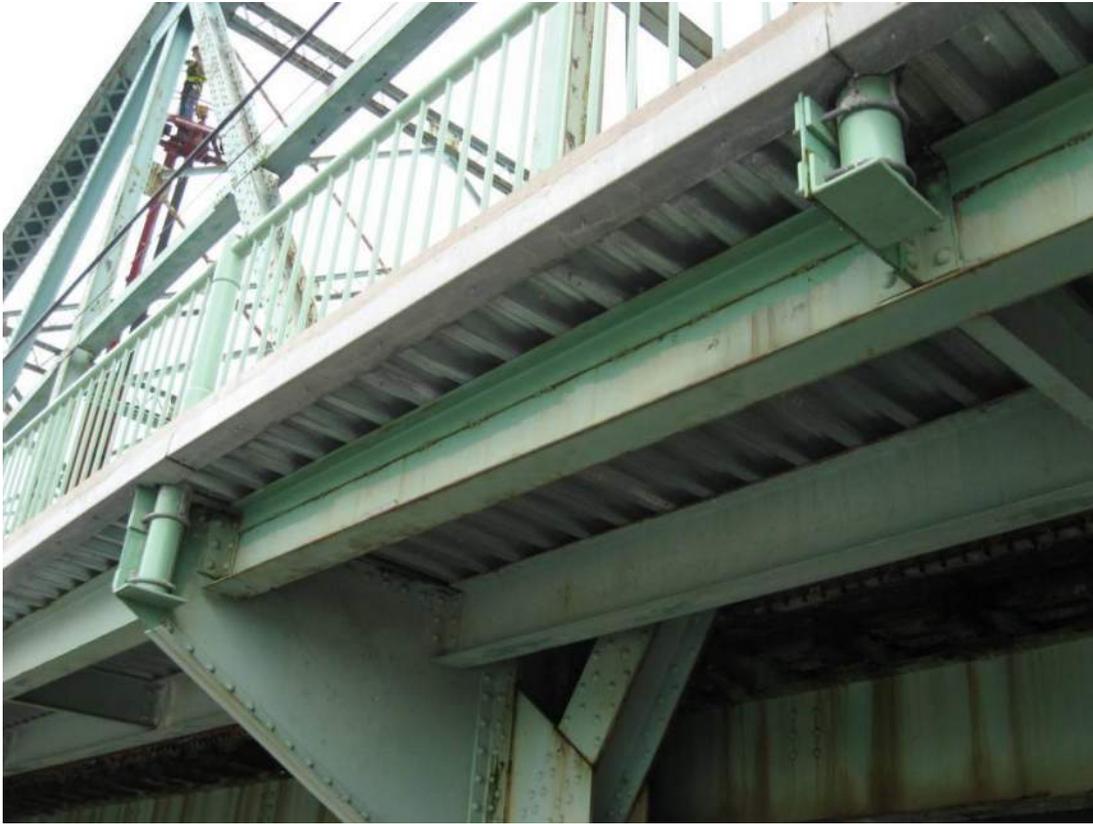
Photo 57– Sidewalk stringer S1 has been previously repaired at numerous panels by stitch welding a pair of angles to top of web, to restore section loss to original top flange.

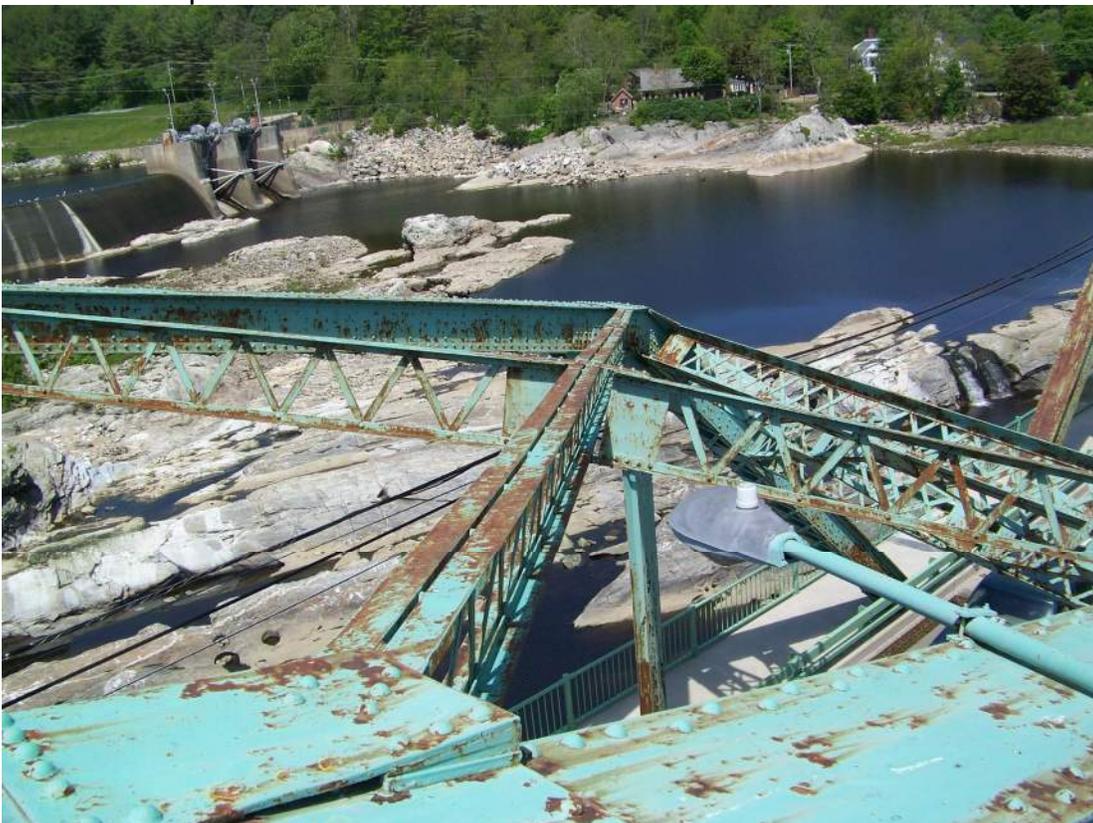
Photo 64 – The paint system is failed over more than 30% of the surfaces of the top chord lateral bracing. View looking northwest in Span 1 toward U9 sidewalk truss.

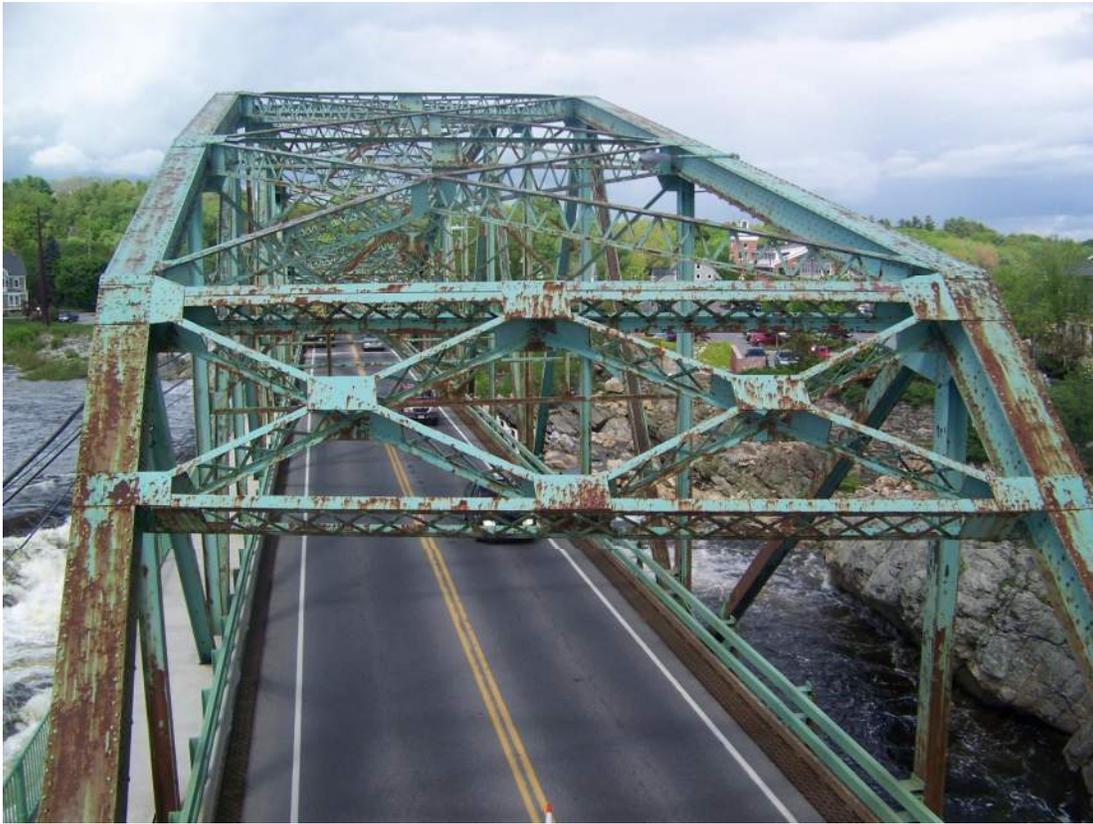
Photo 65– The paint system is failed over more than 30% of the surfaces of the top chord lateral bracing. Looking north toward Span 2 portal.

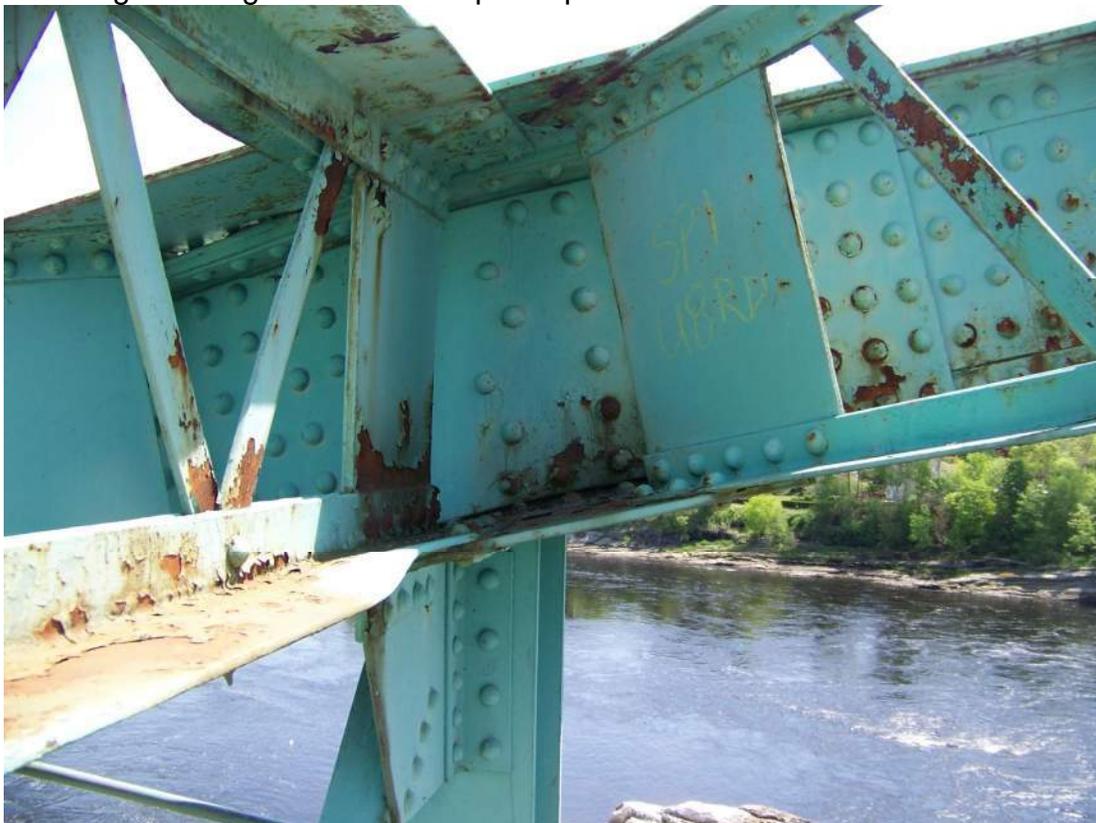
Photo 66 – The ends of the top laterals at numerous locations have intentional crimping-related distortion to accommodate the member slopes at the upper panel points.

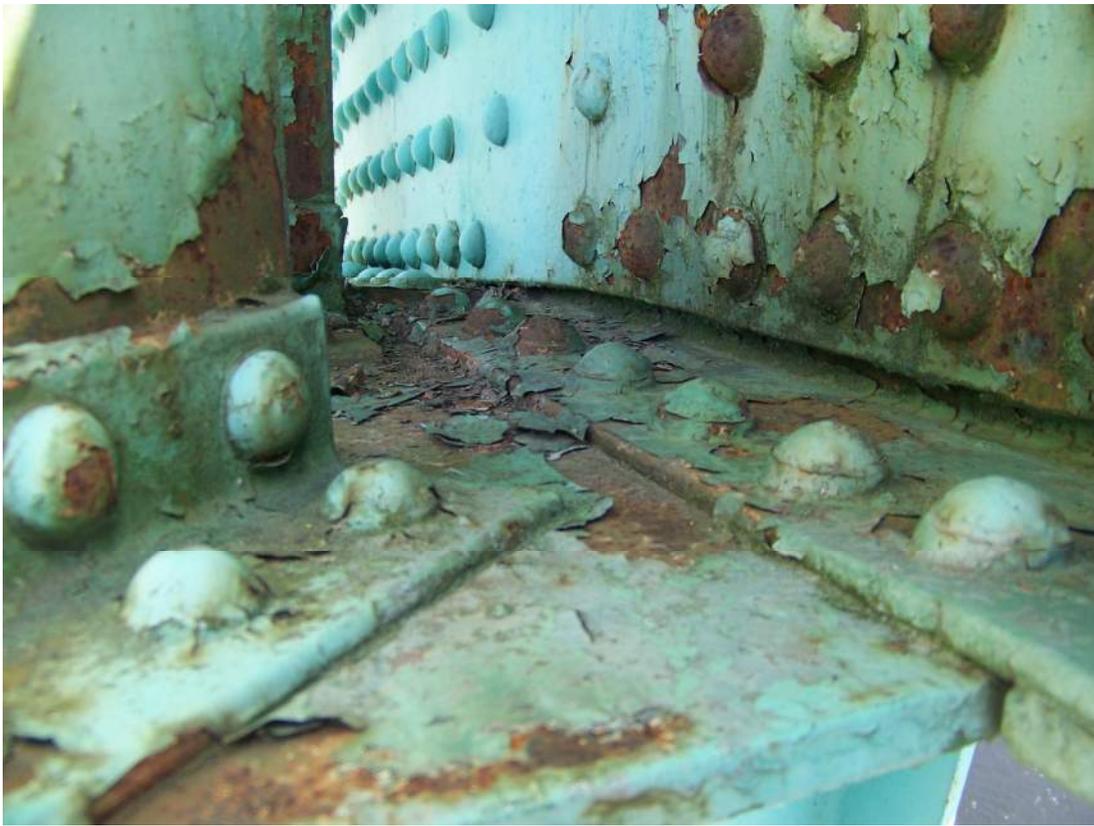
Photo 67– Many of the upper chord lateral bracing connection plates have paint failures and active corrosion. View at Span 1 roadway truss U8.

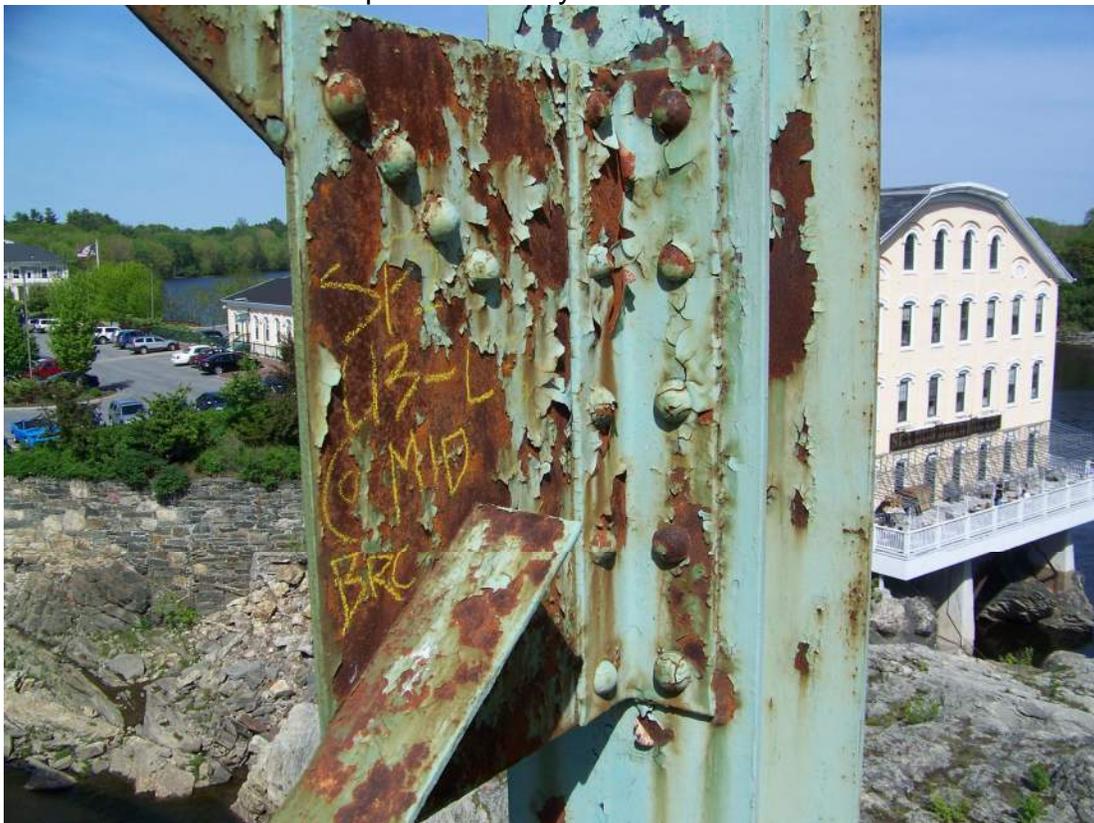
Photo 68 – The mid-lateral sway frame bracing connection plates at U3 to U7 typically have peeling or failed paint. View at Span 2 roadway truss U3-L3 mid-lateral.

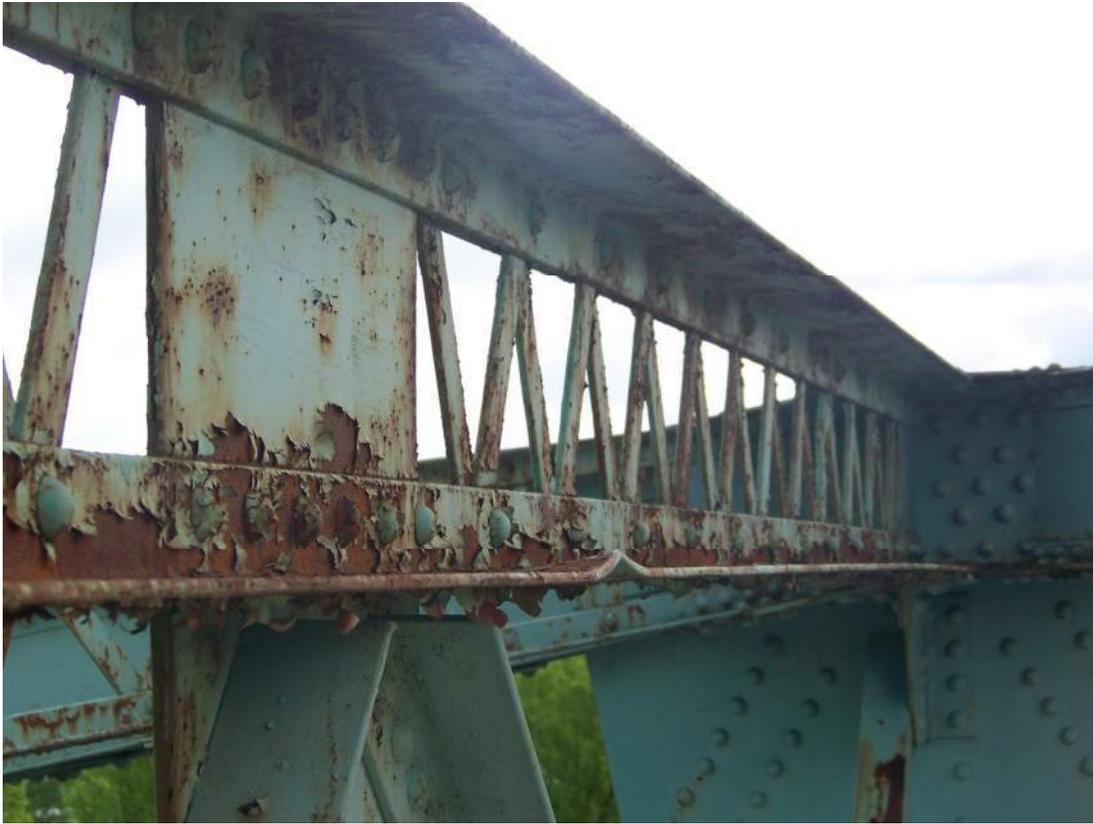
Photo 69– The Span 3 U5 upper chord lateral bracing transverse top strut has a $\frac{3}{4}$ inch upward bend in the south side lower angle edge at one foot east of roadway centerline.

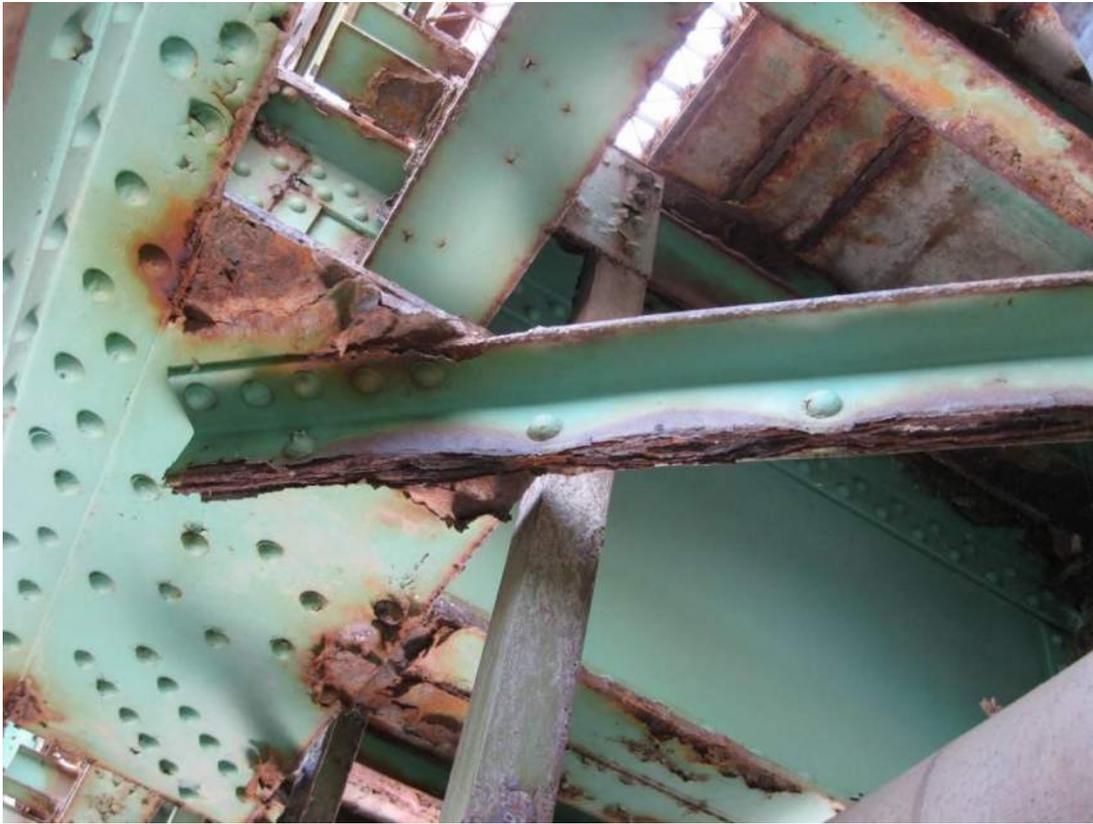
Photo 71– Severe pack rust with active corrosion over a 4' length of lower lateral bracing angle connecting Span 1 L3 roadway truss and L4 sidewalk truss at the L3 end.
