Preliminary Design Report

Frank J. Wood #2016

Brunswick-Topsham, Maine

August 4, 2017

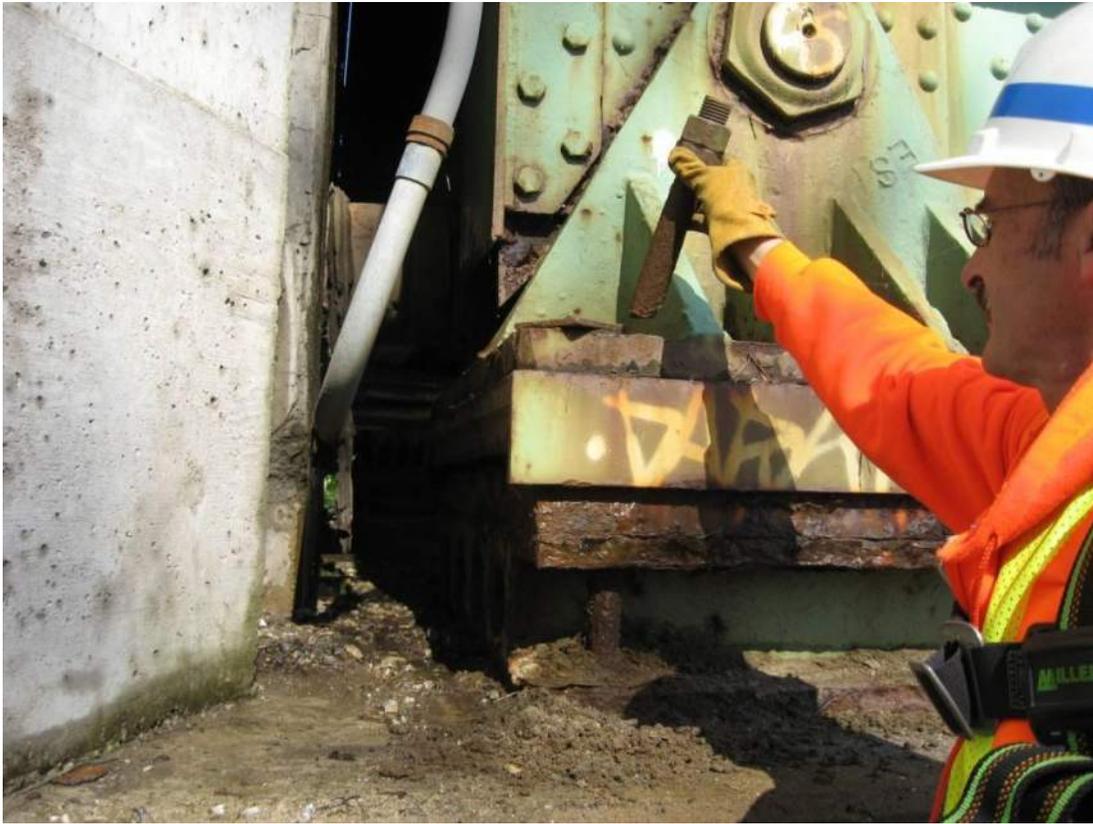
Photo 73– The roadway truss bearing at the south abutment has a loose anchor bolt which was removed, photographed and loosely re-inserted by the inspection crew.

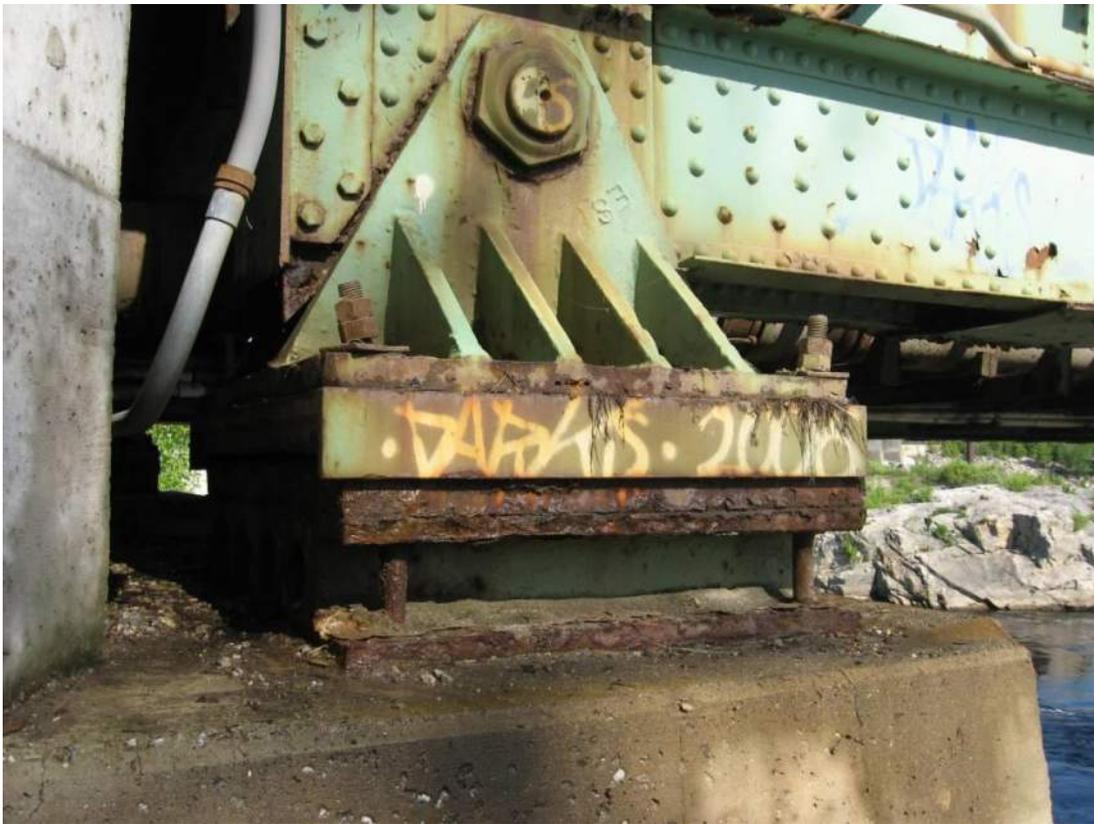
Photo 75– The two anchor bolts on the east side of the south abutment roadway truss bearing were noted to be bent off plumb in opposite directions.

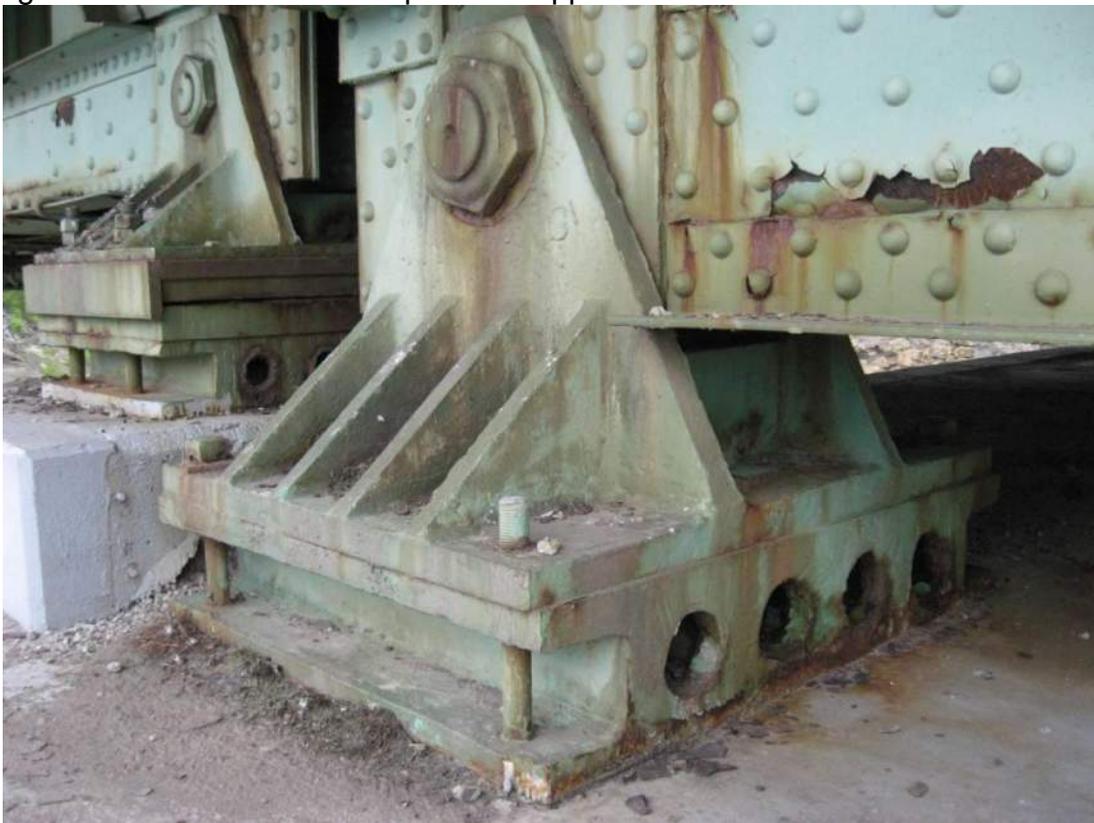
Photo 76 – The Span 2 sidewalk truss fixed bearing at Pier 2 is missing a nut on the southwest anchor bolt. View looking northeast.

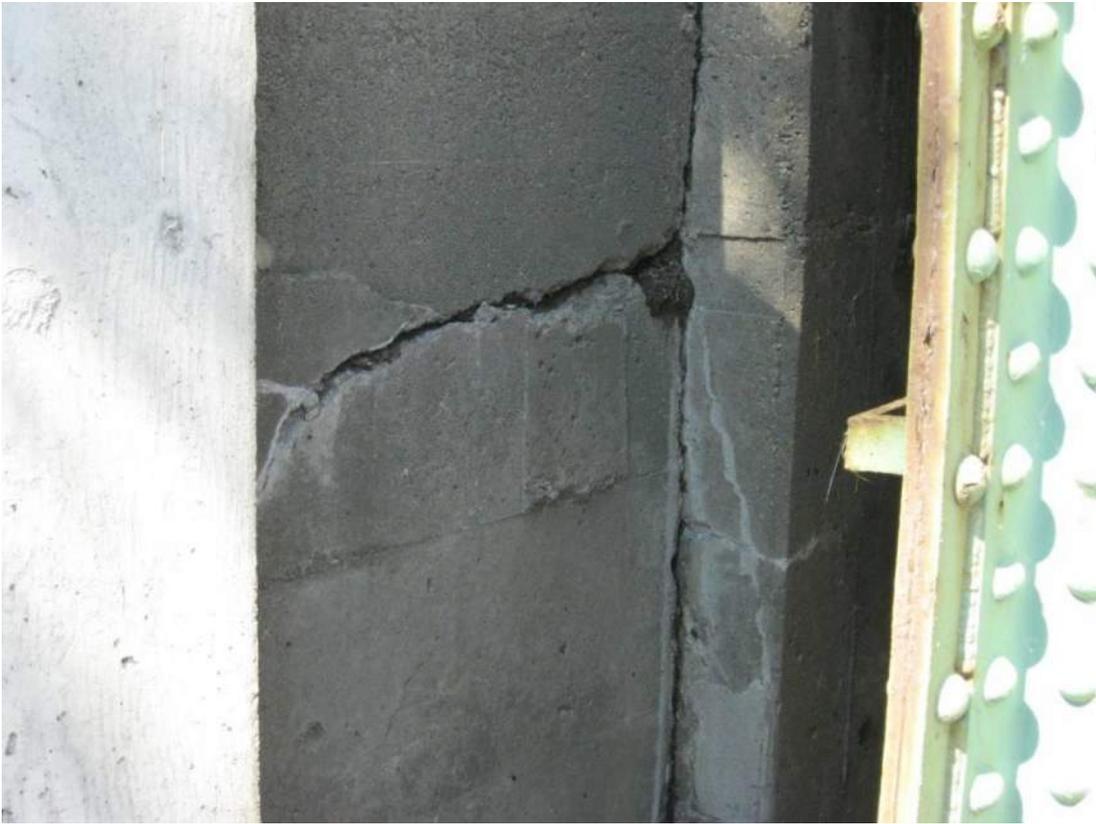
GENERAL CONDITION: The substructures, having been rehabilitated in 2006, are in satisfactory condition. The south abutment has a 2' long horizontal crack about 4' above the bridge seat near the wing wall. A portion of this abutment sits on stone masonry that shows signs of shifting stones.

Photo 77– The south abutment backwall has a wide 2 foot long horizontal crack near the wingwall corner at approximately 4 feet above the bridge seat.

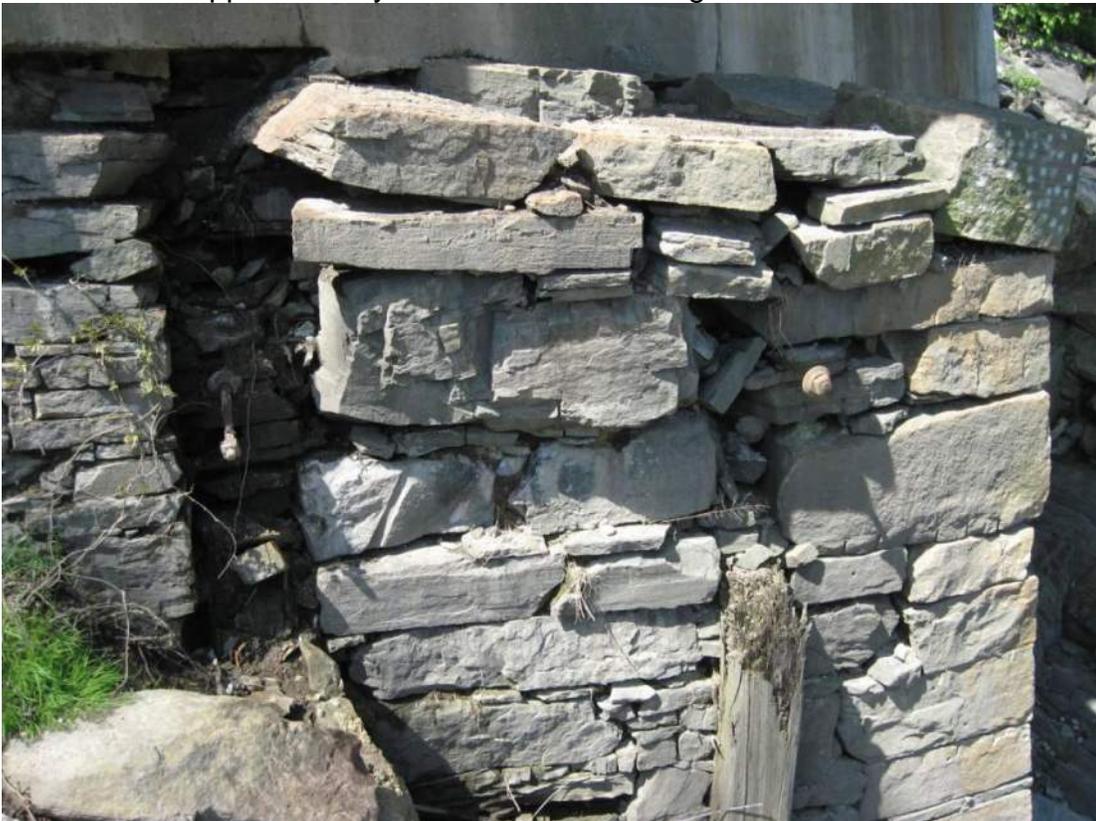
Photo 78 – Older stone masonry portions of south abutment exhibit remnants of missing timber bracing anchors and possible signs of outward shifting of a few of the stones.

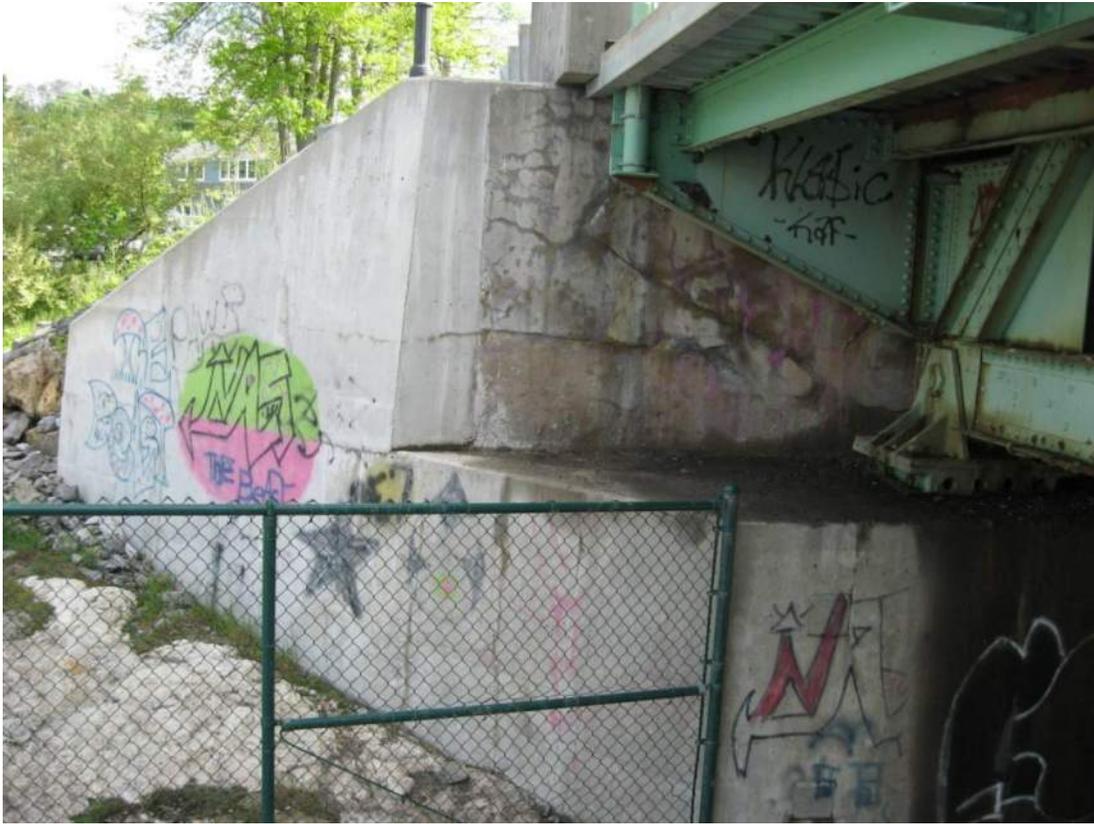
Photo 79– The north abutment backwall has numerous medium diagonal cracks in the portion below the sidewalk. View looking north along sidewalk truss.

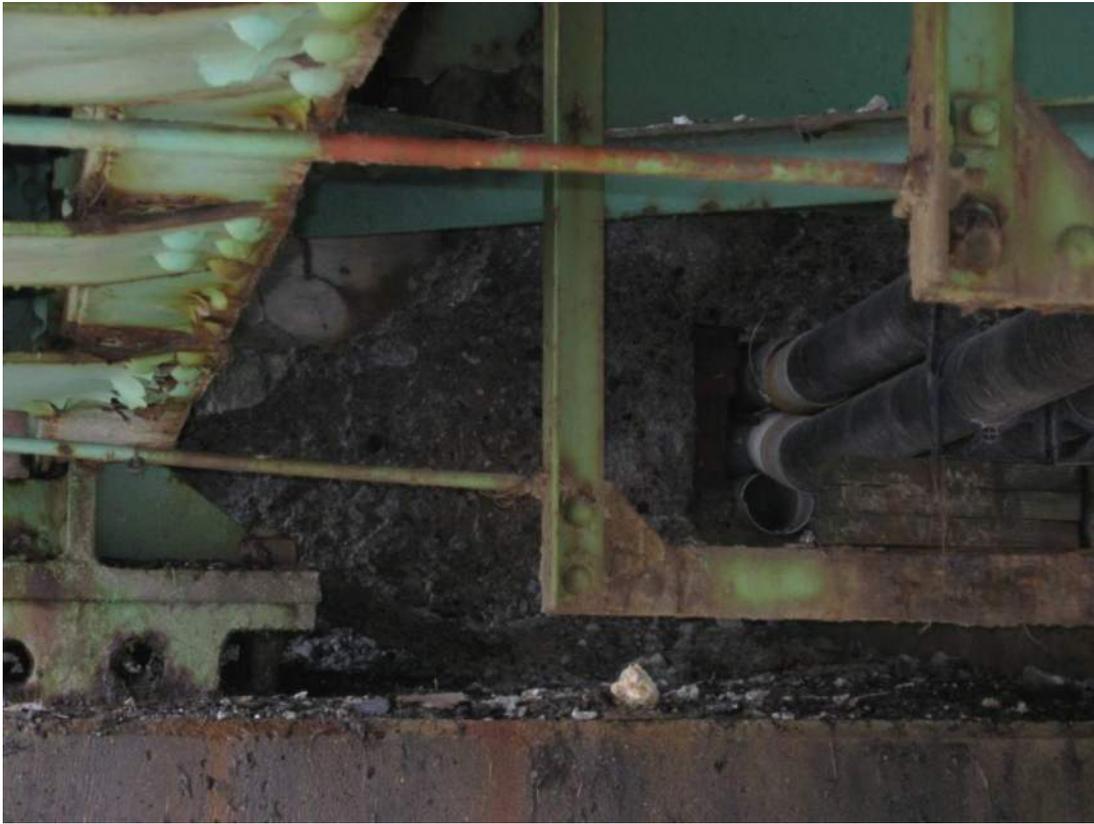
Photo 81– There is a large 3 foot by 3 foot by 3 inch deep spall in lower portion of backwall around edges of utility conduit penetration and extending behind sidewalk truss.

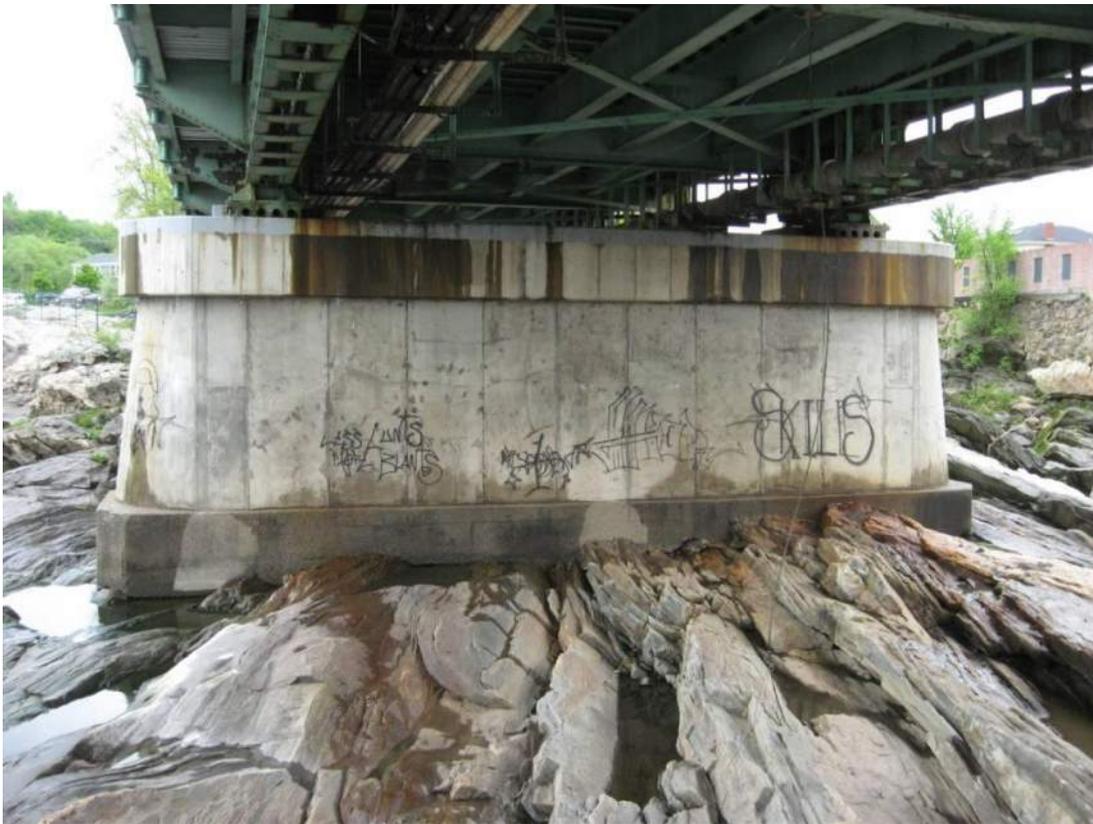
Photo 83– Piers are in satisfactory condition with no significant visible defects. View looking north at south face of Pier 2.

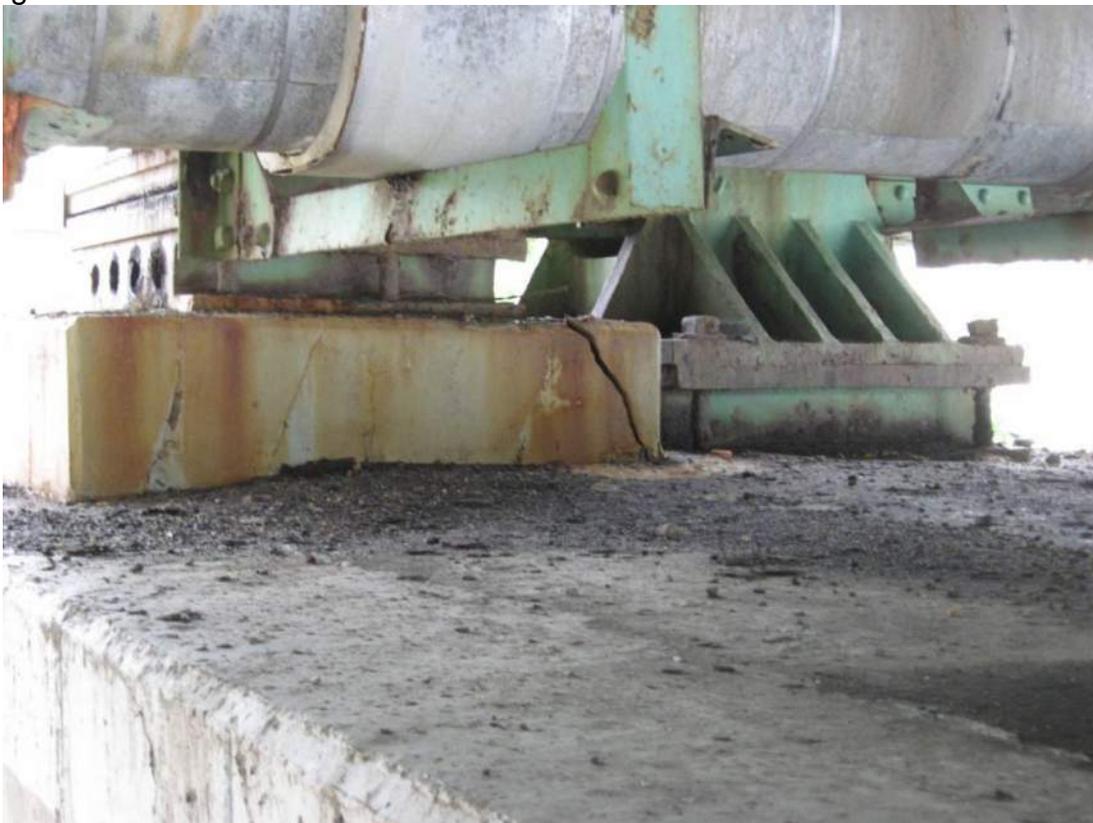
Photo 84 – Pier 2 has a wide diagonal crack in the southwest corner of the sidewalk truss bearing pedestal which extends for the full height of the concrete pedestal.

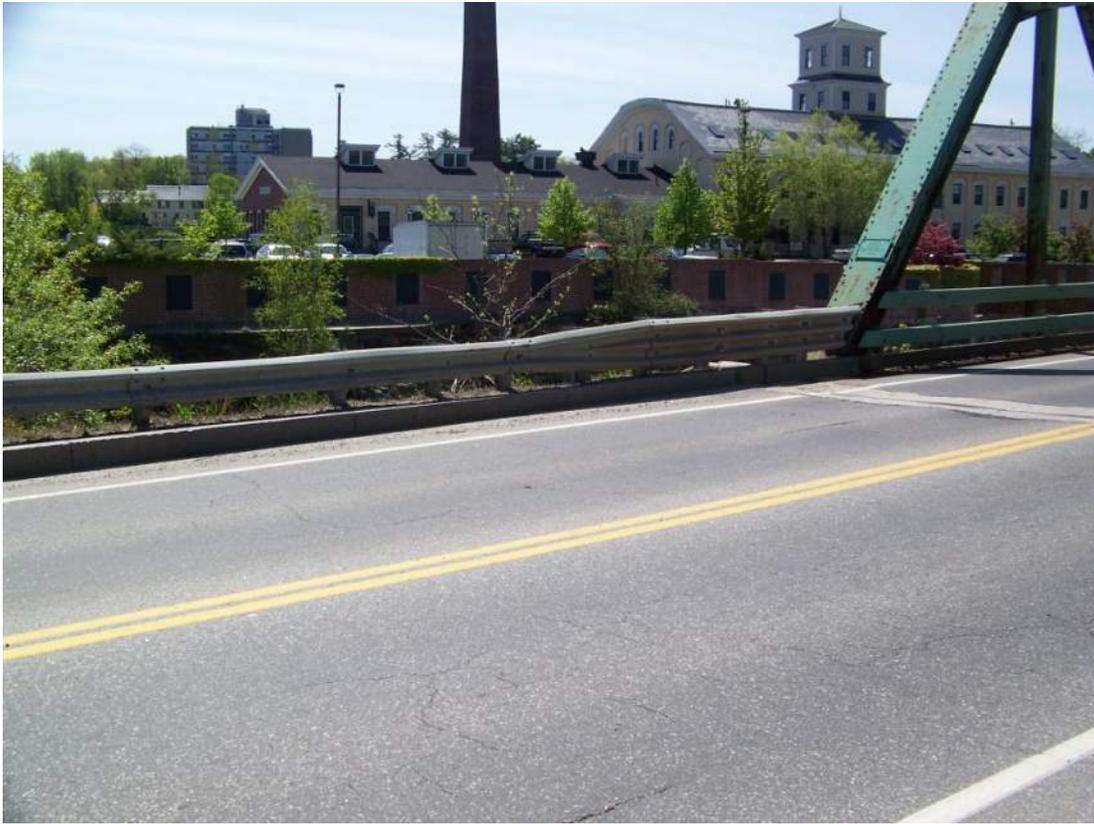
Photo 85– Both approach pavements are in fair condition with several transverse and longitudinal cracks clustered in the wheel paths. Looking southeast at northeast corner.

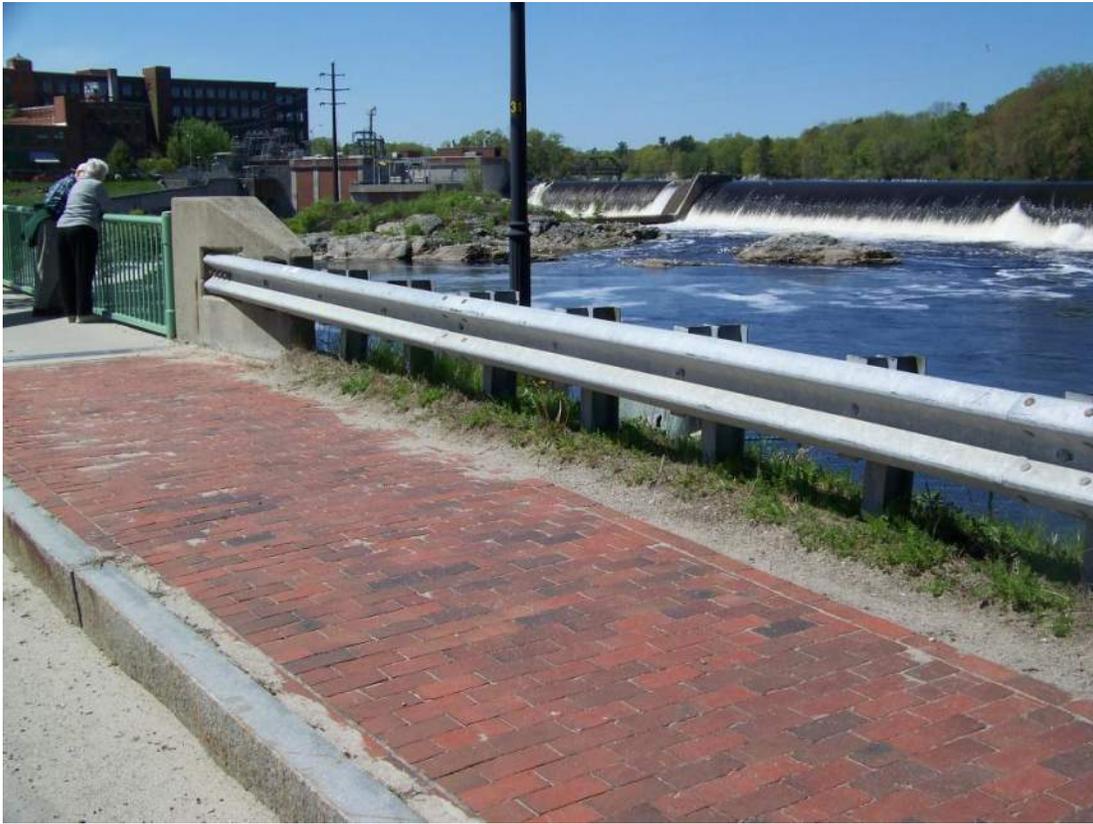
Photo 87– The approach guiderail at the northwest corner of the bridge is aligned with the outboard edge of the sidewalk and connected to the west pylon.

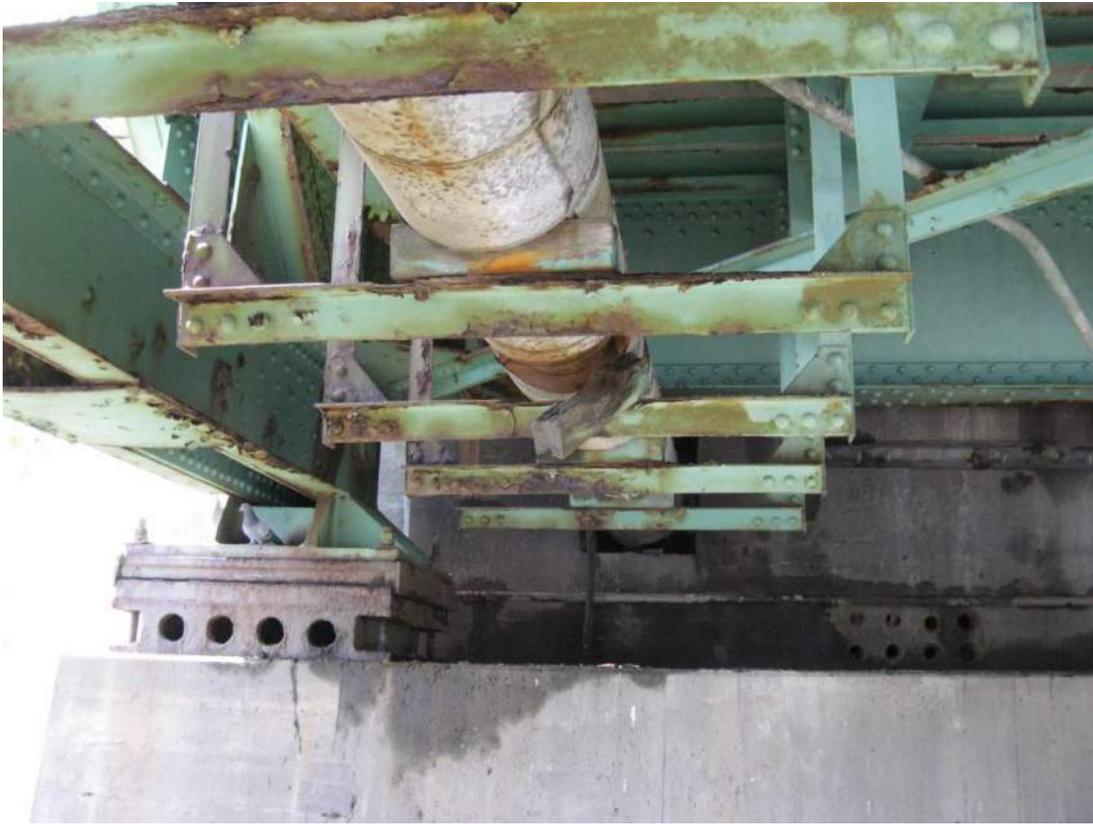
Photo 89—Large insulated under-deck utility located just inboard of roadway truss has missing blocking at several locations. View looking south In Span 1 at south abutment.

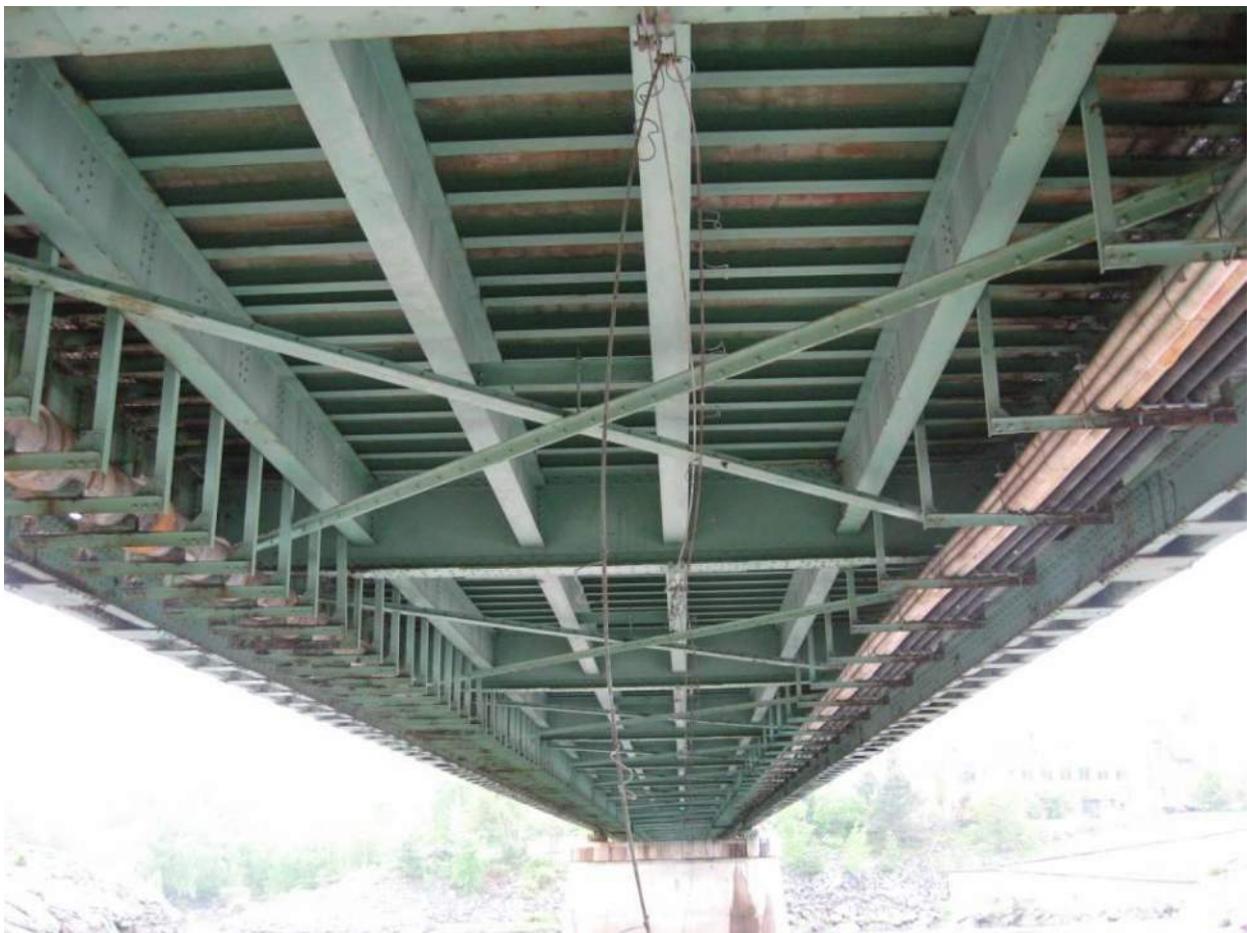
Photo 91– Remnants of an abandoned wire cable attached to the floorbeams were observed dangling at several locations. View looking south in Span
