SPECIAL COLLISION DAMAGE INSPECTION OF RAMP F OVER I 95 BRIDGE # 5807 – AUGUSTA – OCTOBER 3, 2017

Summary of Collision Damage determined from Tuesday, October 3, 2017 Inspection, due to collision impact):

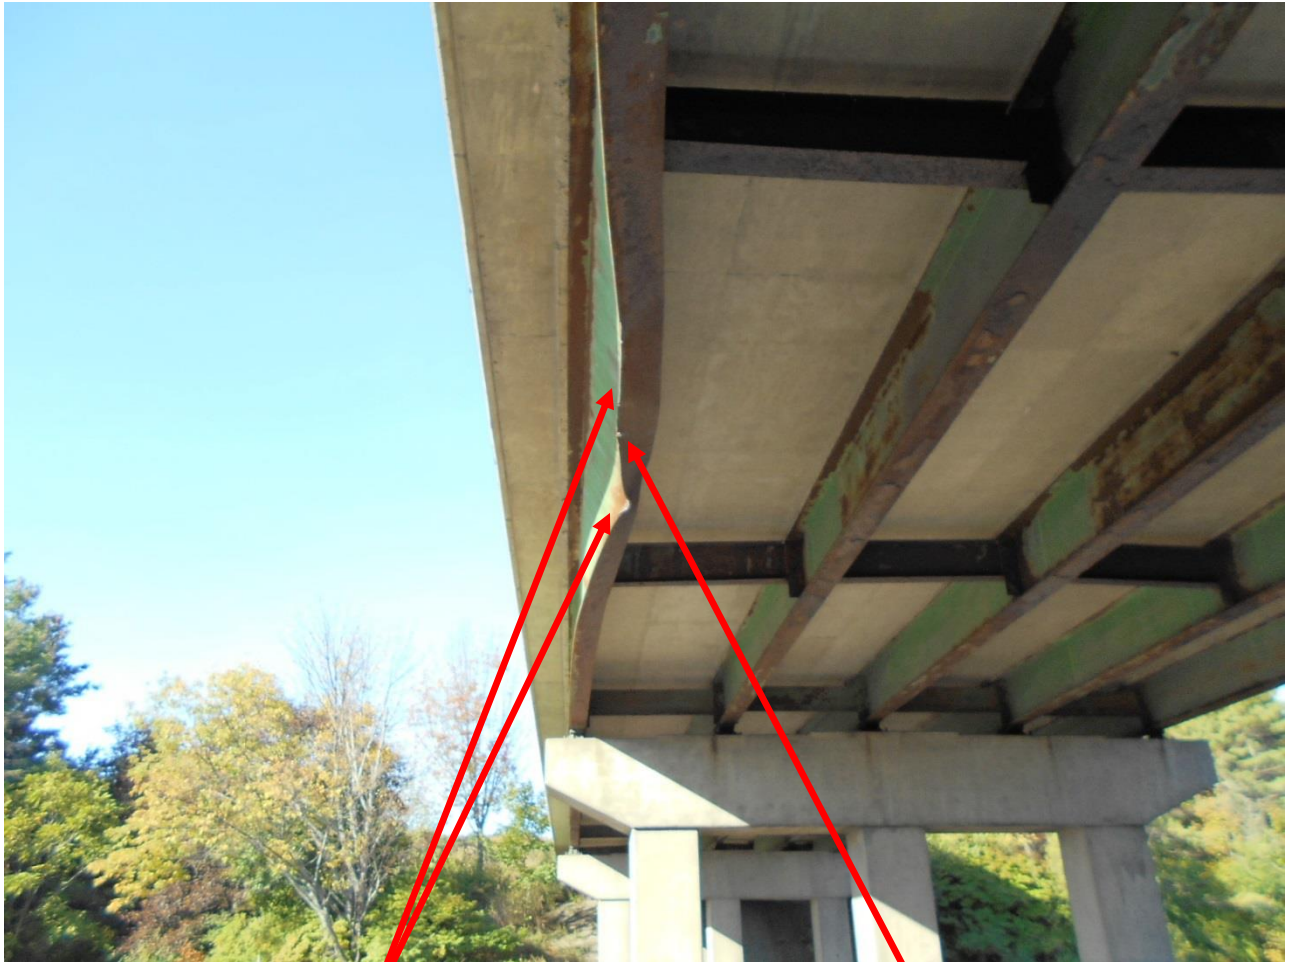
Approximate 12” sweep in southerly exterior beam

Point of contact ("shiny steel")

Notch in bottom flange

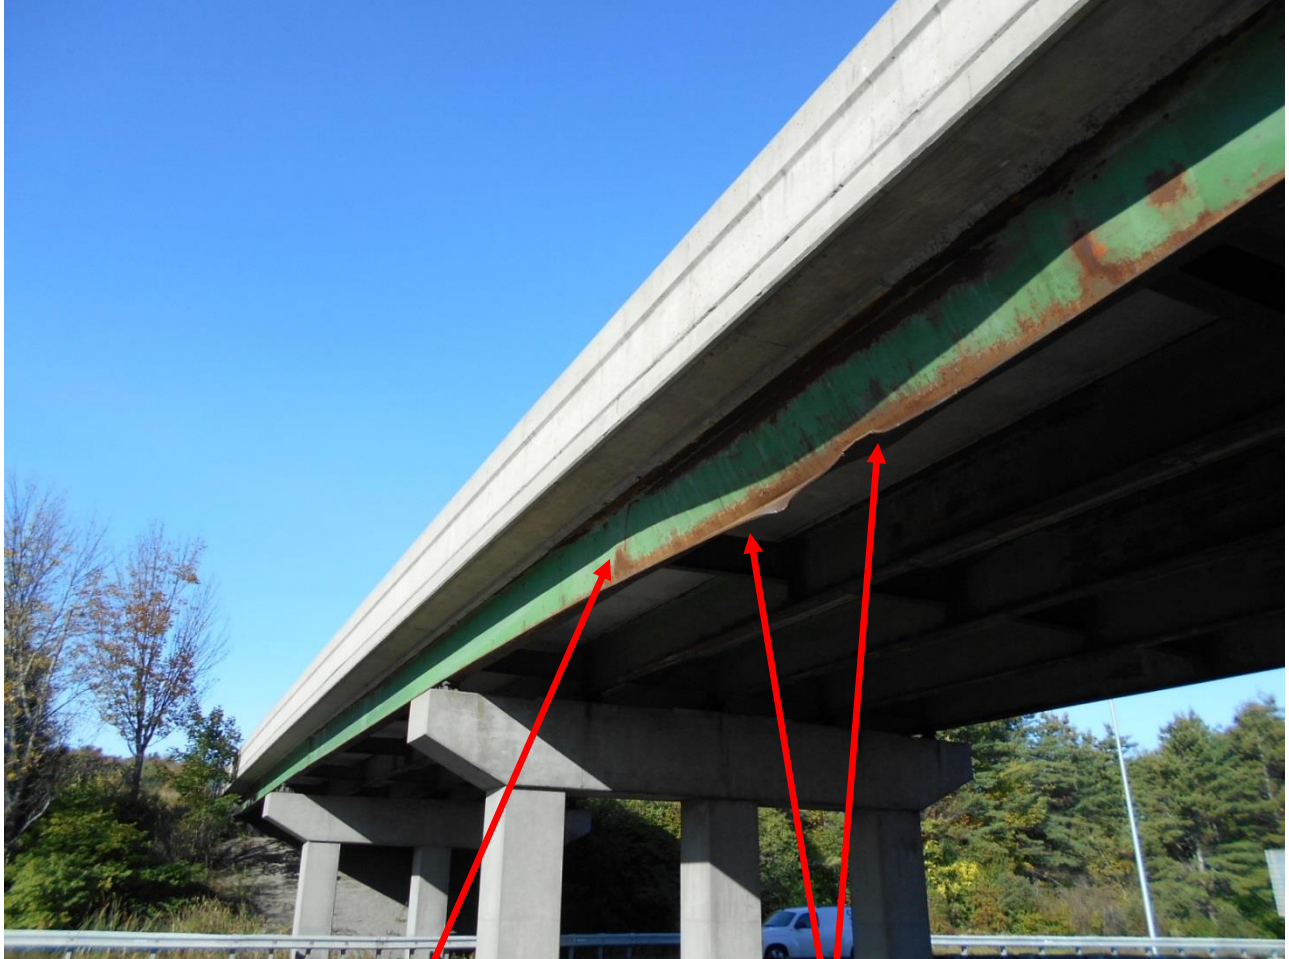
Approximate 12” sweep in beam

Bend in web due to diaphragm

Point of contact (“shiny steel”)

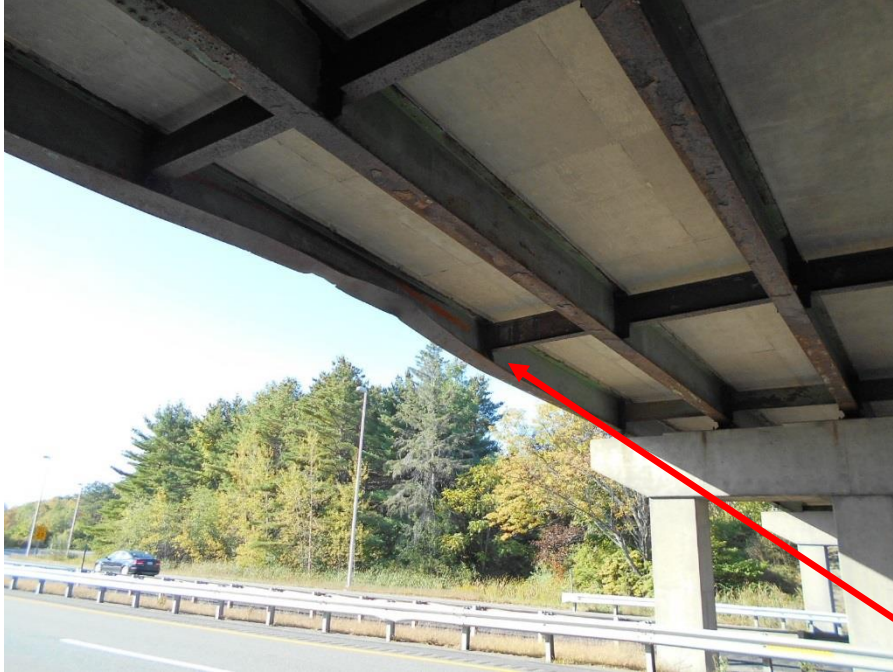
Bent diaphragm connection plate

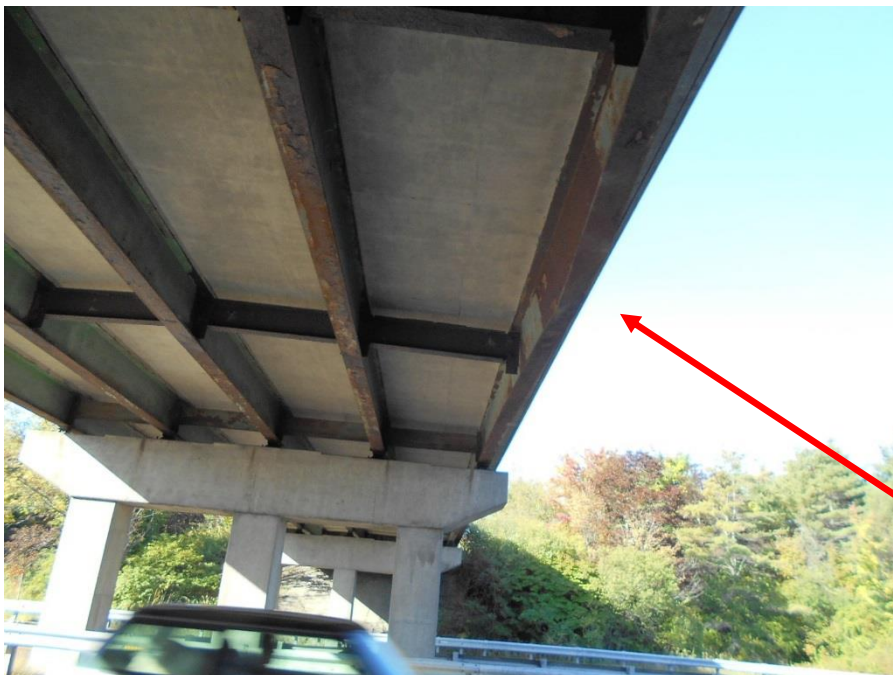
4" plus sweep in northerly exterior beam

Sweep in beam

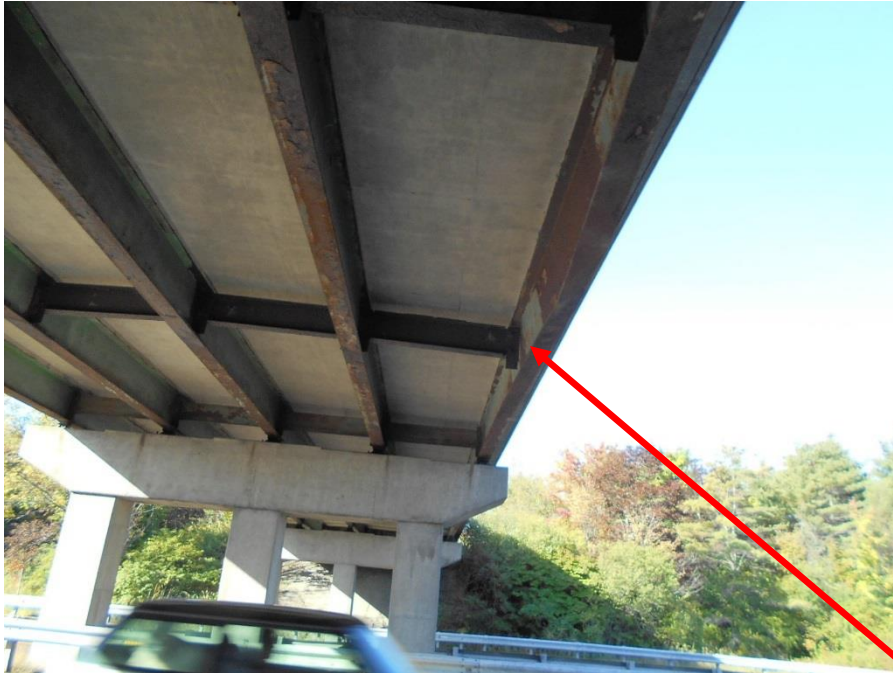
Diaphragm connection plate pulled away from beam on northerly exterior beam

Connection plate
pulled from beam

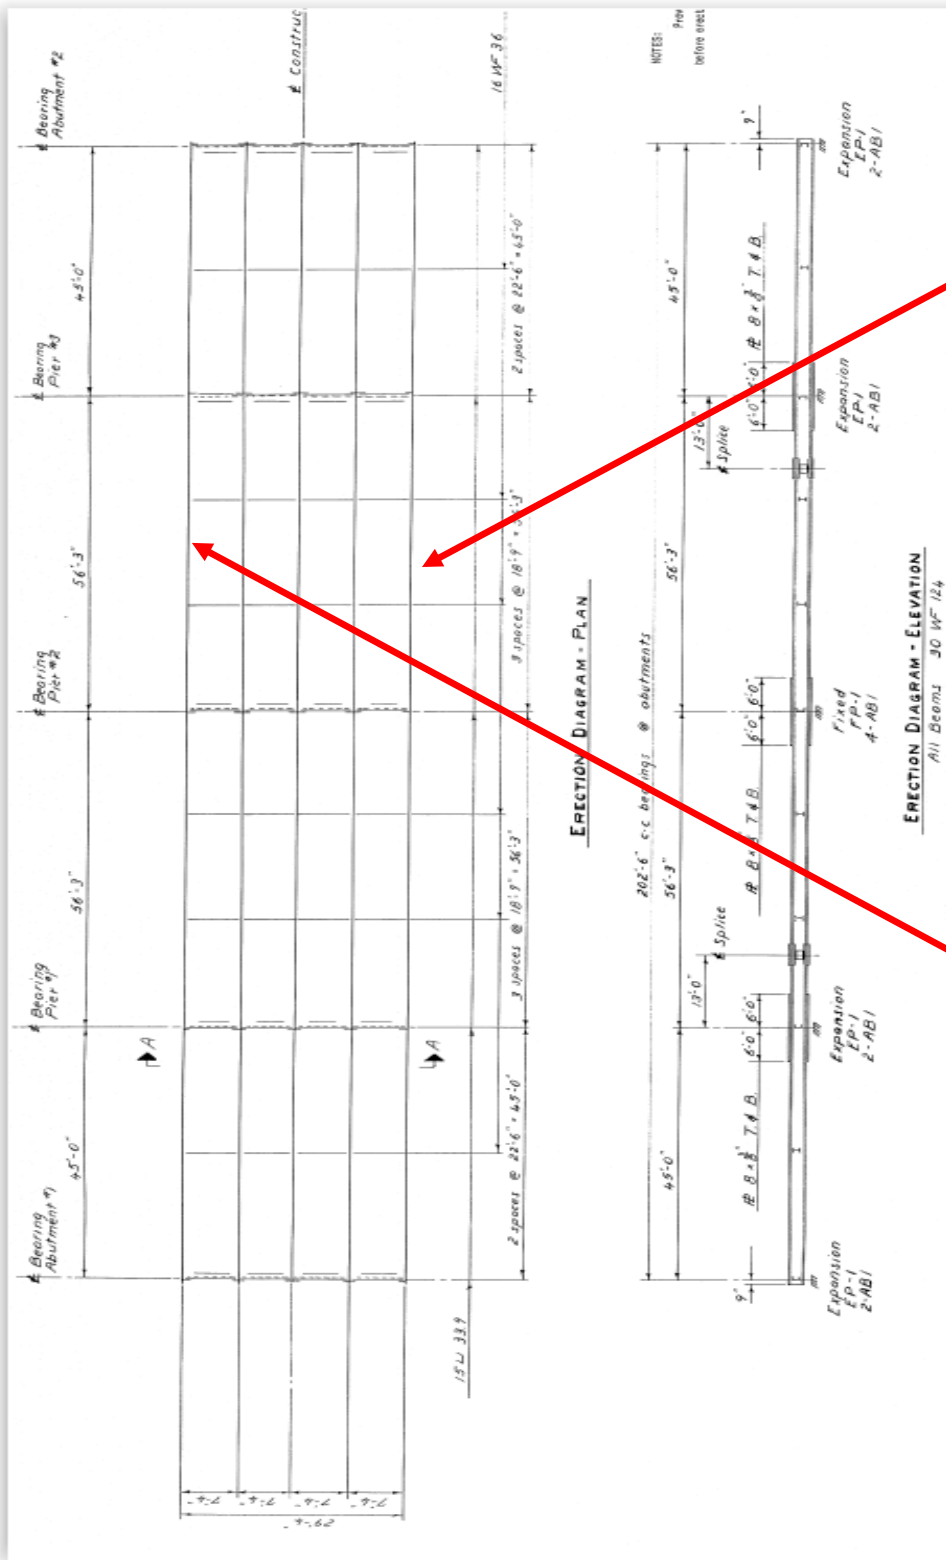
Location of points of contact from hit

Location of possible hit on northerly exterior beam
