**Maine Department of Transportation
FY 2024 Competitive Highway Bridge Program
Off-System Bridge Investment Project
Project Bridges**

Attachment A – Project Bridges

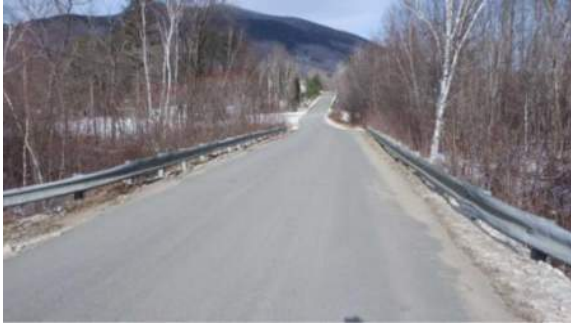
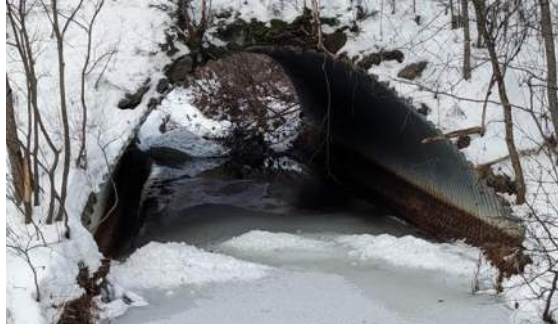
Top of roadway surface.		North Culvert at East End – Section loss and surface rust the entire length of the culvert near the water line.	
0561	Poor	1950	Replacement
Mace Road over McGurdy Stream – Town of Chesterville/Vienna – Franklin Co. 44° 32' 20.4" N, 70° 3' 58.93" W

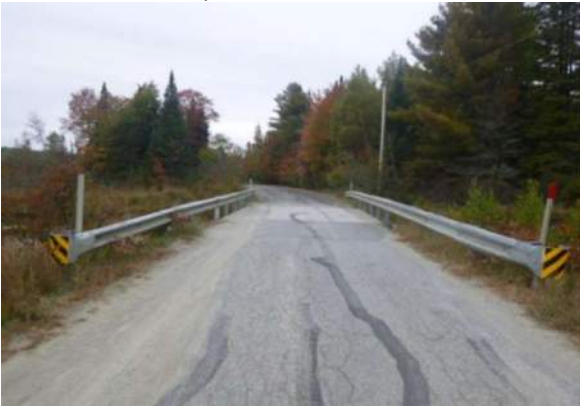
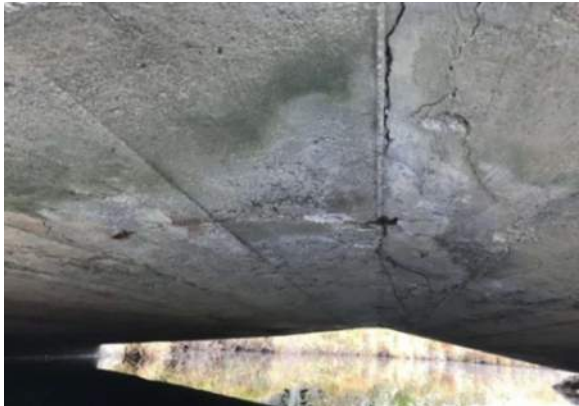
Top of Roadway Surface.		Underside of Deck Slab – Cracks throughout with areas of efflorescence and spalls with exposed reinforcing.

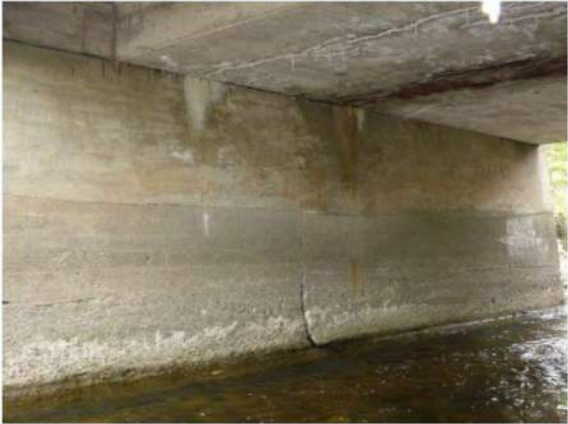
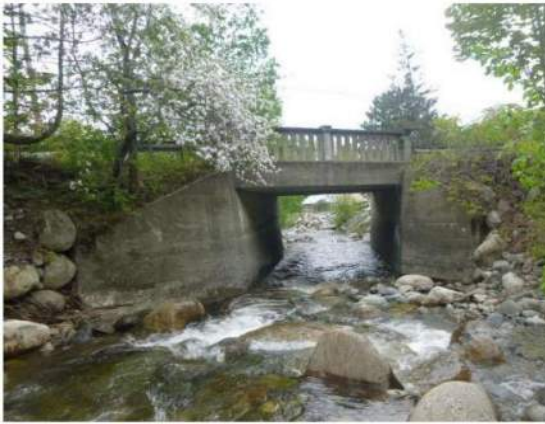
North Abutment near Mid-Length – Large full height vertical crack with minor out-of-plane movement at the crack.		Elevation view.	
3420	Poor	1936	Replacement
Huff Road over Wesserunsett Stream – Cornville – Somerset Co. 44° 83' 62.17" N, 69° 65' 29.76" W

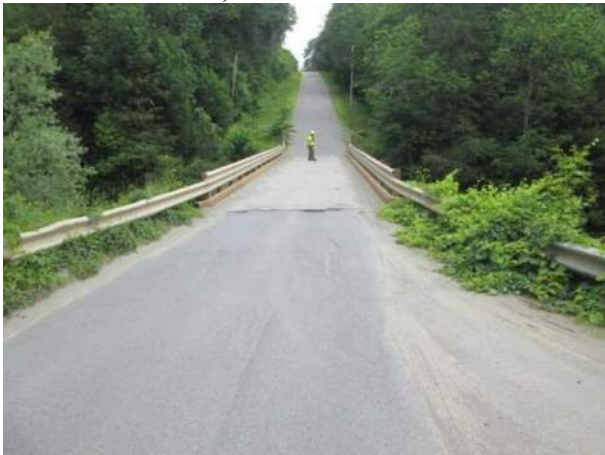
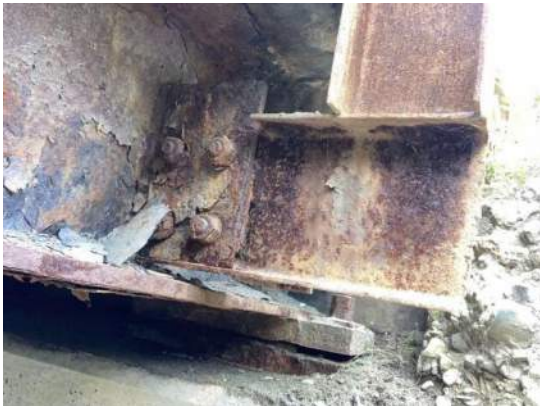
Top of roadway surface looking east.		North end of pier bearing area crumbling concrete CR.

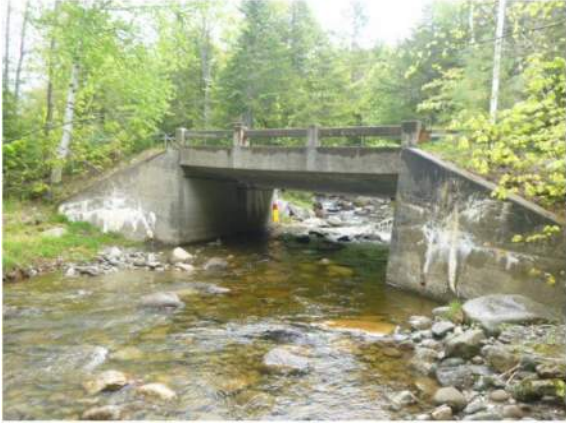
Southern elevation view. Note moderate cracks with efflorescence throughout.

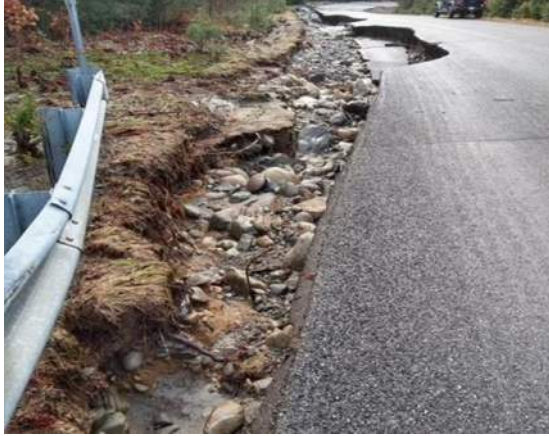
South Approach Roadway – Previous washout of roadway adjacent to bridge in December 2023 due to overtopping and flooding at the bridge.
5123	Poor	1920	Replacement
Cathance Road over Cathance River – Town of Topsham – Sagadahoc Co. 43° 96' 17.9" N, 69° 93' 01.32" W			
 	Top of roadway surface looking east.	 	East shoulder supports with exposed rebar.

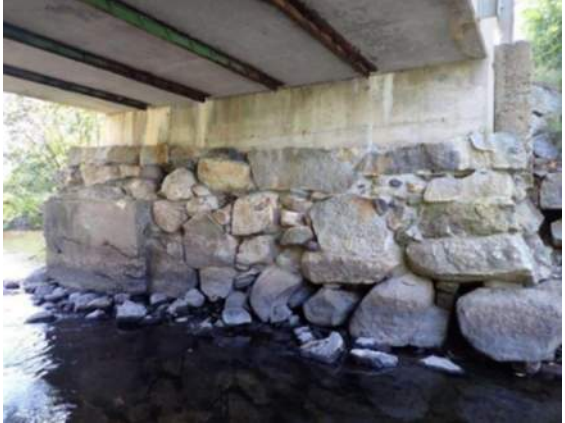
<p>West Abutment Elevation – Loosely stacked stone with multiple gaps between stones. Note masonry portion collapsing at end of the abutment.</p>
5505	Poor	1963	Replacement
Fuller Road over Harvey Brook – Town of Carmel – Penobscot Co. 44° 49' 15.85" N, 69° 2' 23.06" W

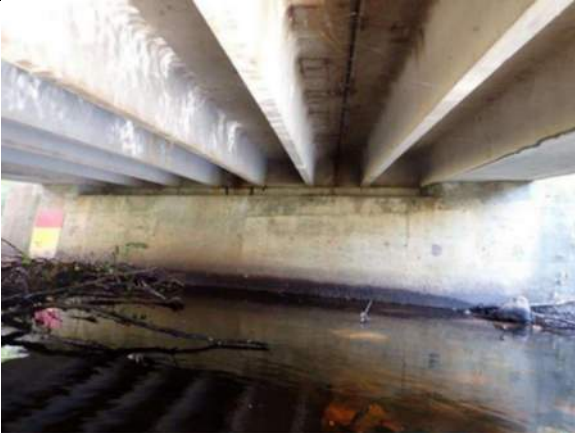
<p>Underside of Superstructure – Evidence of leakage, rust staining, and scattered spalls between beams. Note scour placard on abutment.</p>

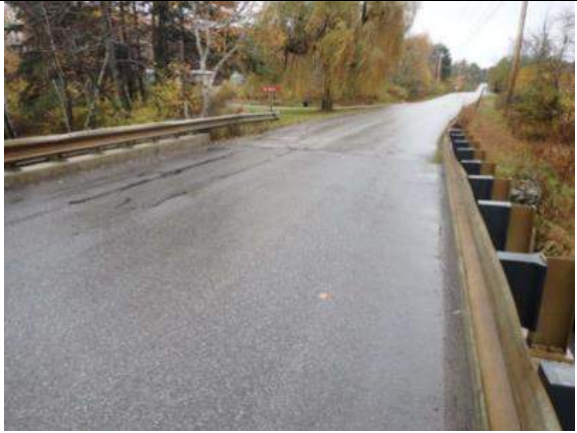
<p>Top of Roadway Surface. Note cracks at the abutments.</p>

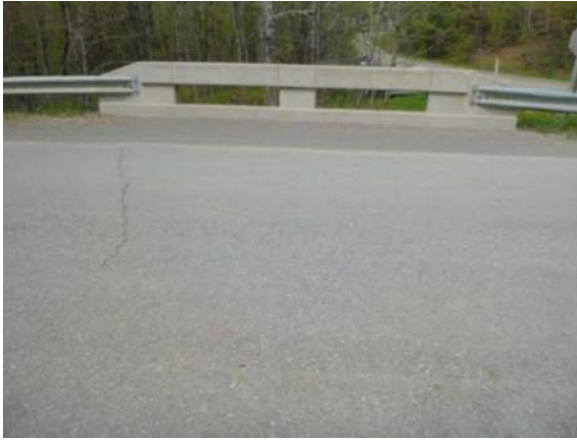
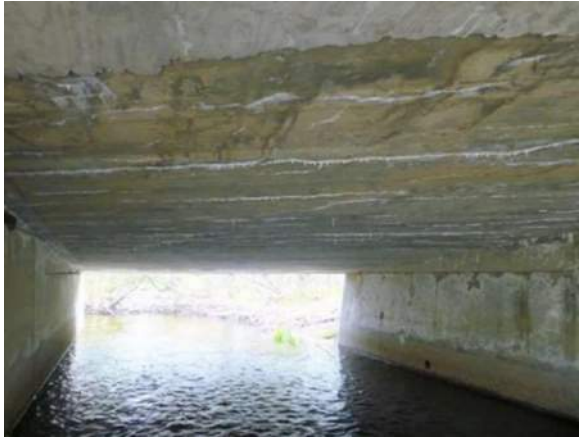
Top of Roadway Surface. Note transverse cracks.		Underside of Concrete Slab – Numerous longitudinal cracks with moderate efflorescence build up.
