Bridge Repair/Strengthening Summary

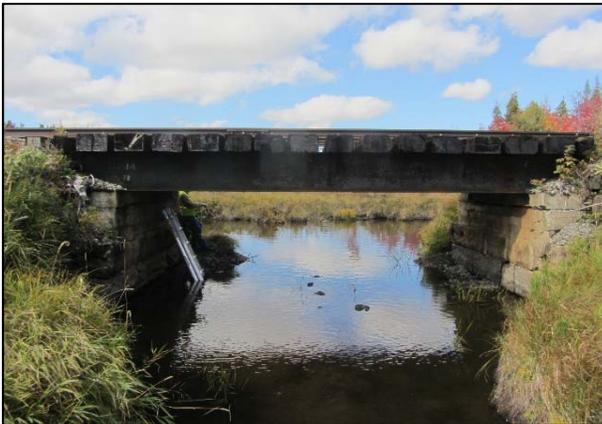
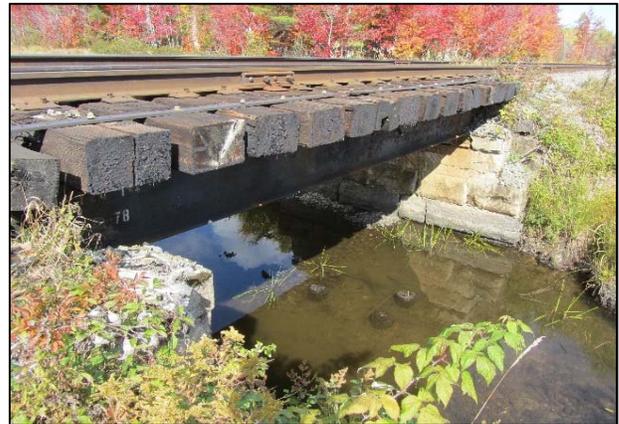
Bridge Photos:

Bridge Description: Single span open timber deck four I-Beam superstructure bearing on concrete bridge seats supported by stone masonry abutments.

Recommendations:	Existing Rating Factor (25mph): <u>229</u>
<ul style="list-style-type: none"> - Replace existing superstructure with new open timber deck steel plate girder superstructure - Replace rotted/failing backwall timbers at both abutments - Repoint granite stone masonry abutments

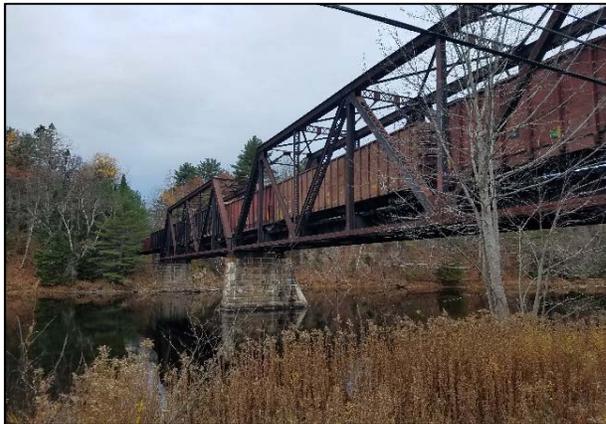
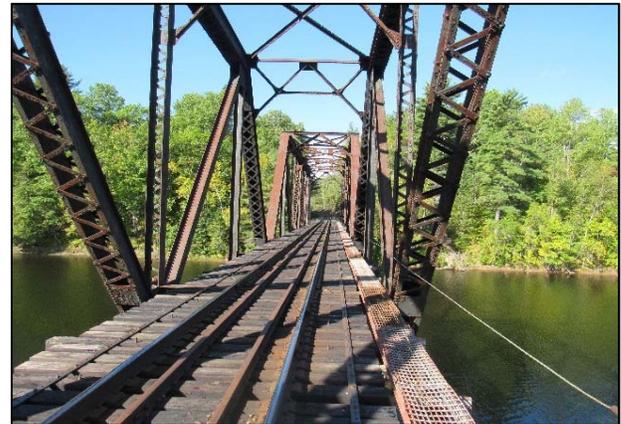
Bridge Photos:

Bridge Description: Two span open timber deck through truss supported by a stone masonry abutment and two stone masonry piers.

Recommendations:	Existing Rating Factor (25mph): <u>350</u>
<ul style="list-style-type: none"> - Replace all bridge timbers - Repair floorbeam crack - Install additional web stiffeners on end floorbeams

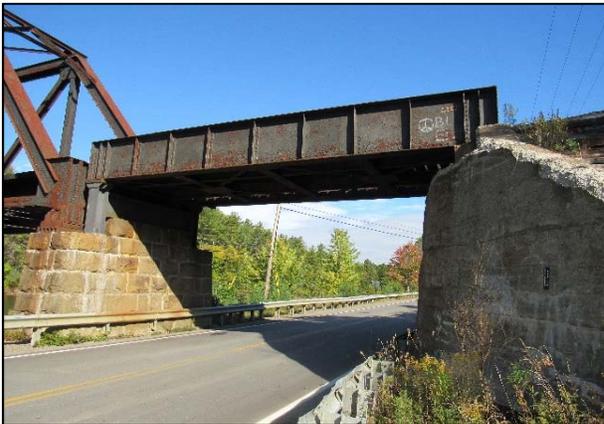
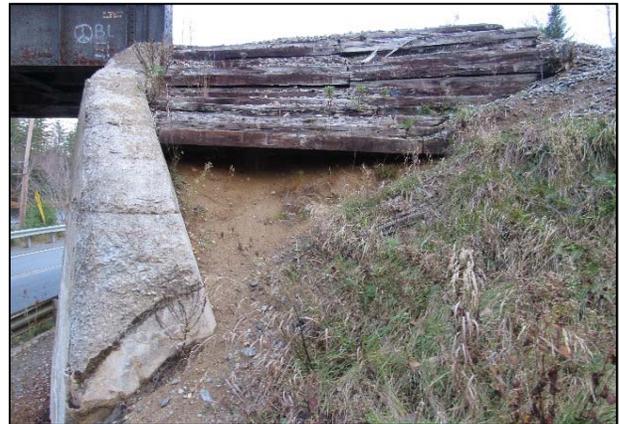
Bridge Photos:

Bridge Description: Single span open timber deck through plate girder superstructure supported by a concrete abutment and a stone masonry pier.

Recommendations:	Existing Rating Factor (25mph): <u>210</u>
<ul style="list-style-type: none"> - Strengthen floorbeams and replace stringers - Replace rotted/failing timber retaining wall behind Northeast wingwall - Concrete patch repair abutment

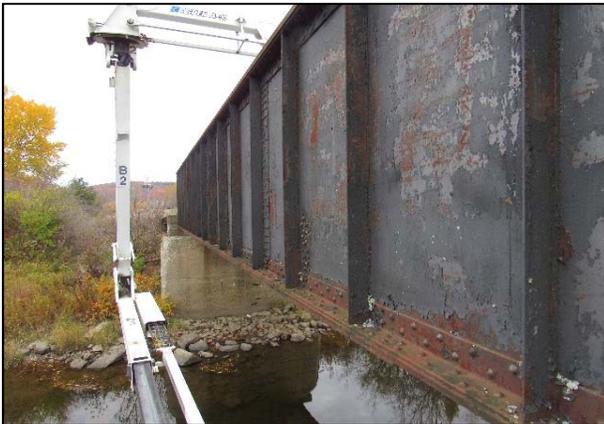
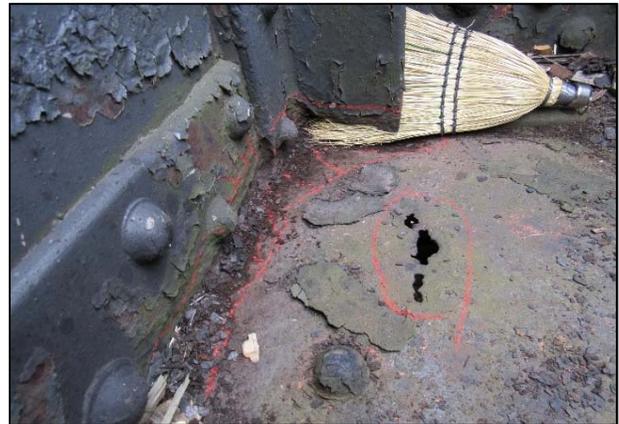
Bridge Photos:

Bridge Description: Single span open timber deck through plate girder superstructure supported by concrete abutments.

- Strengthen floorbeams
- Replace deteriorated bearing stiffeners
- Replace deteriorated lateral bracing connection plates
- Rebuild top of wingwalls and abutment seat/pedestals
- Rebuild failing Southeast timber retaining wall

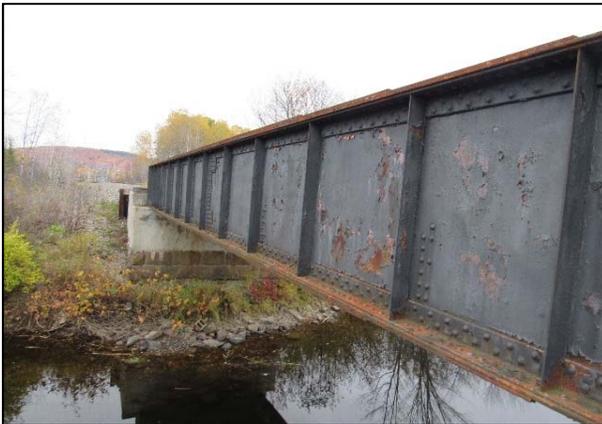
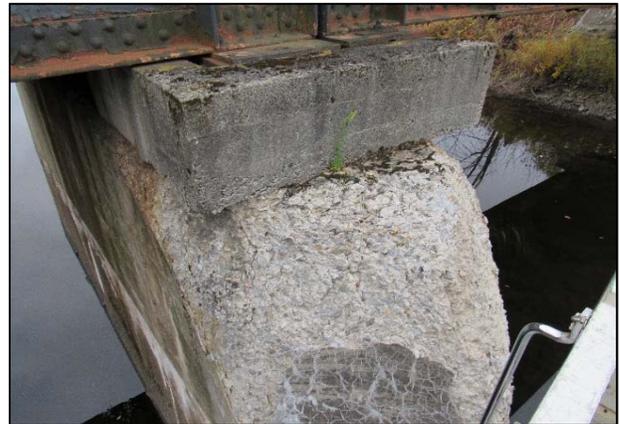
Bridge Photos:

Bridge Description: Two span open timber deck through plate girder superstructure supported by one concrete abutment, one concrete bridge seat on a stone masonry abutment, and a concrete pier.

Recommendations:	Existing Rating Factor (25mph): <u>350</u>
<ul style="list-style-type: none"> - Replace selected bridge timbers - Concrete patch repair pier and south abutment - Rebuild deteriorated corner of pier which is beginning to undermine bearing pedestal

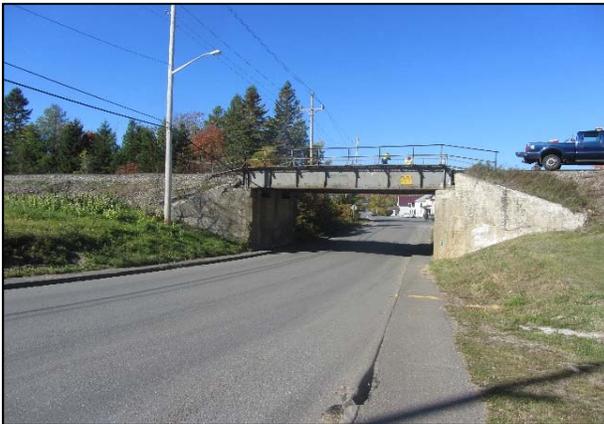
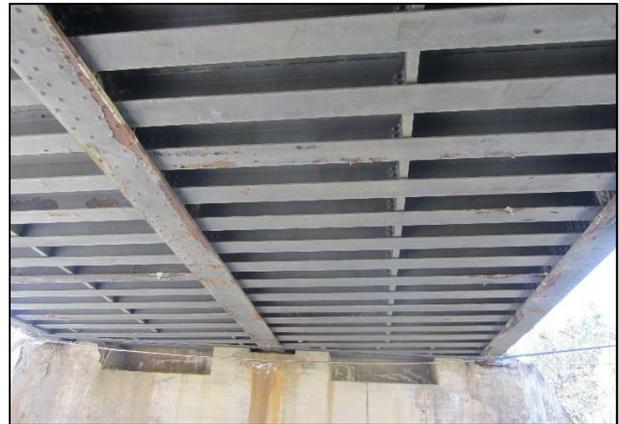
Bridge Photos:

Bridge Description: Single span ballasted through plate girder superstructure supported by concrete abutments. There are three through plate girders supporting two tracks.

Recommendations:	Existing Rating Factor (25mph): <u>254</u>
<ul style="list-style-type: none"> - Strengthen floorbeams - Rebuild concrete pedestals - Concrete patch repair both abutments - Repair damaged knee braces

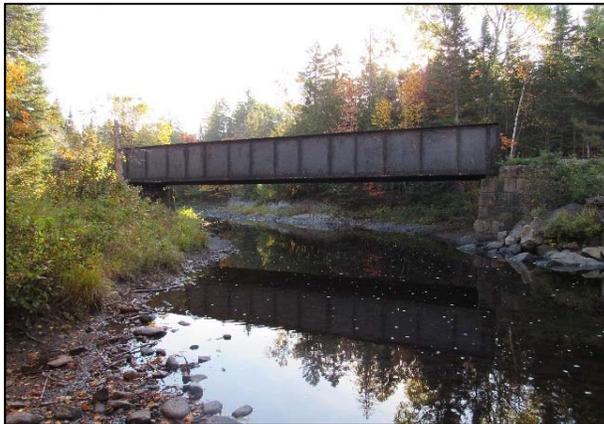
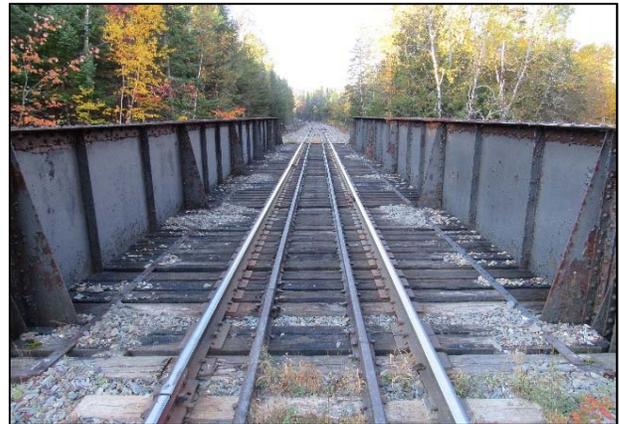
Bridge Photos:

Bridge Description: Single span open timber deck through plate girder superstructure supported by stone masonry abutments.

- Strengthen girders
- Replace bridge timber support shelf angles
- Repair undermining at South abutment
- Repoint stone masonry abutments
- Install additional web stiffeners and retrofit existing web plate splices

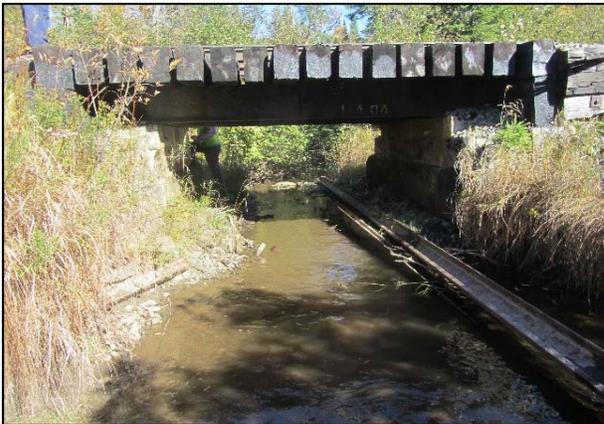
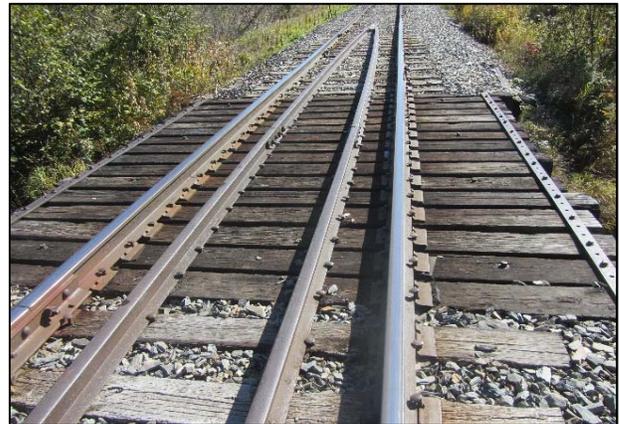
Bridge Photos:

Bridge Description: Single span open timber deck four I-Beam superstructure bearing on concrete bridge seats supported by stone masonry abutments.

Recommendations:	Existing Rating Factor (25mph): <u>189</u>
<ul style="list-style-type: none"> - Replace existing superstructure with new open timber deck steel plate girder superstructure - Repoint granite stone masonry abutments - Replace rotted/failing Southeast timber retaining wall - Rebuild tops of bridge seats

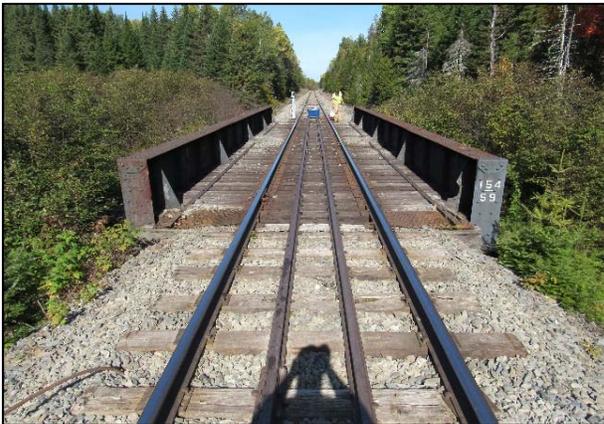
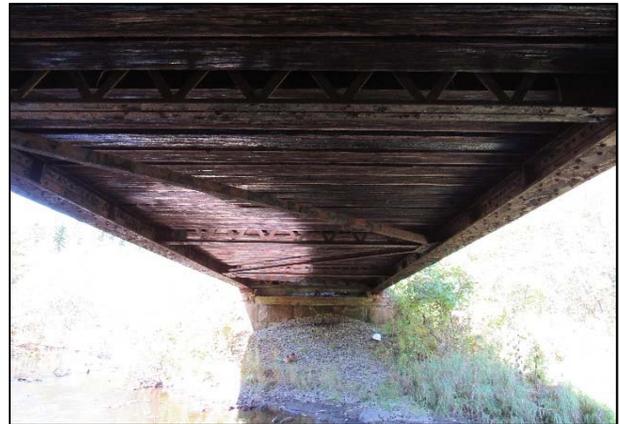
Bridge Photos:

Bridge Description: Single span open timber deck through plate girder superstructure supported by stone masonry abutments.

- Strengthen girders
- Replace bridge timber support shelf angles
- Repoint stone masonry abutments
- Replace all bridge timbers
- Install additional web stiffeners and retrofit existing web plate splices

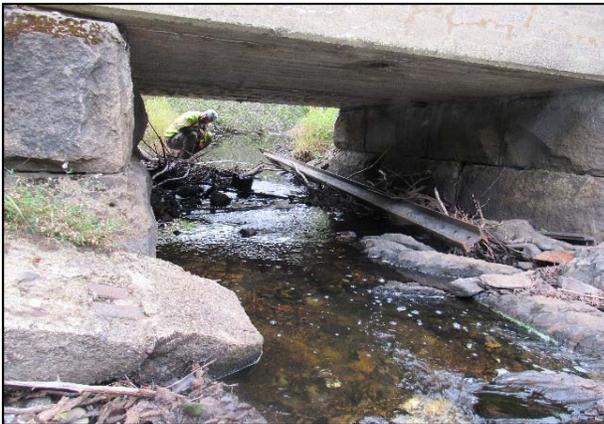
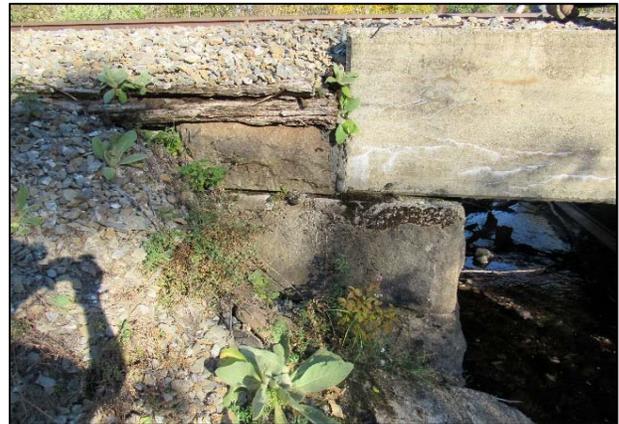
Bridge Photos:

Single span reinforced concrete slab superstructure supported by stone masonry abutments.

- Replace existing superstructure
- Repoint stone masonry abutments
- Rebuild Southeast timber retaining wall

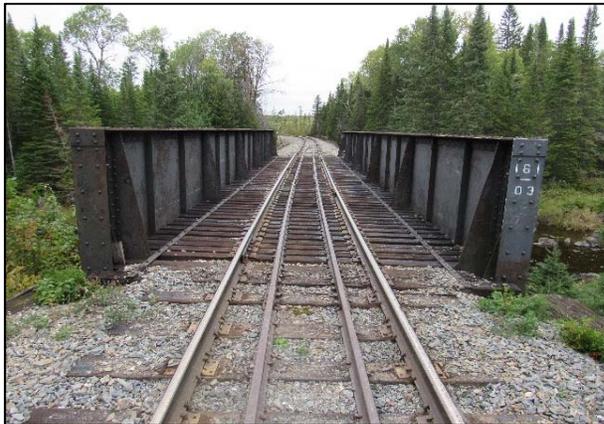
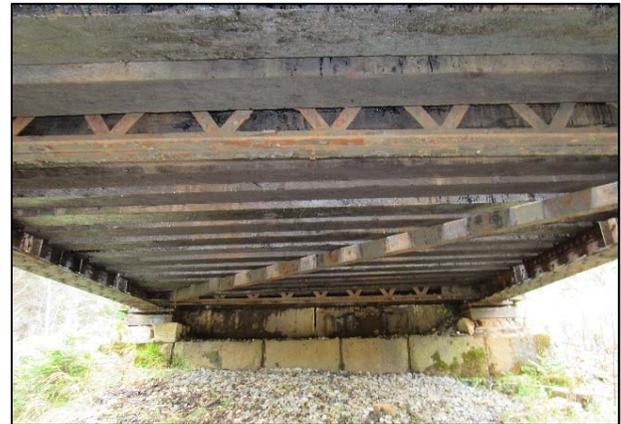
Bridge Photos:

Bridge Description: Single span open timber deck through plate girder superstructure supported by stone masonry abutments.

- Strengthen girders
- Replace bridge timber support shelf angles
- Repoint stone masonry abutments
- Replace all bridge timbers
- Repair damaged knee braces and end plates
- Install additional web stiffeners and retrofit existing web plate splices
- Repair concrete apron around North abutment

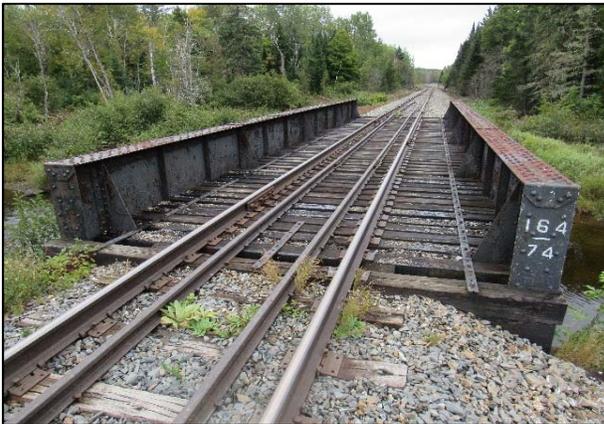
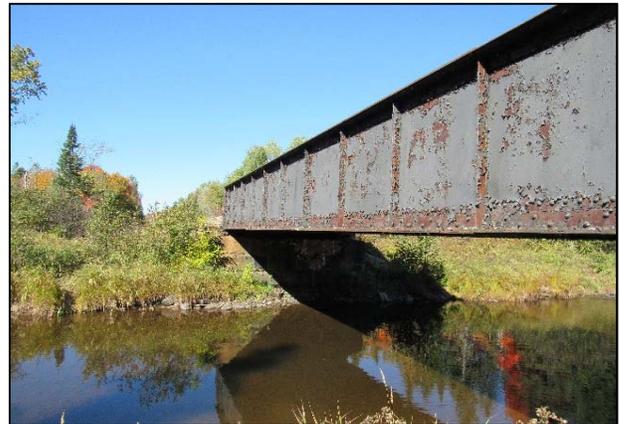
Bridge Photos:

Bridge Description: Single span open timber deck through plate girder superstructure supported by stone masonry abutments.

- Strengthen girders
- Replace bridge timber support shelf angles
- Replace deteriorated stiffener angles
- Repoint stone masonry abutments
- Repair damaged knee braces and end plates
- Install additional web stiffeners and retrofit existing web plate splices

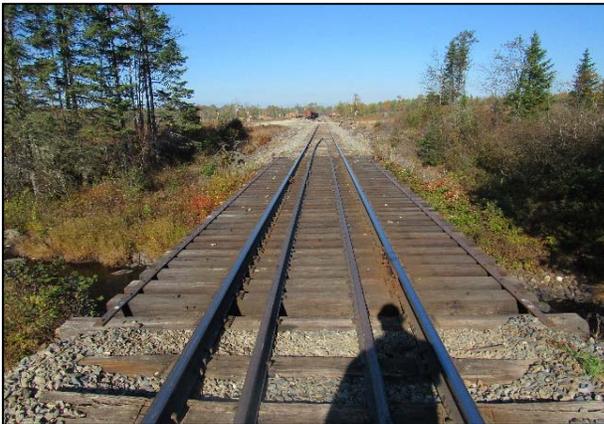
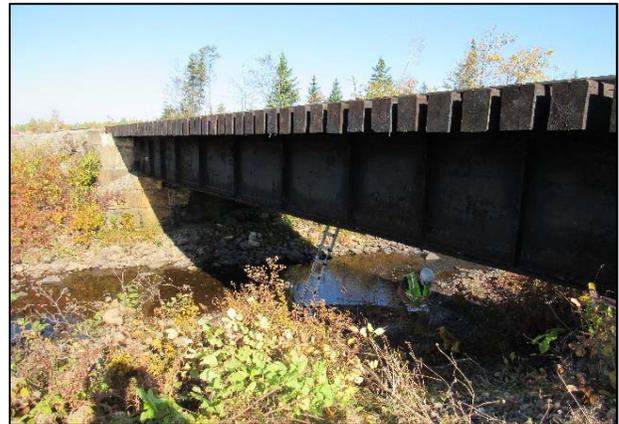
Bridge Photos:

Single span open timber deck plate girder superstructure supported by stone masonry abutments.

Recommendations:	Existing Rating Factor (25mph): <u>205</u>
<ul style="list-style-type: none"> - Strengthen girders - Replace all bridge timbers - Repoint stone masonry abutments - Rebuild tops of concrete backwalls and wingwalls

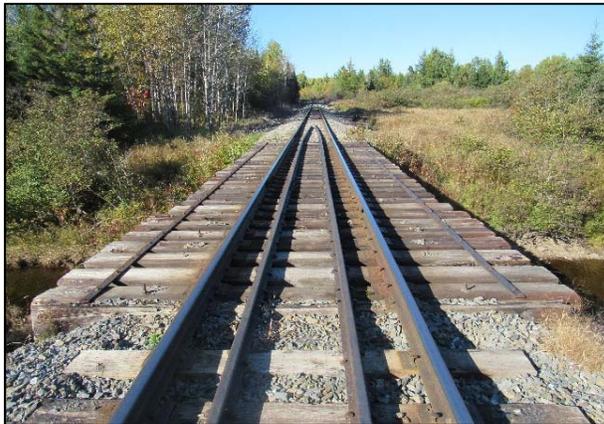
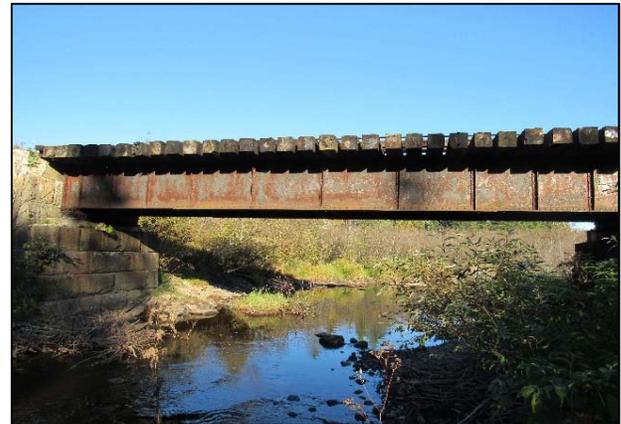
Bridge Photos:

Single span open timber deck plate girder superstructure supported by stone masonry abutments.

Recommendations:	Existing Rating Factor (25mph): <u>205</u>
<ul style="list-style-type: none"> - Strengthen girders - Repoint stone masonry abutments - Rebuild tops of concrete backwalls and wingwalls

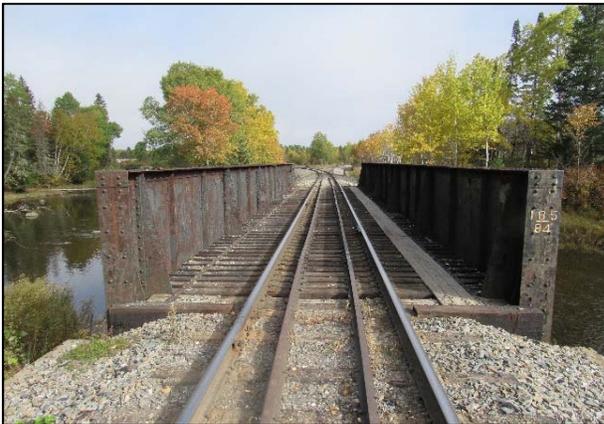
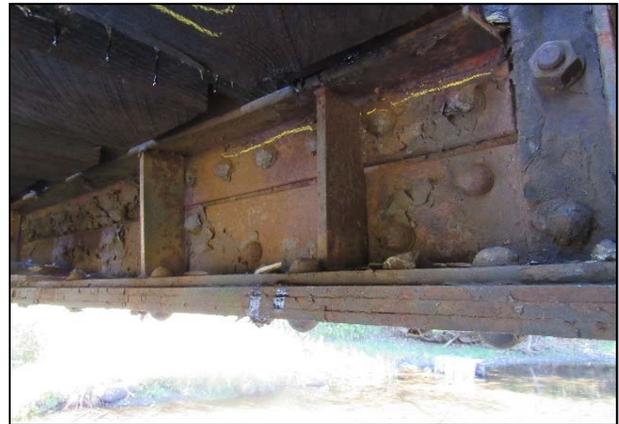
Bridge Photos:

Bridge Description: Single span open timber deck through plate girder superstructure supported by stone masonry abutments.

- Strengthen girders
- Replace bridge timber support shelf angles
- Replace deteriorated stiffener angles
- Repoint stone masonry abutments
- Rebuild top half of North concrete backwall
- Rebuild Southeast timber retaining wall
- Repair damaged end plates
- Retrofit existing web plate splices

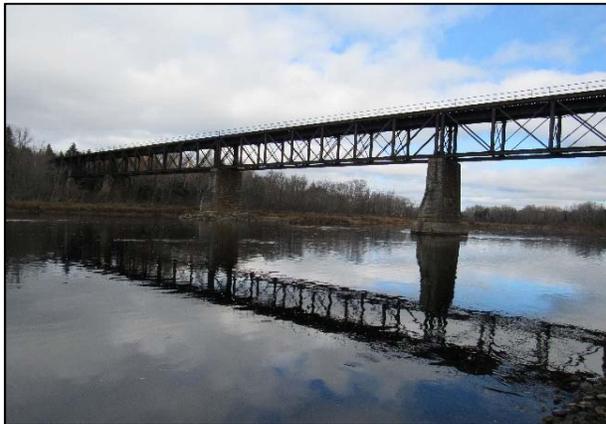
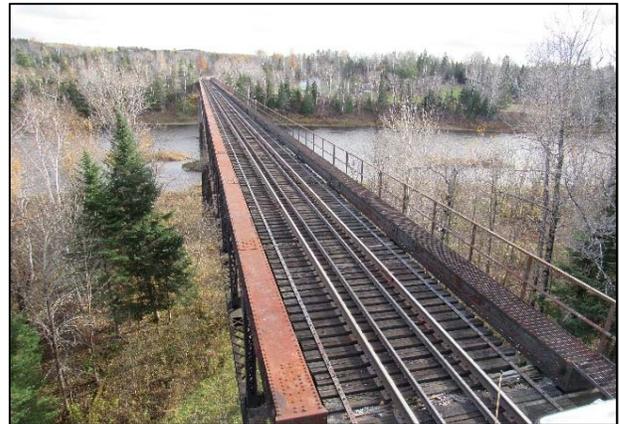
Bridge Photos:

Four span open timber deck truss supported by stone masonry piers.

- Replace truss stringers
- Replace truss diagonals
- Strengthen truss verticals
- Tighten truss counters
- Rehabilitate bearings
- Replace all bridge timbers
- Repoint stone masonry piers
- Concrete patch repair concrete aprons around piers

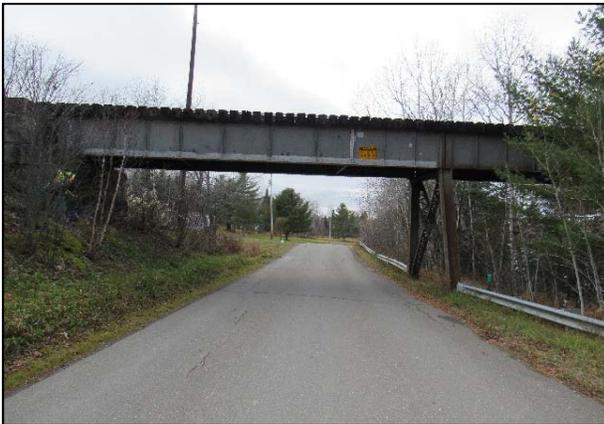
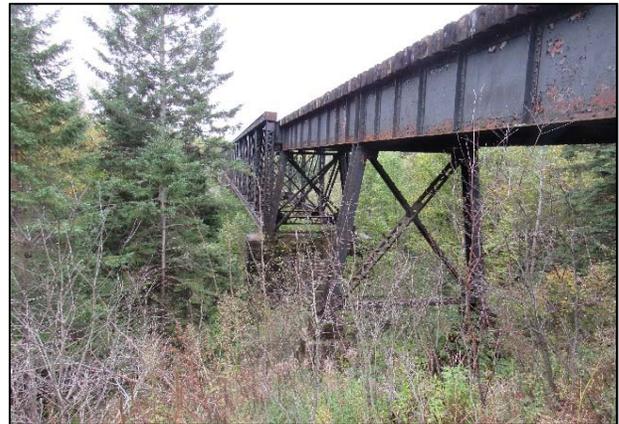
Bridge Photos:

Two two-span open timber deck plate girder approaches supported by stone masonry piers and abutments. These spans are the approaches to the deck truss spans over the Aroostook River.

- Strengthen deck girders
- Repair impact damage to steel pier bent
- Repoint stone masonry abutments
- Replace all bridge timbers
- Rebuild Northwest timber retaining wall
- Install additional web stiffeners and retrofit existing web plate splices

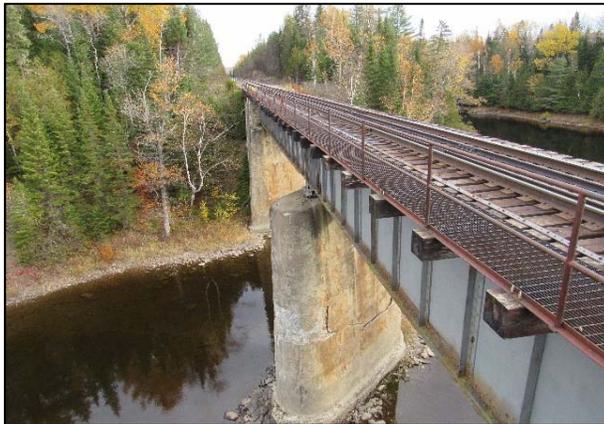
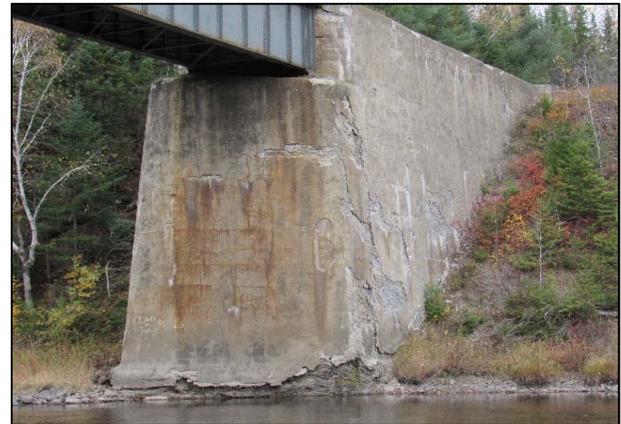
Bridge Photos:

Bridge Description: Two span open timber deck plate girder superstructure supported by a concrete pier and concrete abutments.

Recommendations:	Existing Rating Factor (25mph): <u>350</u>
<ul style="list-style-type: none"> - Install additional web stiffeners - Install wingwall tie-back system at both abutments - Rebuild Northwest corner of abutment backwall/wingwall

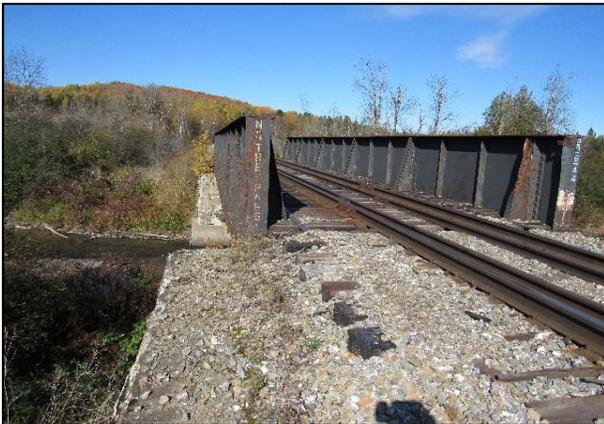
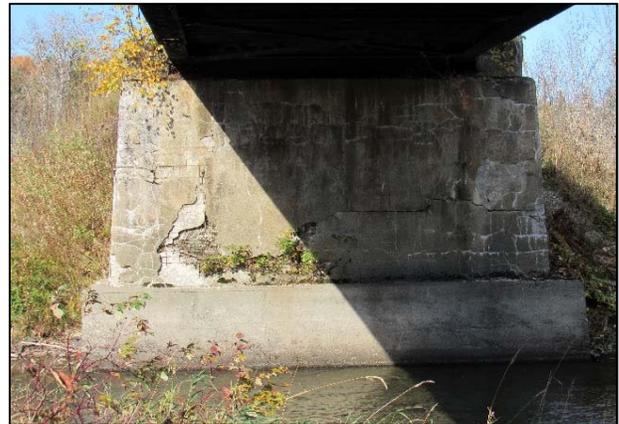
Bridge Photos:

Bridge Description: Single span open timber deck through plate girder superstructure supported by concrete abutments.

- Replace bridge timber support shelf angles
- Repair damaged knee braces
- Install additional web stiffeners
- Repair area of scour under North abutment
- Repair concrete abutments

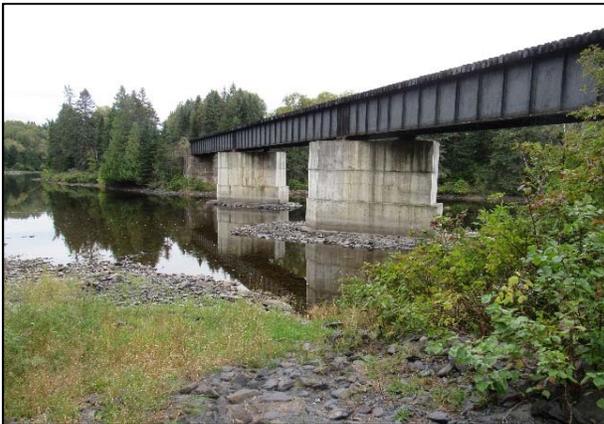
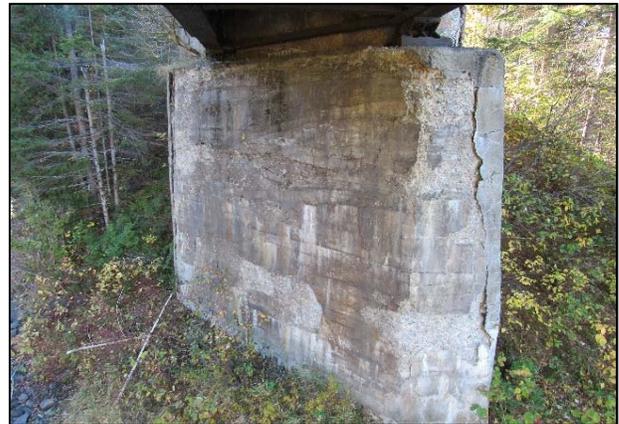
Bridge Photos:

Bridge Description: Three span open timber deck plate girder superstructure supported by concrete piers and concrete abutments.

Recommendations:	Existing Rating Factor (25mph): <u>350</u>
<ul style="list-style-type: none"> - Install additional web stiffeners - Support existing superstructure to remove and replace abutment backwalls and seats - Install wingwall tie-back system - Jacket existing abutments with concrete

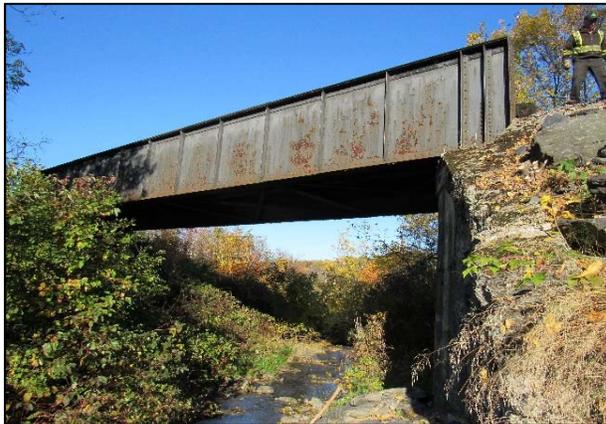
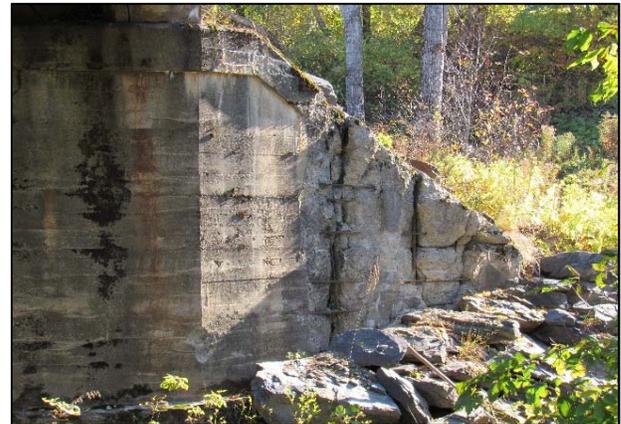
Bridge Photos:

Bridge Description: Single span open timber deck through plate girder superstructure supported by concrete abutments.

Recommendations:	Existing Rating Factor (25mph): <u>260</u>
<ul style="list-style-type: none"> - Strengthen stringers - Rebuild Northeast wingwall - Concrete patch repair both abutments - Install additional web stiffeners and retrofit existing web plate splices

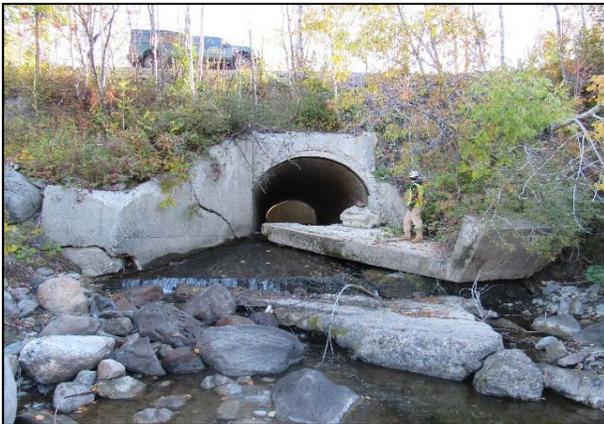
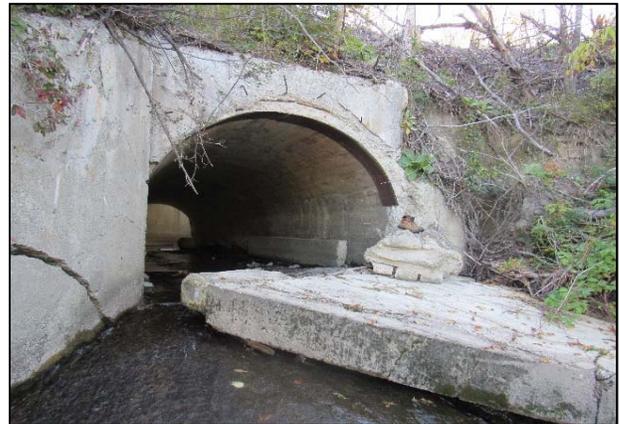
Bridge Photos:

Cast-in-place concrete arch

Recommendations:	Existing Rating Factor (25mph): <u>N/A</u>
- Replace culvert with new precast concrete culvert or arch
