# Inspection Report

## 8/1/16 - 8/2/16

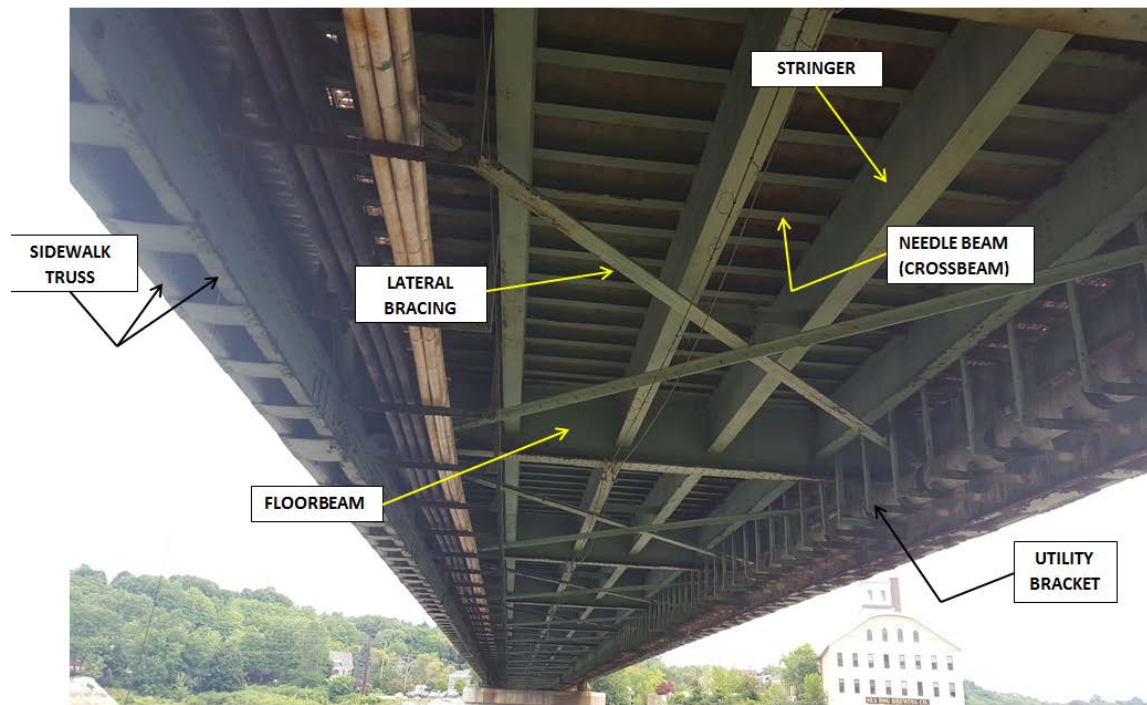
Typ. nomenclature of Frank J Wood Bridge – looking north from Abut. 1 to Pier 1, in Span 1.

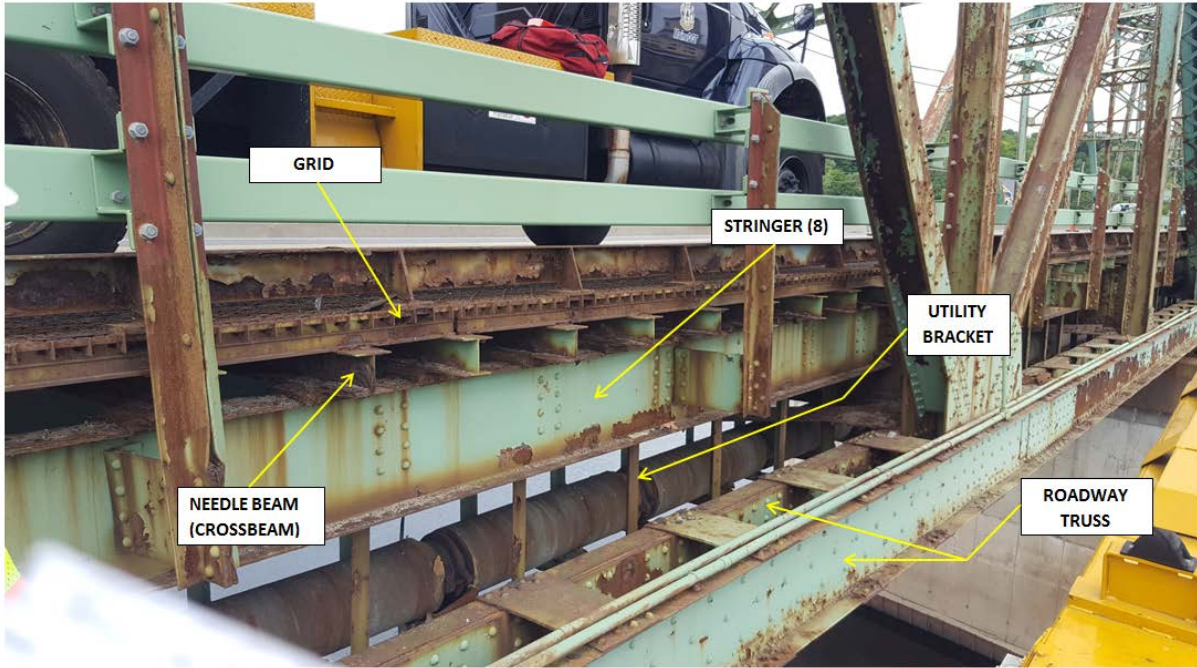
Typical Nomenclature of Frank J Wood Bridge – Looking Northwest midspan of Span 2.

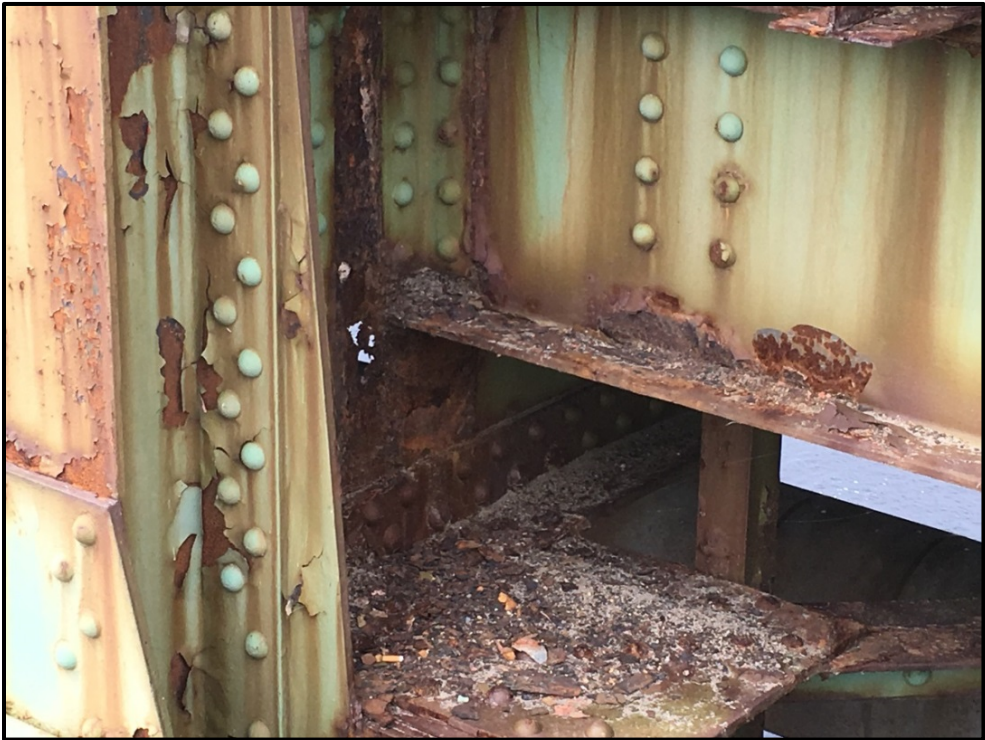
**Photo A1** – Floorbeam 7, Roadway Truss @ Stringer 8 (Exterior)

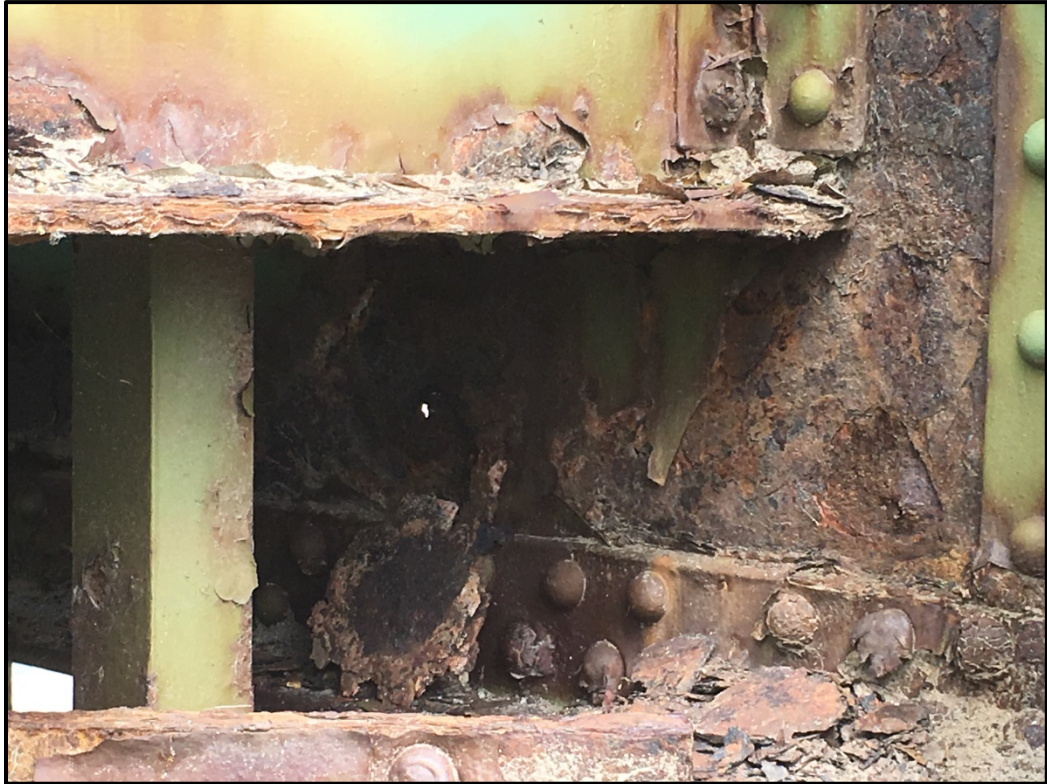
**Photo A3** – Floorbeam 2, Roadway Truss @ Stringer 8 (Exterior)

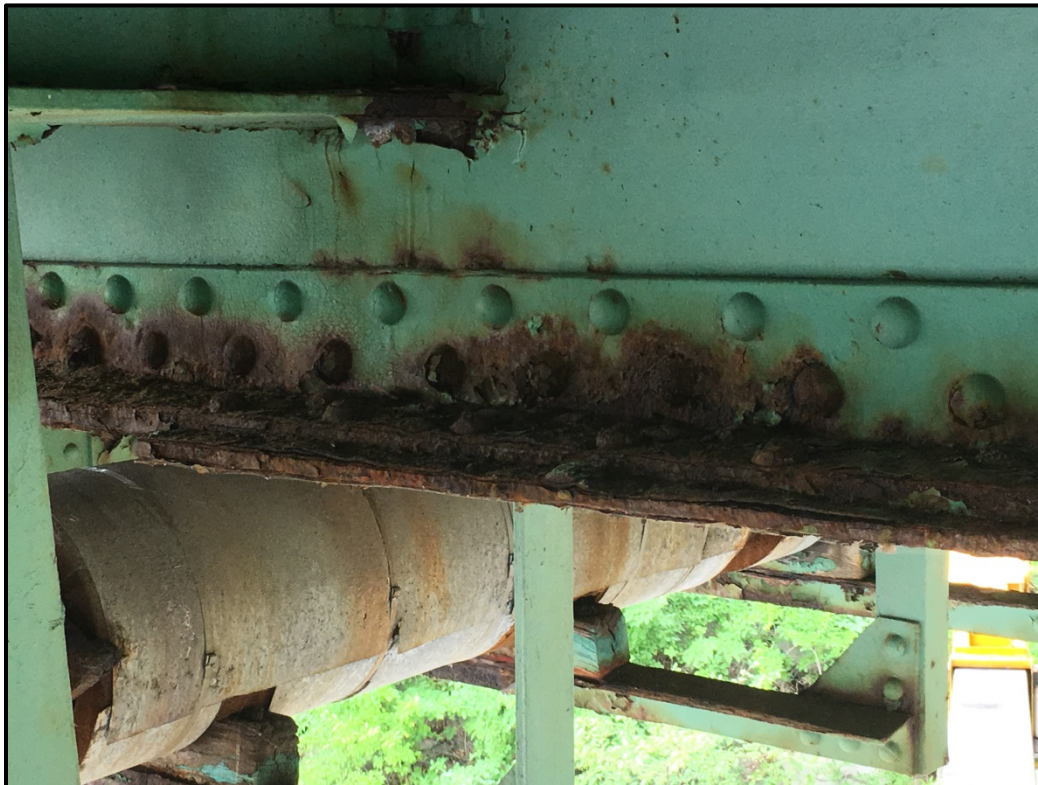
**Photo A4** – Floorbeam 2 coverplate particularly between Stringer 7 & 6 is an area of concern which will be closely monitored.

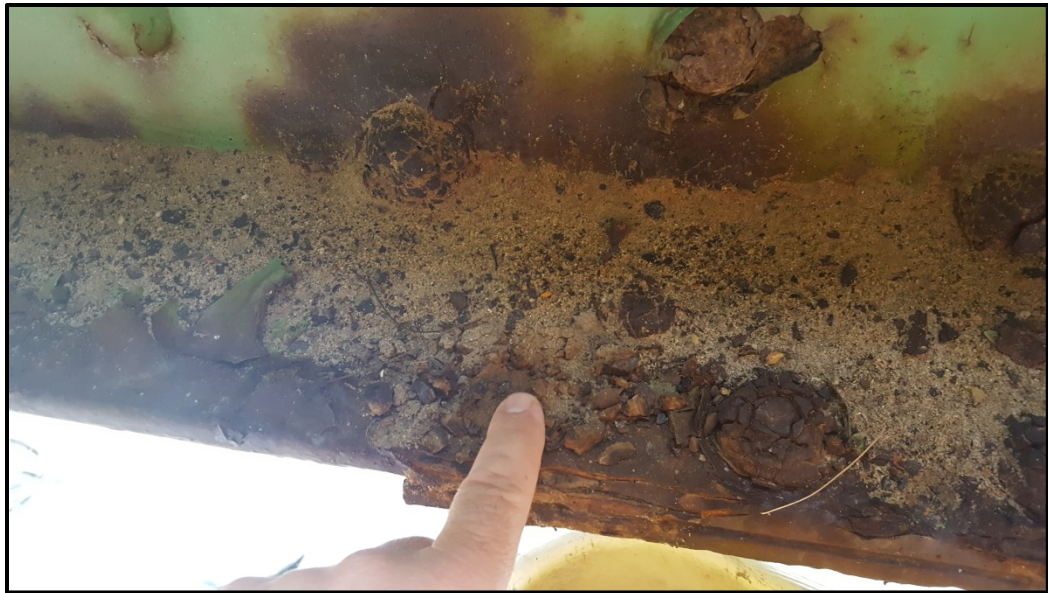
**Photo A5** – Floorbeam 5 coverplate has enough deterioration issues to expect a repair within 5 years.

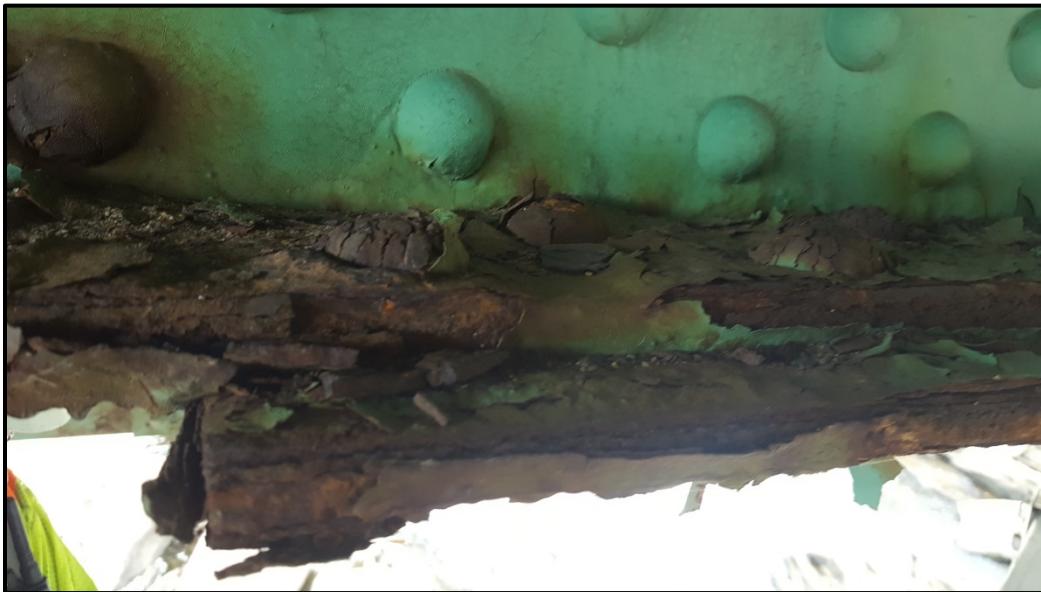
**Photo A6** – Floorbeam 6 exhibiting excessive pack rust and rivet deterioration.

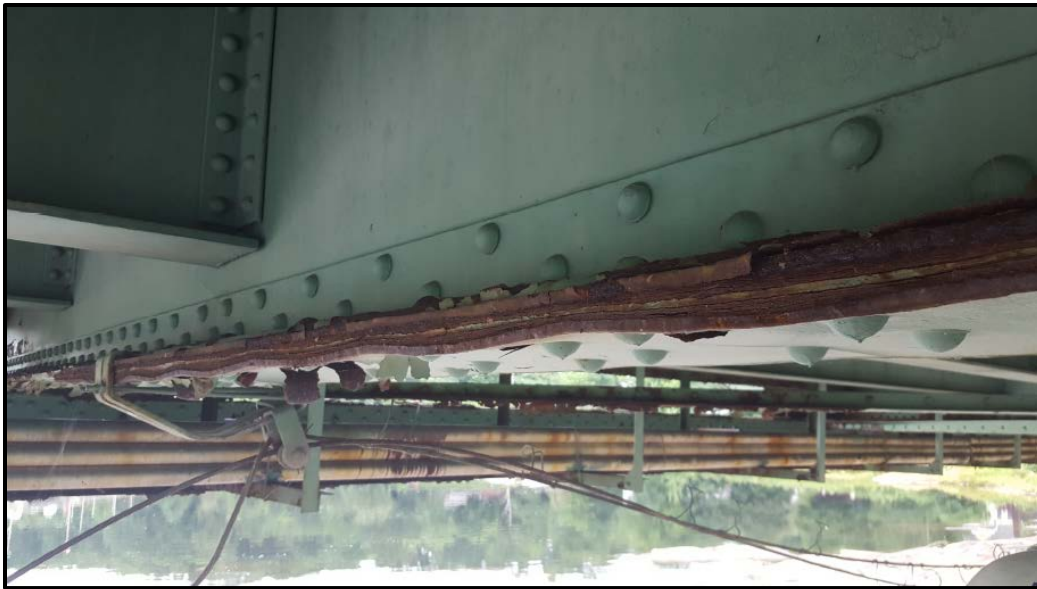
**Photo A7** – Floorbeam 8 bottom flange midspan plies showing pack rust and deformation which may lead to repair activity within the next 5 years.

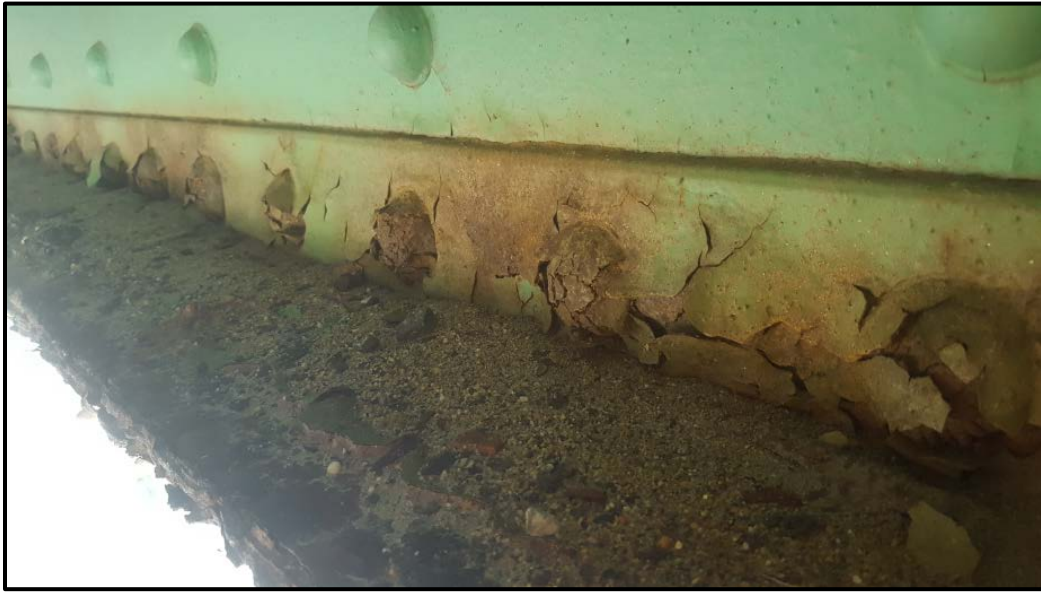
**Photo A8** - View of the inside of Sidewalk Truss's lower angle depicts continuous corroding rivet heads and sand, salts and debris occupying the angle flange.

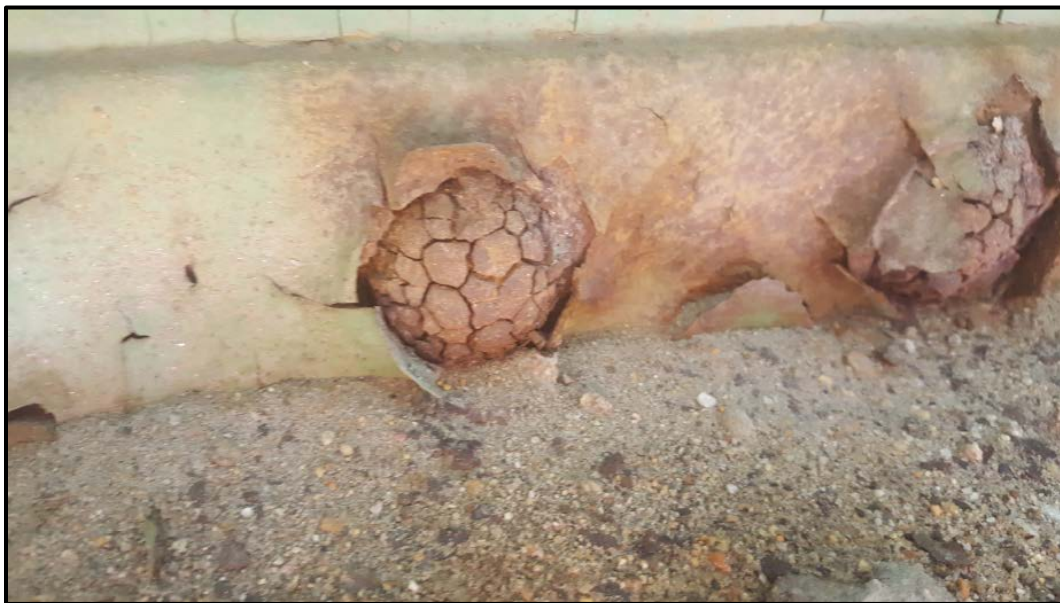
**Photo A9** - Typical rivet head condition along Sidewalk Truss Lower Chord of Span 3 for at least 100 ' length of angle to plate connection.

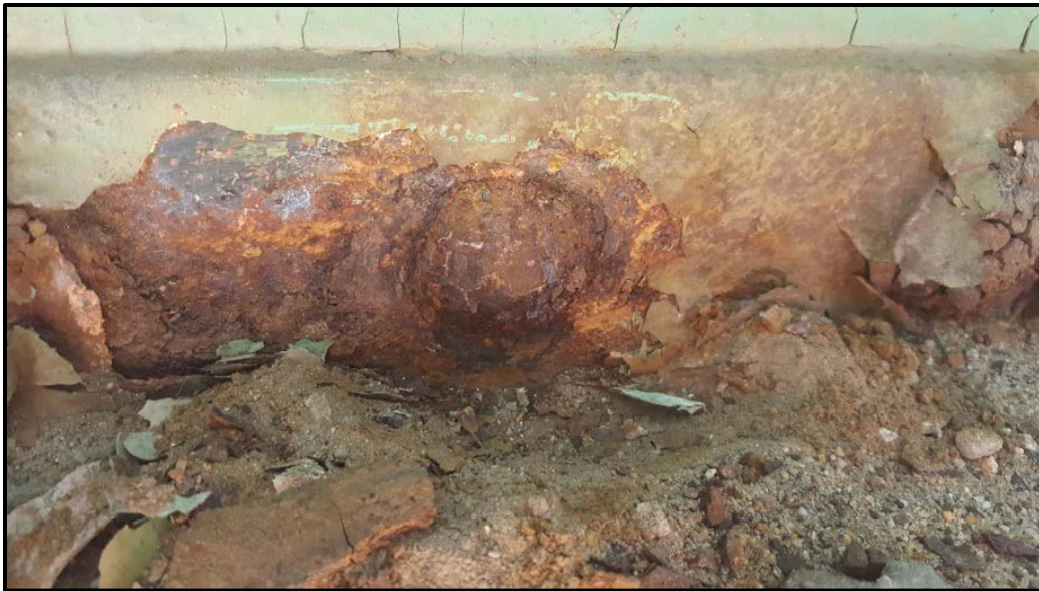
**Photo A10** – This is the same rivet as above after briefly pounding loose corrosion away. The rivet head size is significantly smaller than the diameter and height of a new rivet head.

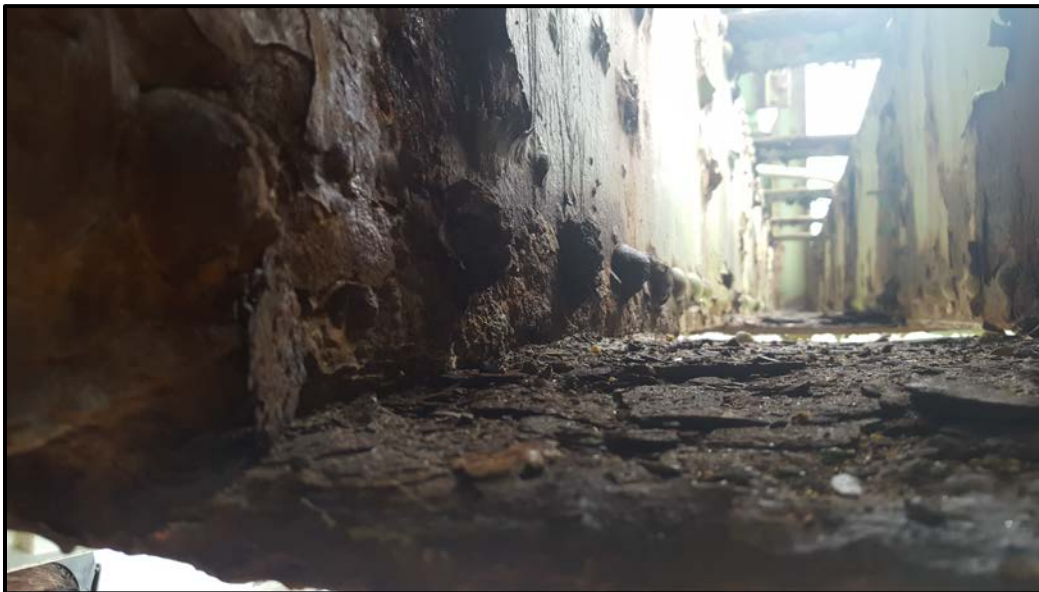
**Photo A11** – This is the general condition view of the inside lower chord truss member collecting rust and debris on the lacing bars.

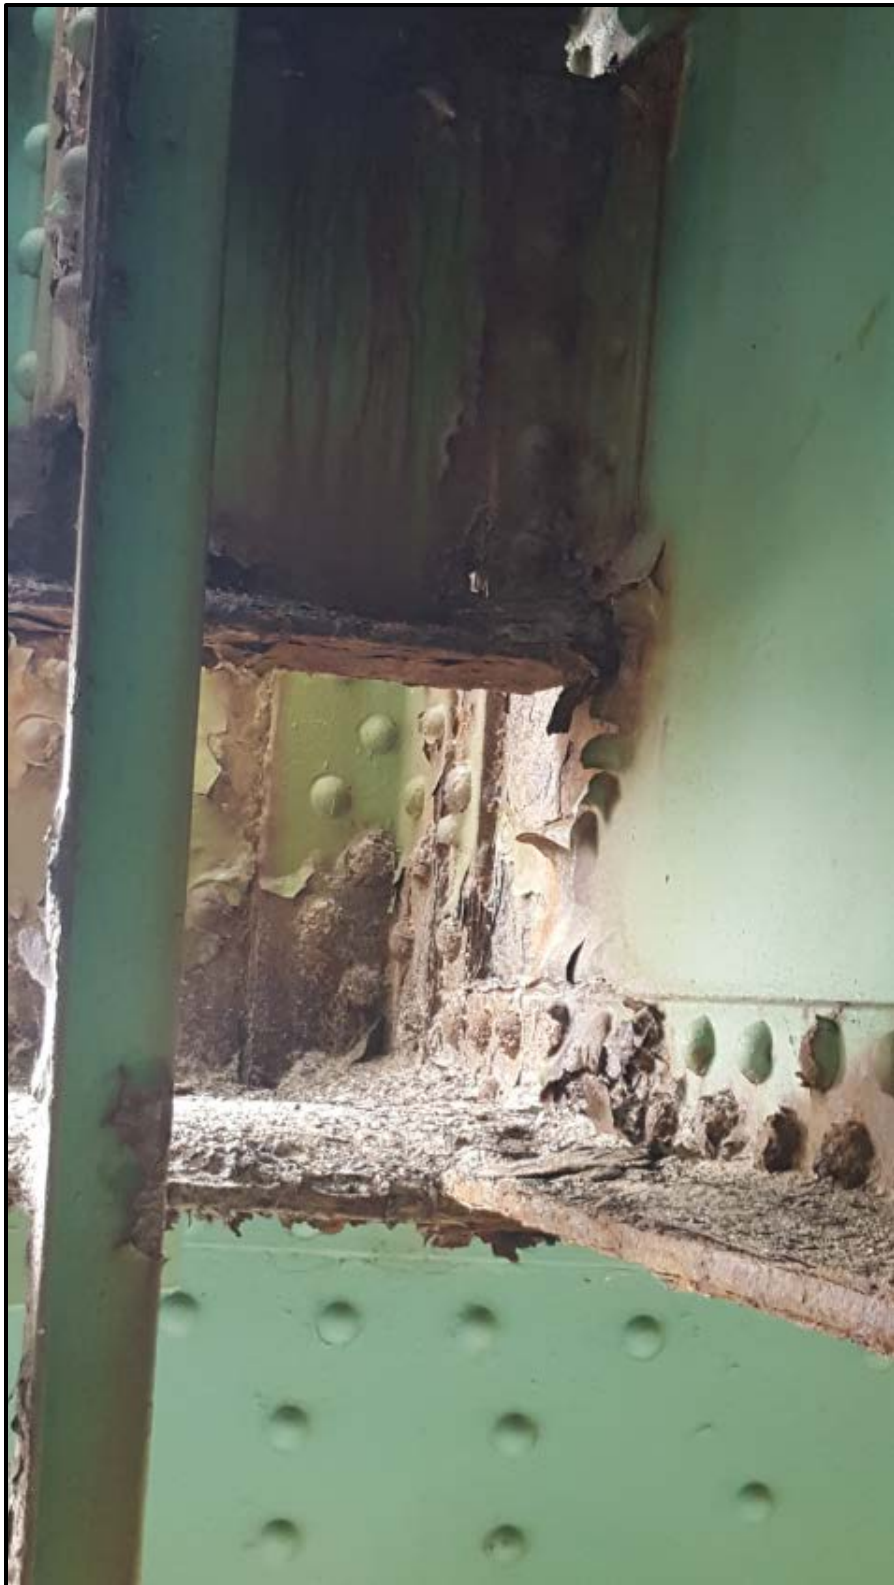
**Photo A12** – Stringer 8, Roadway Truss @ Floorbeam 2 has section loss revealing a web hole.

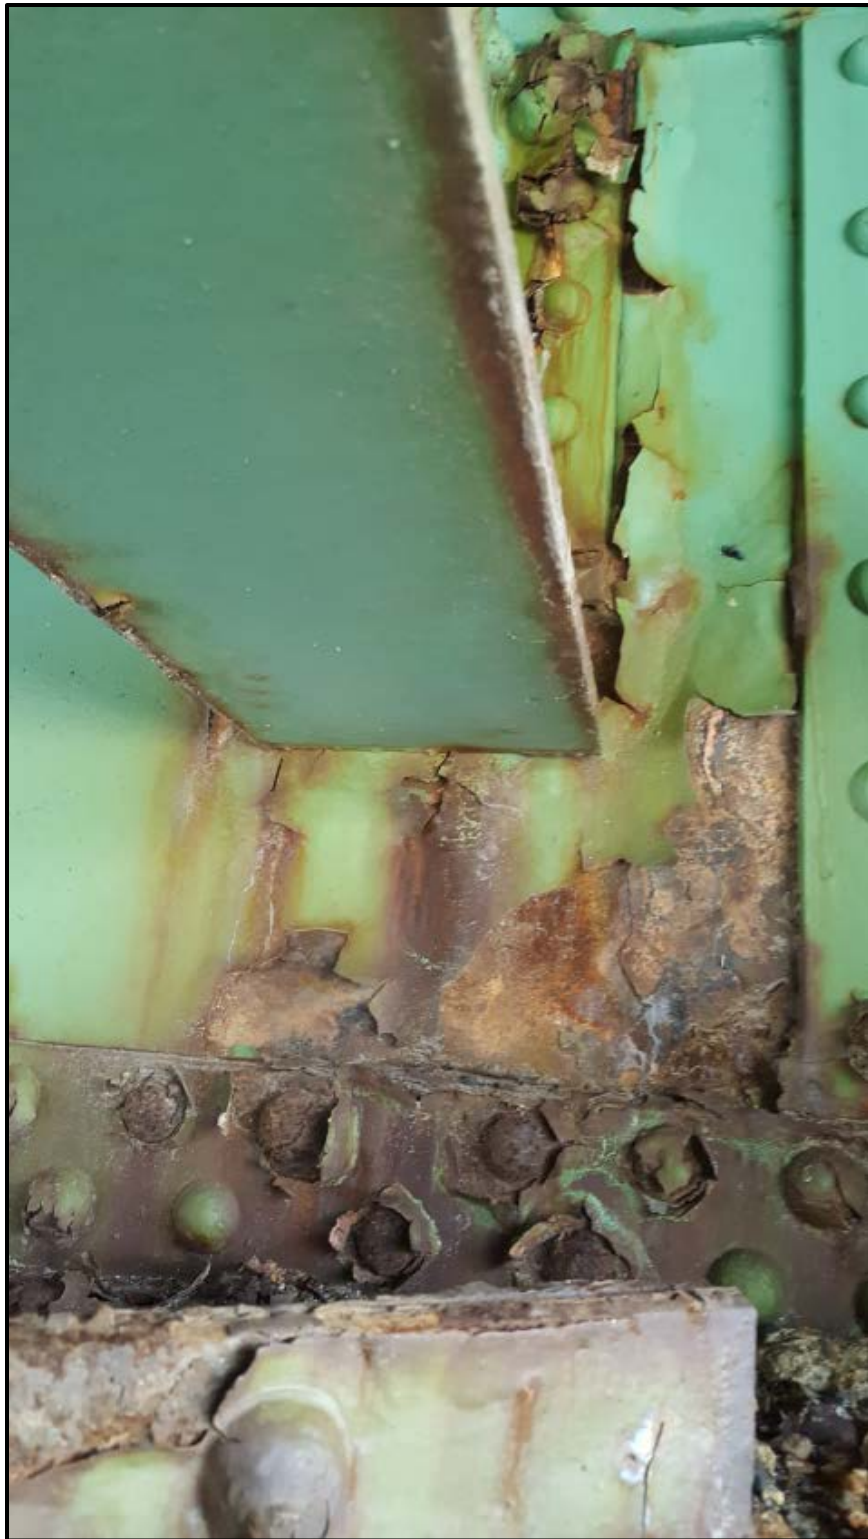
**Photo A13** – Looking at the condition of north end of Stringer 8 attached to Floorbeam 3.

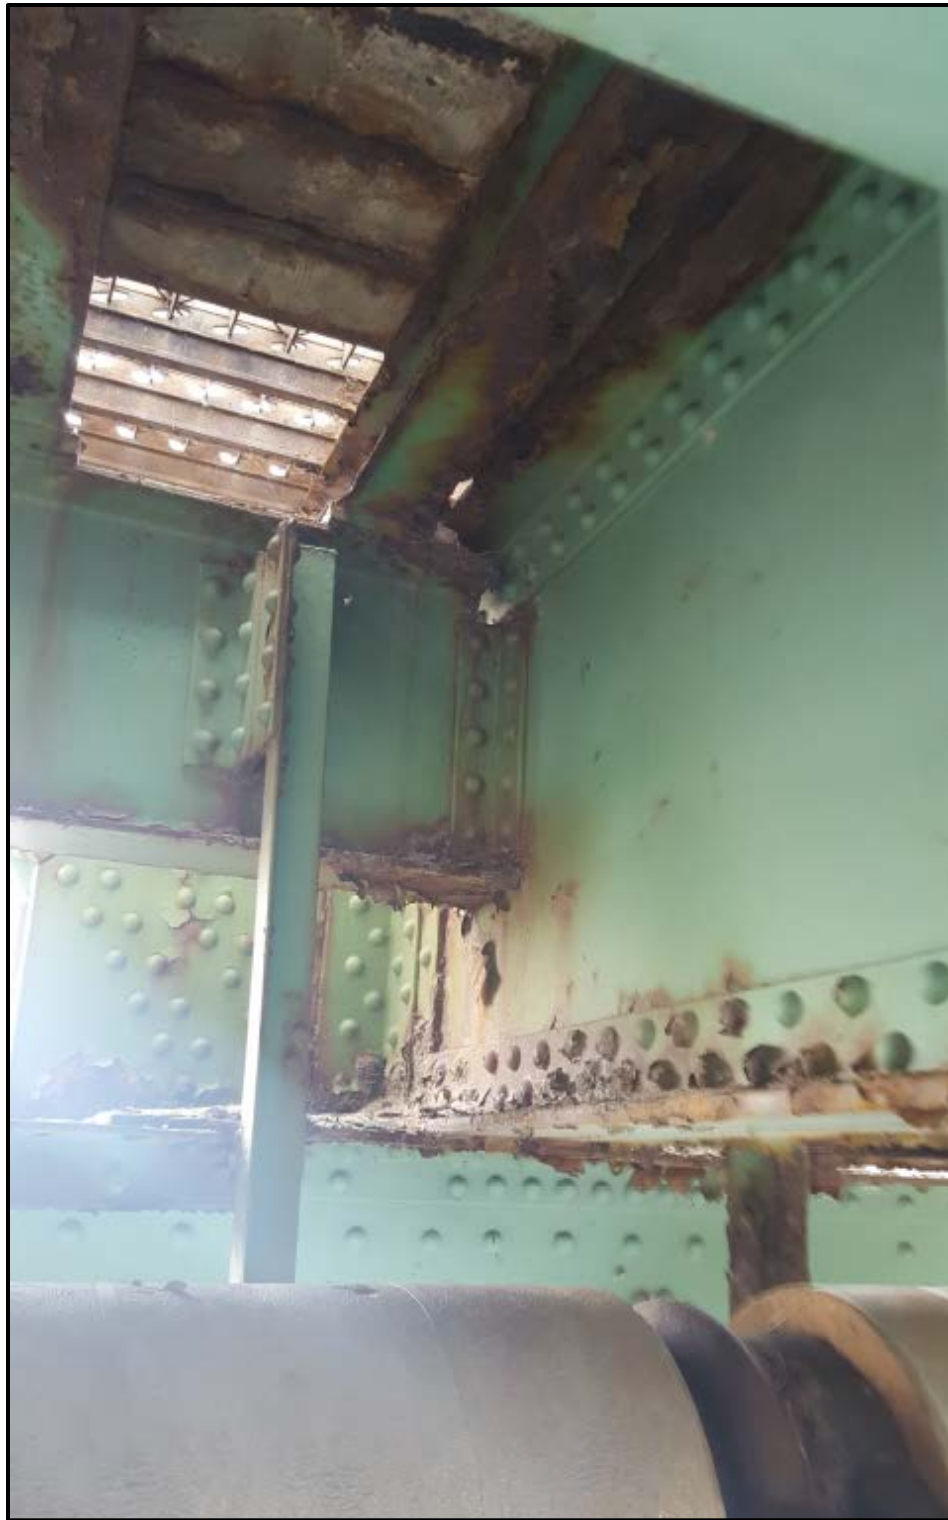
**Photo A14** – Stringer 8 connection to Floorbeam 6, Roadside Truss, may warrant a reattachment repair within 5 years. Similar connection conditions @ Stringer 3 to Floorbeams 6 and 7.

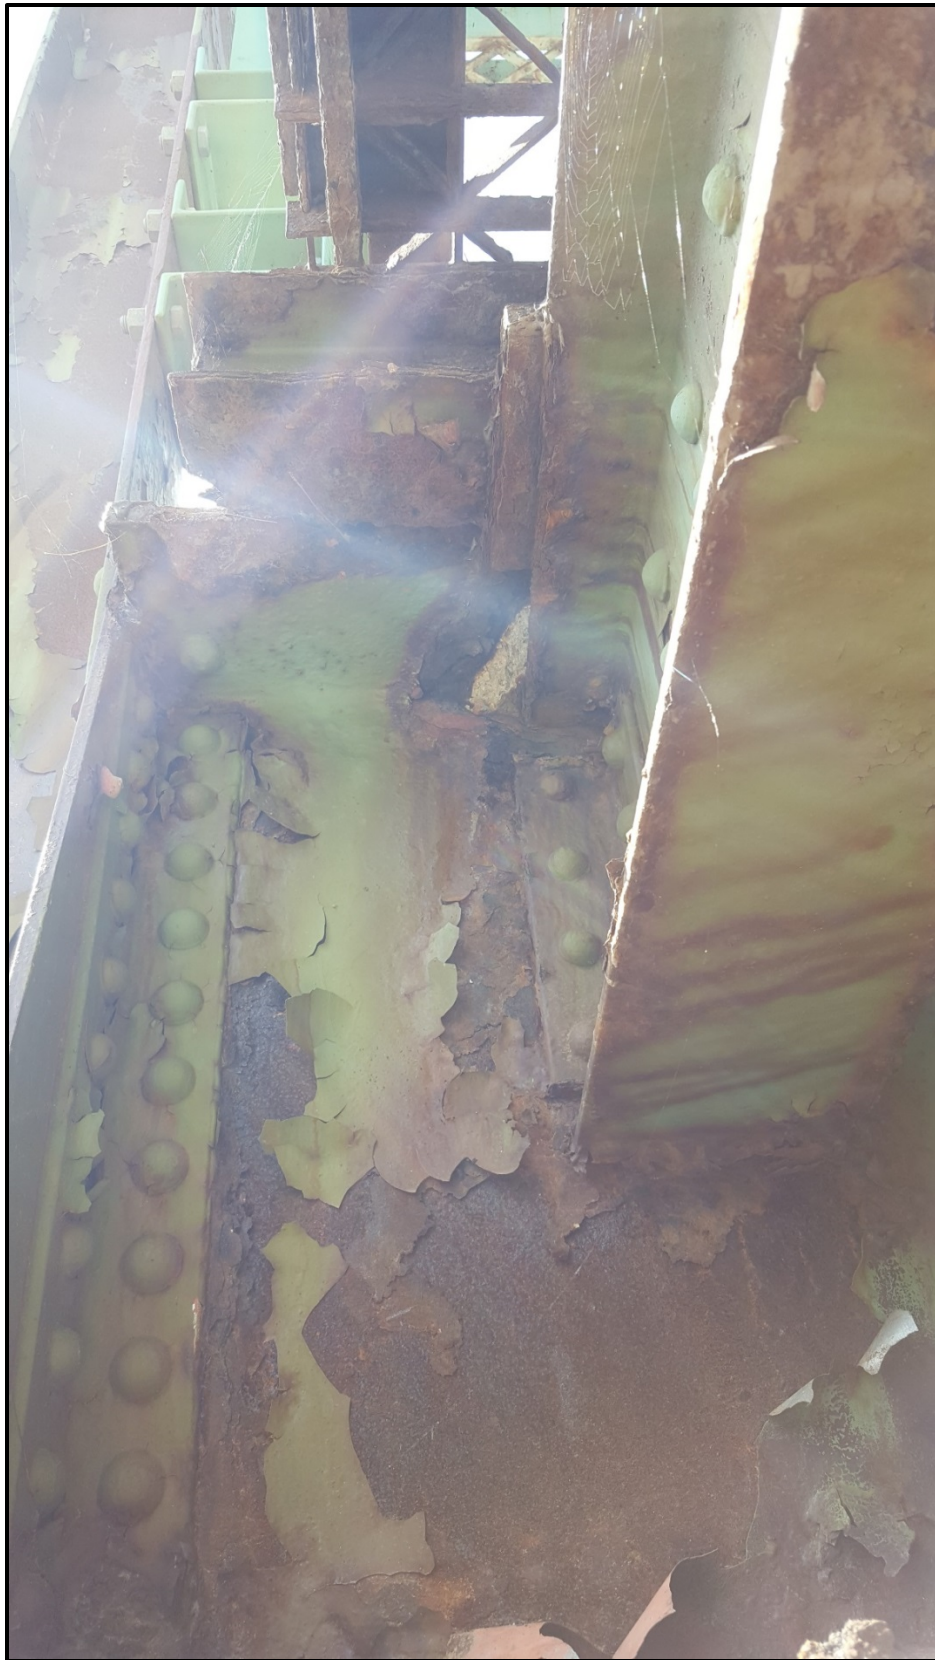
**Photo A15** – Stringer 8 connection to Floorbeam 1 showing active corrosion.

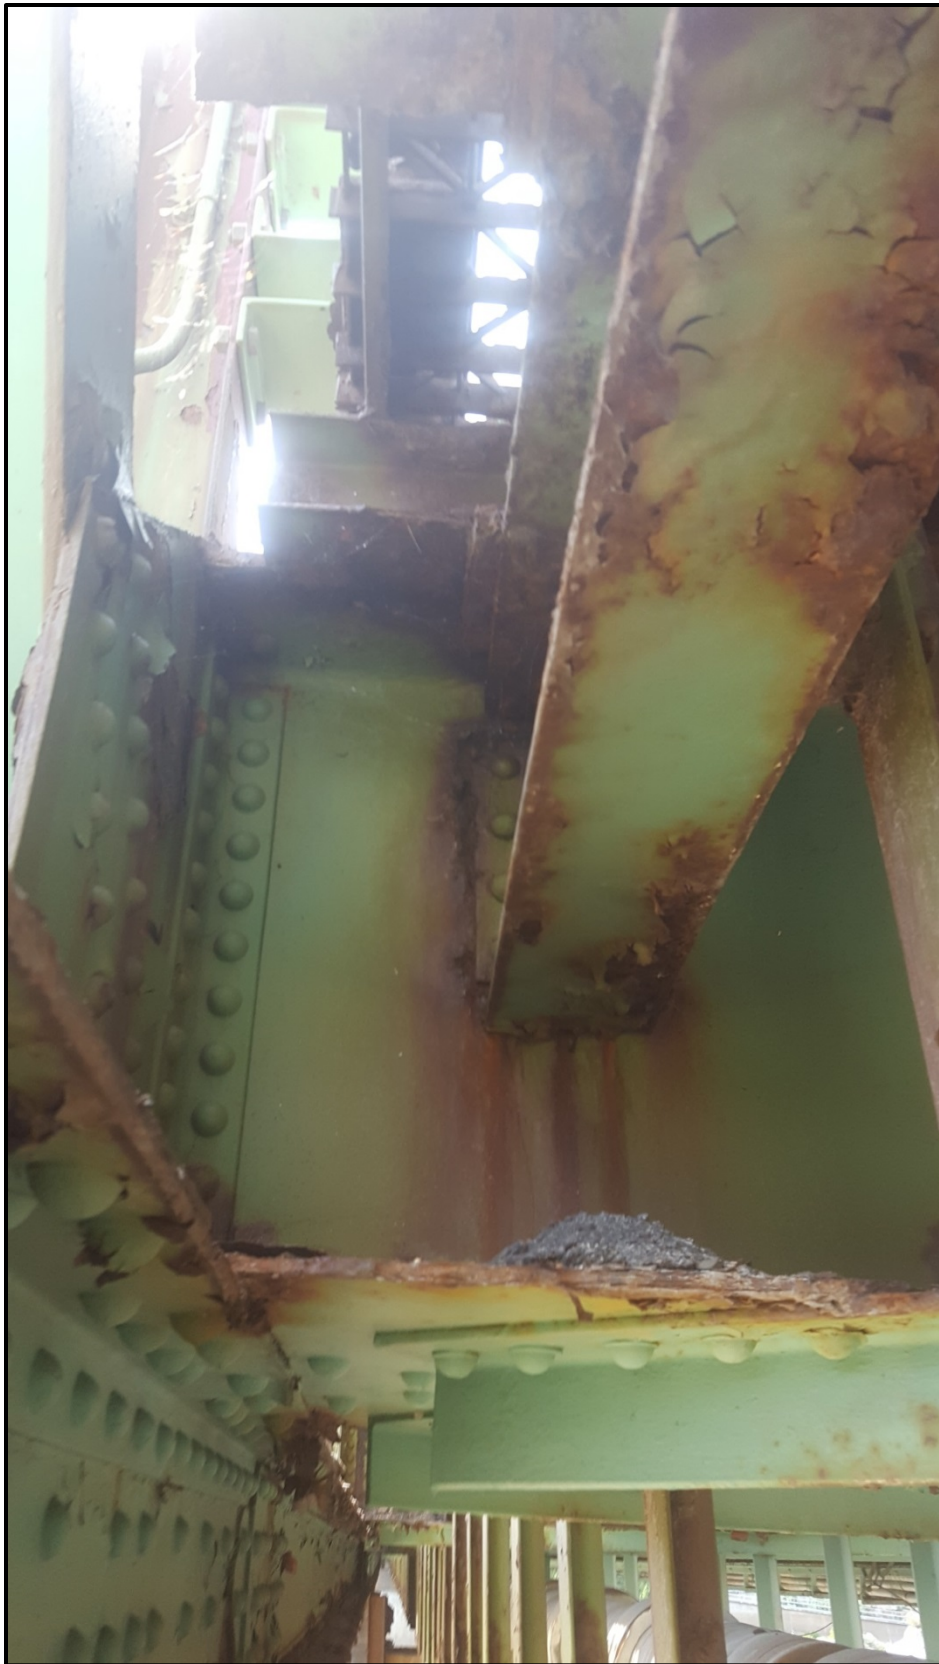
**Photo A16** – Stringer 8 connection to Floorbeam 2 will likely need repair within 5 years.

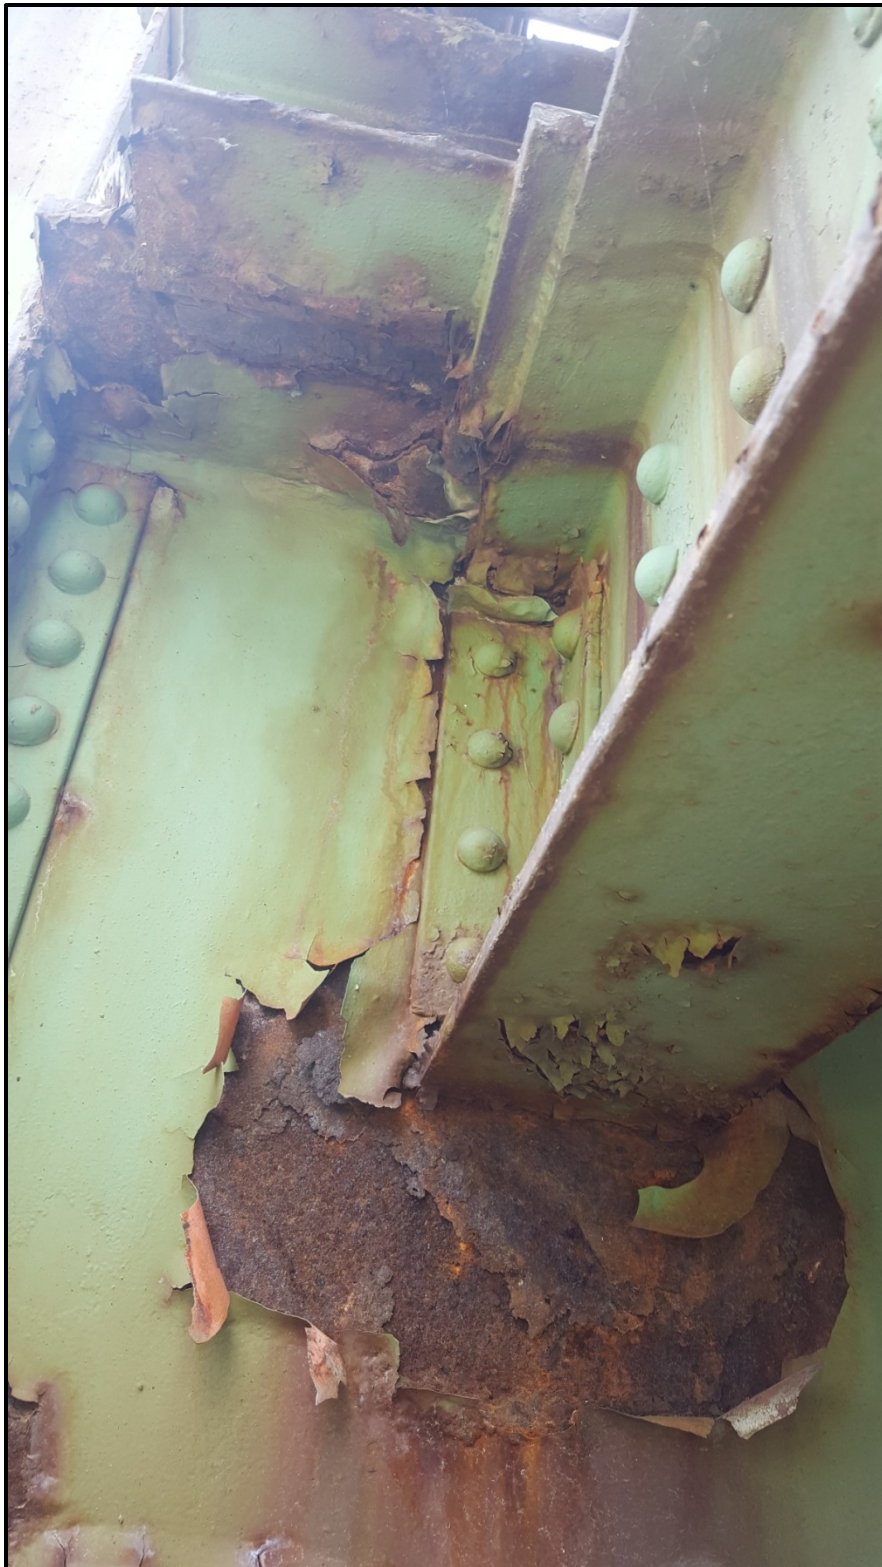
**Photo A17** – Stringer 8 connection to Floorbeam 5 shows active corrosion.

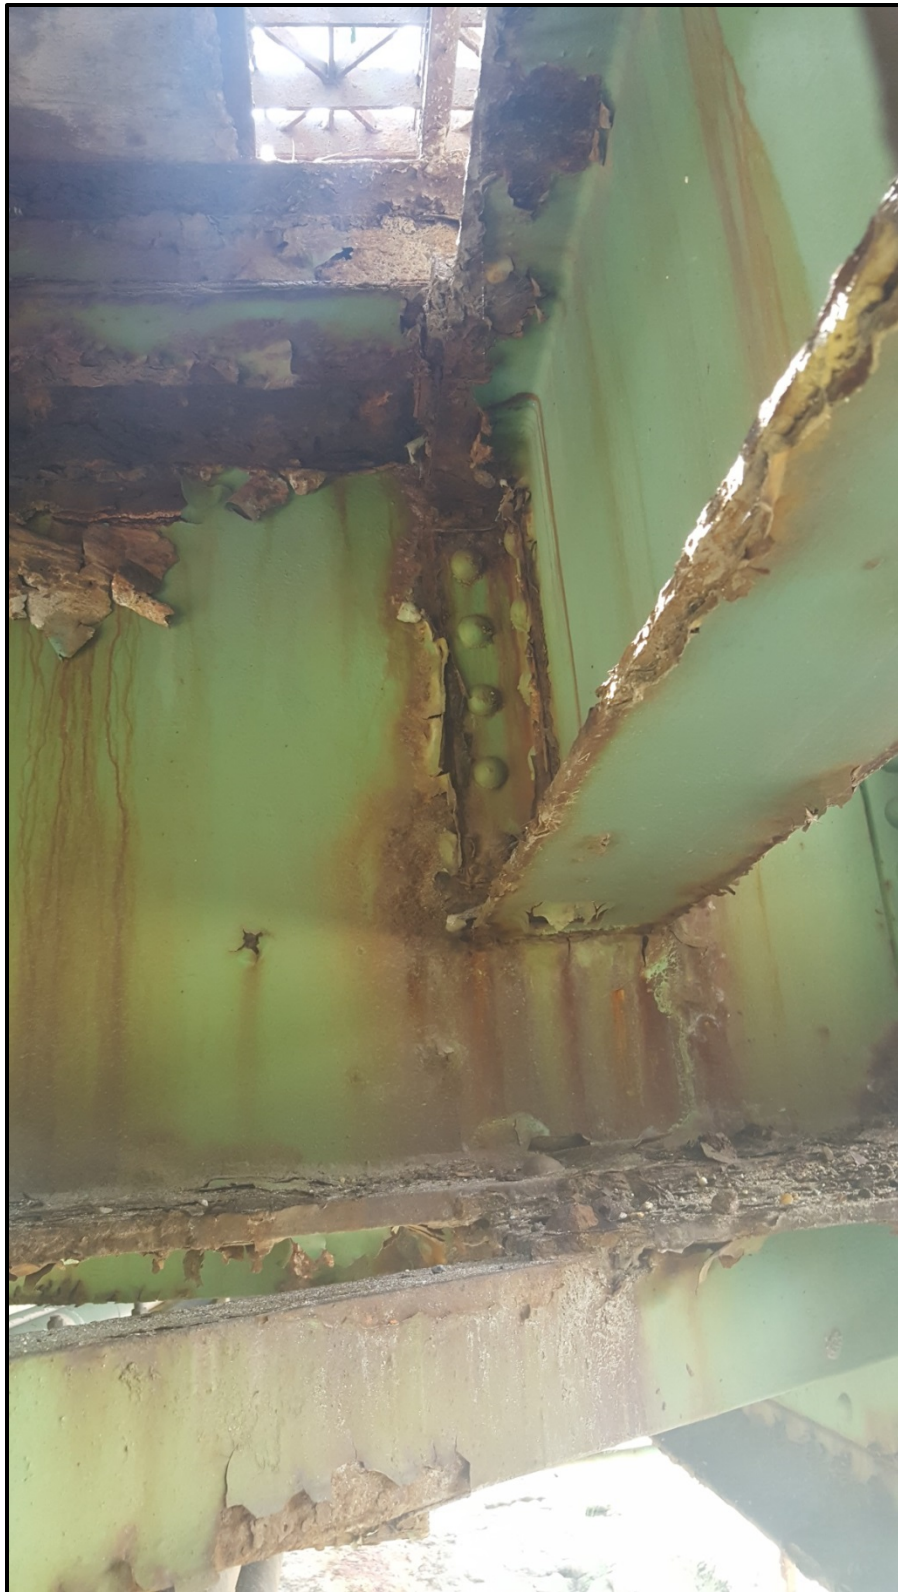
**Photo A18** - Stringer 8 connection to Floorbeam 6. Stringer 3 connection similar condition.

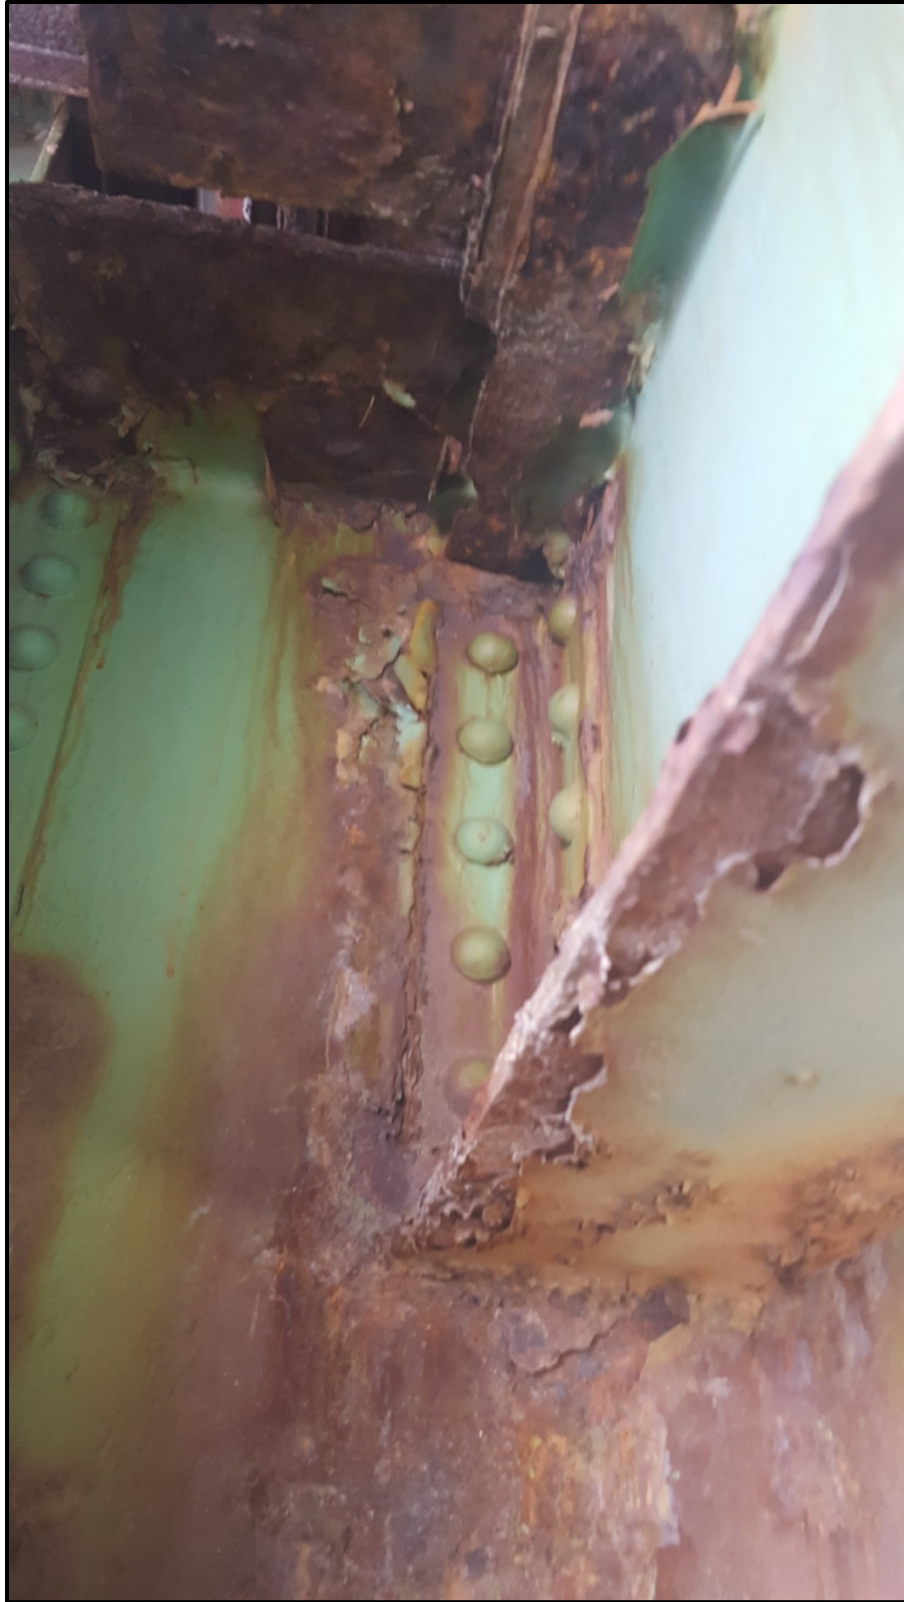
**Photo A19** – Stringer 8 connection to Floorbeam 6 will likely require repairs within 5 years.

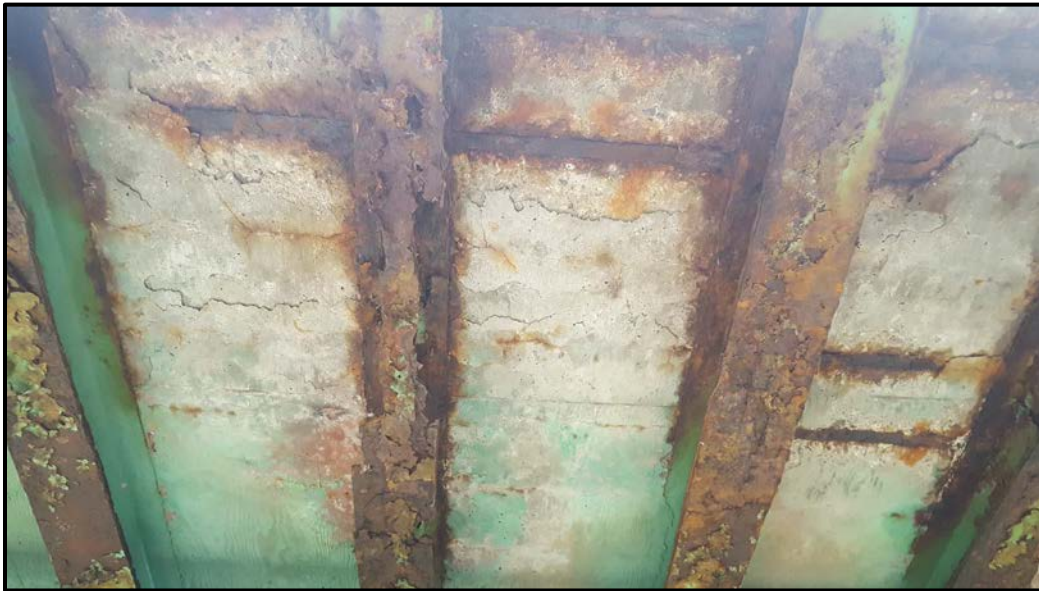
**Photo A20** – Deteriorated Needle Beams shown here in Span1, Floorbeam 0 to 1, are evident throughout all 3 spans. These beams are 2'-0" on center supporting a grid deck mostly filled with concrete supporting an 1 ½ " to 2" asphalt wearing surface.

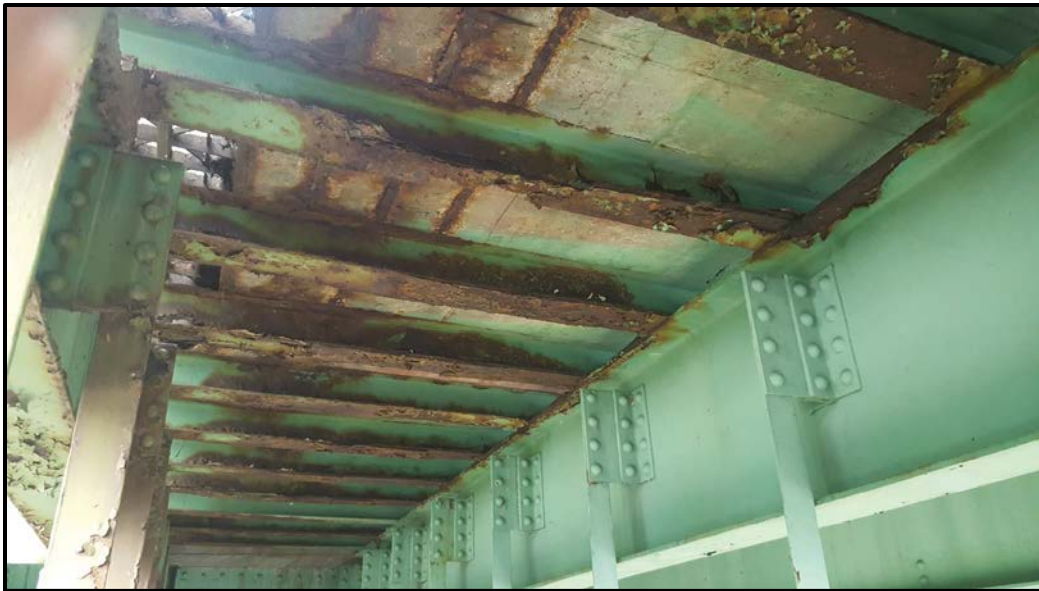
**Photo A21** – View showing Needle Beams between Stringers 7 and 8. Area between stringers 3 and 4 are similar.

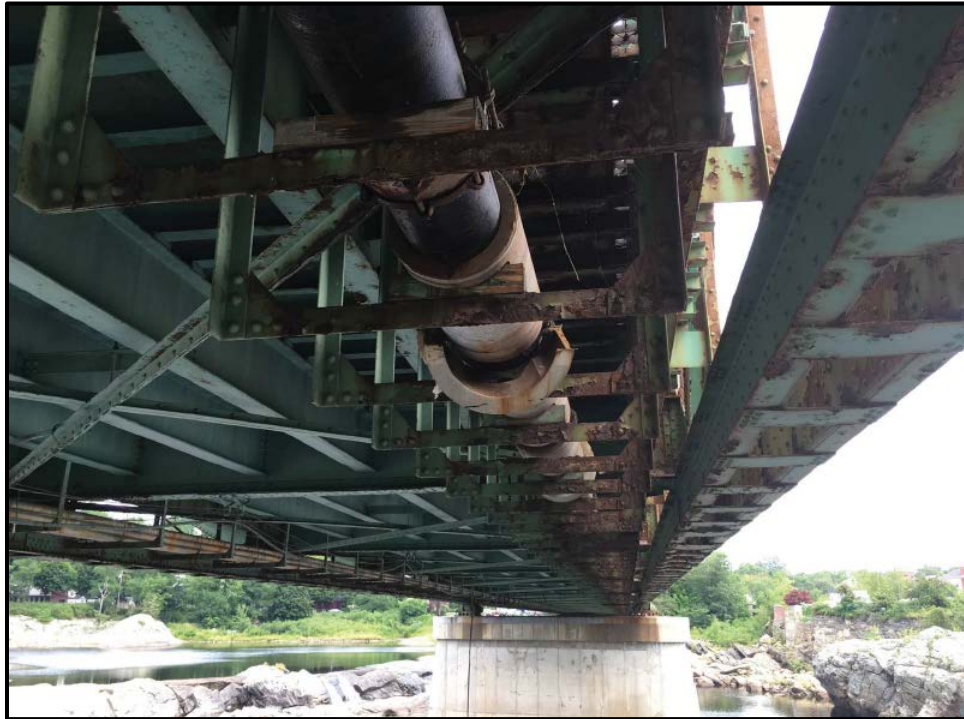
**Photo A23** – View of steel insulated utility pipe extending across the bridge on the Roadside Truss side.

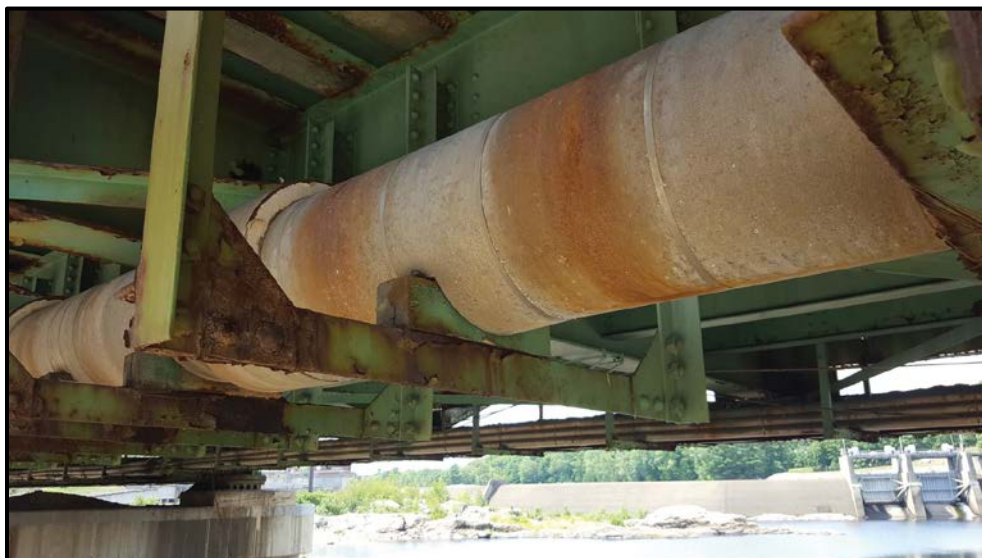
**Photo A24** – The Utility Brackets are in poor condition with extensive active corrosion.
