# Inspection Report

## 8/1/16 - 8/2/16

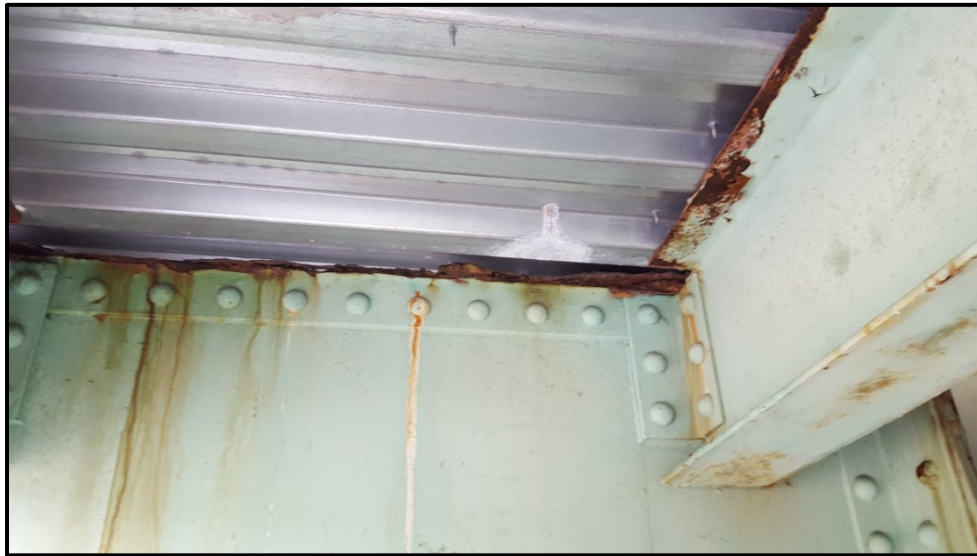
**Photo A25** – View of the top half of cantilevered brackets that support the sidewalk.

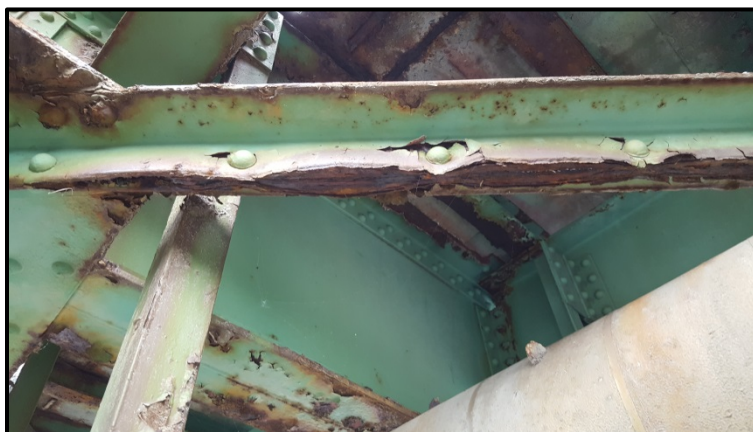
**Photo A26** – In general, a good amount of deterioration exists in the lateral bracing system.

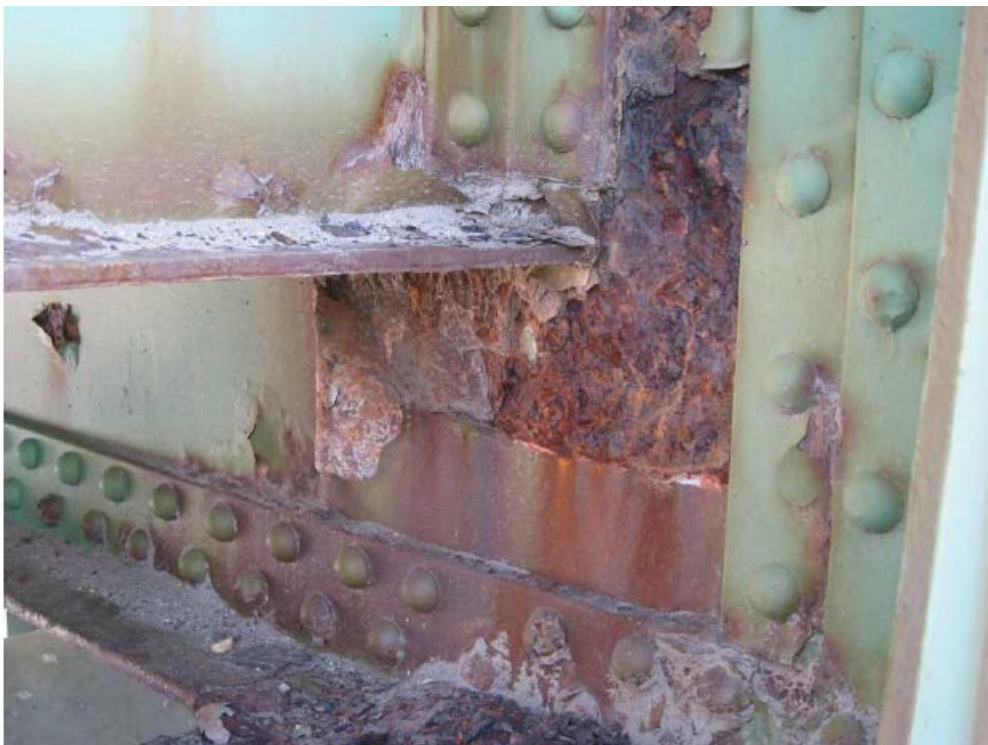
Photo 44 – At Span 1 FB7 below S8 both faces of the web exhibit active corrosion with section loss of 1/8 inch depth over a height of 8 inches and length of 12 inches.

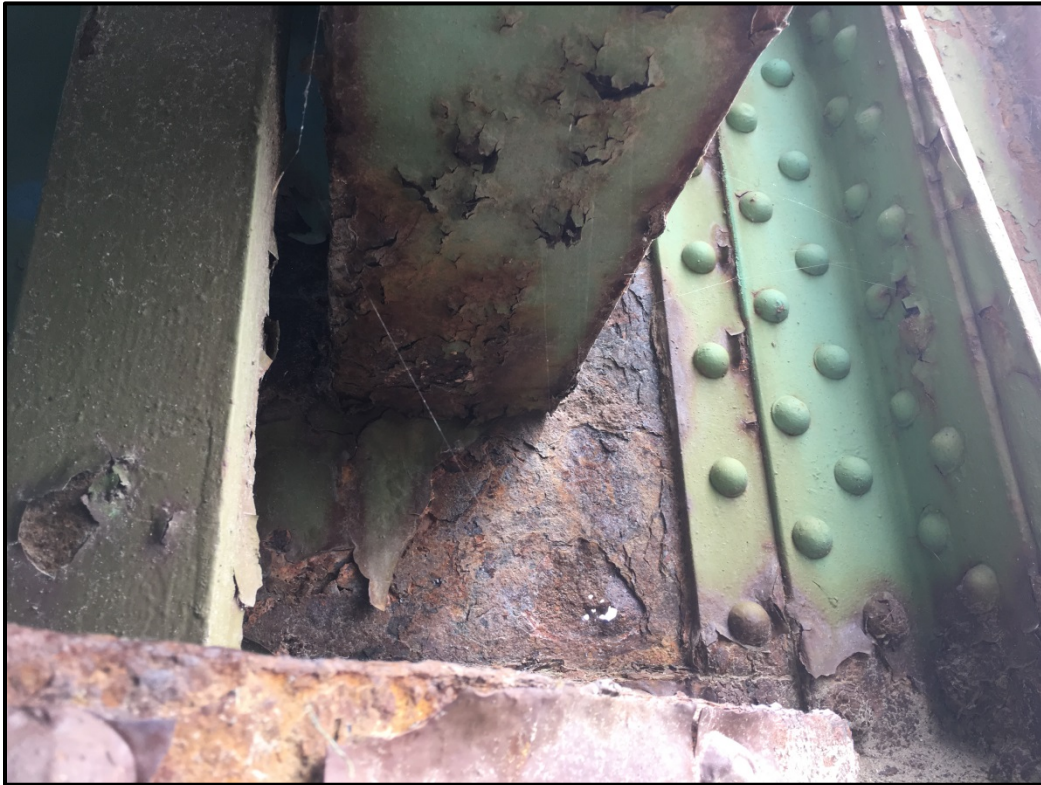
**Photo A2 – Floorbeam 5, Roadway Truss @ Stringer 8 (Exterior)**

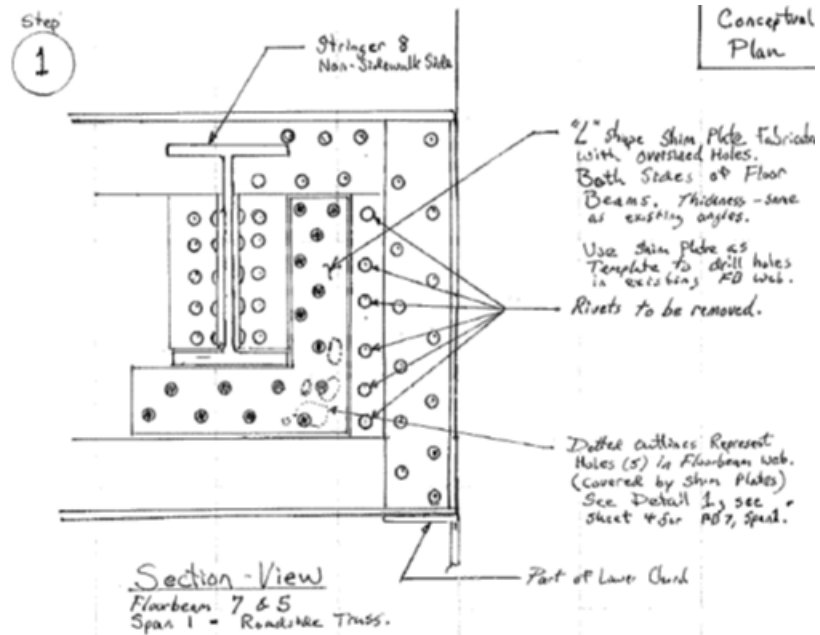
Sketch 2 – Step 1 of Floorbeam Repair.

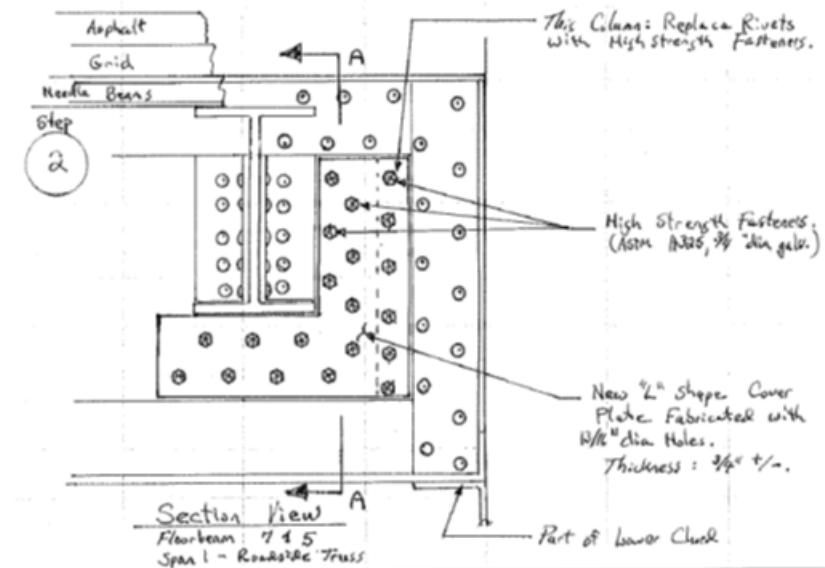
Sketch 3 – Step 2 of Floorbeam Repair.

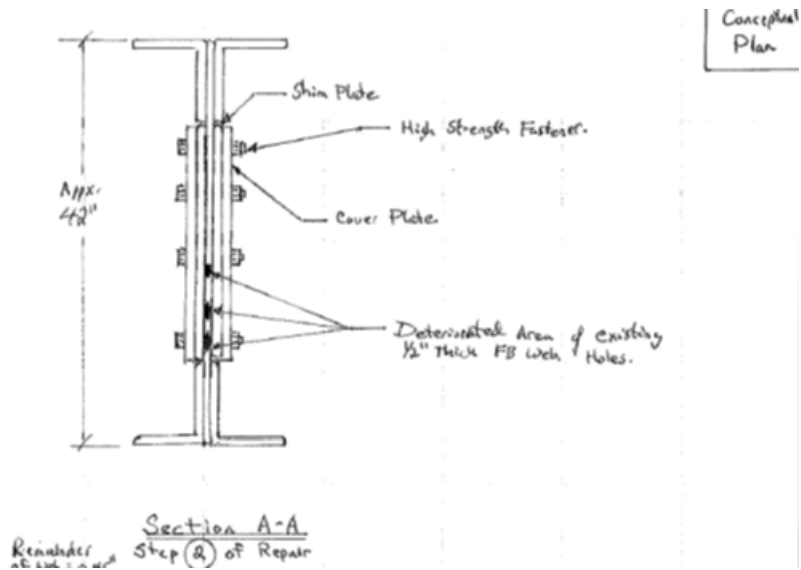
**Sketch 4** – Step 2, Section View of Floorbeam Repair.

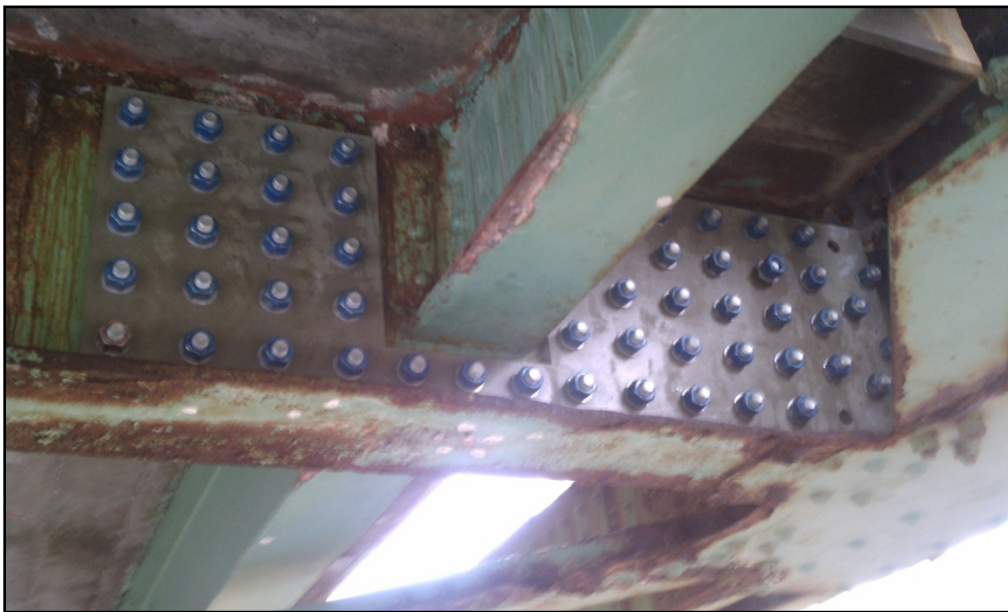
**Photo A26** – End result of similar repair to Floorbeam.

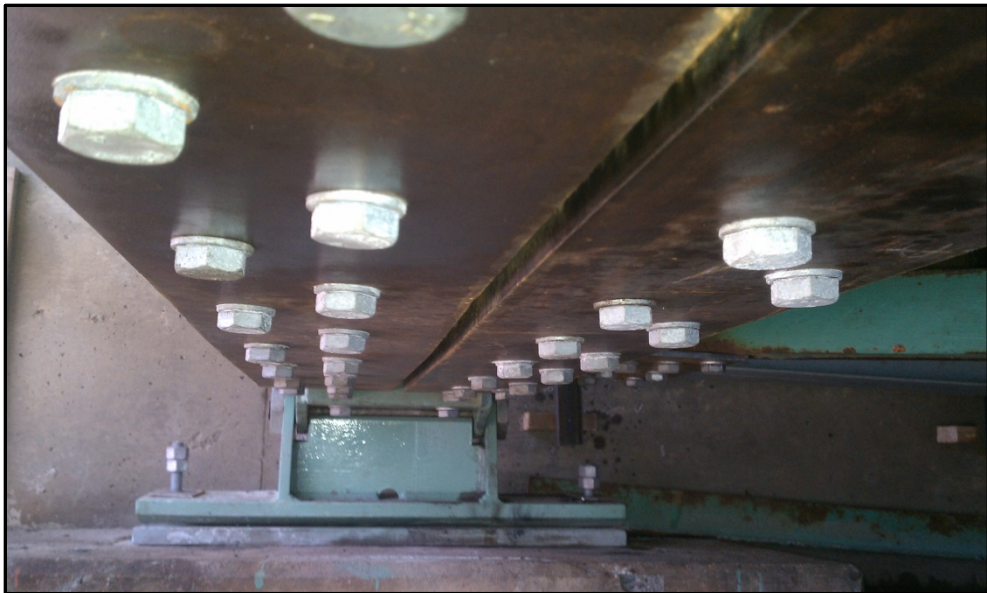
**Photo A27** – End result of repair to built-up Floorbeam bottom flange.

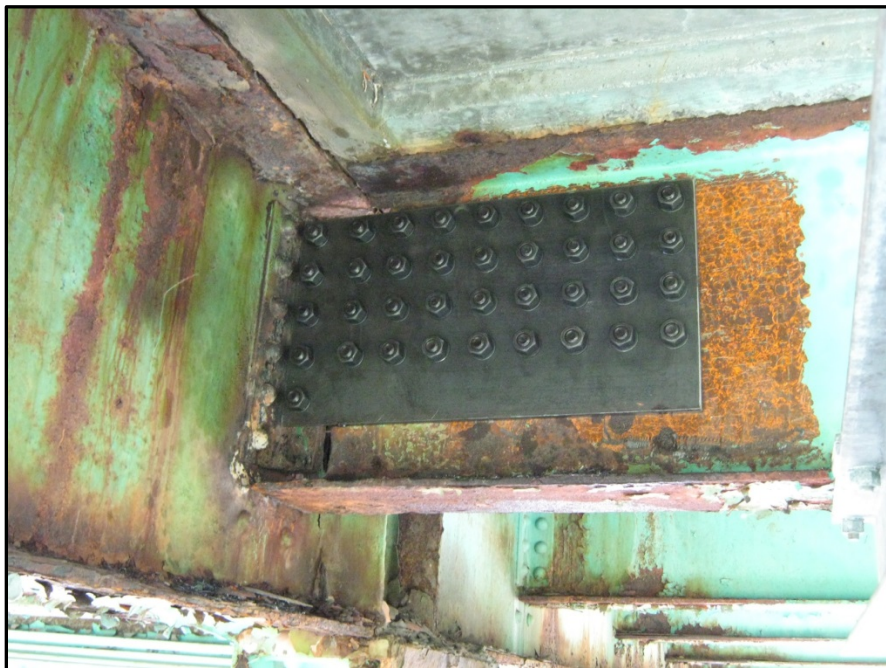
**Photo A28** – End result of a typical Stringer to Floorbeam connection.

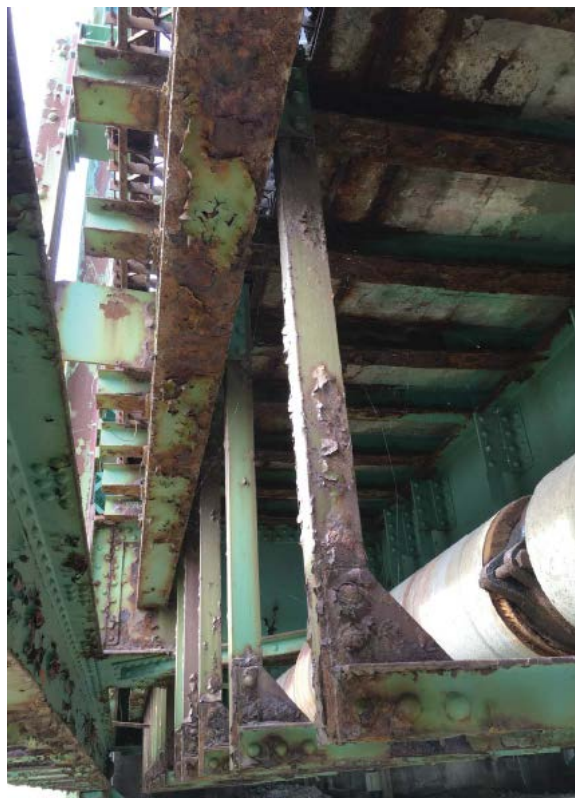
Photo # 8: General view of paint loss and corrosion to bays below the open grid decking in the travel way shoulders on the non-sidewalk side (eastern) of the bridge (8/1/16)

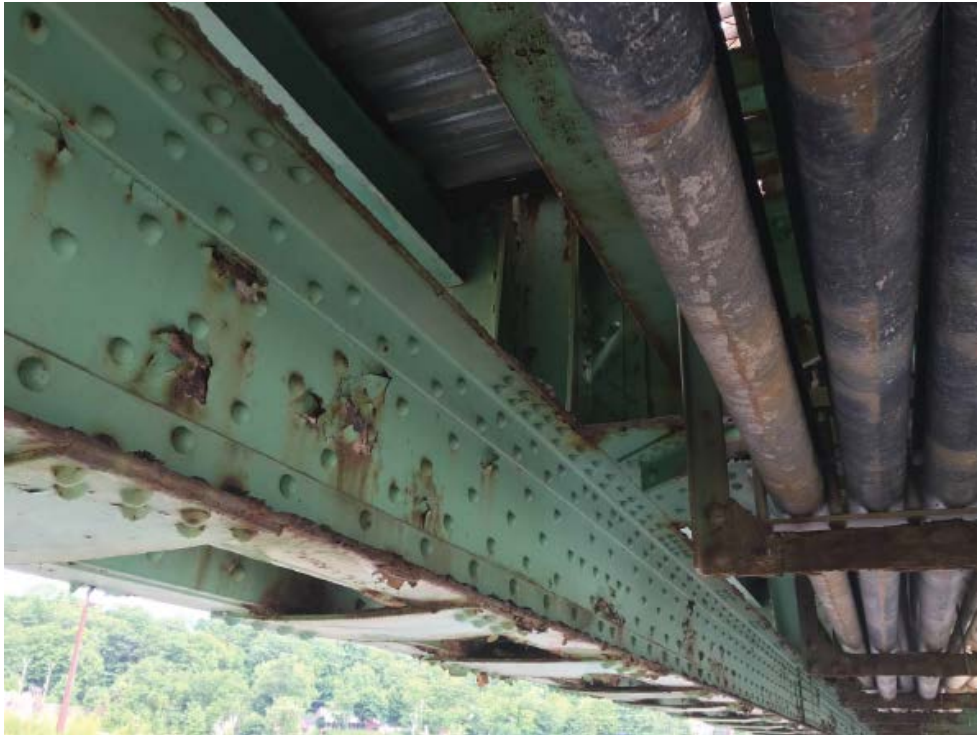
Photo # 9: General view of paint loss and corrosion to bays below the open grid decking in the travel way shoulders on the sidewalk side (western) of the bridge (8/1/16)

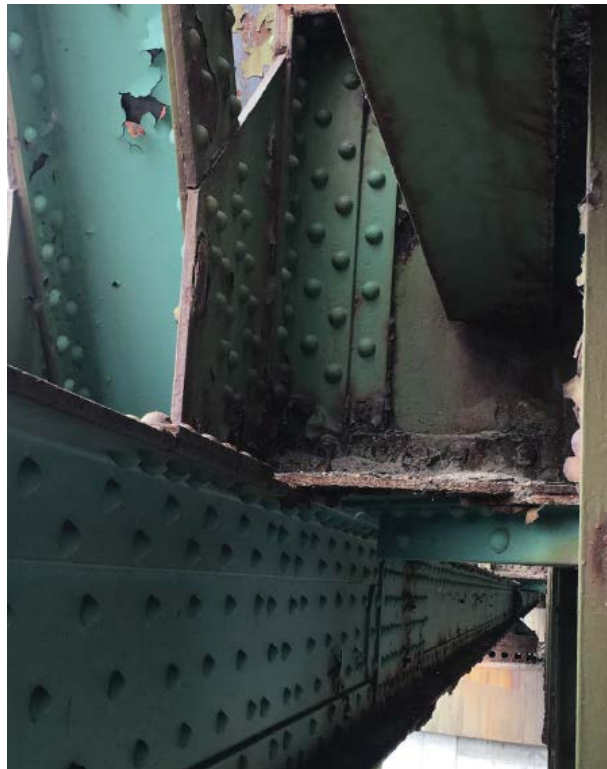
Photo # 10: General view of floor beam to truss gusset plate connection (8/1/16)

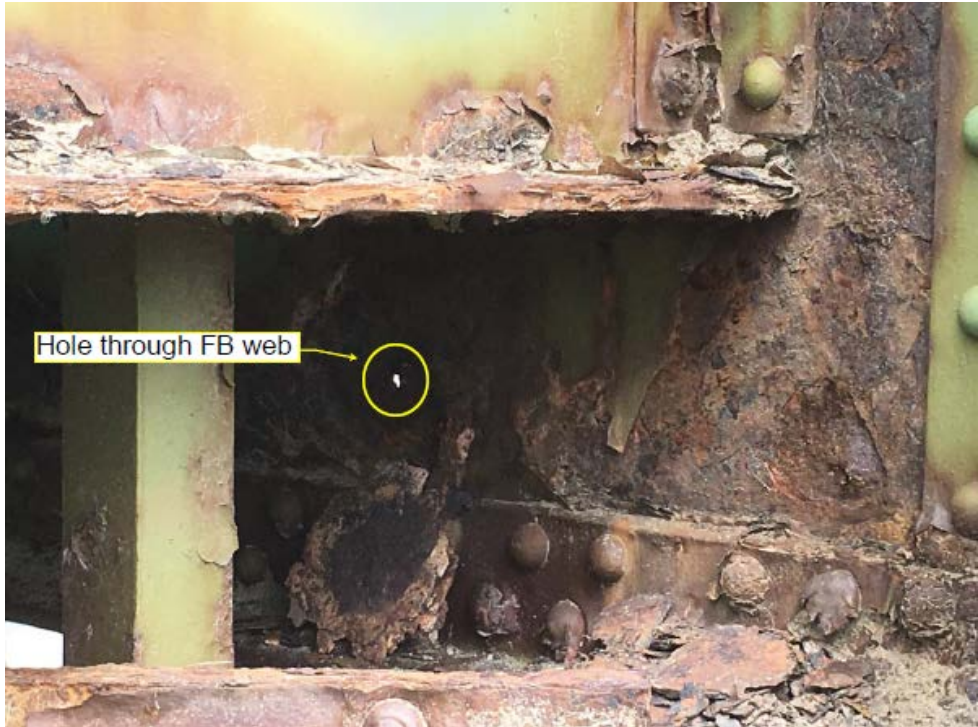
Photo # 12: General view of corrosion & hole through the web on the non-sidewalk (eastern) end of FB2 in span 1 (8/1/16)

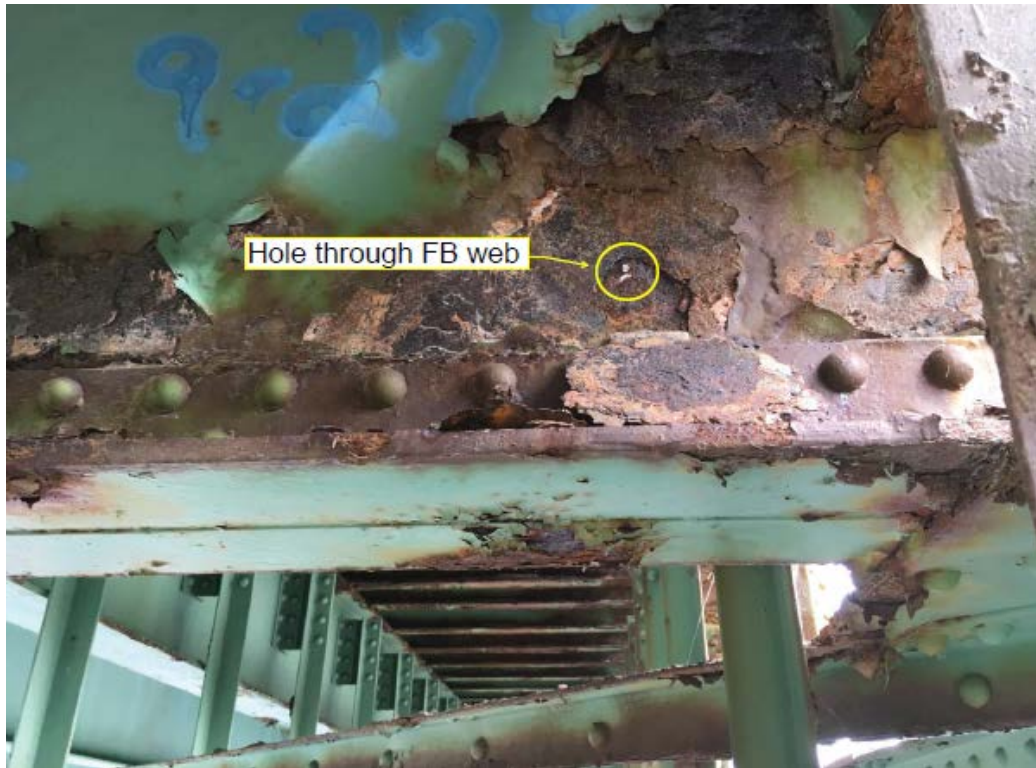
Photo # 13: Closer image of hole through the web of FB2 in span 1 (8/1/16)

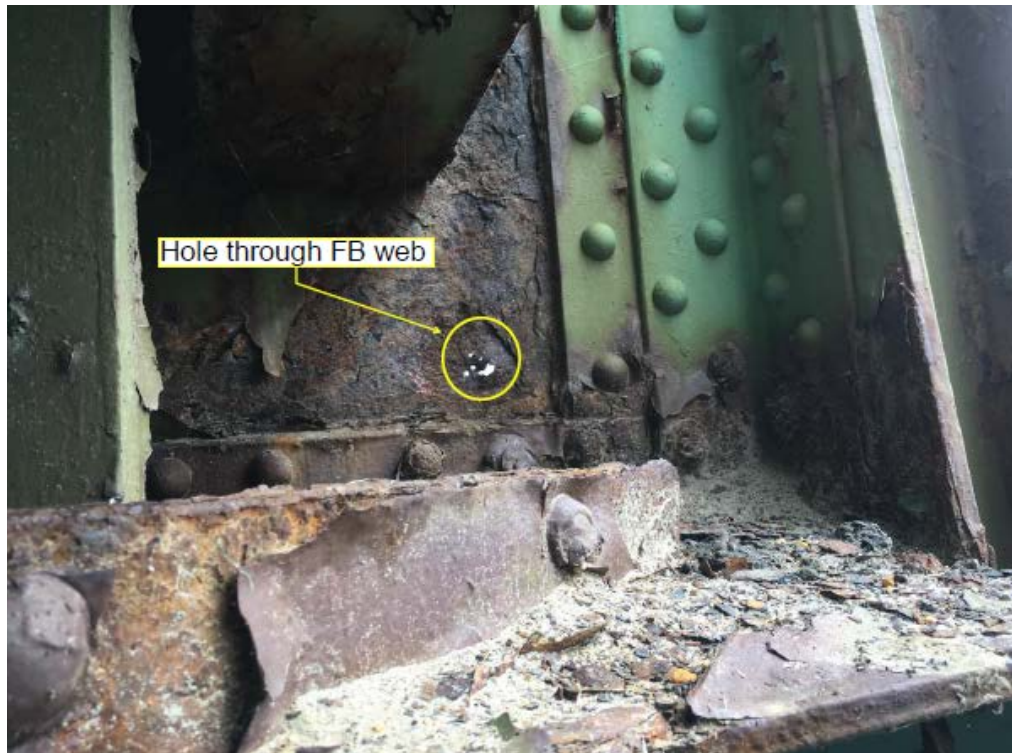
Photo # 14: General view of corrosion and hole through the web of the non-sidewalk (eastern) end of FB5 in span 1 (8/1/16)

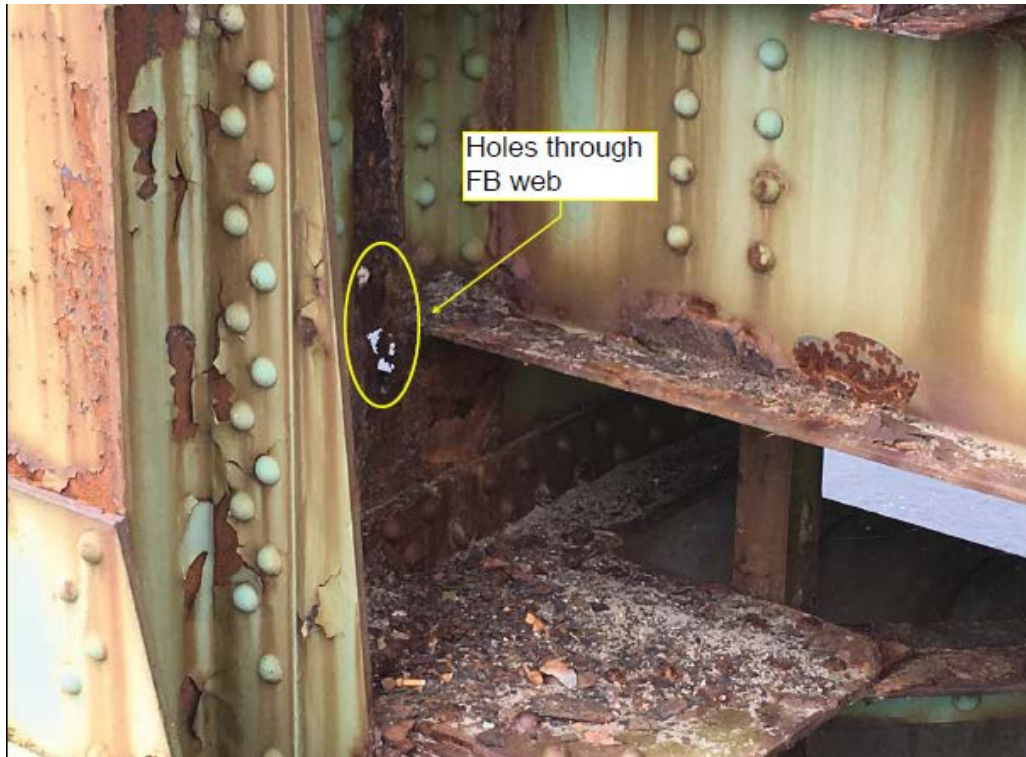
Photo # 15: General view of corrosion and holes through the web of non-sidewalk (eastern) end of FB7 in span 1 (8/1/16)

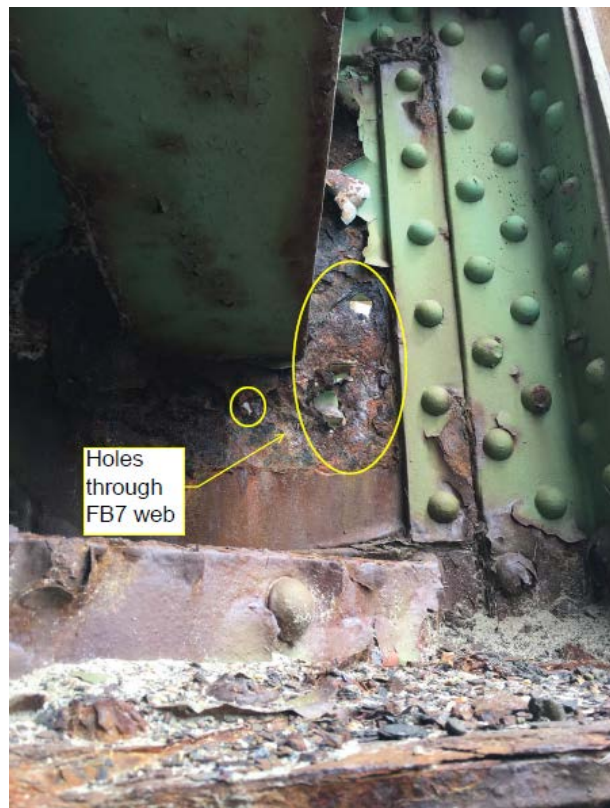
Photo # 16: Closer view of holes through the web of FB7 (8/1/16)

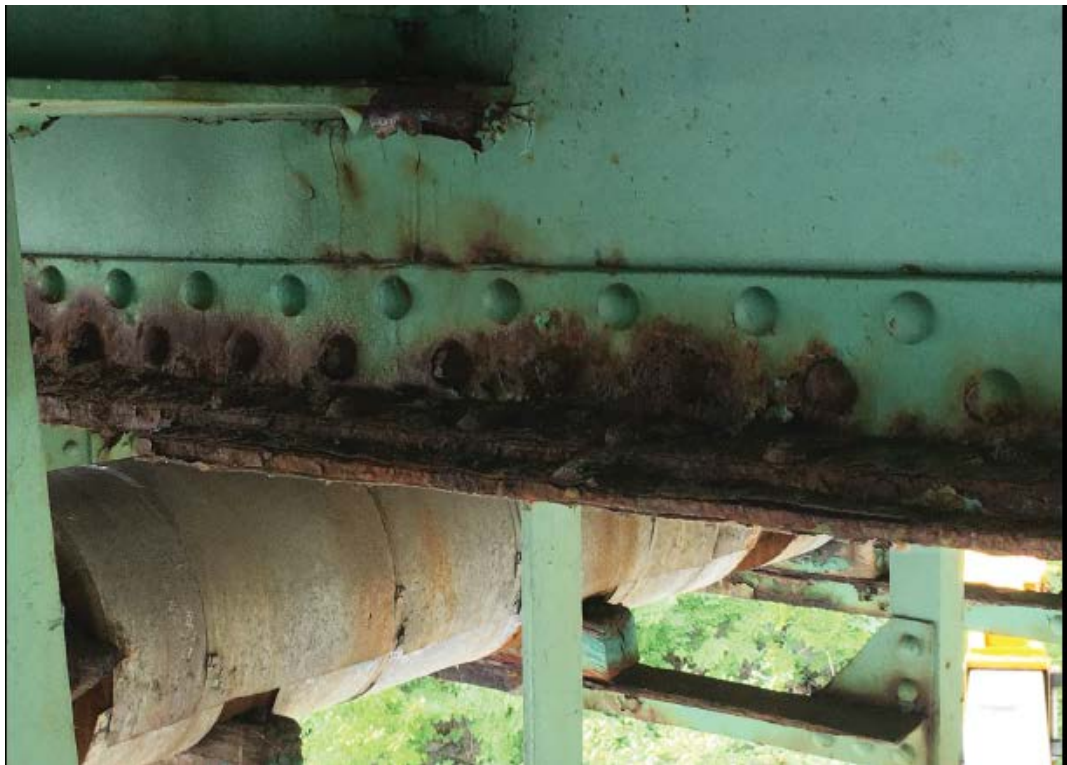
Photo # 18: Severe corrosion & pack rust between the bottom flange of the floor beam and the cover plate near midspan of FB5 in span 2, (span 2 FB4, FB6 & FB7 similar) (8/2/16)

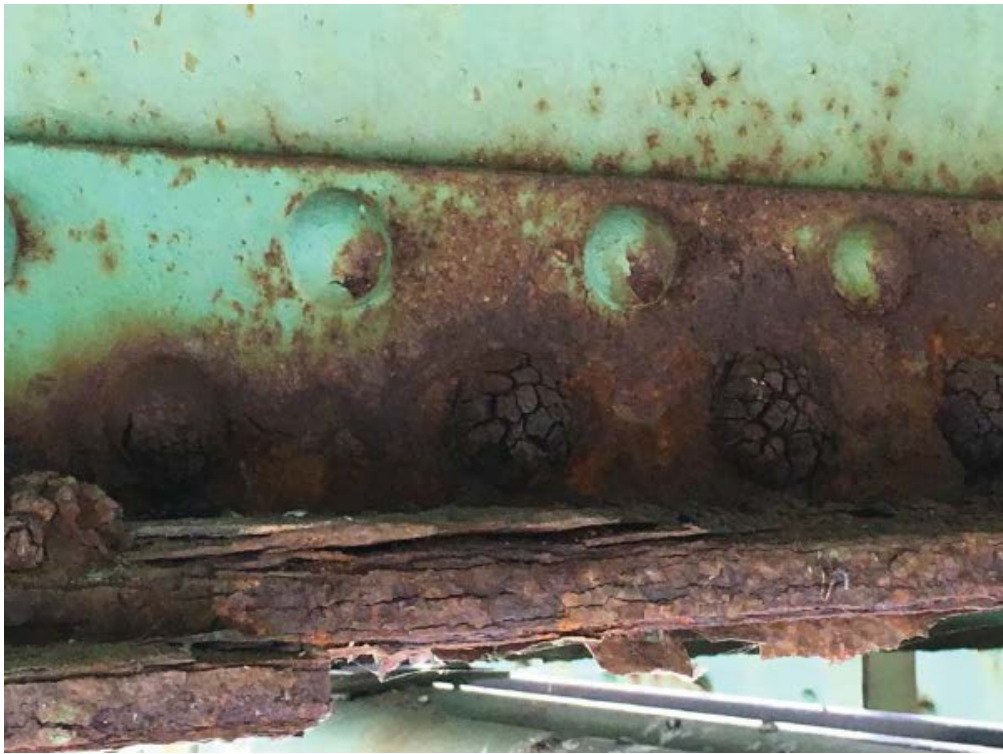
Photo # 19: Severe corrosion to the rivets as well as corrosion & pack rust between the bottom flange of the floor beam and the cover plate near midspan of FB5 in span 2 (span 2 FB4, FB6 & FB7 similar) (8/2/16)

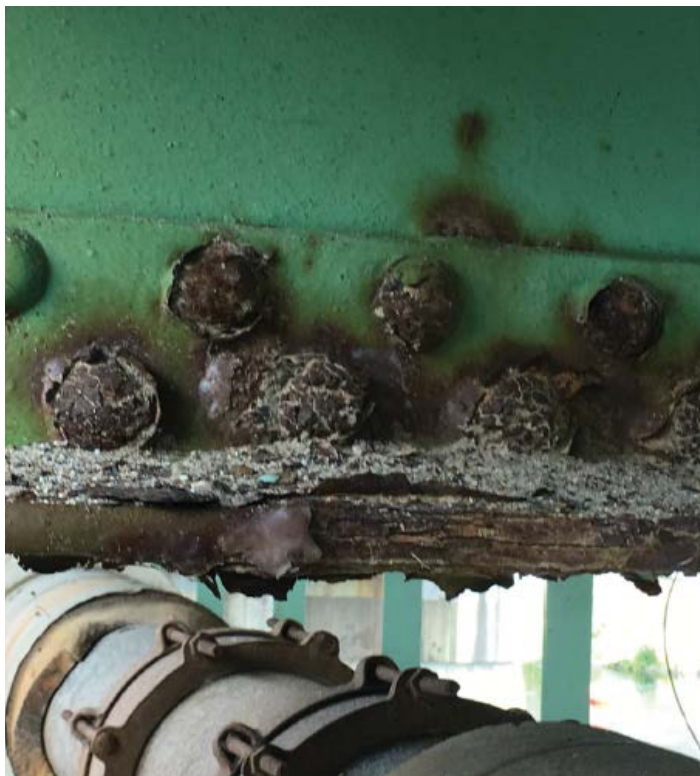
Photo # 20: Advanced deterioration of rivets near midspan of FB7 in span 2 (8/2/16)

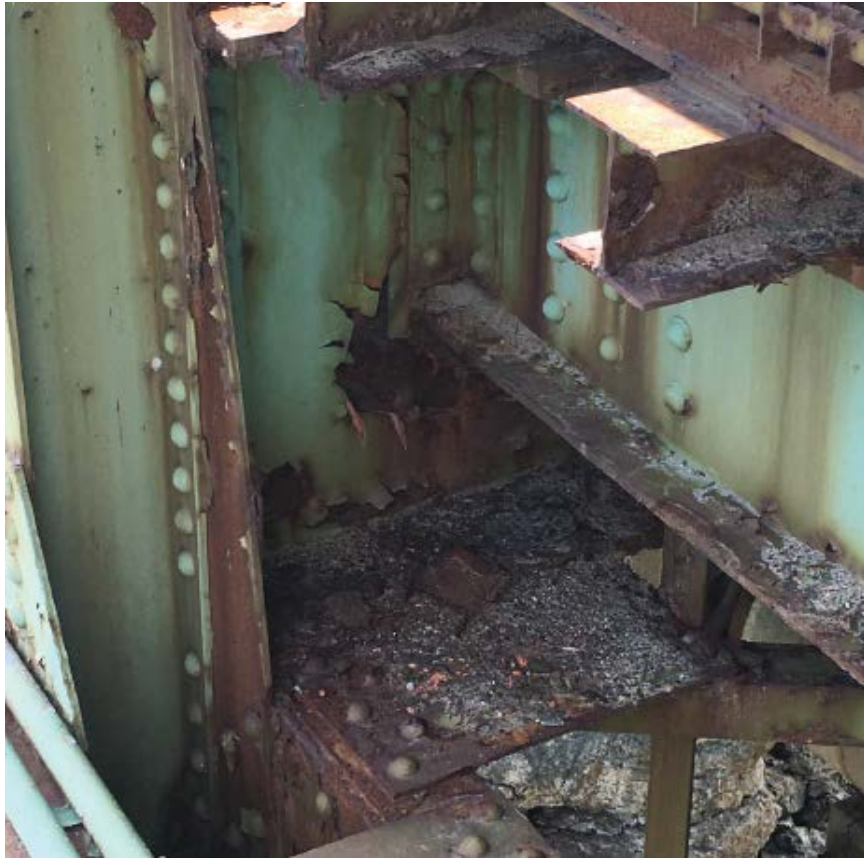
Photo # 21: General view of floor beam end in span 3 (8/2/16)

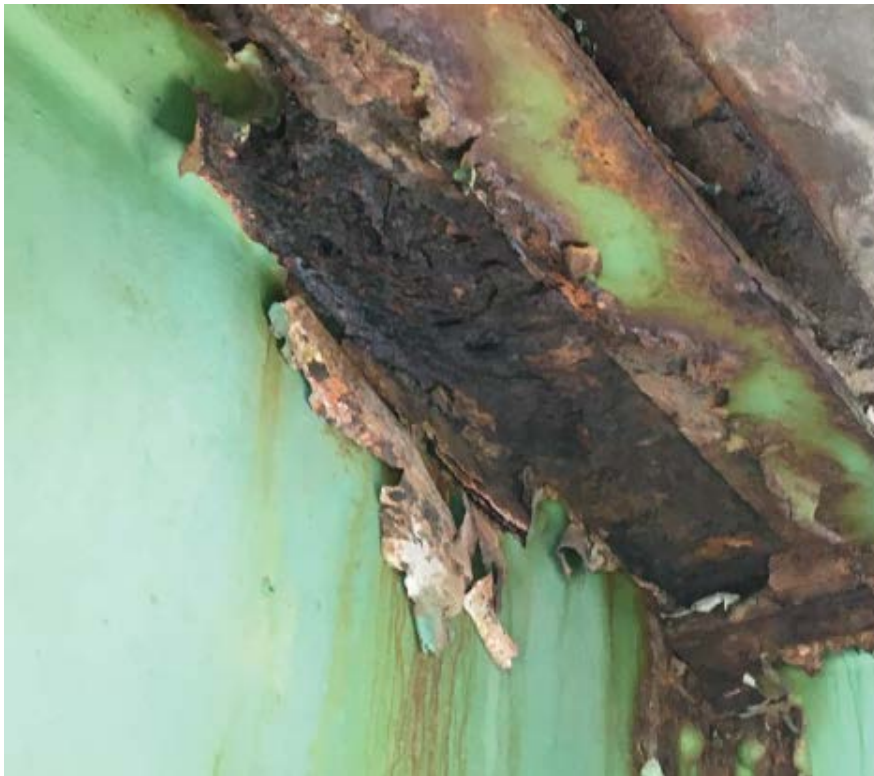
Photo # 22: Top flange corrosion & section loss of FB 5 in span 3 (8/2/16)

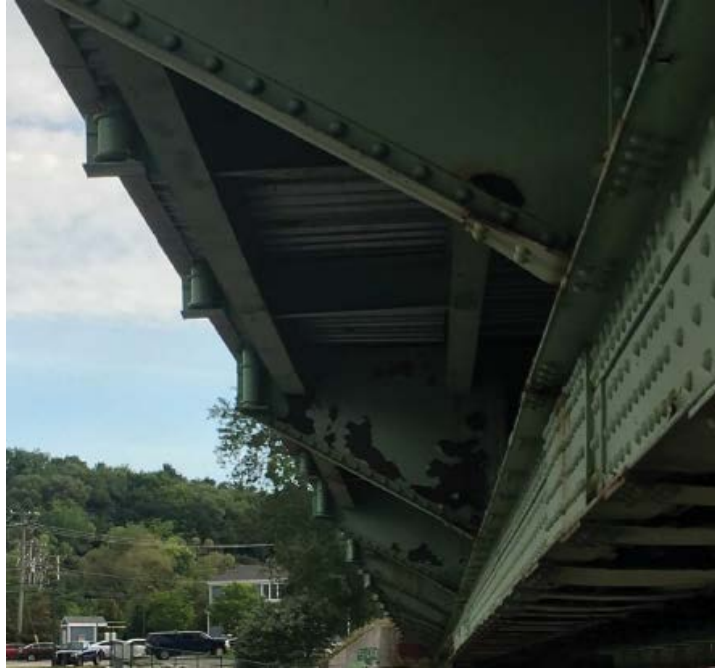
Photo #23: Typical view of the sidewalk stringers (S1 & S2) on the upstream side of the bridge (western side, looking north) (8/1/16)

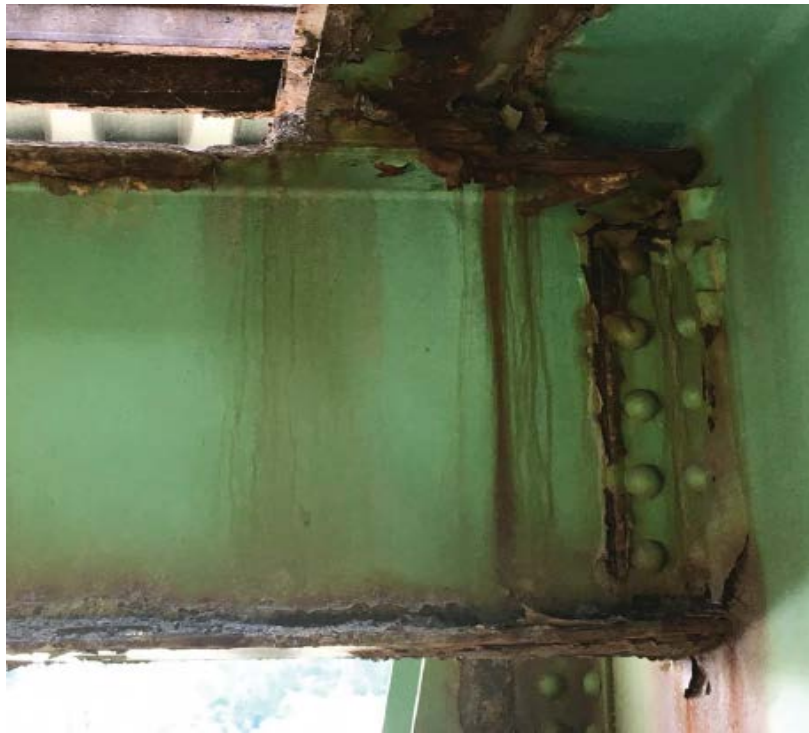
Photo #27: Moderate corrosion to S3 in span 3 near FB4 (8/2/16)

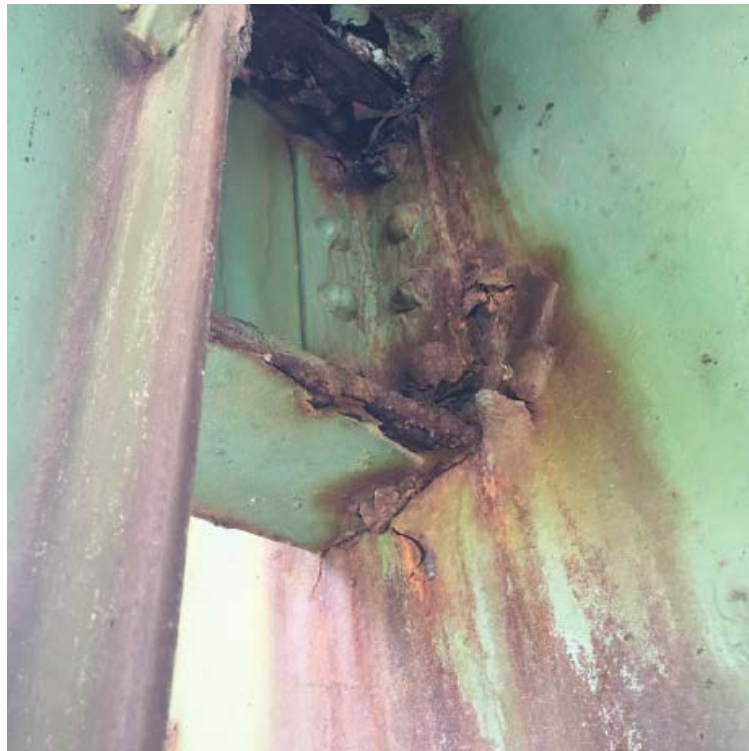
Photo #28: Moderate corrosion with pack rust between the connection angles and floor beam, at S8 in span 3 near FB5 (8/2/16)

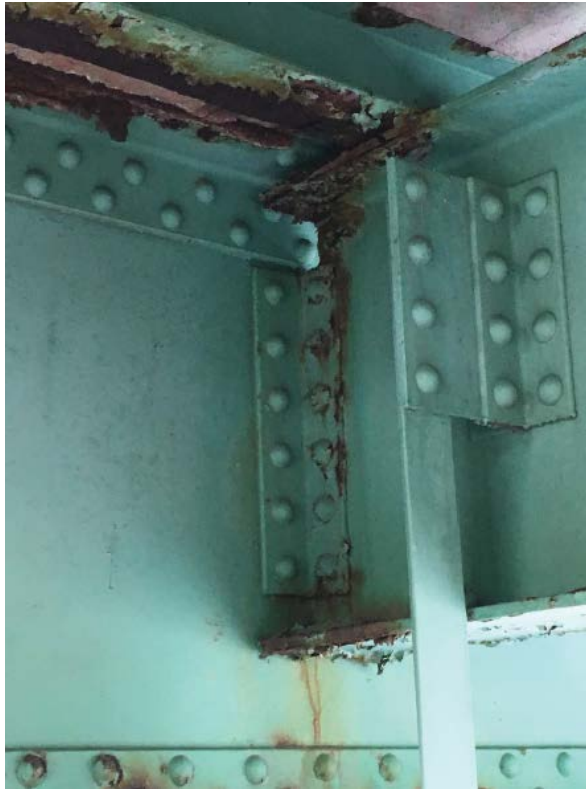
Photo #29: Typical interior stringer (S4 through S7) to floor beam connection (Typ. all spans) (8/1/16)

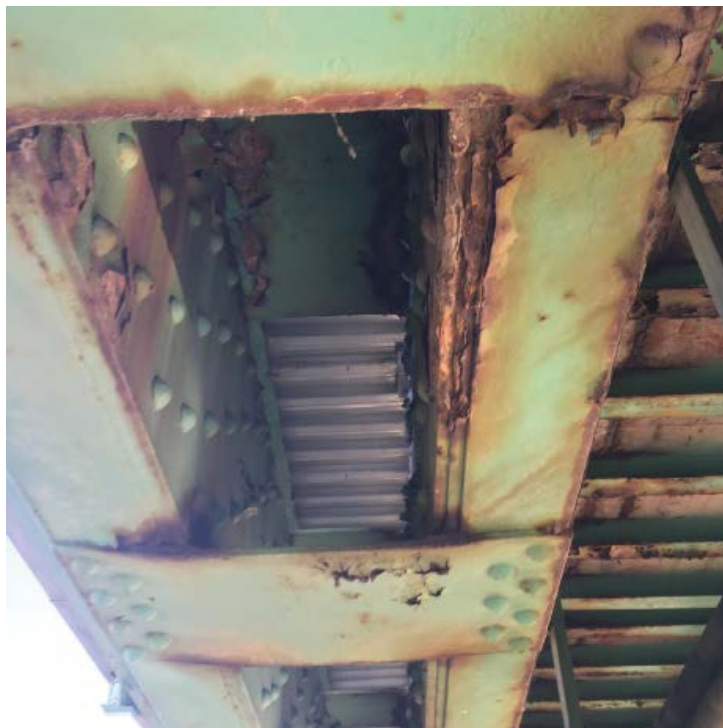
Photo #30: Typical corrosion of the bottom chord of the truss members, showing “bowing” of the Lattice plates due to pack rust (8/2/12)

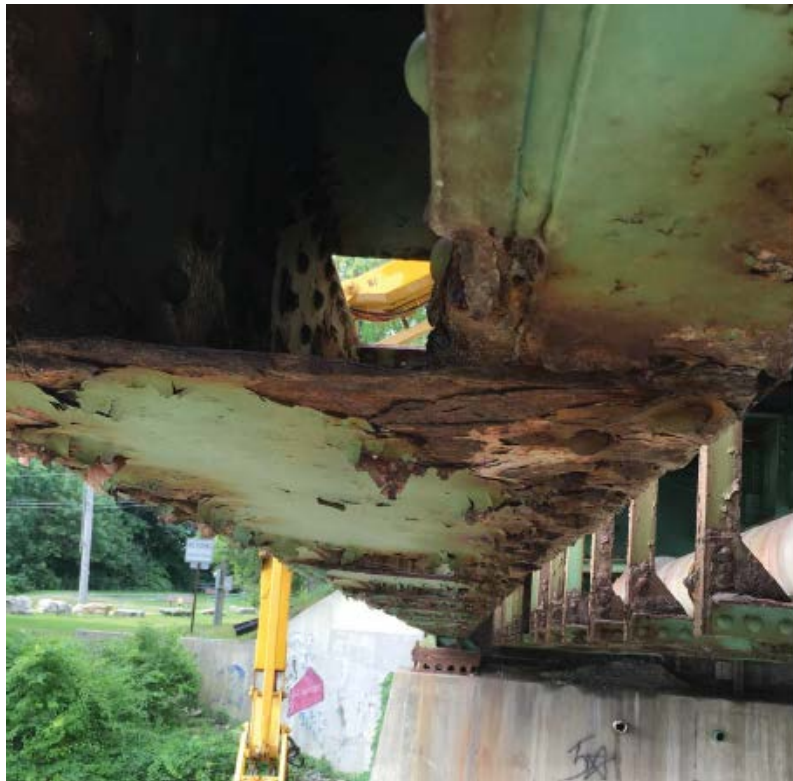
Photo #31: Corrosion of lattice plate on bottom chord of non-sidewalk truss in span 1 (8/1/16)

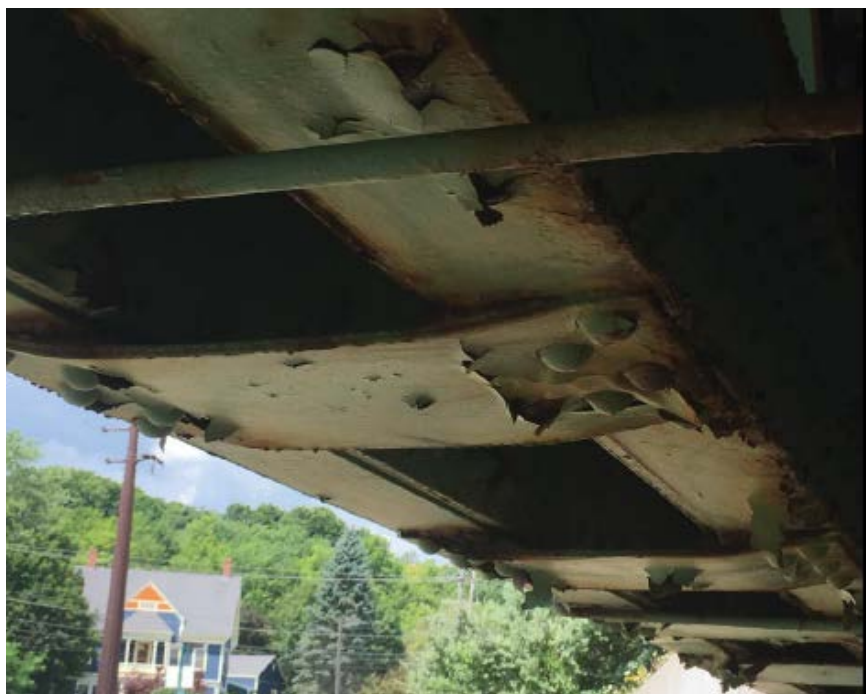
Photo #32: "Bowing" of lattice plates on the bottom chord of the sidewalk truss in span 3 (8/2/16)

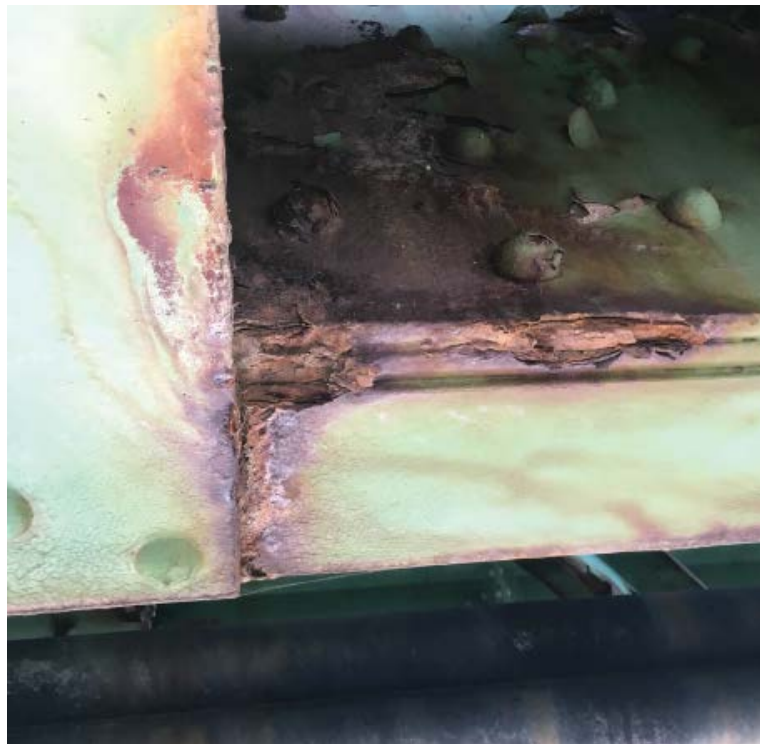
Photo #34: Pack rust between lattice plate and bottom angle on the the bottom chord of the sidewalk truss in span 3 (8//16)

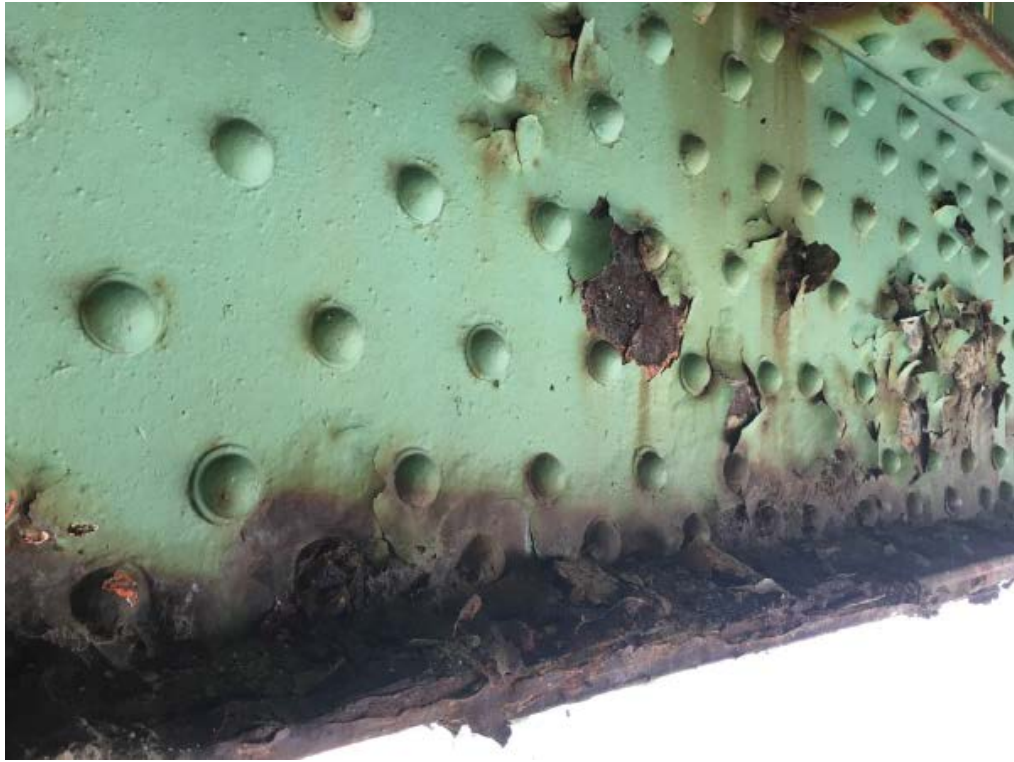
Photo #35: Bottom chord of non-sidewalk (eastern) truss, in span 1 near FB 2 (8/1/16)

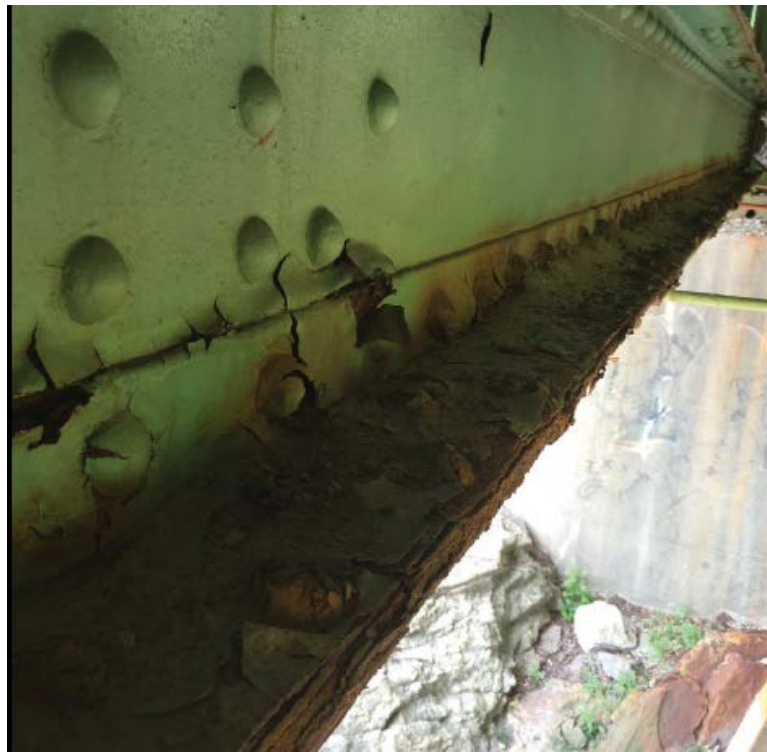
Photo #36: Corrosion to the bottom flange of the bottom chord of the sidewalk side truss in span 3 (western side of the bridge looking north) (8/2/16)

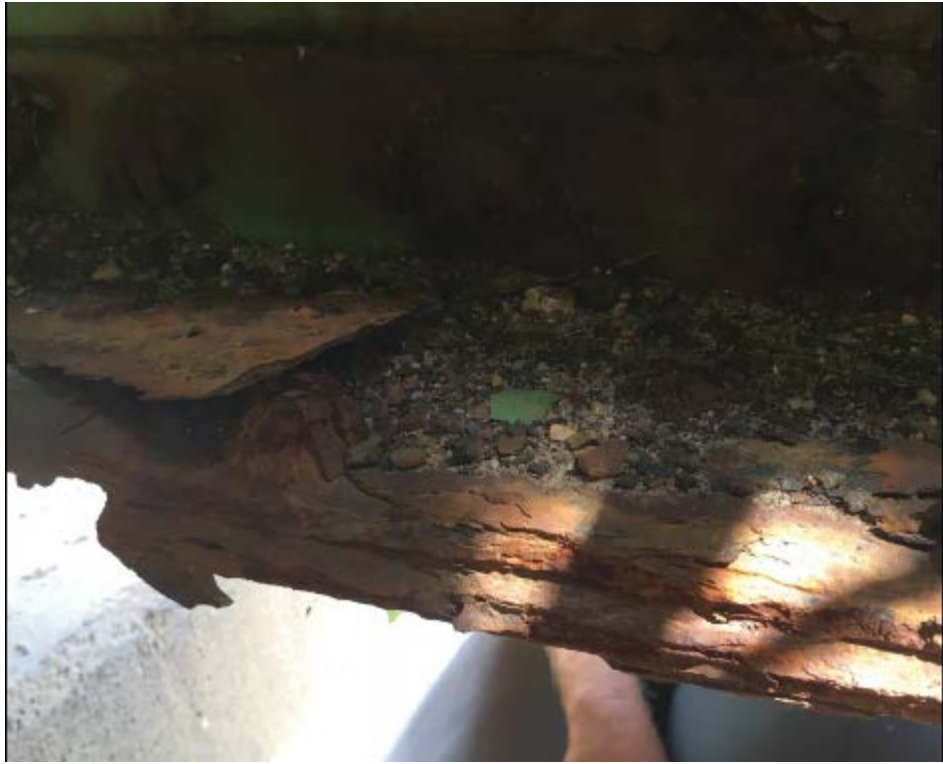
Photo #37: Pack rust between plates on the bottom chord of the non-sidewalk truss in span 3 (eastern side of the bridge) (8/2/16)

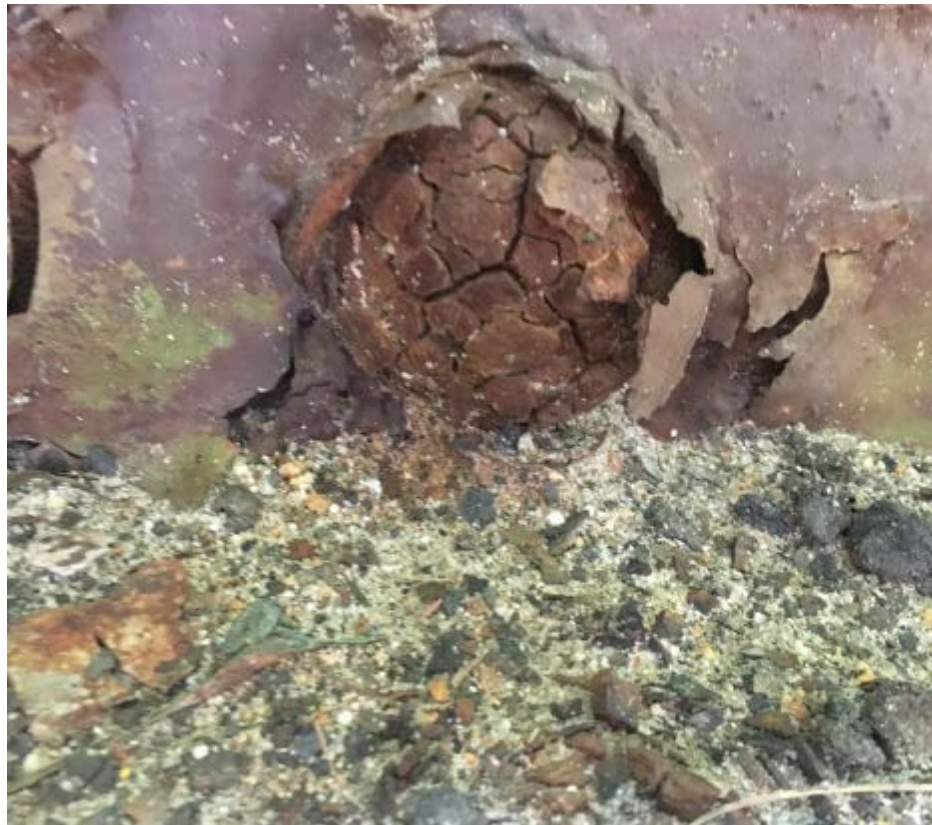
Photo #38: Severely deteriorated rivet heads on the bottom chord of the sidewalk side truss, span 3 (8/2/16)

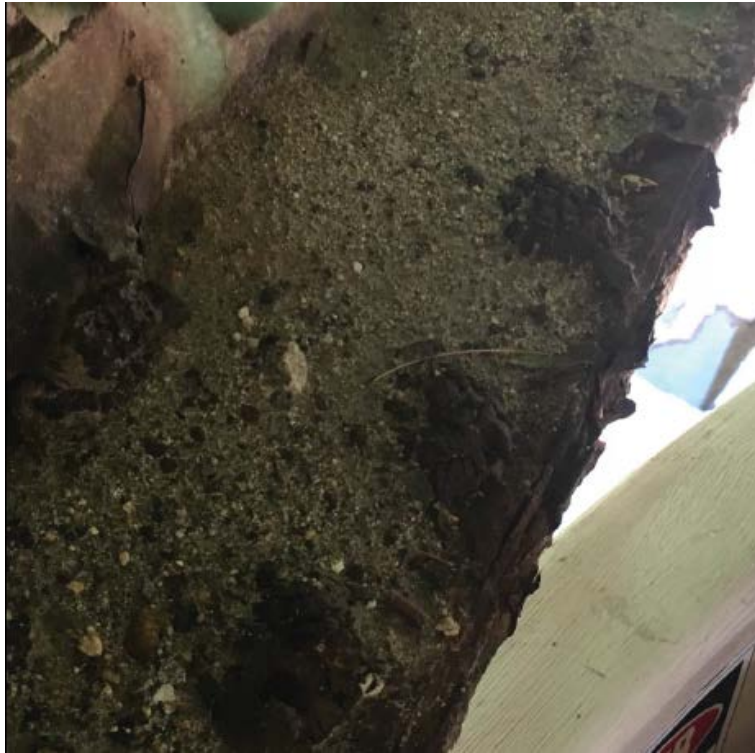
Photo #39: Remnants of rivet heads along the top of the bottom flange of the bottom chord of the sidewalk truss (western) in span 3 (8/2/16)
