# Inspection Report

## 8/1/16 - 8/2/16

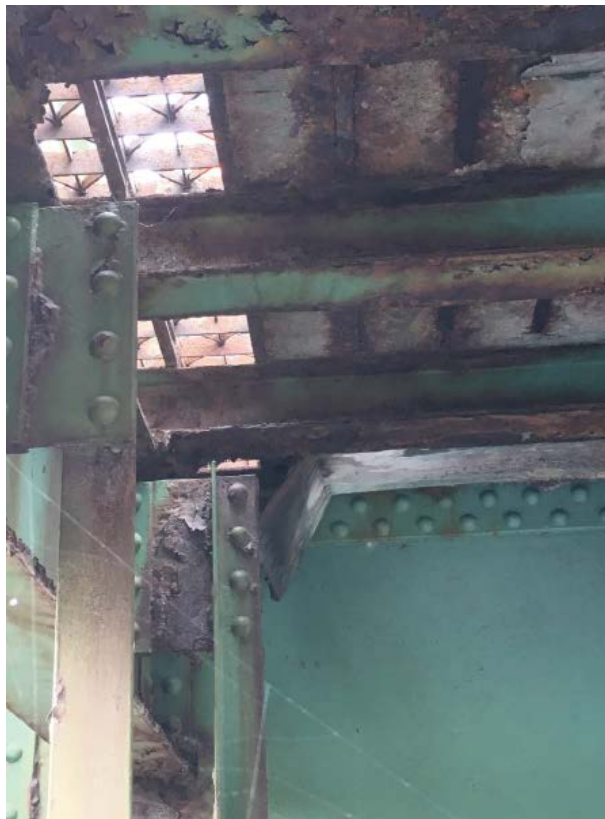
Photo #44: Moderate corrosion to cross beams (needle beam) (Typ.) (8/1/16)

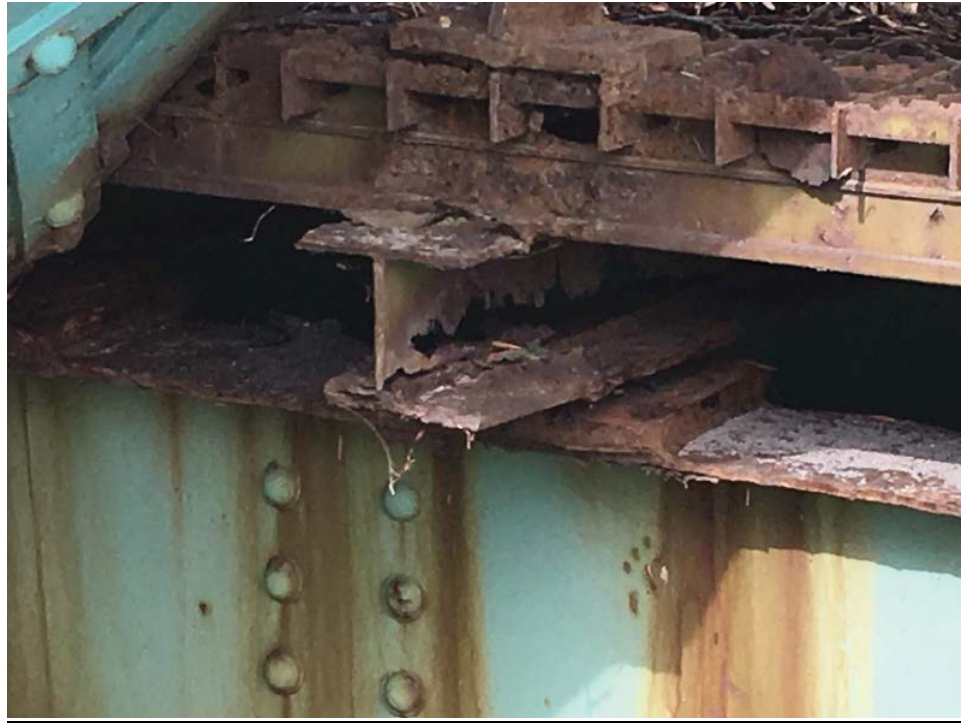
Photo #45: Severe corrosion to a cross beam (needle beam) near FB 1 in span 1 of non-sidewalk (eastern) truss (8/1/16)

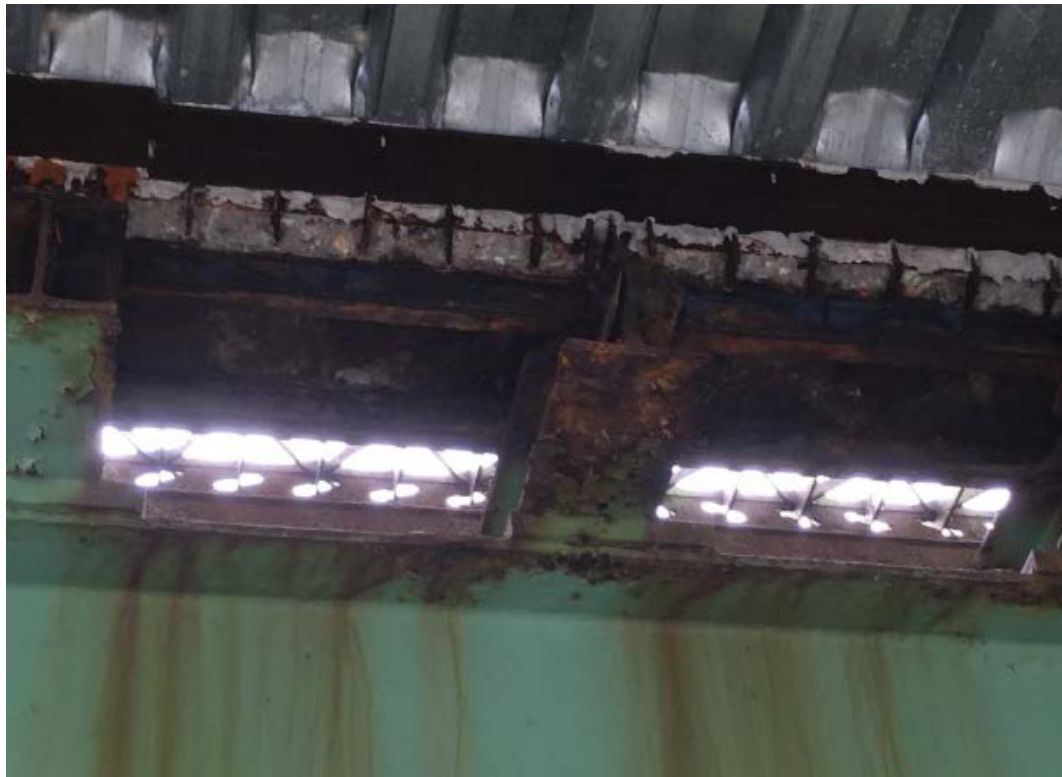
Photo #46: Severe corrosion to a cross beam (needle beam) on the sidewalk (western) truss (8/1/16)

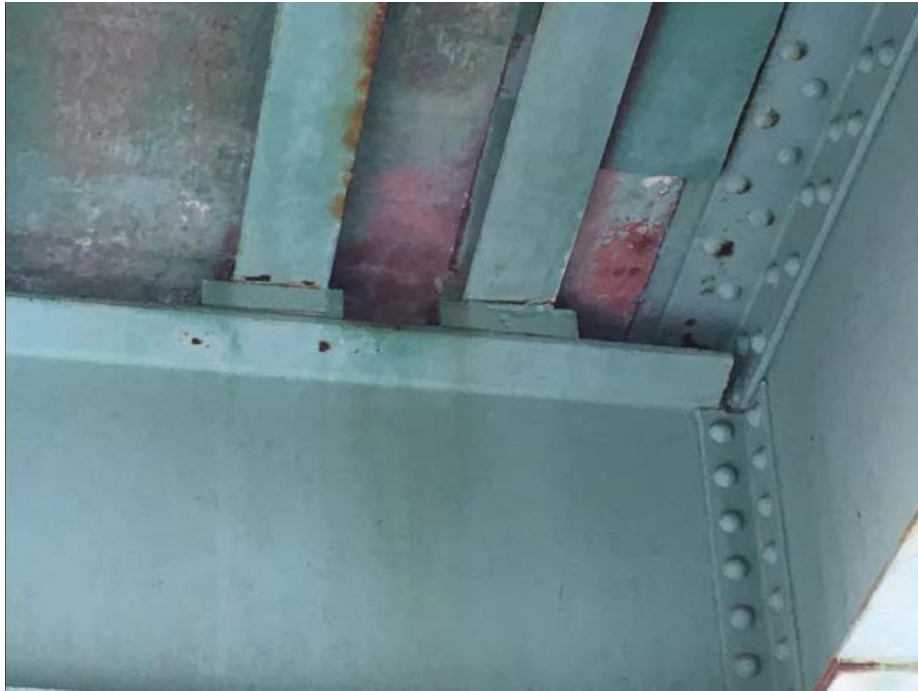
Photo #47: Failed weld between needle beam and an interior stringer in span 1 (8/1/16)

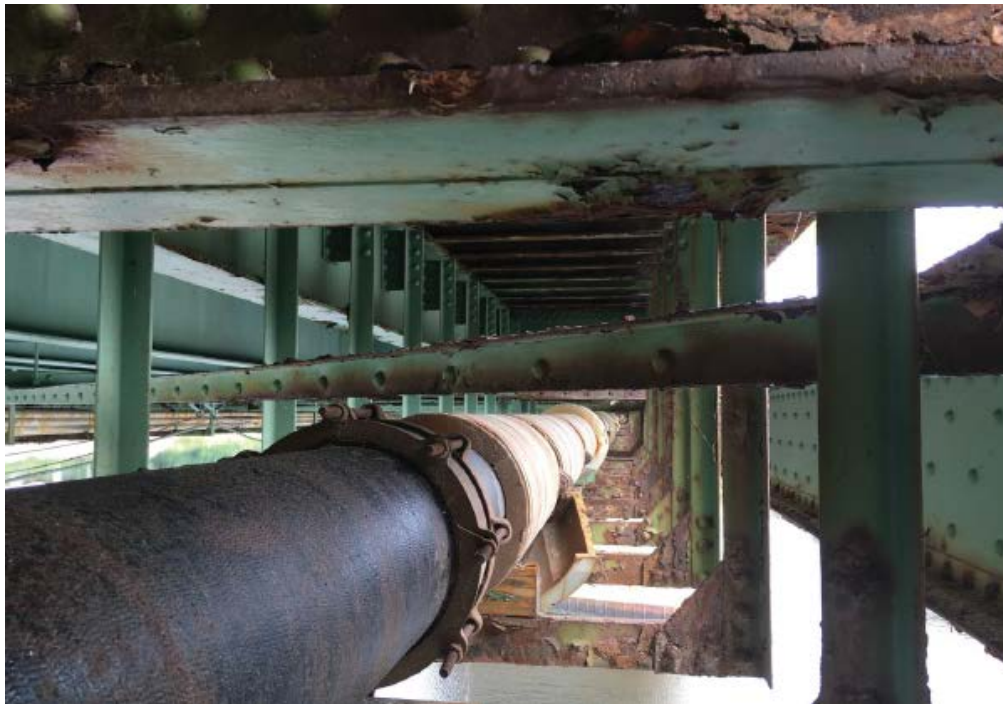
Photo #48: General view of lateral bracing spanning between utility supports in span 1 & 2 (8/1/16)

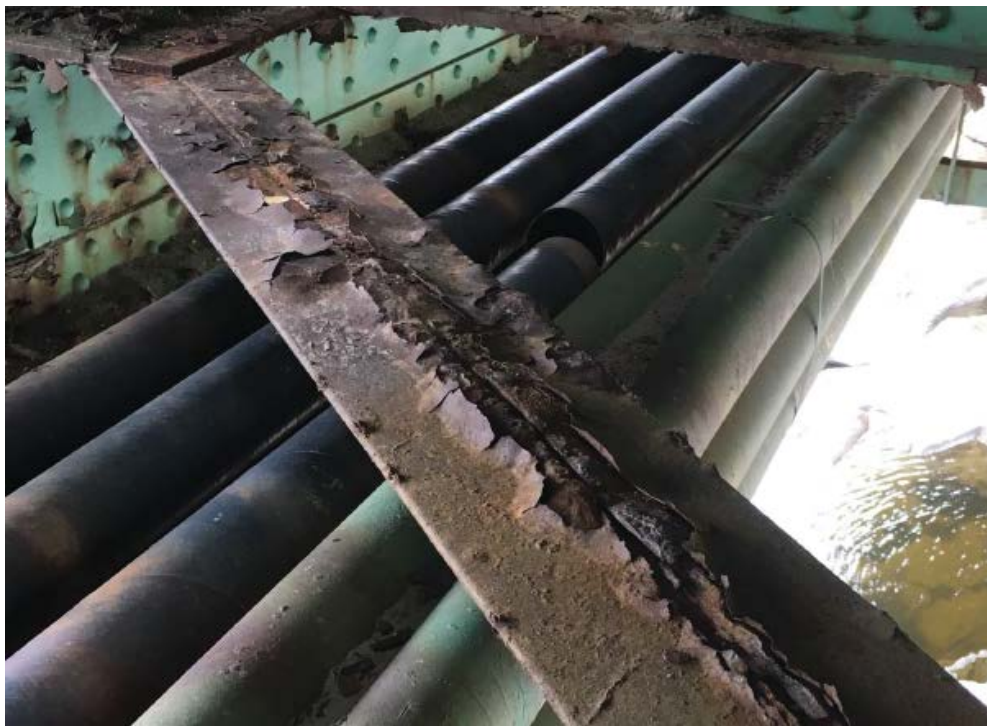
Photo #50: Severely corroded lateral bracing member view from top of double angle in spans 1 & 2 (8/1/12)

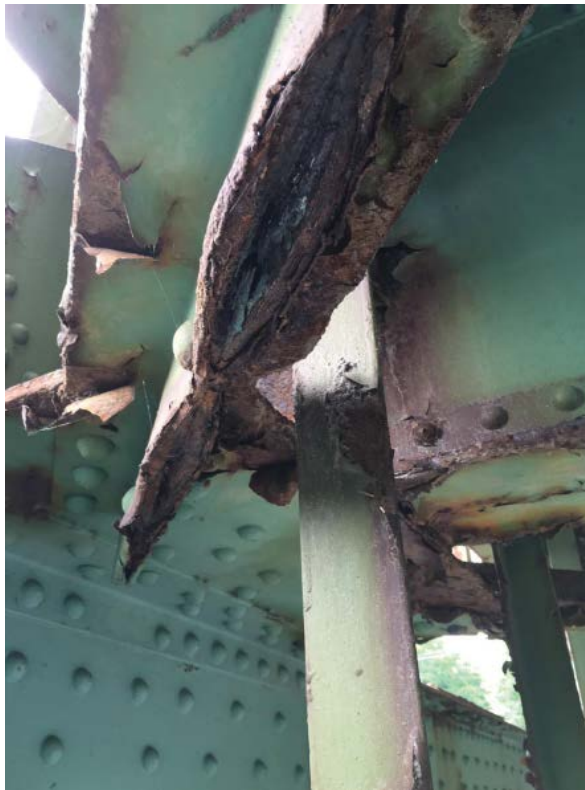
Photo #51: Severely corroded lateral bracing member, view from the bottom of the double angle connections in Spans 1 & 2 (8/1/12)

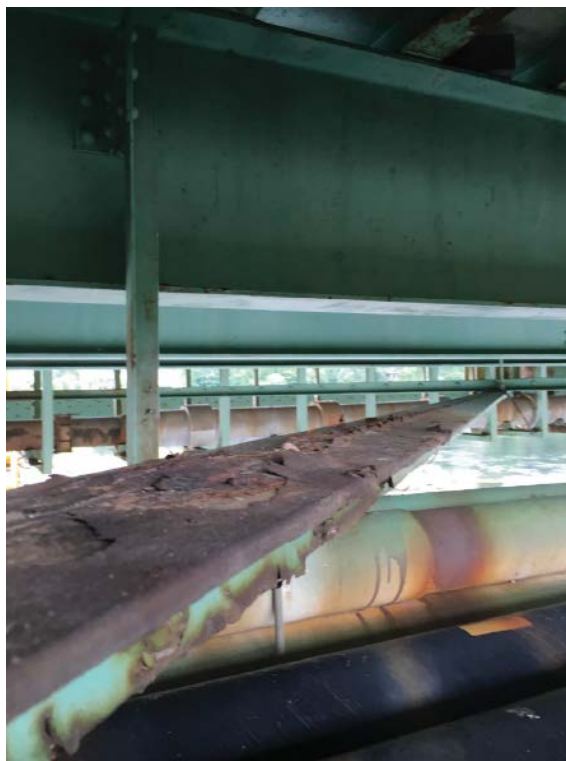
Photo #52: General top view of lateral bracing span (inverted) from non-sidewalk truss to sidewalk truss in spans 1 & 2 (8/2/16)

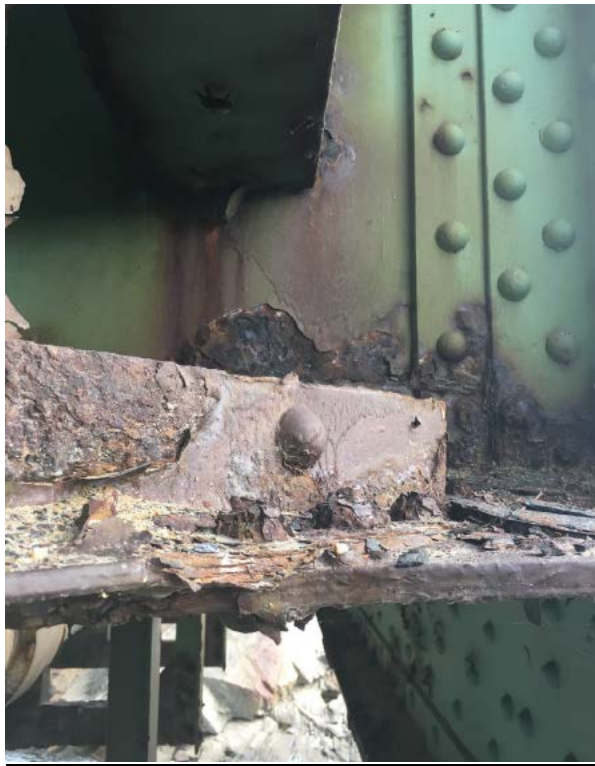
Photo #54: Corroded lateral bracing end at its connection to the horizontal plate at FB8 span 2 (8/2/16)

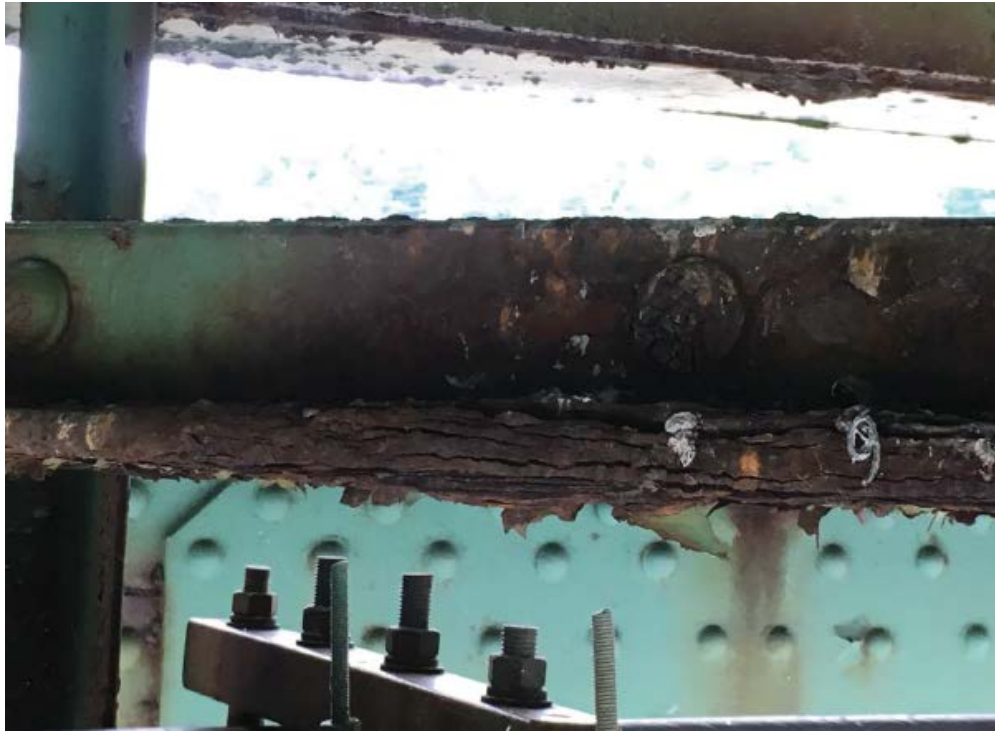
Photo #55: Pack rust and section loss to the lateral bracing near FB6 in span 1 (8/1/16)

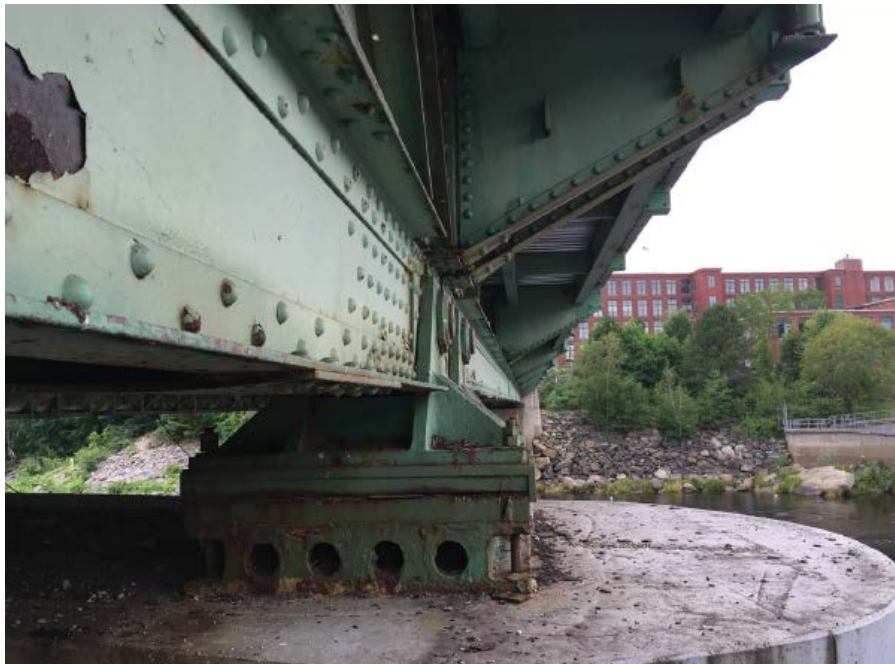
Photo #56: Typical view of the bearings at pier 1 (8/1/16)
