# Sandy River Restoration Project

FISHERY INTERIM SUMMARY REPORT SERIES NO. 09-01  
SANDY RIVER RESTORATION PROJECT

January 2009

JOB NO. F-027  
SANDY RIVER RESTORATION  
INTERIM SUMMARY REPORT (2006-2008)

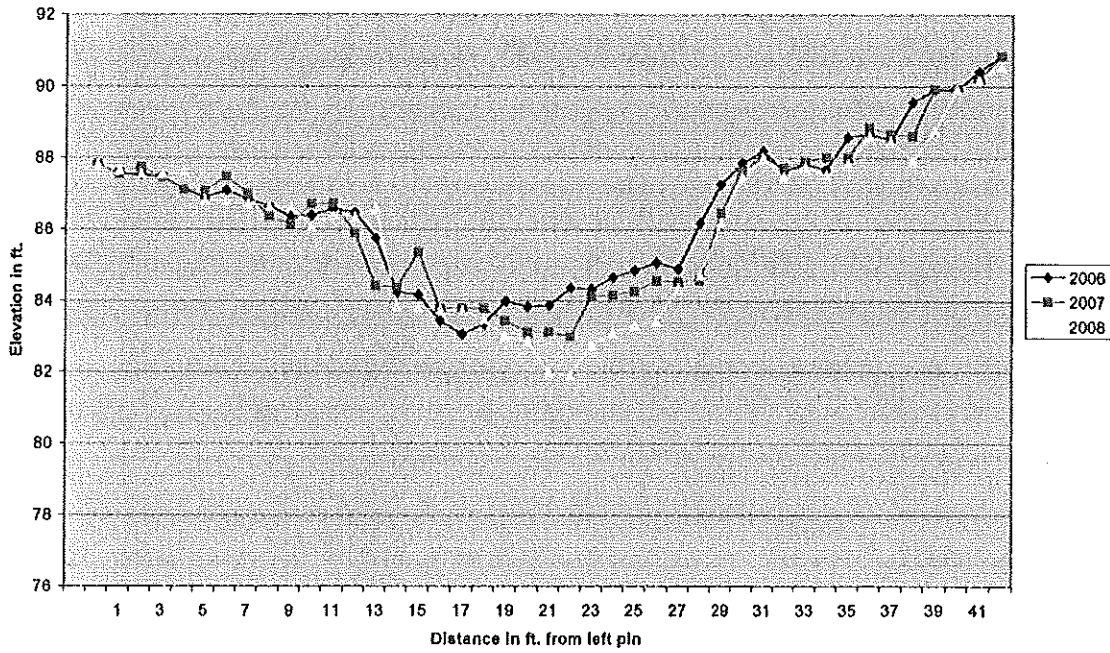
**Transect 4A, Station 502 (Pool)  
Rock Weir 3**

- Rock Weir No. 3 withstood high flows and needed no repair through the fall of 2008.
- Rock Weir No. 4 (furthest downstream) collapsed when its rocks were carried out of position by high flows in October 2006 and was rebuilt in October 2007 with larger boulders and remained stable through the fall of 2008.

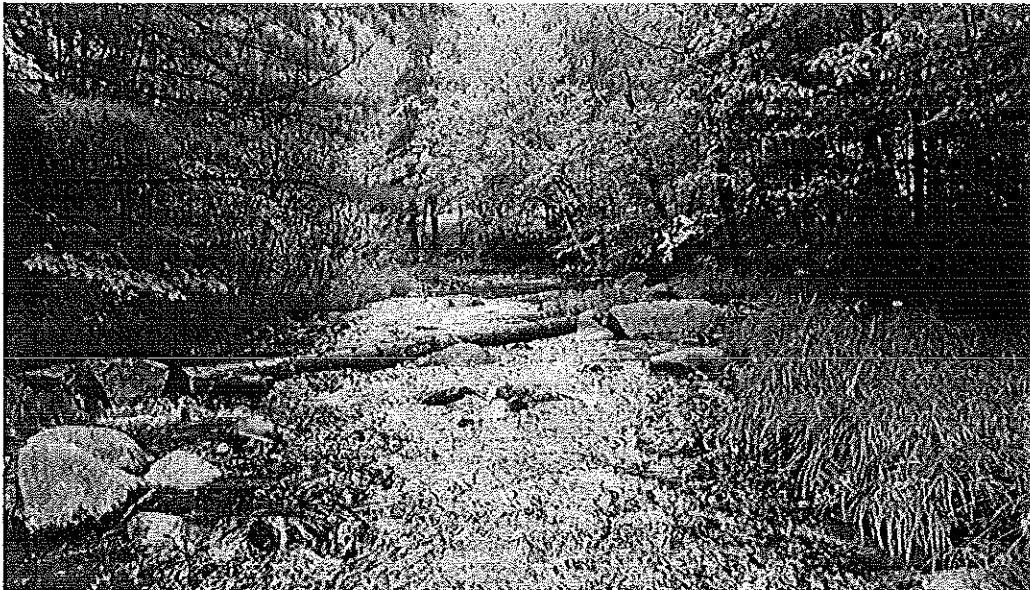
- Of the two logs cabled and weighted mid-channel in an effort to narrow the channel, the upper log attachment failed and the log was washed downstream next to the lower log, where both continued to trap sediment and woody material but are not diverting flow as intended. The situation could likely be remedied by the placement of additional logs secured by larger boulders.

Transect 2 (Station 159, Project Area) looking upstream, September 2006, showing uppermost of 2 cabled logs placed diagonally to divert flow, thereby narrowing channel.
