25 November 2019

Project Number: 3611191238

**Subject: Waterfront Access Site Evaluation, North Haven, Maine
Penobscot Bay Working Waterfront Resiliency Analysis
State of Maine, Department of Marine Resources**

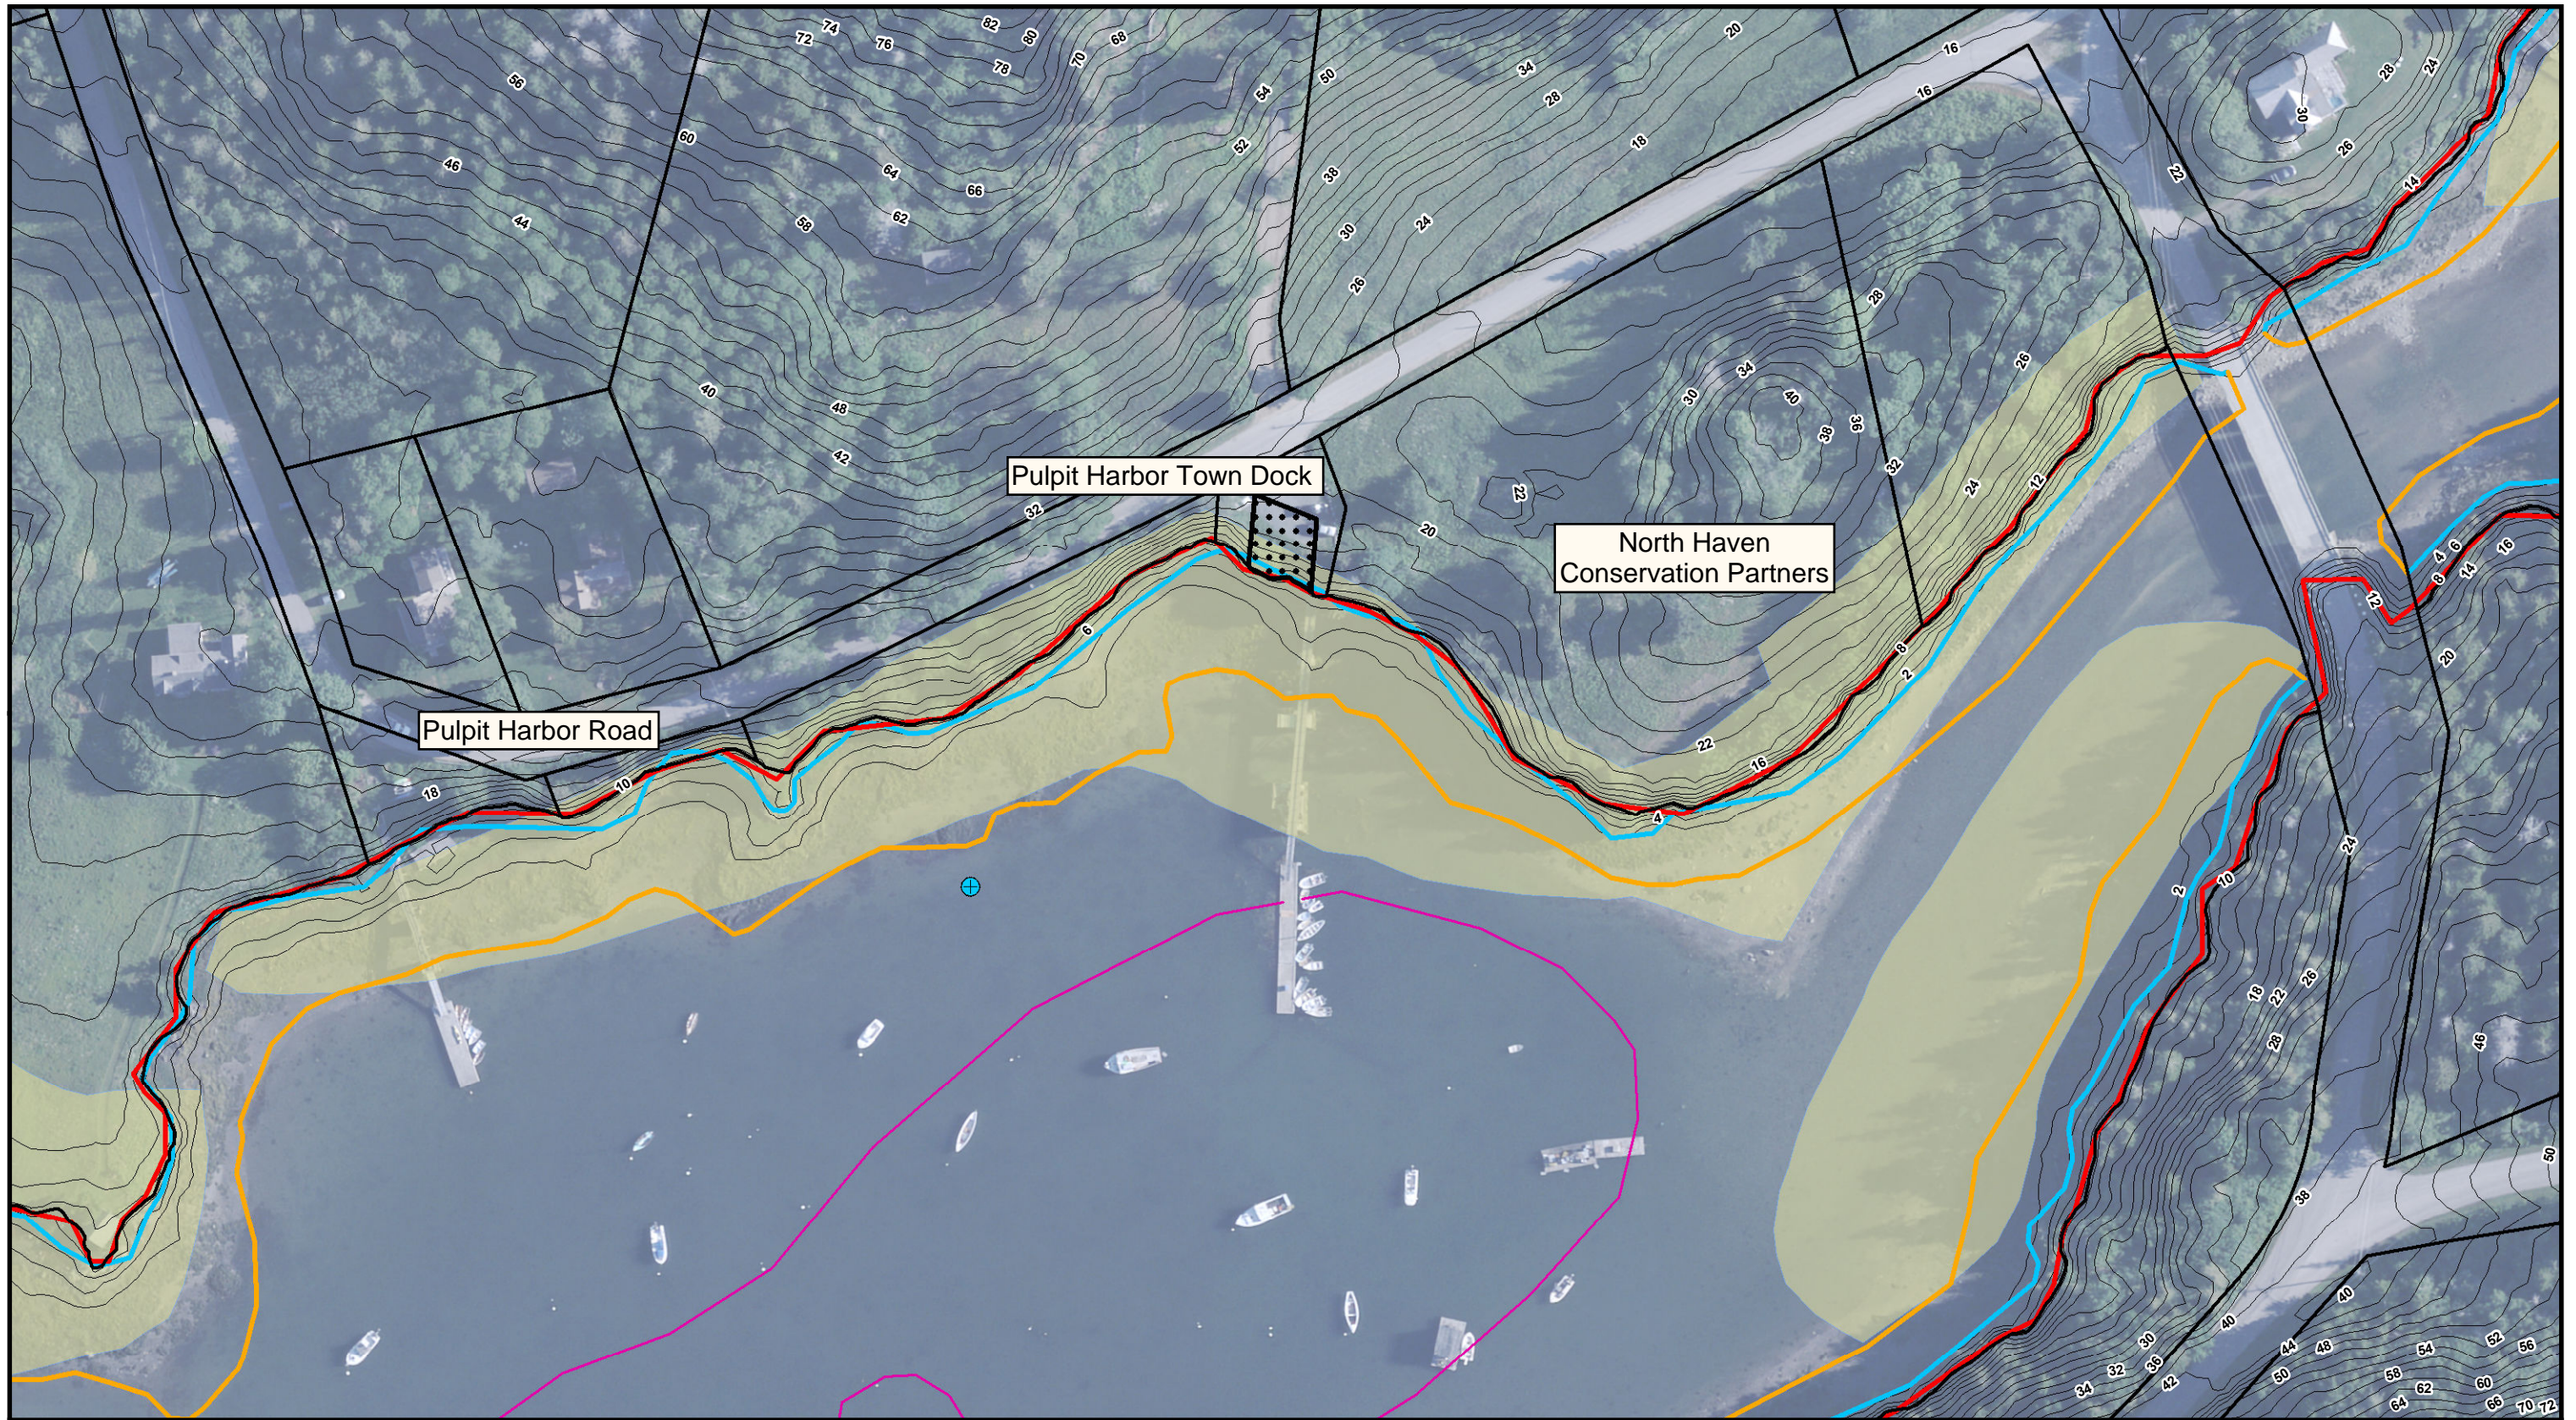
Figure 2
Pulpit Harbor Town Dock

The town currently operates a public dock at Pulpit Harbor with parking for about 7 vehicles, an approximately 150-ft long fixed pier, and two floating docks (**Figure 2**). The town owns less than 1 acre of land at the dock, and leases access to the dock from a non-profit conservation group, the North Haven Conservation Partners (NHCP). The NHCP owns about 3 acres of undeveloped land adjacent, and east of, the town dock. Review of data for this location, including plan details on **Figures 2 and 6**, indicates the following strengths and limitations.

- Existing facility which provides public access to harbor;
- Reasonably good line-of-site along Pulpit Harbor Road;
- Existing parking area, though limited spaces, above HAT elevation plus 1.6 ft SLR;
- Reasonable distance to all-tide access for most boats;
- Well-protected harbor with few navigational hazards;
- Low risk of storm impact;
- Existing boat moorings;
- No mapped wading bird habitat or eel grass beds proximate to the dock; and
- Relatively flat, accessible land owned by non-profit group to east with six additional parking spaces along road.

- Limited space for parking on town-owned land;
- Narrow stretch of harbor prone to congestion and limited number of moorings for future growth;
- Relatively steep shoreline posing challenges for boat ramp construction; and
- Nearby residential properties with potential for concerns regarding noise, traffic and changes in aesthetics.

Pulpit Harbor Town Dock: Improvements could enhance recreational boating and limited commercial use experienced at this location. Upgrades for consideration could include:

- Levelling and resurfacing the parking area to improve access and reduce erosion;
- Working with NHCP to identify potential adjacent land for expanded parking;
- Implementing stormwater runoff controls in association with improved landscaping for buffering noise and maintaining scenic quality;
- Coastal slope protection (e.g., riprap)
- Water and power service;
- Expanding the pier width and adding one or more finger docks for added tie up capacity; and
- A mooring layout plan that identifies the optimum number and location of moorings for safety and ease of access.

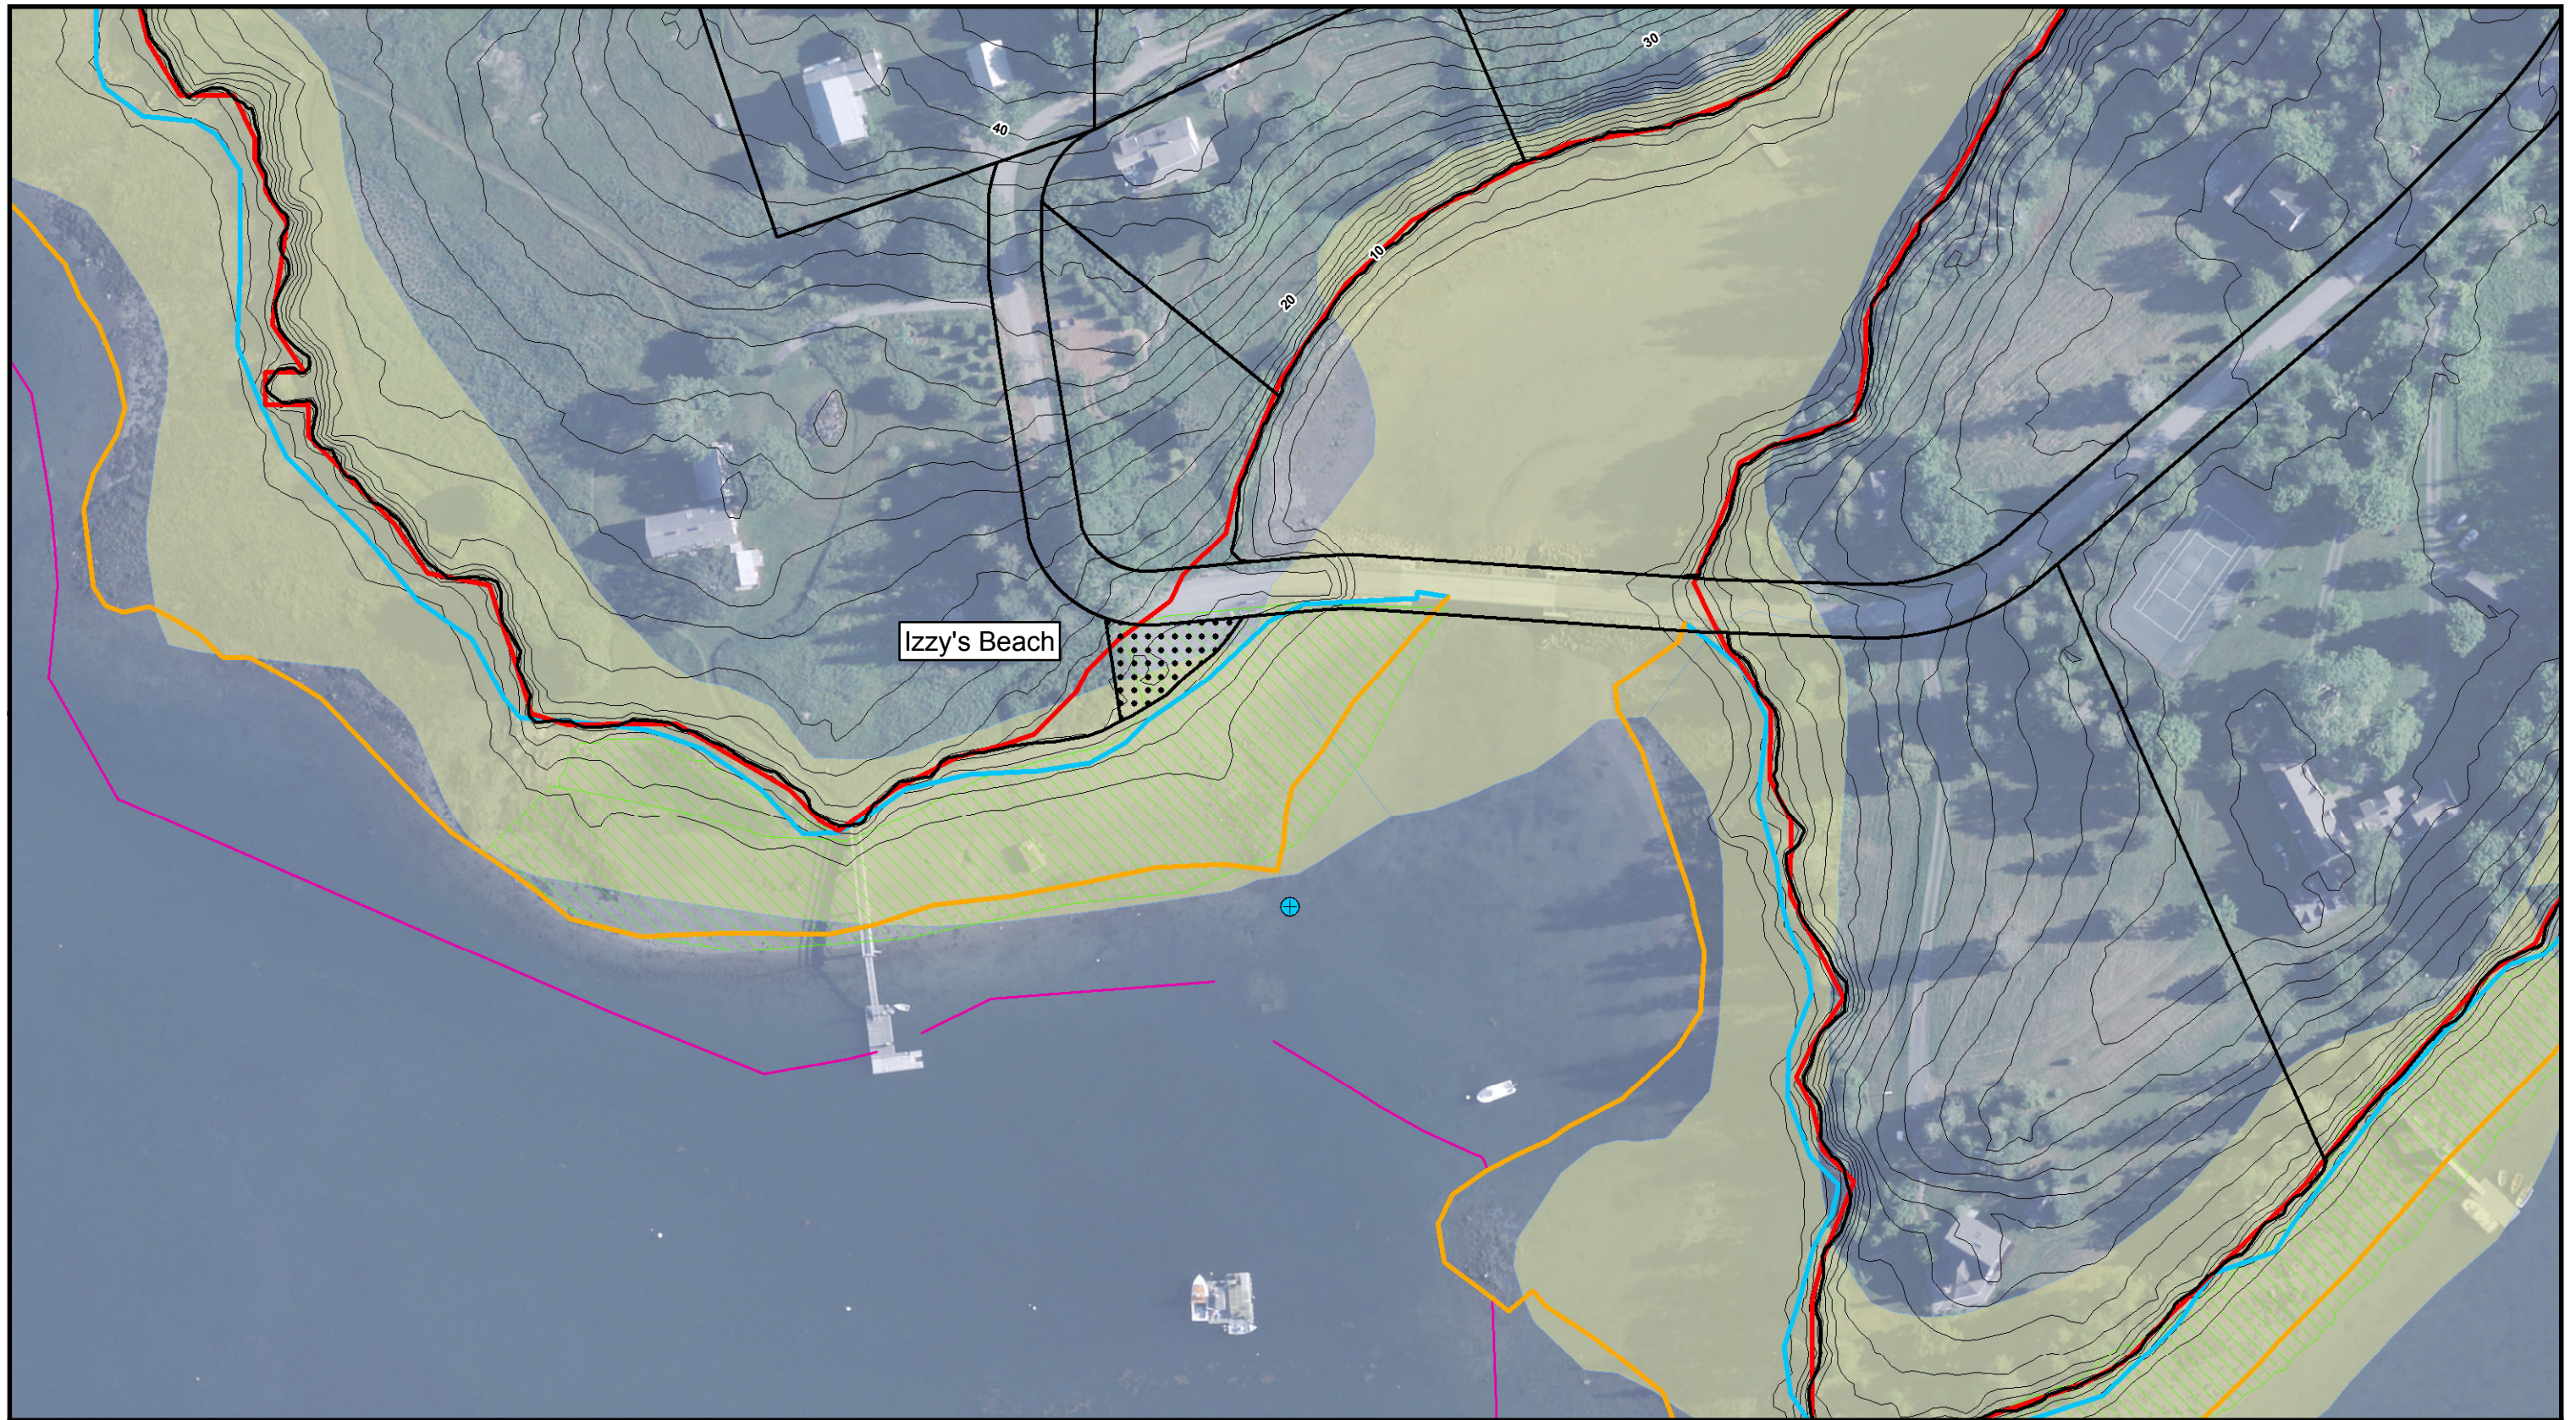
Figure 3
Izzy's Beach

Izzy's beach includes about 0.25 acres of town-owned land currently used for seasonal access by lobster fishermen for loading and unloading lobster traps (**Figure 3**). The site slopes gently to the shoreline,

allowing trailer access for launching, or hauling of trap and other gear to boats at or near high tide. The town has installed wooden bumpers along the south side of the adjacent bridge to help minimize the impact of boat contact with the bridge.

- Gently sloping beach head provides public access to harbor for launching or loading gear;
- Shoreline amenable to boat ramp construction;
- Reasonable distance to all-tide access for most boats (about 180 ft from high tide mark); and
- Well-protected harbor with few navigational hazards.

- Limited line-of-site along Pulpit Harbor Road;
- Very limited space for parking on town-owned land;
- Mapped wading bird habitat along shoreline;
- Elevation of Town-owned land below HAT plus 1.6 ft SLR (i.e., prone to flooding);
- Vulnerable to high-intensity storm damage; and
- Nearby residential properties with potential concern regarding noise, traffic and changes in aesthetics.

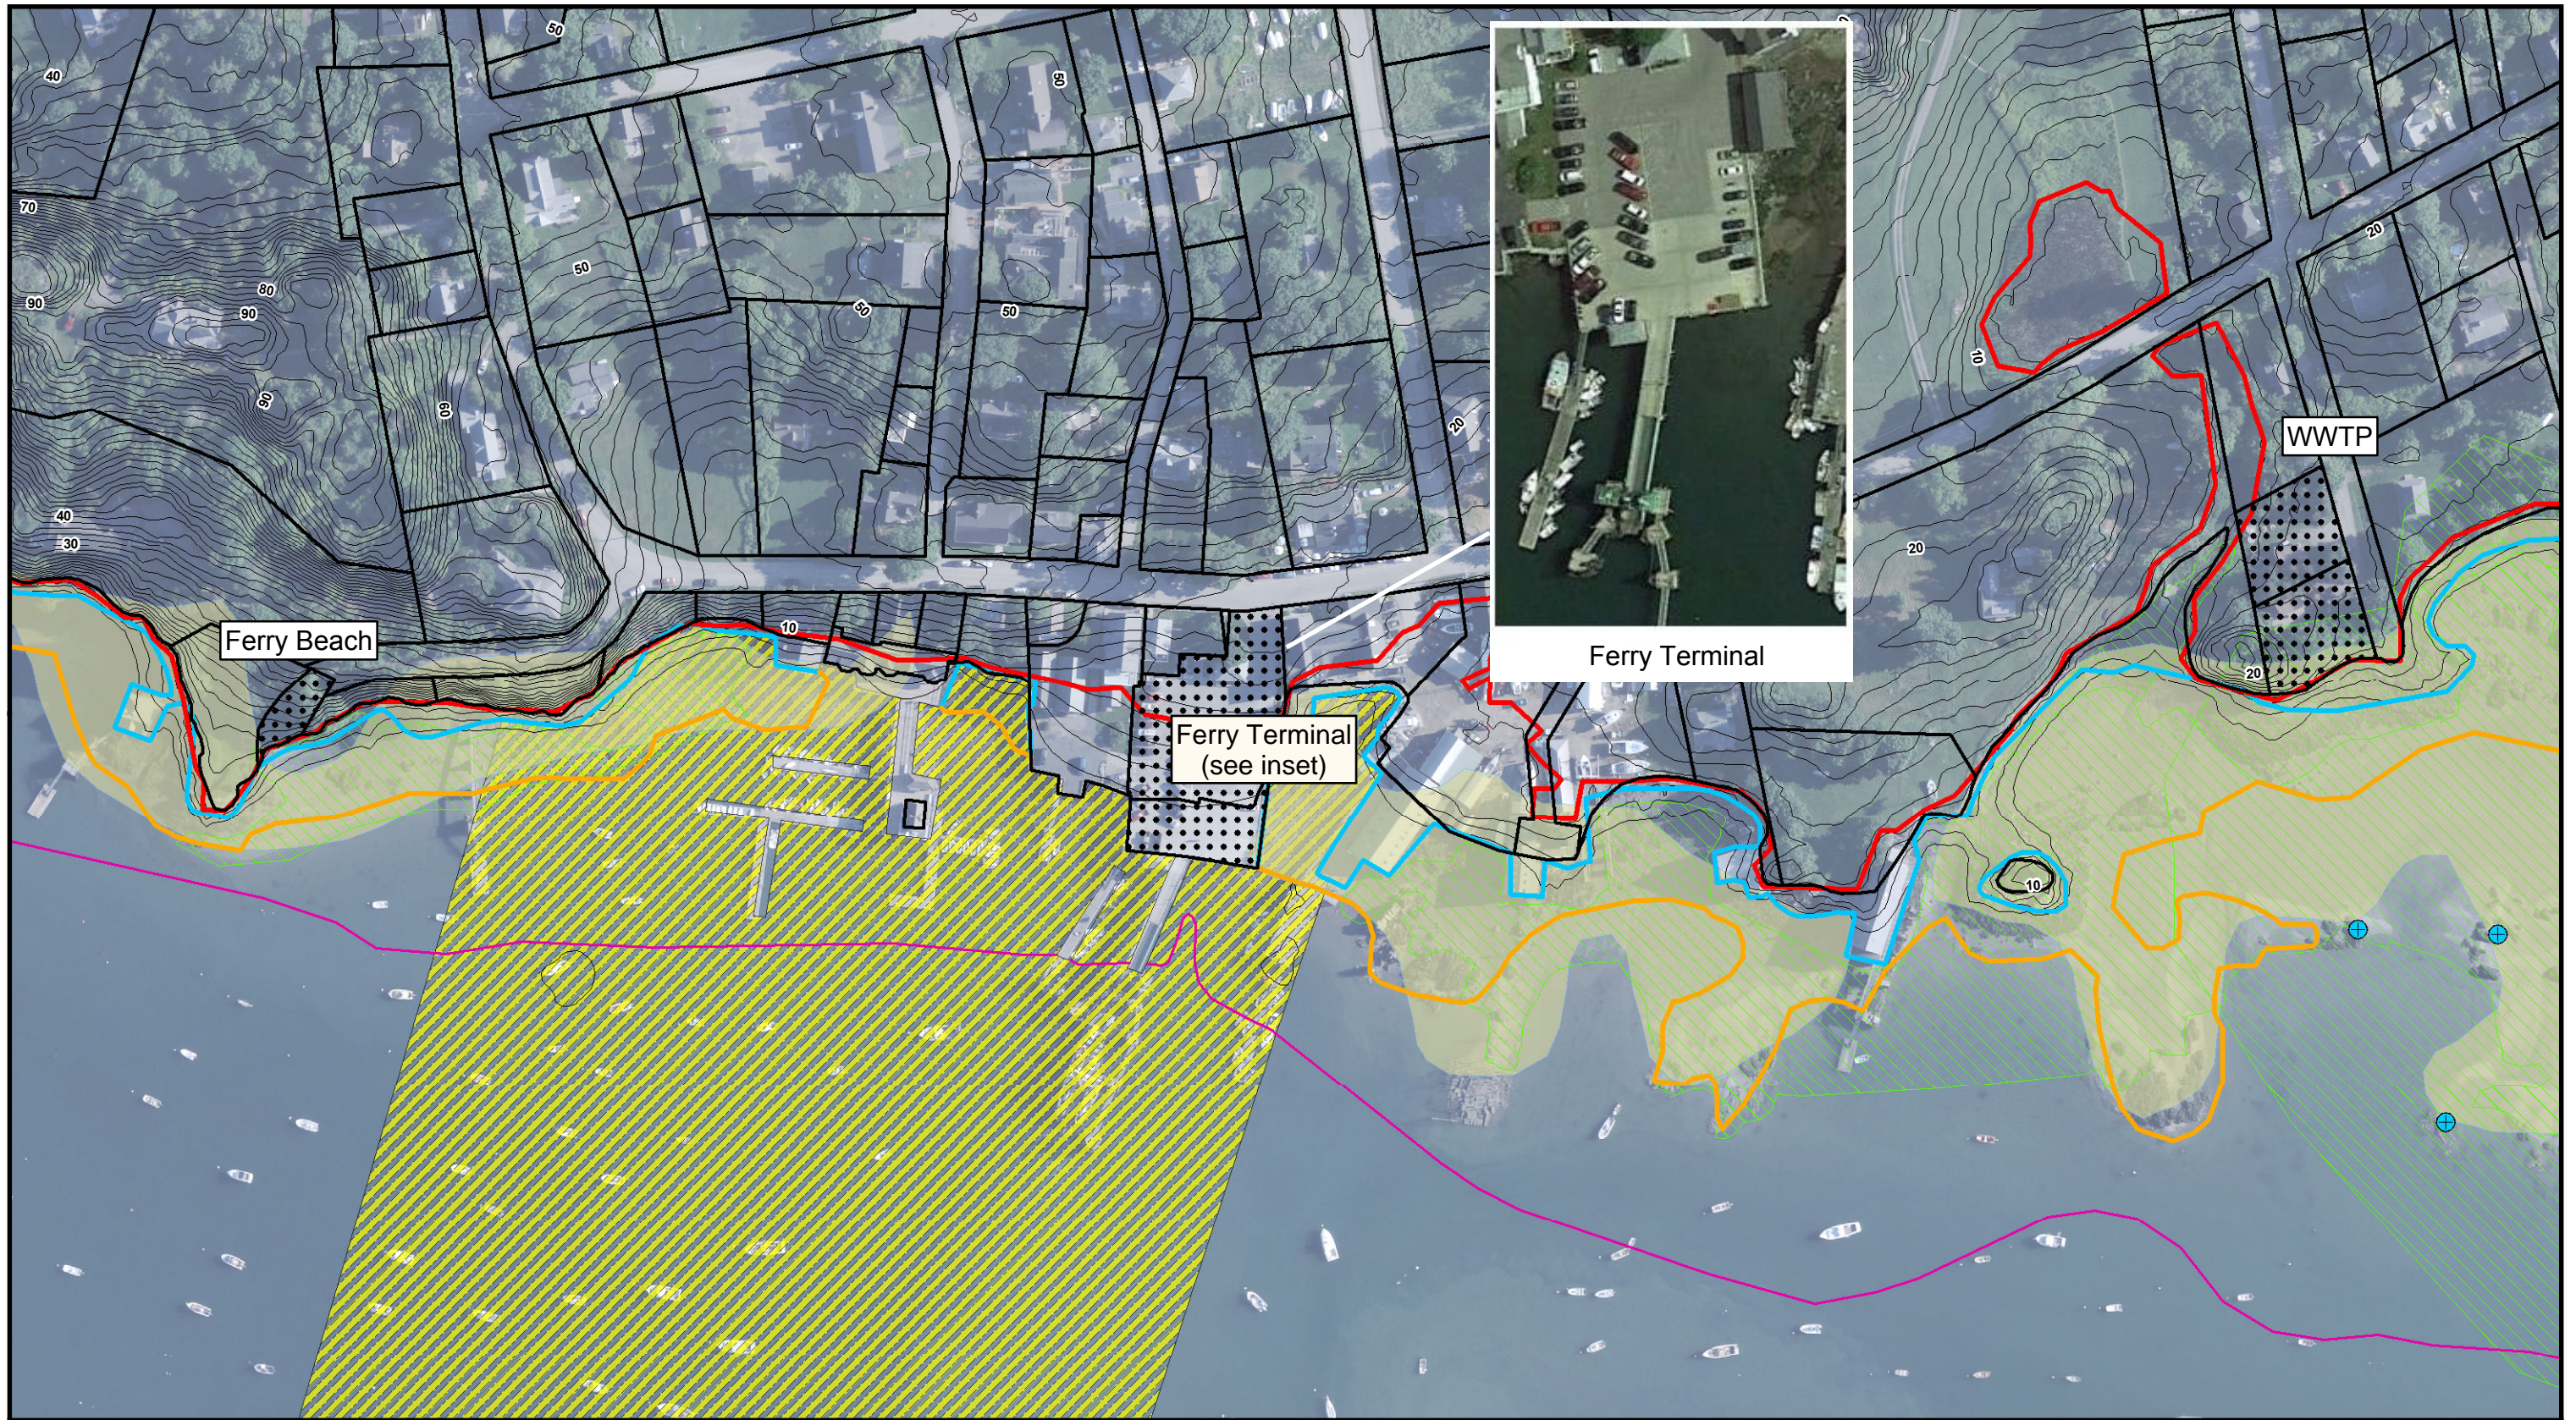
Figure 4
Ferry Beach to WWTP

The town waterfront option extends roughly from Ferry Beach to the west, to the WWTP to the east (**Figure 4**) and focuses on town-owned land. This area of shoreline includes town-owned waterfront at Ferry Beach (<0.25 acre), and at the WWTP (about 0.3 acres). The town leases land to the Maine State Ferry Service/Department of Transportation, and about 25 parking spaces are shared by the town and ferry service at the terminal area (about 0.5 acres).

The ferry terminal includes a concrete pier with shared use by the ferry service and town. The pier provides access at or near high tide for boats loading/unloading gear. The town operates a floating dock for boat tie-up on the southwest corner of the concrete ferry terminal pier. The WWTP includes a leased residence, subgrade wastewater treatment tanks, and about 100 ft of waterfront.

- Close to town center and amenities;
- Existing town dock with some parking at ferry terminal;
- Concrete deck at ferry terminal with access for gear loading/unloading;
- Reasonable distance to all-tide access for most boats in area of ferry terminal (about 200 ft from high tide mark); and
- Limited extent of coastal wetlands.

- Congested town center with limited parking;
- Predominance of privately-owned waterfront land;
- Busy harbor with substantial boat traffic;
- Substantial distance to all-tide access (about 500 ft) and navigational hazards in vicinity of WWTP;
- Town-owned land below HAT elevation plus 1.6ft SLR at ferry terminal (i.e., prone to flooding);
- Vulnerable to high-intensity storm damage; and
- Cable/utility crossing area between Ferry Beach and boatyard east of ferry terminal.

Town Pier and Dock: Improvements at the pier and town dock on the town waterfront could focus on commercial boating needs based on current heavy use by fishermen and proximity to commercial boatyards, fuel and supplies. Examples of improvements for consideration:

- Expanding the concrete deck for added parking and loading space;
- Water and power service to the pier and dock;
- Adding a power lift for loading/unloading gear; and

- Expanding length and number of floating docks.

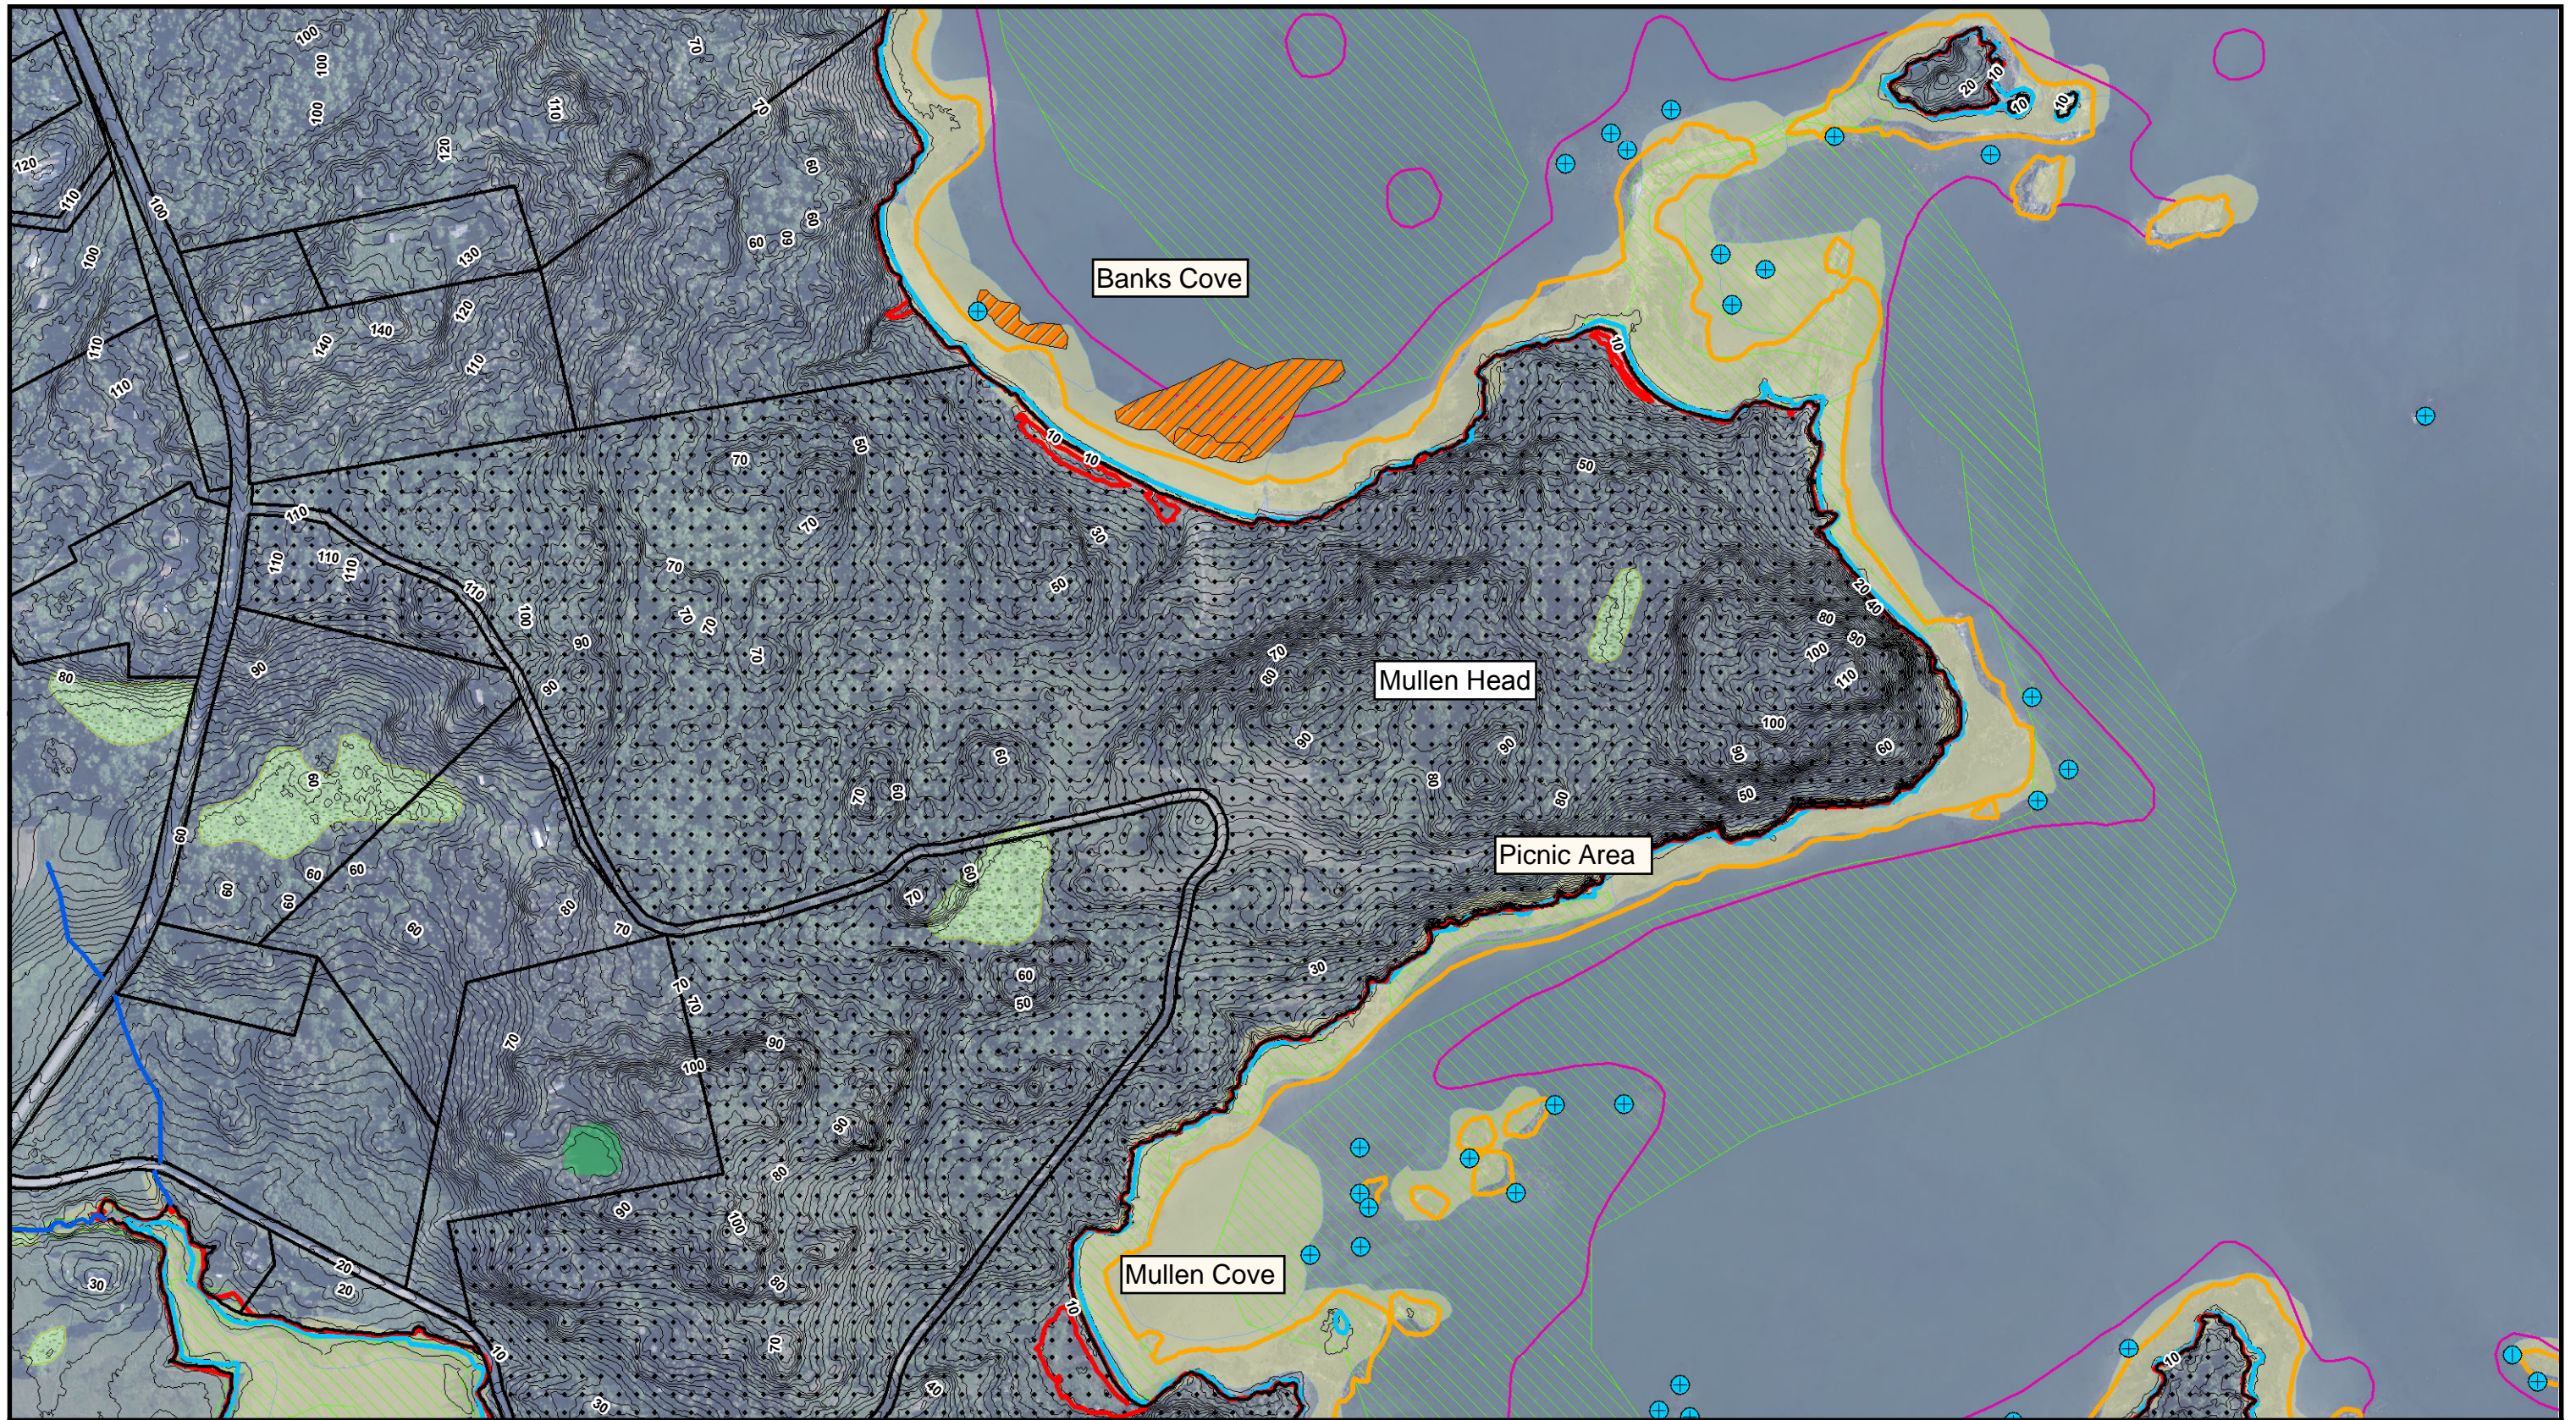
Figure 5
Mullen Head

The town owns an estimated 200 acres of largely undeveloped land at Mullen Head (**Figure 5**). The property is accessed by a gravel road and includes a dedicated camping area (for use by area residents and guests), picnic tables and barbeque grills, outhouses, and a storage barn for maintenance equipment. The drive from the town center to the shore at Mullen Head is about 4 miles.

- Substantial available town-owned land for access and parking;
- Gently sloping shoreline at Banks Cove (Big Beach), picnic area on southeast side of Mullen Head, and other waterfront locations;
- HAT plus 1.6 ft SLR line close to MHHW mark (i.e., low risk of tide-induced inland flooding); and
- Moderate distance to all-tide access for most boats (e.g., about 250 ft from high tide mark at Big Beach and picnic area).

- Approximate 4-mile drive to town center;
- Access currently provided over narrow winding and undulating gravel roads;
- Northeast exposure with high risk of impact from storms (e.g., northeasters);
- Mapped wading bird habitat along shoreline east of ferry terminal and in vicinity of ferry beach;
- Mapped eel grass beds in Banks Cove (although eel grass not readily apparent during site visit on September 25, 2019); and
- Navigational hazards in Banks Cove.

Mullen Head: Improvements at Mullen Head could focus on recreational and limited commercial use to help preserve the scenic qualities of this area. Improvements could include:

- A public boat ramp at a suitable location, such as at the picnic area where existing roads and relatively flat access area could accommodate parking and launching;
- Landscaping and associated erosion control and storm water runoff minimization;
- Modest widening and levelling of roads; and
- Water and power service.

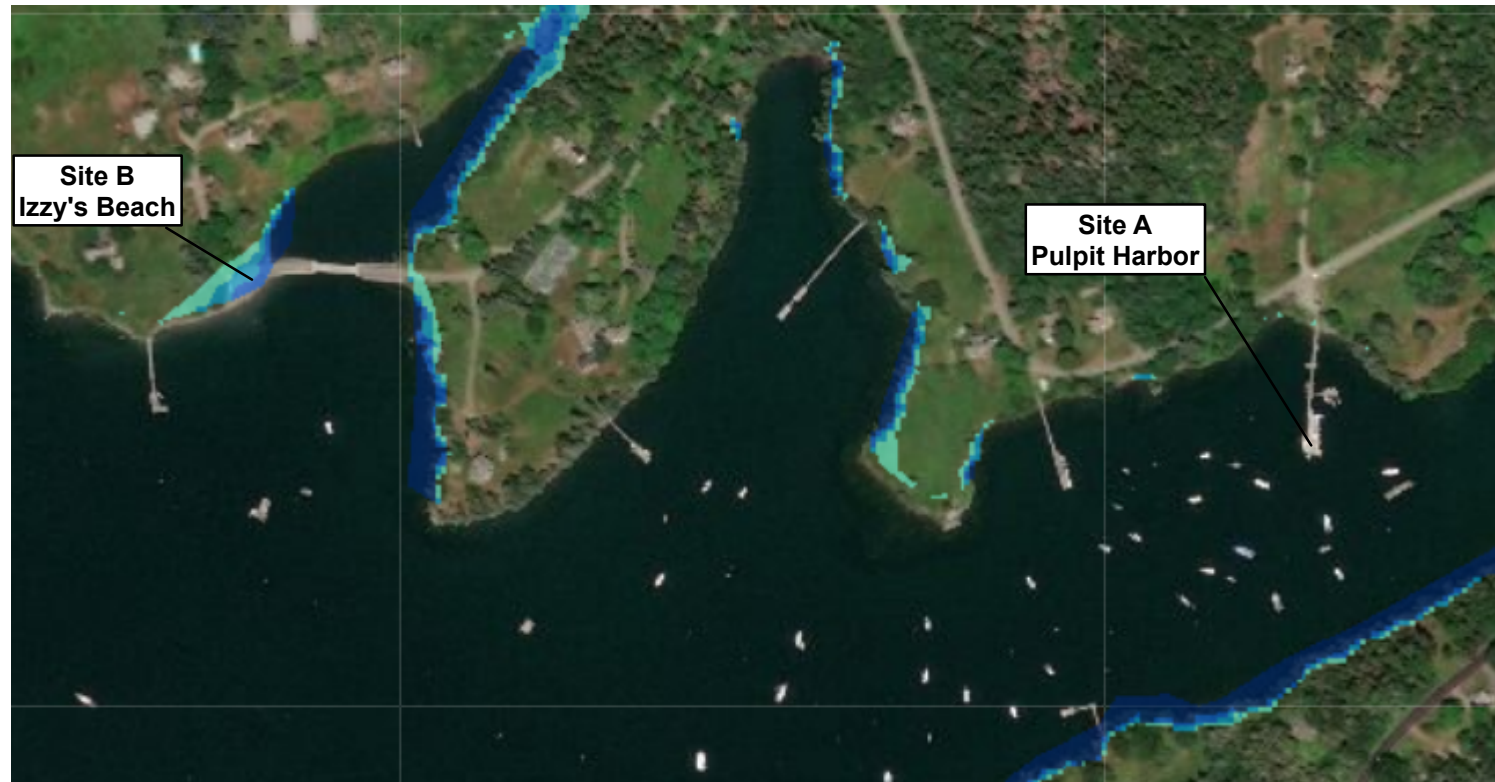
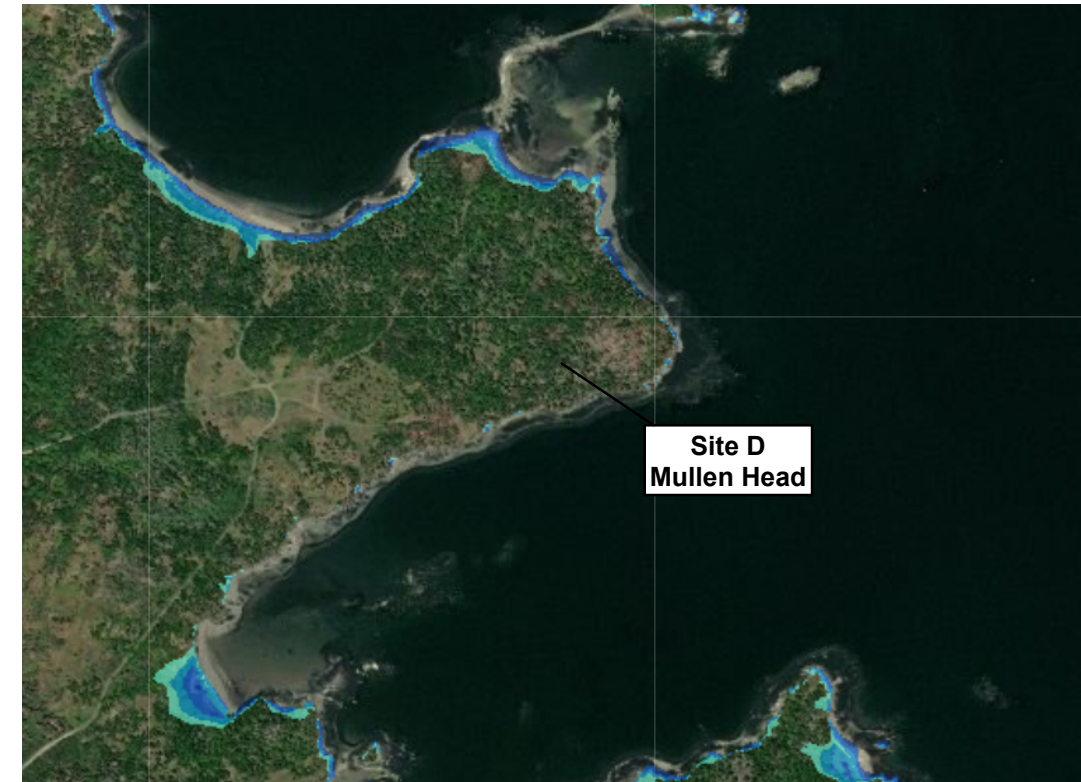
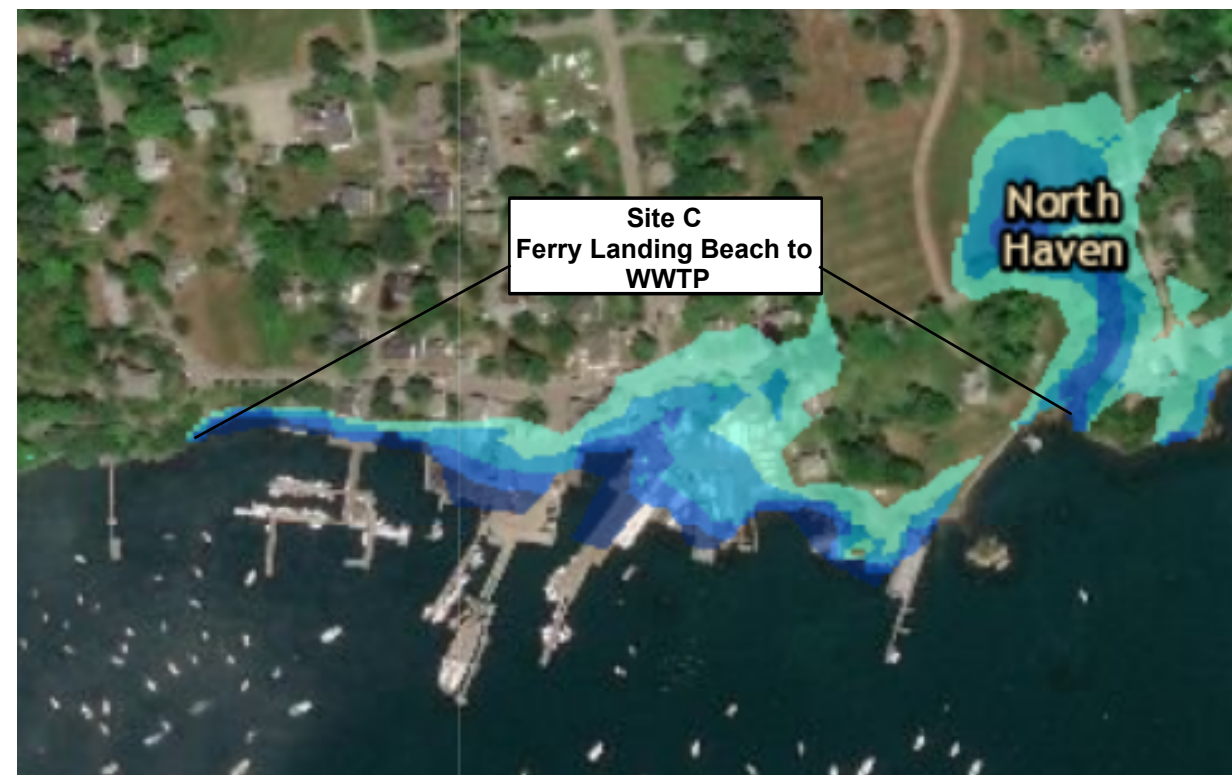
Figure 6
 Storm Surge Hazard - Category 2 Hurricane

Figure 6 shows potential storm surge hazards for a hypothetical category 2 hurricane as mapped by the Maine Geological Survey using the National Oceanic and Atmospheric Administration (NOAA) Sea, Lake, and Overland Surges from Hurricanes (SLOSH) model (<https://www.maine.gov/dacf/mgs/hazards/slosh/faq.htm>). Hurricanes striking Maine are rare, and evaluation of a category 2 event provides a reasonably conservative basis to assess vulnerability of each site location.

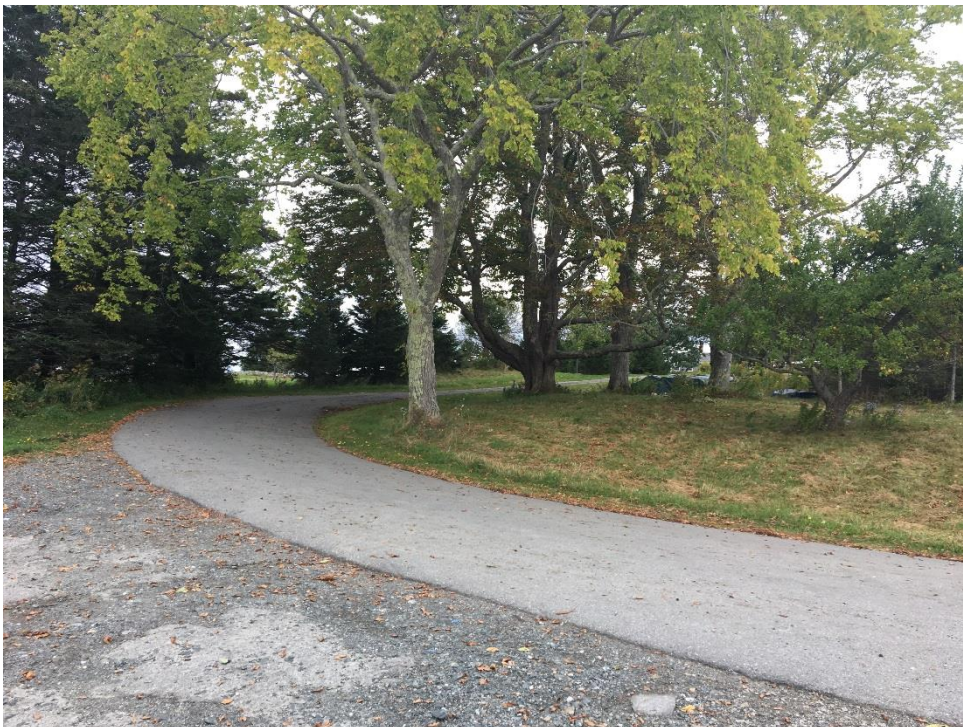
PHOTO 8:

Sharp turn in road leading from Izzy's Beach to residence to the west.

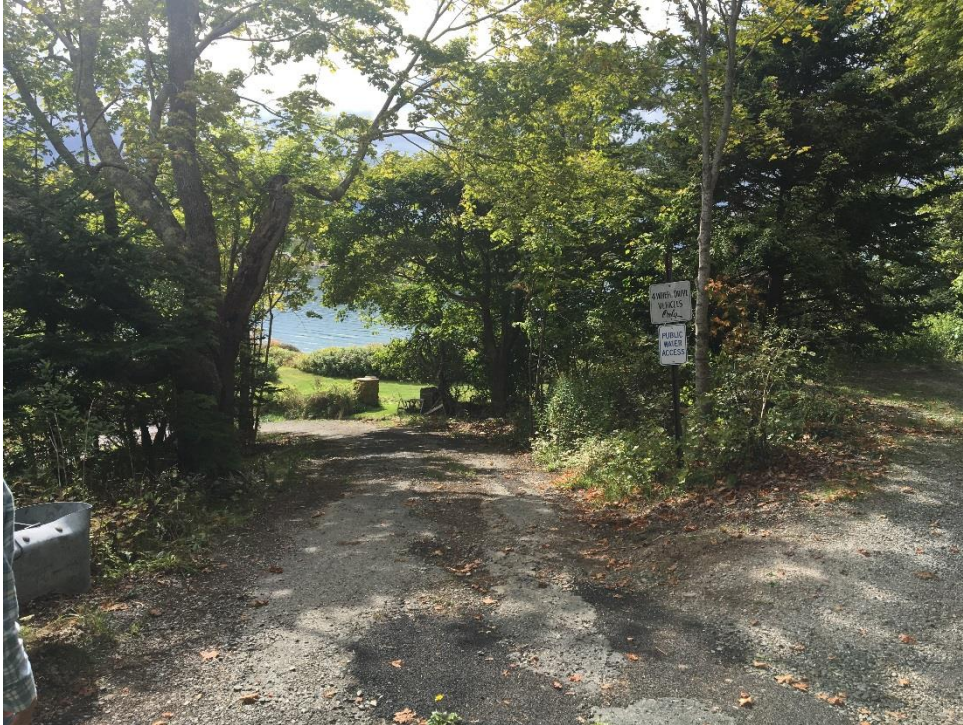
PHOTO 9:
Narrow winding road leading to Ferry Beach, view to southwest.

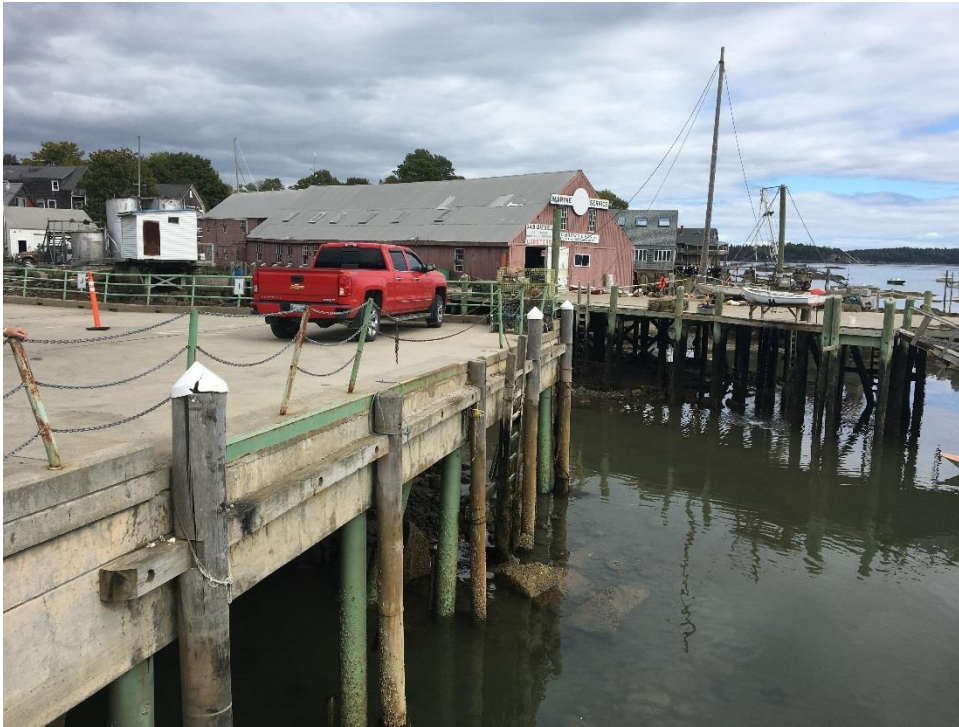
PHOTO 13:

Concrete pier deck at ferry terminal, provides access for loading/unloading gear at or near high tide; commercial wharf in background of photo to east.

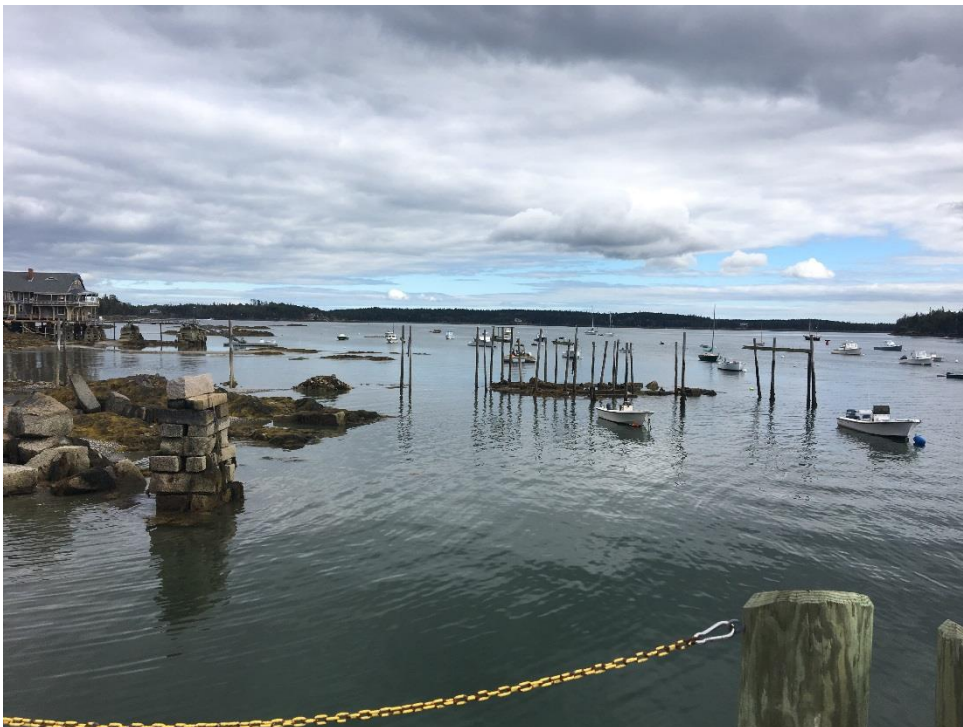
PHOTO 18:

Near shore of harbor east-southeast of ferry terminal; stone and wood pilings are remnants of former coal wharf.
