25 November 2019

Project Number: 3611191238

**Subject: Waterfront Access Site Evaluation, North Haven, Maine
Penobscot Bay Working Waterfront Resiliency Analysis
State of Maine, Department of Marine Resources**

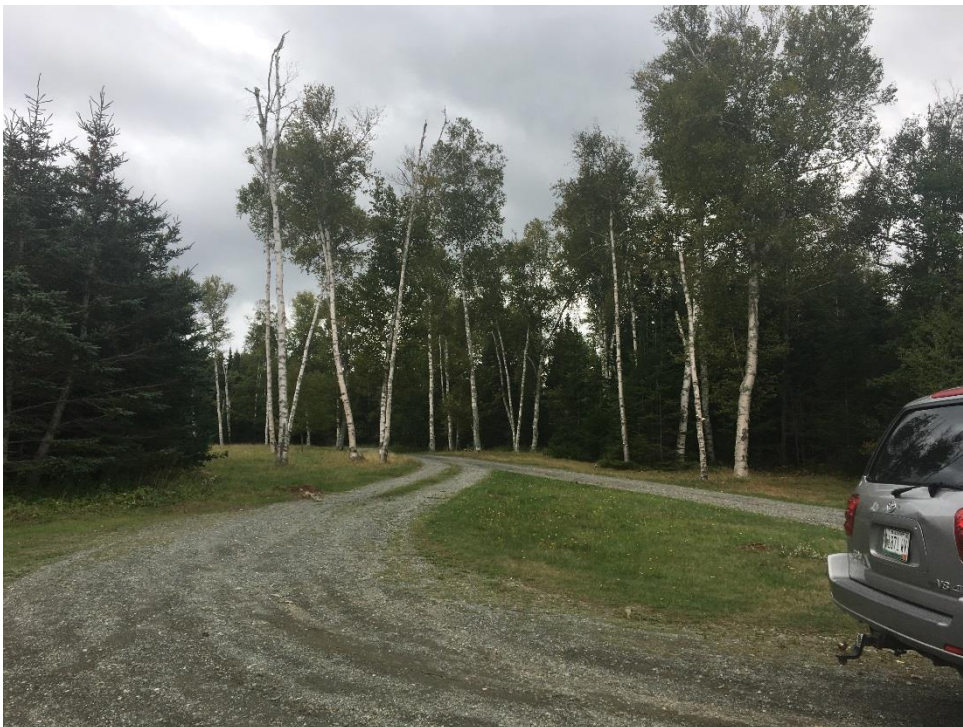
PHOTO 22:

Gravel access road leading to Big Beach at Mullen Head.
