APPENDIX D

WATERBODY PHOTO DOCUMENTATION

Company: Patriot Renewables, LLC
Project: Canton Mountain Wind Project – 2010 Resource Surveys

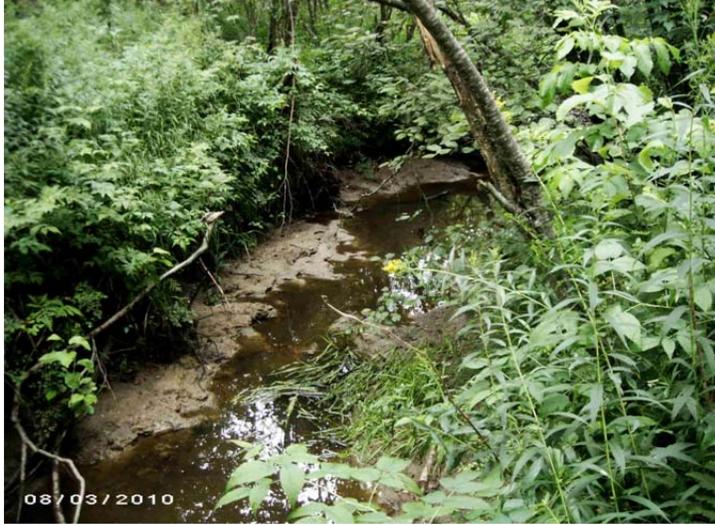
Photo No.: 1
Plan ID: AS6
Waterbody: CASBK13
Date: August 3, 2010
Photographer: Rodney Kelshaw

Comments: A southerly flowing perennial stream that has an average width of 6 feet and an average bank width of 10 feet.

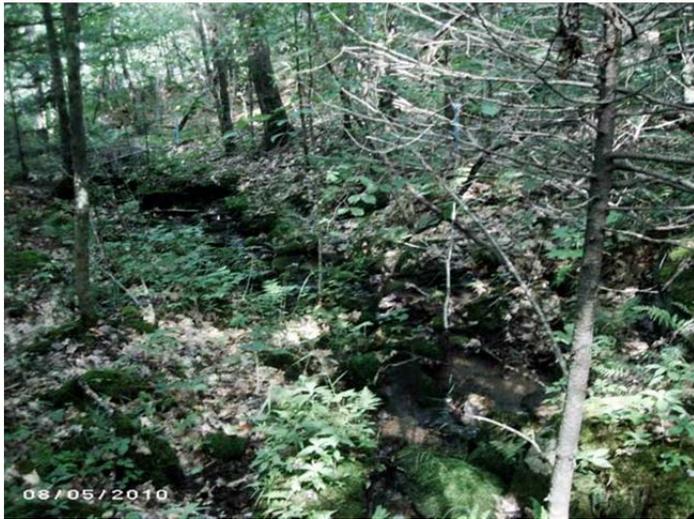
Photo No.: 2
Plan ID: AS9
Waterbody: CASBK22
Date: August 5, 2010
Photographer: Rodney Kelshaw

Comments: Intermittent stream that has an average width of 1.5 feet and an average bank width of 3 feet. Stream flows through wetland CAWBK12 in a westerly direction. Photo is looking west.

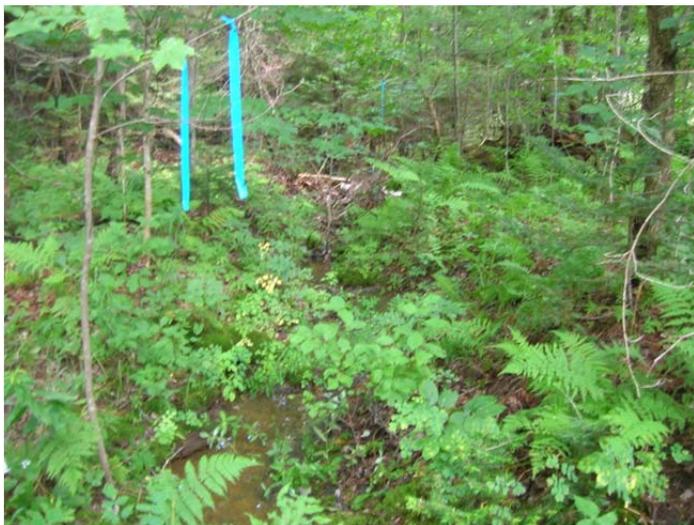
Photo No.: 3
Plan ID: AS13
Waterbody: CASBK18
Date: August 5, 2010
Photographer: Rodney Kelshaw

Comments: Intermittent stream with average stream width of 2 feet and an average bank width of 4 feet. Photo is looking downstream.

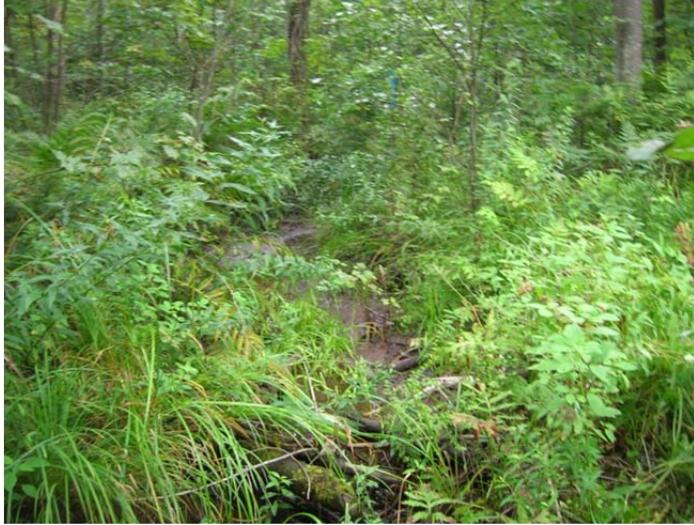
Photo No.: 4
Plan ID: AS17
Waterbody: CASBK23
Date: August 5, 2010
Photographer: Rodney Kelshaw

Comments: Perennial stream flowing southwest. Average width is 4 to 5 feet with an average bandwidth of 6 to 8 feet. Bank substrate is silt/clay with organic material. Photo is looking east.

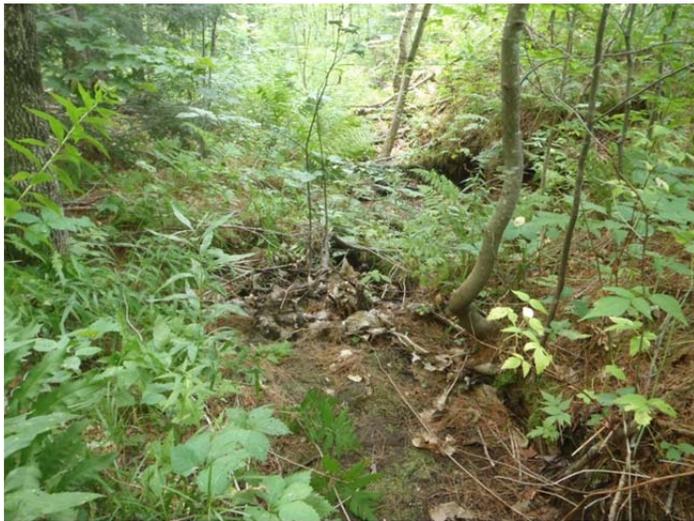
Photo No.: 5
Plan ID: AS19
Waterbody: CASBJ4
Date: August 6, 2010
Photographer: Richard Jordan

Comments: Intermittent stream is associated with wetland CAWBK28. There is evidence of upstream erosion. The stream crosses under two access roads and flows in a southerly direction. Photo depicts where the stream becomes steep.

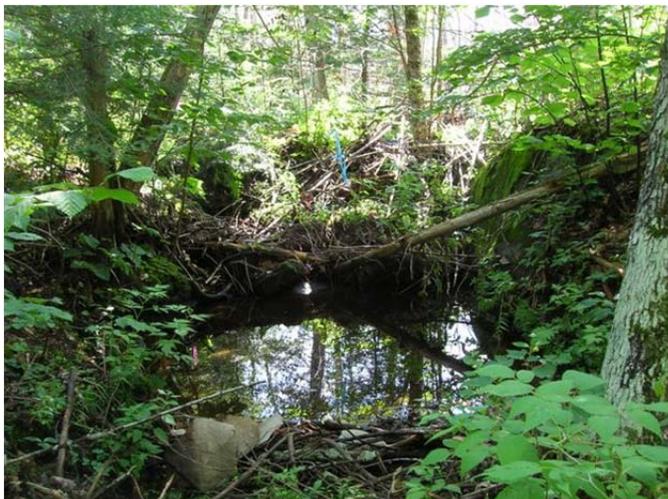
Photo No.: 6
Plan ID: AS28
Waterbody: CASBW5
Date: August 9, 2010
Photographer: Heather Storlazzi Ward

Comments: Easterly flowing perennial stream that has an average width of 4 feet. Photo taken looking west.

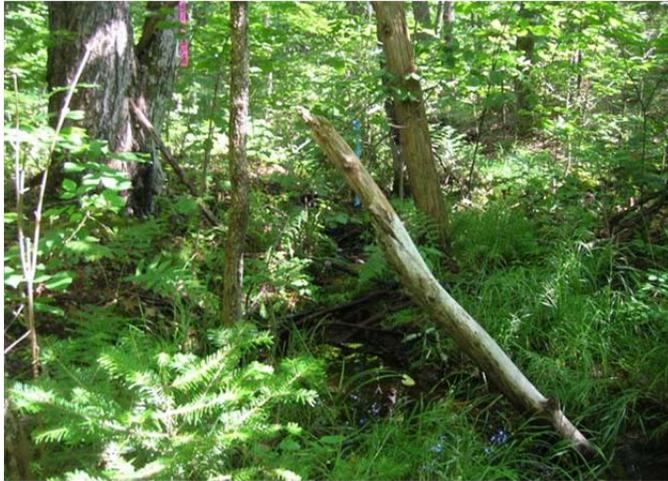
Photo No.: 7
Plan ID: AS28
Waterbody: CASBW5
Date: August 9, 2010
Photographer: Heather Storlazzi Ward

Comments: Easterly flowing perennial stream that has an average width of 4 feet. Photo taken looking east.

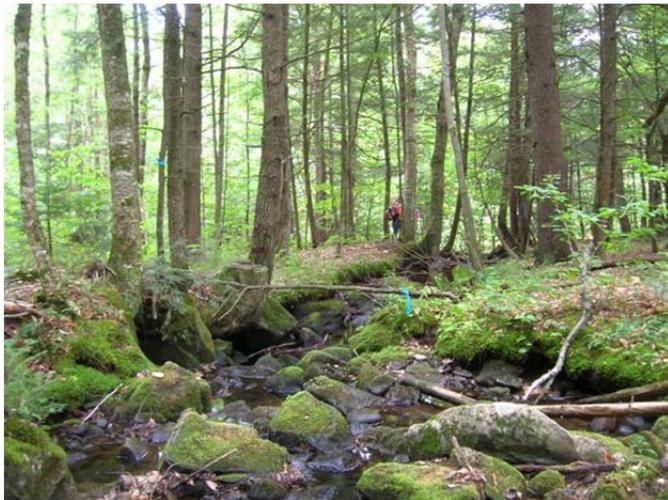
Photo No.: 8
Plan ID: AS29
Waterbody: CASBW6
Date: August 9, 2010
Photographer: Heather Storlazzi Ward

Comments: Westerly flowing perennial stream with an average stream width of 30 feet and an average bank width of 50 feet. Photo was taken looking south.

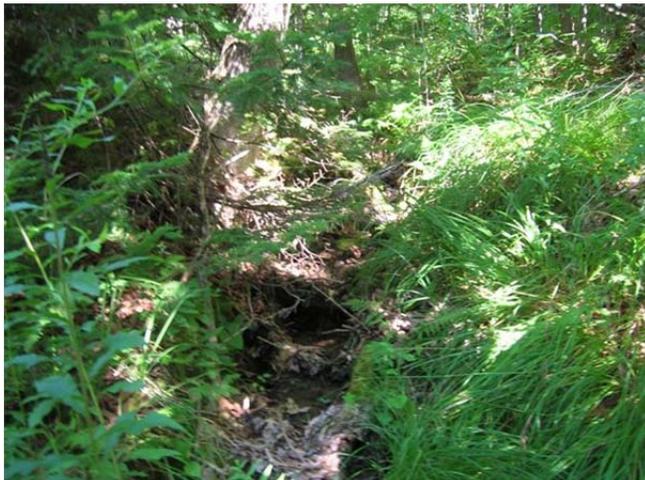
Photo No.: 9
Plan ID: AS31
Waterbody: CASBB3
Date: August 10, 2010
Photographer: David Brenneman

Comments: Intermittent stream with small pools of water but was not flowing during the 8/10/2010 visit. Stream appears to go underground and diffuses out into the associated wetland CAWBB1. Photo looking upstream to the north.

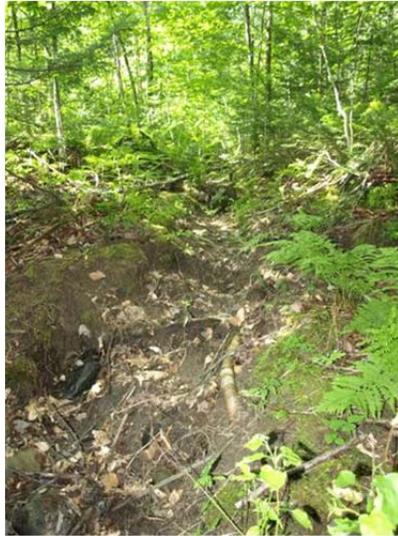
Photo No.: 10
Plan ID: AS35
Waterbody: CASBW7
Date: August 9, 2010
Photographer: Heather Storlazzi Ward
Comments: Southerly flowing intermittent stream with a bank width of 2 feet and a depth of 6 inches. Stream at the road culvert. Photo taken looking north.

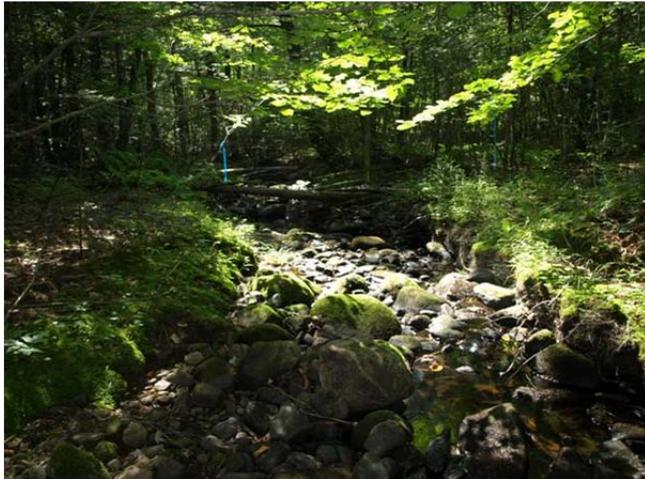
Photo No.: 11
Plan ID: AS37
Waterbody: CASBW8
Date: August 10, 2010
Photographer: Heather Storlazzi Ward
Comments: Westerly flowing perennial stream with an average width of 3-4 feet and an average bank width of 8-10 feet. This feature is a tributary to Ludden Brook with moss covered cobblestone and exposed bedrock. Photo was taken looking downstream.

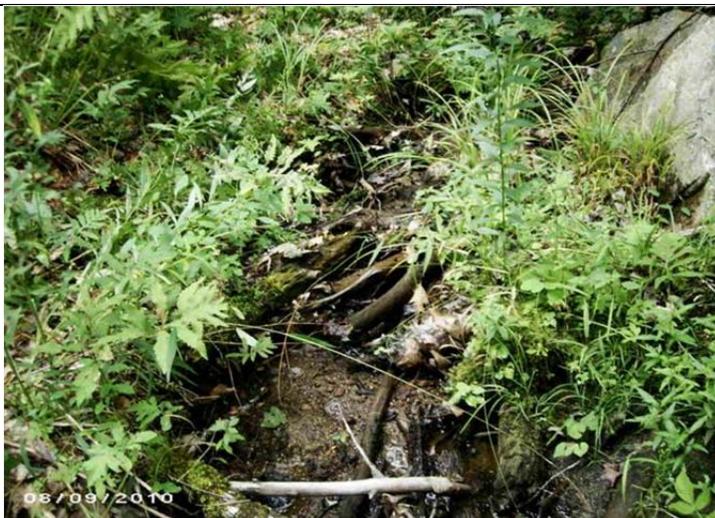
Photo No.: 12
Plan ID: AS46
Waterbody: CASBK38
Date: August 9, 2010
Photographer: Rodney Kelshaw
Comments: Intermittent stream with a total width of 2 feet. Photo is looking north.

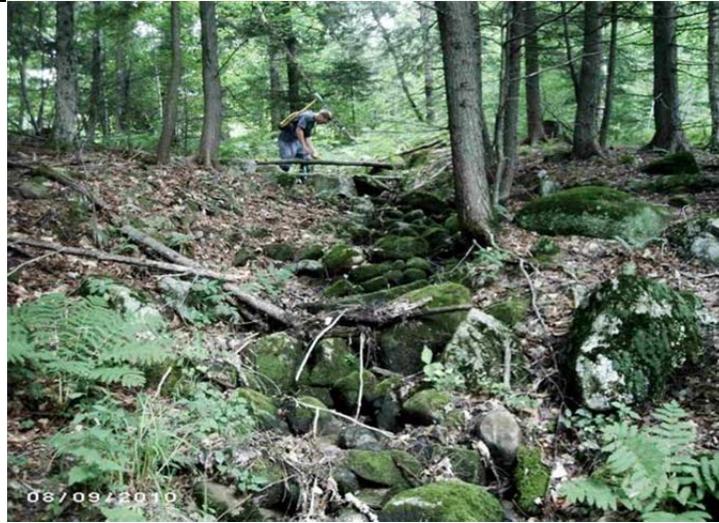
Photo No.: 13
Plan ID: AS48
Waterbody: CASBK41
Date: August 9, 2010
Photographer: Rodney Kelshaw

Comments: Westerly flowing intermittent stream that has an average width of 3 feet with an average bank width of 4 feet. Photo was taken looking east.

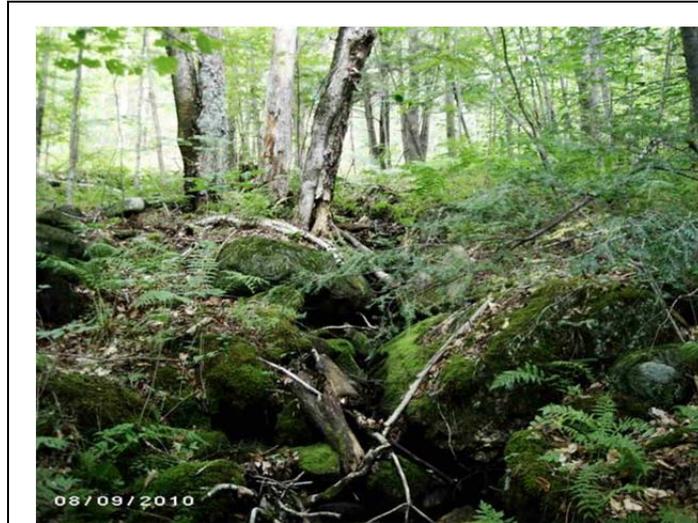
Photo No.: 14
Plan ID: AS49
Waterbody: CASBK42
Date: August 9, 2010
Photographer: Rodney Kelshaw

Comments: Westerly flowing intermittent stream with an average width of 3 feet and an average bank width of 5 feet. Photo was taken looking west.

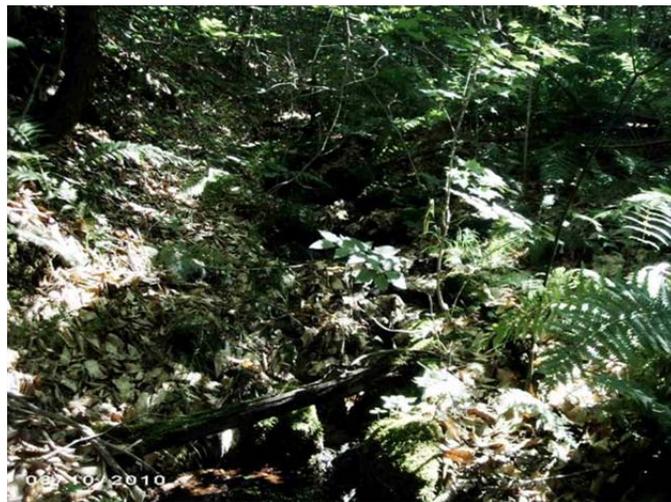
Photo No.: 15
Plan ID: AS51
Waterbody: CASBK46
Date: August 10, 2010
Photographer: Rodney Kelshaw

Comments: Westerly flowing intermittent stream with an average width of 3 feet and an average bank width of 3.5 feet. Stream connects to CADBK45 downslope. Photo is looking east.

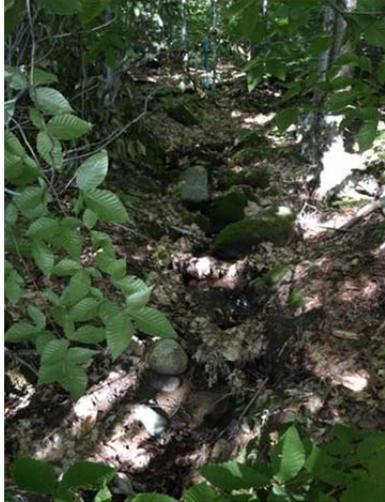
Photo No.: 16
Plan ID: AS58
Waterbody: CRSBW23
Date: August 11, 2010
Photographer: Heather Storlazzi Ward

Comments: A perennial stream that was an average width of 2 feet and an average bank width of 3 feet. Photo is looking upstream.

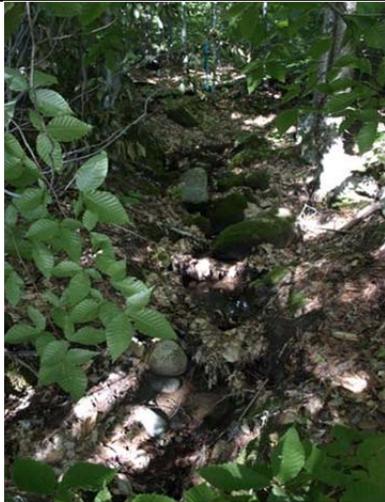
Photo No.: 17
Plan ID: AS59
Waterbody: CRSBW23
Date: August 11, 2010
Photographer: Heather Storlazzi Ward

Comments: A perennial stream that was an average width of 2 feet and an average bank width of 3 feet. Photo is looking upstream.

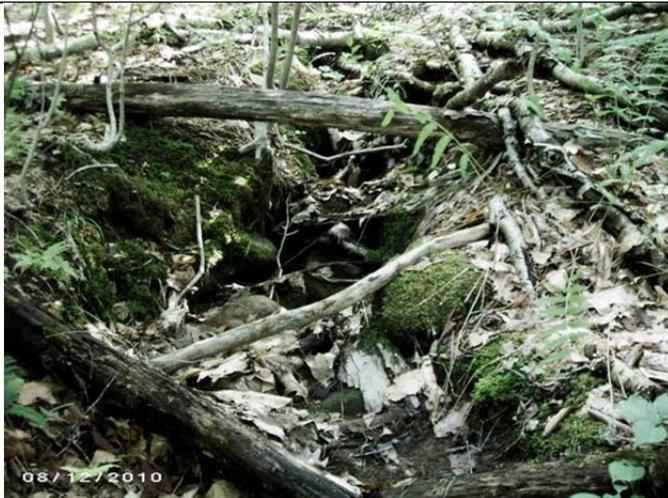
Photo No.: 18
Plan ID: AS60
Waterbody: CRSBK58
Date: August 12, 2010
Photographer: Rodney Kelshaw

Comments: A westerly flowing intermittent stream with an average width of 2 feet and an average bank width of 3 feet. Stream begins abruptly from a hill slope and extends offsite west of the gravel road. Photo is looking east.

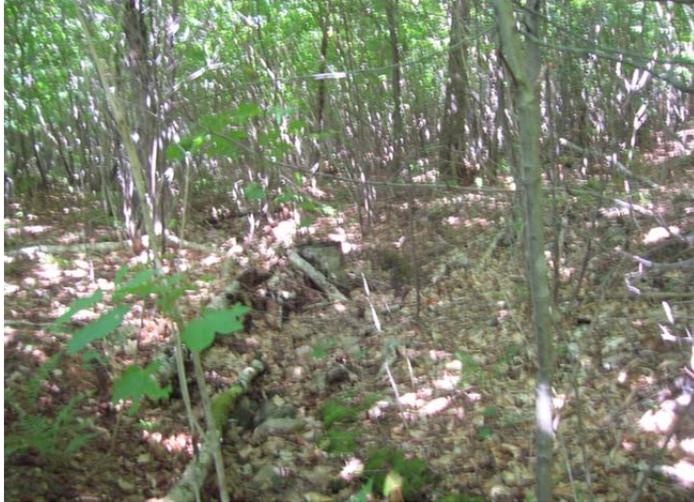
Photo No.: 19
Plan ID: AS61
Waterbody: CRSBB8
Date: August 12, 2010
Photographer: David Brenneman

Comments: Well-defined rocky channel on hillside. Photo facing west (down-slope) at stream channel.

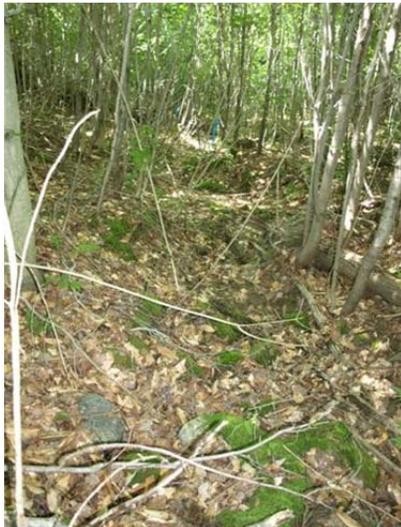
Photo No.: 20
Plan ID: AS62
Waterbody: CRSBW28
Date: August 12, 2010
Photographer: Heather Storlazzi Ward

Comments: A westerly flowing intermittent stream that has an average bank width of 3-5 feet. Photo taken looking west.

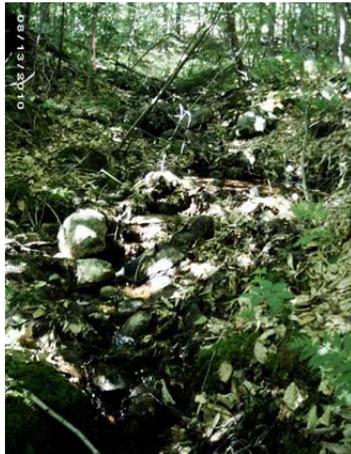
Photo No.: 21
Plan ID: RS67
Waterbody: CRSBK35
Date: August 13, 2010
Photographer: Heather Storlazzi Ward

Comments: A southerly flowing perennial stream that has an average width of 1–2 feet with a bank width of 5 feet. Photo was taken looking north.
