CLOSURE EXPENSE MEMO

Re: Site closure: Winthrop Commerce Center, 149 Main Street, Winthrop, ME 04364
Spill # A-157-2005

BRWM Petroleum Program Priority List
Site Closure Memo

To: Project File Date: June 13, 2014
Project Name: Winthrop Commerce Center Spill No.: A-157-2005
Town: Winthrop
Project Manager: Tom Benn Closer: Dani Obery

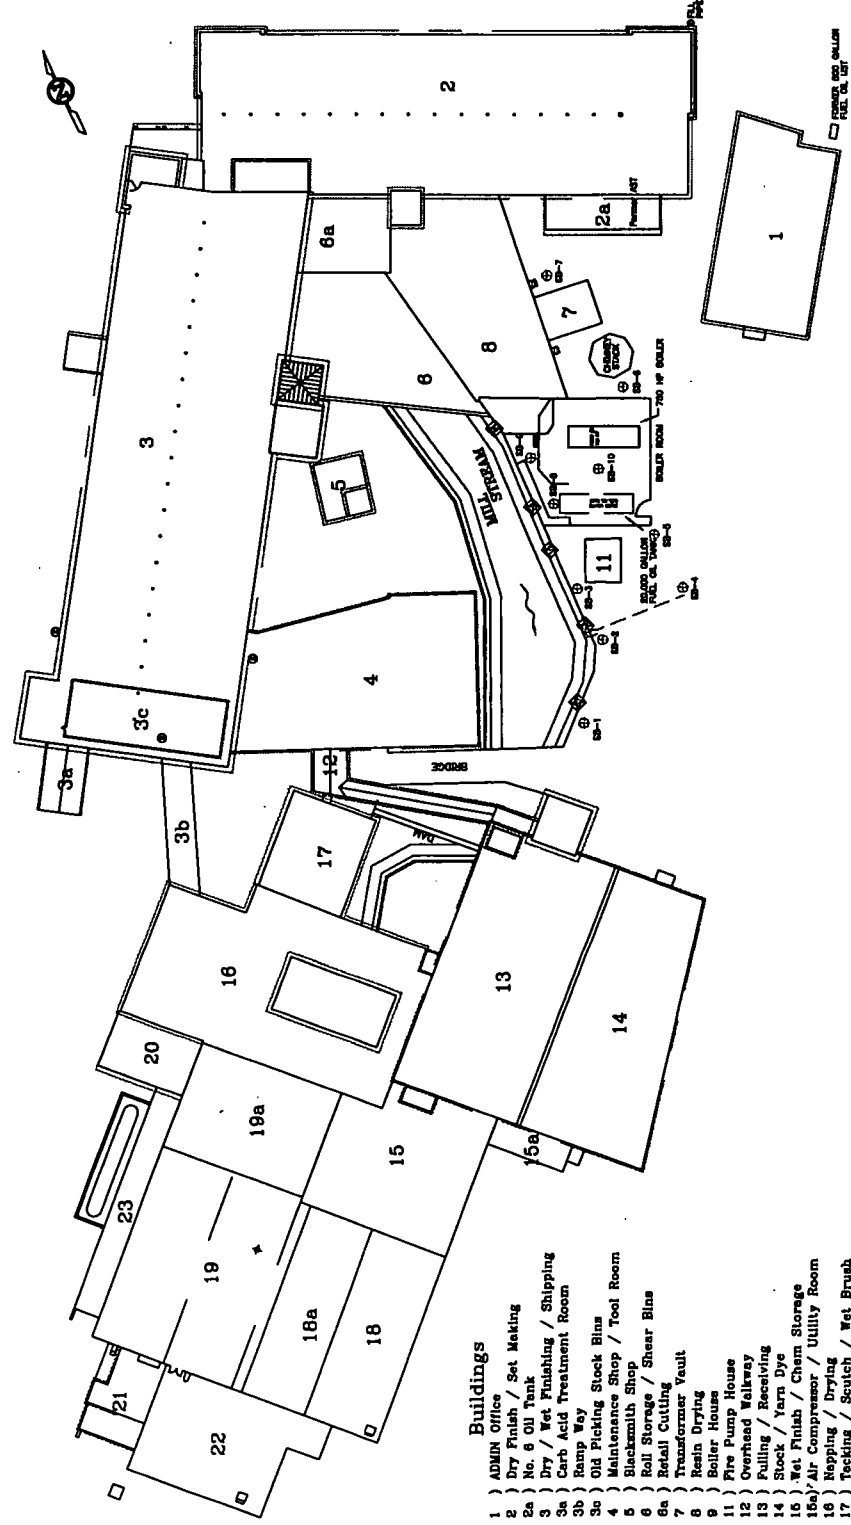
Figure 1
WINTHROP COMMERCE CENTER

LOCATION OF FUEL OIL TANK IS APPROXIMATE
 MAP SOURCE:
 Carleton Woolen Mills, Inc.
 Dyeing and Finishing Mill
 Record Drawing Schedule May 3, 1998
