Scour Critical Bridge
Plan of Action (POA) Report

Form with checkboxes for Full POA and Abbreviated POA

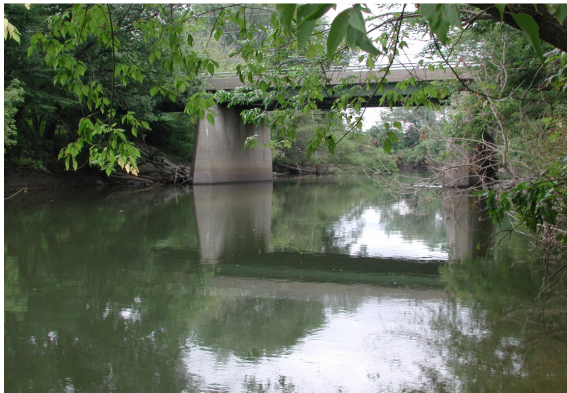
Final Recommended Action section with checkboxes for inspection frequency, flood monitoring, closure triggers, and countermeasures.

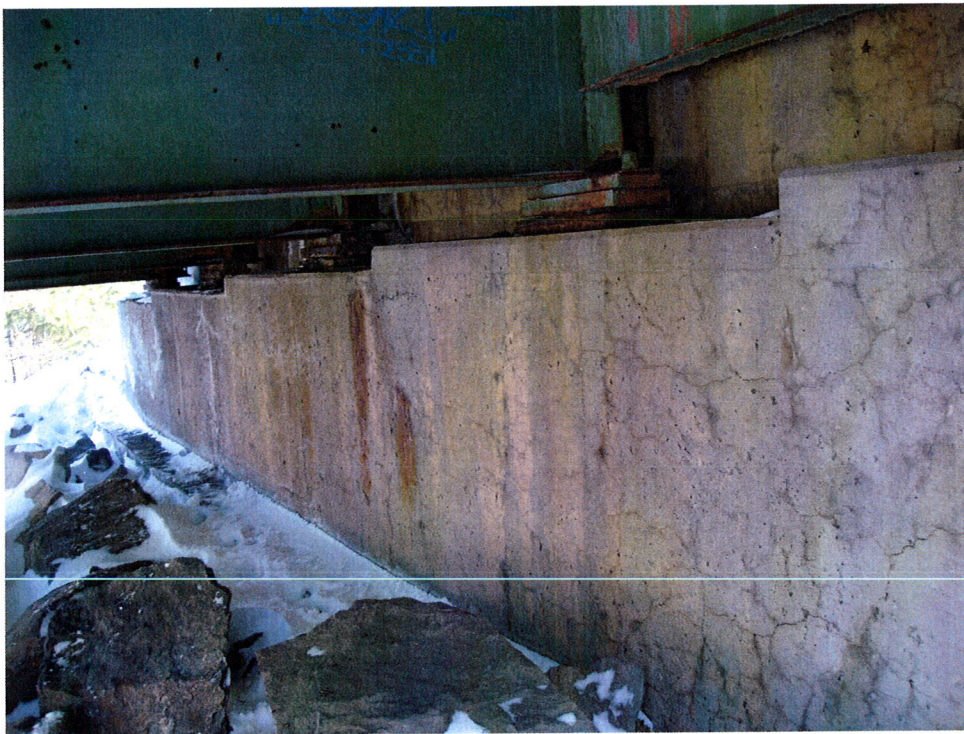
Looking left  
along approach  
sideslope - swale

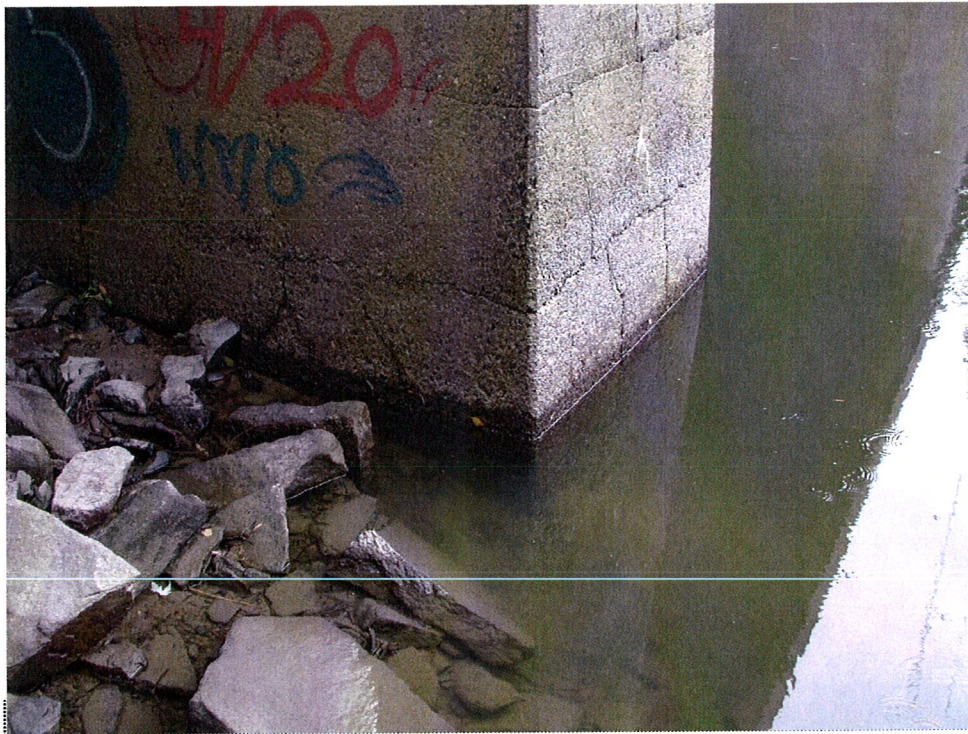
D/S left bank  
from Left Bank  
Under Bridge  
showing bank  
erosion

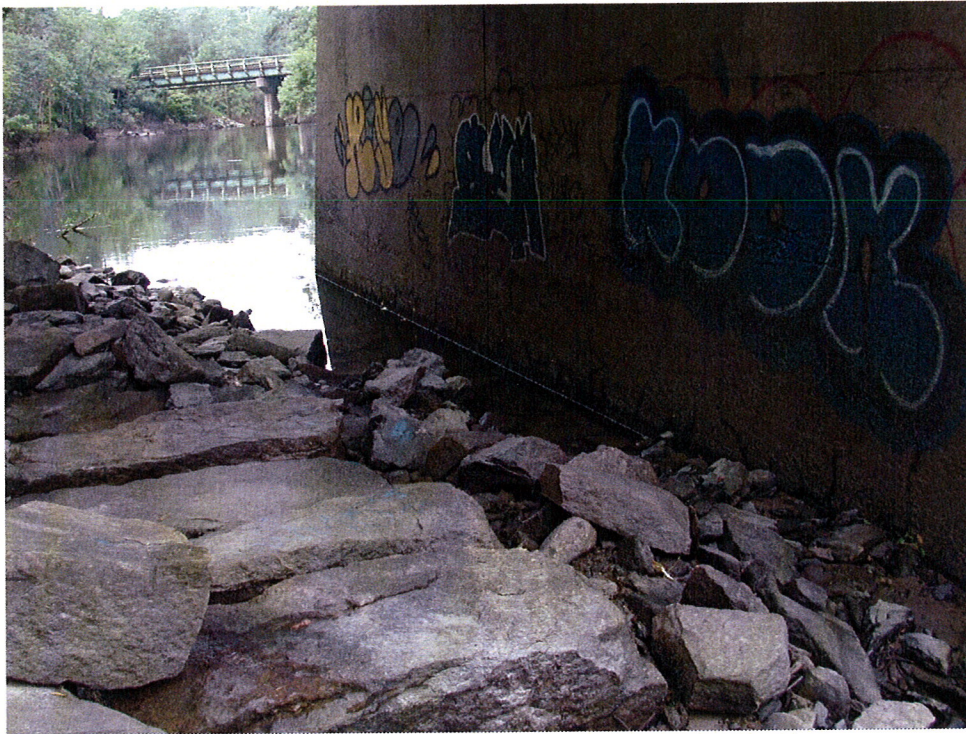
## Site Investigation Pictures

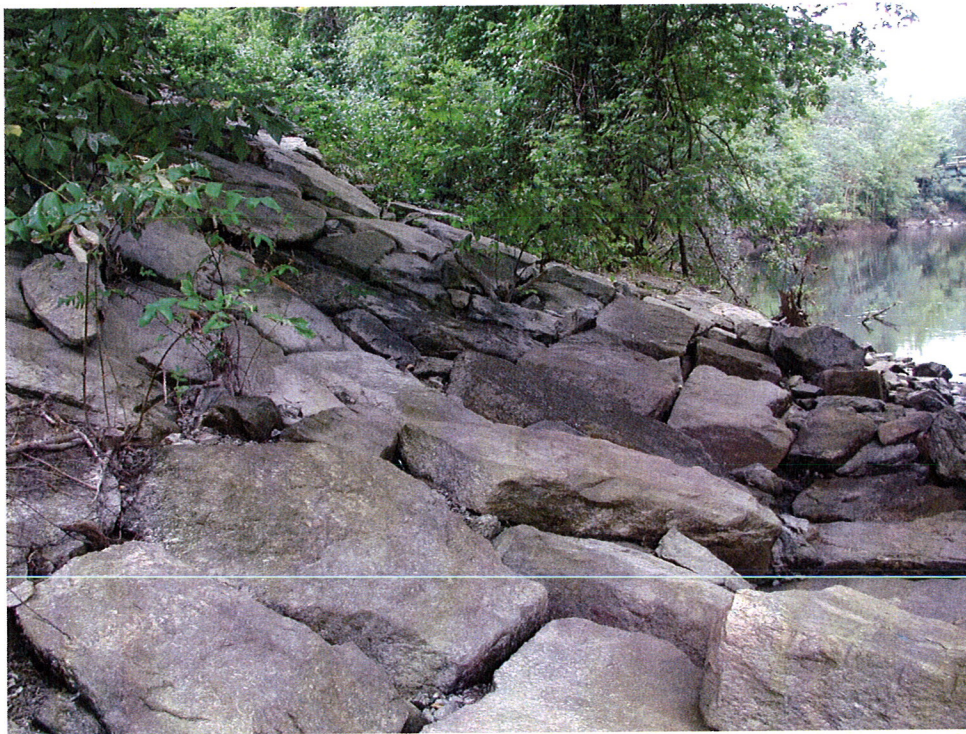
Looking U/S at right pier from D/S right bank showing riprap condition and extent

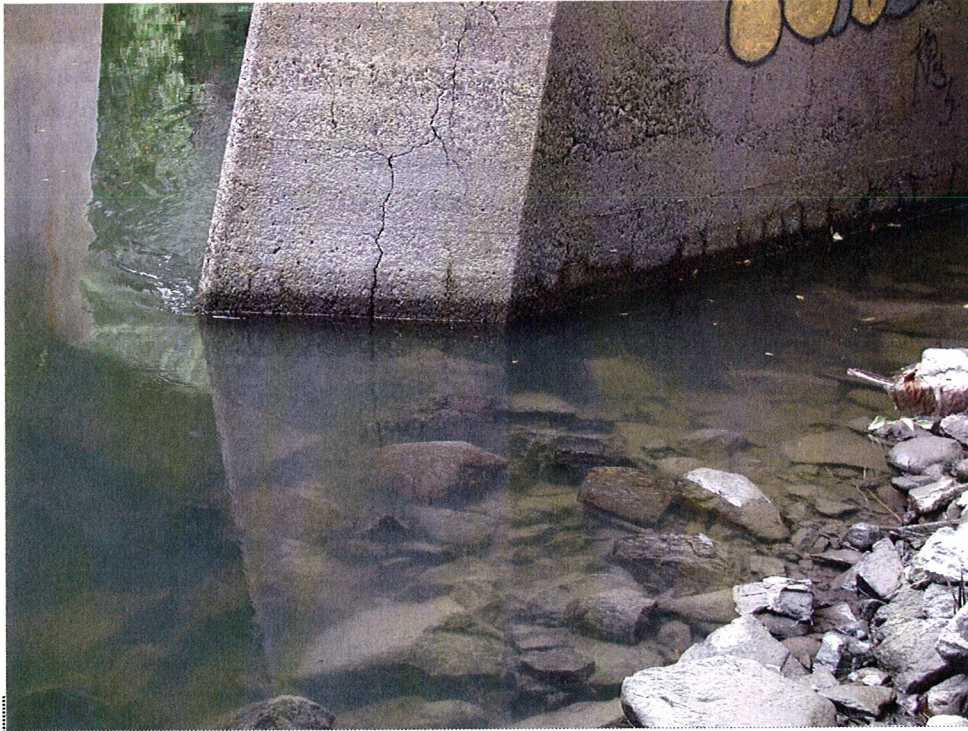
## Site Investigation Pictures

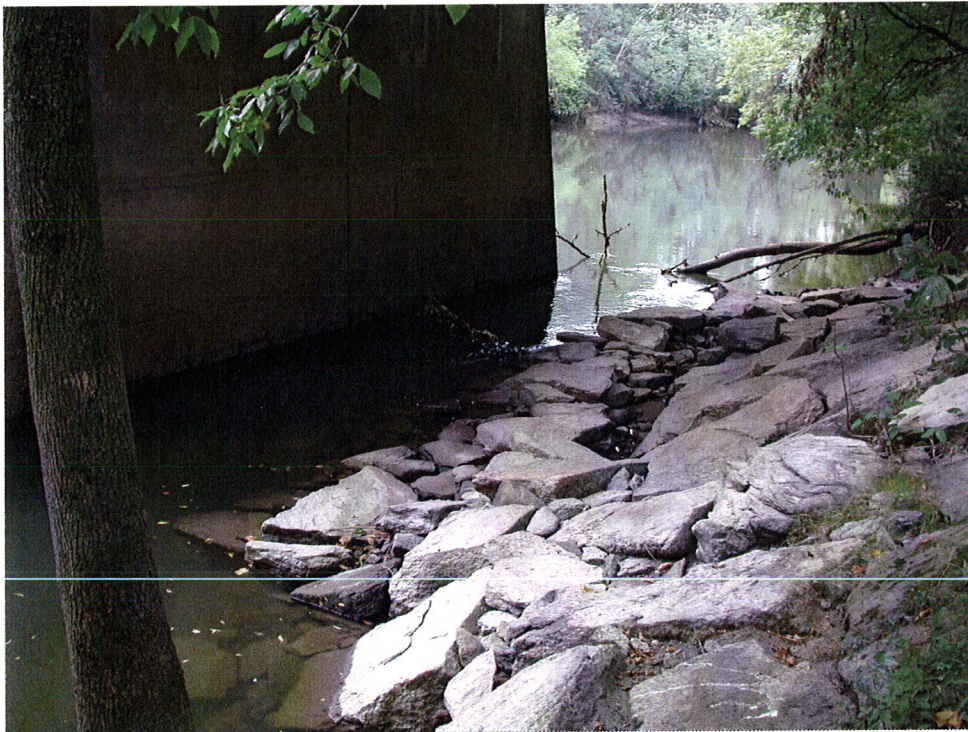
U/S face of right pier from U/S right bank showing riprap to right & deep water to left where riprap is missing

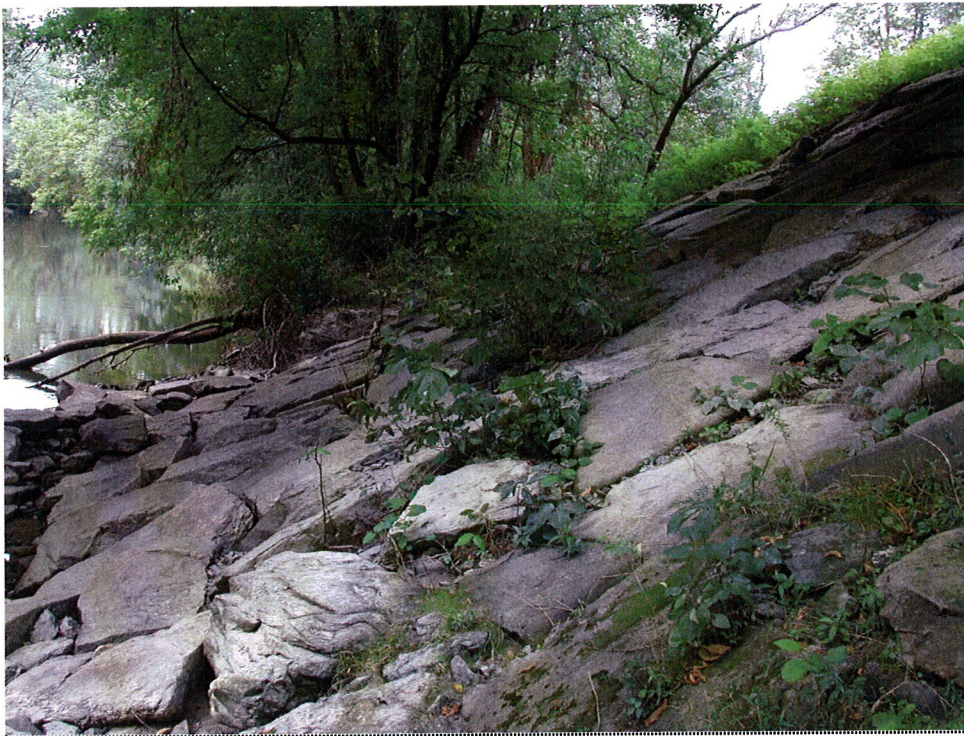
## Site Investigation Pictures

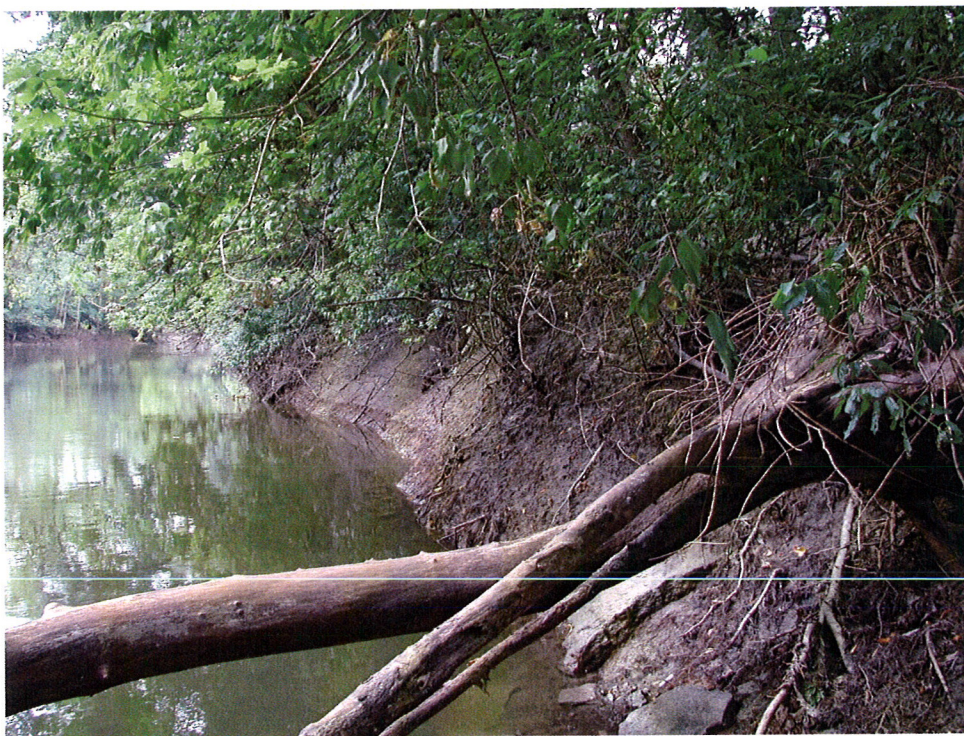
Looking U/S at slope protection under bridge - showing riprap condition and extent on left bank

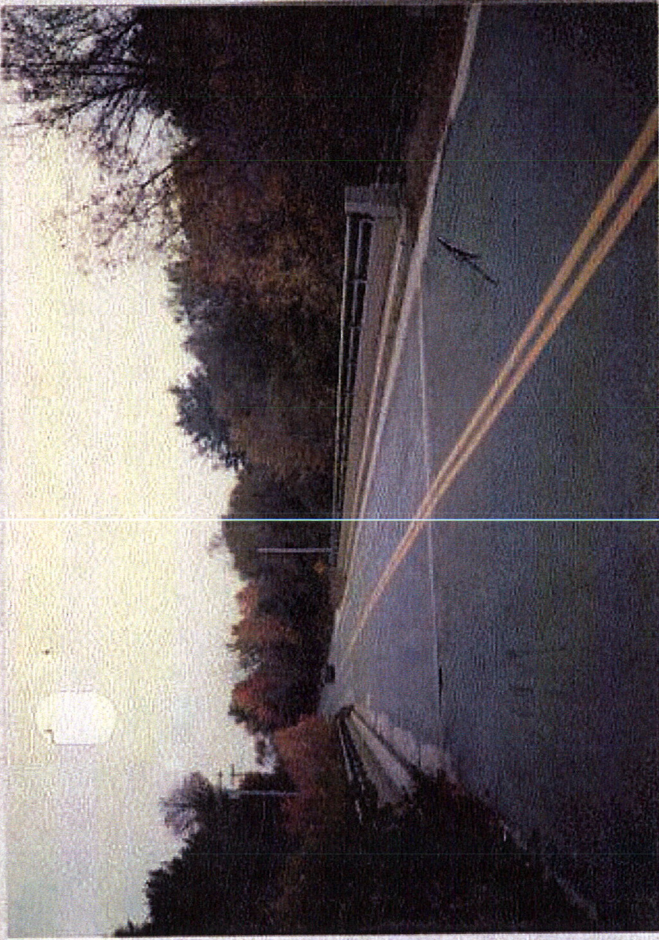
Looking right from  
left bank U/S  
of bridge - showing  
right bank erosion

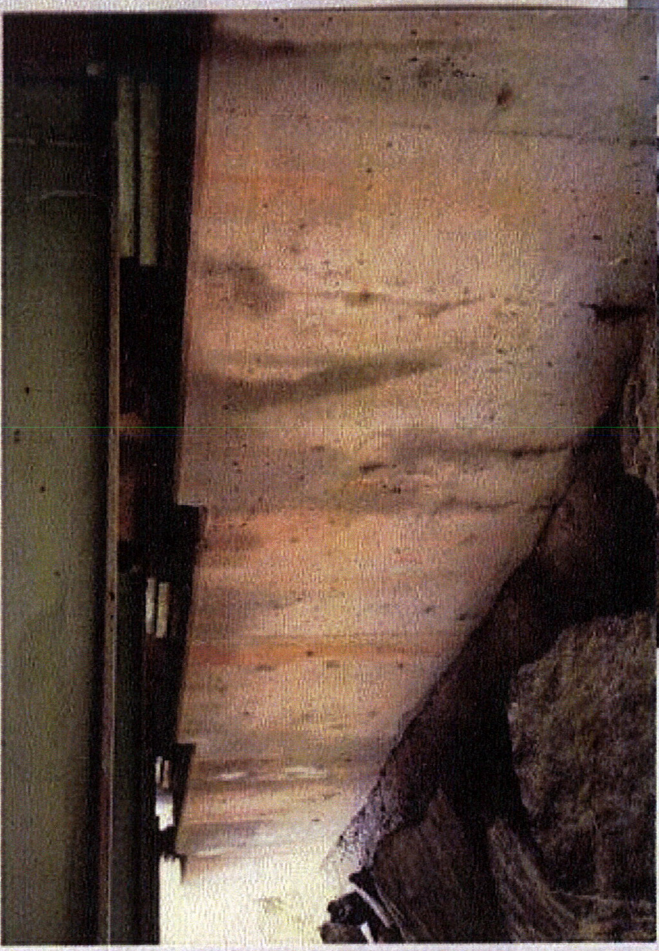
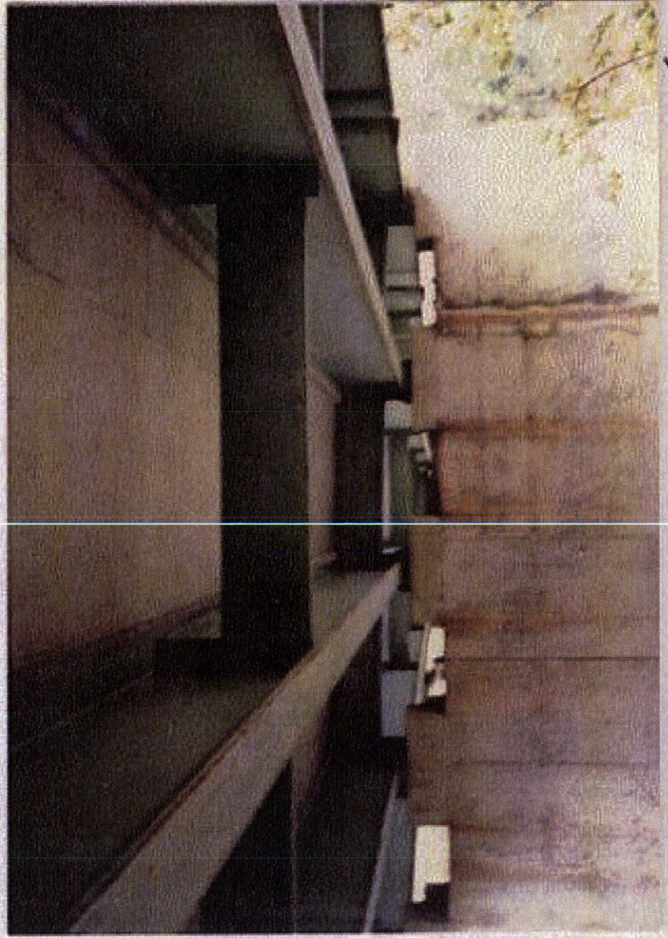
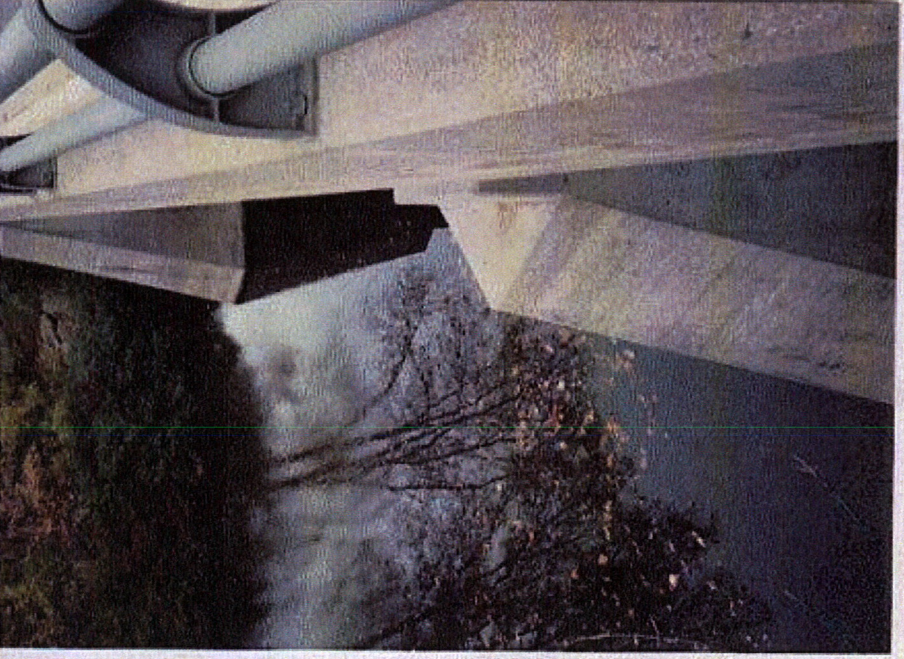
*Felwood, Lambert St.  
# 5553*

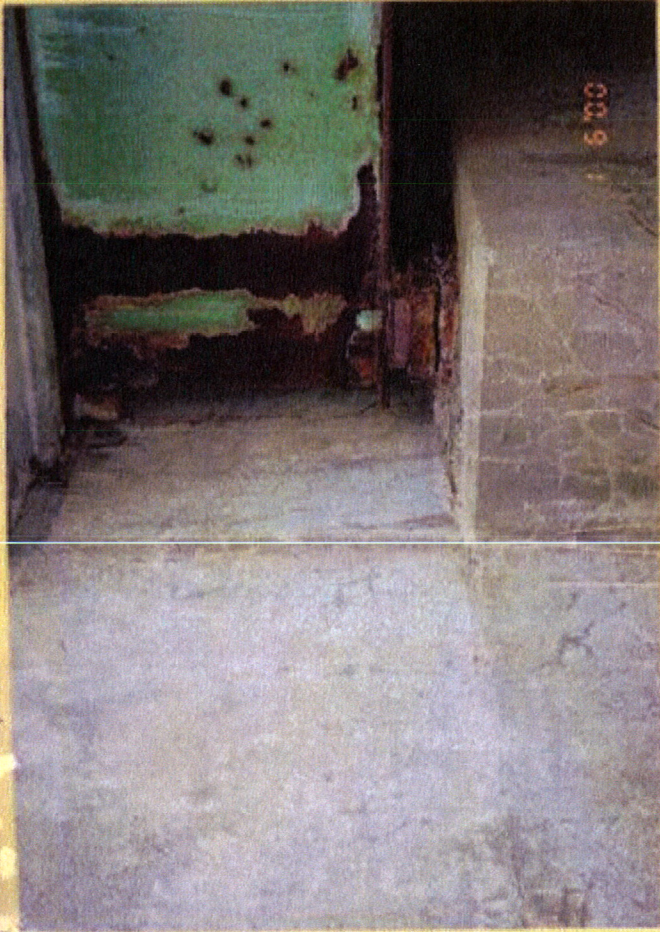
Corrosion defer. w. penetration est.  $\leq 3/16"$ .

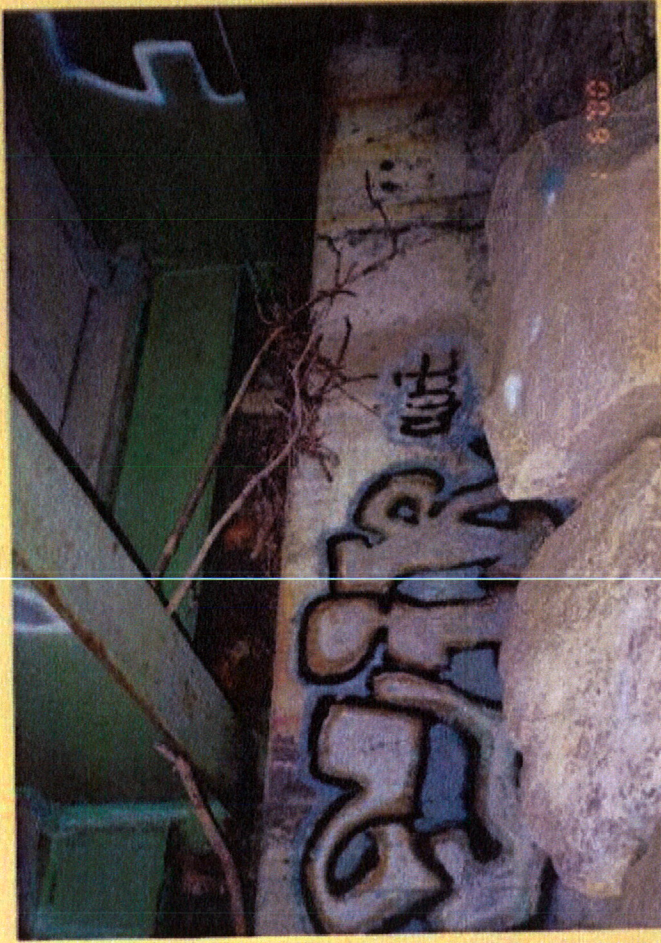
At N/ly abut., apparent drift accumulation. Note riprap configuration compared to S/ly abut. # 5553  
FALMOUTH

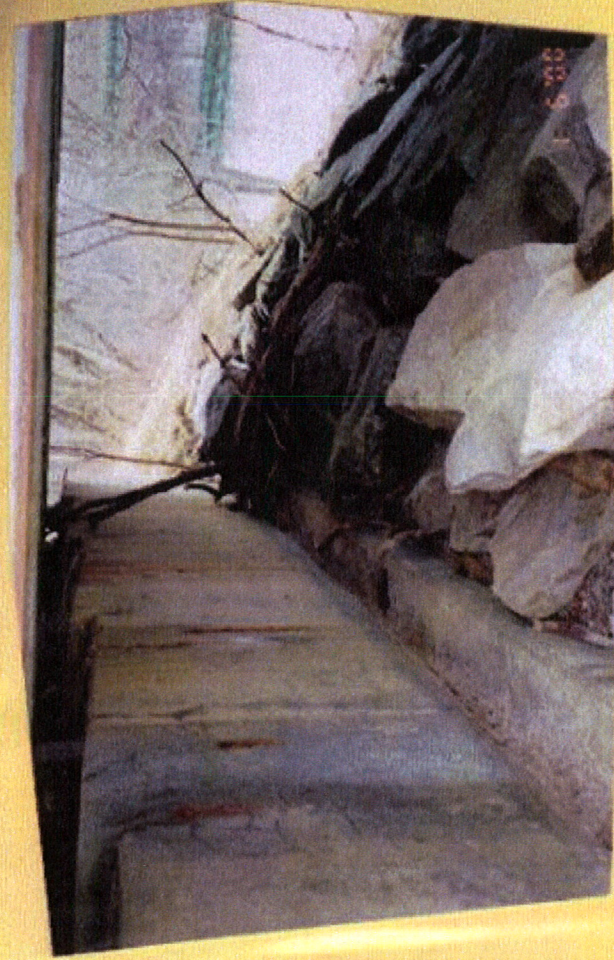
Concrete deterioration. S/ly footing exp'd  $\leq 0.7'$  vertical. Appears to be drift accum. inc. on bridge seats.

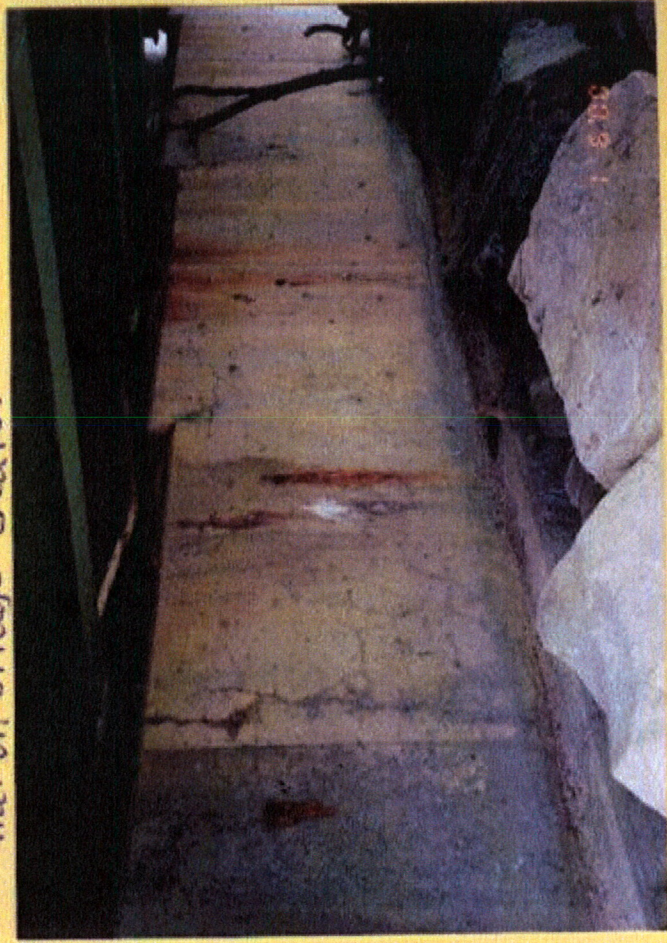
Hambert Street  
1/6/2000  
DIV. 6

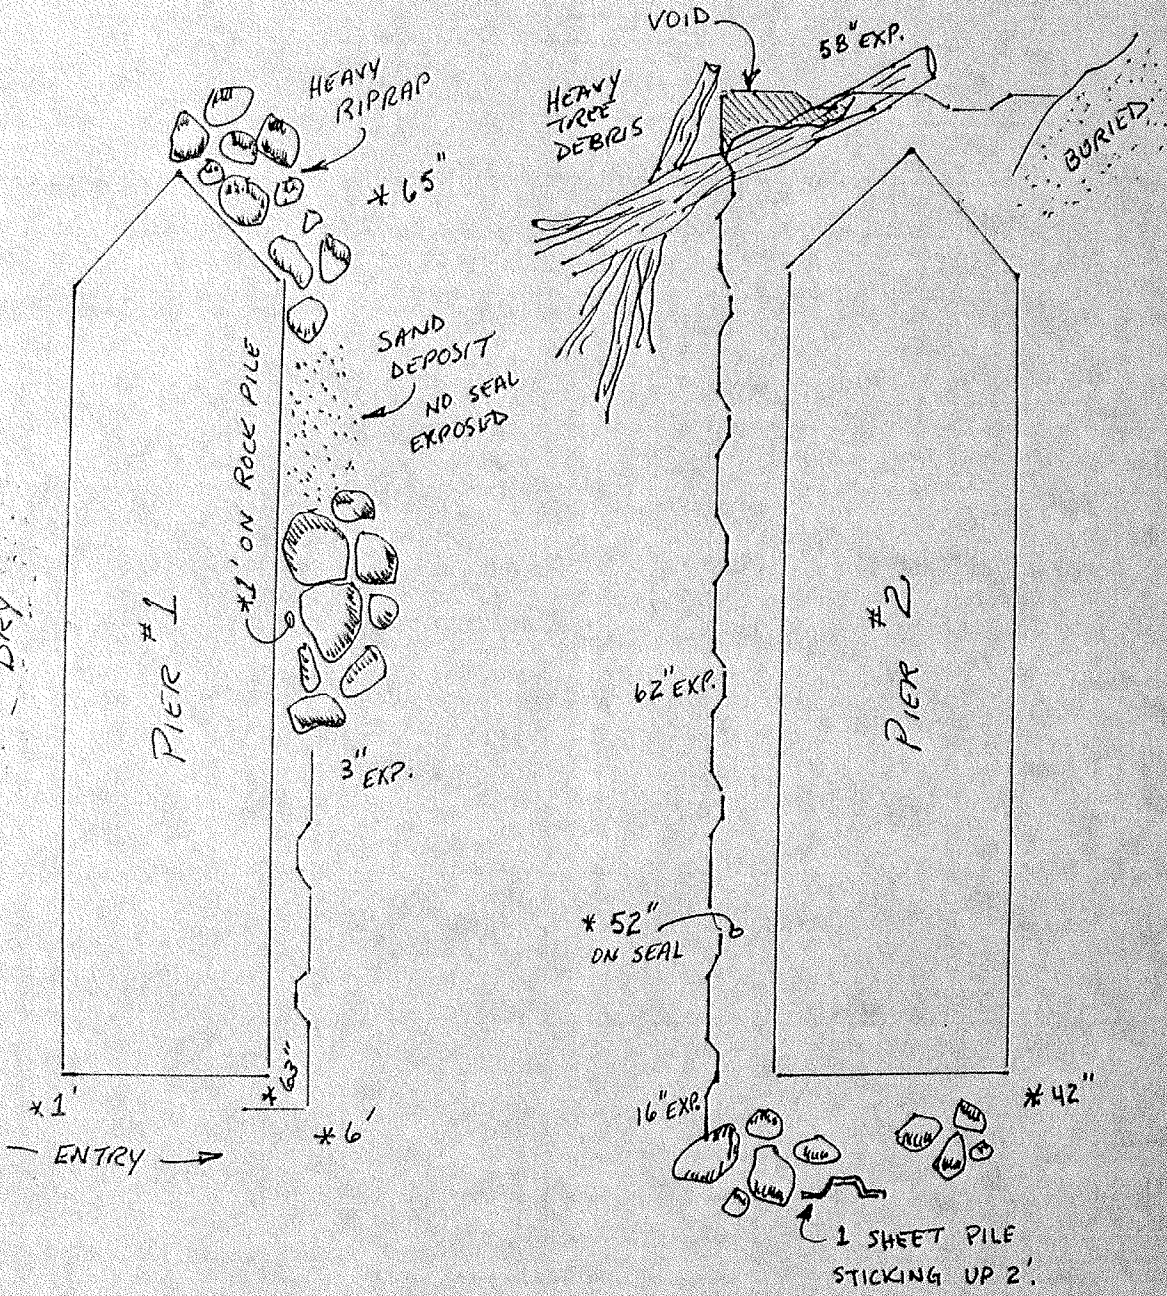
\* = WATER DEPTH  
EXP. = EXPOSED SEAL

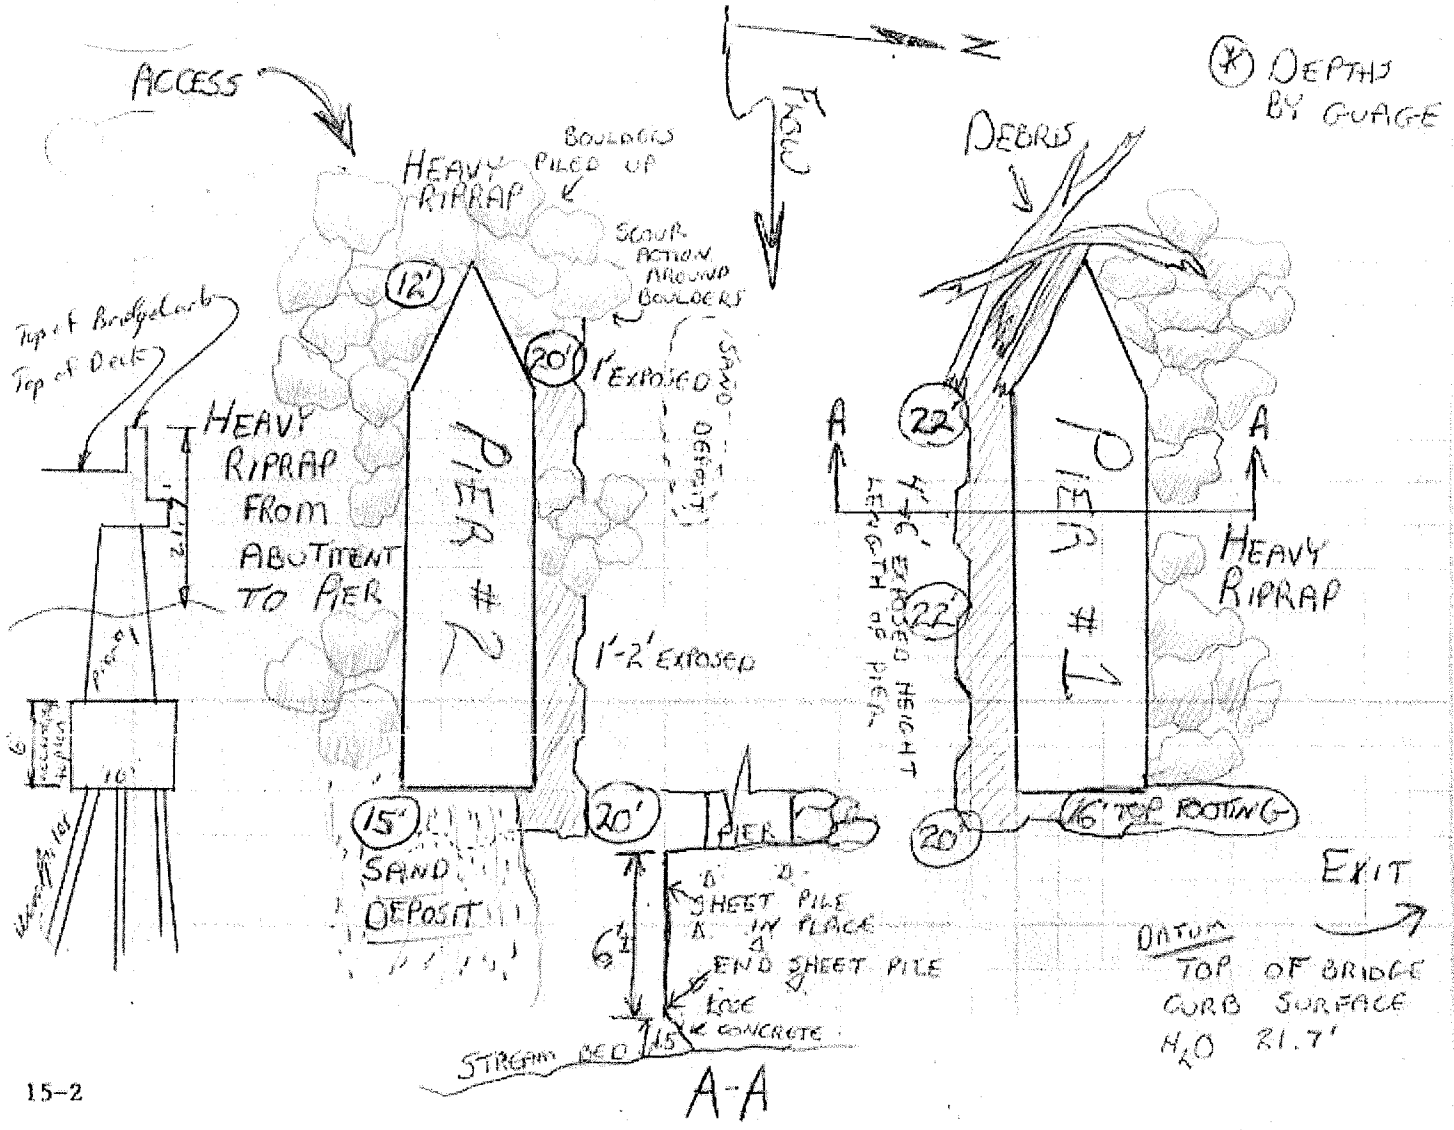
UNDERWATER INSPECTION REPORT

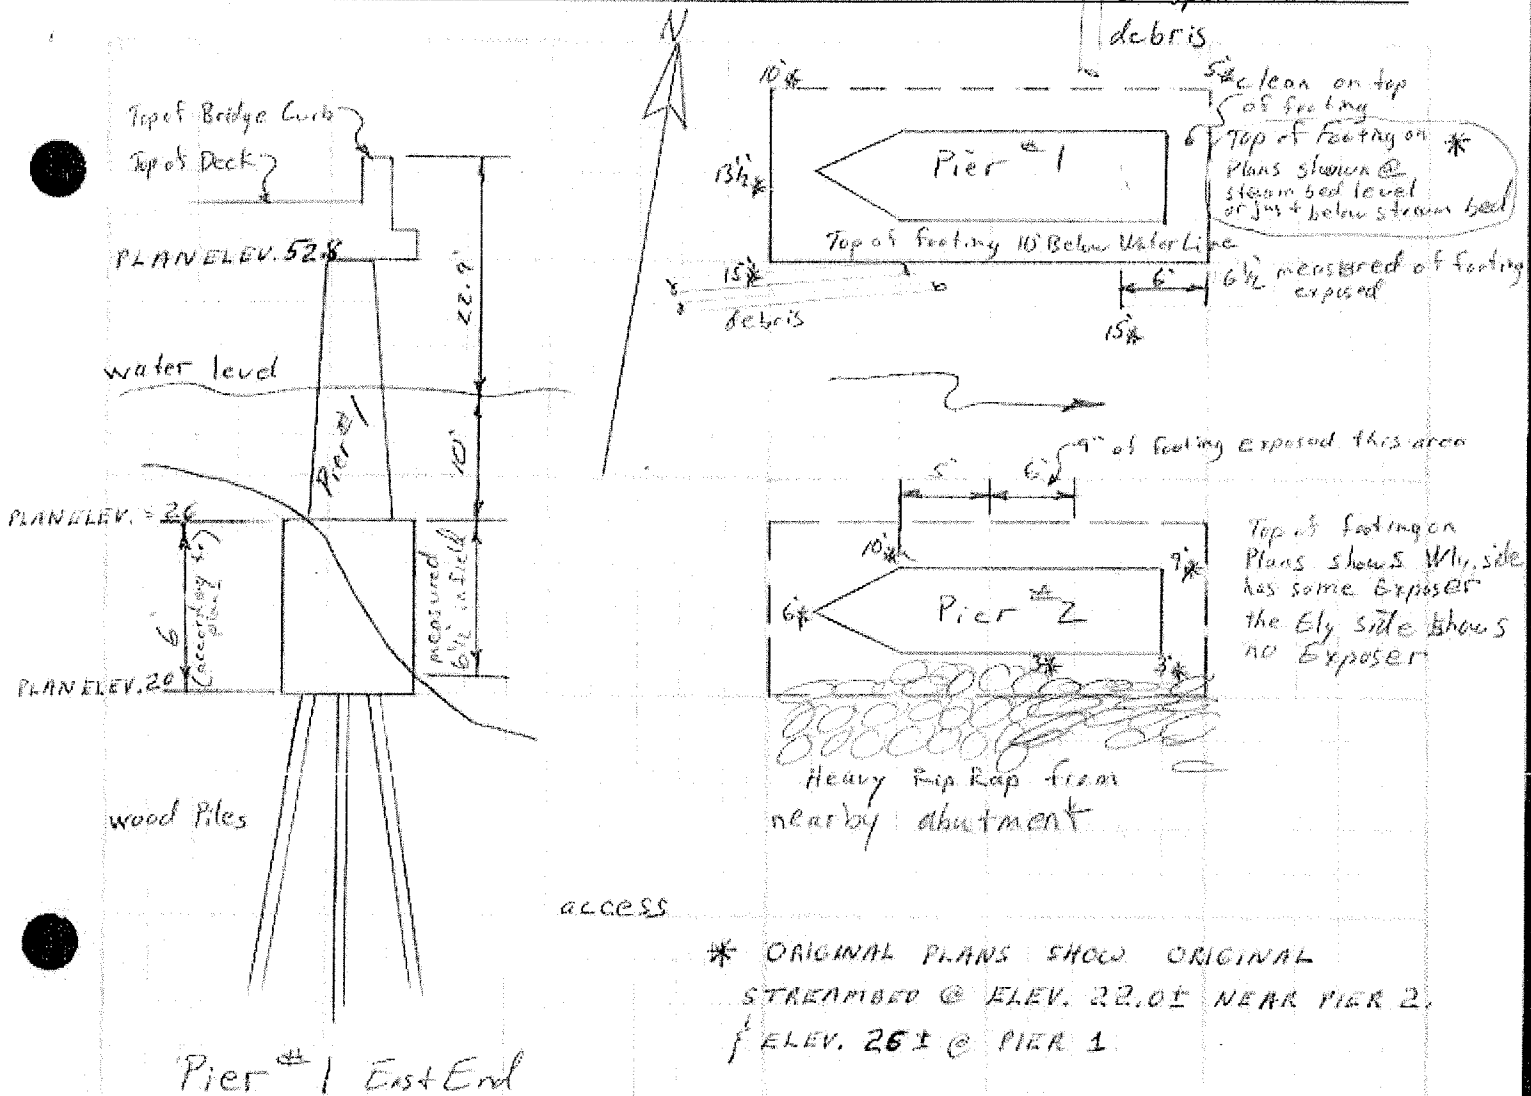
INSPECTION REPORT (2) mass conc. piers 10' W x 46' L w/ leveled up stream ends on 6' conc. footings. Pier #1 has exposed footing while Pier #2 has one small section exposed.  
on Pier #2 some things are above the footing while one is below. Also some things are above the footing to stream and other side of stream. Would recommend placing some rip rap on the Nly. pier.

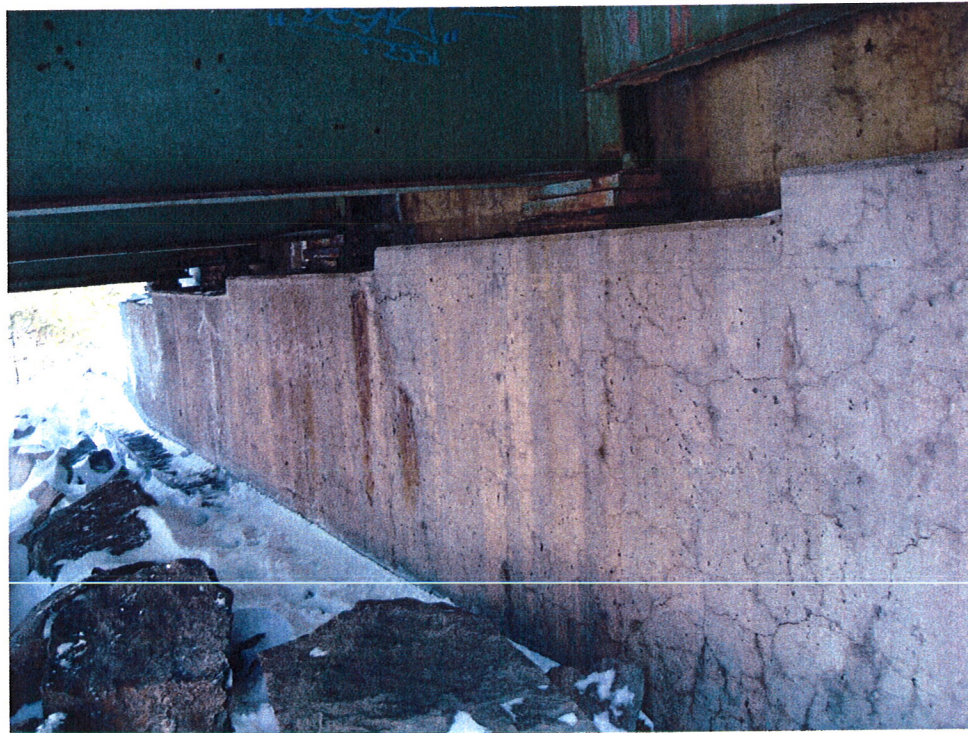
Looking left  
along approach  
sideslope - swale

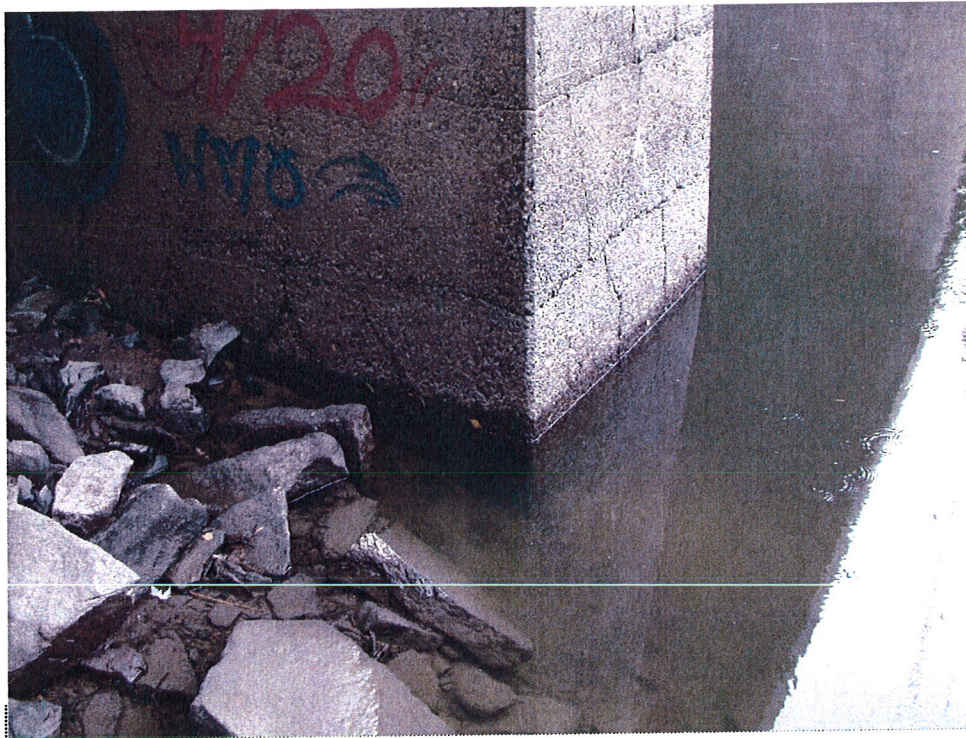
D/S left bank  
from Left Bank  
Under Bridge  
showing bank  
erosion

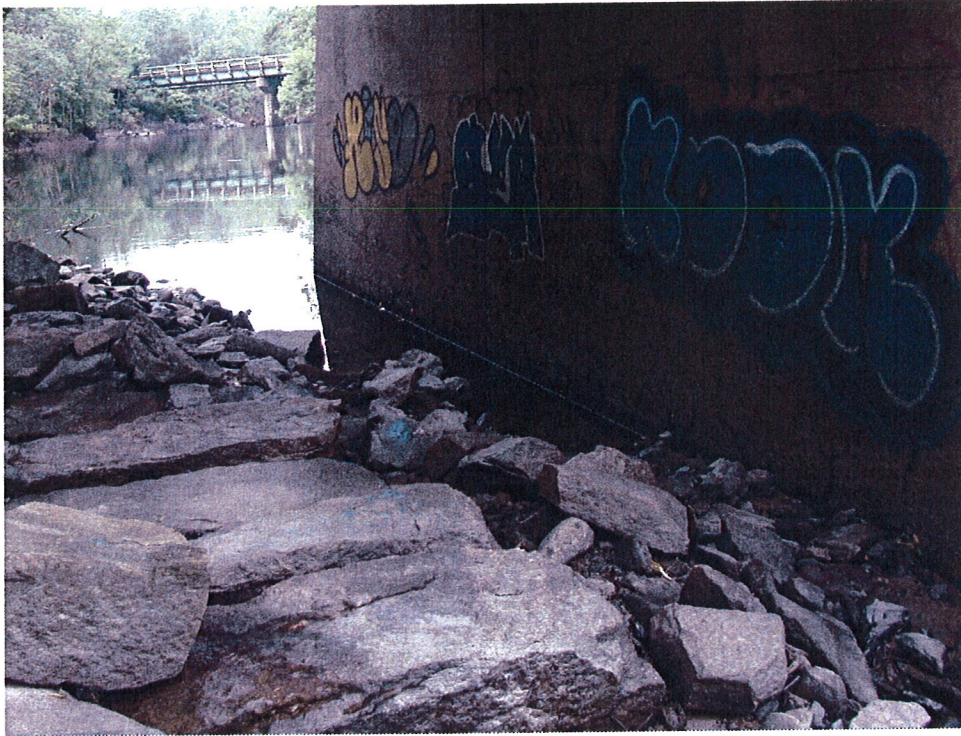
## Site Investigation Pictures

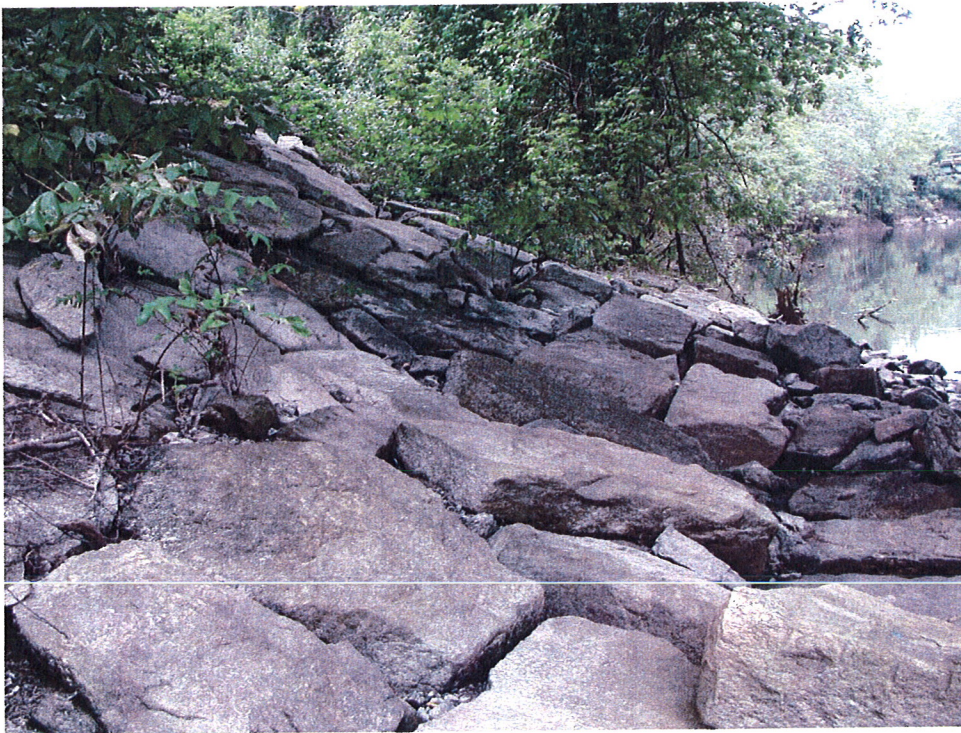
Looking U/S at right pier from D/S right bank showing riprap condition and extent

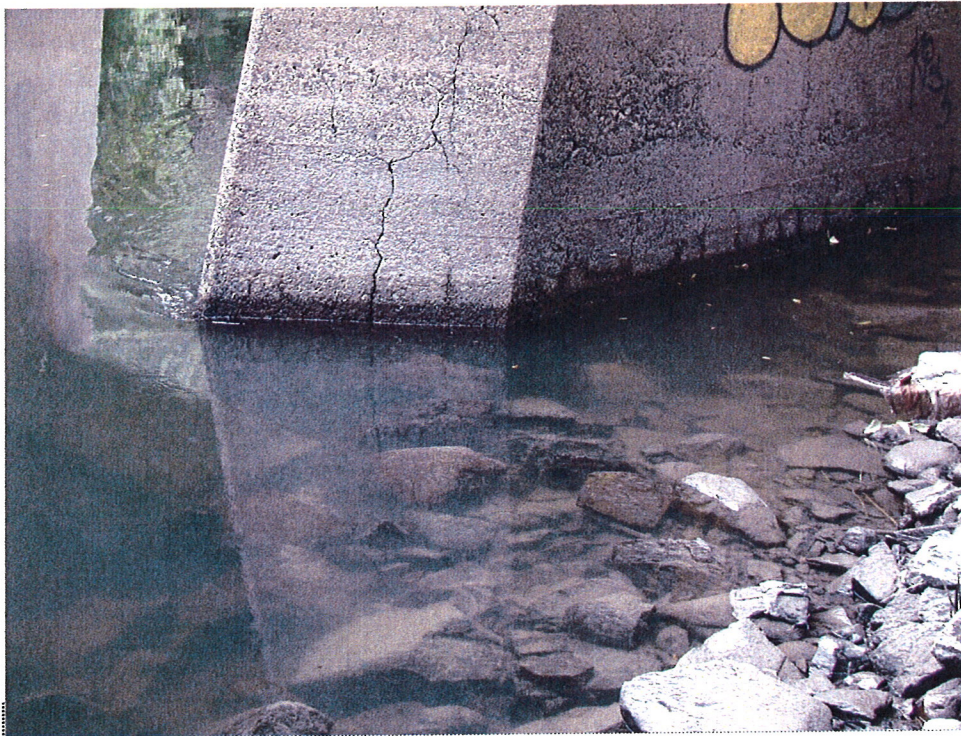
## Site Investigation Pictures

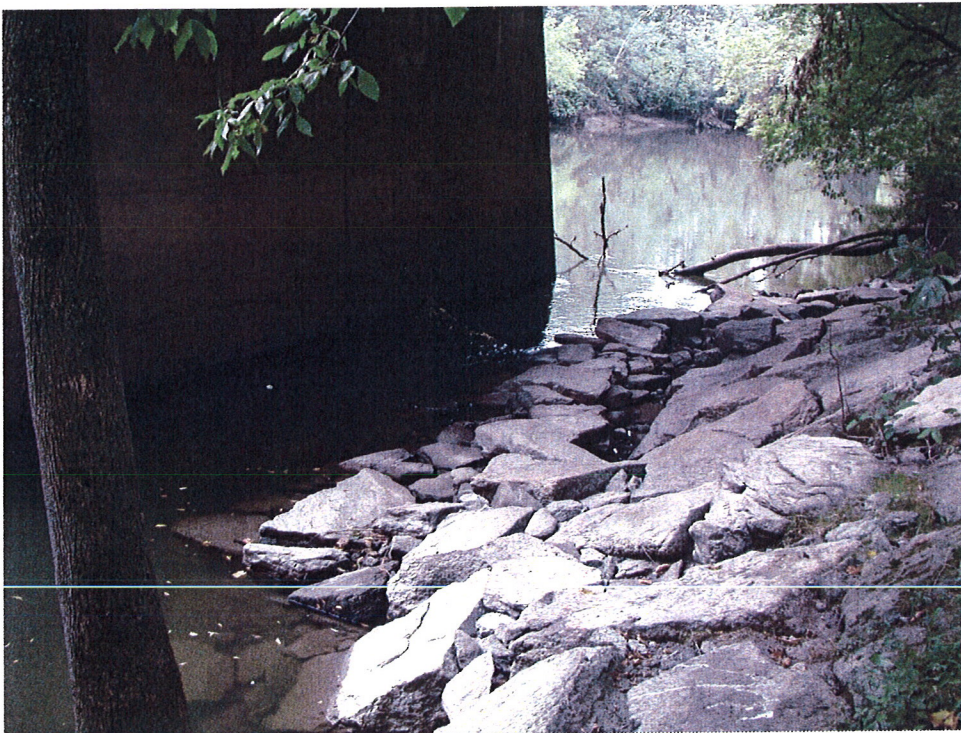
U/S face of right pier from U/S right bank showing riprap to right & deep water to left where riprap is missing

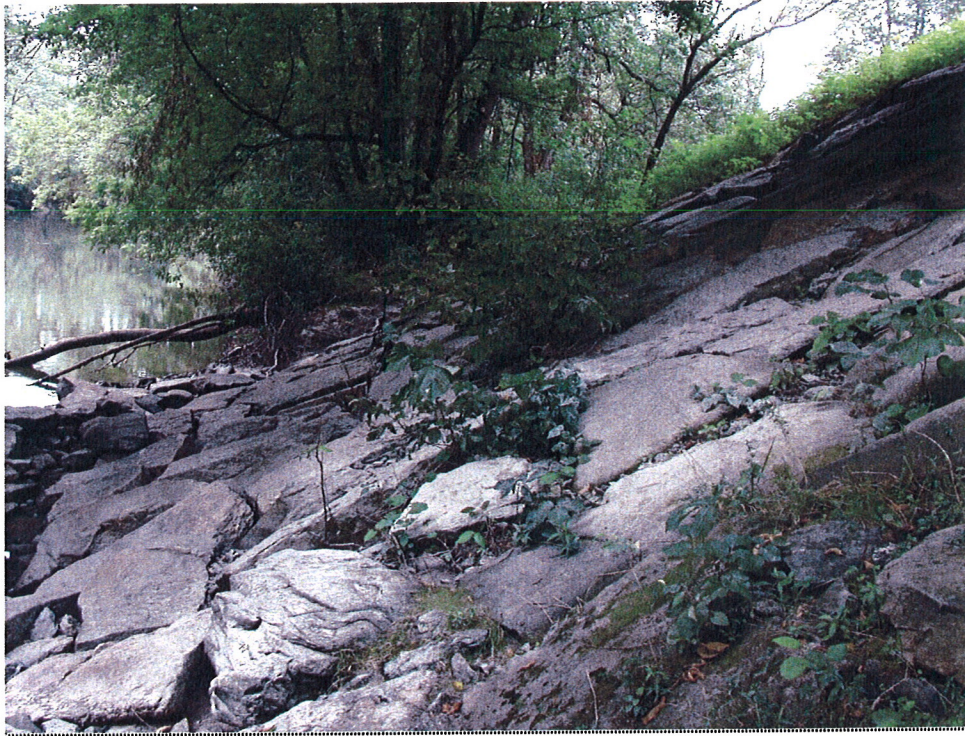
## Site Investigation Pictures

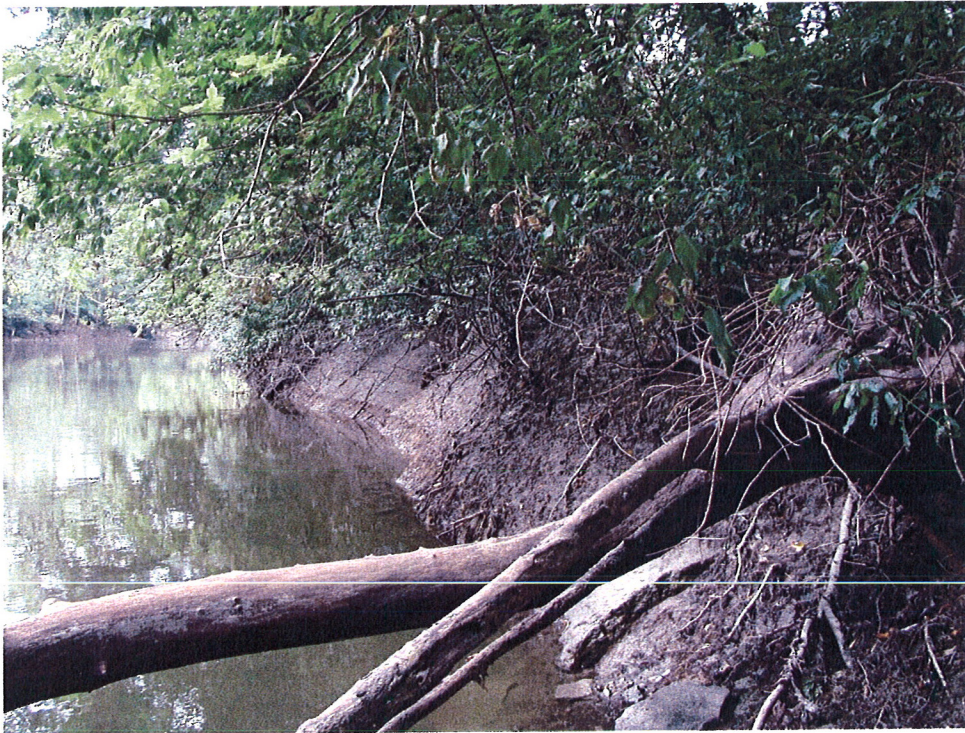
Looking U/S at slope protection under bridge - showing riprap condition and extent on left bank
