Scour Critical Bridge
Plan of Action (POA) Report

Form with checkboxes for Full POA and Abbreviated POA

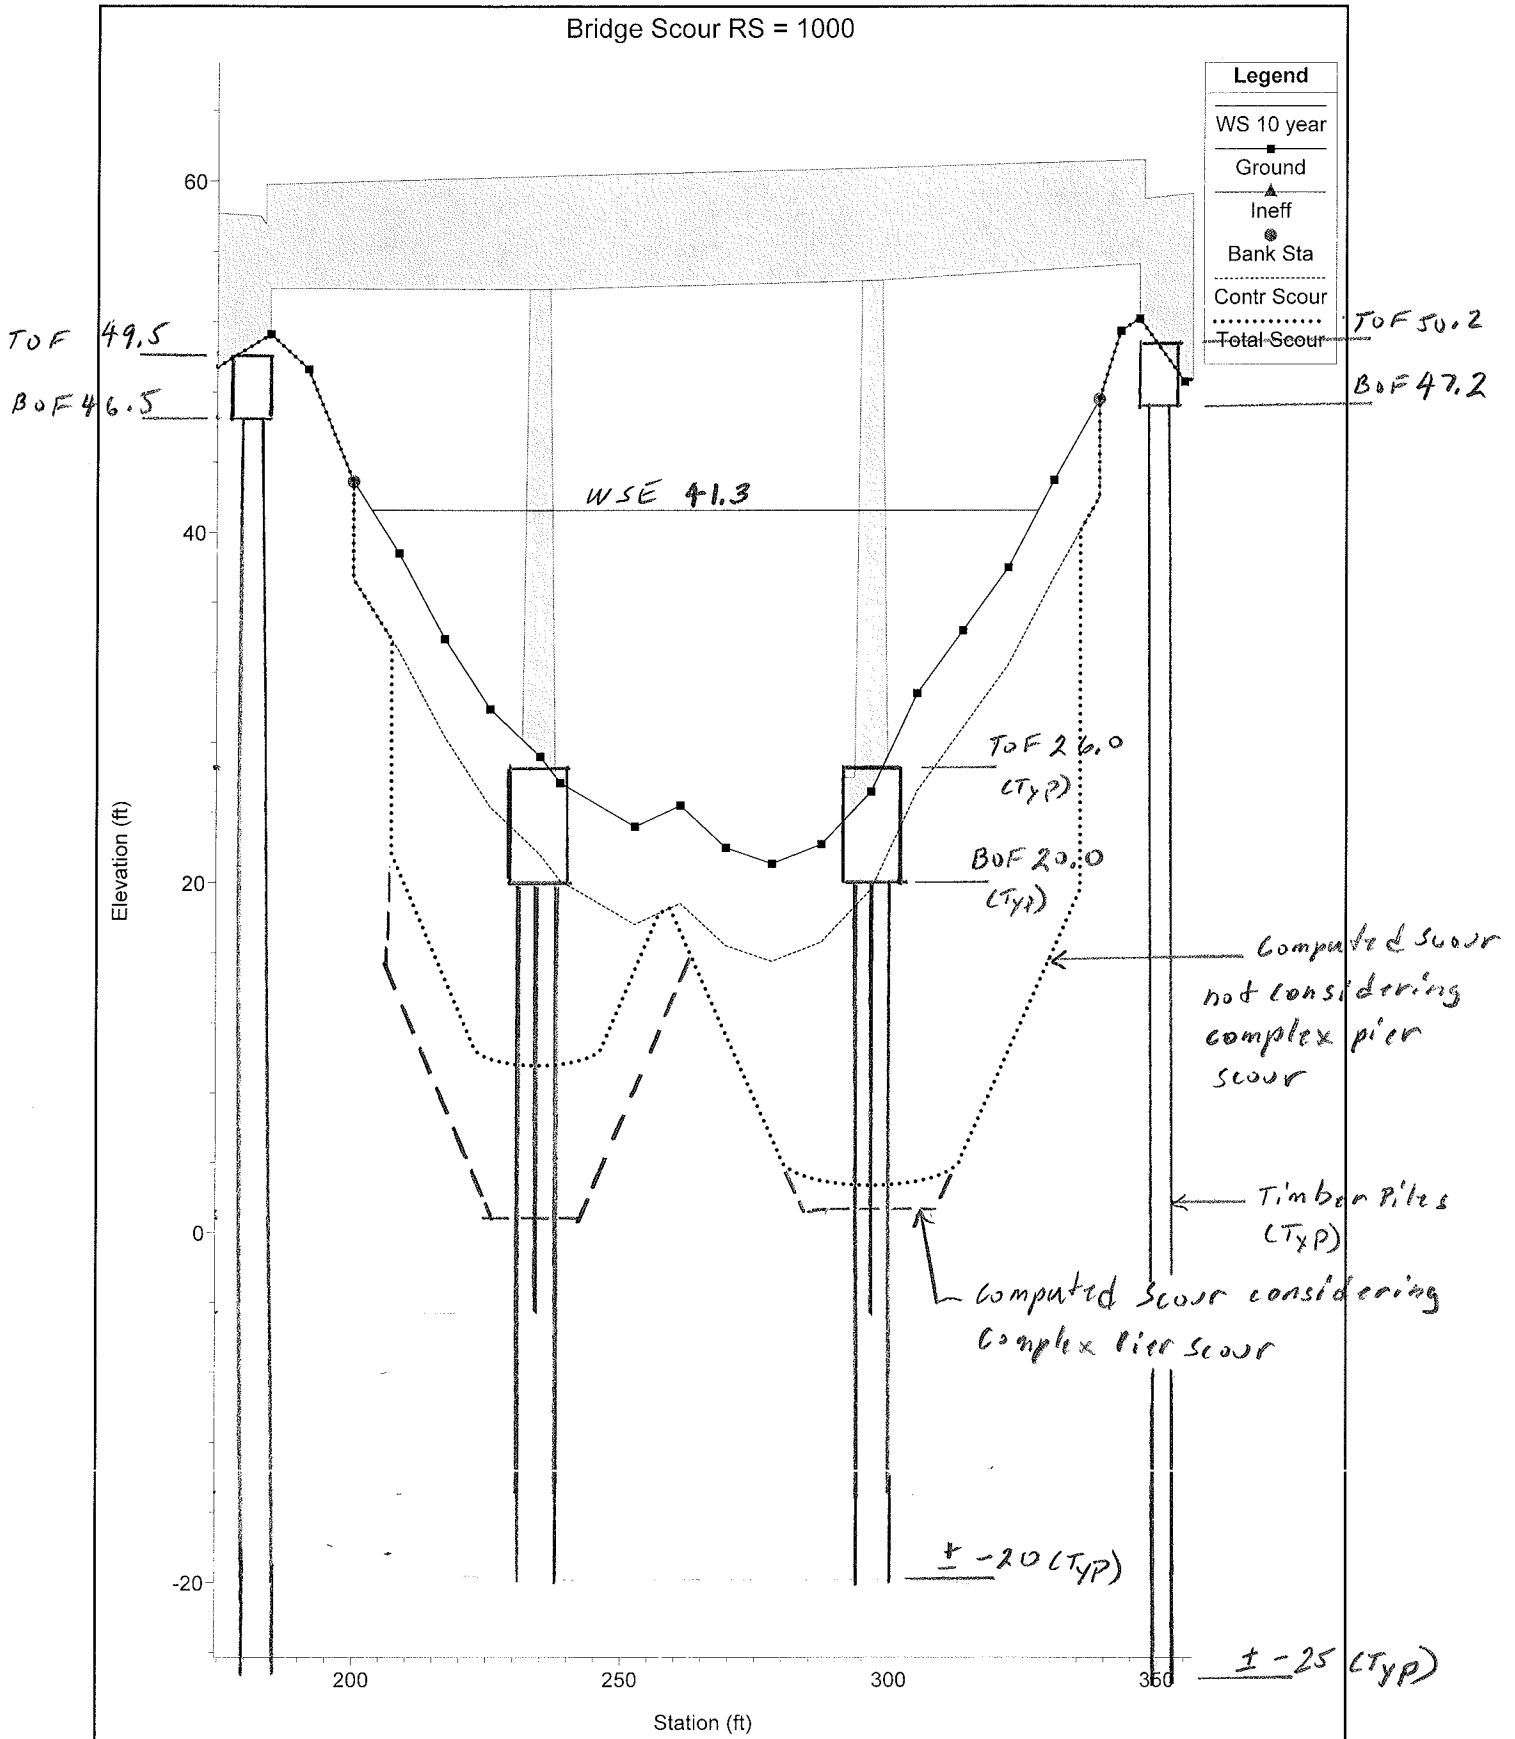
COMP BY: RMH  
 CHECK BY:  
 DATE: 12/23/2010
