# WIN 27708.00 Brownville ADA Pedestrian Ramp Report

# WIN 27708.00 Milo ADA Pedestrian Ramp Report

# WIN 27708.00 Hermon ADA Pedestrian Ramp Report

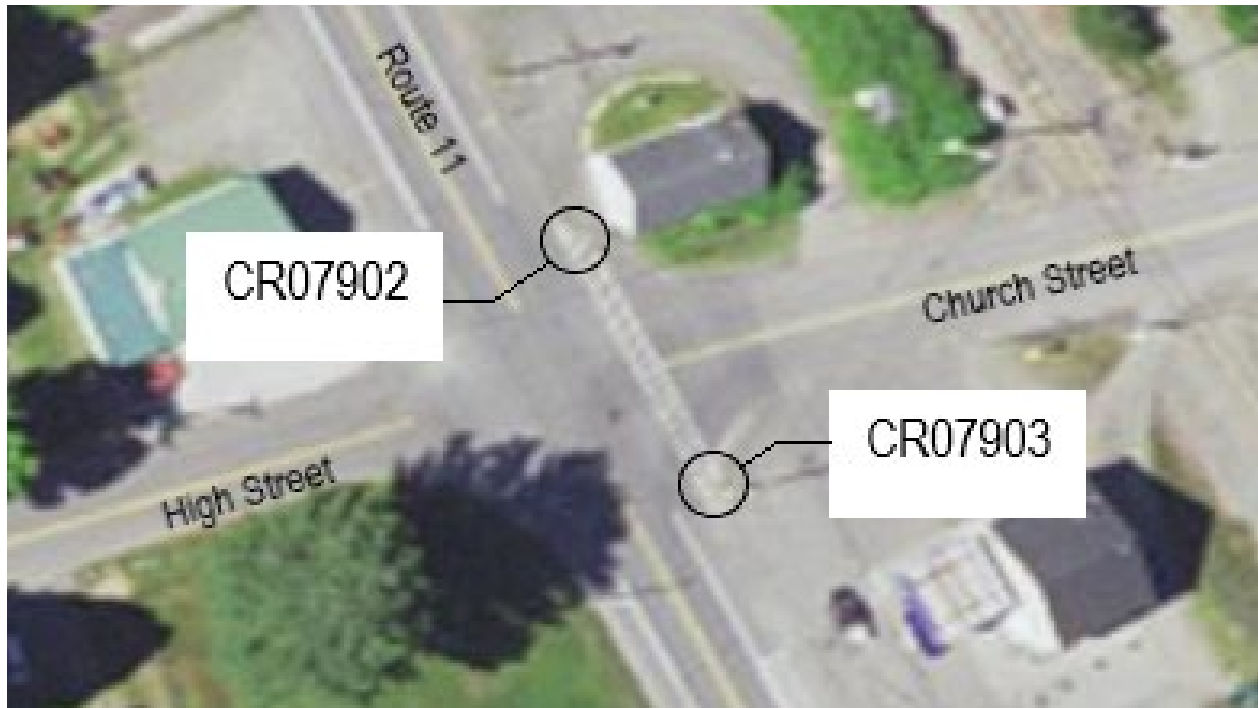
## **Route 11 @ northerly side Church Street (CR07902)**

Construct Pedestrian Ramp on Easterly side of existing catch basin.

## **Route 11 @ southerly side Church Street (CR07903)**

Construct Pedestrian Ramp

- Construct per SD 801(20)
- Remove 24' x 5' existing paved sidewalk
- Regrade existing sidewalk
- Install (2) 8ft. bituminous tip-downs
- Repave sidewalk
- Install 7' x 2' Detectable Warning Fields
- Paint new crosswalk across Church Street between Asset ID's CR07092 & CR07093.

- Construct per SD 801(20)
- Remove existing bituminous curb and paved island
- Construct new island / sidewalk covering existing island footprint plus additional minimum width of 6 ft. to face of rear curb behind existing utility pole.
- Place new bituminous curb to form front & back sides of new island.
- Pave new island / sidewalk
- Install 7' x 2' Detectable Warning Fields

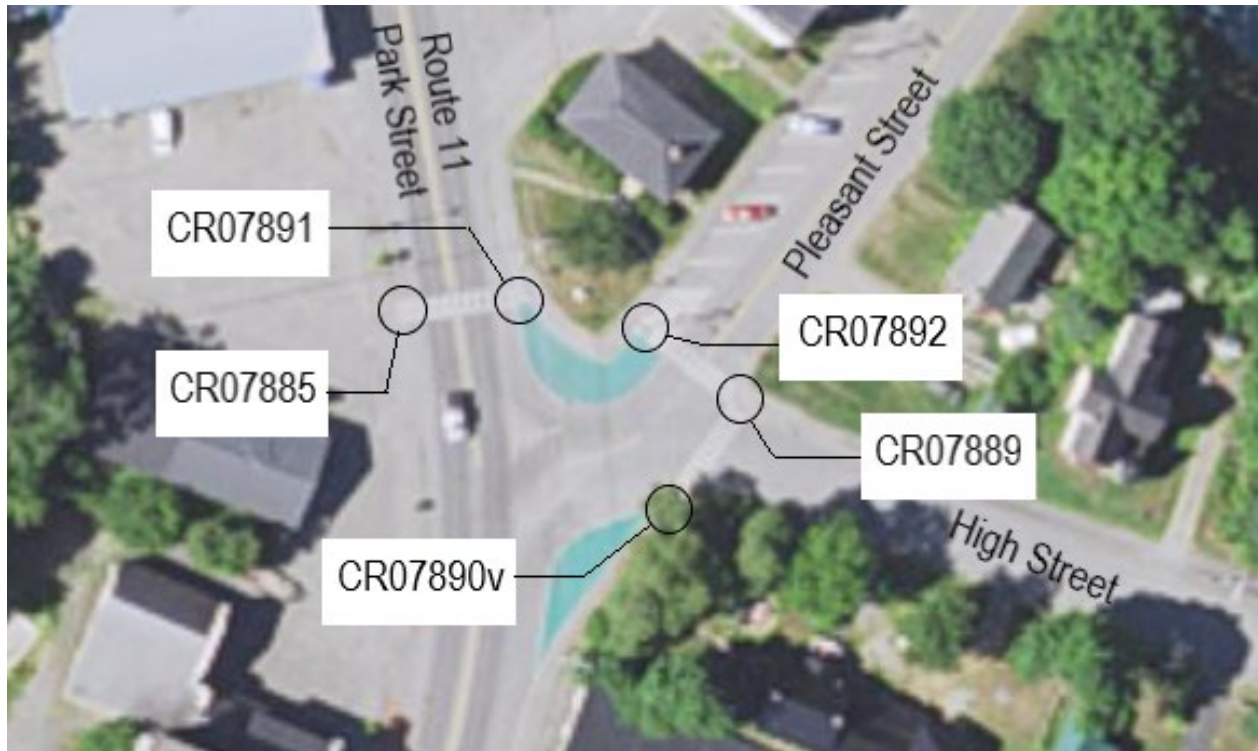
## **Route 11 (Park Street) west side north of Pleasant Street (CR07885)**

### Reconstruct Pedestrian Ramp

## **Route 11 (Park Street) east side north of Pleasant Street (CR07891)**

- Construct similar to SD 801(27)
- Remove existing pavement on sidewalk approx. 22' x 10' and on shoulder approx. 22' x 2'
- Remove 21'-5" existing Curb Type 1
- Reset existing 7' Curb Type 1 tip-down
- Regrade existing sidewalk approx. 22' x 10' & shoulder approx. 22' x 2'
- Repave sidewalk (2") & shoulder (4") along face of curb
- Install 5' x 2' Detectable Warning Fields
- Paint new crosswalk across Route 11 (Park Street) between Asset ID's CR07885 & CR07891
- Install regulatory pedestrian signs

- Construct per SD 801(14)
- Remove existing pavement on sidewalk approx. 31' x 6' and on shoulder approx. 31' x 2'
- Remove 31' existing Curb Type 1
- Reset 25'-4" existing Curb Type 1
- Regrade existing sidewalk approx. 31' x 6' & shoulder approx. 31' x 2'
- Repave sidewalk (2") & shoulder (4")
- Install 5' x 2' Detectable Warning Fields
- Place loam, seed, & mulch as needed behind newly paved sidewalk
- Install regulatory pedestrian signs

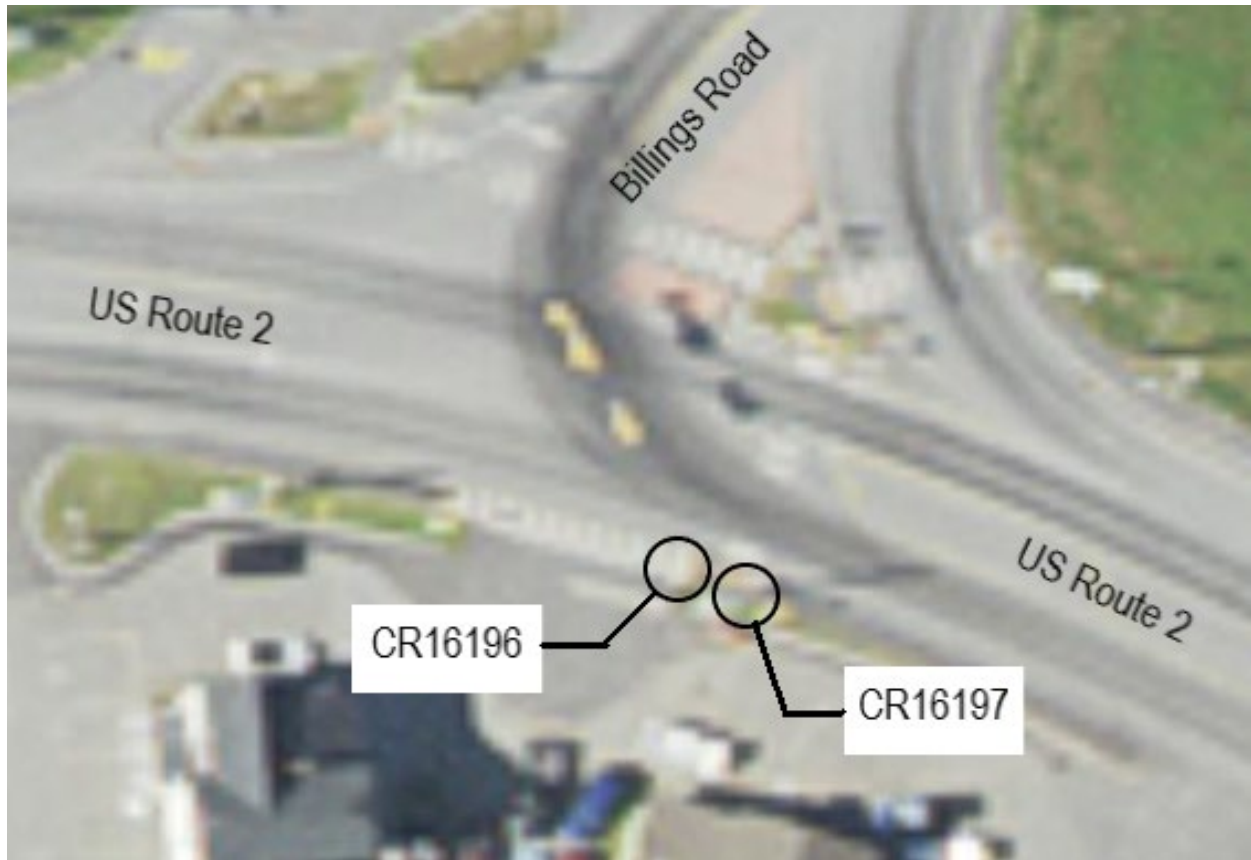
## **US Route 2 southerly side across from Billings Road (CR16196 & CR16197)**

Reconstruct pedestrian ramp combining (2) separate DWF locations into (1) DWF location

- Construct per SD 801(22)
- Remove existing pavement on sidewalk approx. 23' x 5' and on shoulder approx. 23' x 2'
- Remove 8' existing Curb Type 1 tip-down
- Reset 8' existing Curb Type 1 tip-down
- Install 9' new vertical Curb Type 1 at back edge of sidewalk (if needed)
- Install new 8' terminal Curb Type 1 at back edge of sidewalk (if needed)
- Regrade existing sidewalk approx. 22' x 5' & shoulder approx. 10' x 2'
- Repave sidewalk (2") & shoulder (4") along face of curb
- Install 12.67 SF Detectable Warning Fields (see Hermon Proposed Sketches)
- Place loam, seed, & mulch as needed behind newly paved sidewalk
- Paint new crosswalks parallel to US Route 2 across driveway to Tucker Auto Repair & across US Route 2 towards Billings Road.

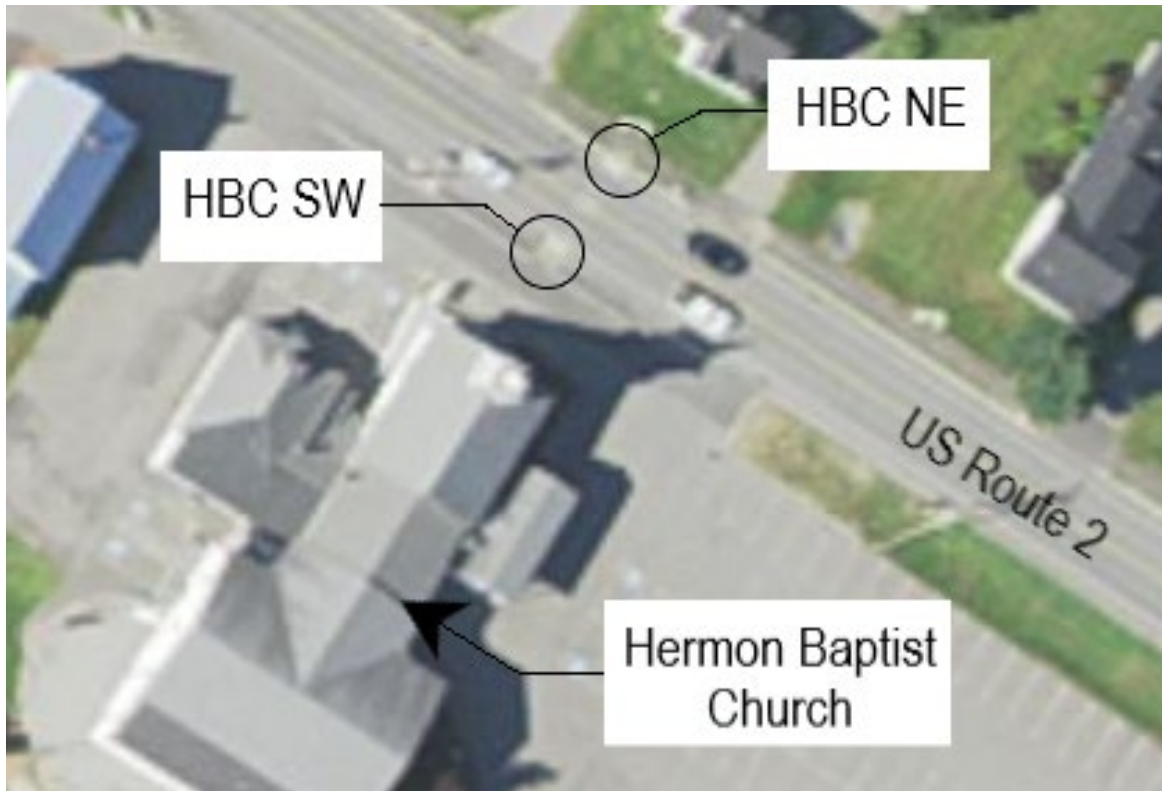
## **US Route 2 northeast side across from Hermon Baptist Church (HBC NE)**

### Reconstruct Pedestrian Ramp

## **US Route 2 southwest side in front of Hermon Baptist Church (HBC SW)**

- Construct similar to SD 801(23)
- Remove existing pavement on sidewalk approx. 20' x 5' and on shoulder approx. 22' x 2'
- Remove & Reset (2) existing 7' Curb Type 1 tip-downs
- Regrade existing sidewalk approx. 20' x 5' & shoulder approx. 22' x 2'
- Repave sidewalk (2'') & shoulder (4'') along face of curb
- Install 6' x 2' Detectable Warning Fields
- Place loam, seed, & mulch as needed in esplanade & behind newly paved sidewalk
- Install regulatory pedestrian signs

- Construct similar to SD 801(14)
- Remove existing pavement on sidewalk approx. 20' x 6', on shoulder approx. 22' x 2', and in parking lot approx. 22' x 2'
- Remove & Reset (4) existing 7' Curb Type 1 tip-downs (2 on road side and 2 on parking lot side of sidewalk)
- Regrade existing sidewalk approx. 20' x 6', shoulder approx. 22' x 2', & parking lot approx. 22' x 2'
- Repave sidewalk (2''), shoulder (4''), & parking lot (match existing depth)
- Install 6' x 2' Detectable Warning Fields
- Install regulatory pedestrian signs
- Repaint crosswalk across US Route 2

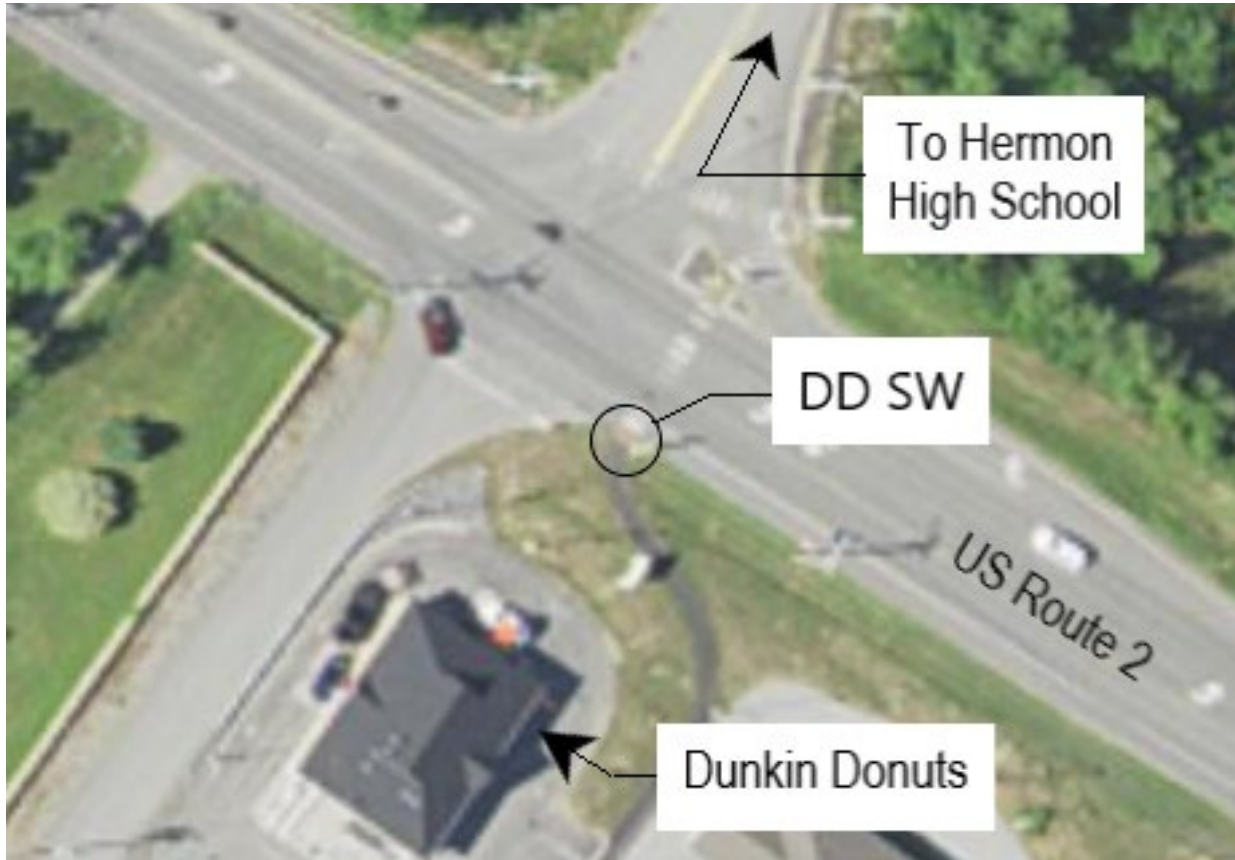
## **US Route 2 southerly side in front of Dunkin Donuts (no Asset ID))**

Reconstruct pedestrian ramp setting new DWF's flush with edge of shoulder

- No SD for this location
- There is no existing or proposed curb at this location
- Set new DWF's at 1.5% max. downward slope going AWAY from edge of shoulder
- Remove 15' x 6' existing pavement
- Regrade 15' x 6' sidewalk with 1.5% max. downward slope for minimum of 4' behind new DWF's, then grade remaining removal area to match into existing sidewalk at 5% maximum downward slope.
- Install 6' x 2' Detectable Warning Fields
- Place loam, seed, & mulch as needed along both sides of newly paved sidewalk
- Repaint crosswalk across US Route 2
