DOVER BRIDGE

PISCATAQUIS RIVER

DOVER - FOXCROFT

EAST ABUTMENT REHAB

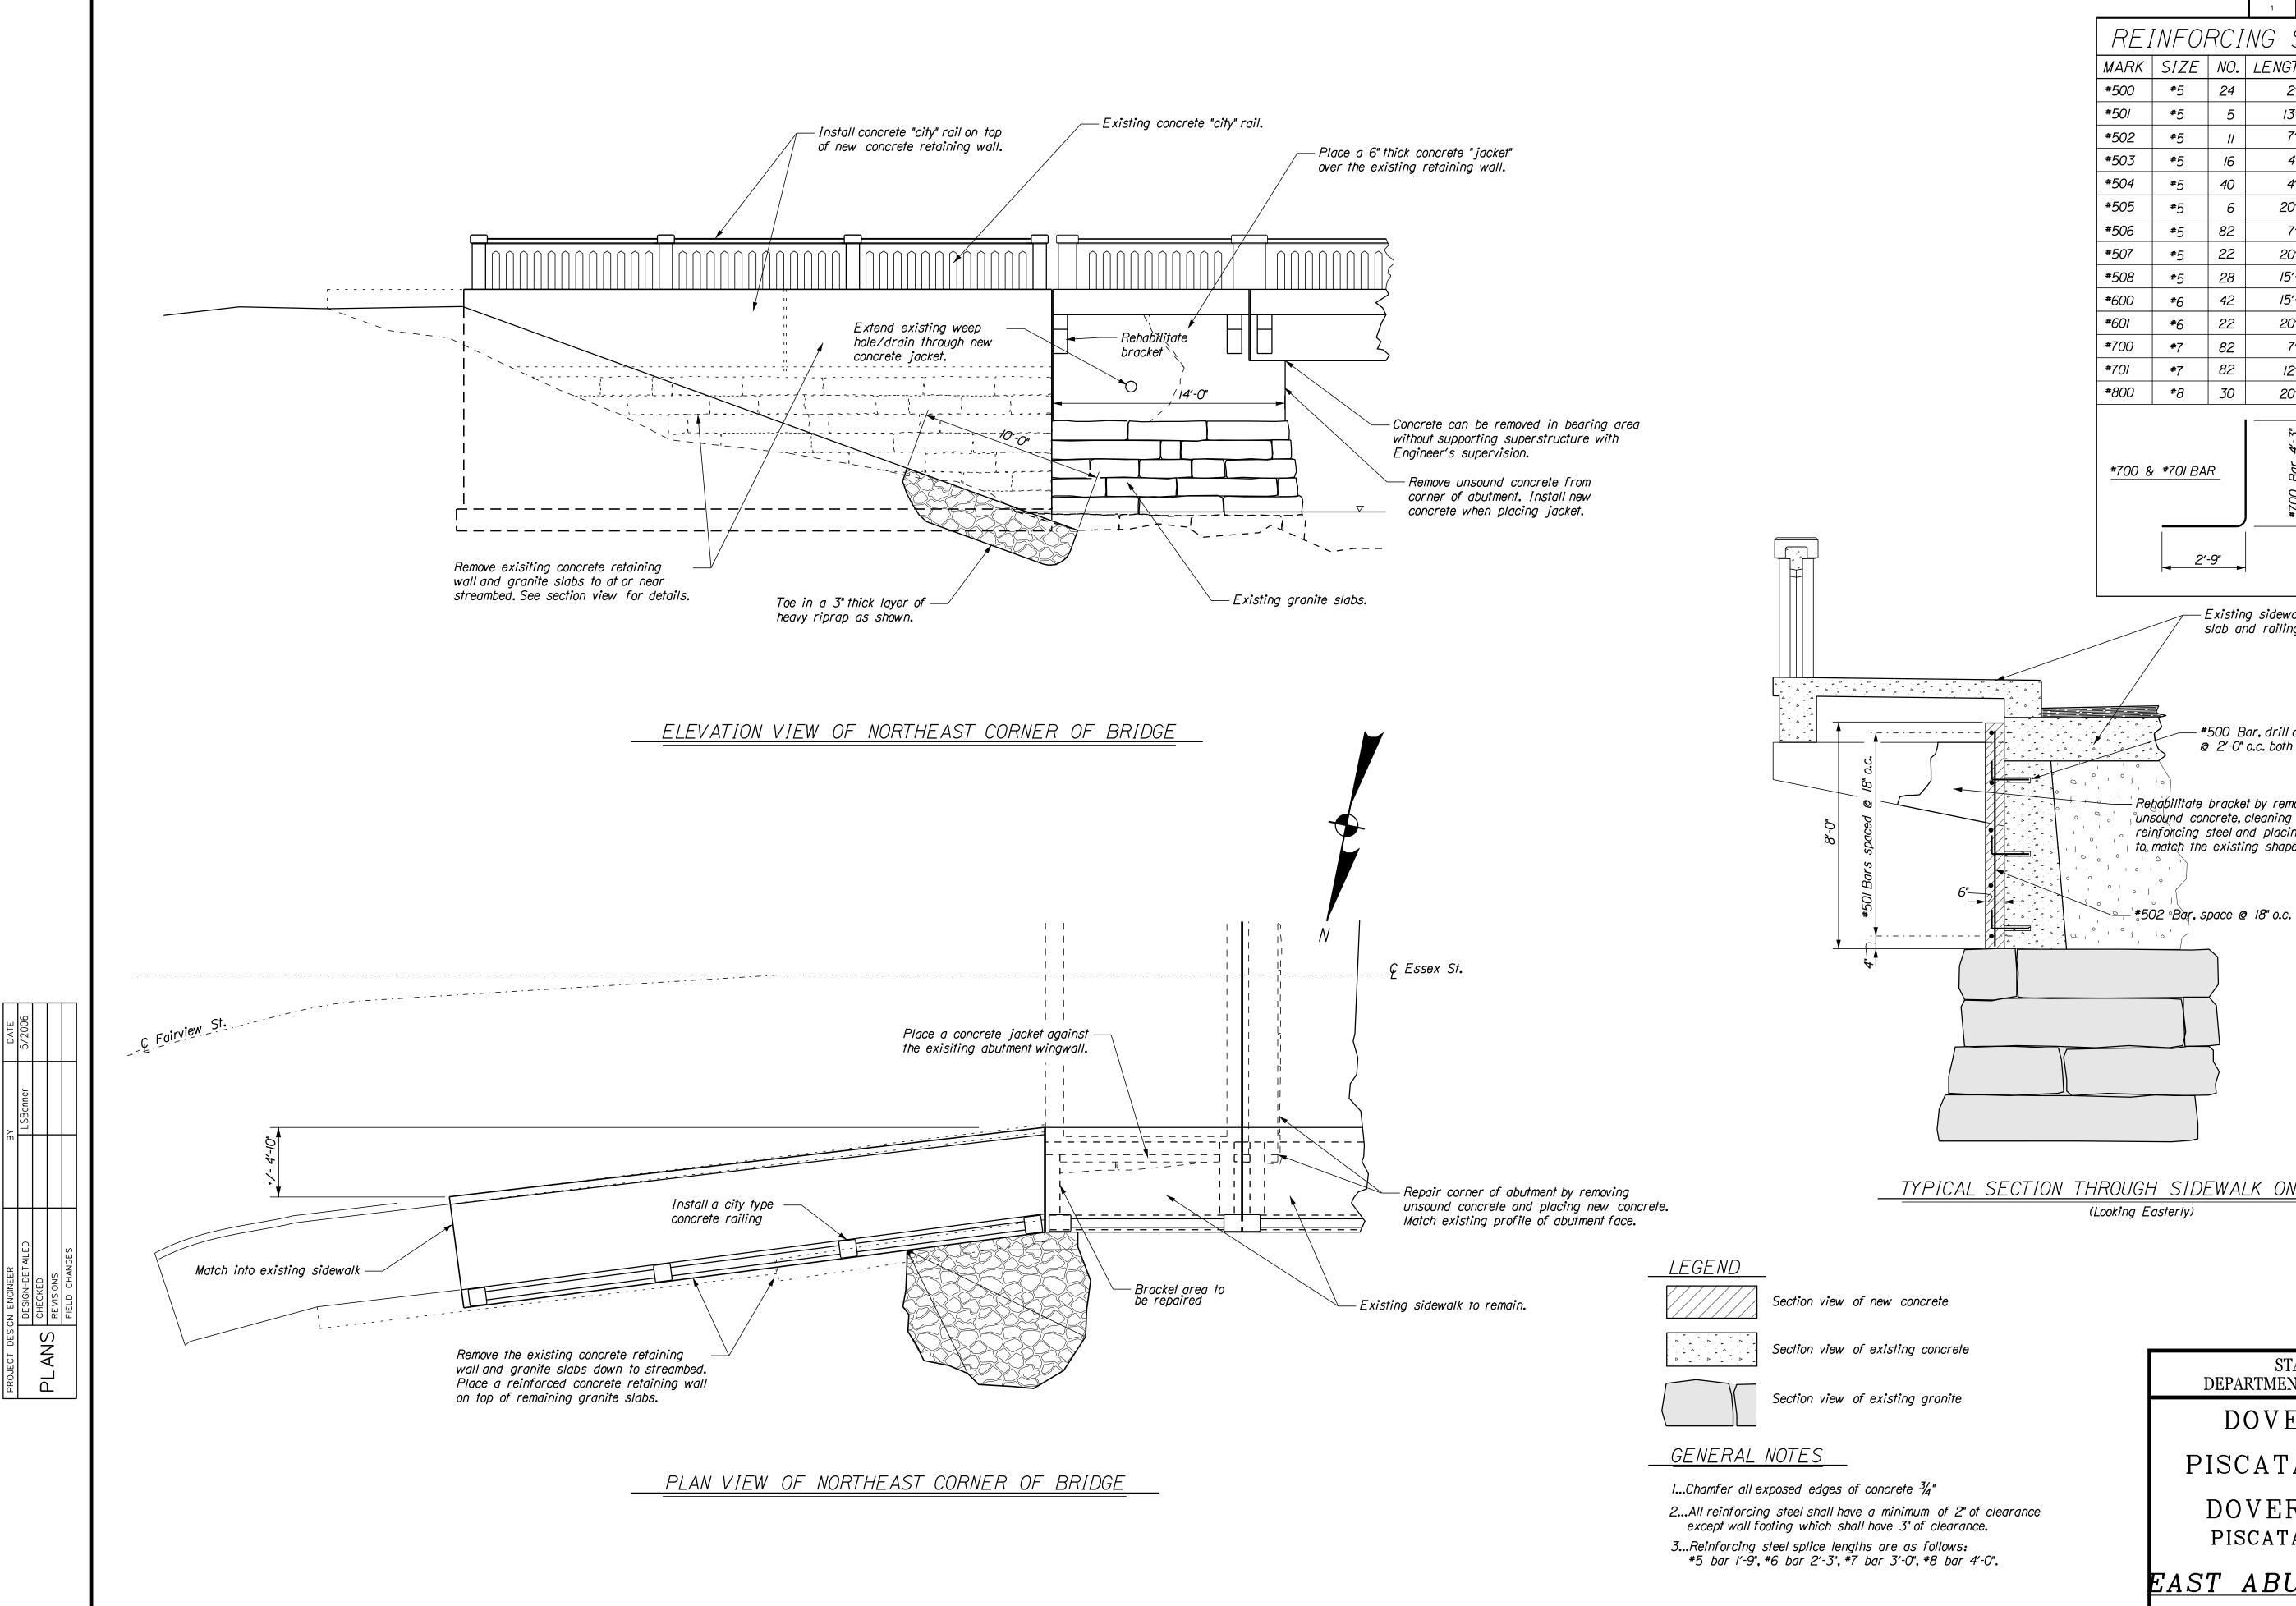
TYPICAL SECTION THROUGH SIDEWALK ON BRIDGE

Existing sidewalk, roadway slab and railing to remain.

Rehabilitate bracket by removing all sunsound concrete, cleaning remaining reinforcing steel and placing new concrete to, match the existing shape and profile.

#500 Bar, drill and grout

@ 2'-0" o.c. both ways.
