MaineDOT ENVIRONMENTAL OFFICE

From: Mark Lickus, C.G., Hydrology Section
To: Justin Sweitzer, Biologist, Field Studies
Project: Howland Rt 116 Large Culvert (WIN 18826.00) Habitat Connectivity Design Report
Date: October 3, 2018

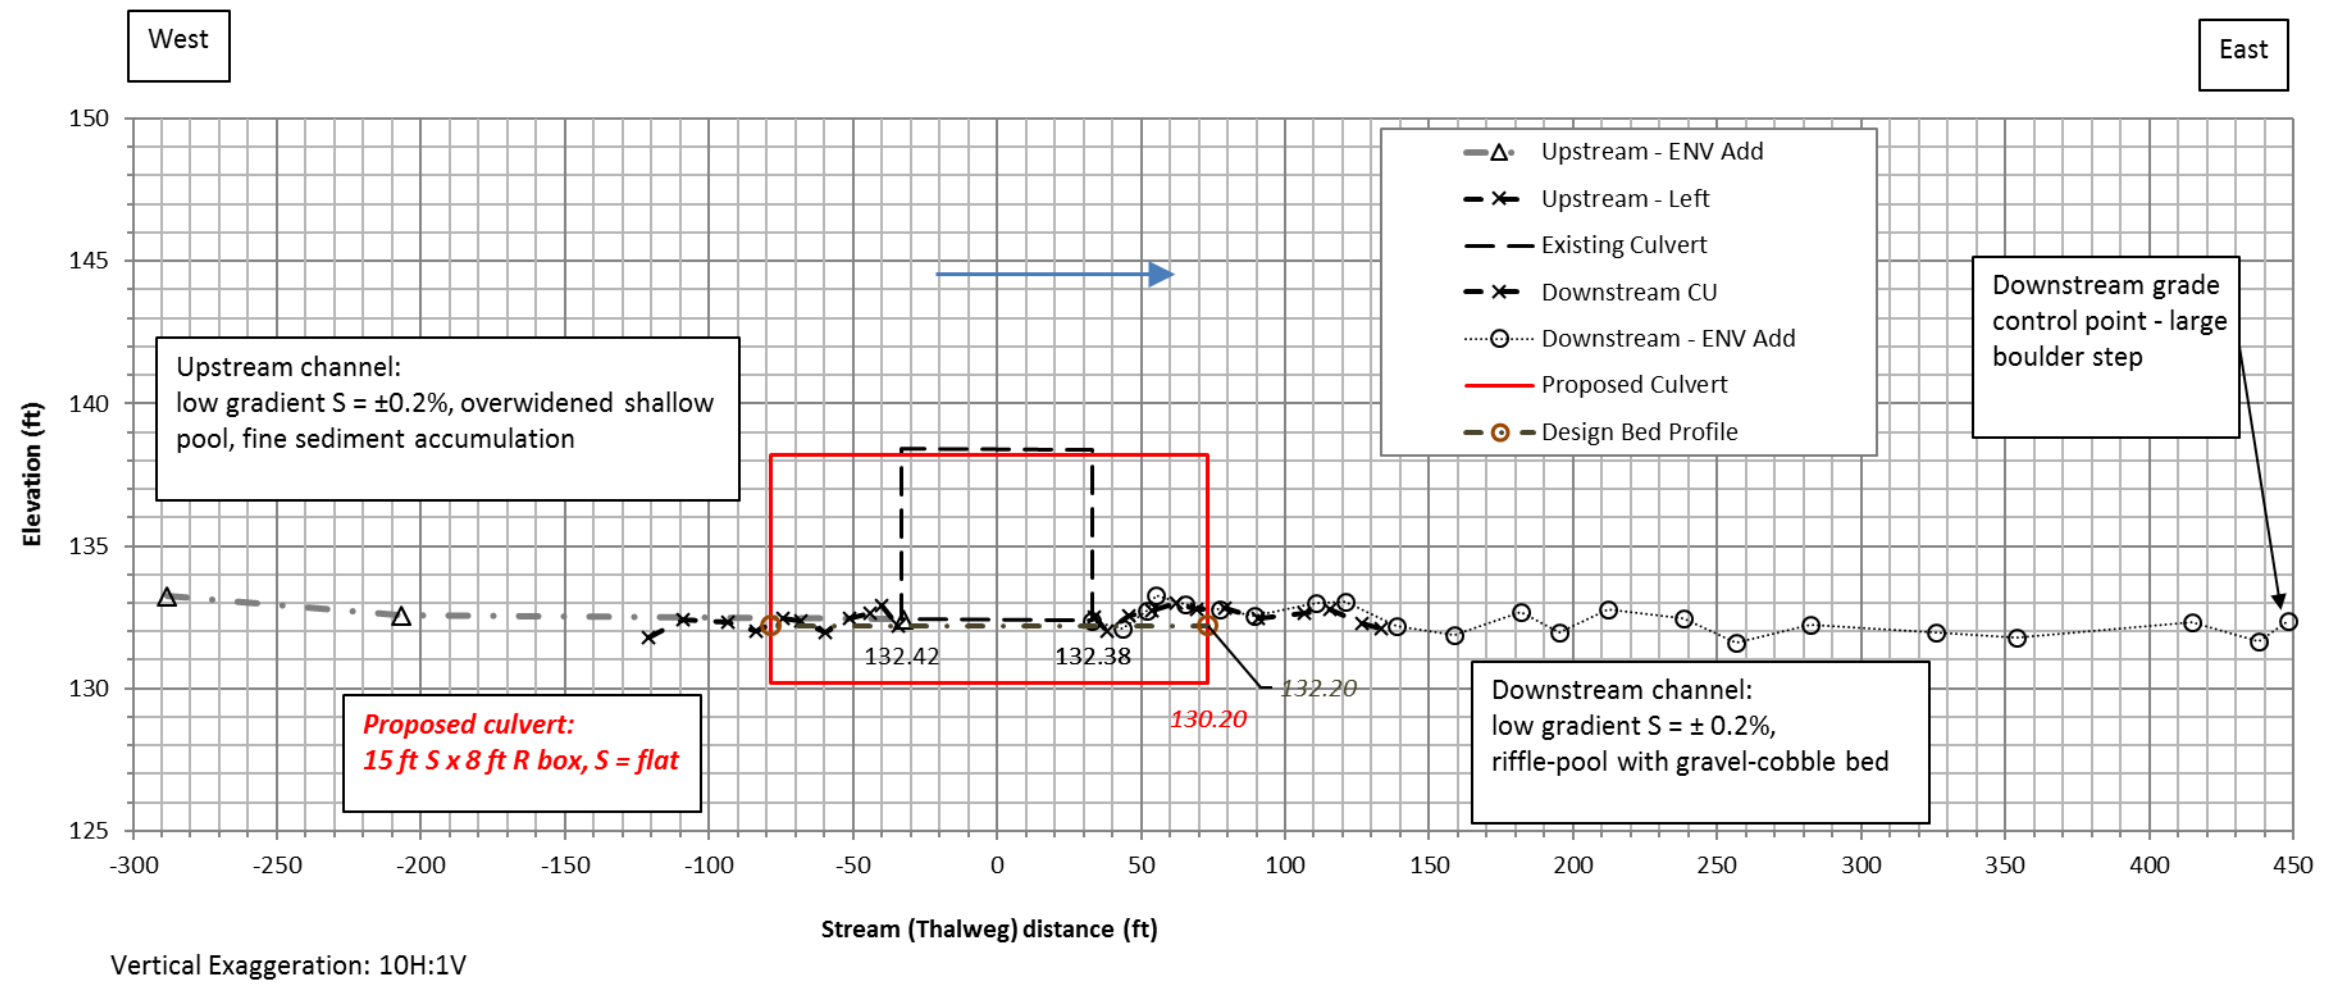
Figure 2. Longitudinal profile showing channel, and existing and proposed culvert inverts.

number of points that could be collected. This section of Emerson Runaround is a very low gradient channel with an average overall (combined upstream and downstream) slope of about 0.2%. (Figure 2).

The proposed culvert will be set at a flat design slope (Figure 2). This slope was selected because of the slightly higher elevation of the riffle crests in the downstream channel compared to upstream, and to improve constructability. The average bed elevation will be set slightly lower than the first downstream riffle crest. This will maintain a minimum of several inches of water in the culvert during low flow conditions. This approach fits the overall slope of this section of the existing channel, and meets the following design objectives: 1) maintain backwater depths in the culvert similar to existing conditions to allow for aquatic organism passage under low/no flow conditions, and 2) mimic channel morphology in the reference reach downstream.

The results of the VAP analysis confirm that the proposed culvert inverts will be below the lower VAP line and suggests that the proposed 24 inches of streambed material will provide adequate depth of material should local scour occur within the culvert.

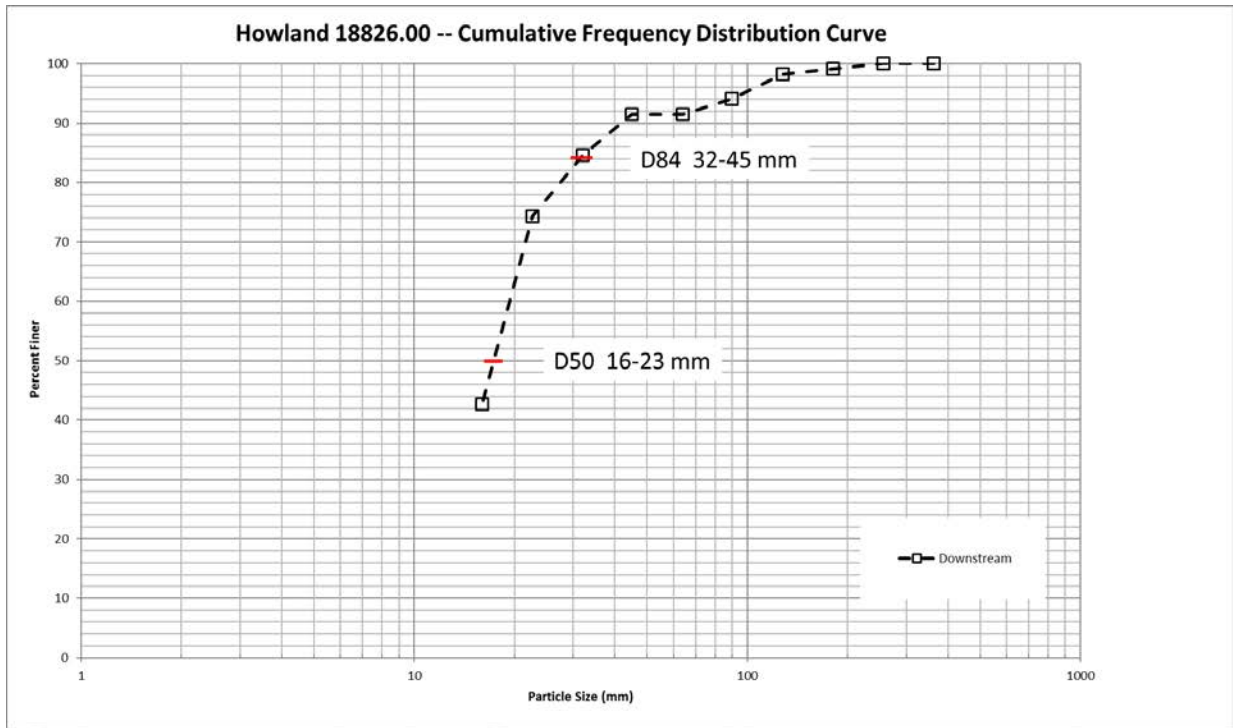
Figure 3. Downstream particle size distribution curve based on bulk sample and field sieve analysis.

Measuring particle sizes with a standard pebble count was not practicable at the time of the site visit in November 2017 due to cold temperatures and water depths greater than 1 foot. Instead, a composite bulk sample was collected from several points in the bed of the downstream channel by shovel, and a set of square mesh sieves was used in the field to estimate the particle size distribution (Photo 8). The bed was armored with a well embedded layer of very coarse gravel to large cobbles that were underlain by a mix of gravel, sand and some fines. The riffle crests and scattered individual feature rocks were comprised of small cobbles to boulders typically ranging in size from about 64 mm up to 400 mm. The D50 particle size of the downstream channel was estimated to be between 16 and 23 mm (medium to coarse gravel) (Figure 3.).

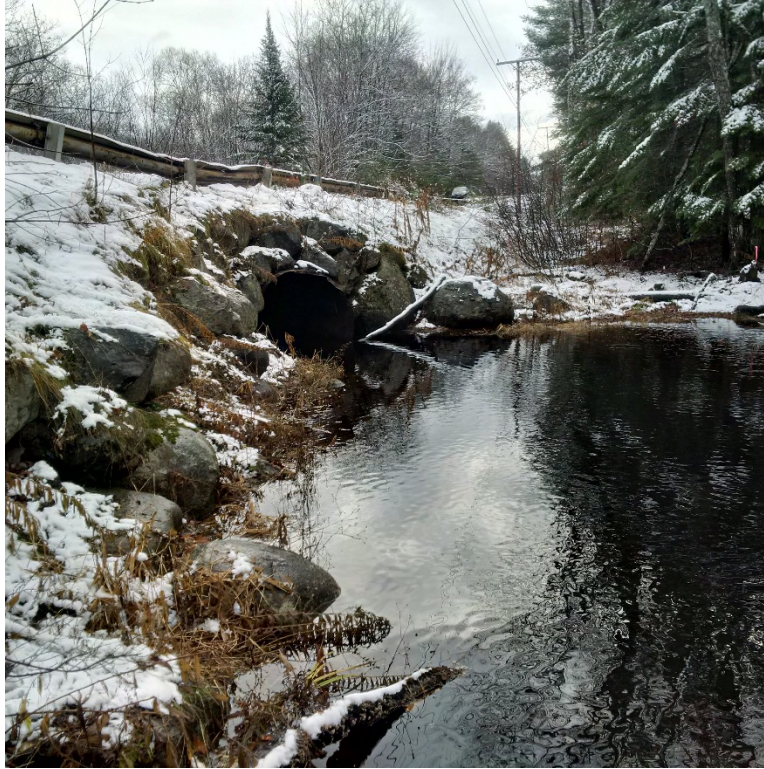
MaineDOT staff were unable to measure representative bankfull widths upstream of the crossing because of ponded conditions and very soft soils. The inlet was partially blocked with 6 to 12 inches of woody material at the time of site visits in 2015 and 2017 which helps create a shallow overwidened channel upstream. Therefore, MaineDOT relied on measured values taken from the downstream channel to size the replacement structure, as summarized below:

Upstream of the culvert, the channel is overwidened due to the shallow (approx. 1 to 3 feet deep) ponded conditions (photos 1, 2 and 3). Forested uplands border both banks and a patch of emergent wetland vegetation occurs along a portion of the right bank. Water depth appears to have been controlled over time by both woody material that collects at the inlet and raises the upstream water level, and by the elevation of natural grade control features in the bed downstream of the culvert. These features appear to maintain typical water depths in the culvert of 1 to 2 feet, based on observations made during site visits. The shallow ponding, and very low slope have resulted in the extensive deposition of fine textured sediment that covers and obscures any preexisting streambed features located upstream.

Photo 1. Culvert inlet (A. Walsh 11/23/2015).

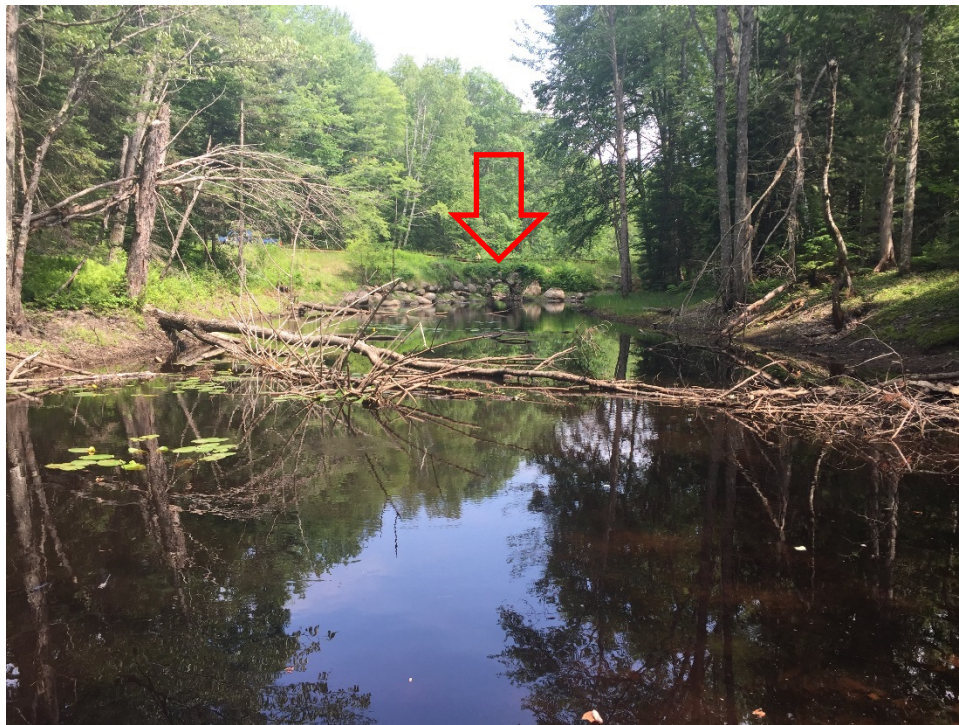
Photo 2. View looking downstream toward culvert inlet (red arrow) (8/7/2018).

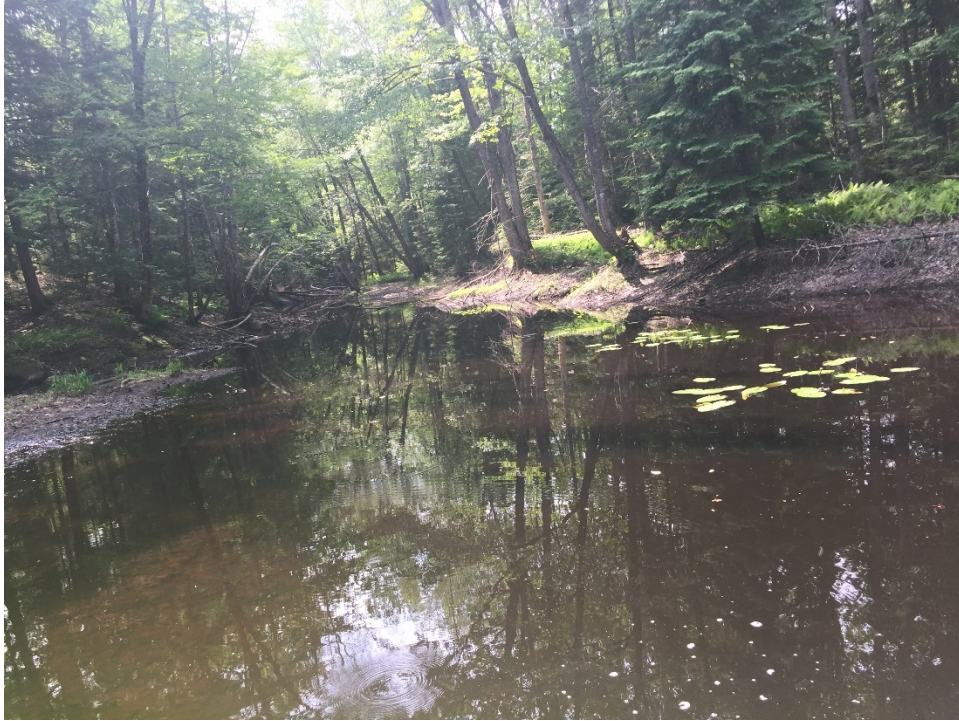
Photo 3. View upstream from location of Photo 2. (8/7/2018).

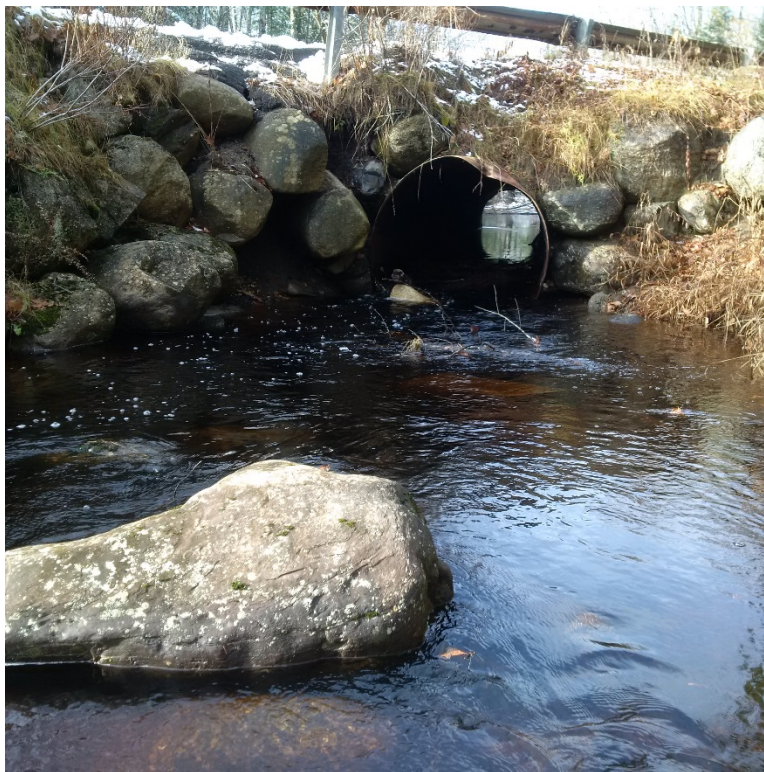
Downstream of the culvert, a section of straight to slightly curved riffle-pool channel extends about 400 feet downstream before reaching a very stable grade control point (rock step) made up of large to very large boulders (photos 4, 5, 6 and 7). At the culvert outlet there is an approximately 10-foot wide by 15-foot long by 1.5-foot deep pool with a stable gravel-cobble push bar. Below the push bar, the downstream channel is bordered by forested uplands along the left bank and a densely vegetated emergent wetland floodplain along the right bank (Photos 2 and 3). The channel has a variable bed that includes both cobble-gravel substrate and deposits of finer textured sediment in pool bottoms. Several shallow pool-and-riffle features with an irregular spacing of about 50 to 60 feet were present.

Photo 4. Culvert outlet and scour pool (A. Walsh 11/23/2015).

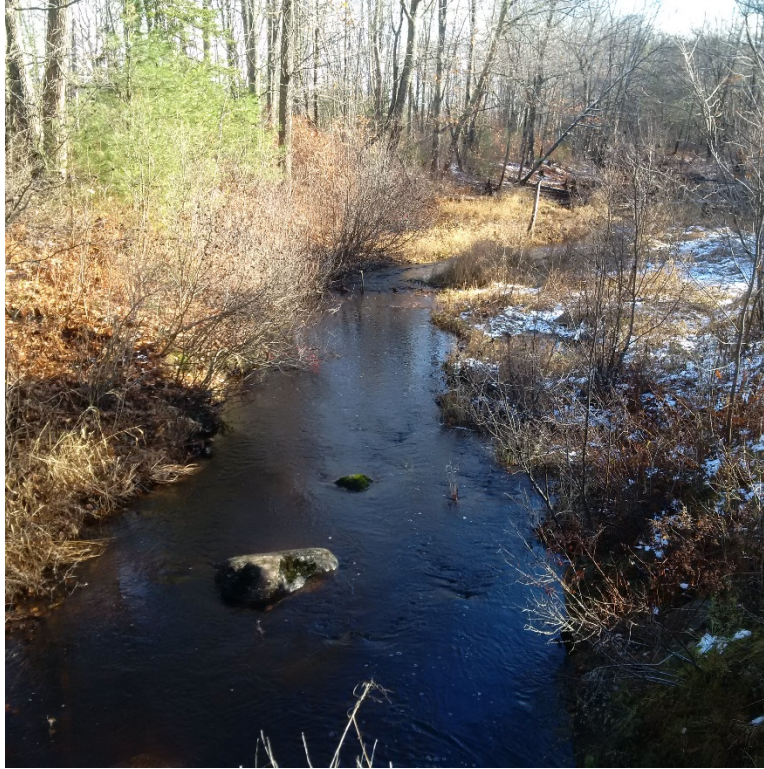
Photo 5. View of upper portion of downstream channel from road (A. Walsh 11/23/2015).

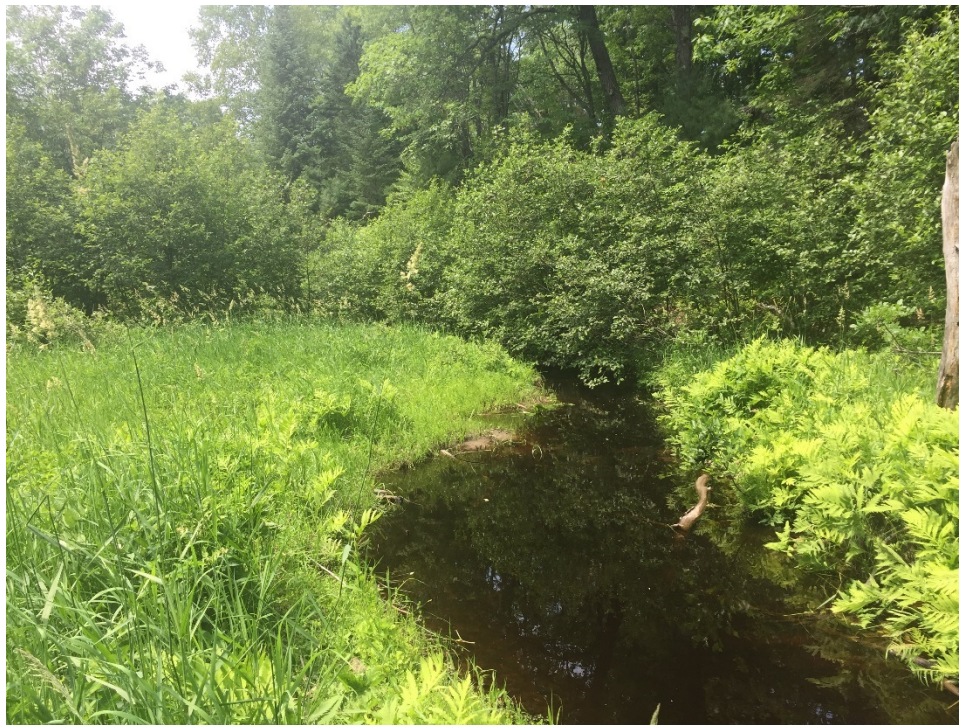
Photo 6. View of downstream channel looking upstream toward outlet (8/7/2018).

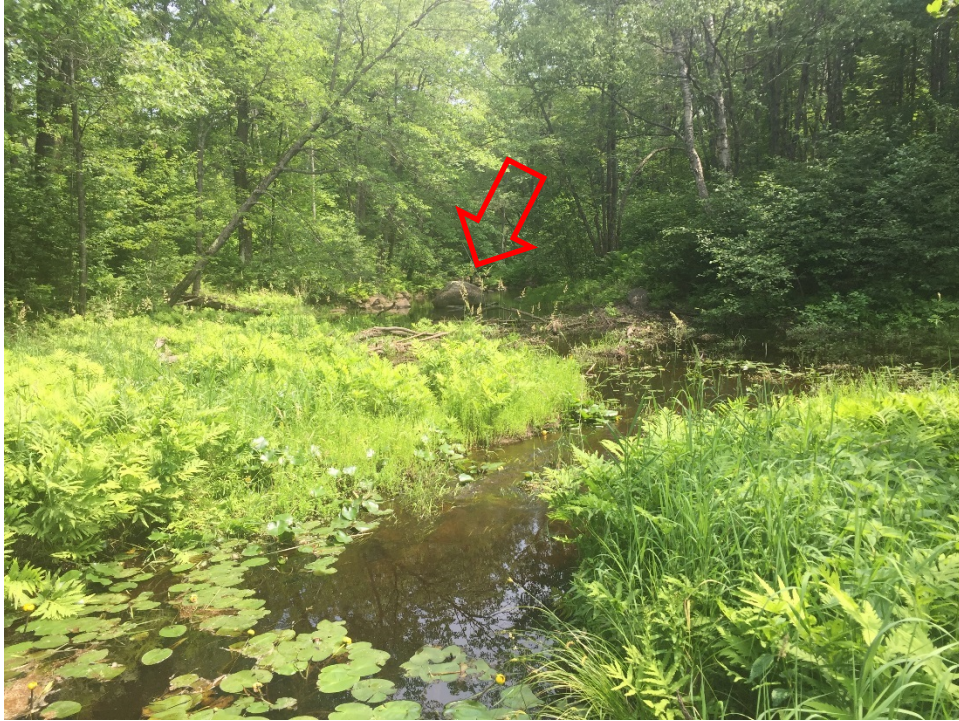
Photo 7. View of lower downstream channel with large rocks (in distance – red arrow) that provide grade control (8/7/2018).

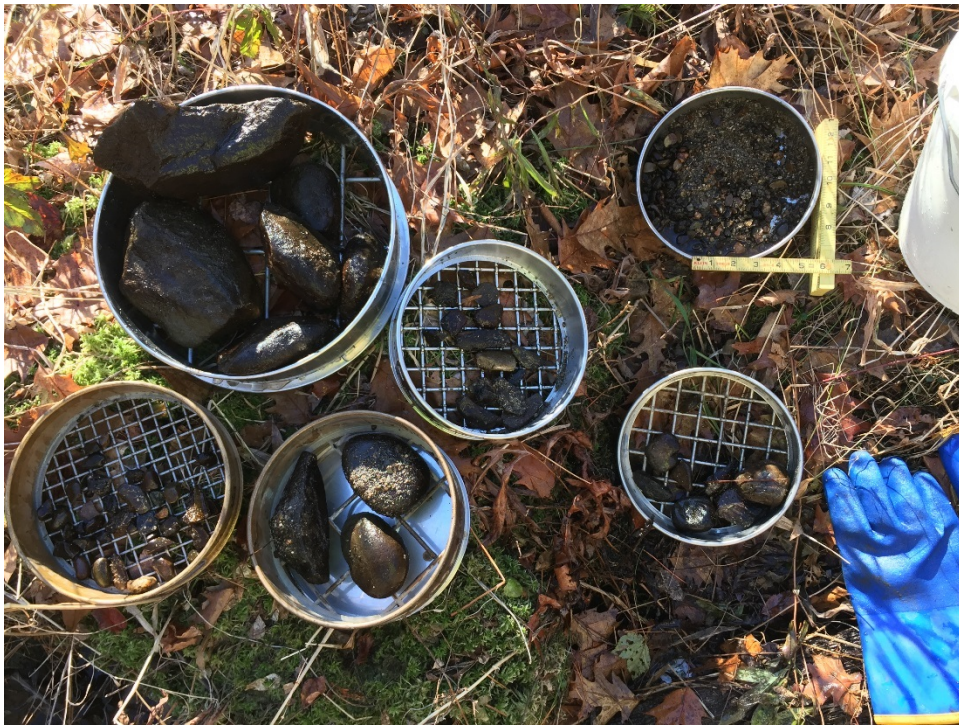
Photo 8. Streambed particles collected from downstream reference reach (11/29/2017).
